DEKRA's commission No. : PKOL(W)/LODZ/87134/26/09/16(55913)  
commission/ damage No. : PS24/04529  
Date of commission: 16-09-2026 11:54:00

| Manufacturer | MAZDA |
| Type / version | CX-60 3.3 D mHEV Homura AWD aut |
| Registration /record No. | NO341CS |

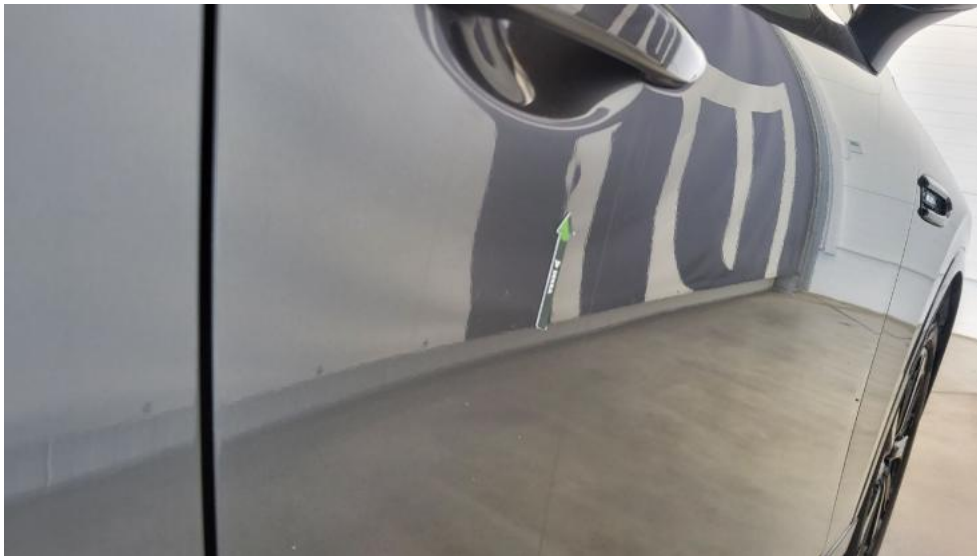
**Photo 45.**

Drzwi przednie P - Wgniecenie/odkształcenie 1

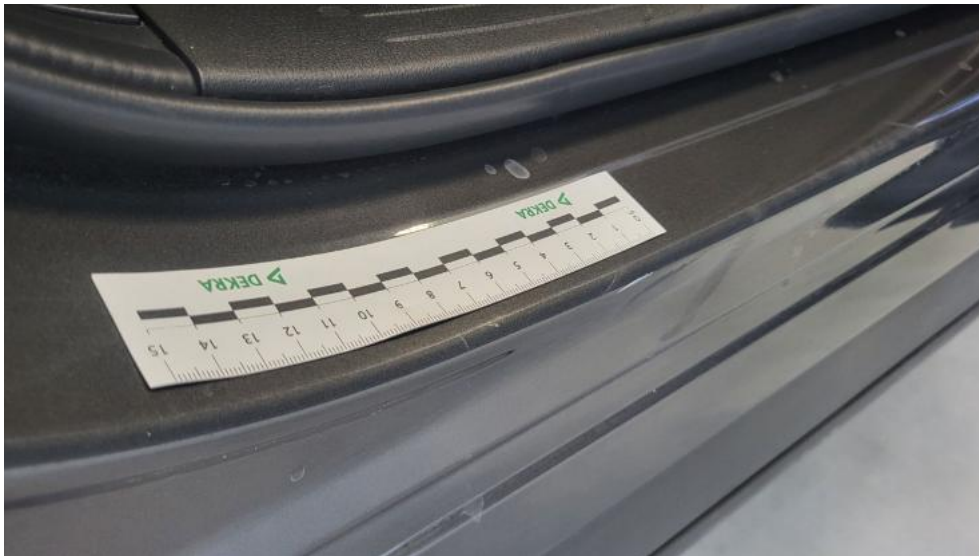
**Photo 47.**

Próg P - Rysa/odprysk 1

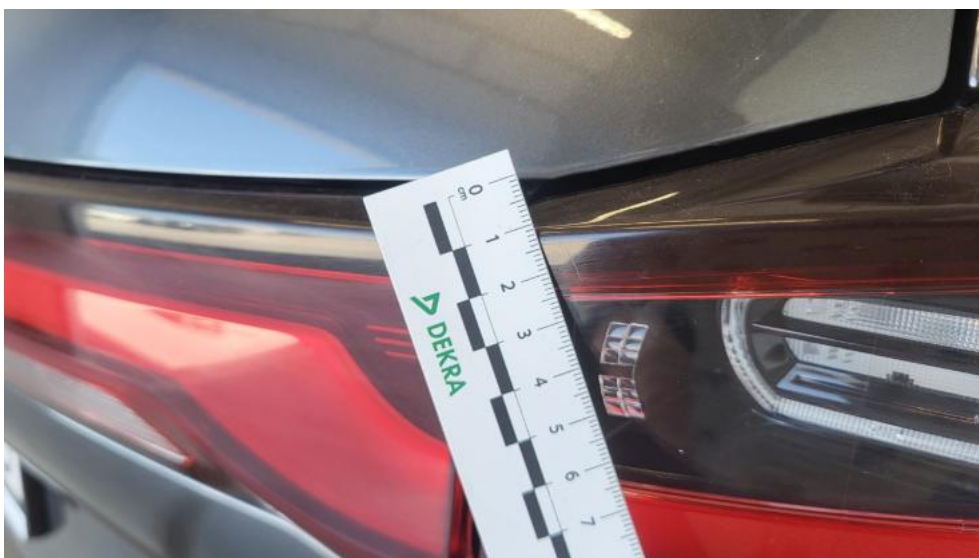
**Photo 48.**

Lampa tylna zew P - Rysa/odprysk 1

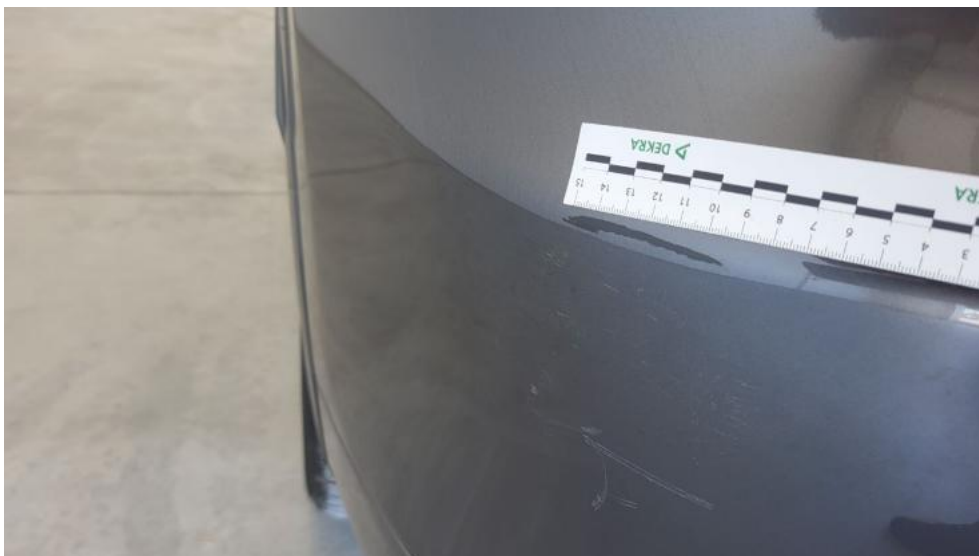
**Photo 50.**

Zderzak tylny - Rysa/odprysk 1

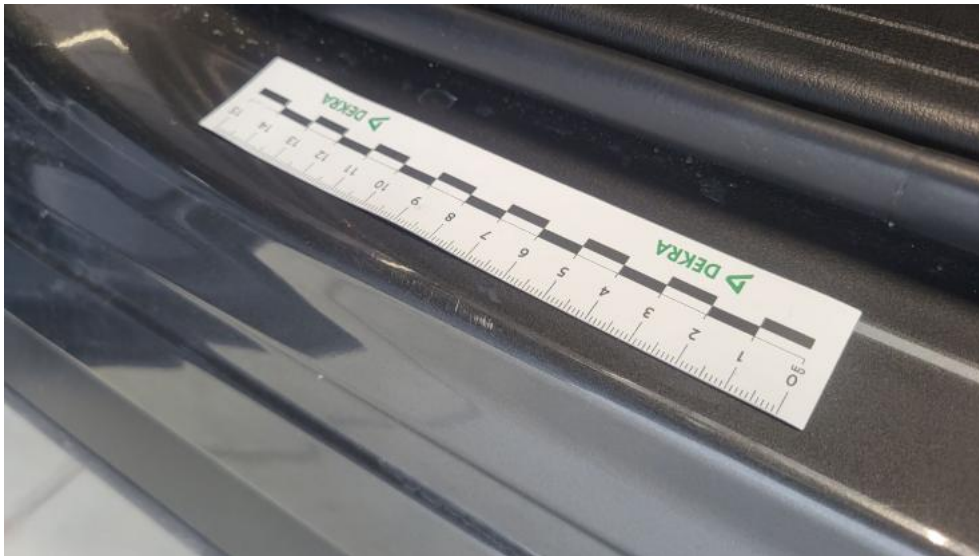
**Photo 55.**

Próg L - Rysa/odprysk 1

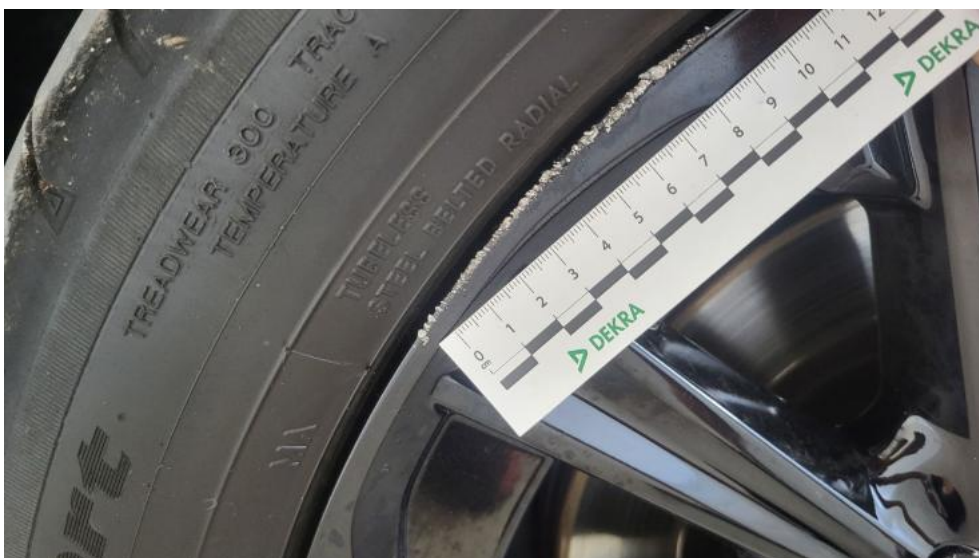
**Photo 56.**

Felga Aluminiowa przednia L - Rysa/odprysk 1

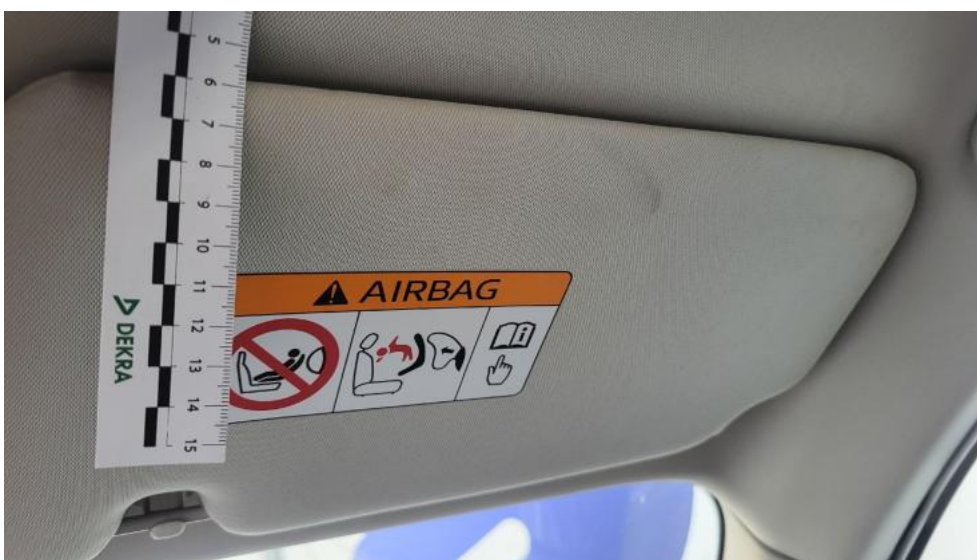
**Photo 58.**

Osłona p/słoneczna prawa - Inne 1
