DEKRA's commission No. : PKOL(W)/LODZ/91452/26/09/30  
commission/ damage No. : 23/013596  
Date of commission: 30-09-2026

| Manufacturer | CADILLAC |
| Model | XT6 |
| Registration /record No. | SK318XS |

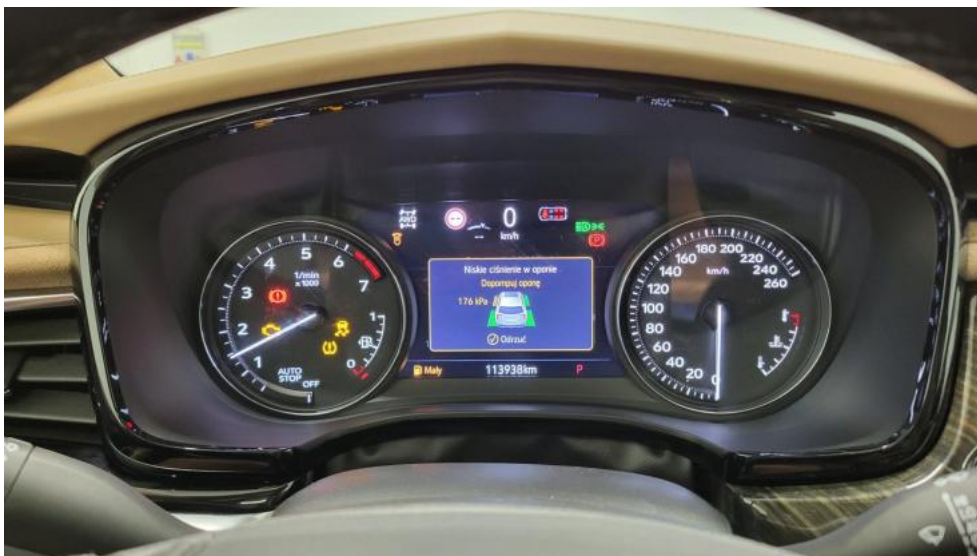
**Photo 25.**

Rysy na samochodzie. Aktywne kontrolki. Aktywna kontrolka ciśnienia w kołach. Aktywna kontrolka silnika. Informacja system wspomagania hamowania wymaga serwisowania. Układ stabilitrak wymaga serwisowania. Ograniczone działanie układu wspomagania kierowania. Układ oświetlenia AFL wymaga serwisu. Nierówna praca silnika, do weryfikacji serwisowej. Dostarczono ksero pozwolenia czasowego.

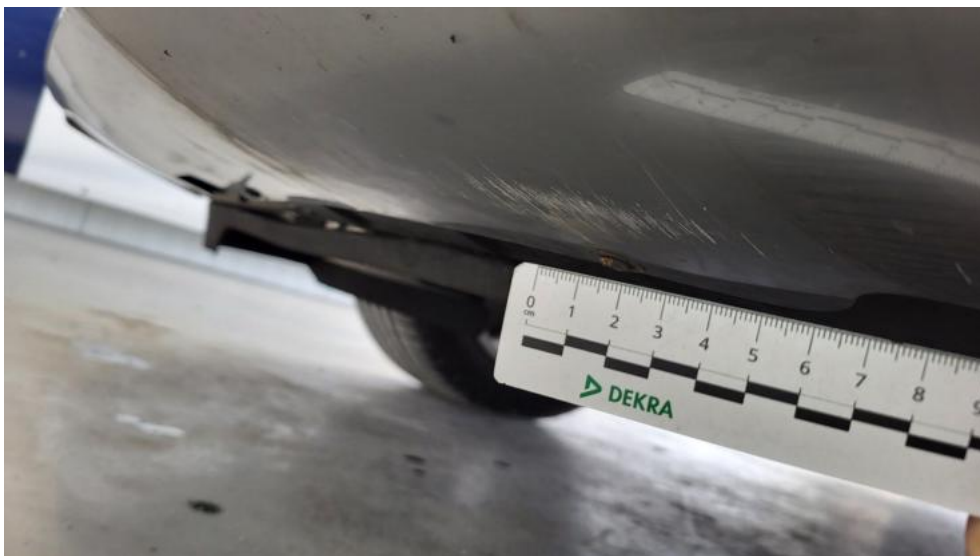
Spoiler zderzaka przedniego - Rysa/odprysk 1

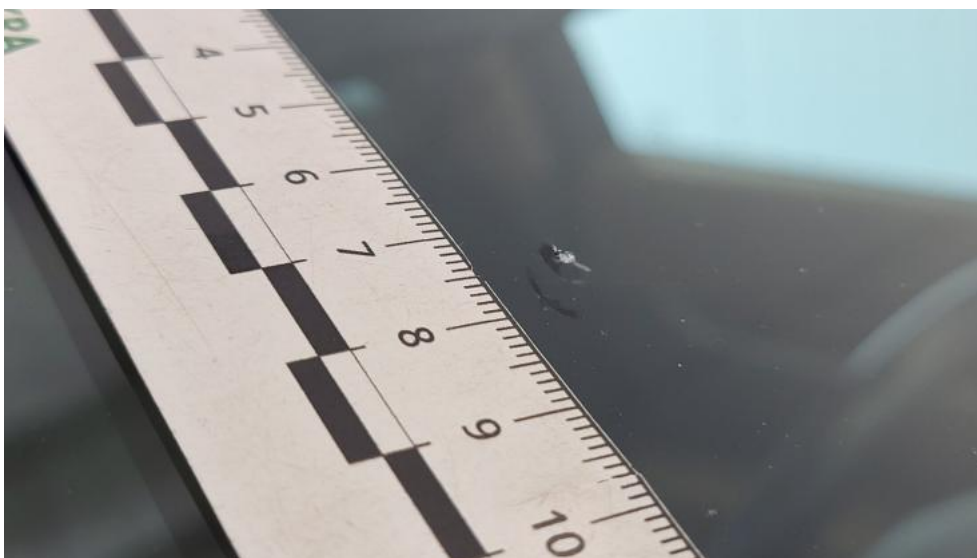
Szyba czołowa - Pęknięcie/rozerwanie 1

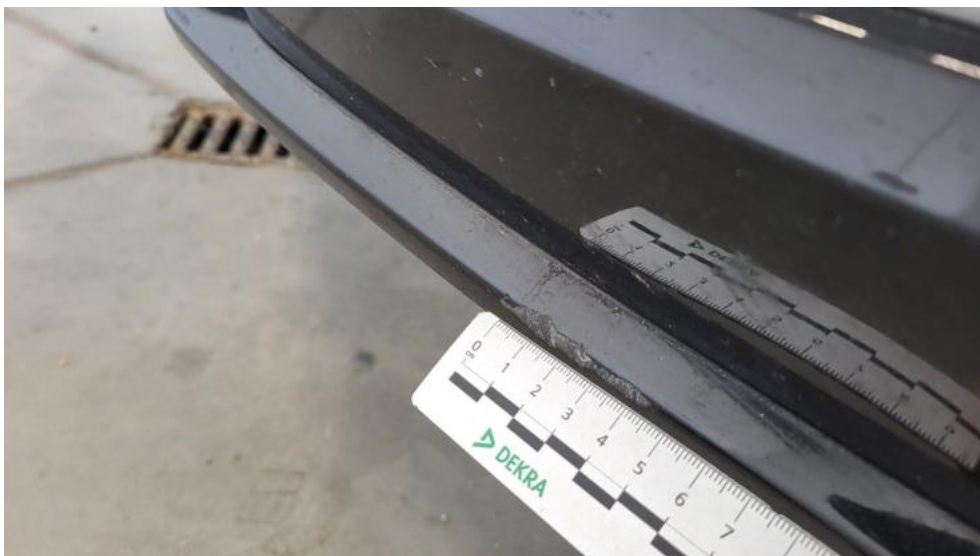
Zderzak przedni cz dolna - Wgniecenie/odkształcenie 1

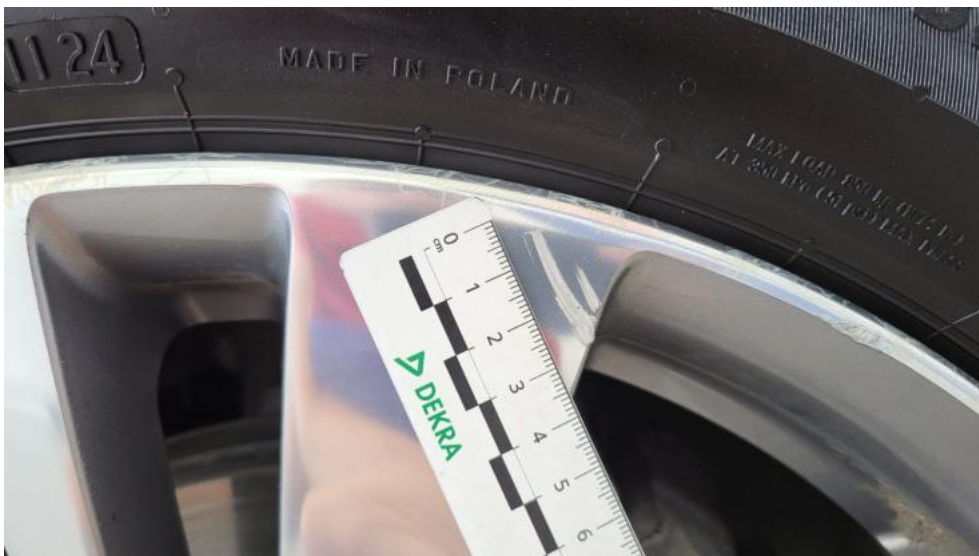
Felga aluminiowa przednia P - Rysa/odprysk 1

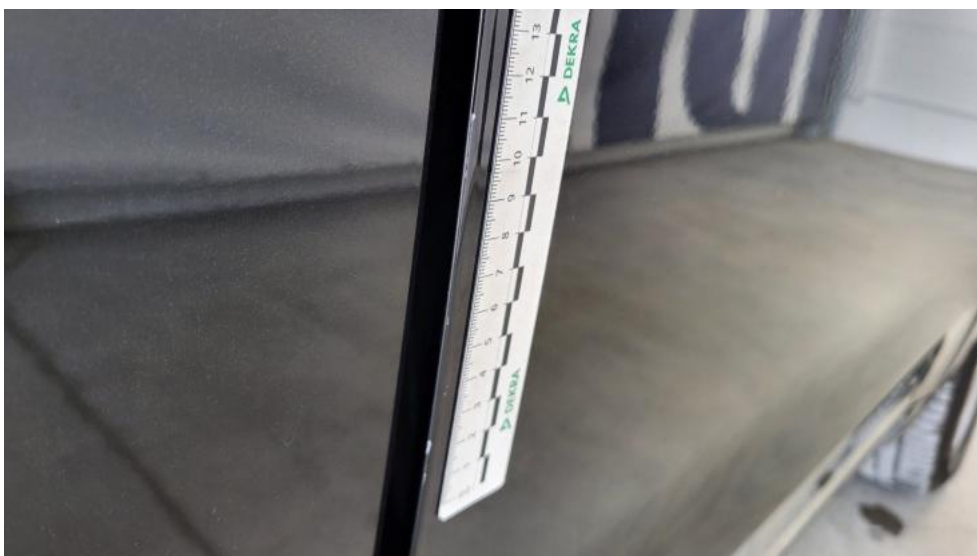
**Photo 62.**  
Drzwi przednie P - Rysa/odprysk 1

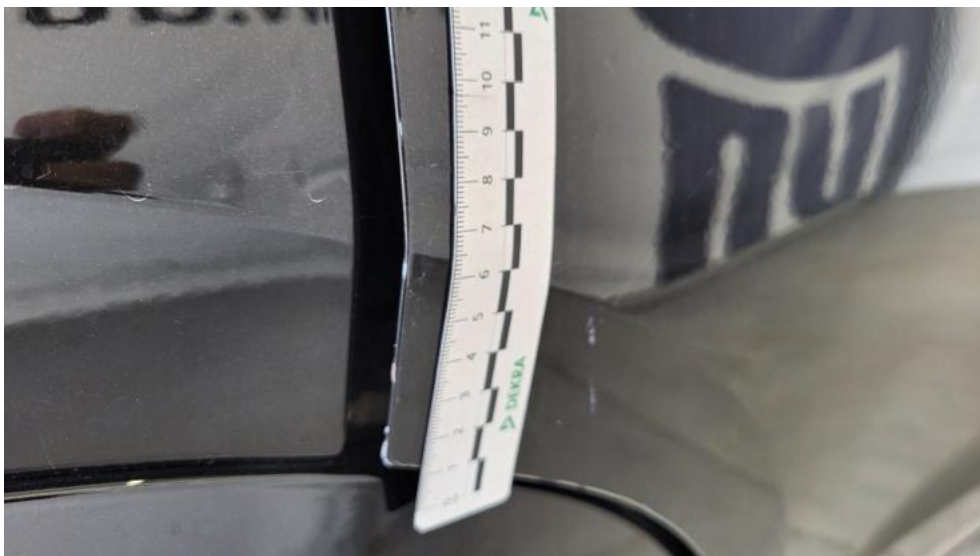
Drzwi tylne P - Rysa/odprysk 1

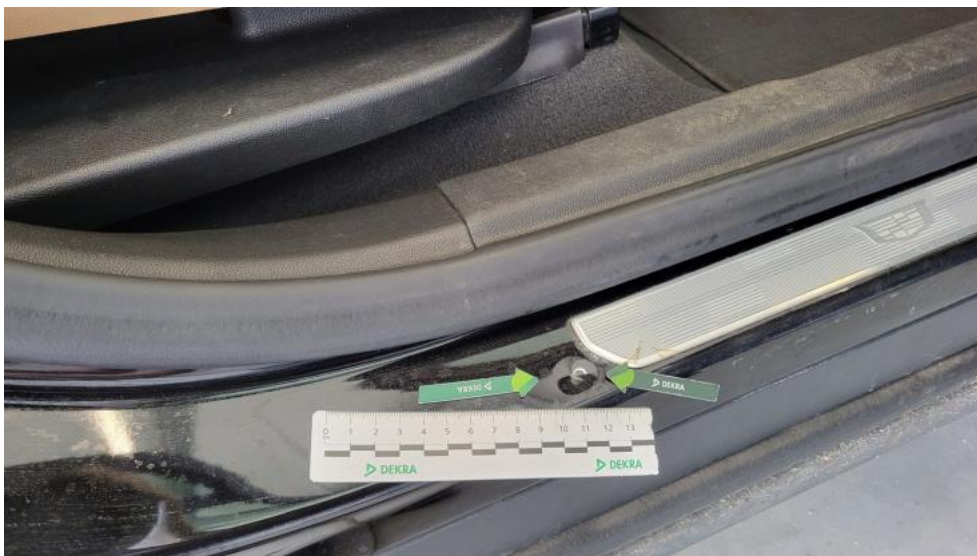
Próg P - Wgniecenie/odkształcenie 1

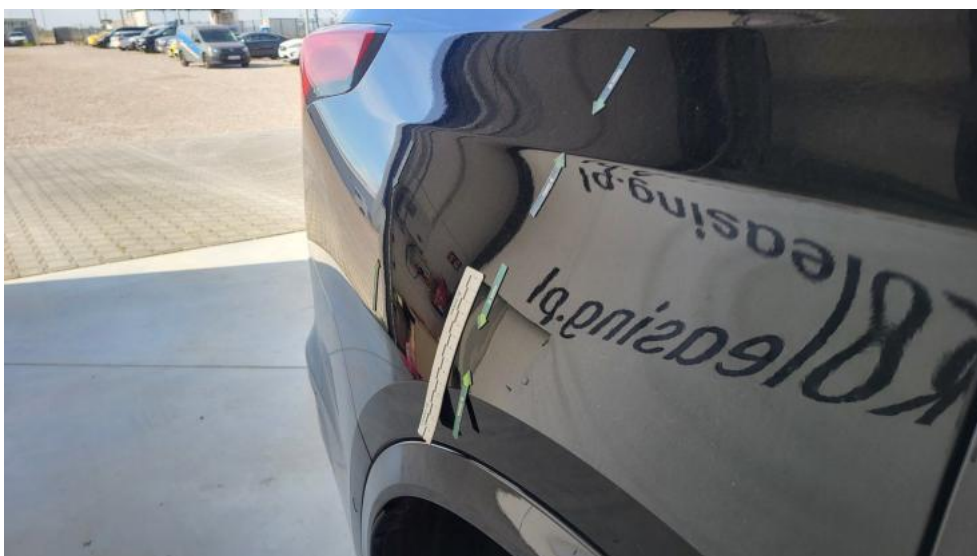
Ścianka tylna P / Ścianka boczna P - Wgniecenie/odkształcenie 1

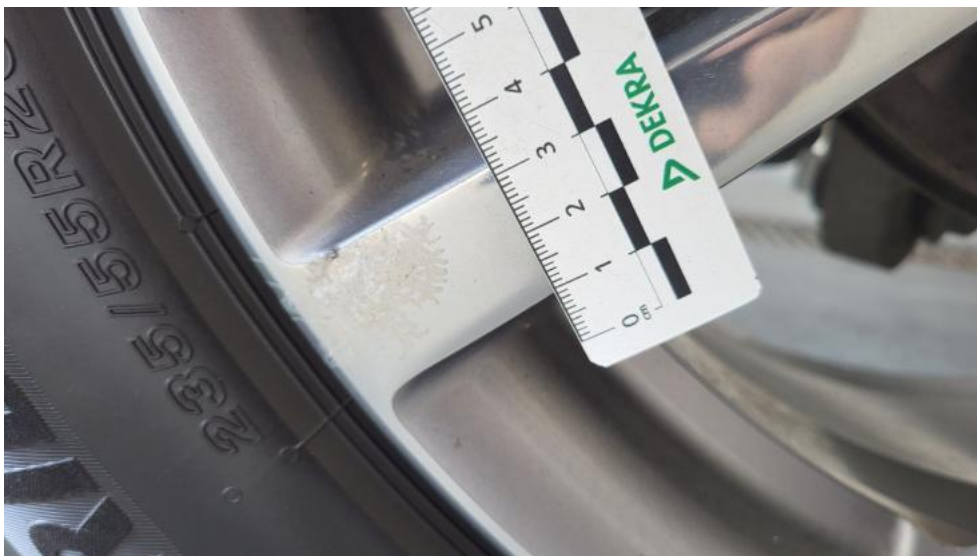
Felga aluminiowa tylna P - Rysa/odprysk 1

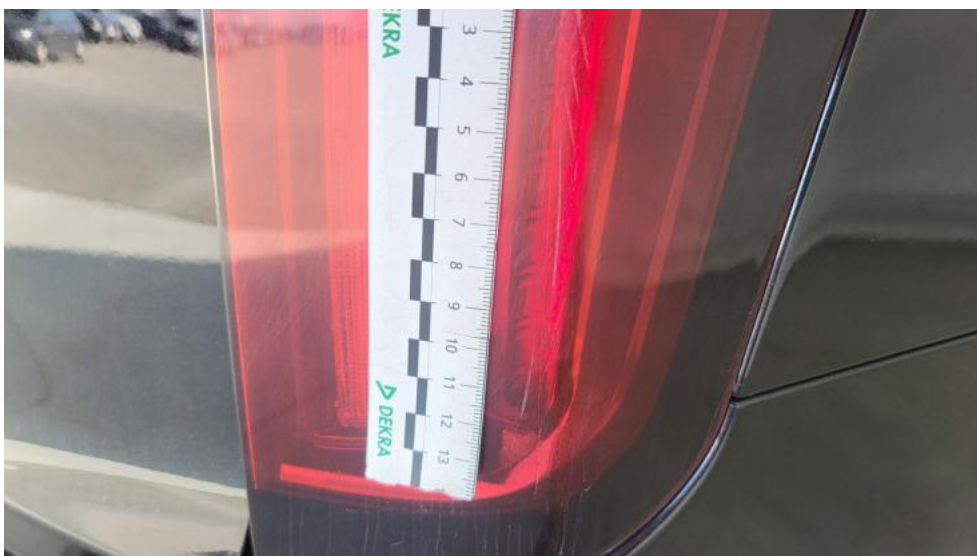
Lampa tylna zew P - Rysa/odprysk 1

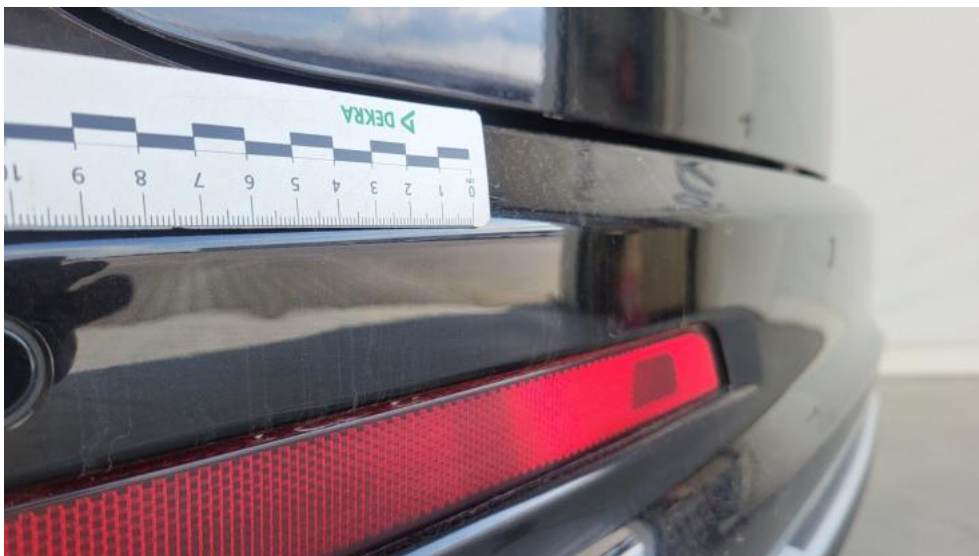
Zderzak tylny - Wgniecenie/odkształcenie 1

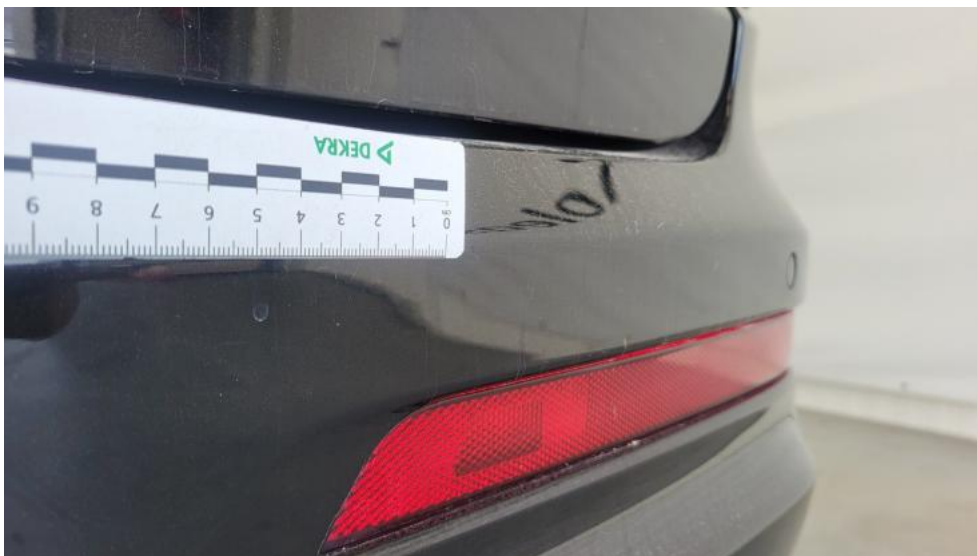
Zderzak tylny - Wgniecenie/odkształcenie 2

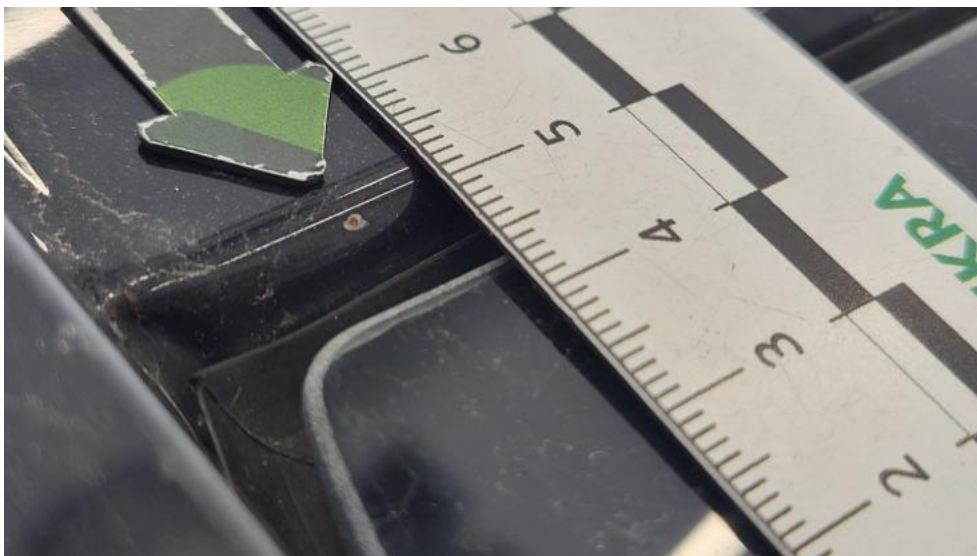
Dach - Inne 1

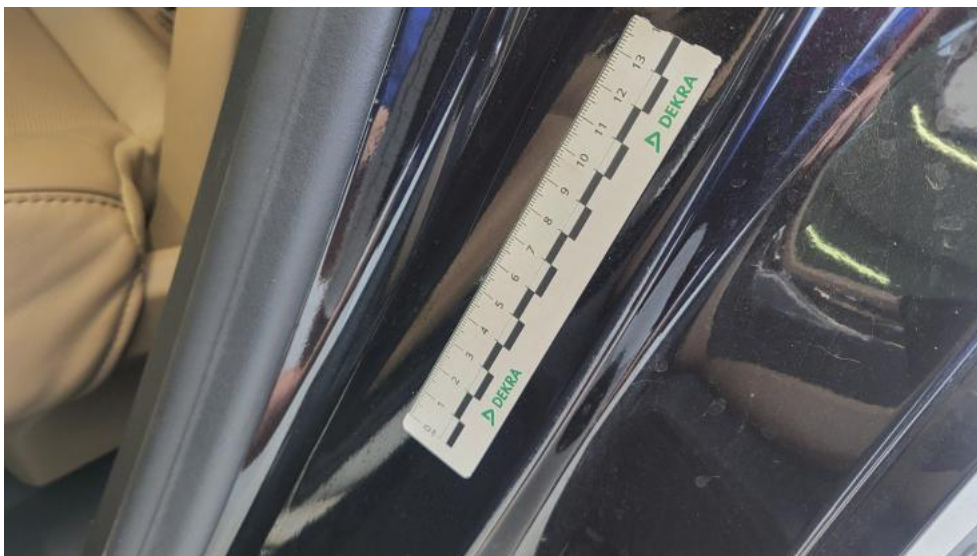
Błotnik tylny L / Ściana boczna L - Rysa/odprysk 1

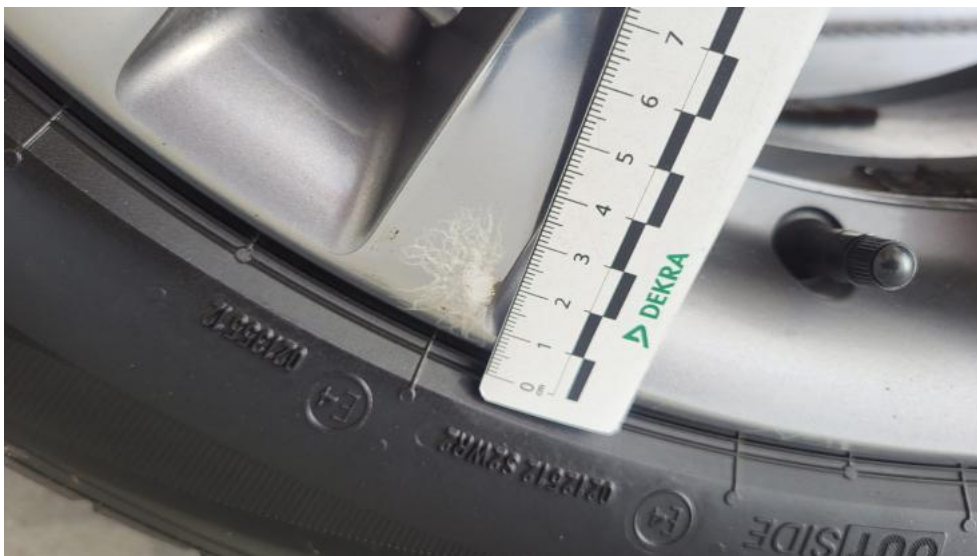
Felga aluminiowa tylna L - Rysa/odprysk 1

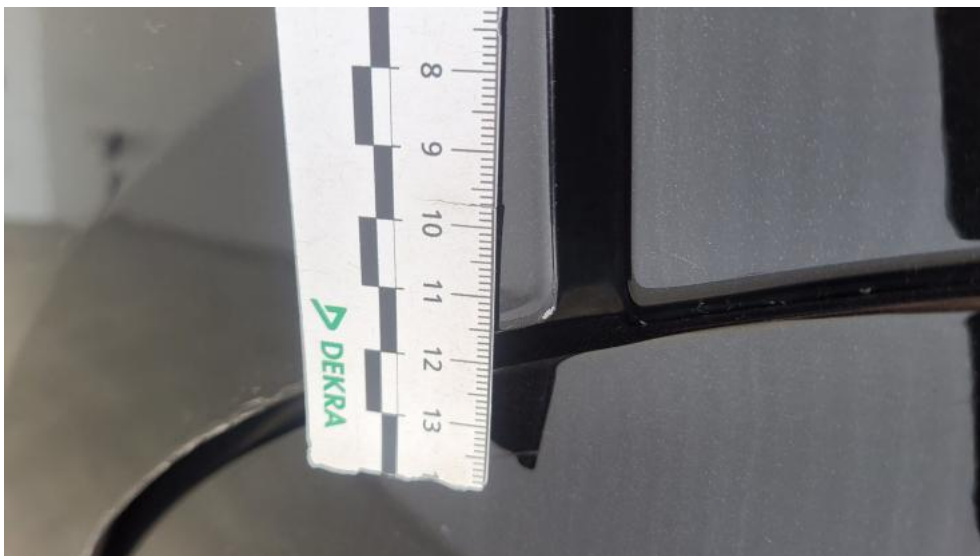
Drzwi tylne L - Rysa/odprysk 1

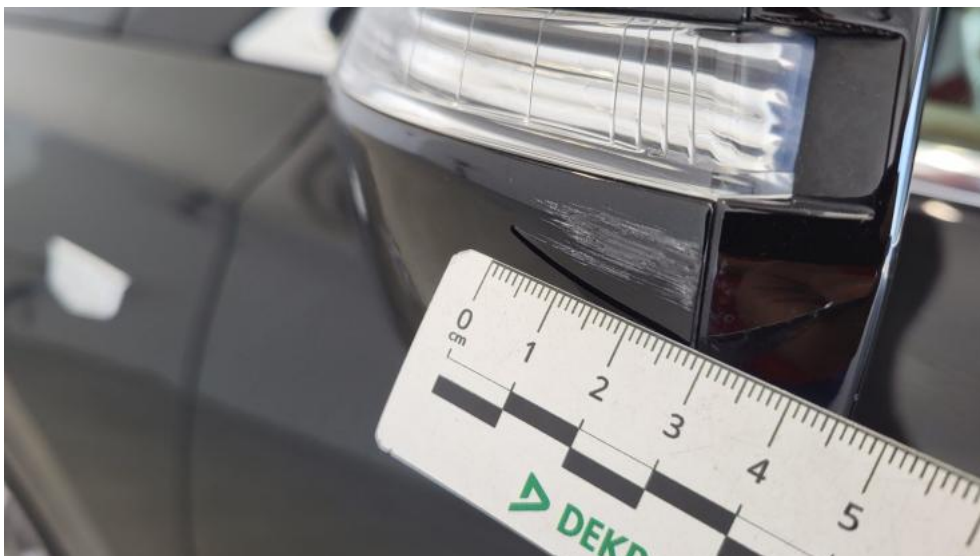
Lusterko zew L - Rysa/odprysk 1

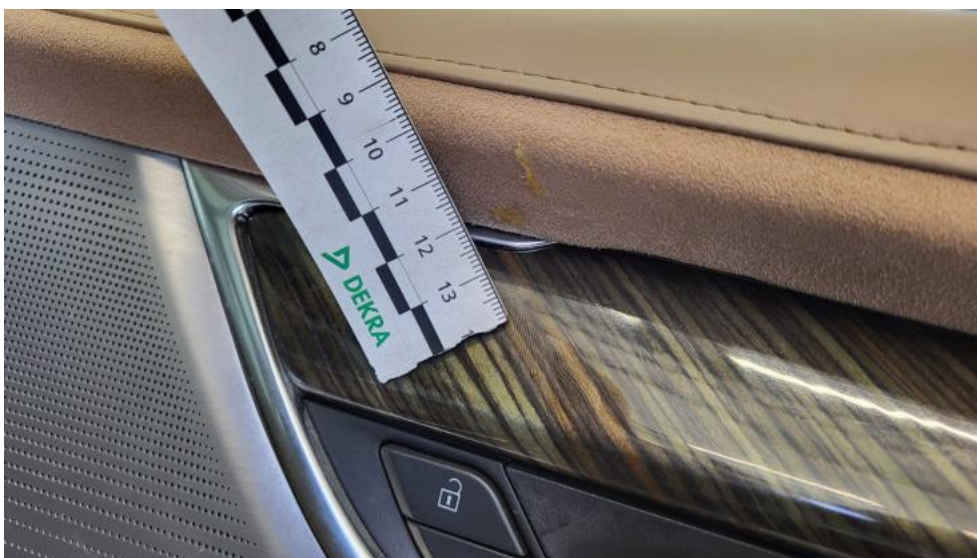
Tapicerka drzwi przednich P - Inne 1

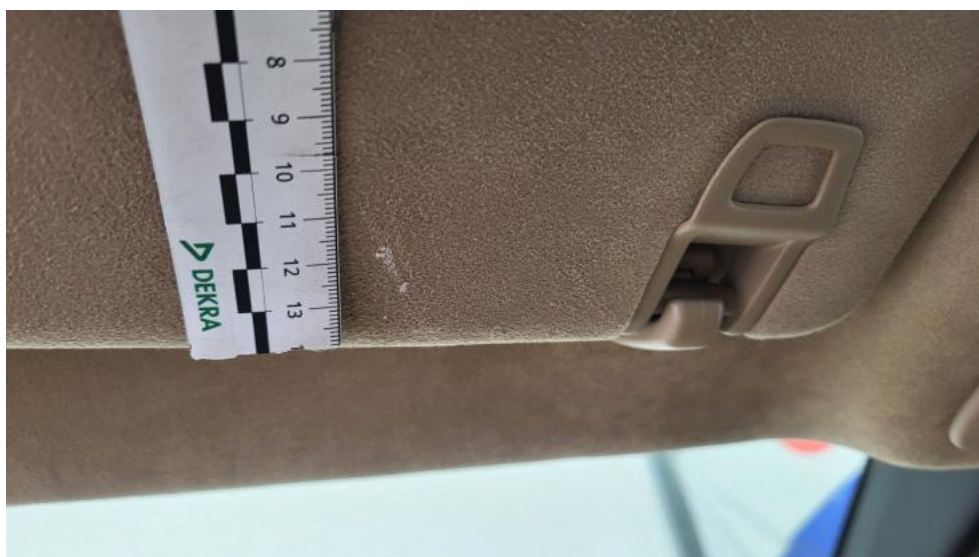
Osłona p/słoneczna lewa - Inne 1
