DEKRA's commission No. : PKOL(W)/LODZ/57946/26/06/24  
commission/ damage No. : PS24/043321  
Date of commission: 24-06-2026

**DEKRA Poland - Headquarters**  
02-673 Warszawa, ul. Konstruktorska 12A

| Manufacturer | TOYOTA |
| Type / version | Camry 2.5 Hybrid Comfort CVT |

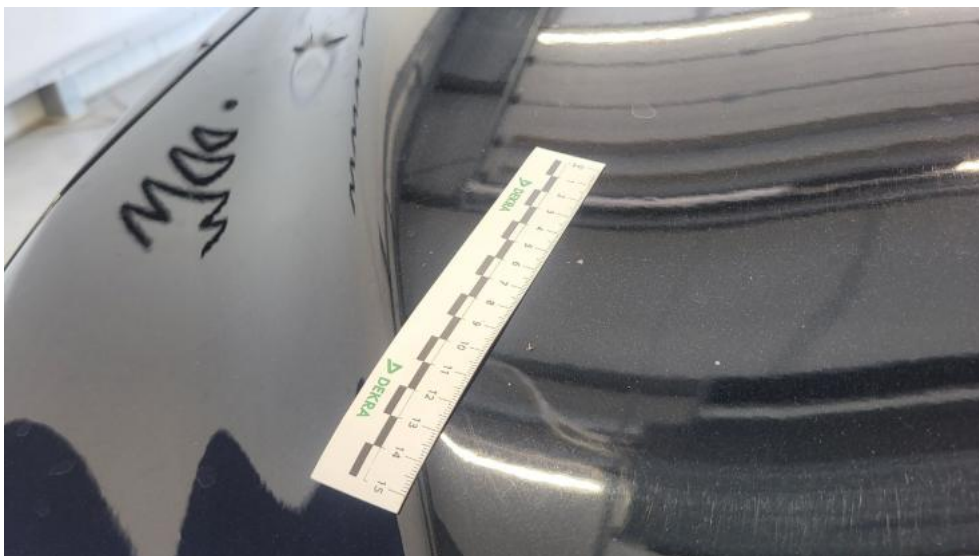
**Photo 38.**

Pokrywa komory silnika - Rysa/odprysk 1

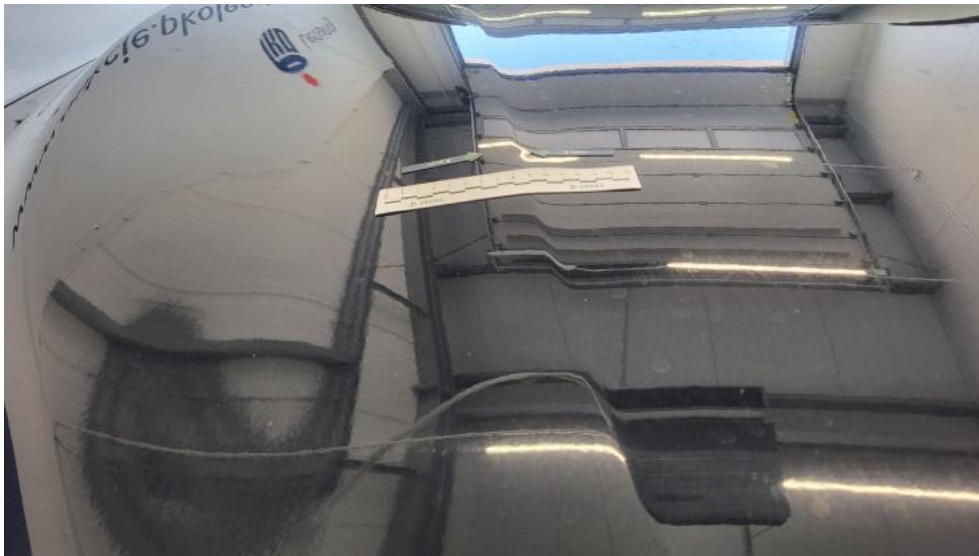
**Photo 39.**

Pokrywa komory silnika - Wgniecenie/odkształcenie 1

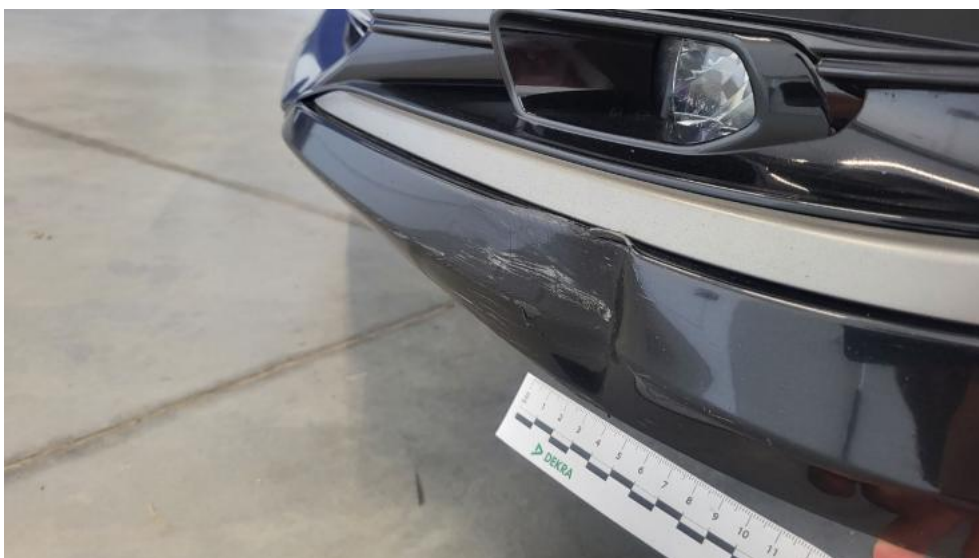
**Photo 40.**

Zderzak - Wgniecenie/odkształcenie 1

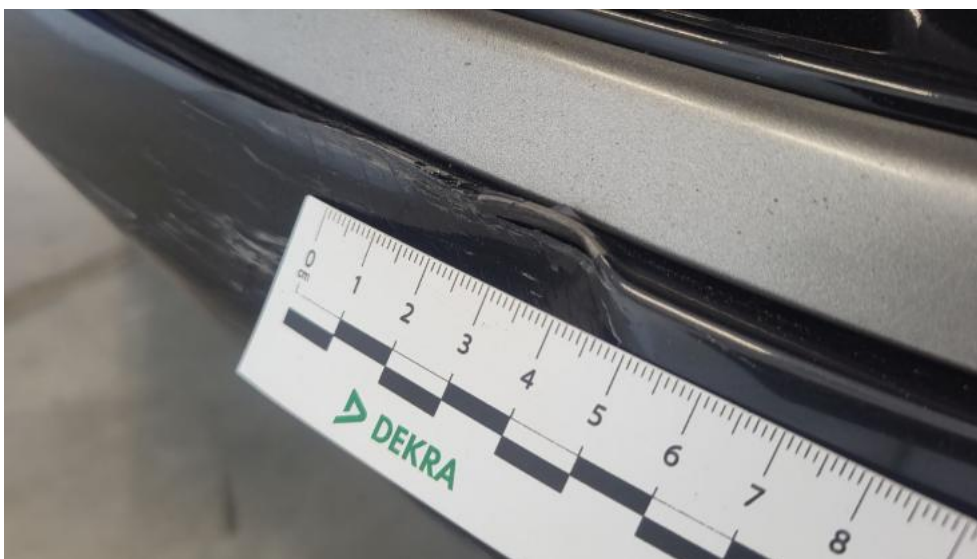
**Photo 41.**

Zderzak - Pęknięcie/rozerwanie 1

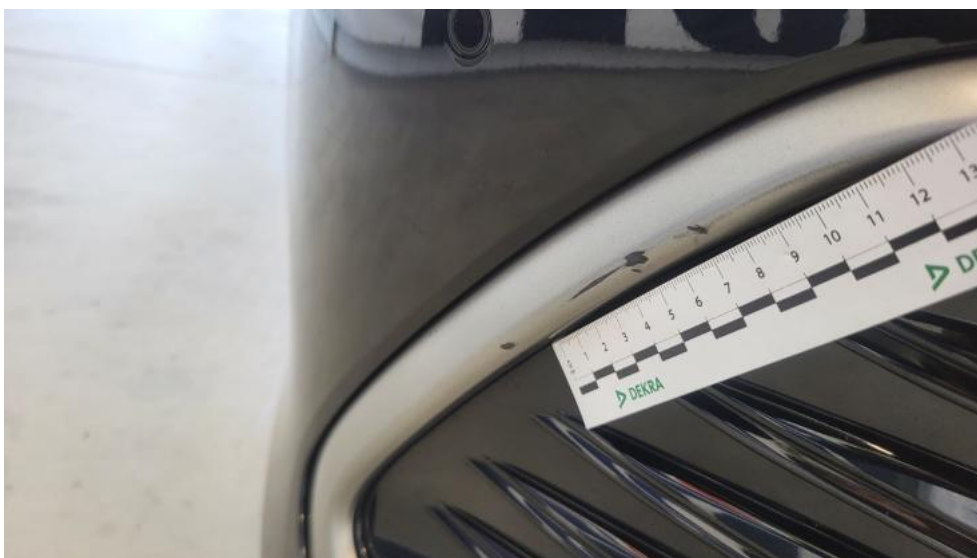
**Photo 42.**

Zderzak przedni cz P - Rysa/odprysk 1

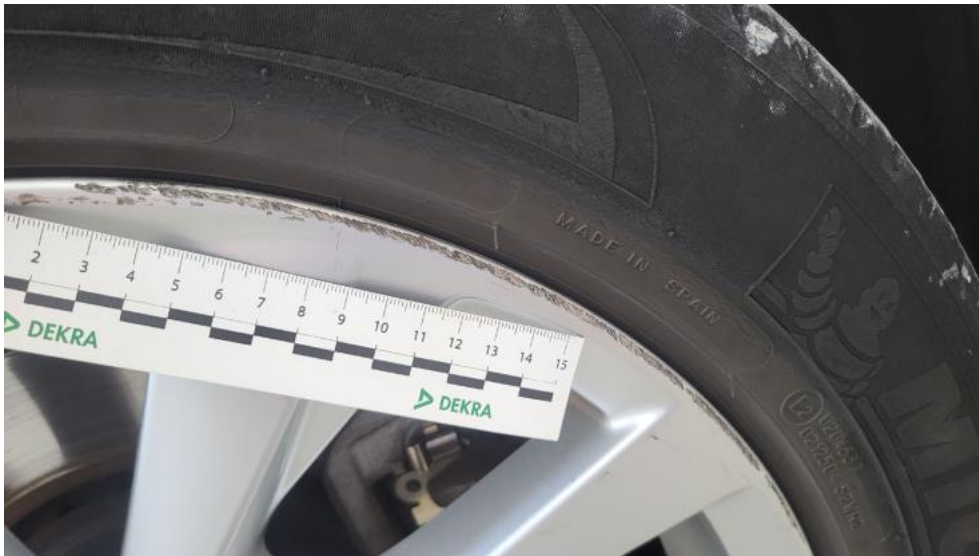
**Photo 43.**

Felga aluminiowa przednia P - Rysa/odprysk 1

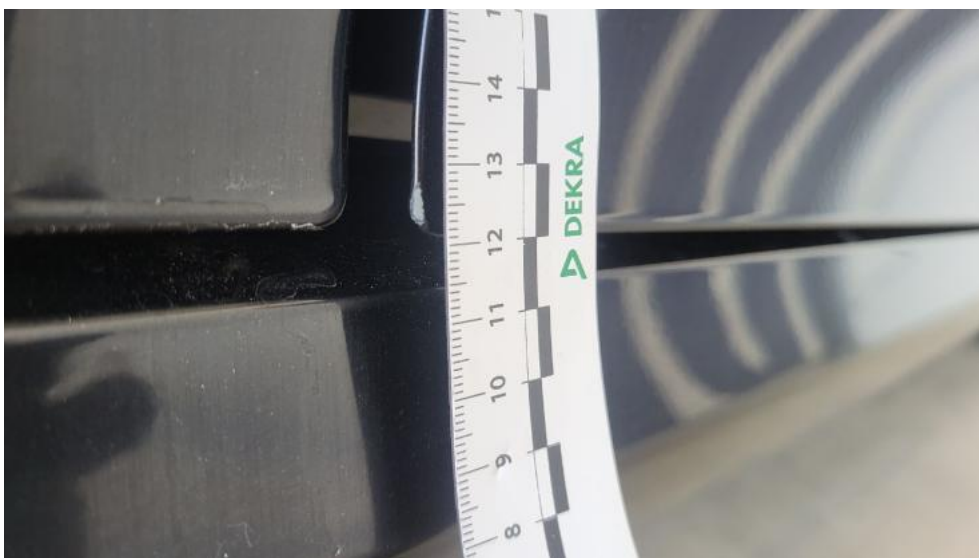
**Photo 44.**

Drzwi przednie P - Rysa/odprysk 1

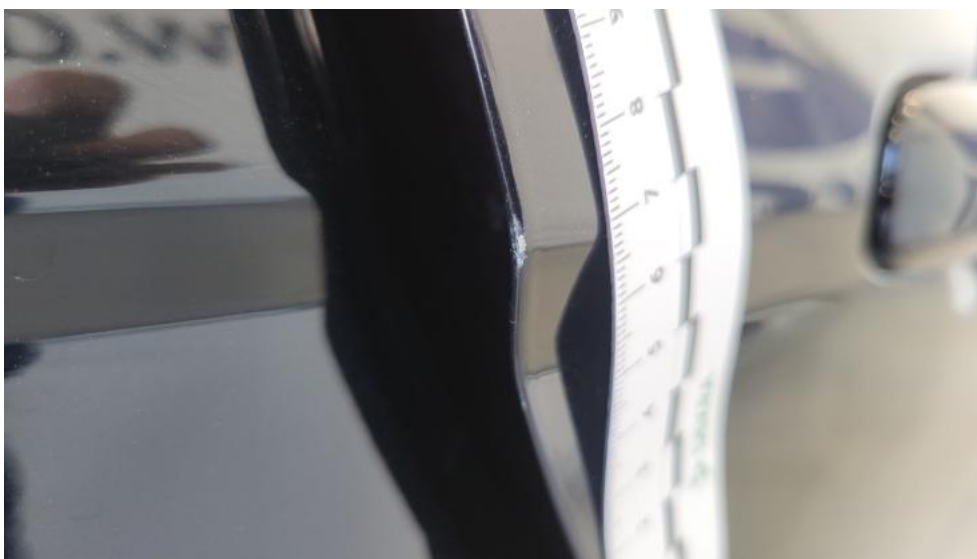
**Photo 45.**

Drzwi tylne P - Rysa/odprysk 1

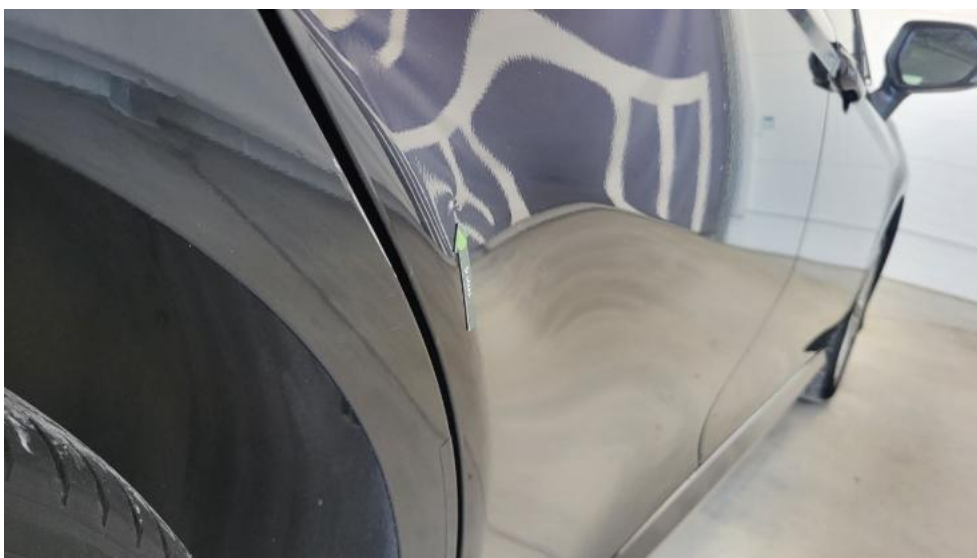
**Photo 46.**

Drzwi tylne P - Wgniecenie/odkształcenie 1

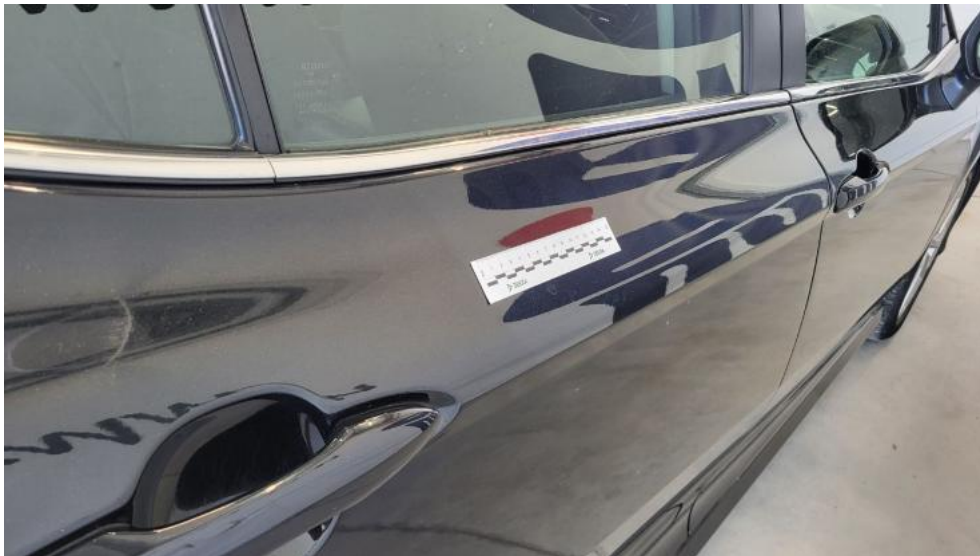
**Photo 47.**  
Drzwi tylne P - Inne 1

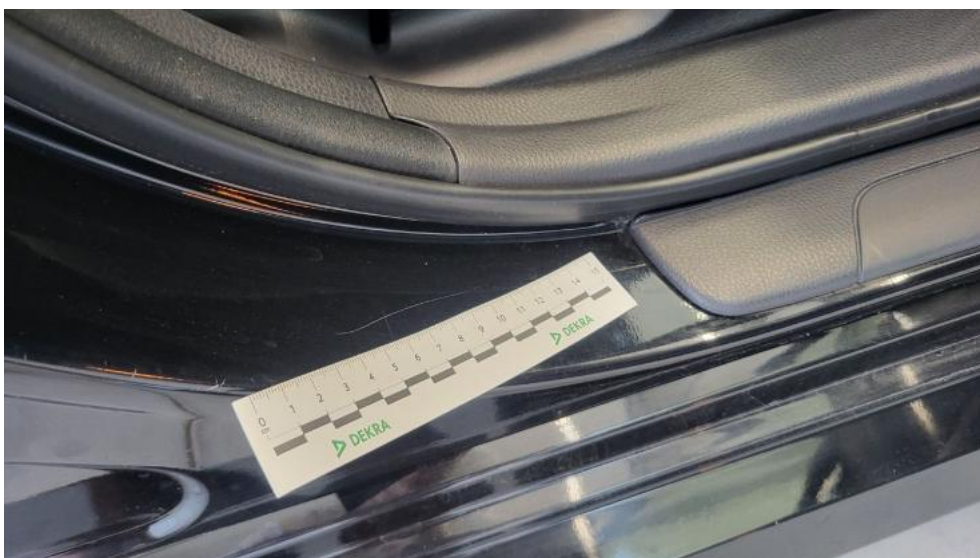
**Photo 48.**  
Próg P - Rysa/odprysk 1

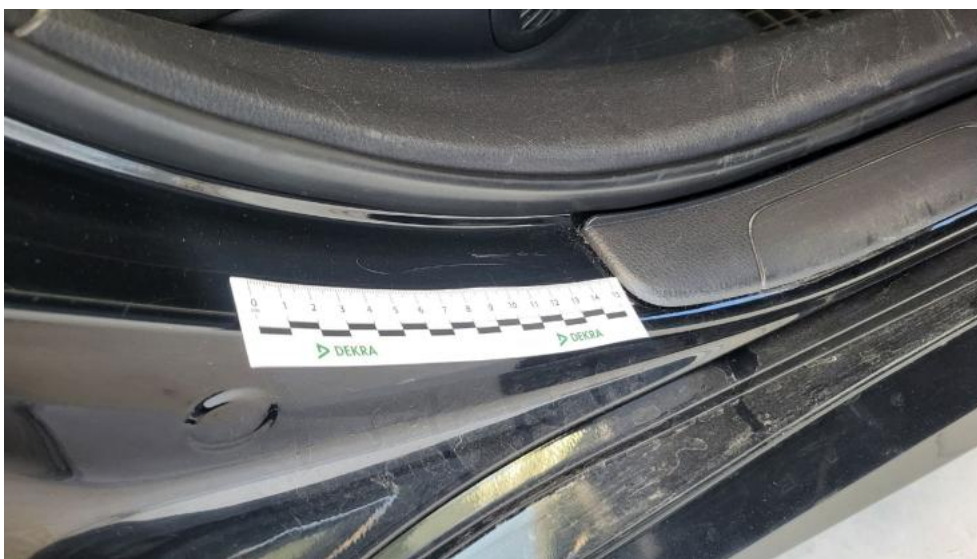
**Photo 49.**

Próg P - Rysa/odprysk 2

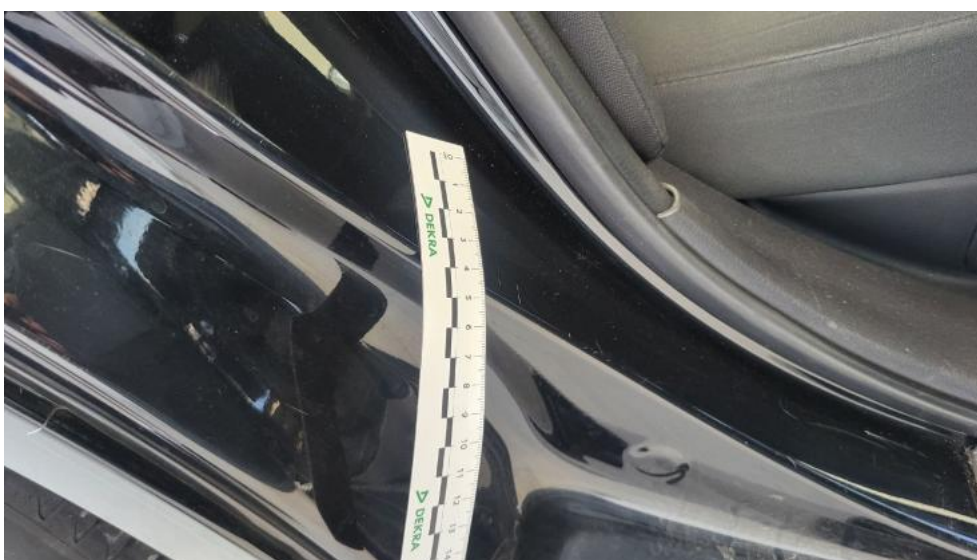
**Photo 50.**

Ścianka tylna P / Ścianka boczna P - Rysa/odprysk 1

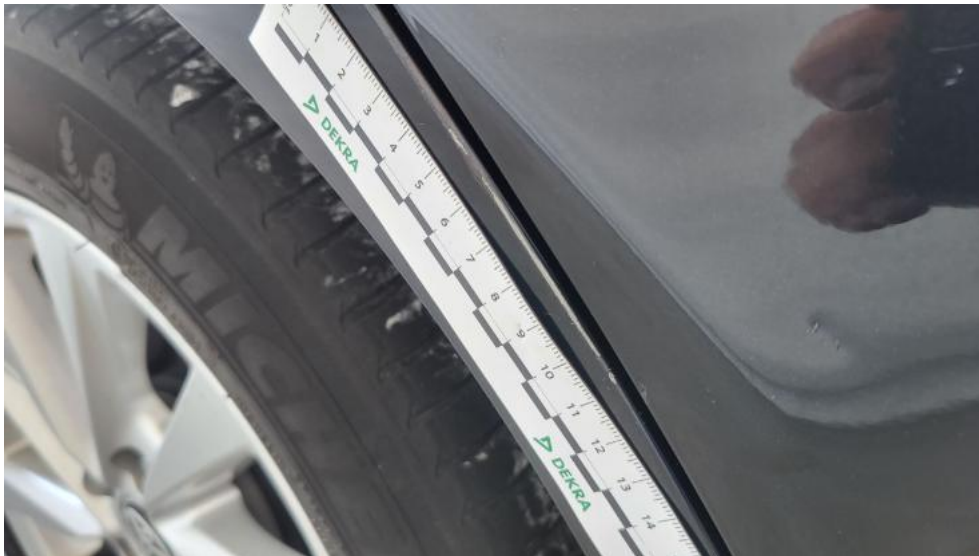
**Photo 51.**

Błotnik tylny P / Ściana boczna P - Rysa/odprysk 2

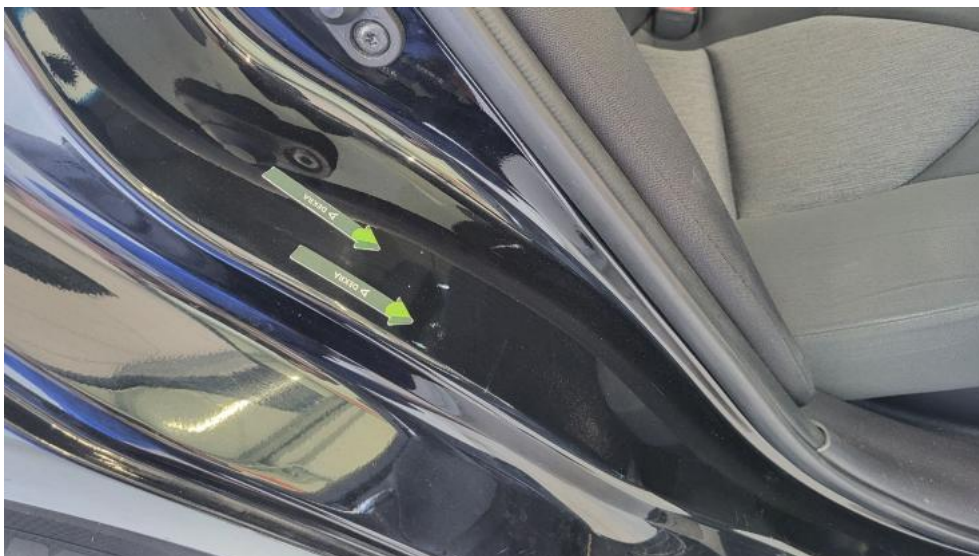
**Photo 52.**

Błotnik tylny P / Ściana boczna P - Wgniecenie/odkształcenie 1

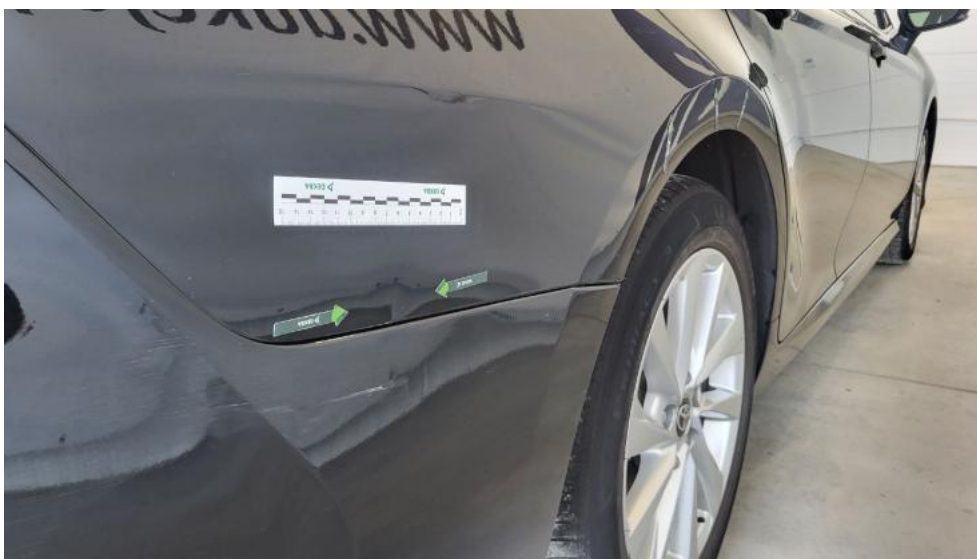
**Photo 53.**

Błotnik tylny P / Ściana boczna P - Wgniecenie/odkształcenie 2

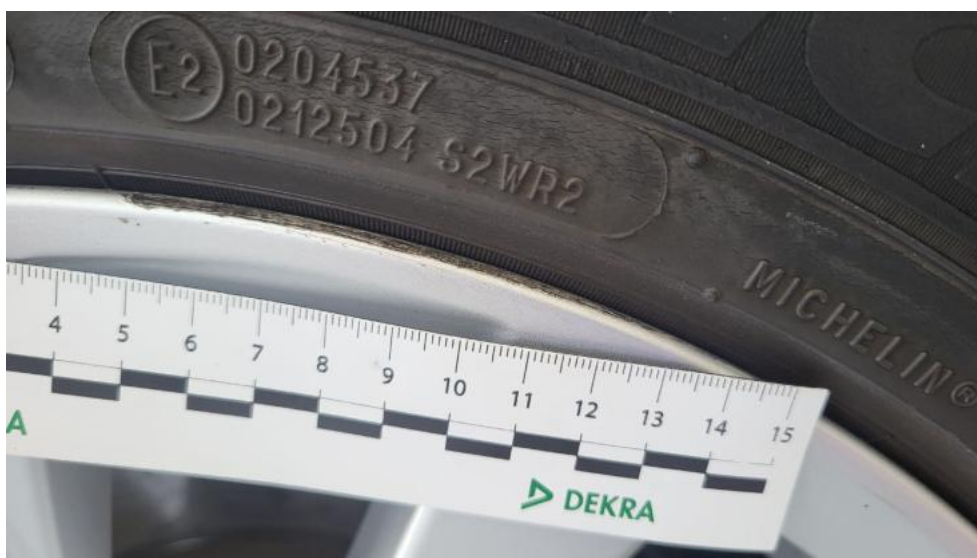
**Photo 54.**

Felga aluminiowa tylna P - Rysa/odprysk 1

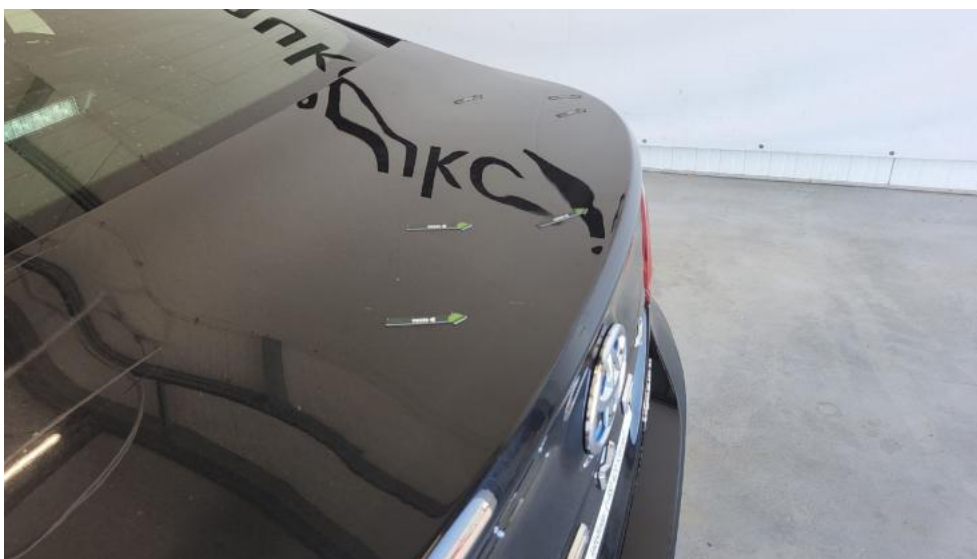
**Photo 55.**

Pokrywy bagażnika - Wgniecenie/odkształcenie 1

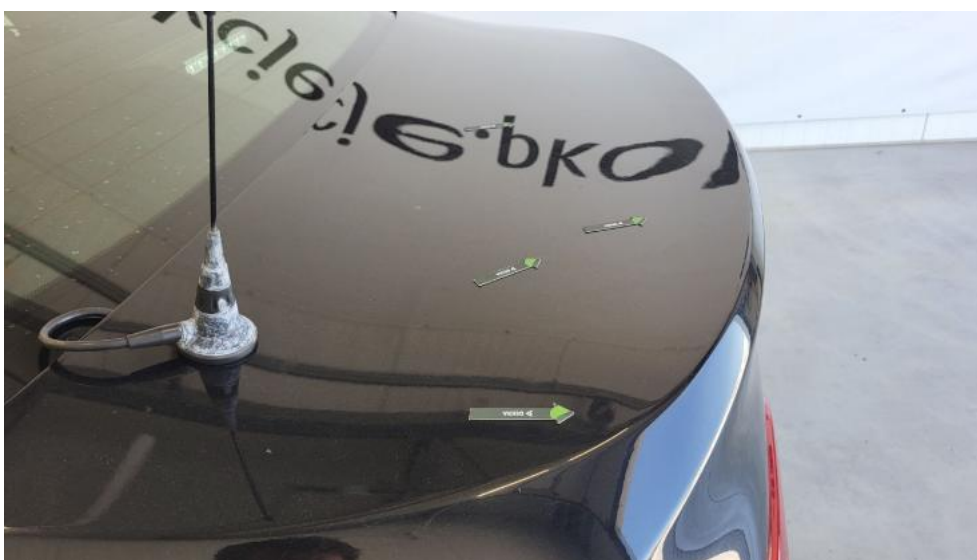
**Photo 56.**

Pokrywy bagażnika - Wgniecenie/odkształcenie 2

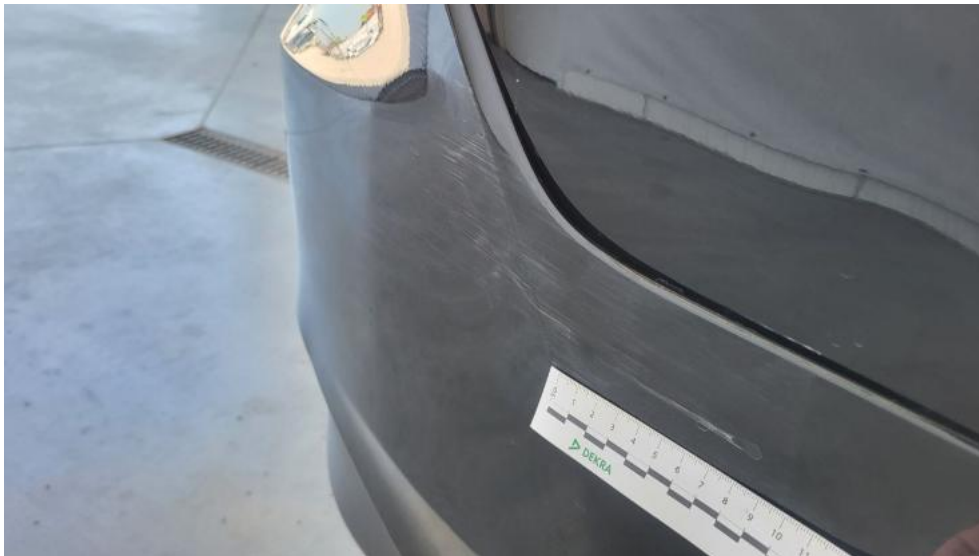
**Photo 57.**

Zderzak tylny - Rysa/odprysk 1

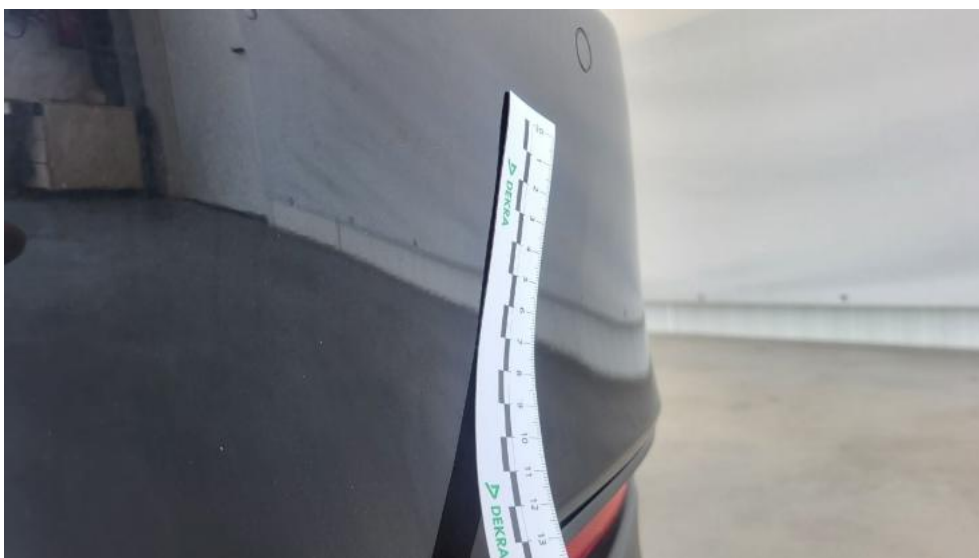
**Photo 58.**

Zderzak tylny - Wgniecenie/odkształcenie 1

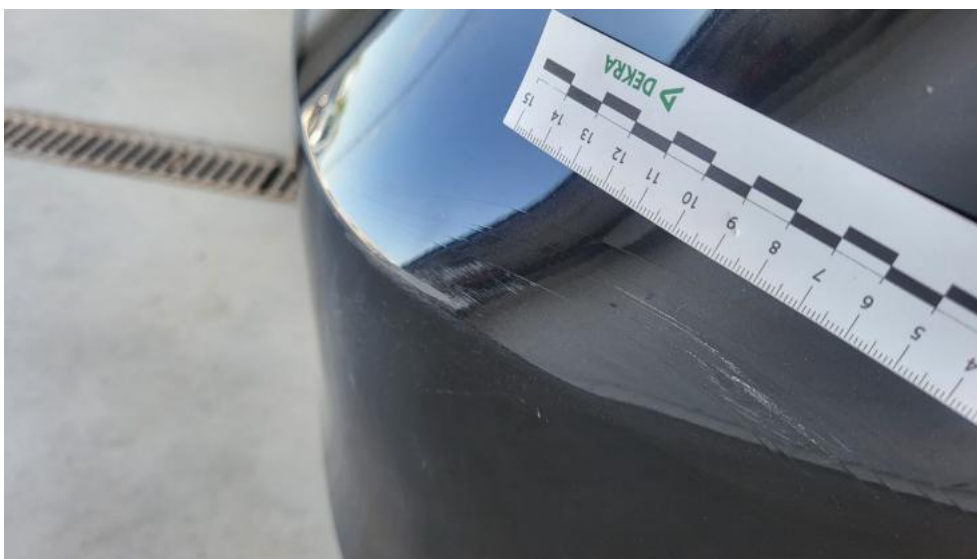
**Photo 59.**

Zderzak tylny - Pęknięcie/rozerwanie 1

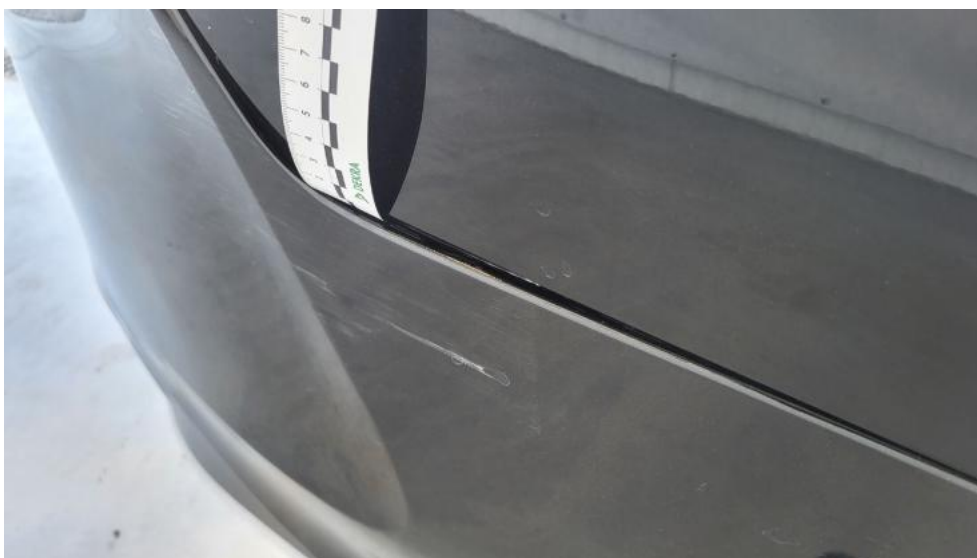
**Photo 60.**

Zderzak tylny - Inne 1

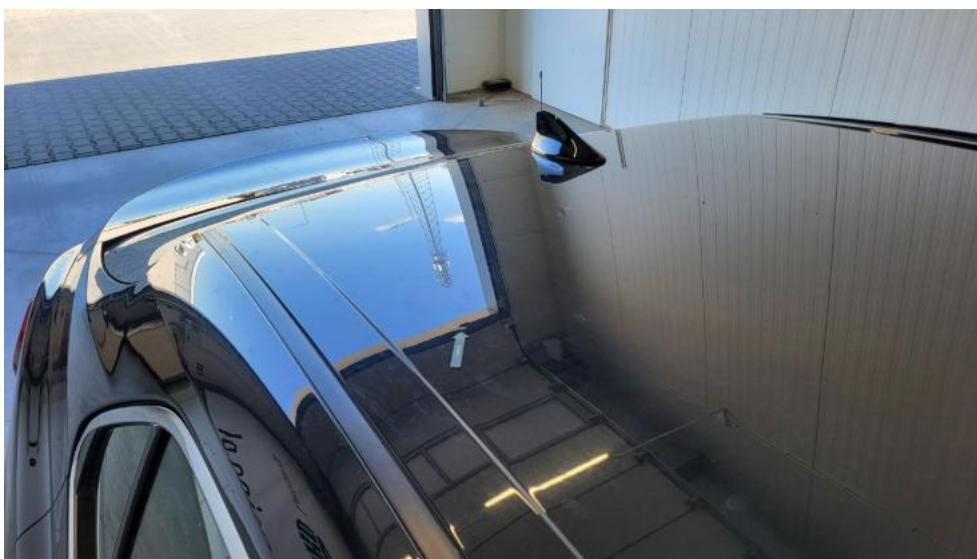
**Photo 61.**

Dach - Wgniecenie/odkształcenie 1

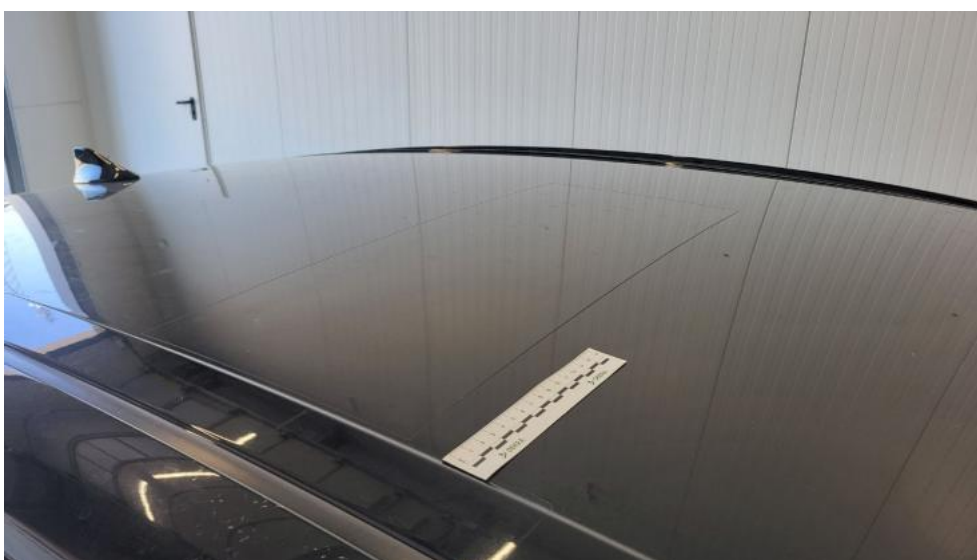
**Photo 62.**

Dach - Inne 1

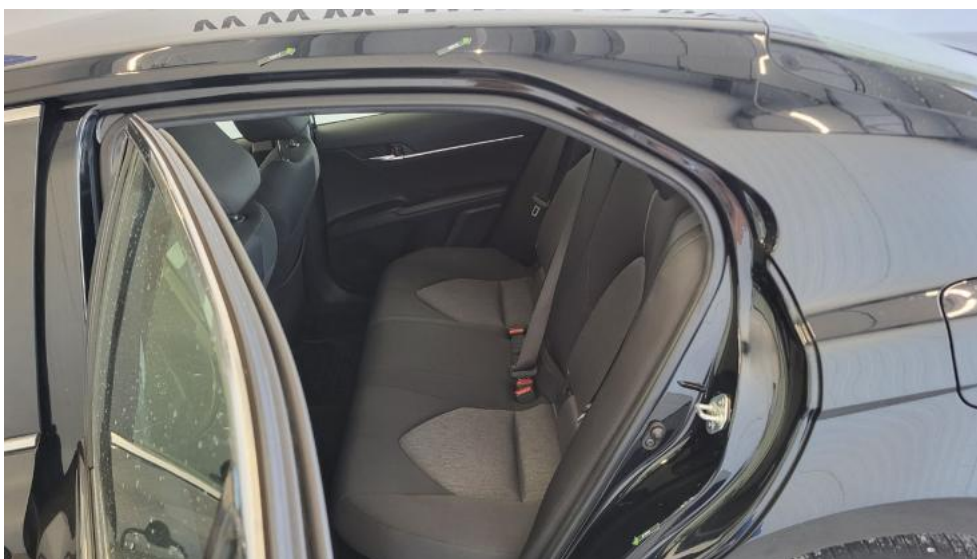
**Photo 63.**

Ścianka tylna L / Ścianka boczna L - Wgniecenie/odkształcenie 1

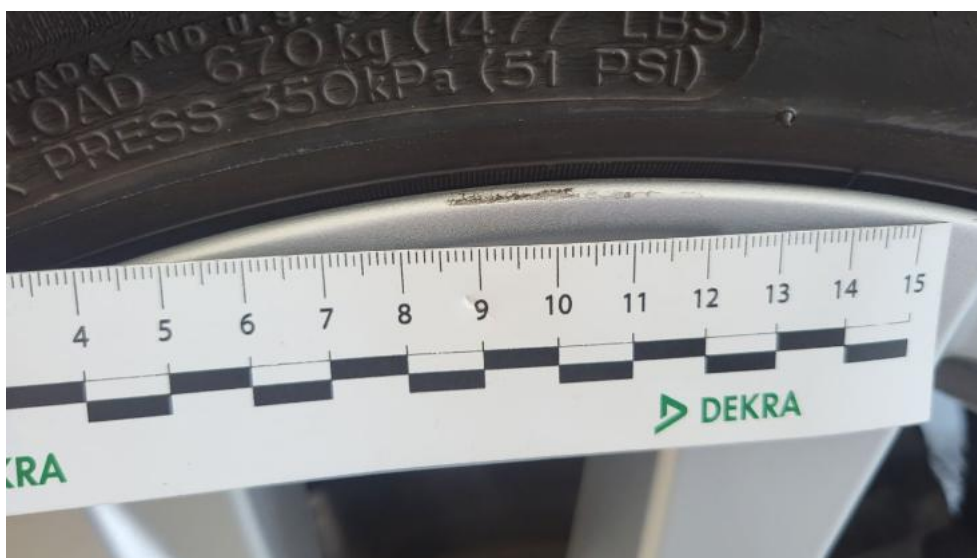
**Photo 64.**

Felga aluminiowa tylna L - Rysa/odprysk 1

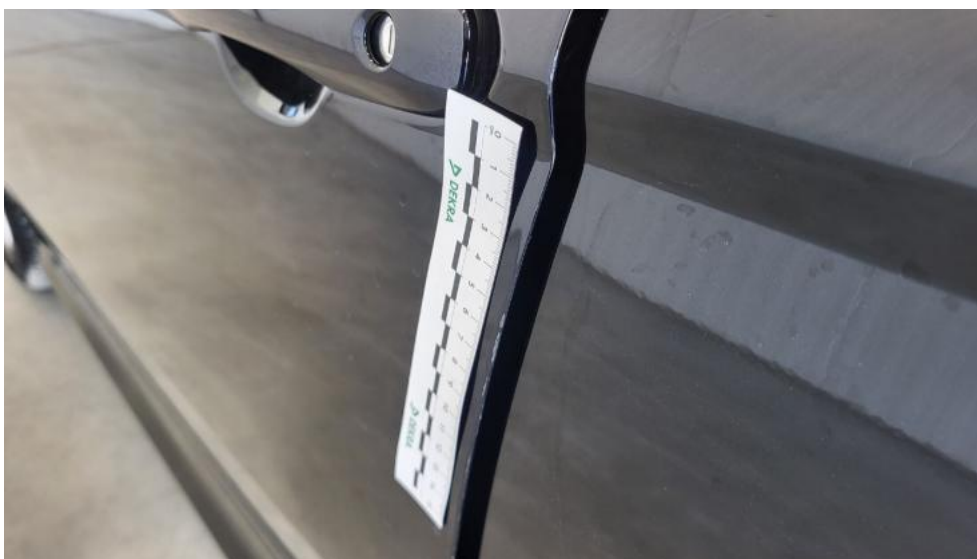
**Photo 65.**

Drzwi przed L - Rysa/odprysk 1

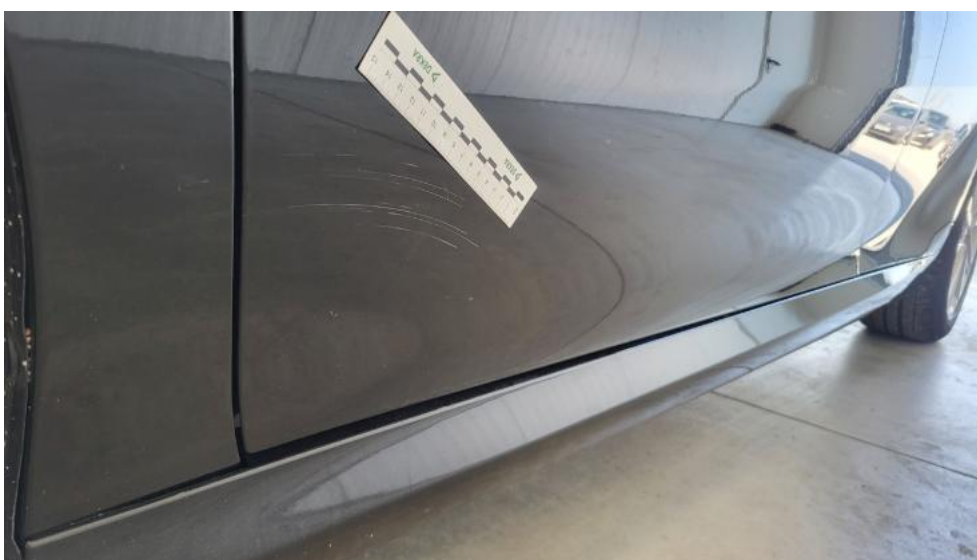
**Photo 66.**

Drzwi przed L - Rysa/odprysk 2

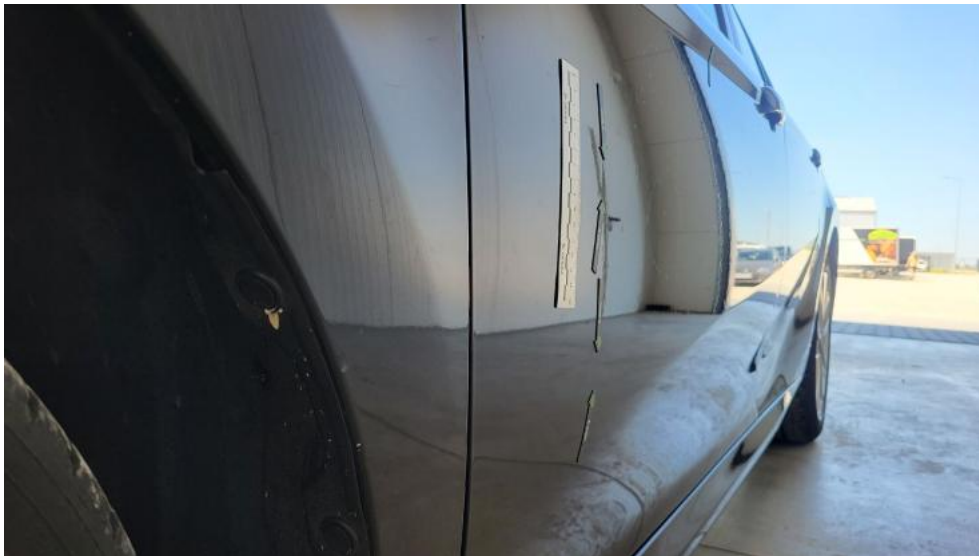
**Photo 67.**

Drzwi przed L - Wgniecenie/odkształcenie 1

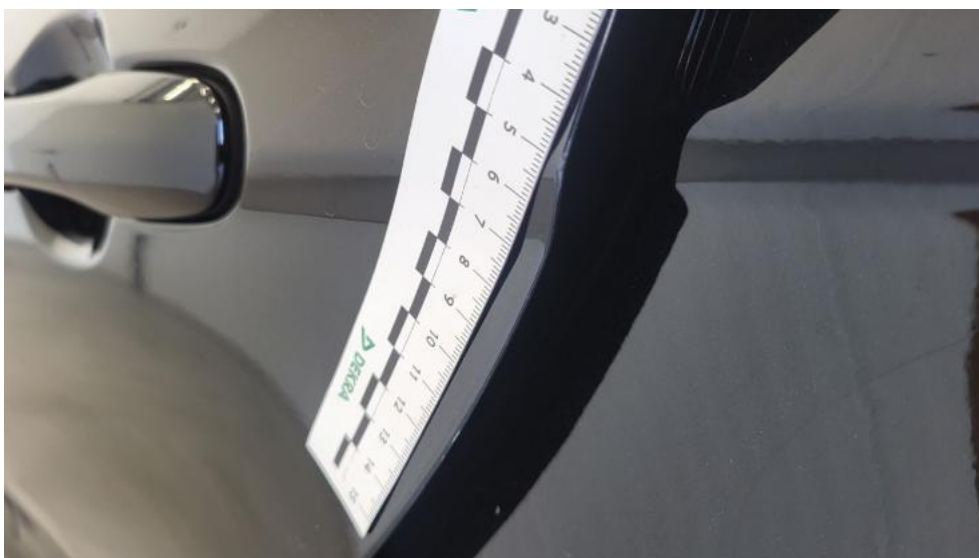
**Photo 68.**

Drzwi tylne L - Rysa/odprysk 1

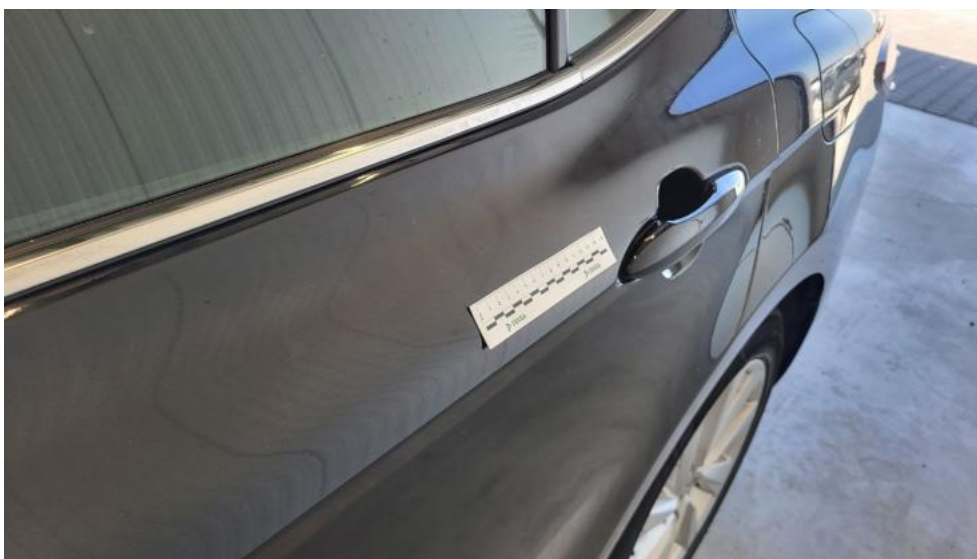
**Photo 69.**

Drzwi tylne L - Inne 1

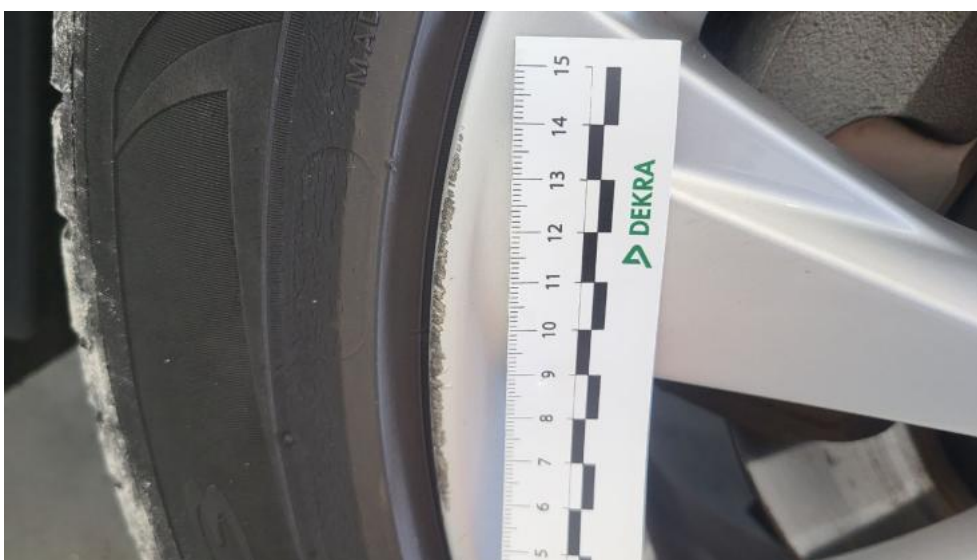
**Photo 70.**

Felga Aluminiowa przednia L - Rysa/odprysk 1

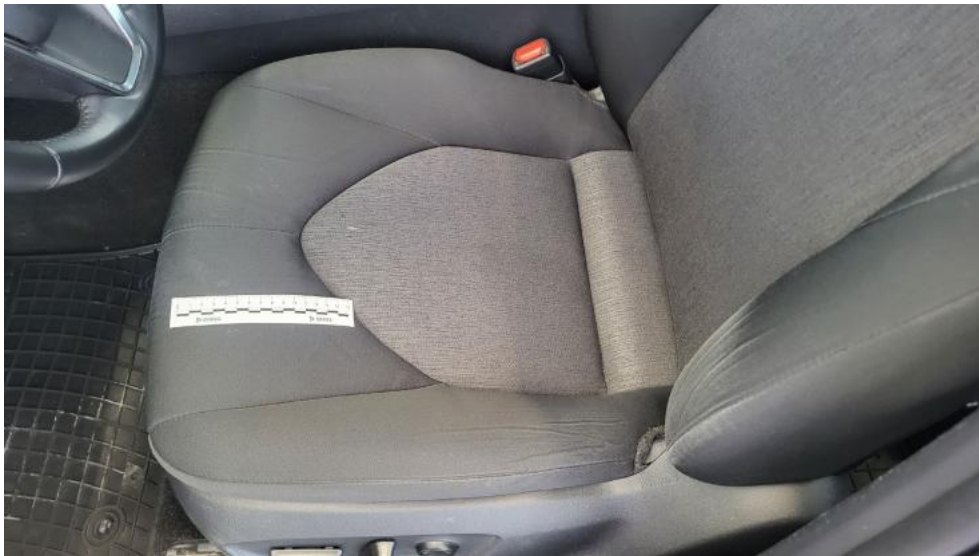
**Photo 71.**

Fotel prz. lew. - Inne 1

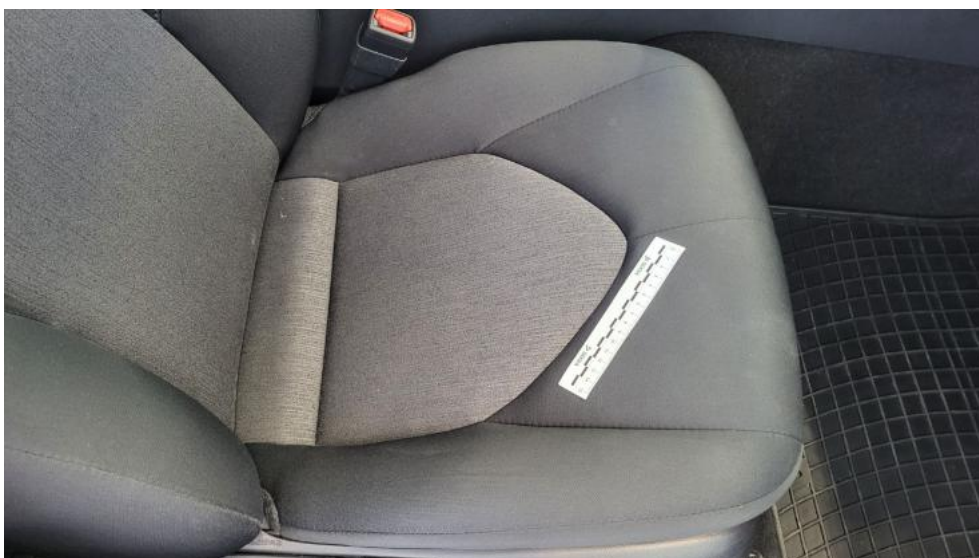
**Photo 72.**

Fotel prz. praw. - Inne 1

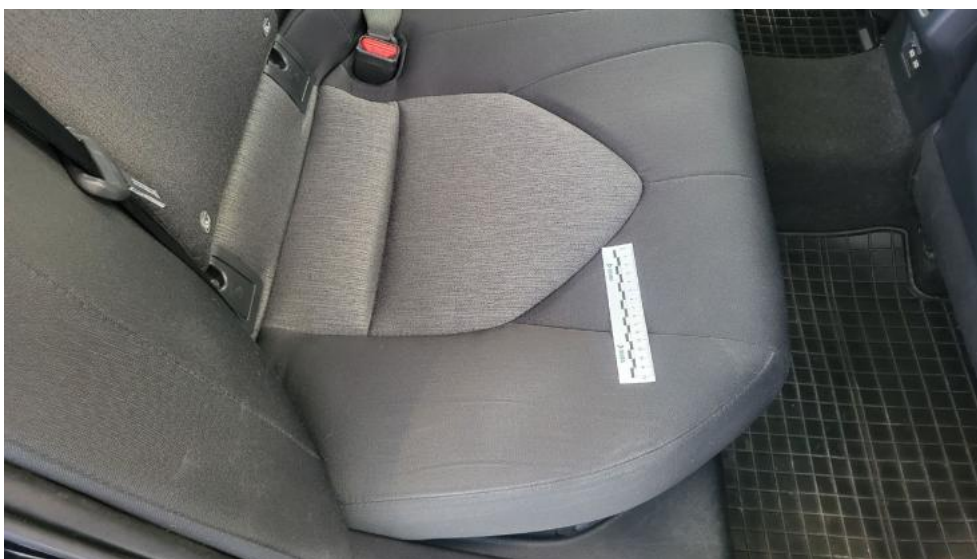
**Photo 73.**  
Kanapa tyl. - Inne 1

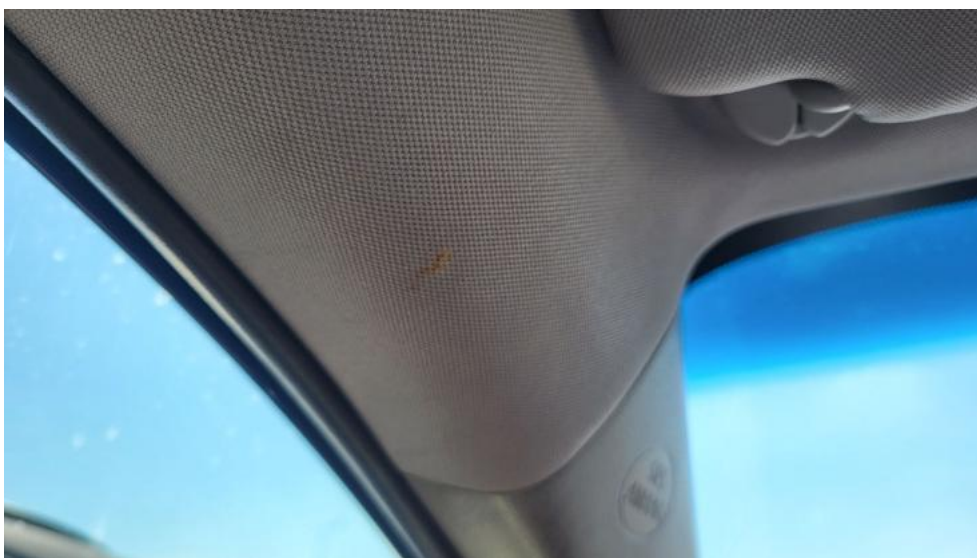
**Photo 74.**  
Podsufitka - Inne 1

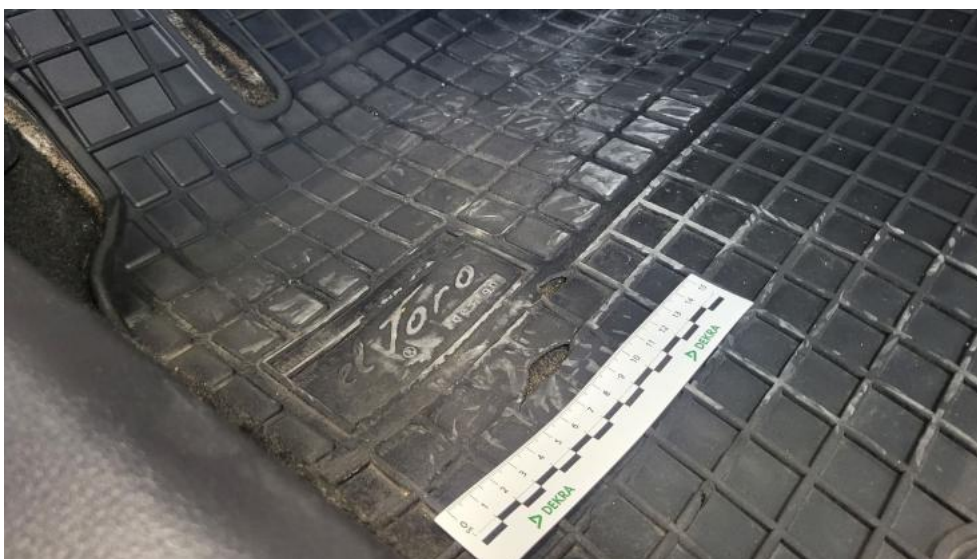
**Photo 75.**

Dywanik prze L - Pęknięcie/rozerwanie 1

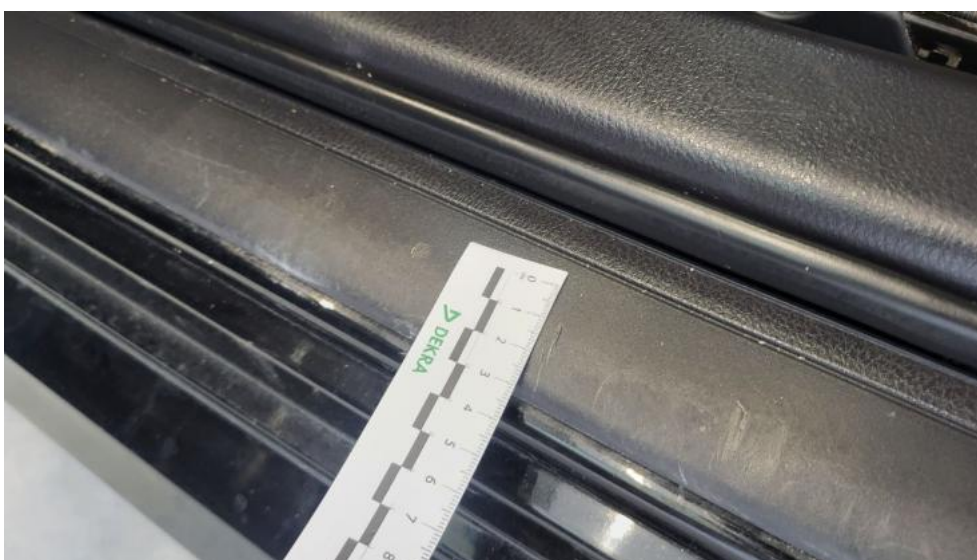
**Photo 76.**

Listwy progowe lew. - Rysa/odprysk 1

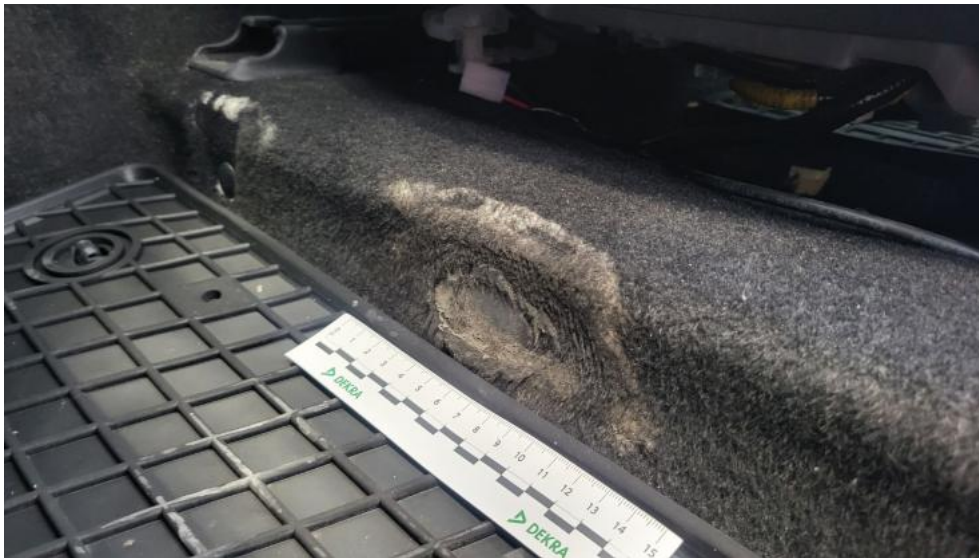
**Photo 77.**

Wykładzina podłogi - Pęknięcie/rozerwanie 1

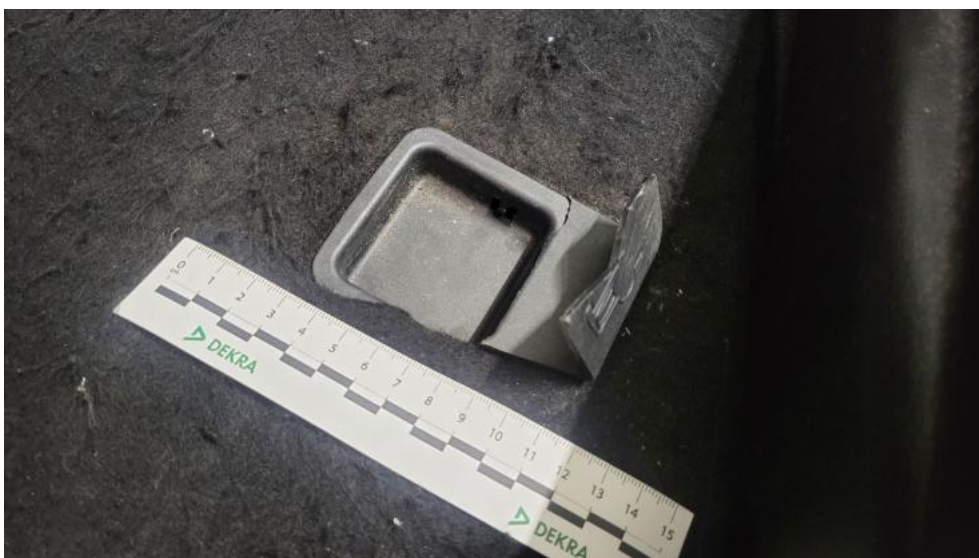
**Photo 78.**

Wykładzina podłogi bagażnika - Pęknięcie/rozerwanie 1
