DEKRA's commission No. : PKOL(W)/LODZ/80099/26/08/27  
commission/ damage No. : 25/020388  
Date of commission: 27-08-2026

**DEKRA Poland - Headquarters**  
02-673 Warszawa, ul. Konstruktorska 12A

**Vehicle data**

| Model | A8 [4N] 17-21 |

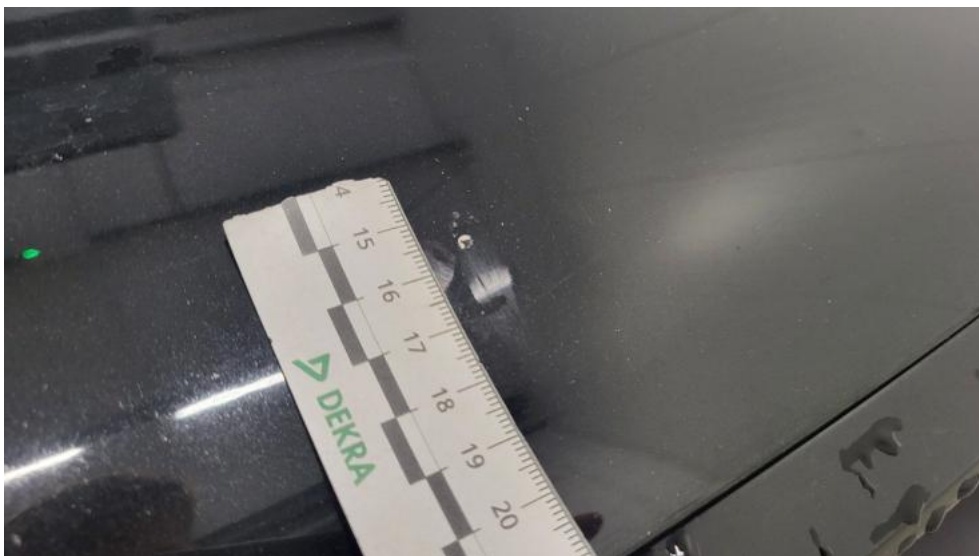
**Photo 50.**

Pokrywa komory silnika - Rysa/odprysk 1

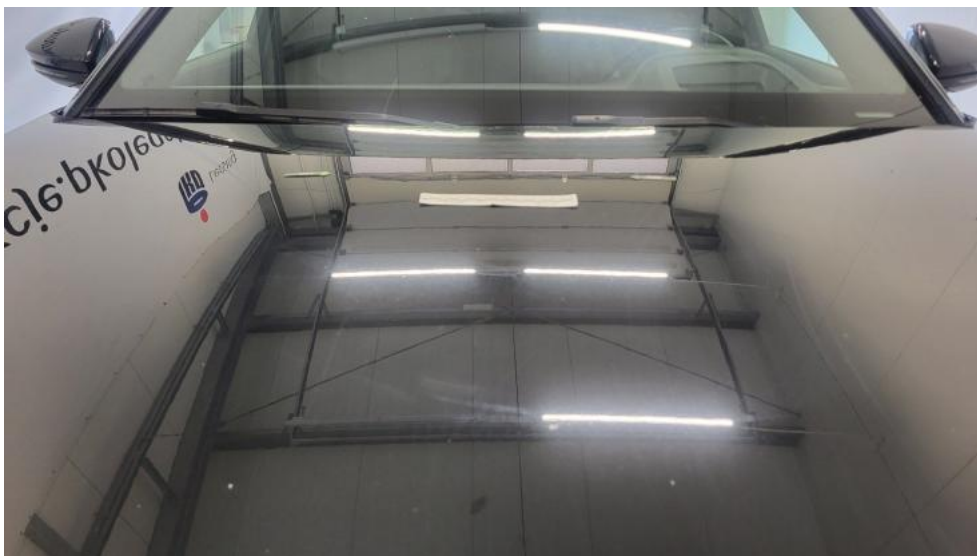
**Photo 51.**

Pokrywa komory silnika - Wgniecenie/odkształcenie 1

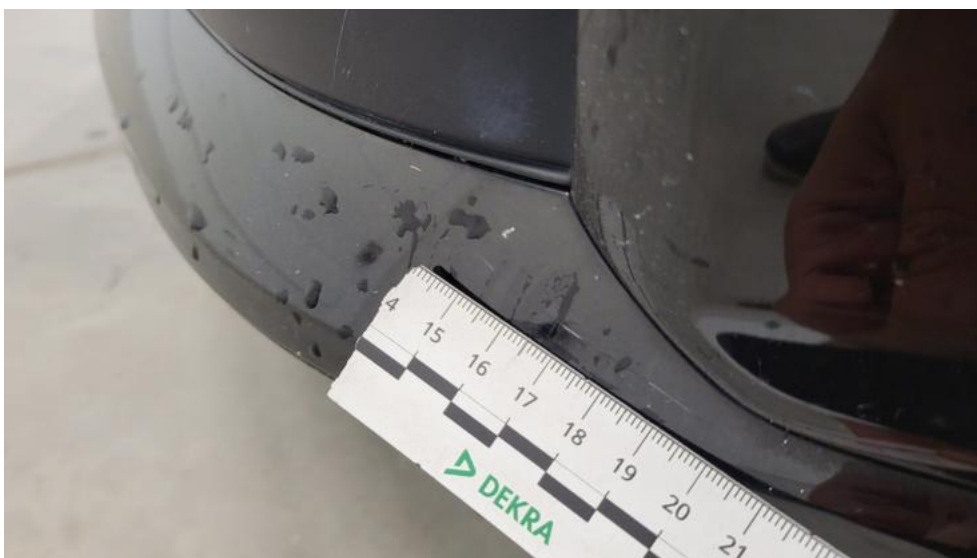
**Photo 52.**

Zderzak przedni cz dolna - Rysa/odprysk 1

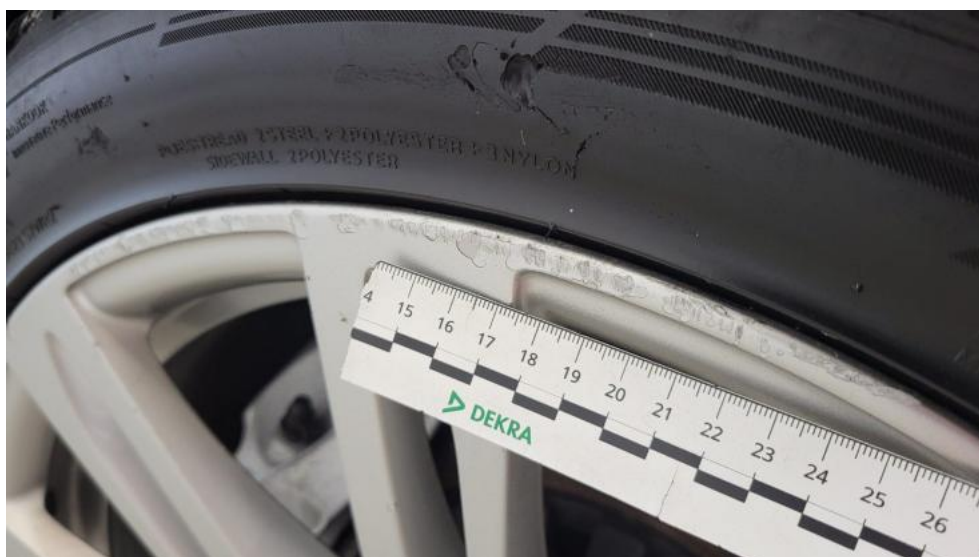
**Photo 53.**

Felga aluminiowa przednia P - Rysa/odprysk 1

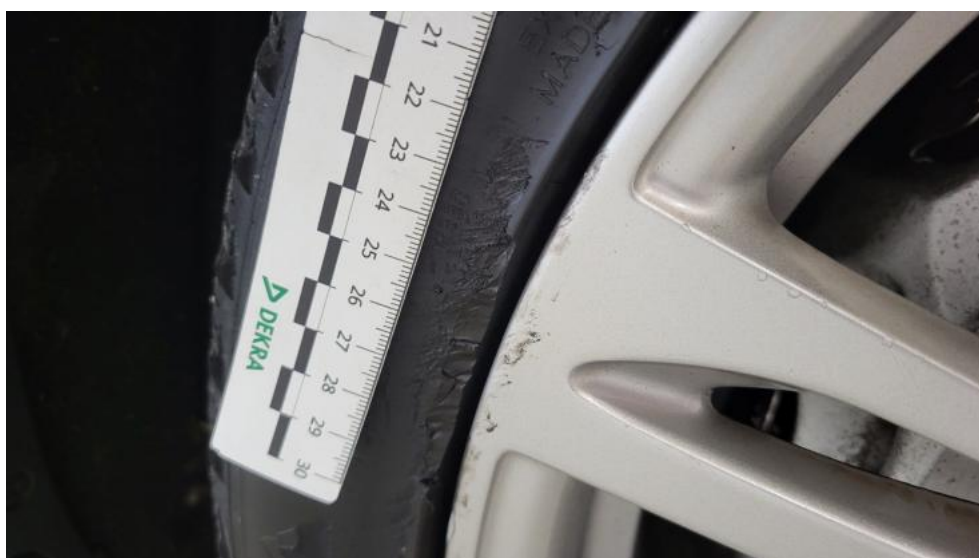
**Photo 54.**

Opona przednia P - Pęknięcie/rozerwanie 1

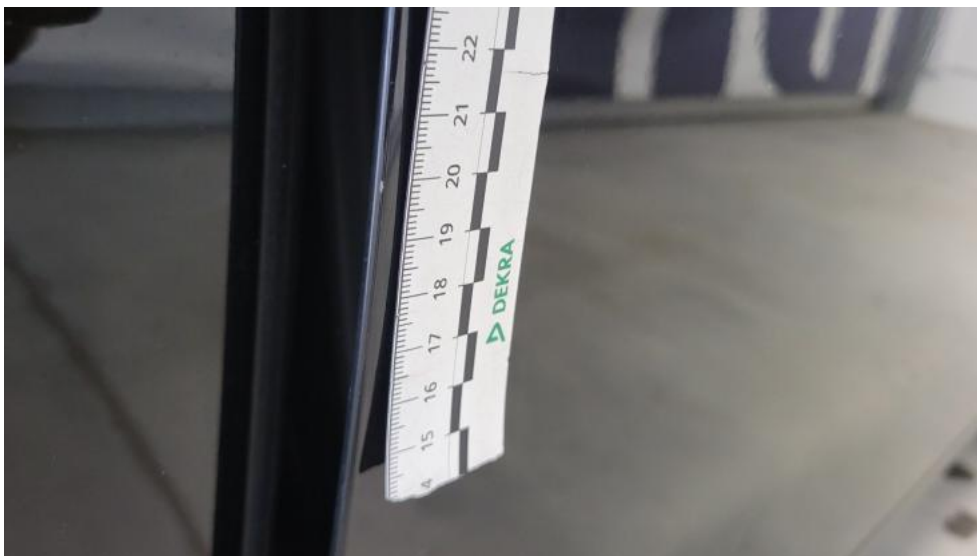
**Photo 55.**

Drzwi przednie P - Rysa/odprysk 1

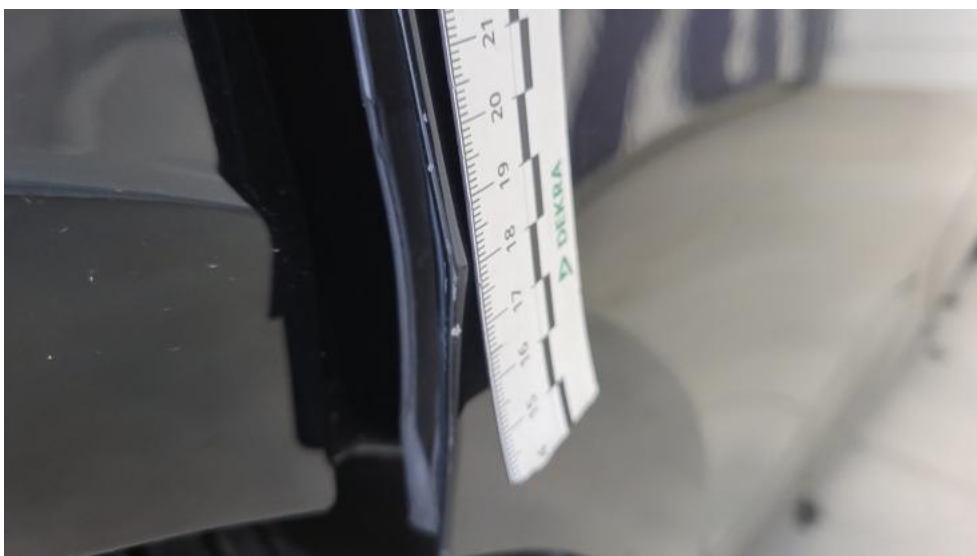
**Photo 56.**

Drzwi tylne P - Rysa/odprysk 1

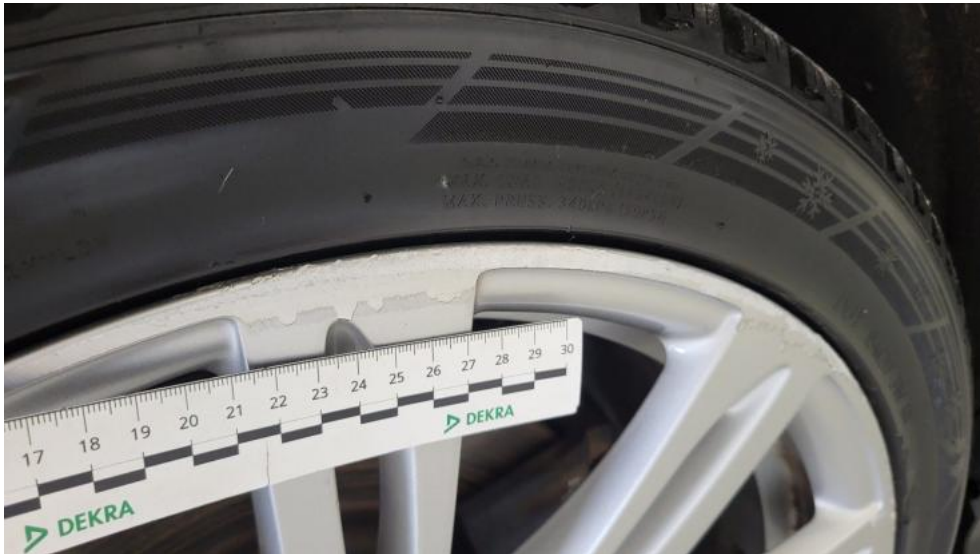
**Photo 57.**

Felga aluminiowa tylna P - Rysa/odprysk 1

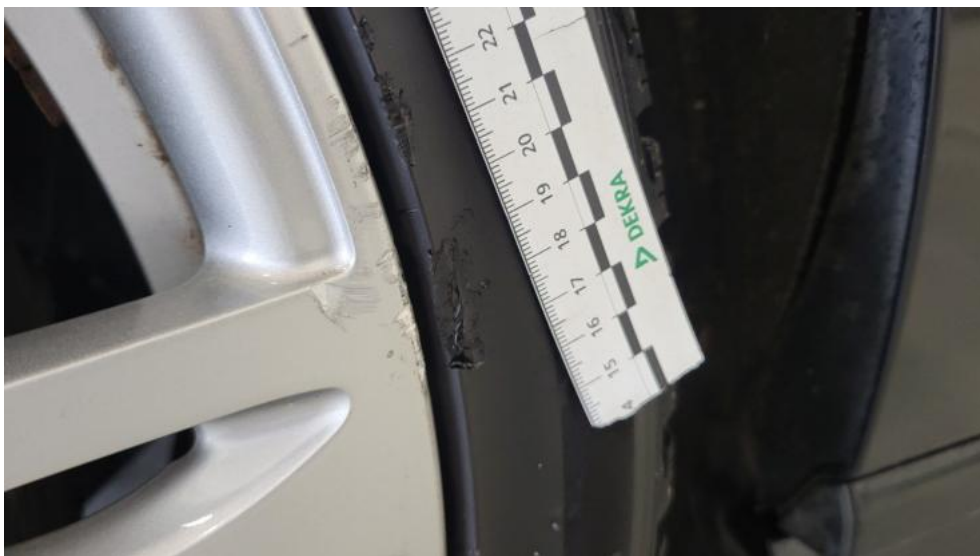
**Photo 58.**

Opona tylna P - Pęknięcie/rozerwanie 1

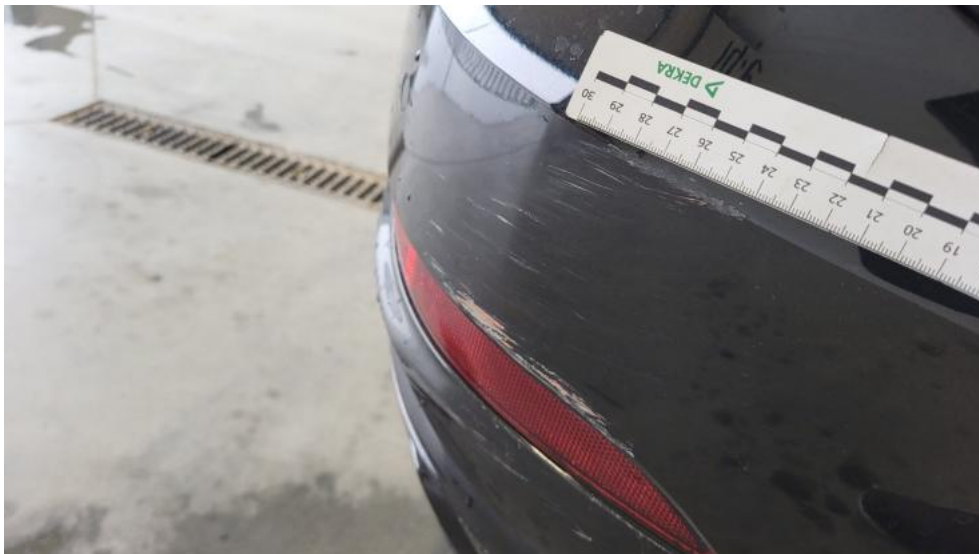
**Photo 59.**

Zderzak tylny - Rysa/odprysk 1

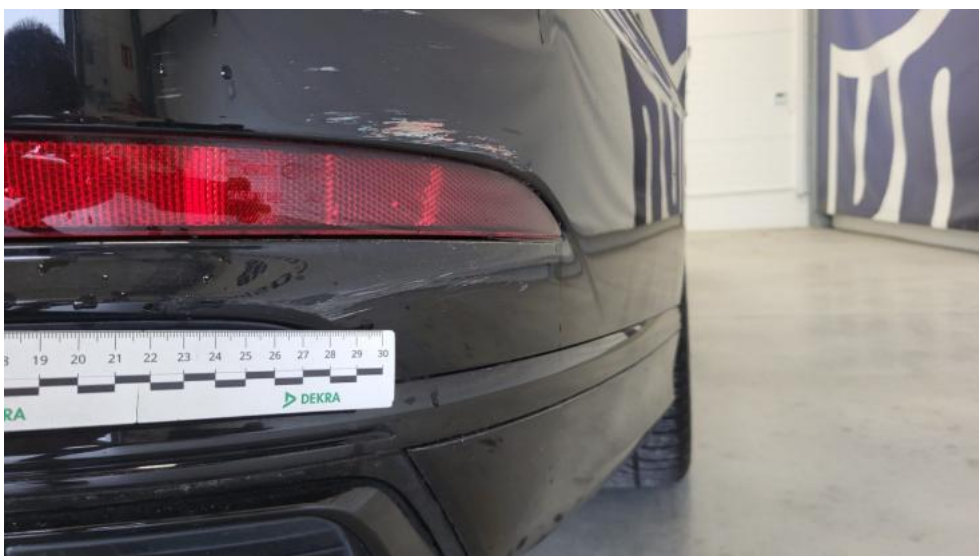
**Photo 60.**

Zderzak tylny - Rysa/odprysk 2

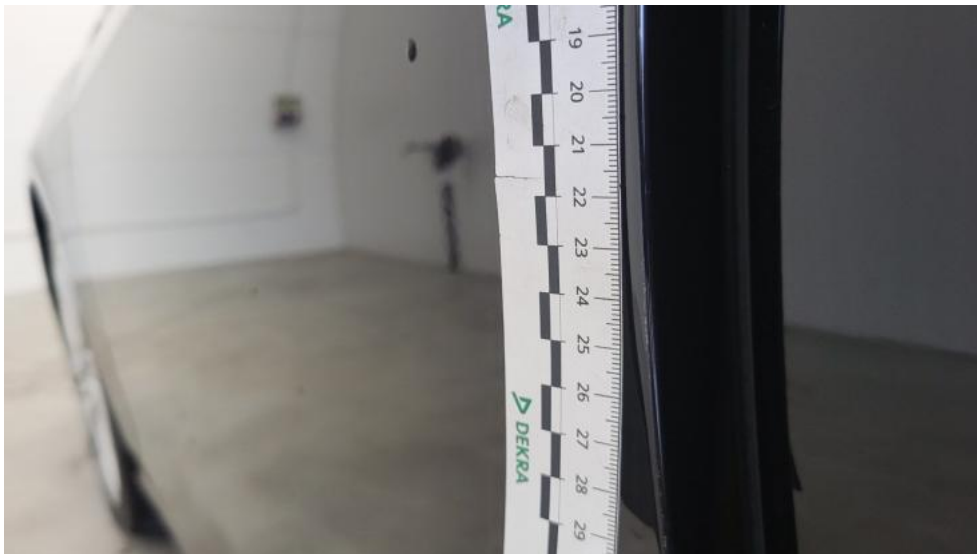
**Photo 61.**

Drzwi przed L - Rysa/odprysk 1

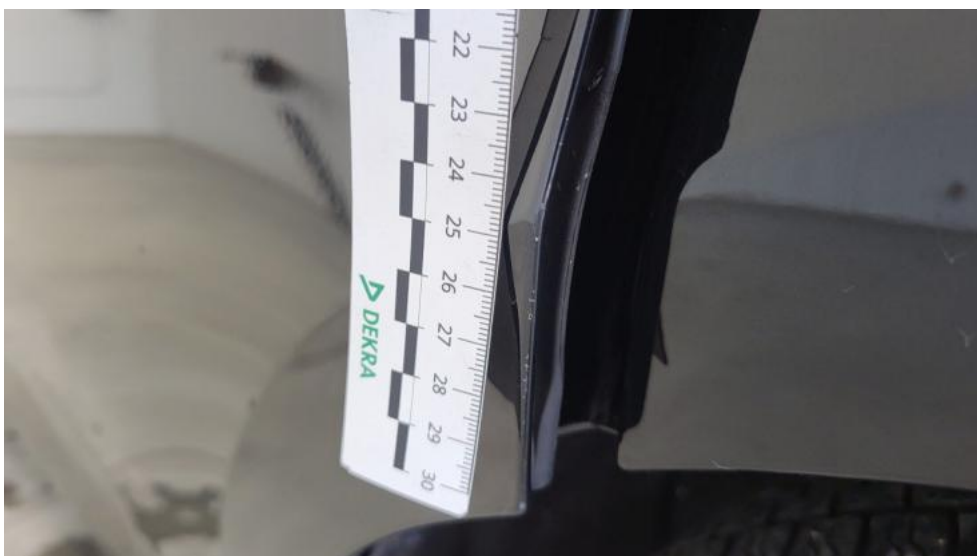
**Photo 62.**

Drzwi tylne L - Rysa/odprysk 1

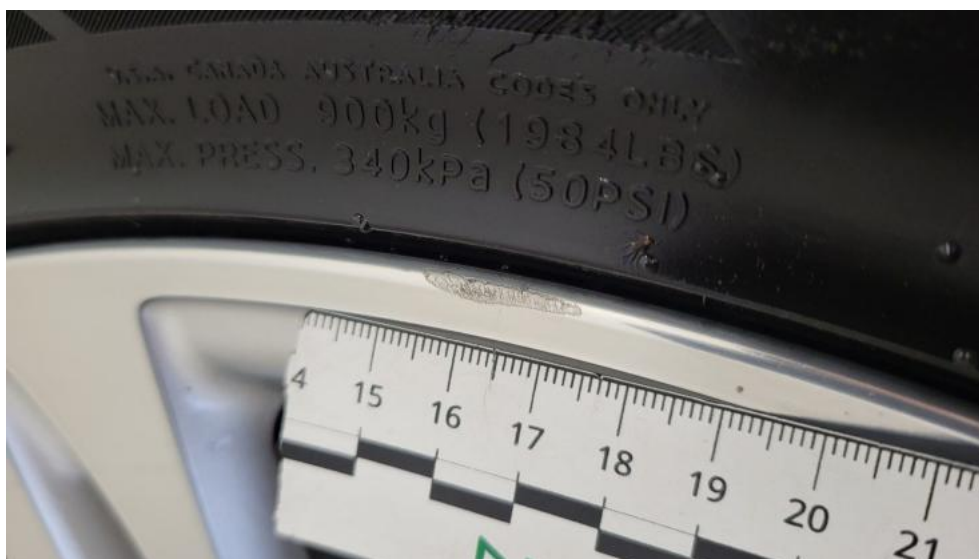
**Photo 63.**

Felga Aluminiowa przednia L - Rysa/odprysk 1

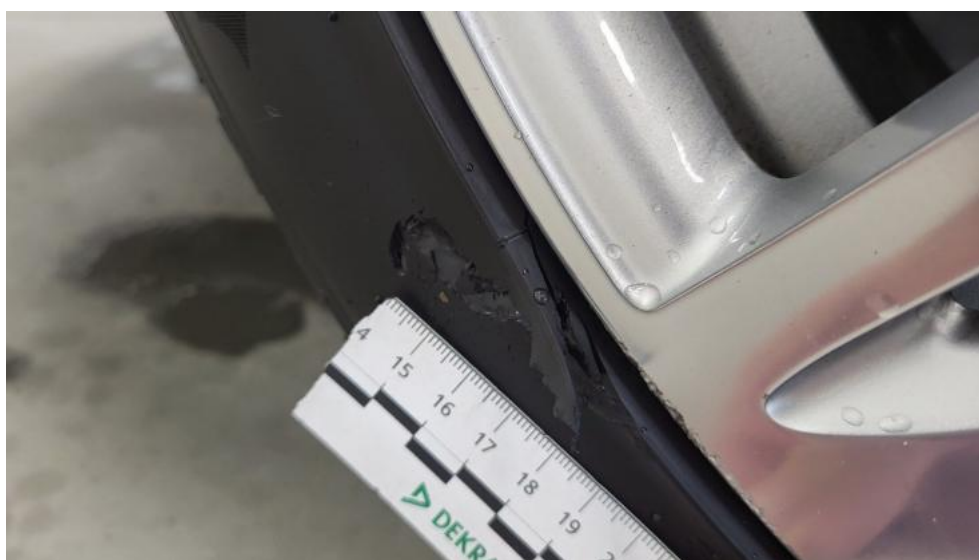
**Photo 64.**

Opona przednia L - Pęknięcie/rozerwanie 1

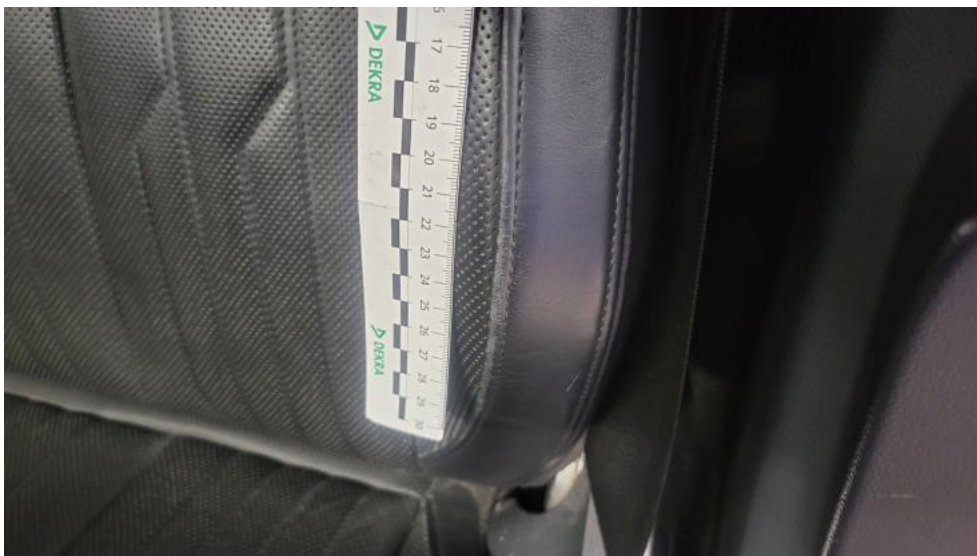
**Photo 65.**

Fotel prz. lew. - Rysa/odprysk 1

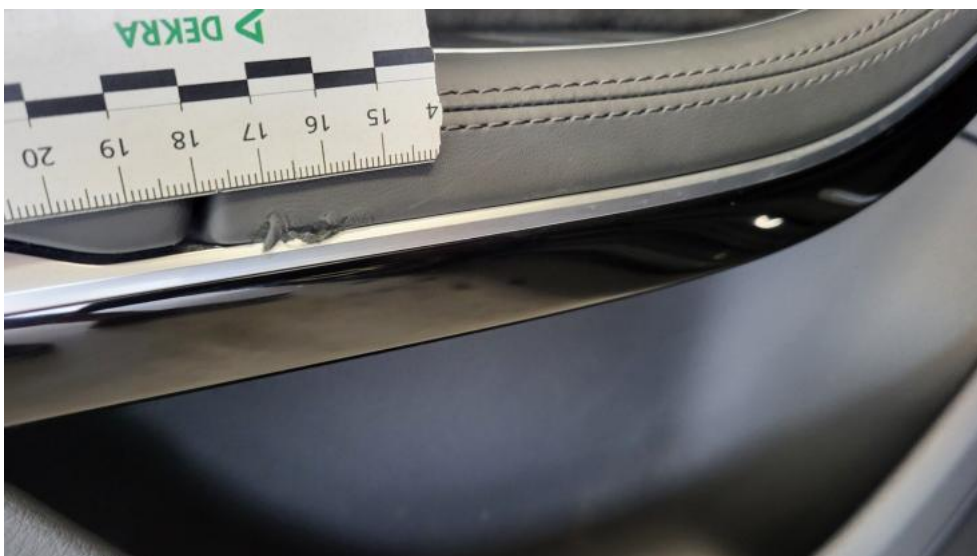
**Photo 66.**

Uchwyt drzwi tyl L - Pęknięcie/rozerwanie 1
