DEKRA's commission No. : PKOL(W)/LODZ/85606/25/11/05  
commission/ damage No. : 21/055223  
Date of commission: 05-11-2025

**Vehicle data**

| Manufacturer | RENAULT |
| Model | Arkana 21-23 |

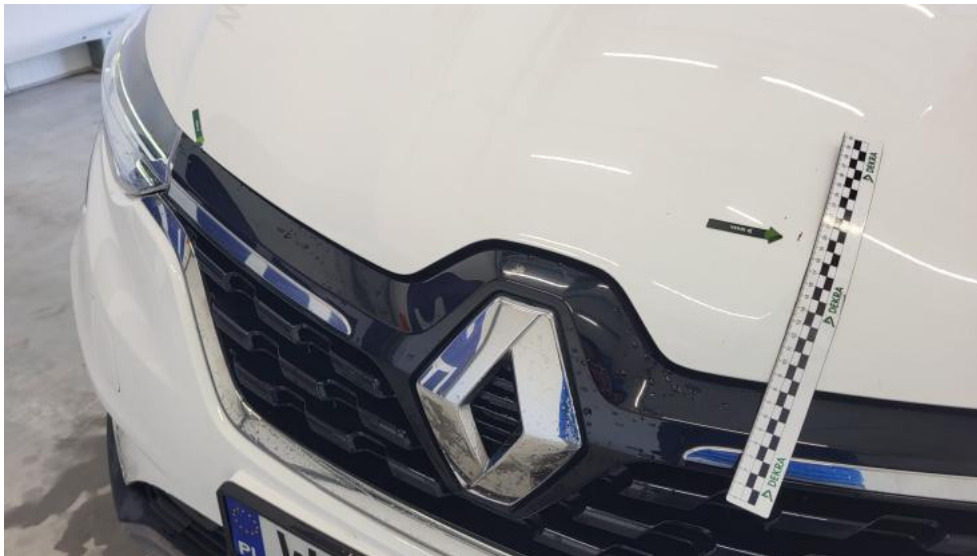
**Photo 37.**

Pokrywa komory silnika - zdjęcie pogładowe 1

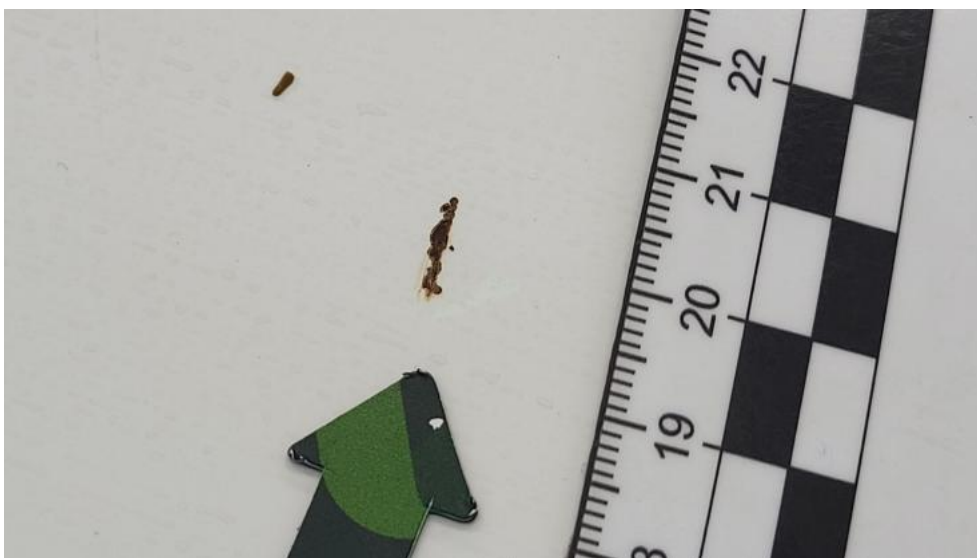
**Photo 38.**

Pokrywa komory silnika - Inne 1

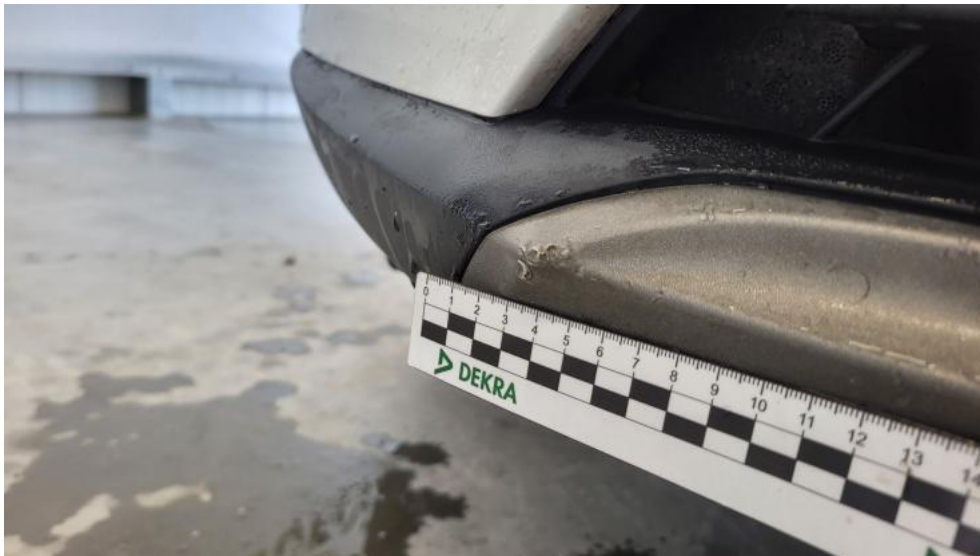
**Photo 39.**

Spoiler zderzaka przedniego - Rysa/odprysk 1

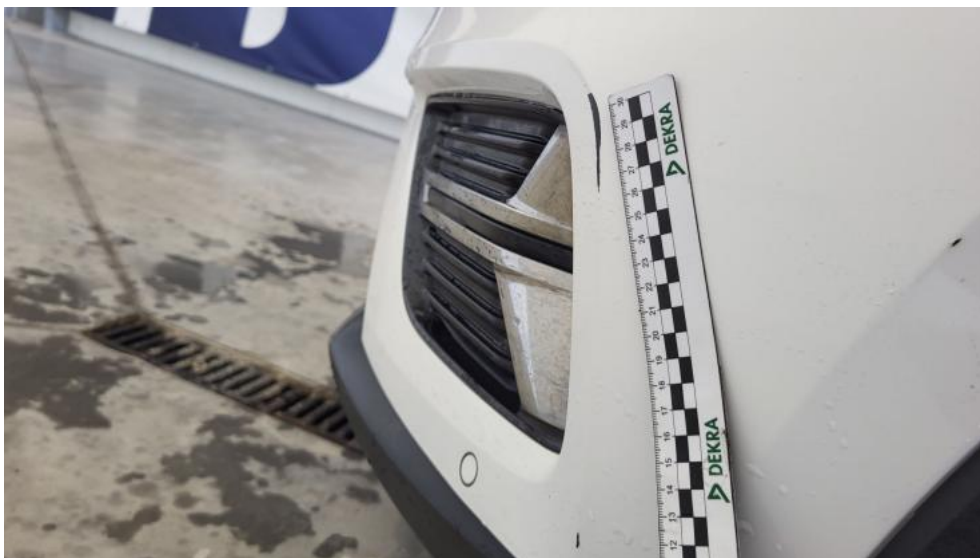
**Photo 40.**

Zderzak - Rysa/odprysk 1

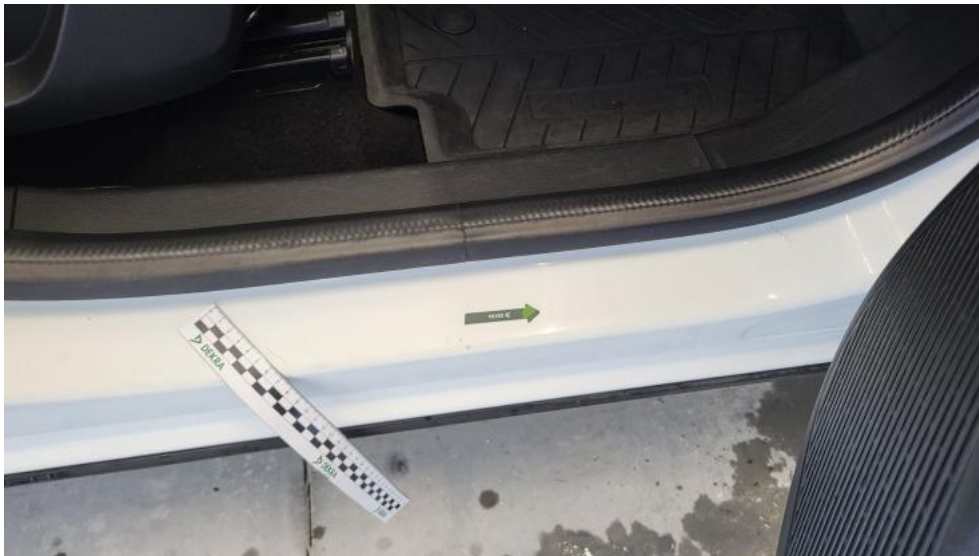
**Photo 43.**

Próg P - Wgniecenie/odkształcenie 1

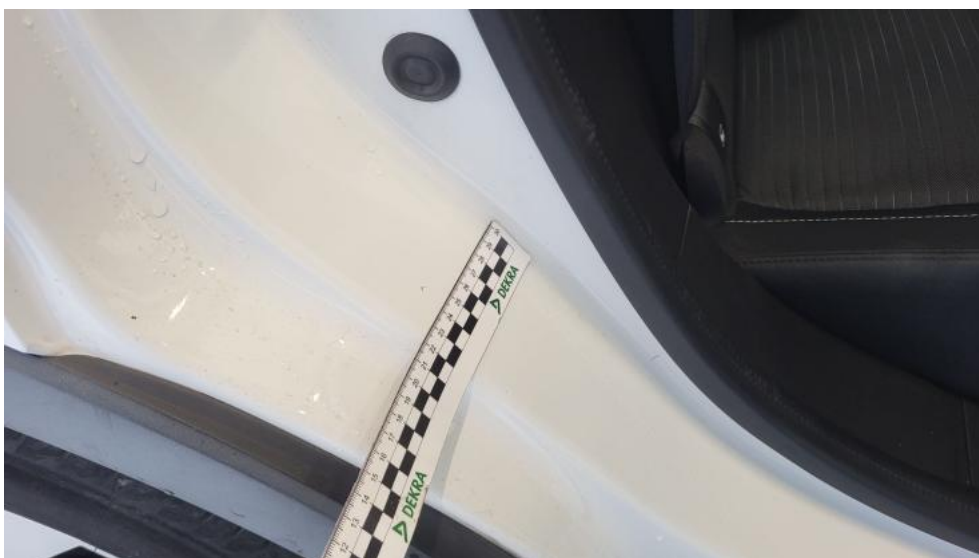
**Photo 44.**

Błotnik tylny P / Ściana boczna P - Rysa/odprysk 1

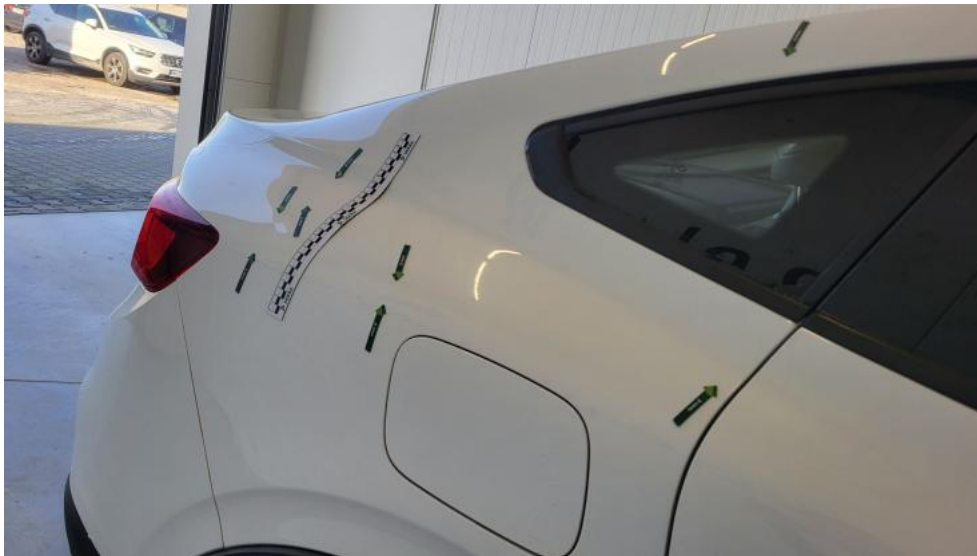
**Photo 45.**

Błotnik tylny P / Ściana boczna P - Wgniecenie/odkształcenie 1

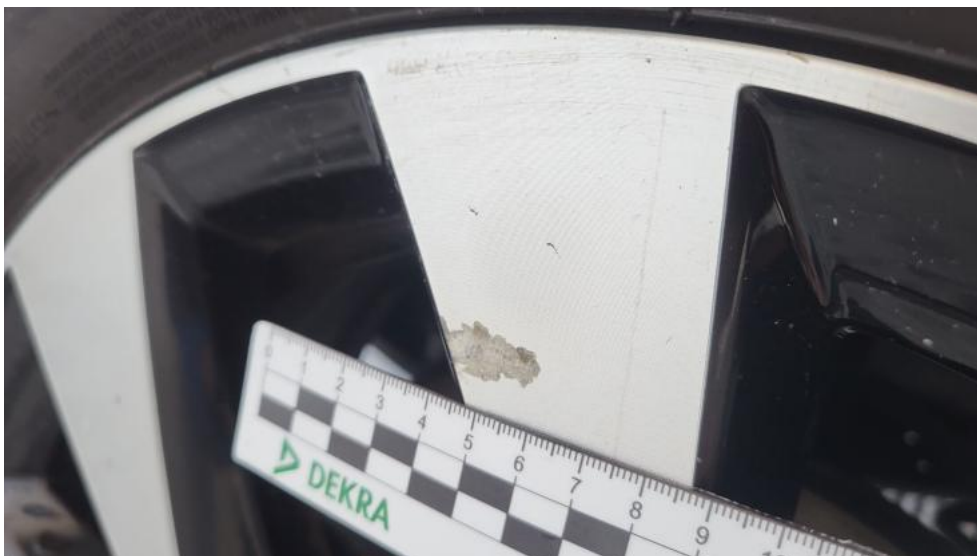
**Photo 46.**

Felga aluminiowa tylna P - Rysa/odprysk 1

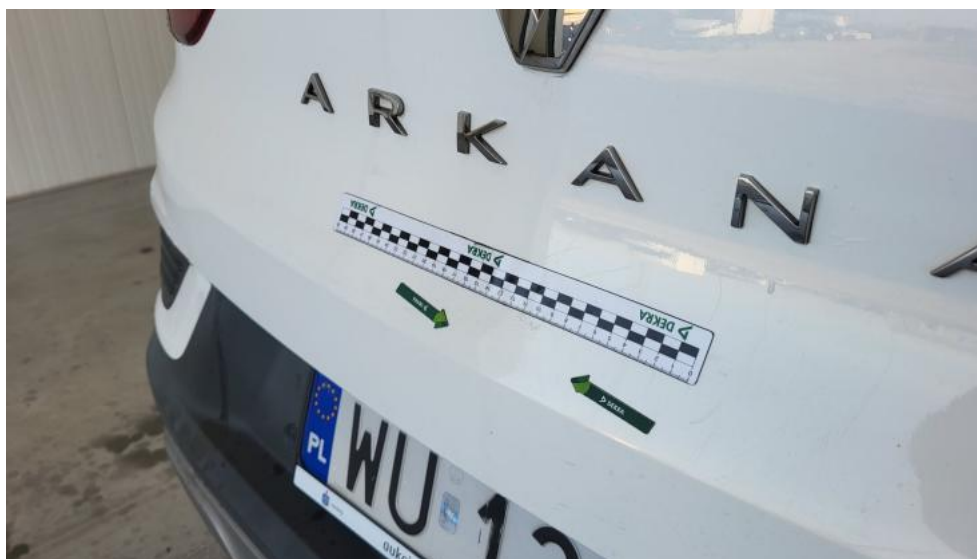
**Photo 47.**

Pokrywy bagażnika - Wgniecenie/odkształcenie 1

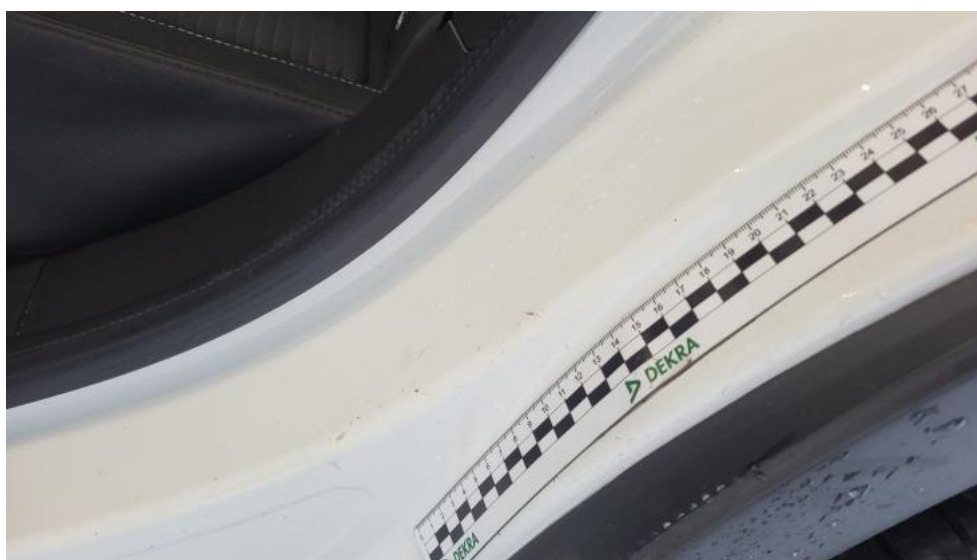
**Photo 48.**

Ścianka tylna L / Ścianka boczna L - Rysa/odprysk 1

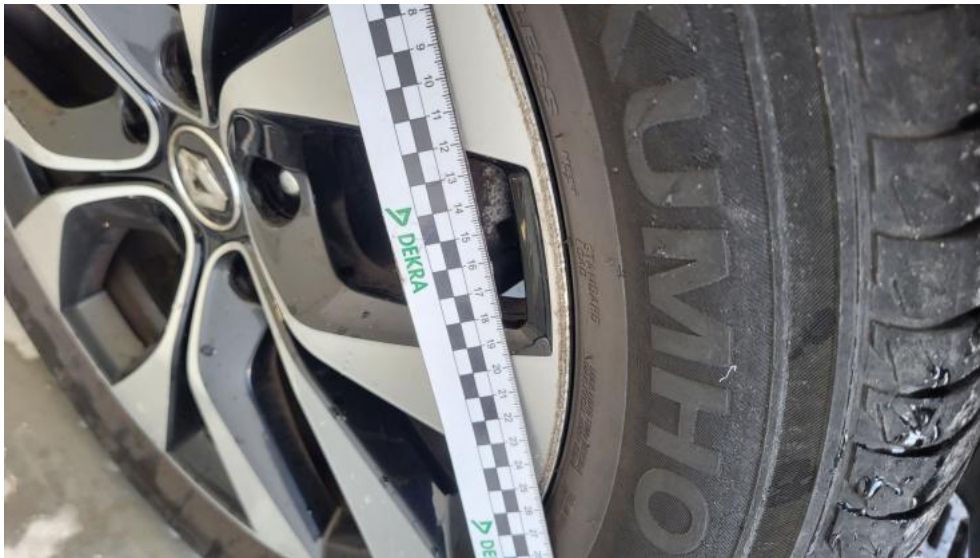
**Photo 51.**

Felga aluminiowa tylna L - Rysa/odprysk 1

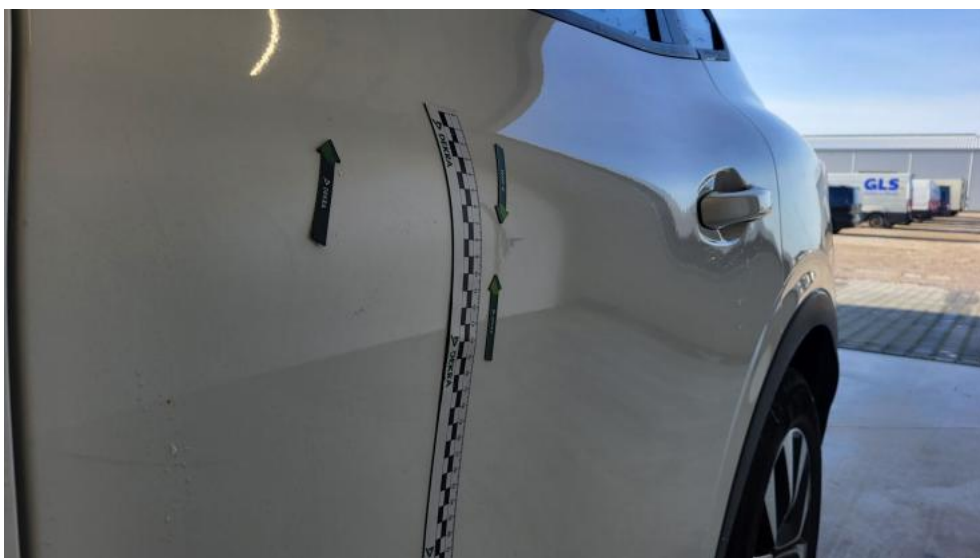
**Photo 52.**

Drzwi tylne L - Wgniecenie/odkształcenie 1

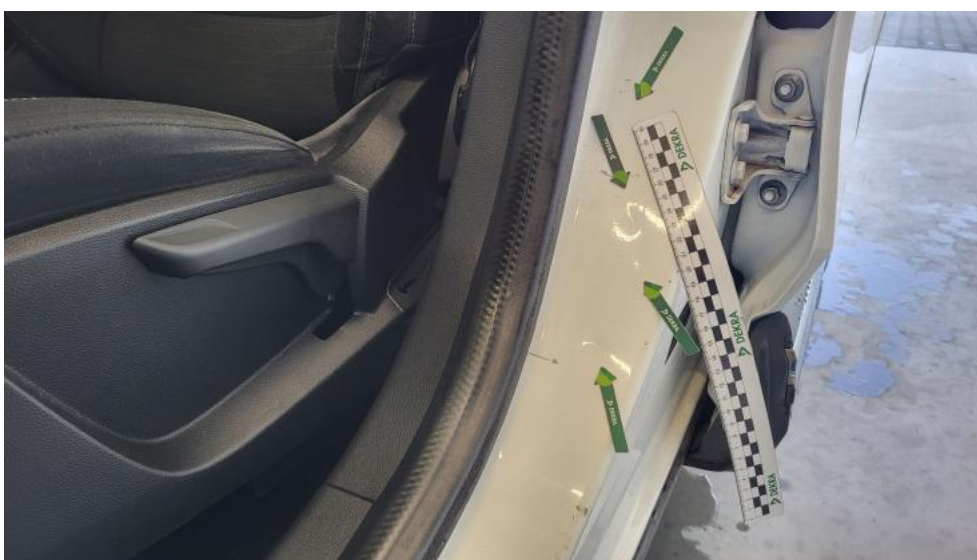
**Photo 54.**

Słupek środkowy L - Wgniecenie/odkształcenie 1

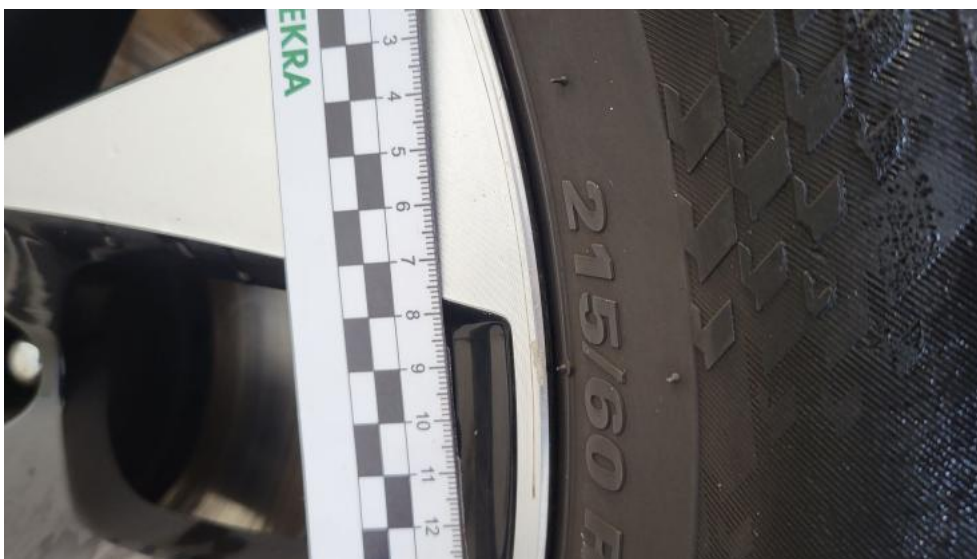
**Photo 55.**

Felga Aluminiowa przednia L - Rysa/odprysk 1

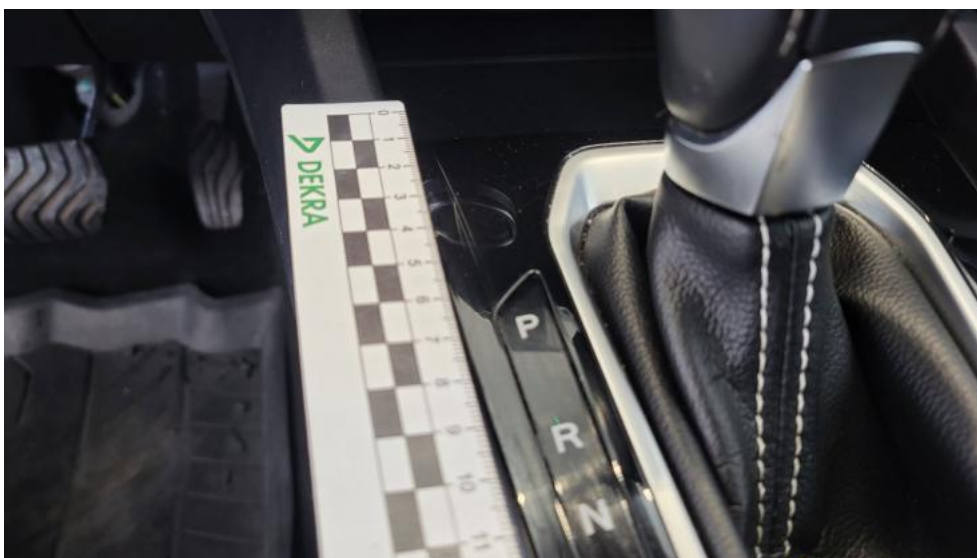
**Photo 56.**

Konsola tunelu śr. - Rysa/odprysk 1

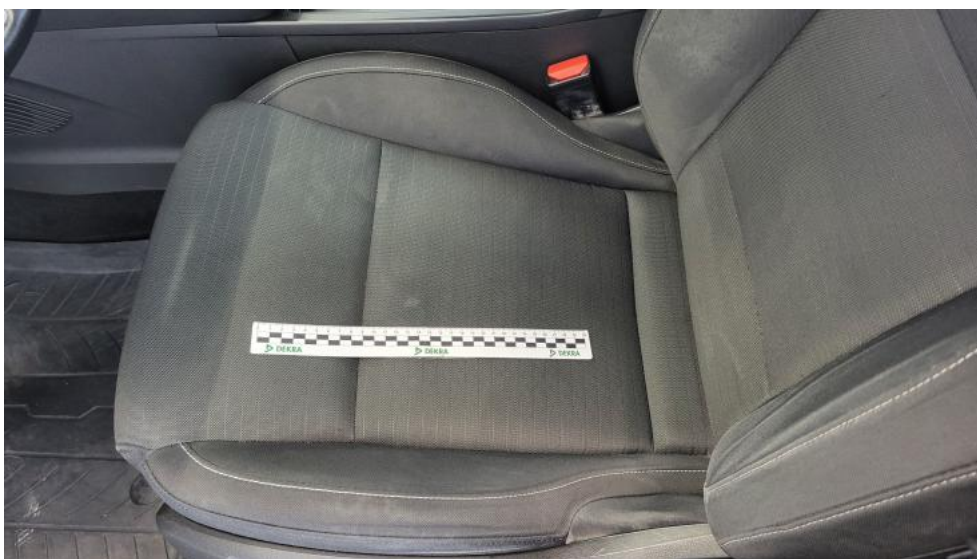
**Photo 57.**

Fotel prz. lew. - Inne 1

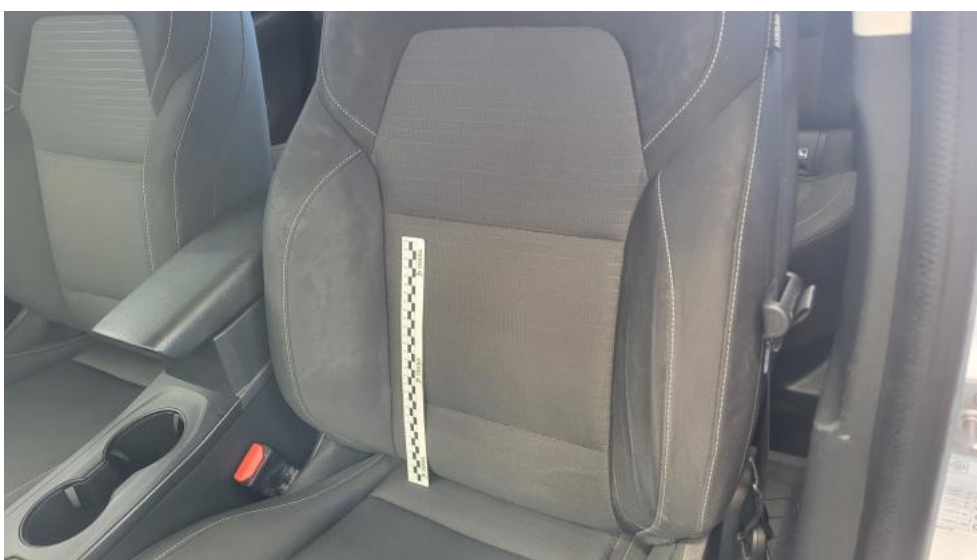
**Photo 58.**

Fotel prz. lew. - Inne 2

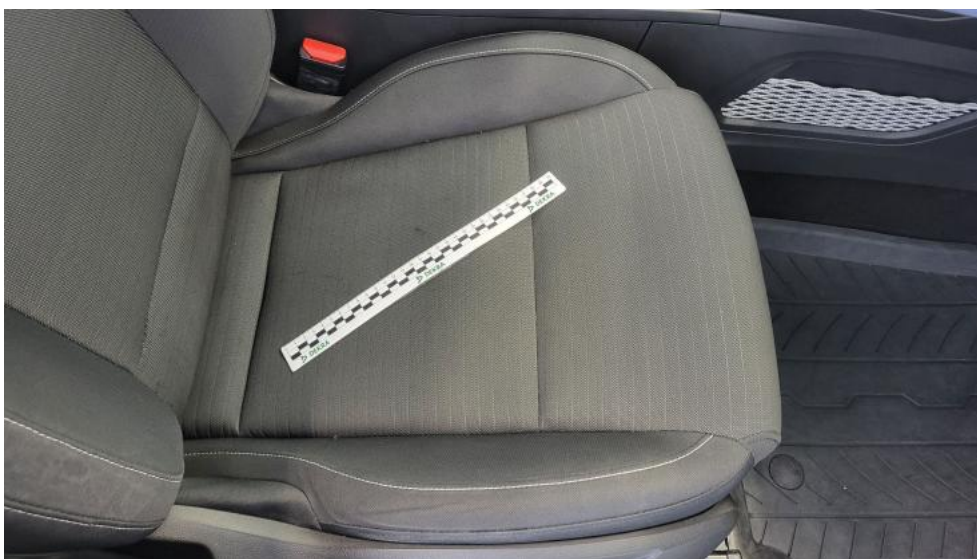
**Photo 59.**

Fotel prz. praw. - Inne 1

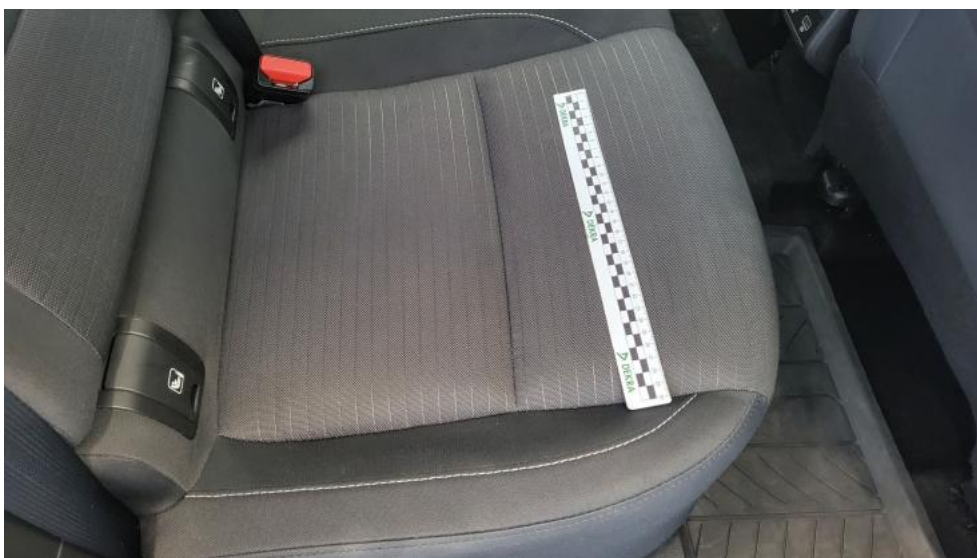
**Photo 60.**

Kanapa tyl. - Inne 1

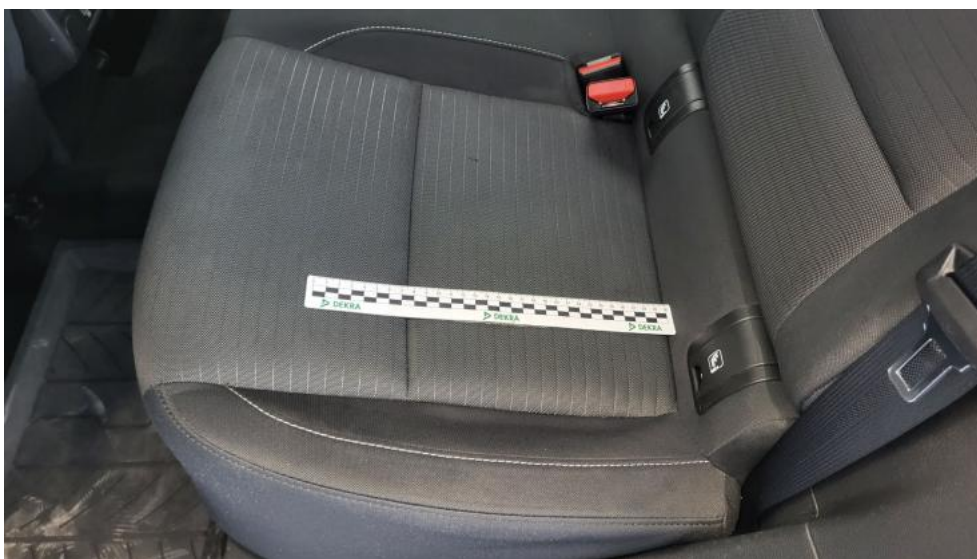
**Photo 61.**  
Kanapa tyl. - Inne 2

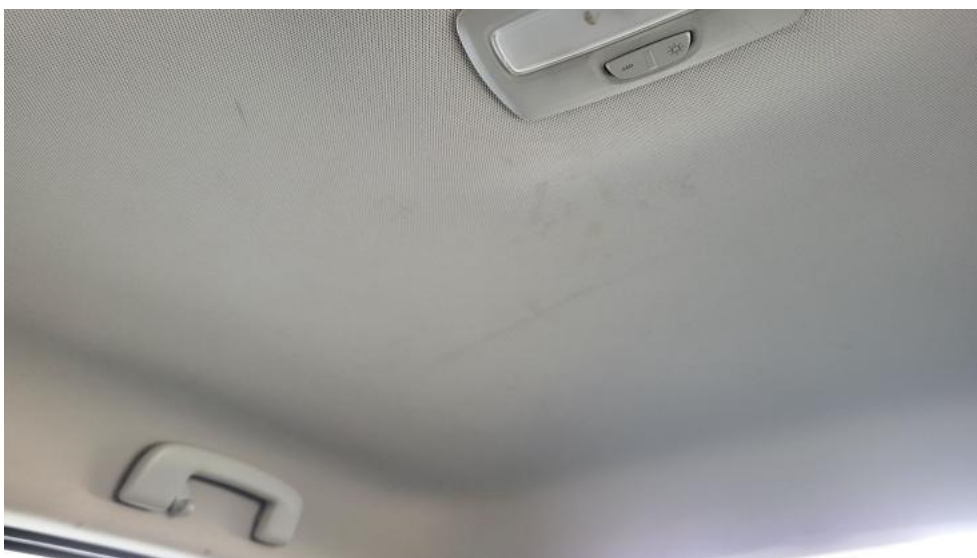
**Photo 62.**  
Podsufitka - Inne 1

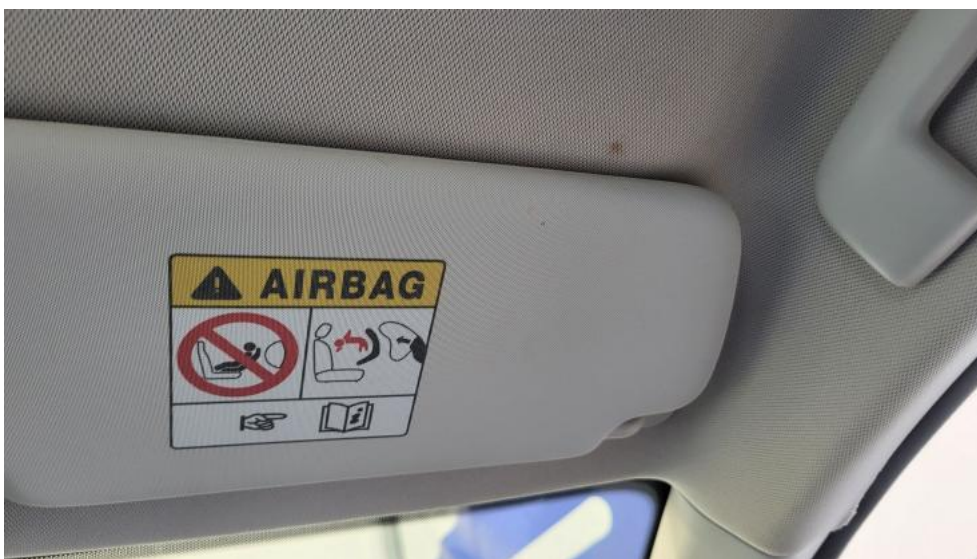
**Photo 63.**  
Podsufitka - Inne 2

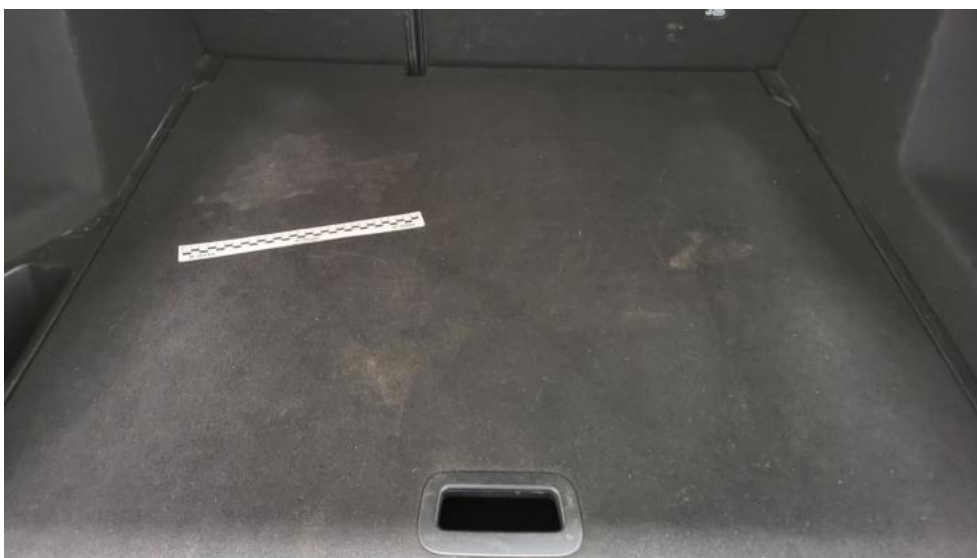
**Photo 64.**  
Wykładzina podłogi bagażnika - Inne 1

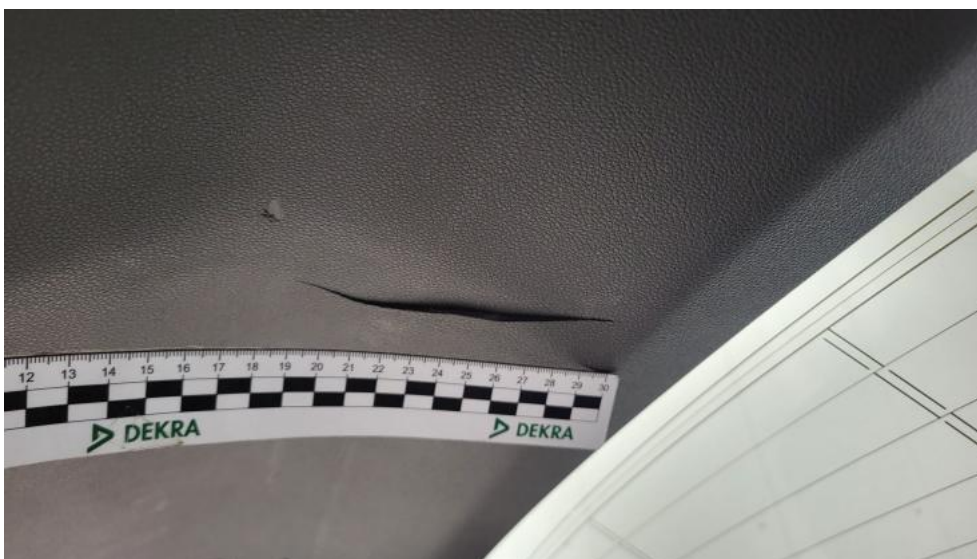
**Photo 65.**

Wykładzina pokrywy tylnej - Pęknięcie/rozerwanie 1
