DEKRA's commission No. : PKOL(W)/LODZ/72452/24/09/19
commission/ damage No. : 00469/LF/23
Date of commission: 19-09-2024

PKO Leasing SA
Świętokrzyska 36
00-116 Warszawa

Vehicle data

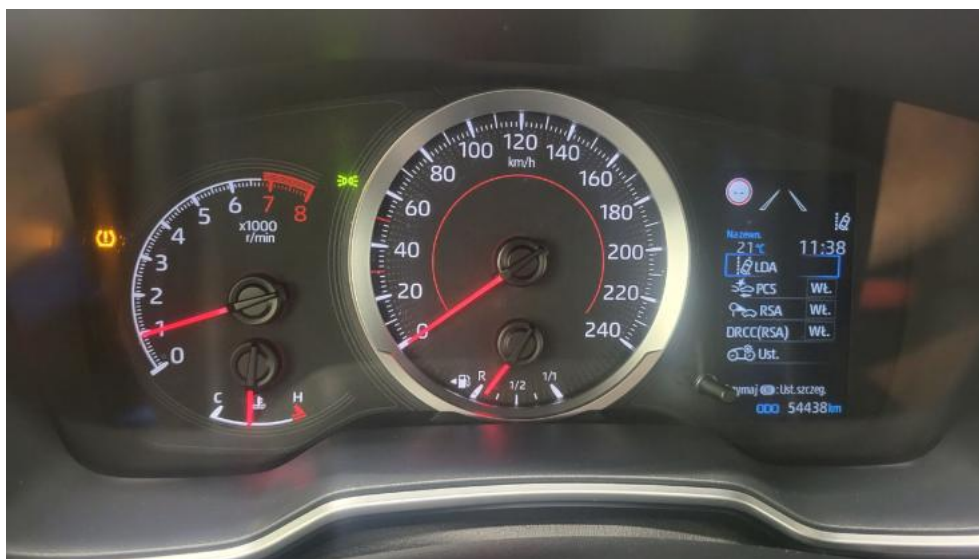
Rysy na samochodzie. Aktywna kontrolka ciśnienia w kołach.

Photo 25.
Zestaw wskaźników - serwis

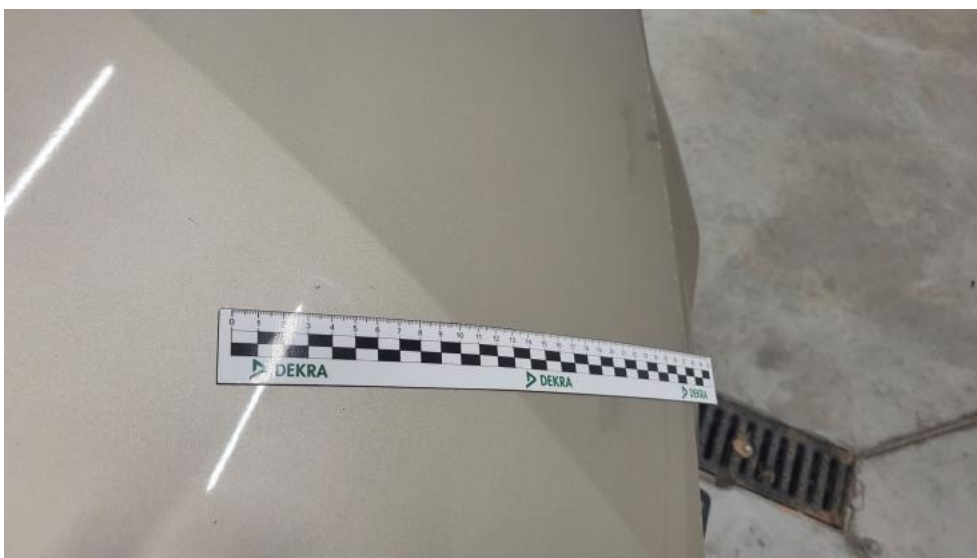
Photo 36.
Pokrywa komory silnika - Rysa/odprysk 1

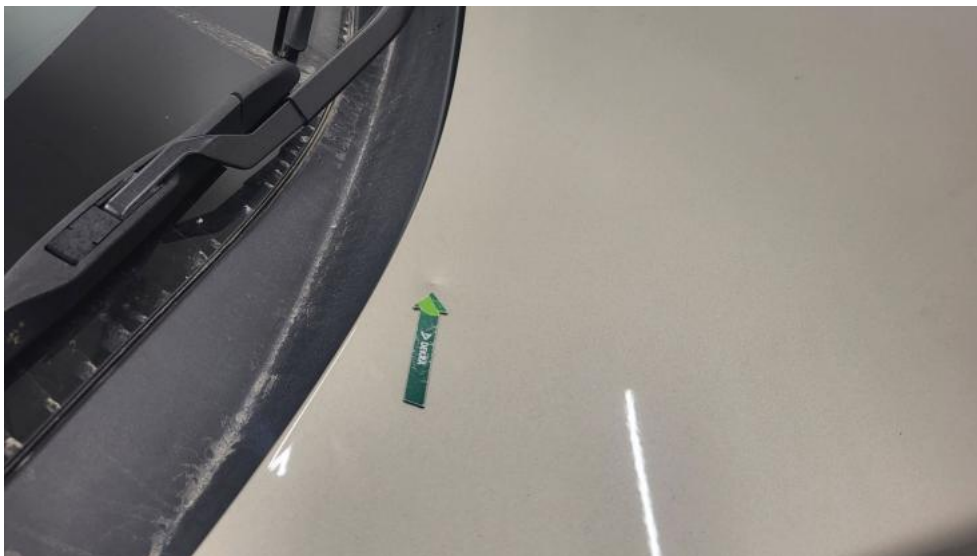
Photo 37.
Pokrywa komory silnika - Wgniecenie/odkształcenie 1

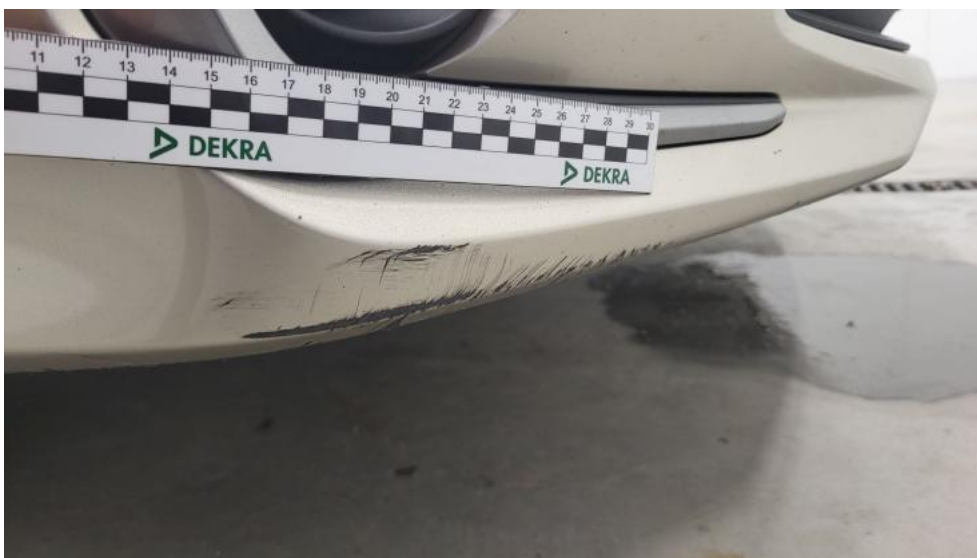
Photo 38.
Zderzak - Rysa/odprysk 1

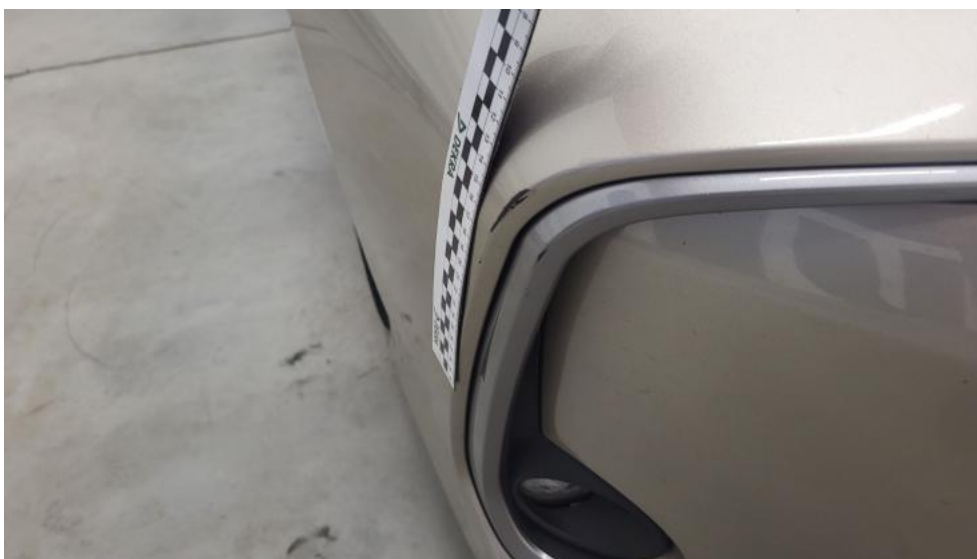
Photo 39.
Zderzak - Rysa/odprysk 2

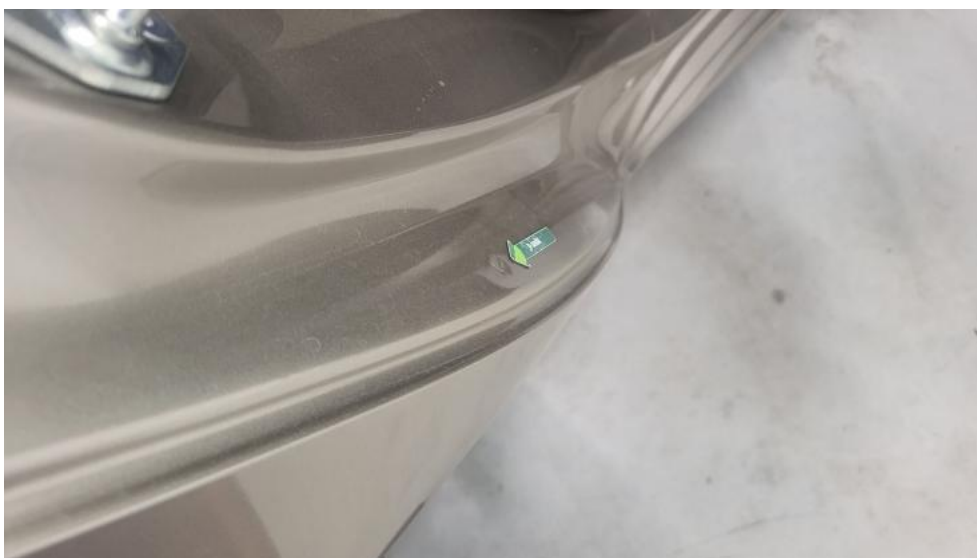
Photo 40.
Słupek tylny prawy - Wgniecenie/odkształcenie 1

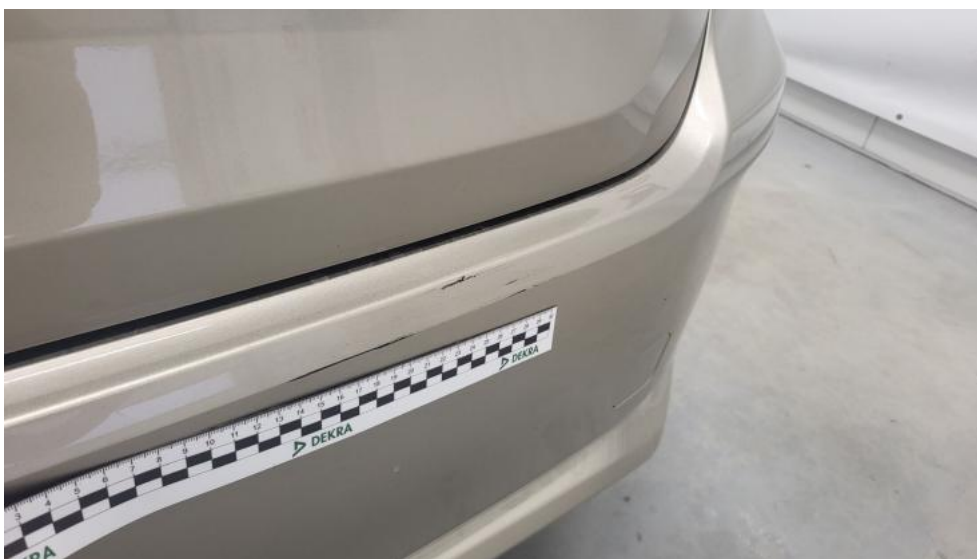
Photo 41.

Zderzak tylny - Rysa/odprysk 1

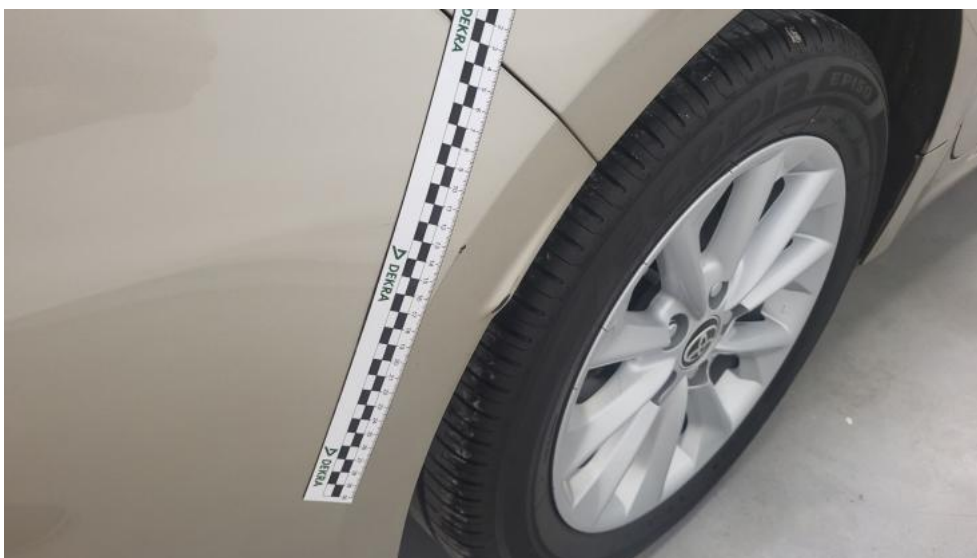
Photo 42.

Zderzak tylny - Rysa/odprysk 2

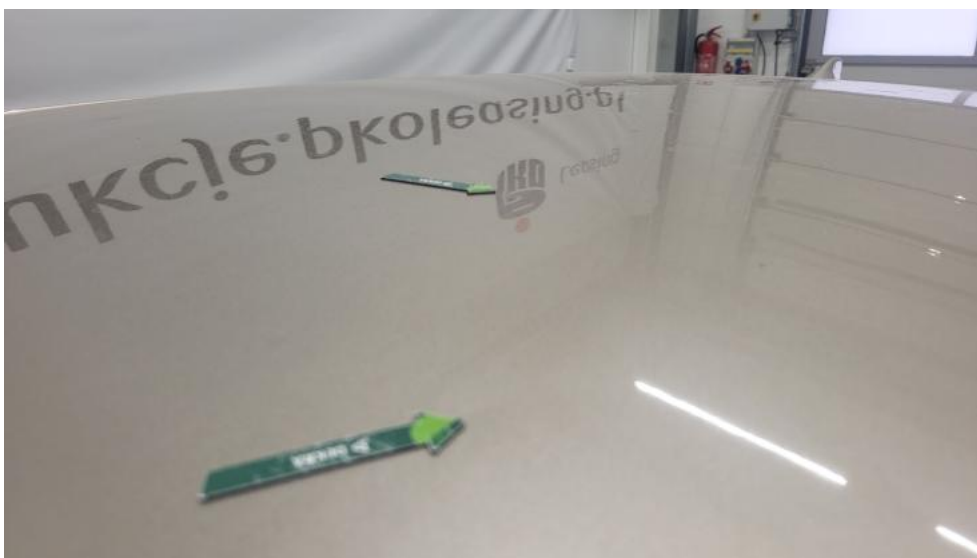
Photo 44.
Dach - Wgniecenie/odkształcenie 1

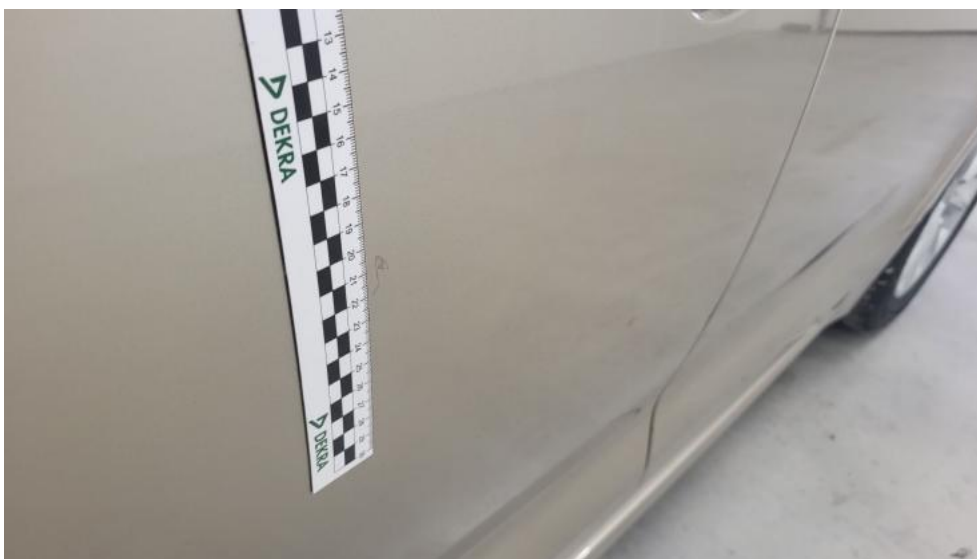
Photo 45.

Drzwi przed L - Rysa/odprysk 1

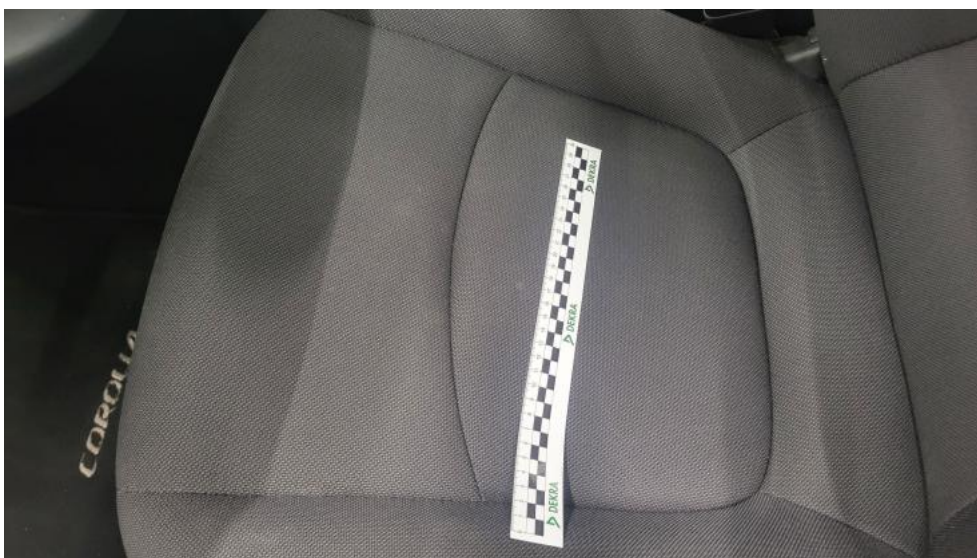
Photo 46.

Fotel prz. lew. - Inne 1
