DEKRA's commission No. : PKOL(W)/LODZ/07468/26/01/29  
commission/ damage No. : 22/015906  
Date of commission: 29-01-2026

| Manufacturer | OPEL |
| Model | Mokka 20-24 |
| Registration /record No. | TK270AY |

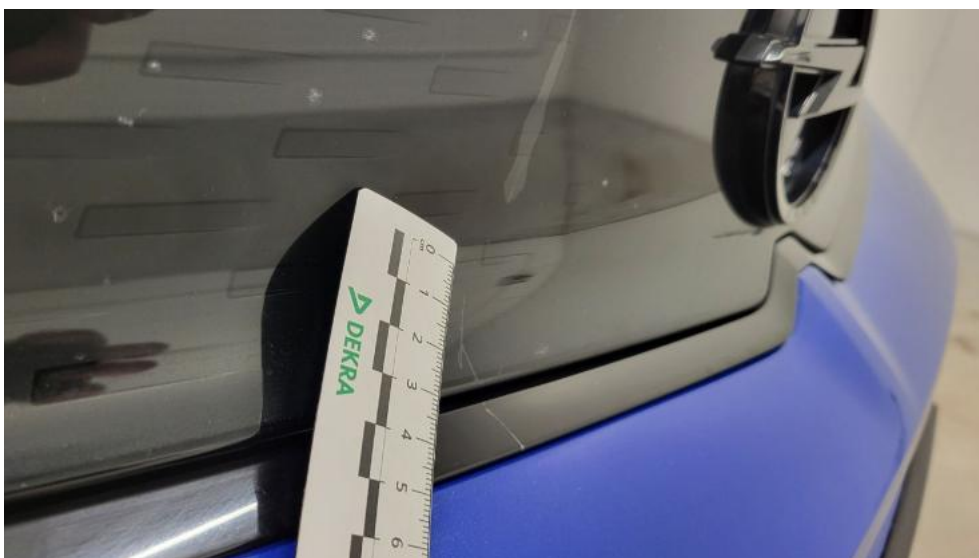
**Photo 38.**

Atrapa przednia - Rysa/odprysk 1

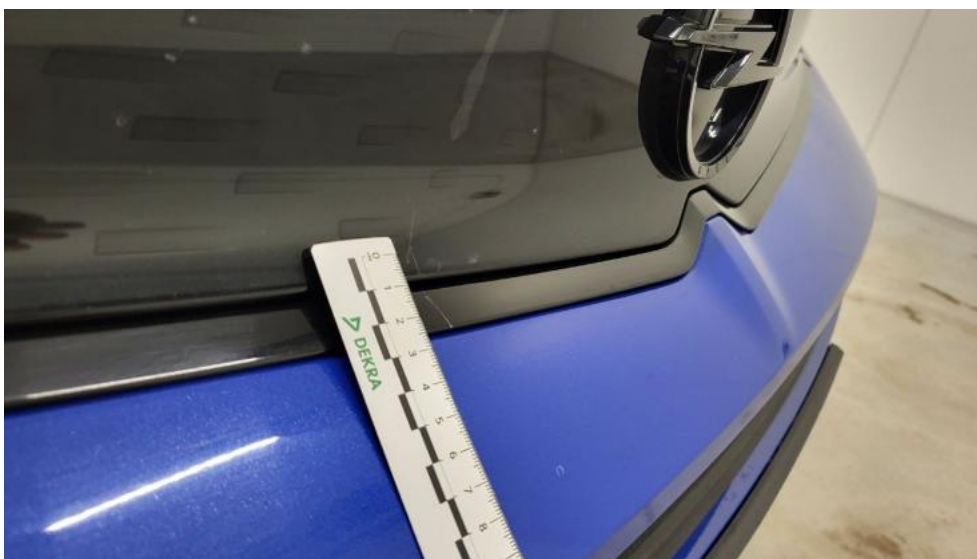
**Photo 39.**

Listwa śr zderzaka przedniego - Rysa/odprysk 1

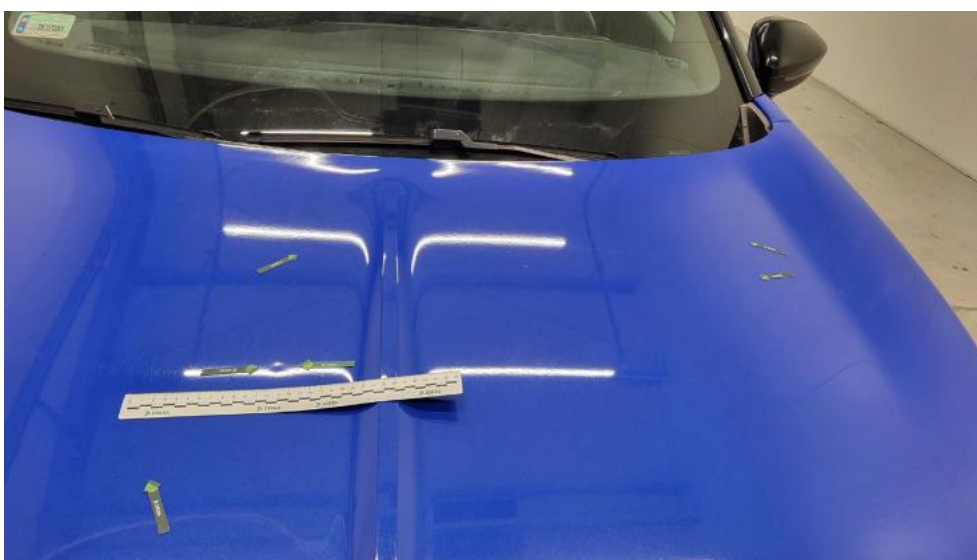
**Photo 40.**

Pokrywa komory silnika - Wgniecenie/odkształcenie 1

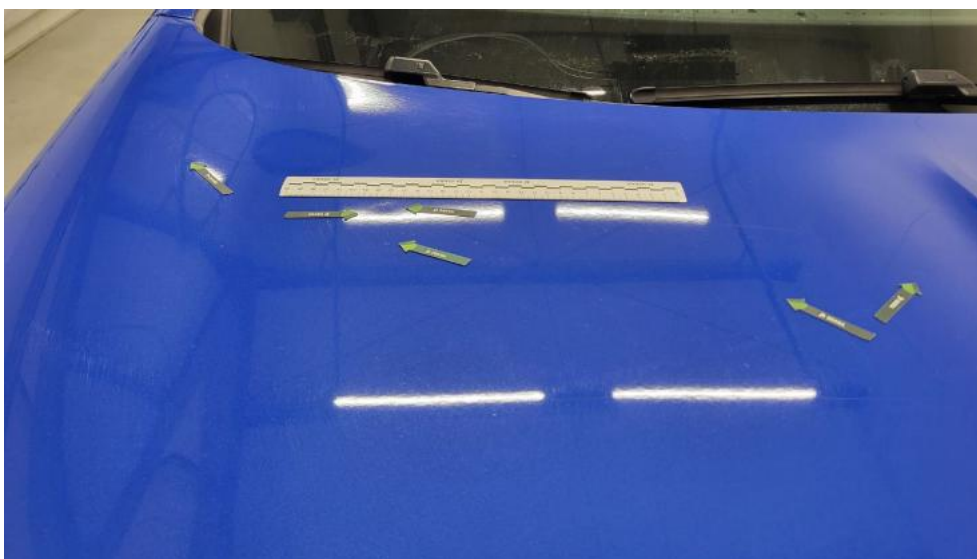
**Photo 41.**

Pokrywa komory silnika - Wgniecenie/odkształcenie 2

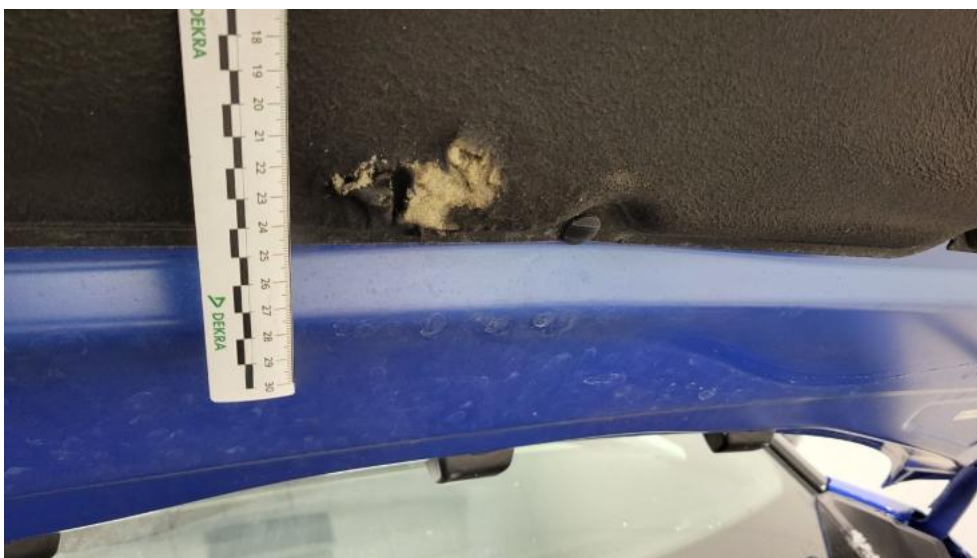
**Photo 42.**

Wykładzina pokrywy komory silnika - Pęknięcie/rozerwanie 1

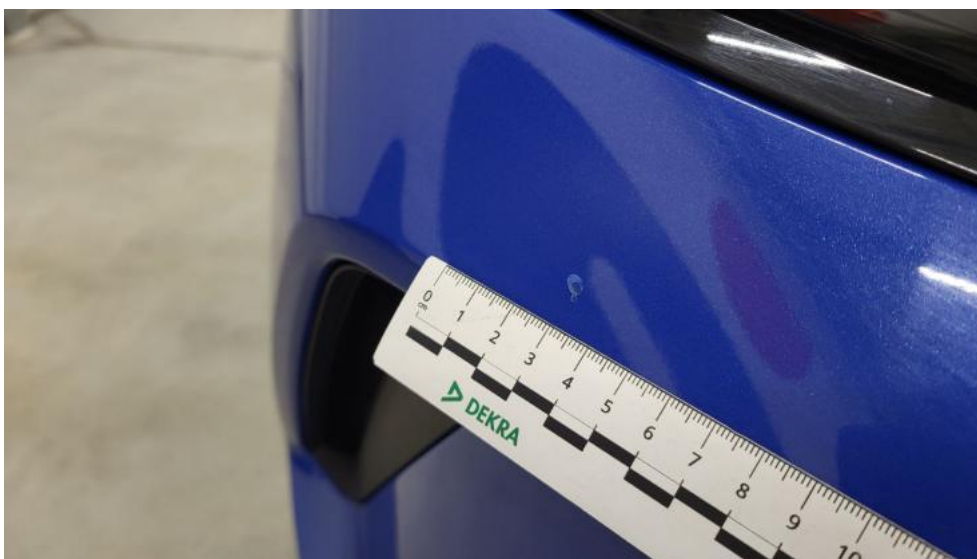
**Photo 43.**

Zderzak - Rysa/odprysk 1

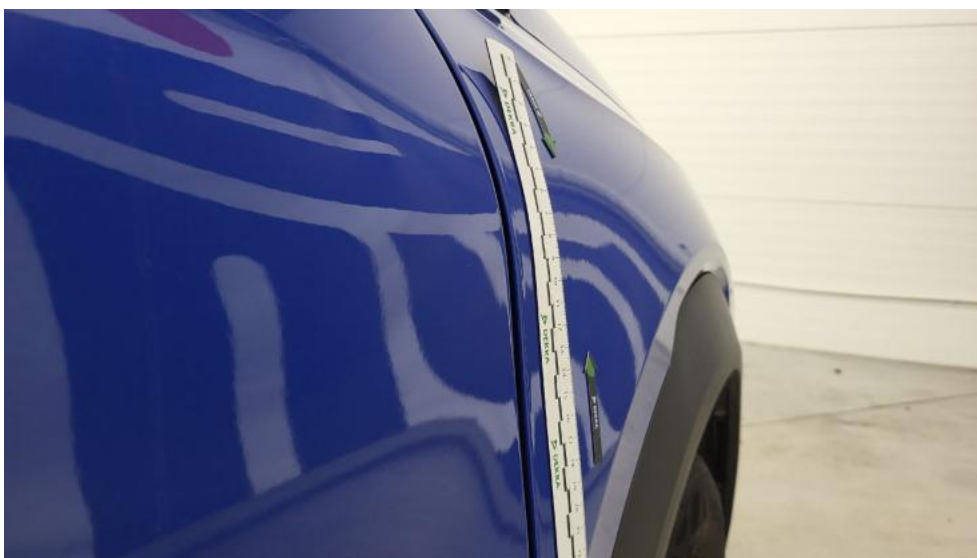
**Photo 44.**

Łotnik przedni P - Wgniecenie/odkształcenie 1

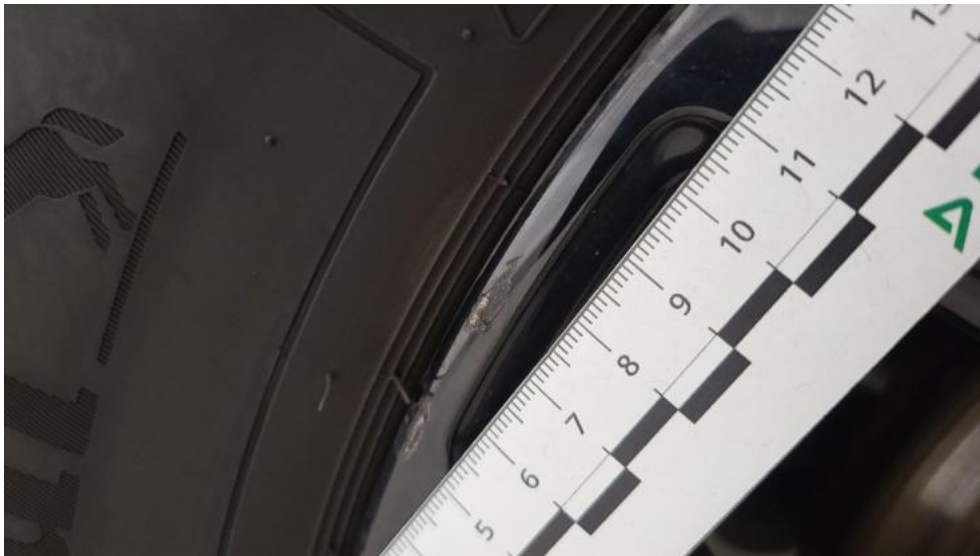
**Photo 45.**

Felga aluminiowa przednia P - Rysa/odprysk 1

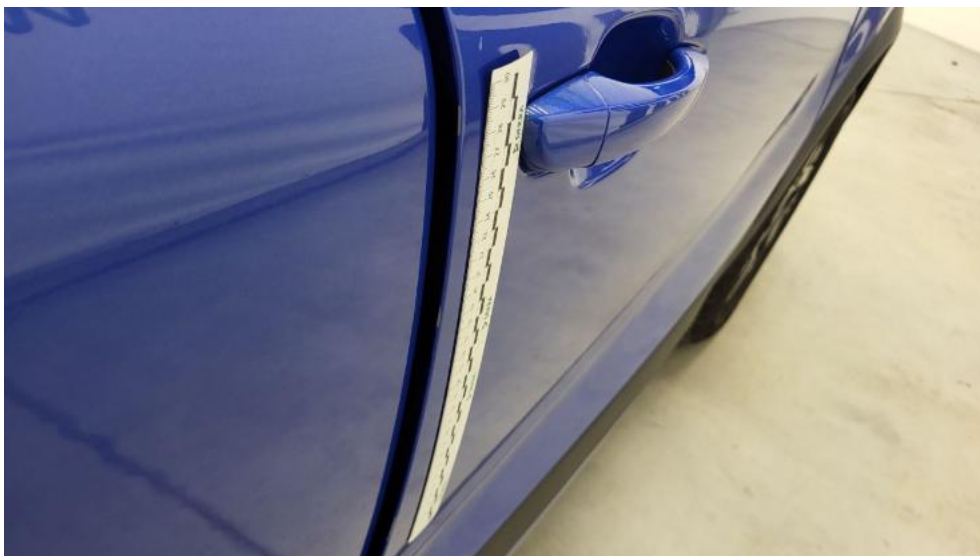
**Photo 46.**

Drzwi przednie P - Rysa/odprysk 1

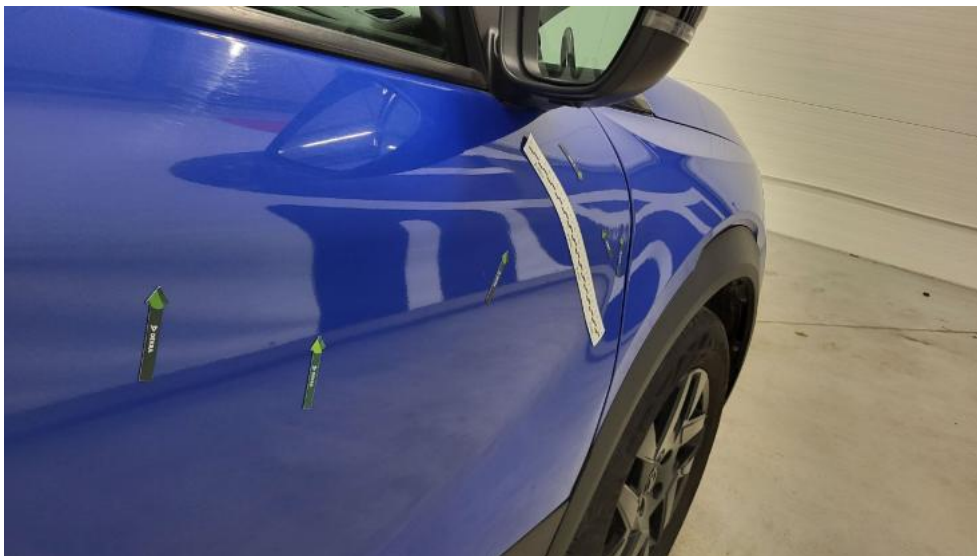
**Photo 47.**

Drzwi przednie P - Wgniecenie/odkształcenie 1

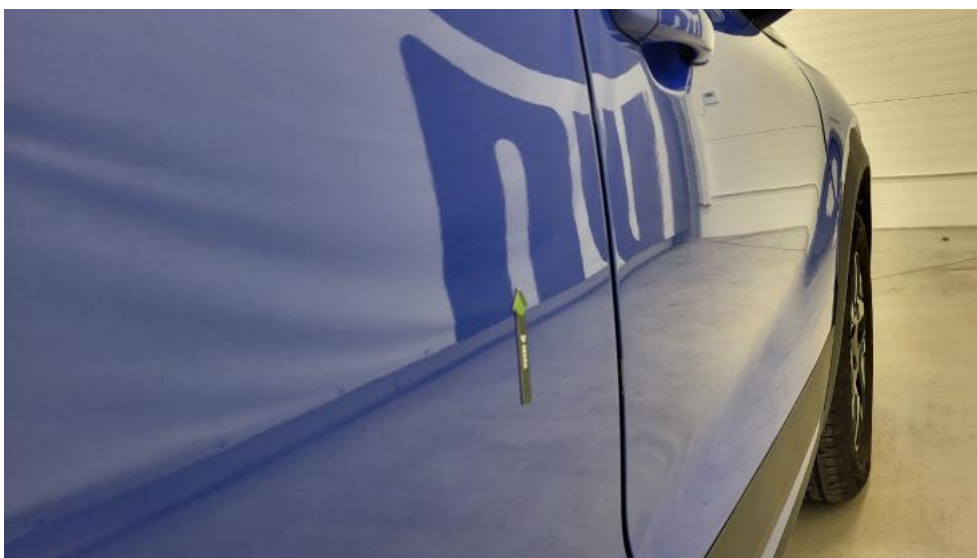
**Photo 48.**

Drzwi tylne P - Wgniecenie/odkształcenie 1

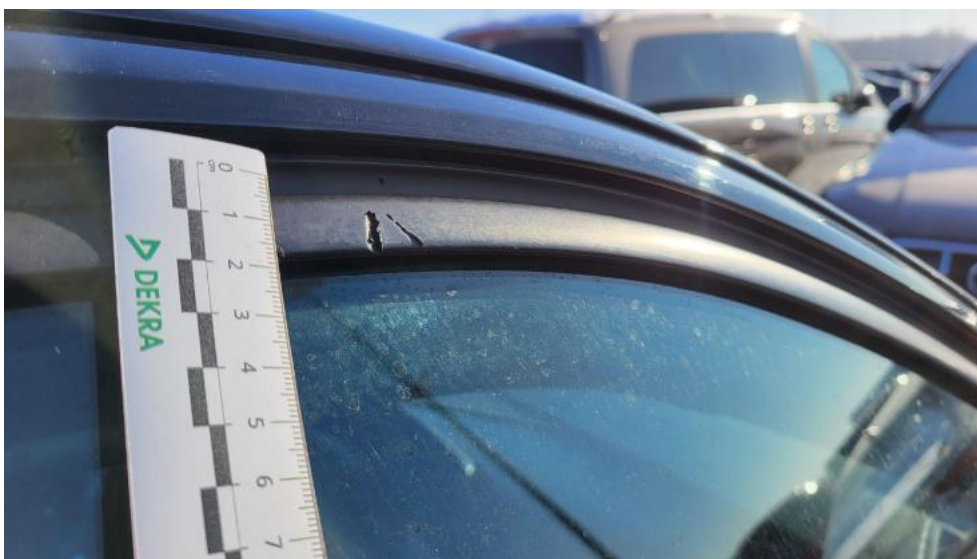
**Photo 49.**

Listwa drzwi przednich P - Rysa/odprysk 1

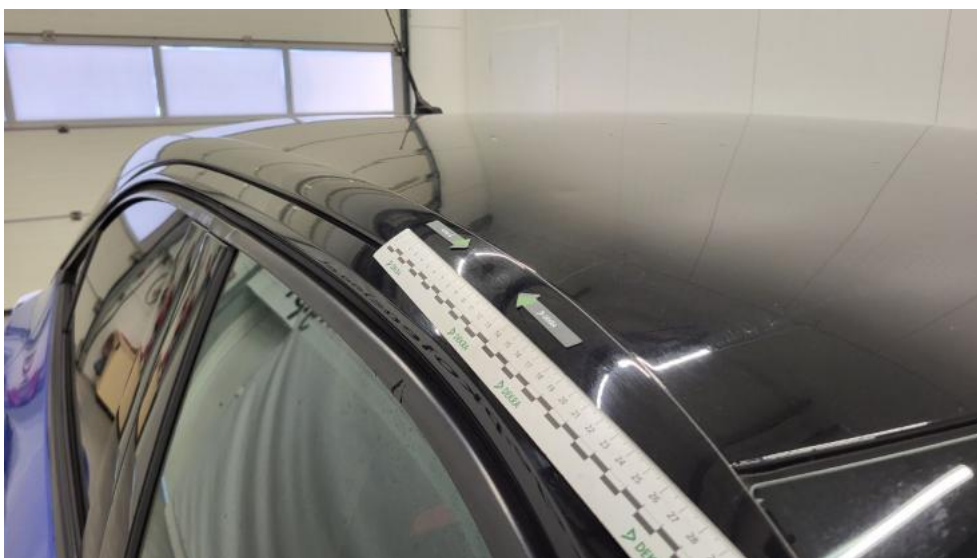
**Photo 50.**

Słupek przedni P - Wgniecenie/odkształcenie 1

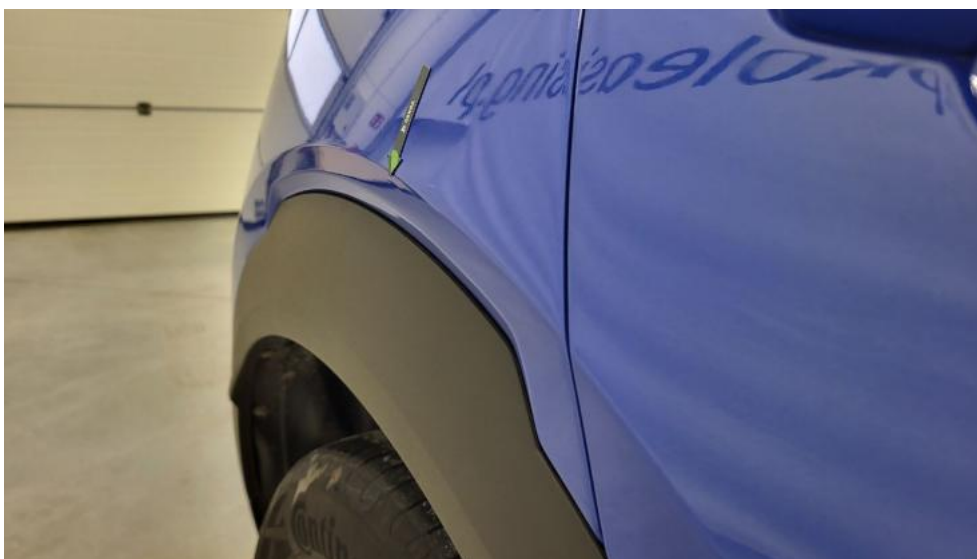
**Photo 51.**

| No. of controlled item | Controlled item | Measured range of thickness of the lacquer coat [μm] |
|---|---|---|
| 11 | Right rear fender | 150 - 1000 |

Błotnik tylny P / Ściana boczna P - Wgniecenie/odkształcenie 1

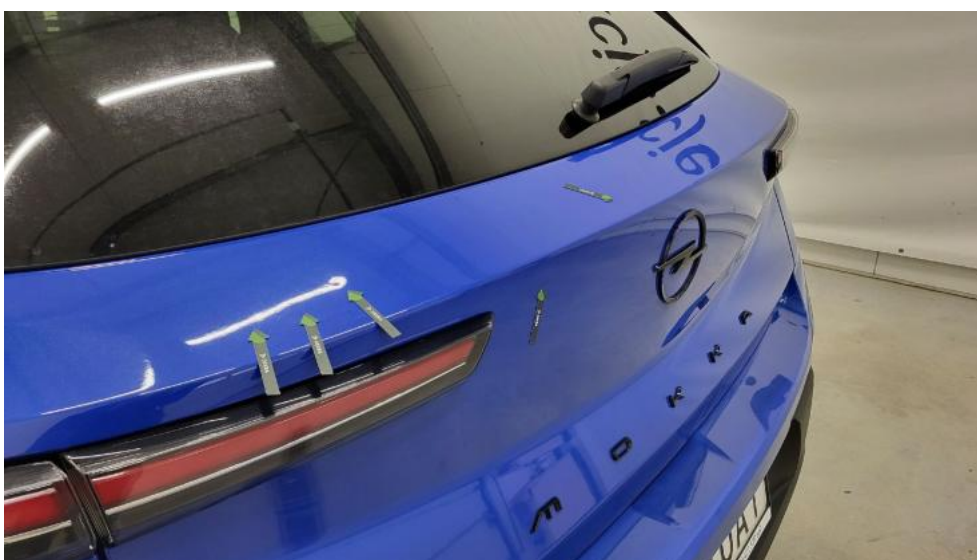
**Photo 52.**

Pokrywy bagażnika - Wgniecenie/odkształcenie 1

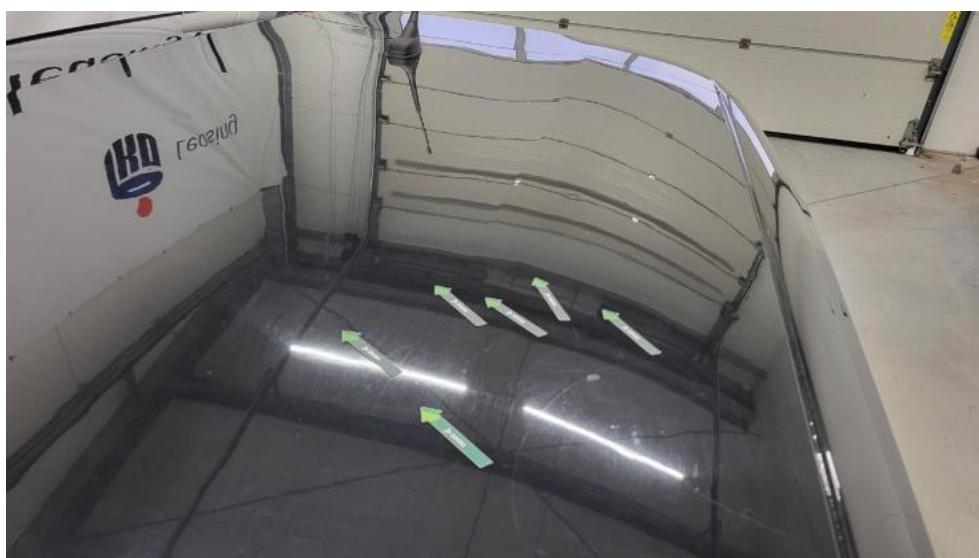
**Photo 54.**

Brak aktualnych badań technicznych. Lewa przednia szyba zacina sie podczas podnoszenia. Odpryski na szybie czołowej. Widoczne wady lakiernicze. Bardzo liczne wgniecenia na dachu. Rysy na samochodzie.

Dach - Wgniecenie/odkształcenie 1

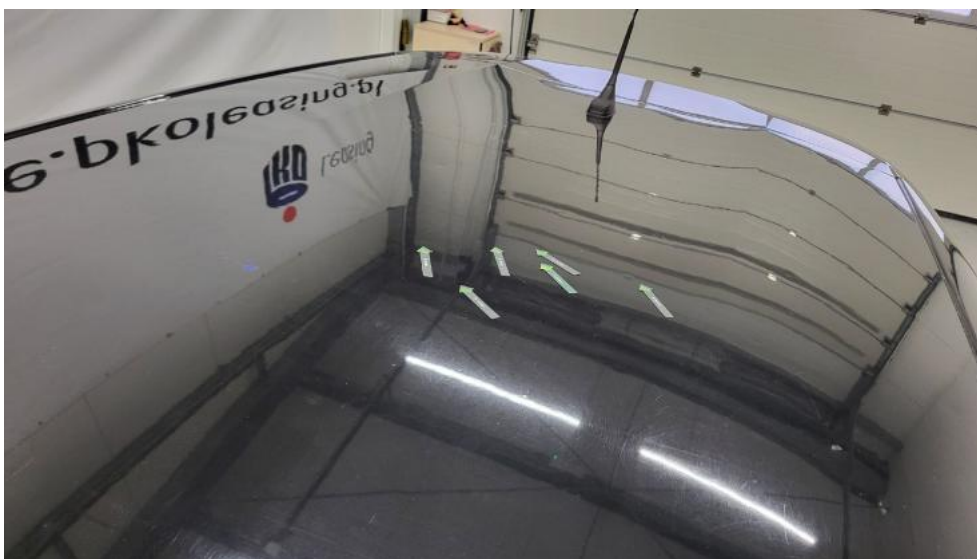
**Photo 55.**

Dach - Wgniecenie/odkształcenie 2

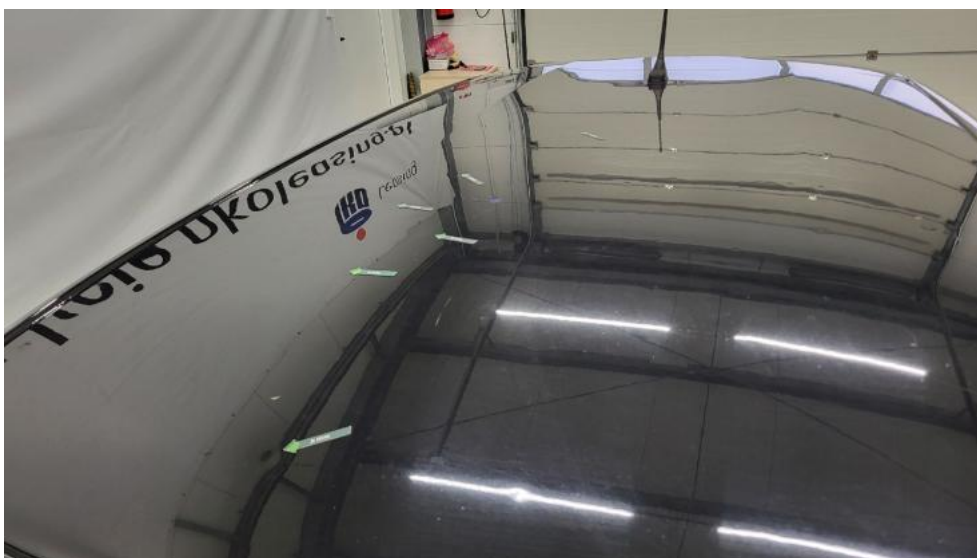
**Photo 56.**

Dach() - Wgniecenie/odkształcenie 3

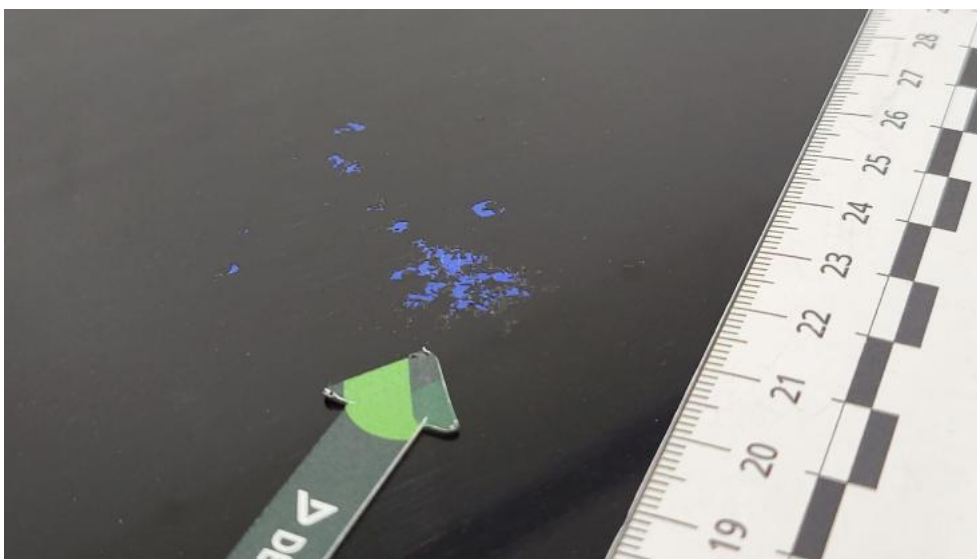
**Photo 57.**  
Dach - Inne 1

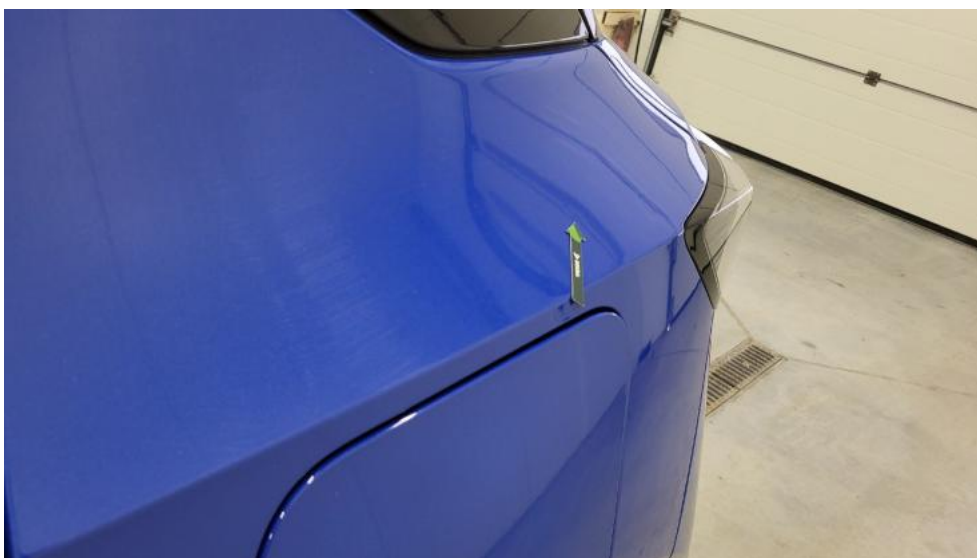
**Photo 58.**  
Błotnik tylny L / Ściana boczna L - Wgniecenie/odkształcenie 1

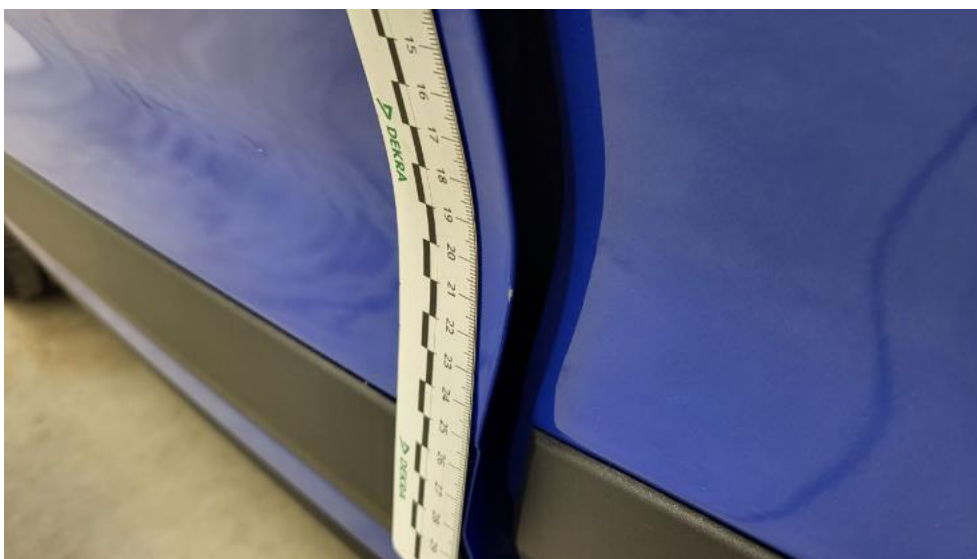
**Photo 59.**

Drzwi przed L - Rysa/odprysk 1

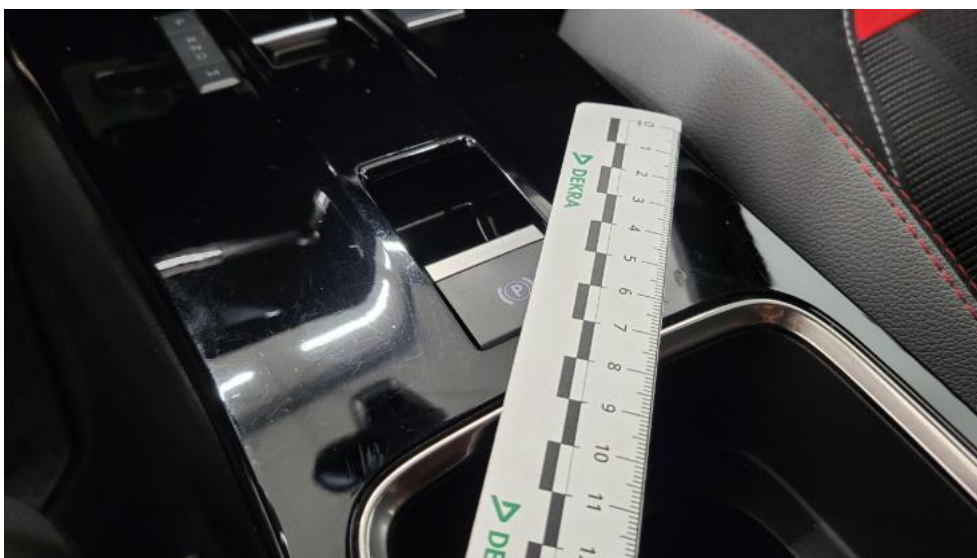
**Photo 60.**

Konsola tunelu śr. - Rysa/odprysk 1

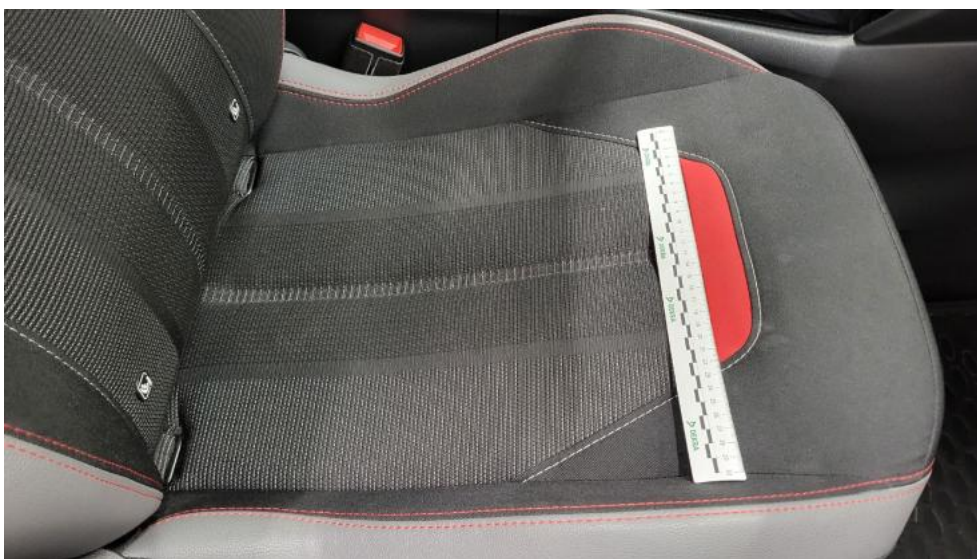
**Photo 61.**

Fotel prz. praw. - Inne 1
