DEKRA's commission No. : PKOL(W)/LODZ/97039/26/10/16  
commission/ damage No. : 00005/EO/23  
Date of commission: 16-10-2026

**DEKRA Poland - Headquarters**  
02-673 Warszawa, ul. Konstruktorska 12A

| Manufacturer | BMW |
| Model | Seria 6 Gran Turismo [G32] 20-23 |

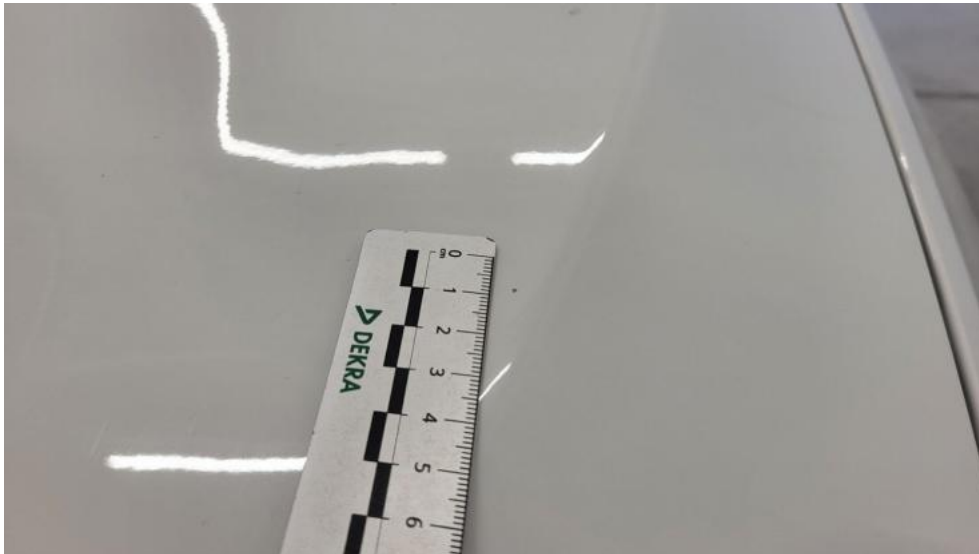
**Photo 43.**

Pokrywa komory silnika - Rysa/odprysk 1

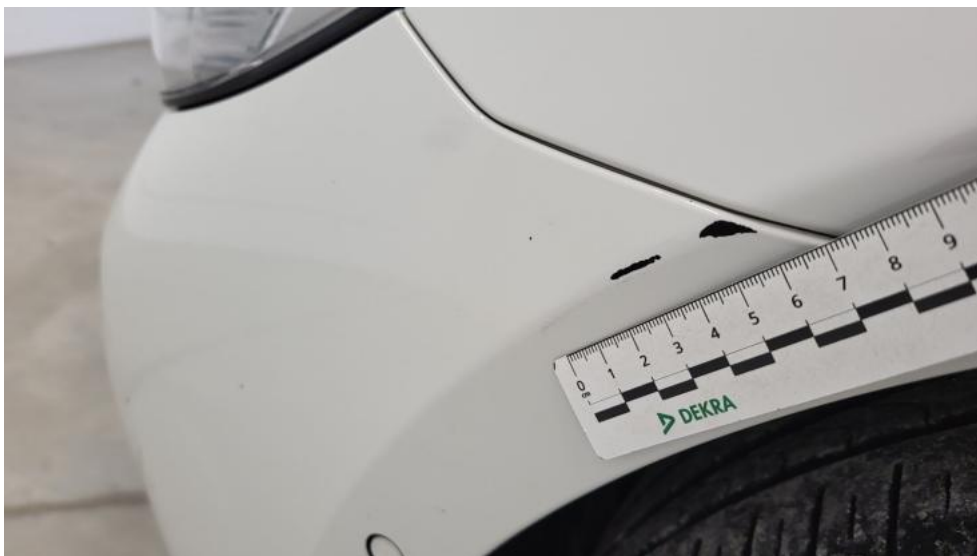
**Photo 45.**

Zderzak - Rysa/odprysk 1

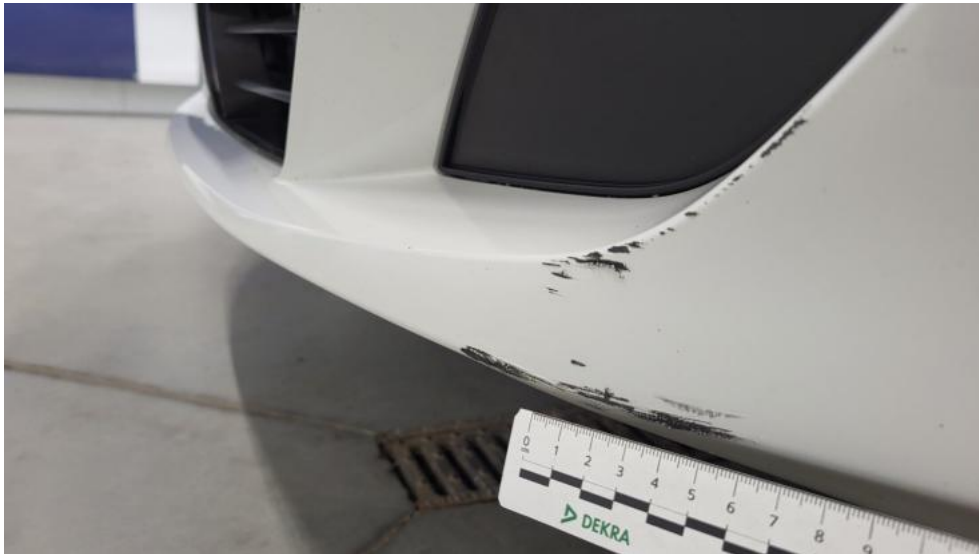
**Photo 47.**

Zderzak() - Rysa/odprysk 3

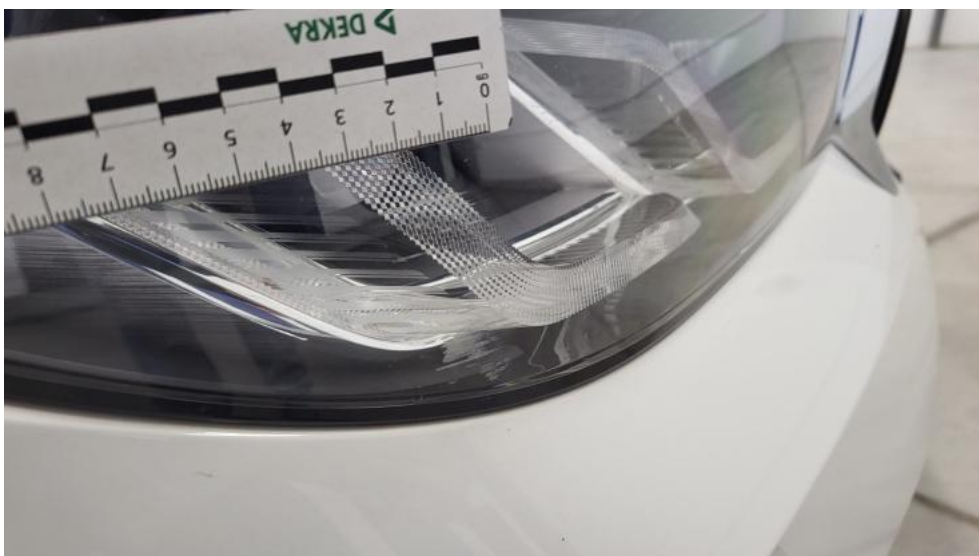
**Photo 48.**

Reflektor P - Rysa/odprysk 1

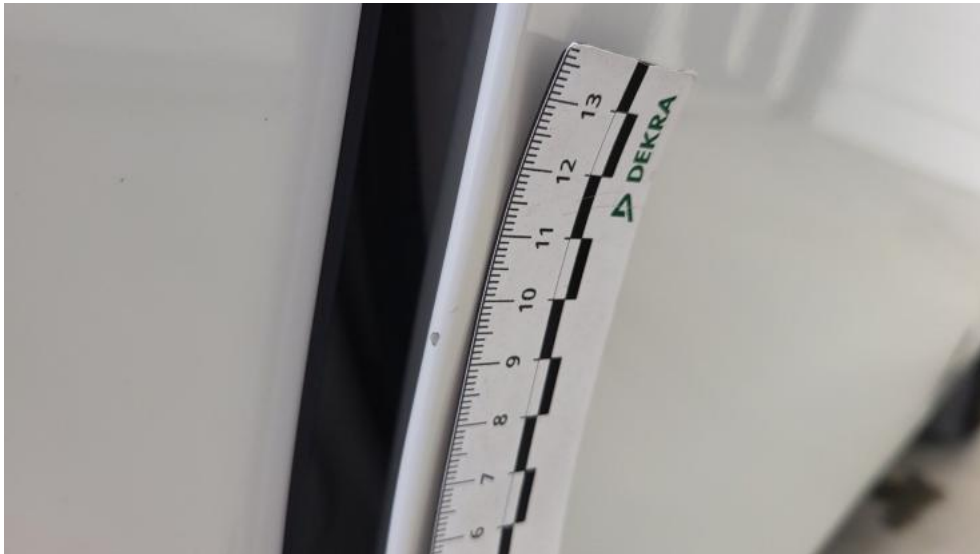
**Photo 49.**

Drzwi przednie P - Rysa/odprysk 1

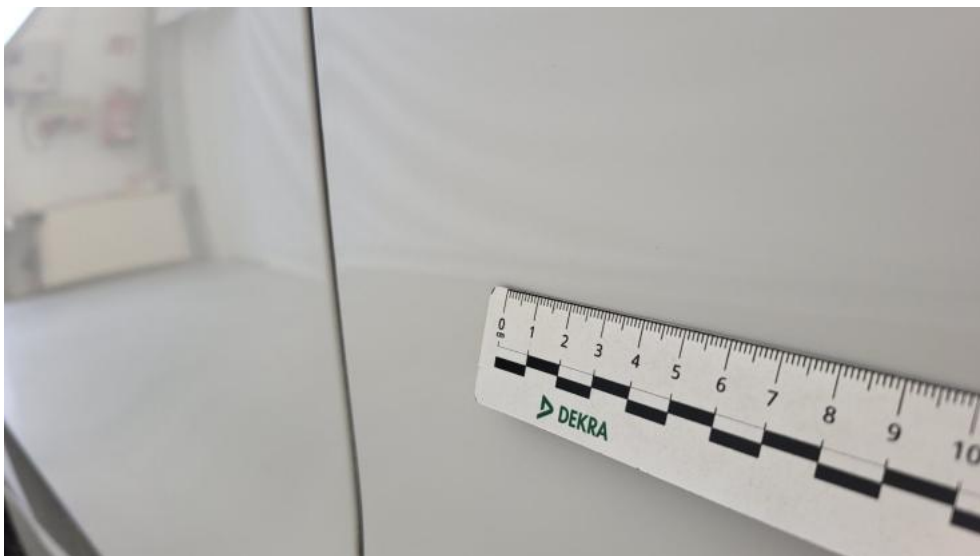
**Photo 50.**

Drzwi przednie P - Wgniecenie/odkształcenie 1

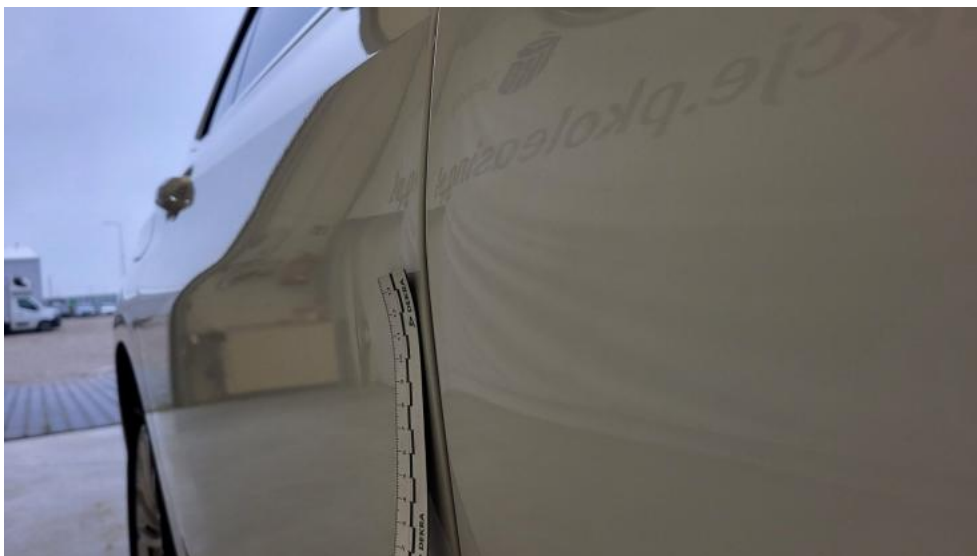
**Photo 51.**

Drzwi tylne P - Wgniecenie/odkształcenie 1

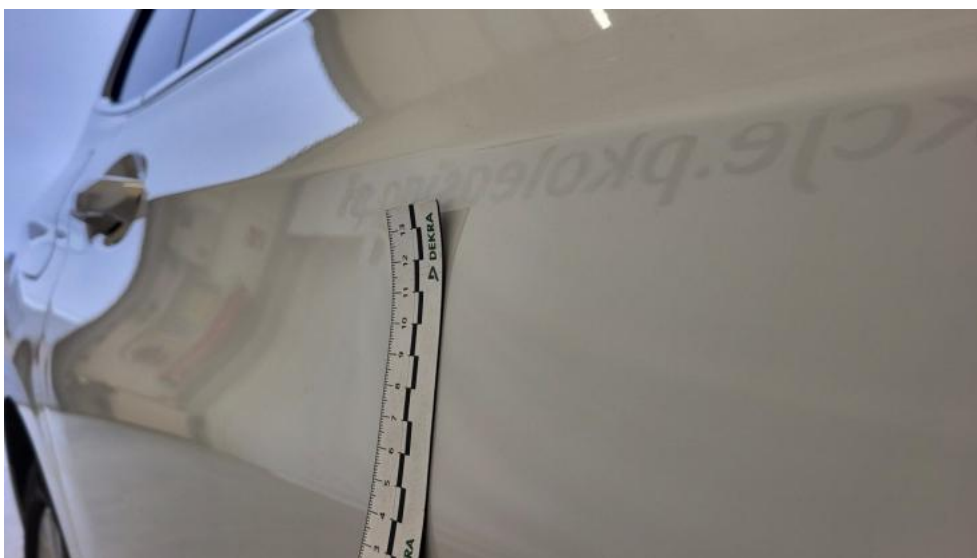
**Photo 52.**

Drzwi tylne P - Wgniecenie/odkształcenie 2

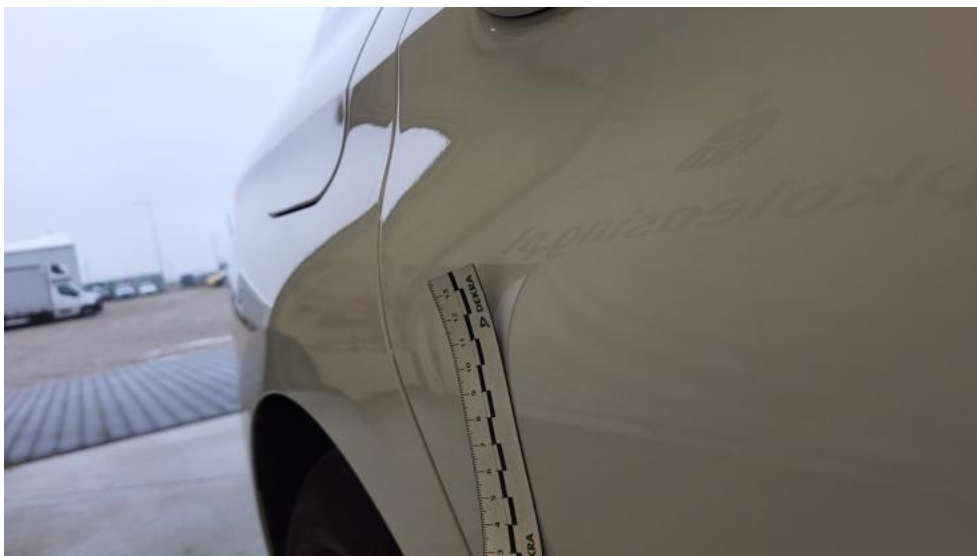
**Photo 53.**

Drzwi tylne P() - Wgniecenie/odkształcenie 3

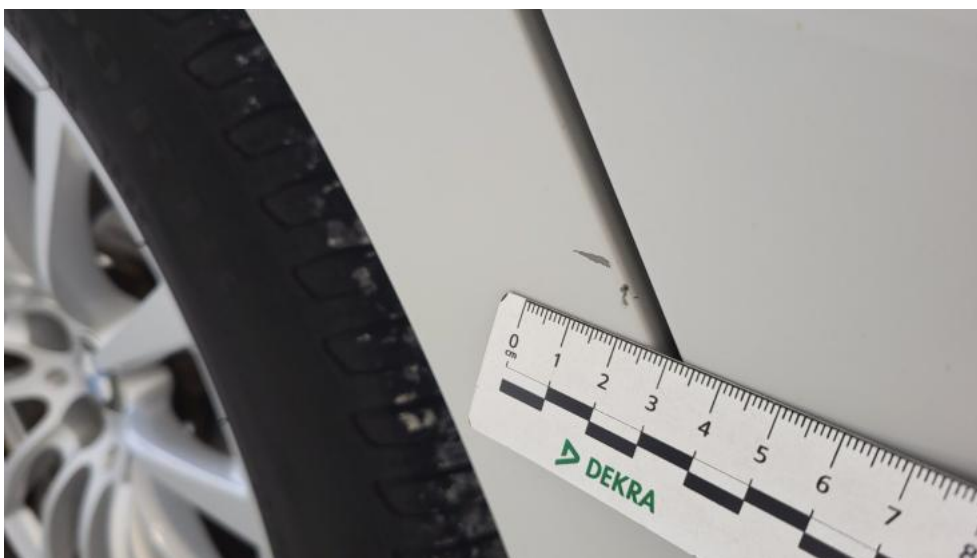
**Photo 54.**

Ścianka tylna P / Ścianka boczna P - Rysa/odprysk 1

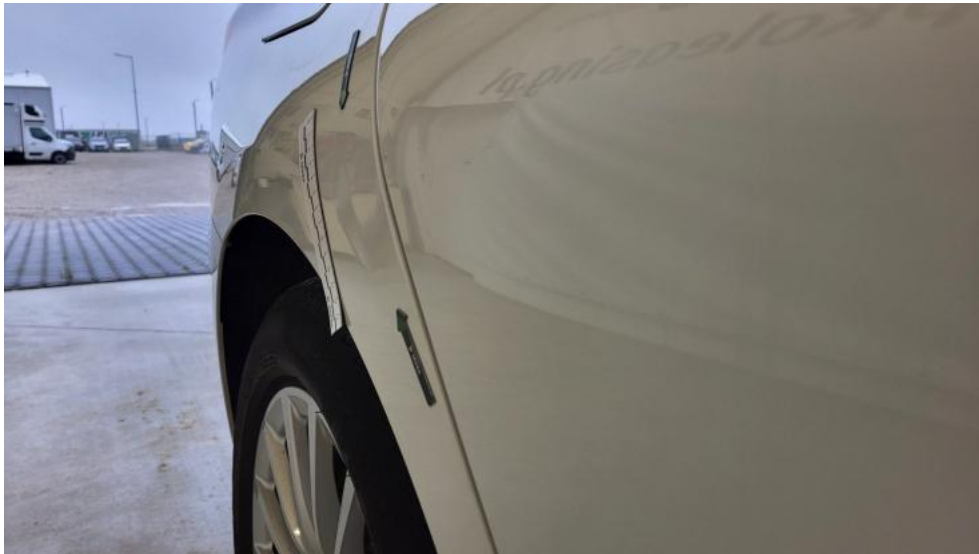
**Photo 55.**

Błotnik tylny P / Ściana boczna P - Wgniecenie/odkształcenie 1

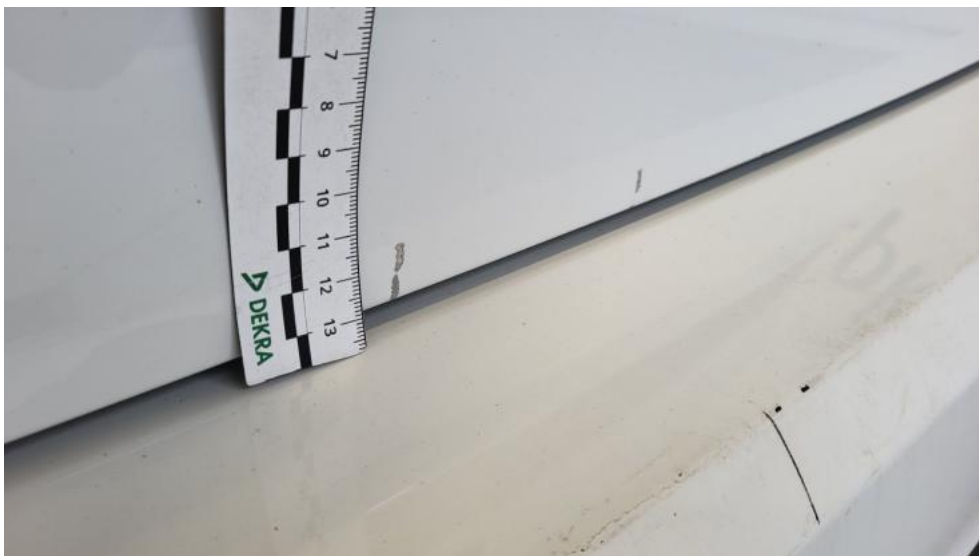
**Photo 56.**

Pokrywy bagażnika - Rysa/odprysk 1

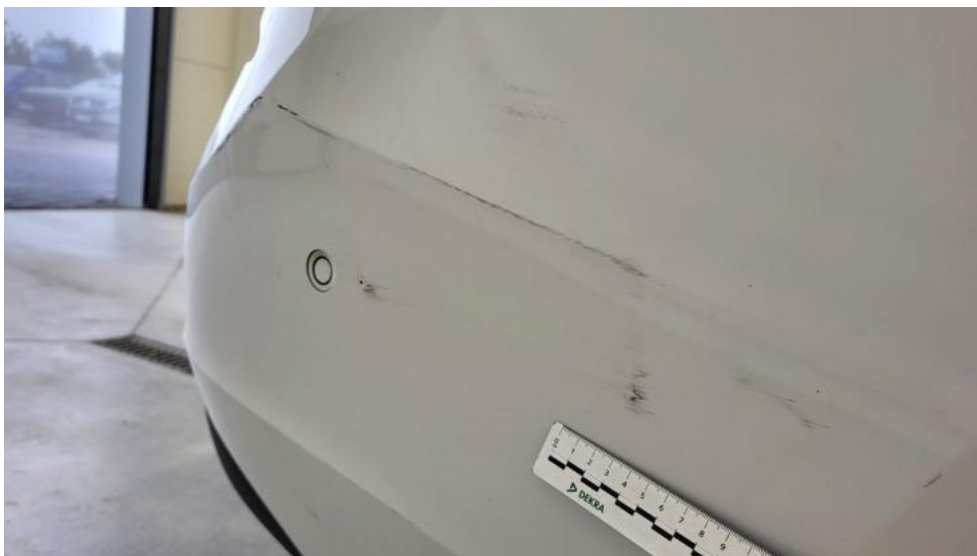
**Photo 57.**

Zderzak tylny - Rysa/odprysk 1

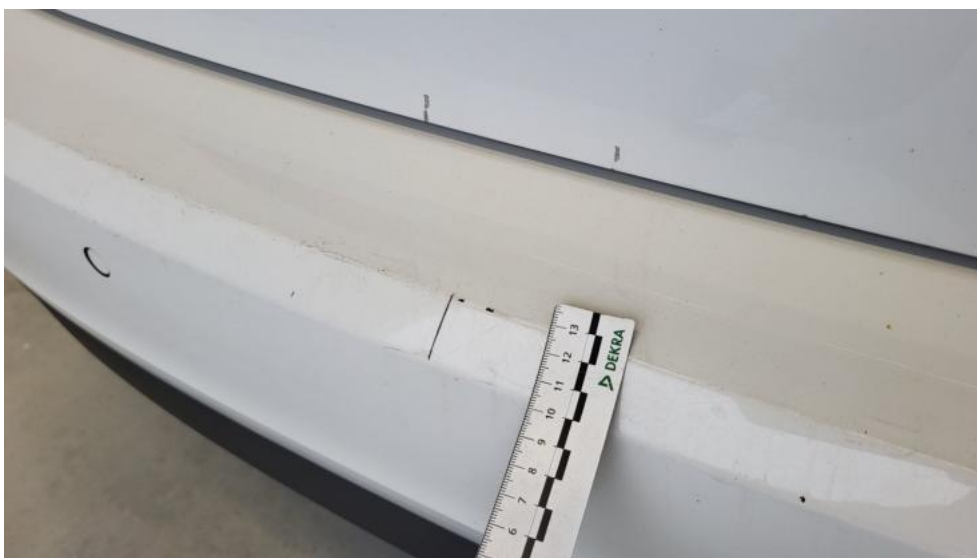
**Photo 58.**

Zderzak tylny - Rysa/odprysk 2

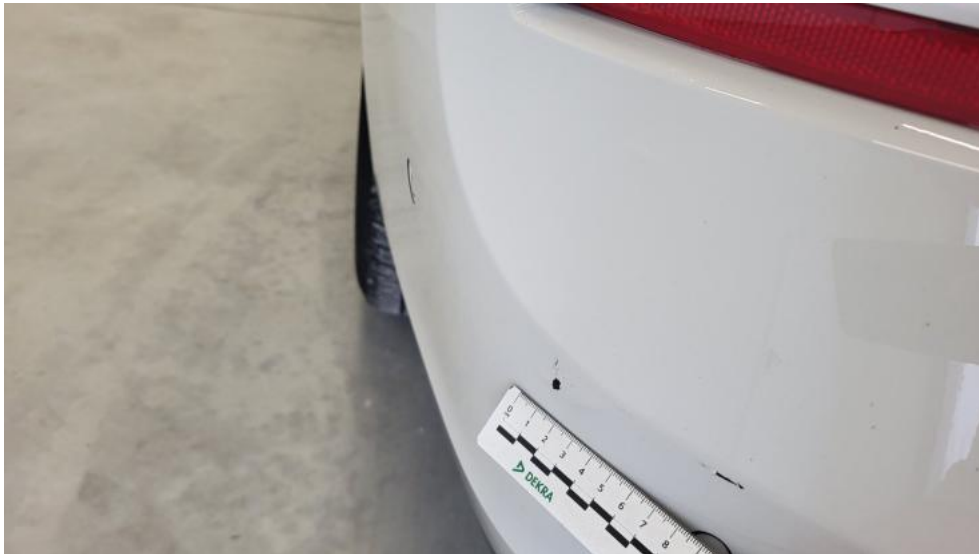
**Photo 59.**

Zderzak tylny - Wgniecenie/odkształcenie 1

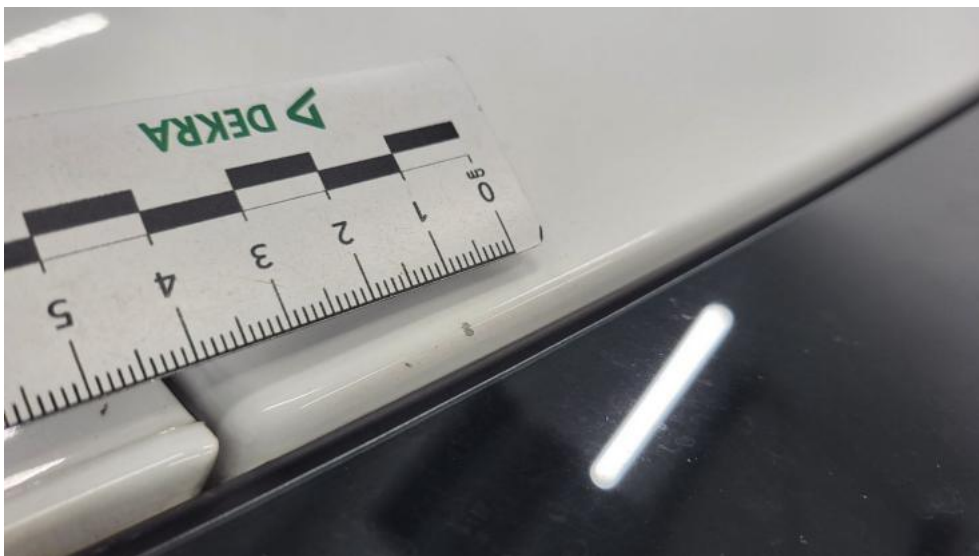
**Photo 60.**

Dach - Rysa/odprysk 1

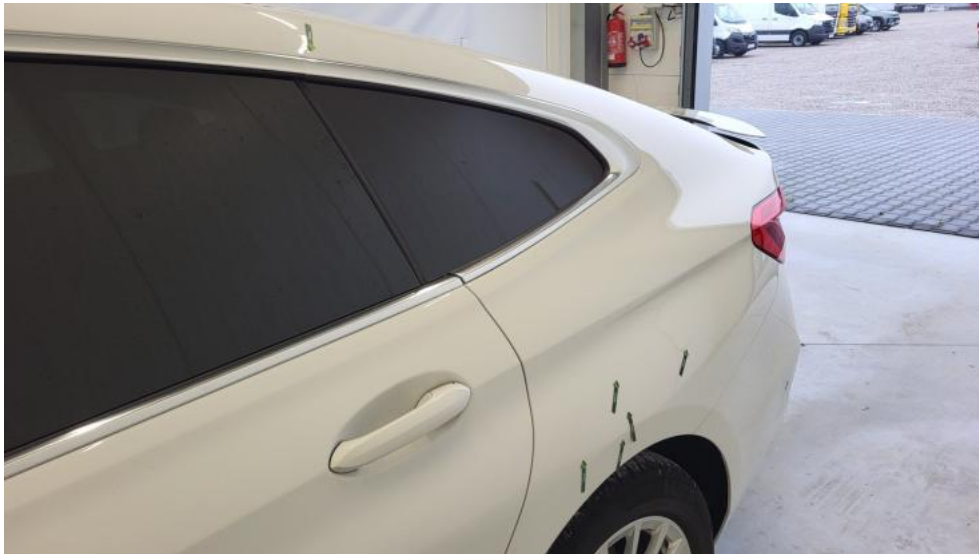
**Photo 61.**

Błotnik tylny L / Ściana boczna L - Wgniecenie/odkształcenie 1

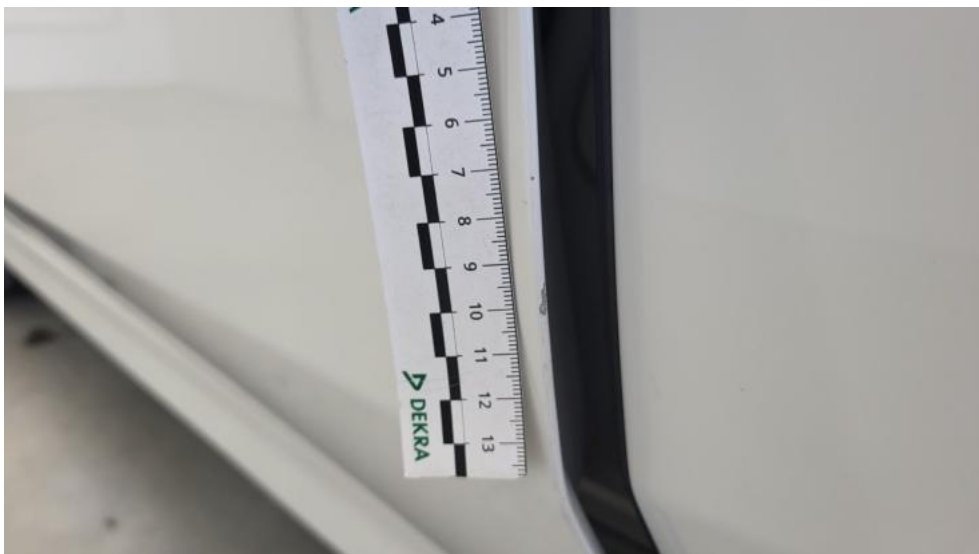
**Photo 62.**

Drzwi przed L - Rysa/odprysk 1

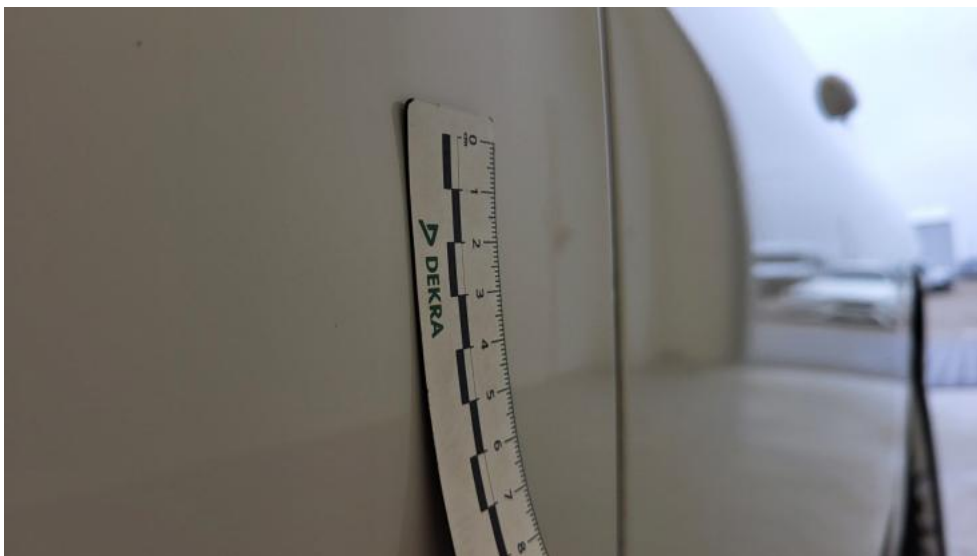
**Photo 63.**

Drzwi przed L - Wgniecenie/odkształcenie 1

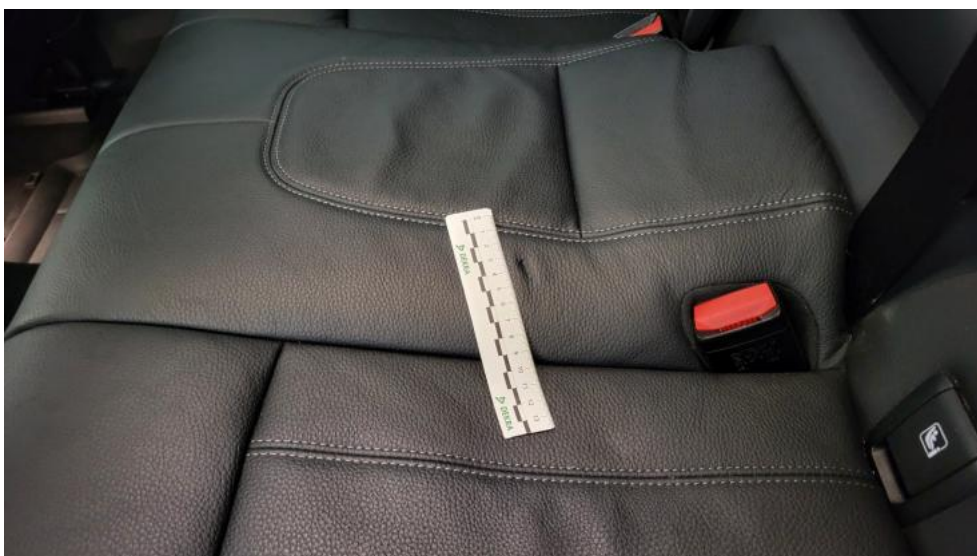
**Photo 64.**

Dostarczono ksero pozwolenia czasowego. Rysy na samochodzie. Minął termin wymiany płynu hamulcowego od 09/2026. Brak zaślepek w tylnej kanapie. Odpryski na szybie czołowej.

Kanapa tyl. - Wgniecenie/odkształcenie 1

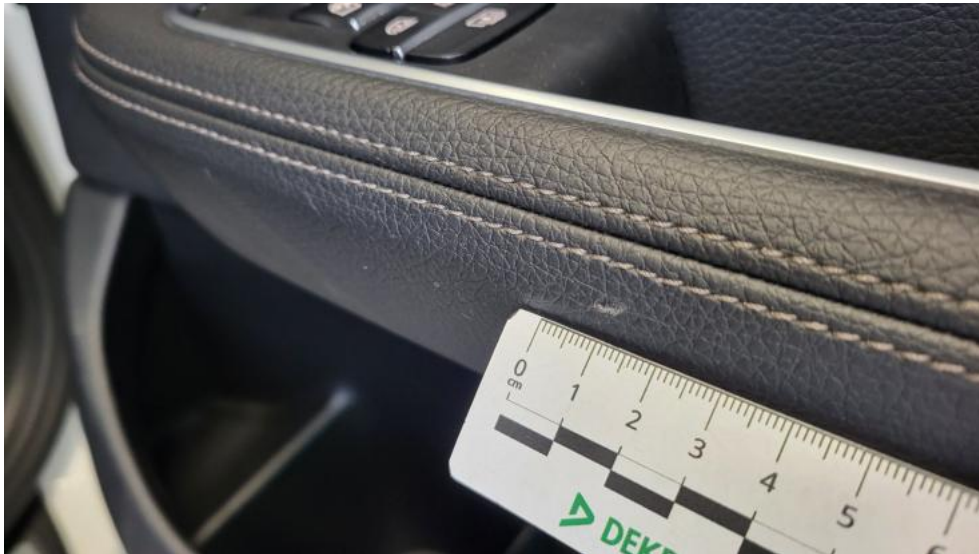
**Photo 65.**

Tapicerka drzwi tylnych P - Pęknięcie/rozerwanie 1

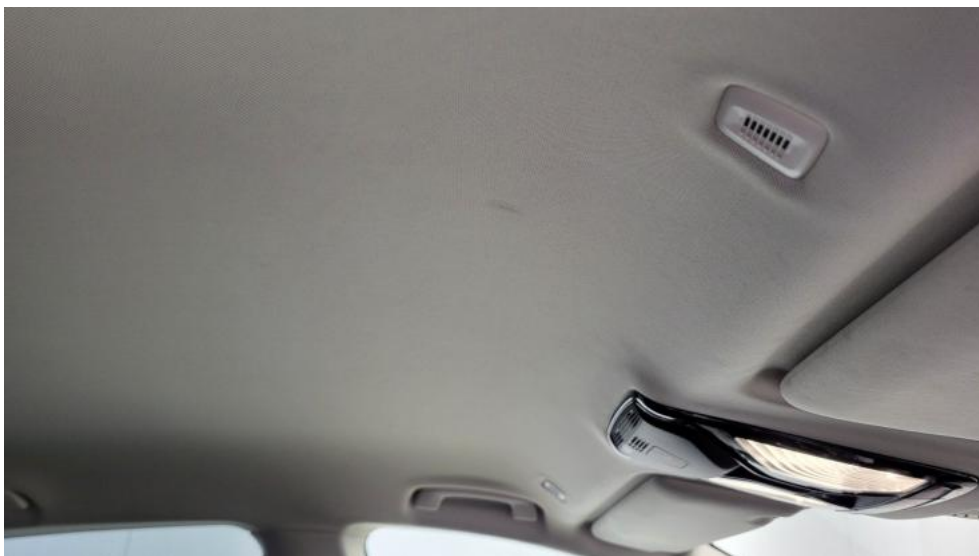
**Photo 66.**

Podsufitka - Inne 1

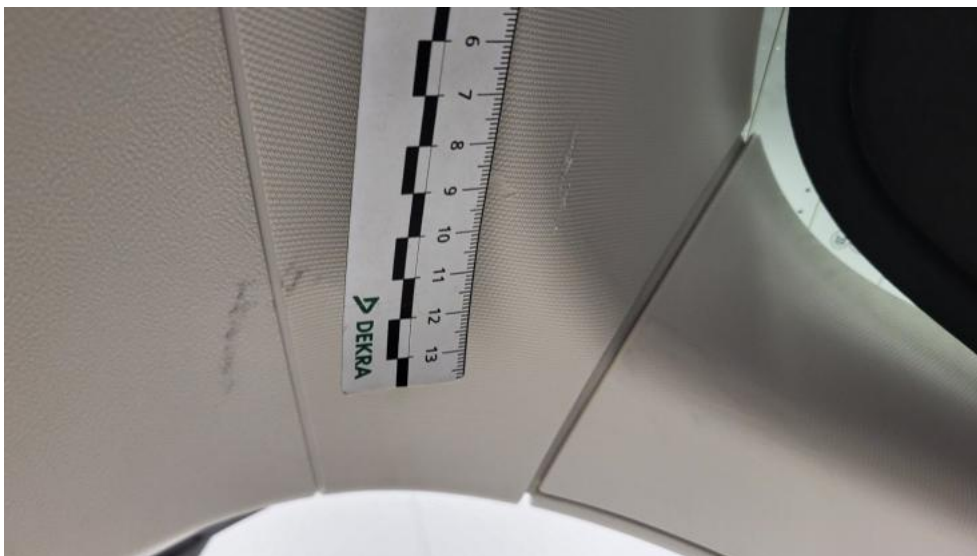
**Photo 67.**

Wykładzina pokrywy tylnej - Rysa/odprysk 1
