DEKRA's commission No. : PKOL(W)/LODZ/25408/26/03/23
commission/ damage No. : 22/032652
Date of commission: 23-03-2026

Vehicle data

Measurement of thickness of the vehicle lacquer coating

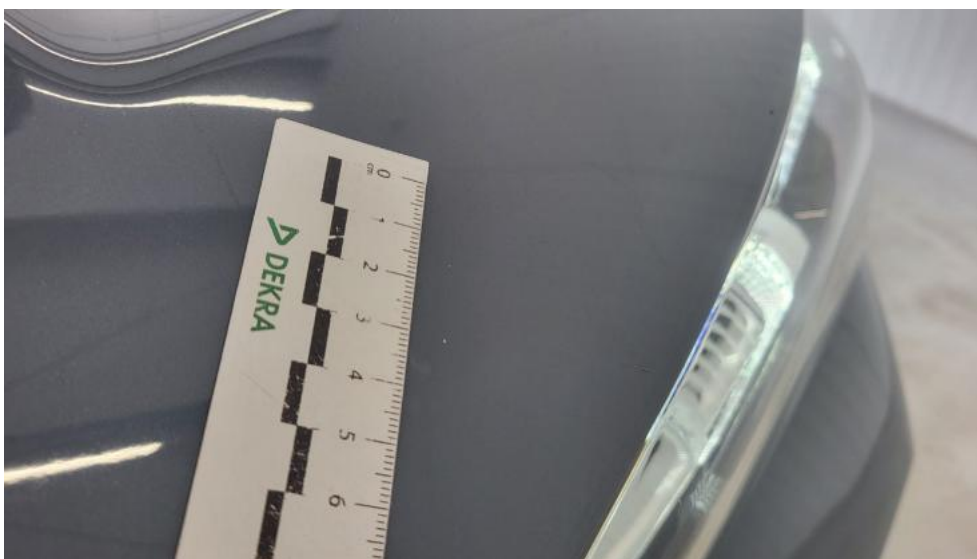
Photo 41.

Pokrywa komory silnika - Rysa/odprysk 1

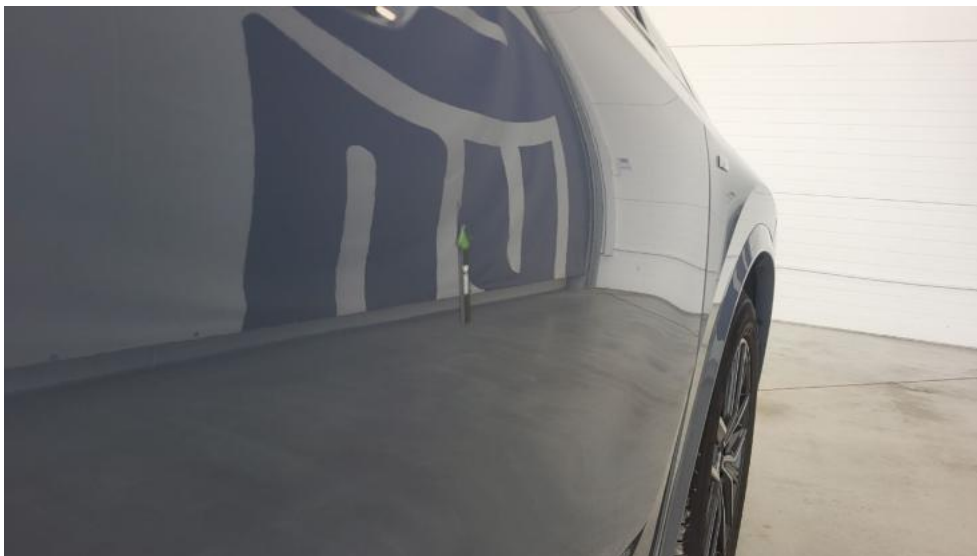
Photo 43.

Drzwi przednie P - Wgniecenie/odkształcenie 1

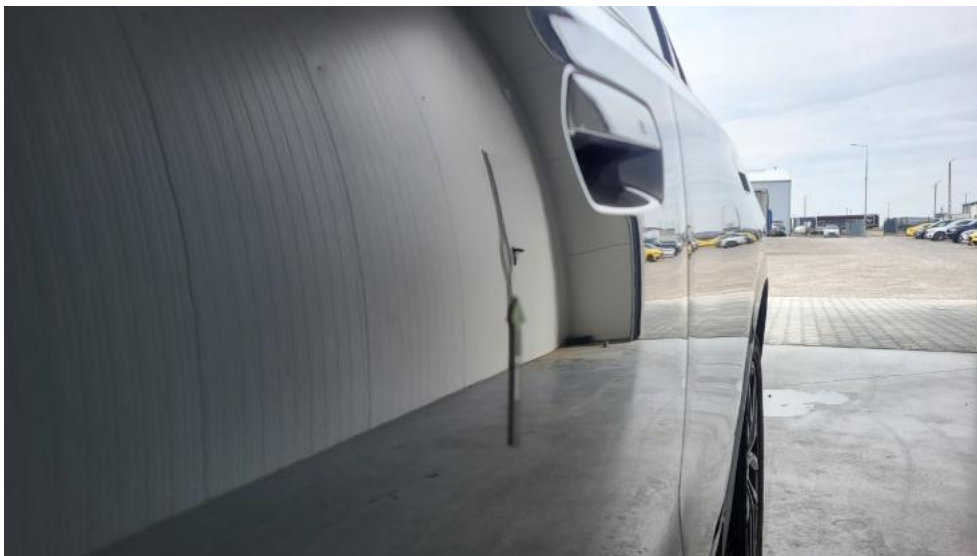
Photo 51.
Drzwi przed L - Wgniecenie/odkształcenie 1

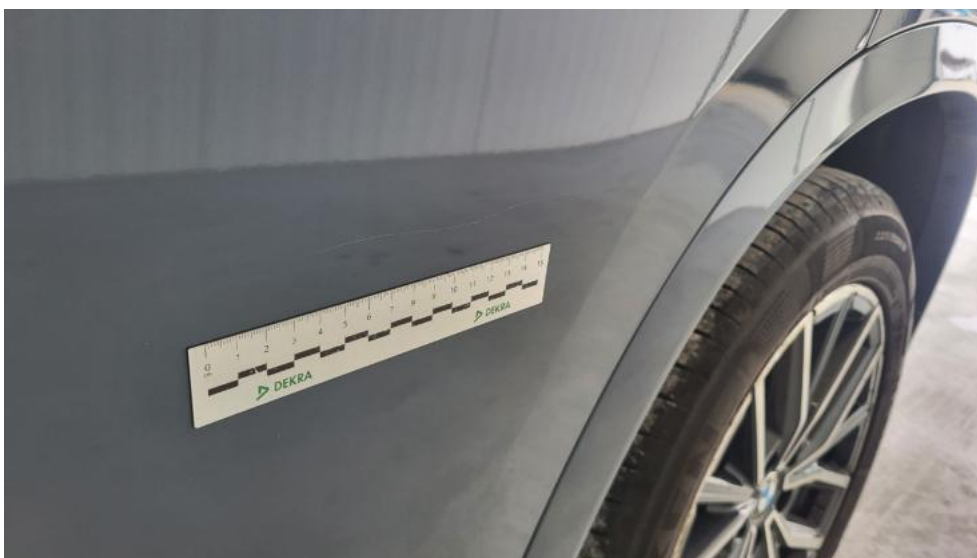
Photo 52.
Drzwi tylne L - Rysa/odprysk 1

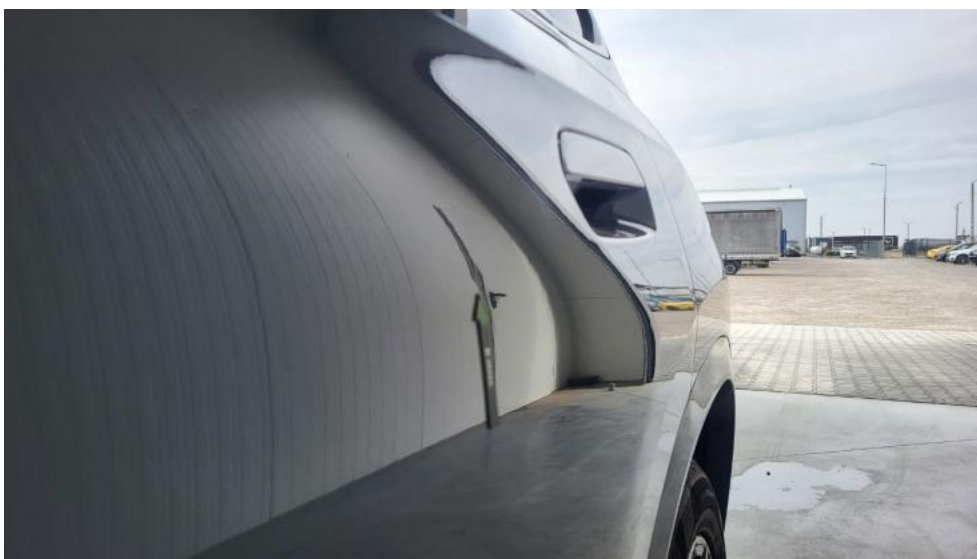
Photo 53.
Drzwi tylne L - Wgniecenie/odkształcenie 1

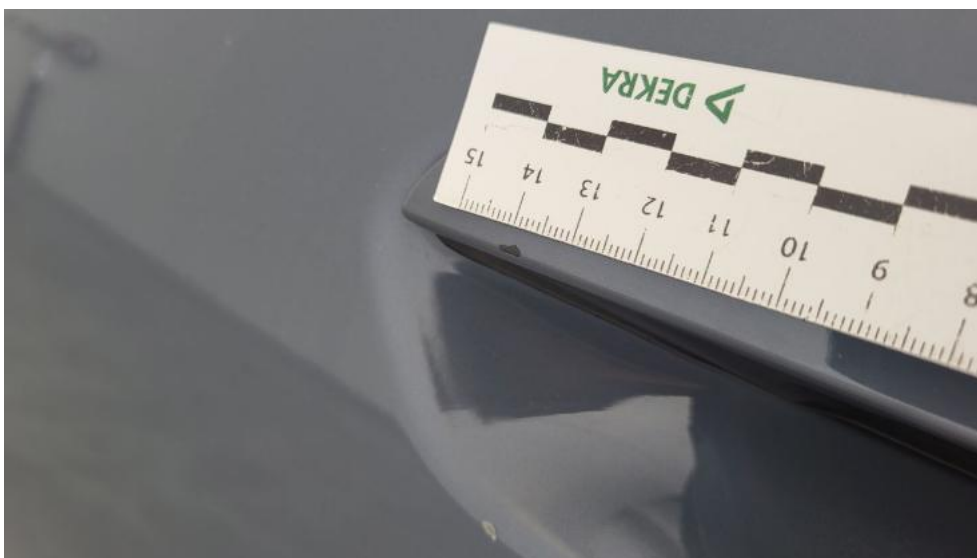
Photo 54.
Klamka drzwi prz L - Rysa/odprysk 1
