DEKRA's commission No. : PKOL(W)/LODZ/74224/24/09/25
commission/ damage No. : 19/025717
Date of commission: 25-09-2024

Vehicle data

Description of the technical condition

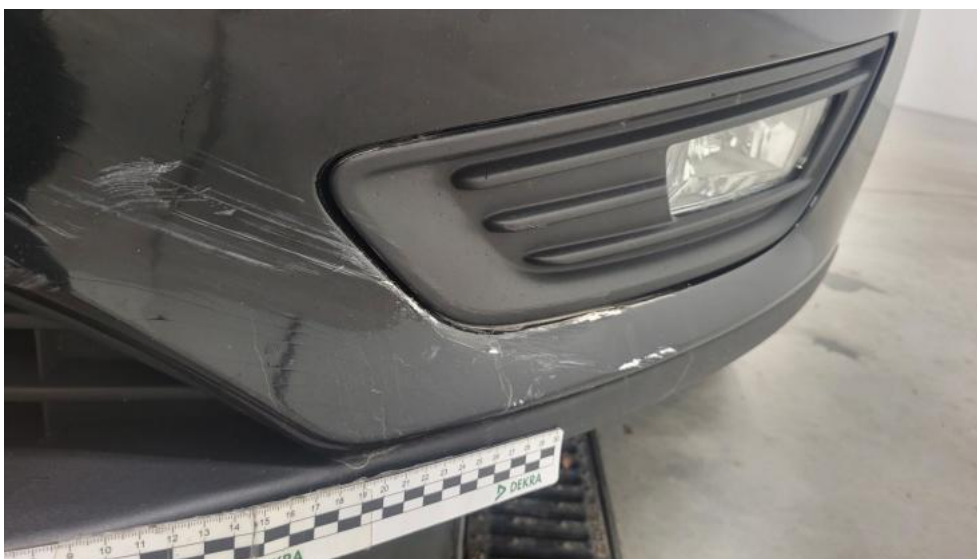
Photo 39.
Zderzak - Rysa/odprysk 1

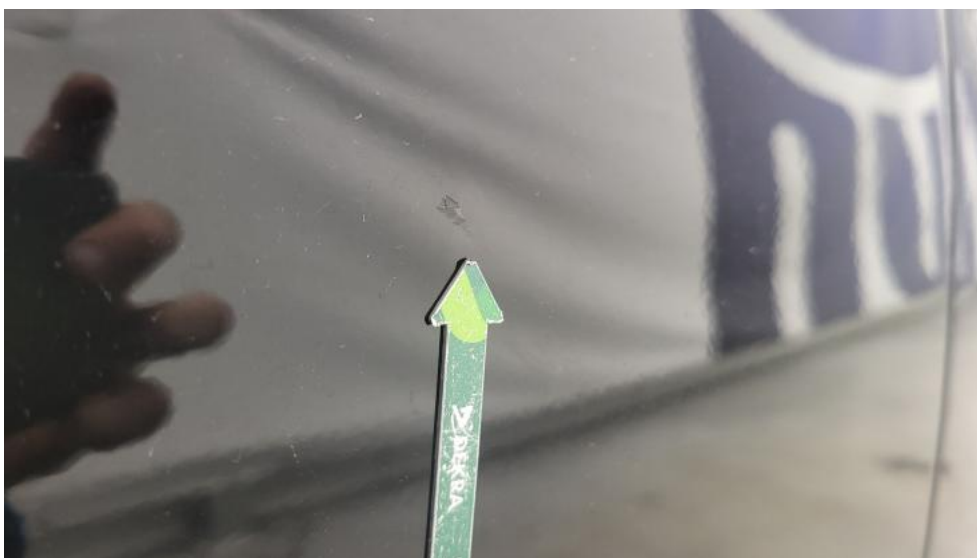
Photo 46.

Drzwi tylne P - Rysa/odprysk 1

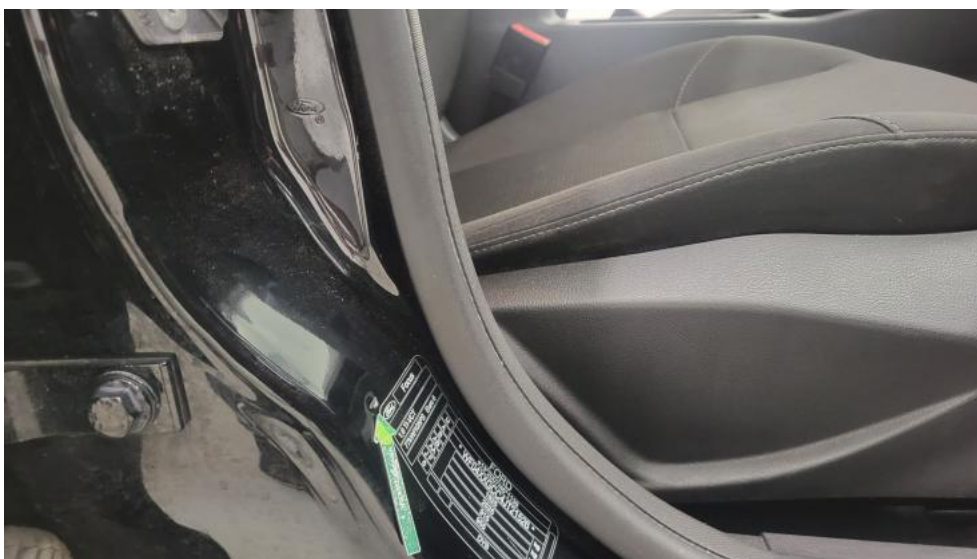
Photo 49.

Stupek środkowy P - Wgniecenie/odkształcenie 1

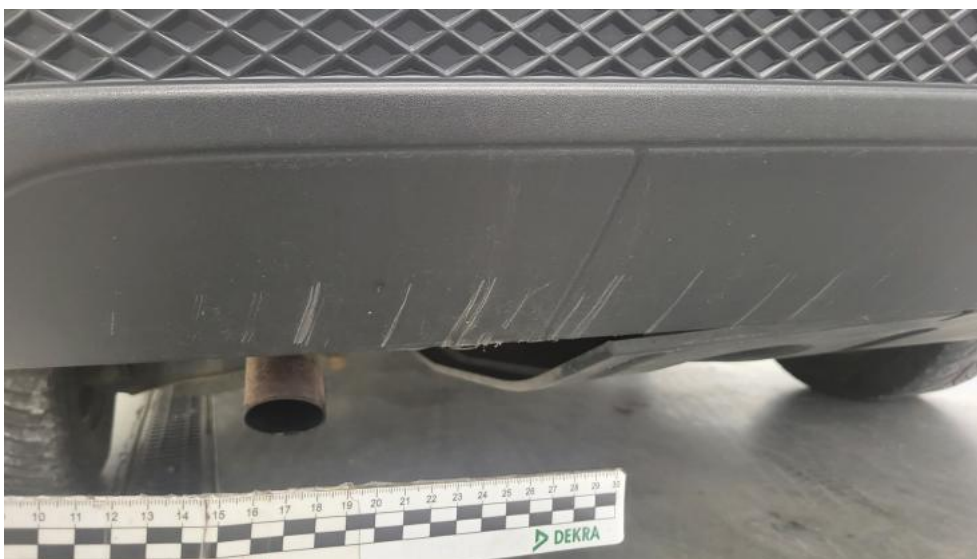
Photo 51.
Zderzak tylny - Rysa/odprysk 1

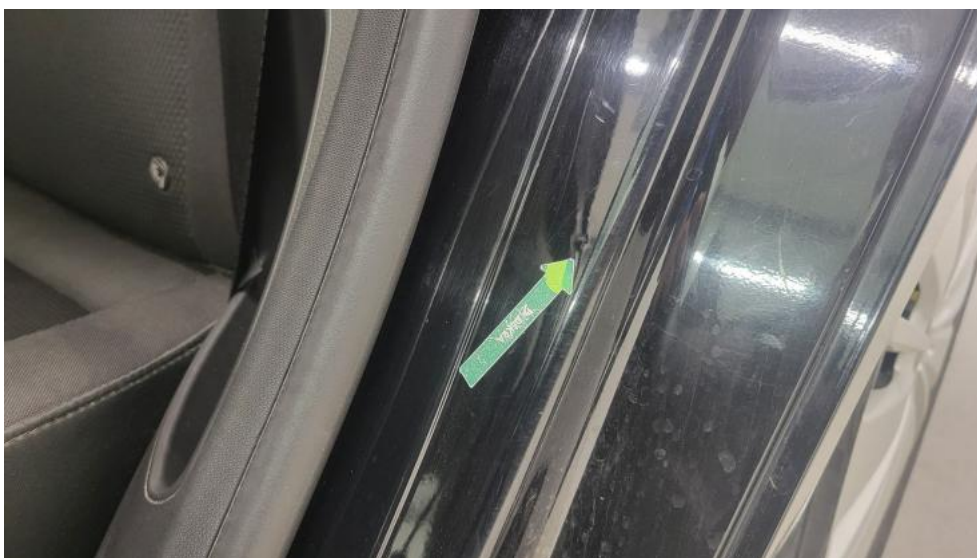
Photo 52.
Błotnik tylny L / Ściana boczna L - Wgniecenie/odkształcenie 1

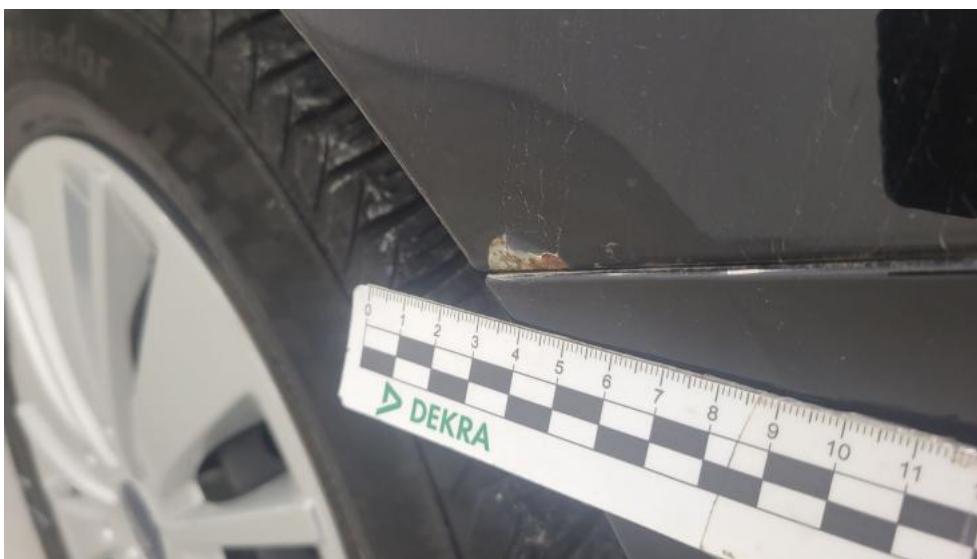
Photo 53.
Błotnik tylny L / Ściana boczna L - Inne 1

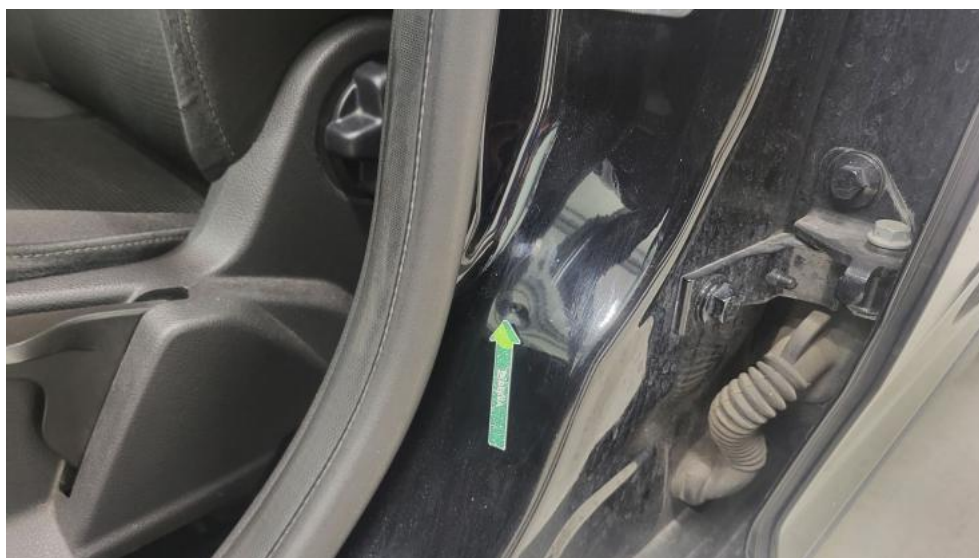
Photo 58.

Słupek środkowy L - Wgniecenie/odkształcenie 1

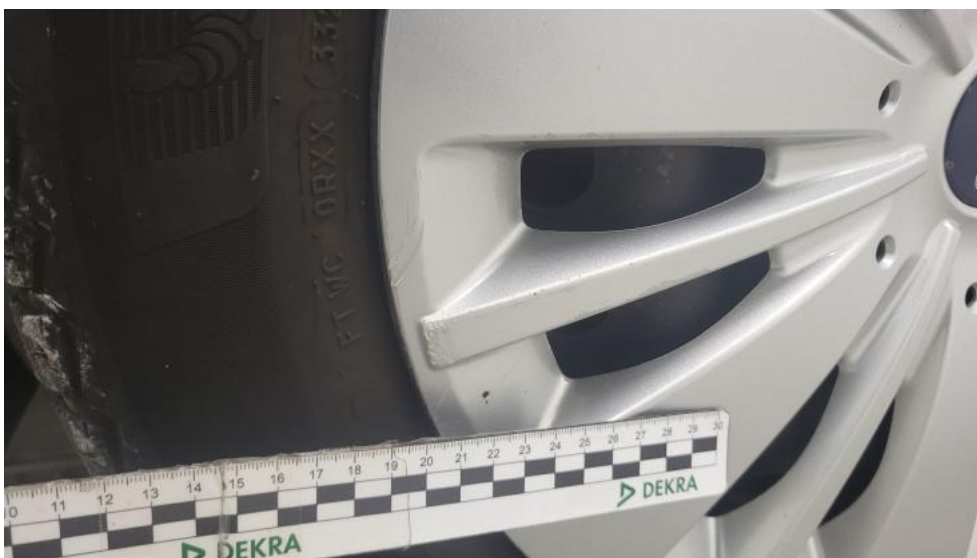
Photo 60.
Kołpak przedni L - Rysa/odprysk 1

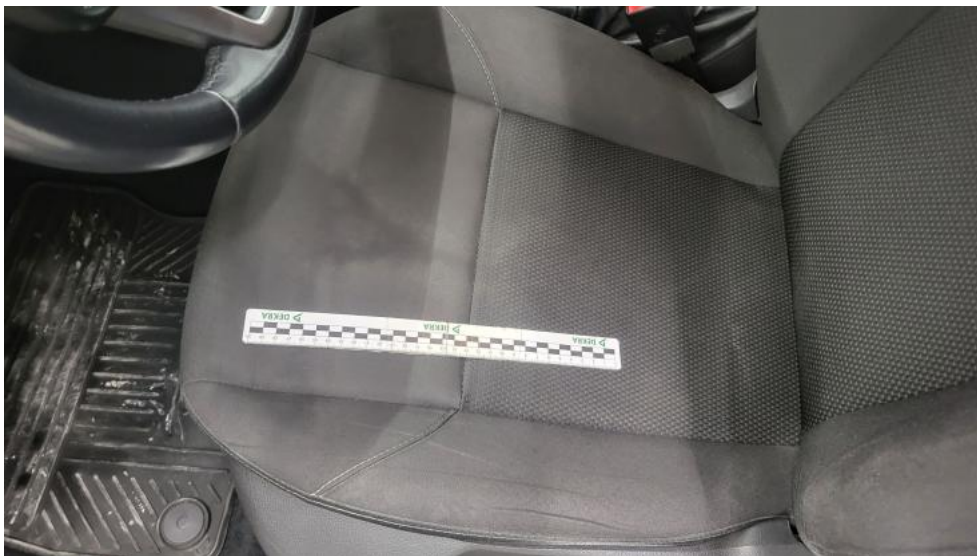
Photo 61.
Fotel prz. lew. - Inne 1

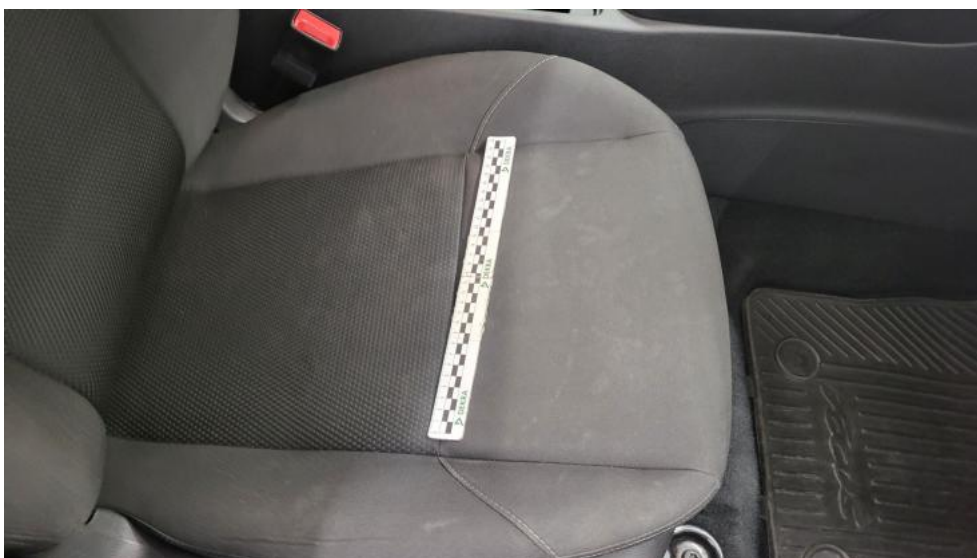
Photo 62.
Fotel prz. praw. - Inne 1

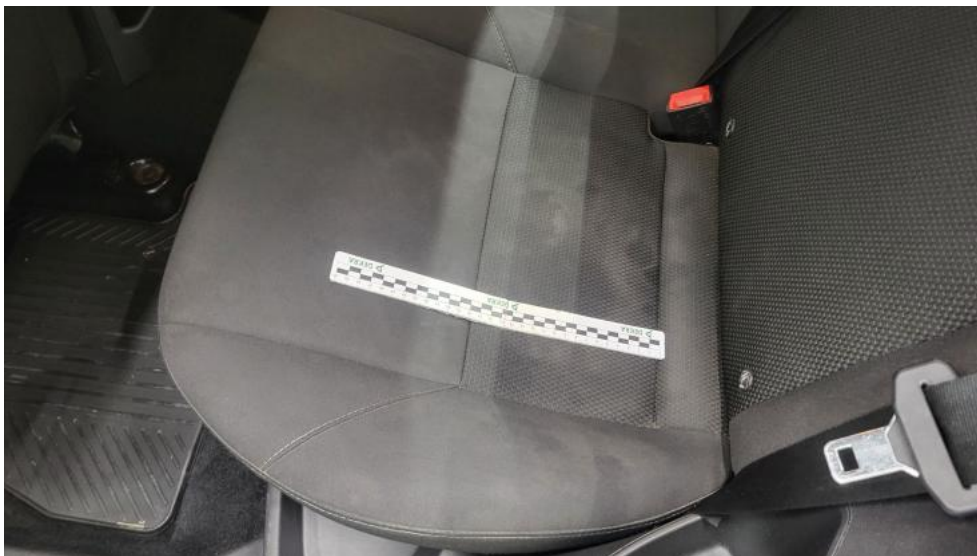
Photo 63.
Kanapa tyl. - Inne 1

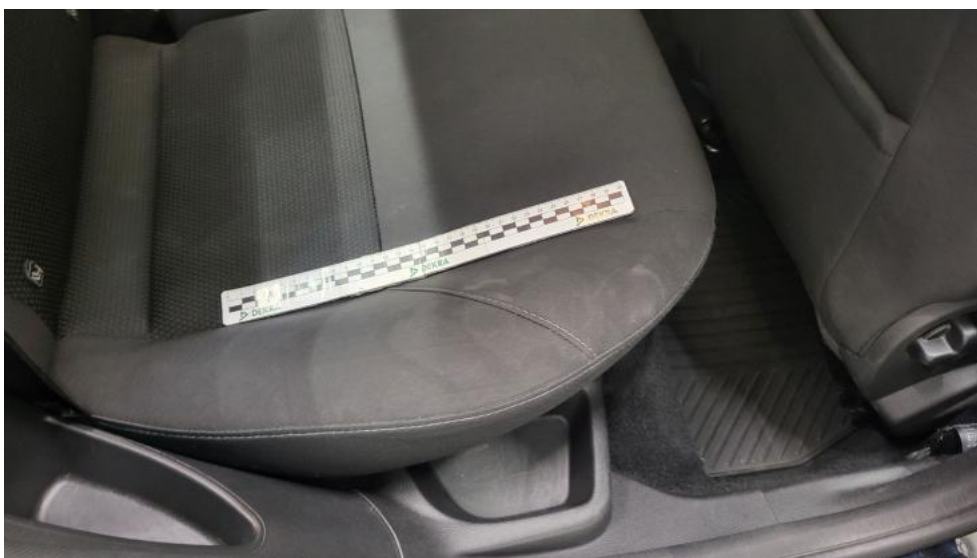
Photo 64.
Kanapa tyl. - Inne 2
