DEKRA's commission No. : PKOL(W)/LODZ/78916/24/10/11  
 commission/ damage No. : 18/041768  
 Date of commission: 11-10-2024

**Vehicle data**

Group of objects (Eurotax)	jeeps
EC code (Eurotax)	0133281
Manufacturer	LAND ROVER
Model	Range Rover Sport 17-22
Type / version	Range Rover S 2.0Si4 GPF HSE
Body type	KOM
Number of doors / seats	5/5
Curb weight [kg]	2386
Gross vehicle weight [kg]	2900
Wheelbase 1/2	2923
Engine type	spark ignition
Supercompression	turbocompressor with intercooler
Pollution reduction system	GPF
Emission standard	EURO 6
Engine capacity [ccm]	1997
Engine Power [hp/kW]	300/221
Gearbox	automatic 8- gear
Registration /record No.	GD595SN
VIN / serial number	SALWA2BX9KA828941
Date of first registration	06-12-2018
Date of next. tech. test	19-05-2024
Year of manufacture	2018
Readout [km]	134 726 (read)
Body color / type of coating	black/METALIK

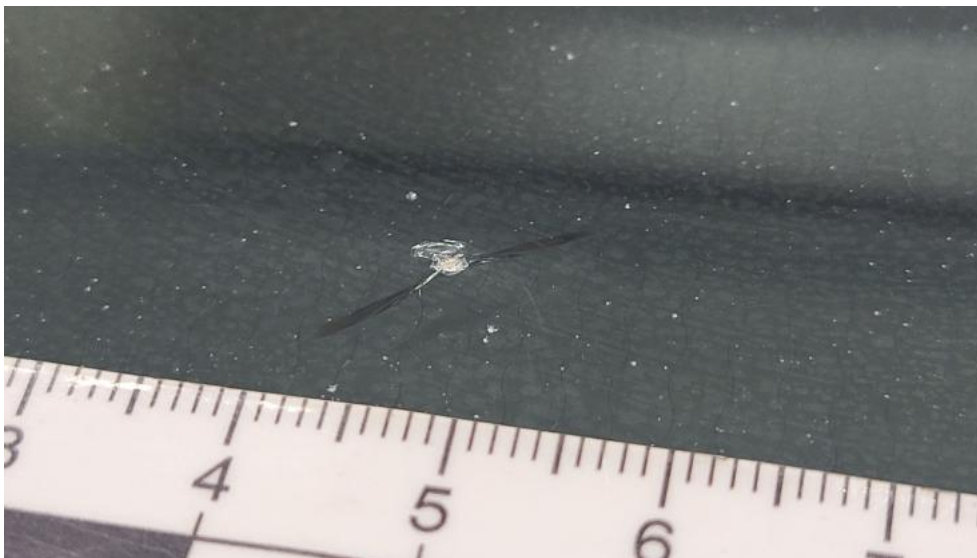
**Photo 39.**  
Szyba czółowa ogrzewana - Pęknięcie/rozerwanie 1

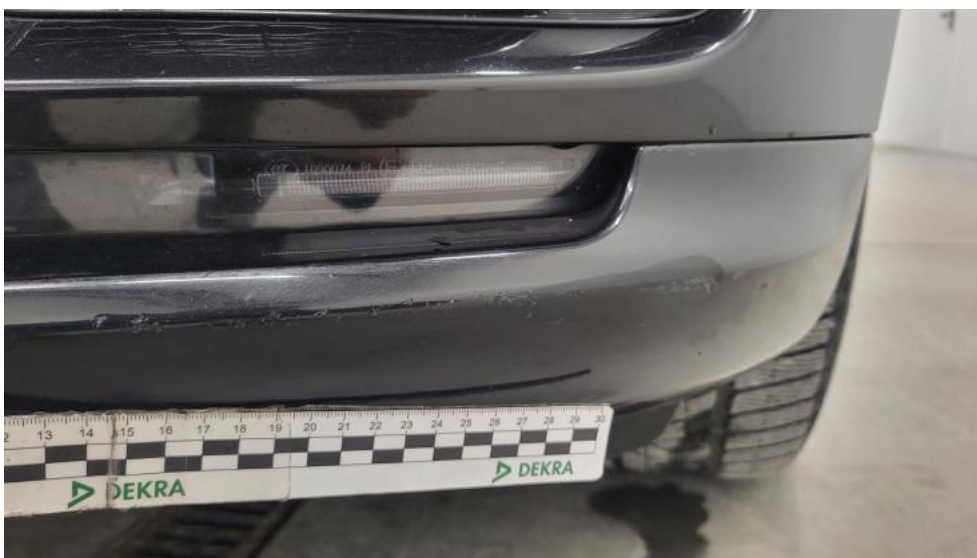
**Photo 40.**  
Zderzak - Rysa/odprysk 1

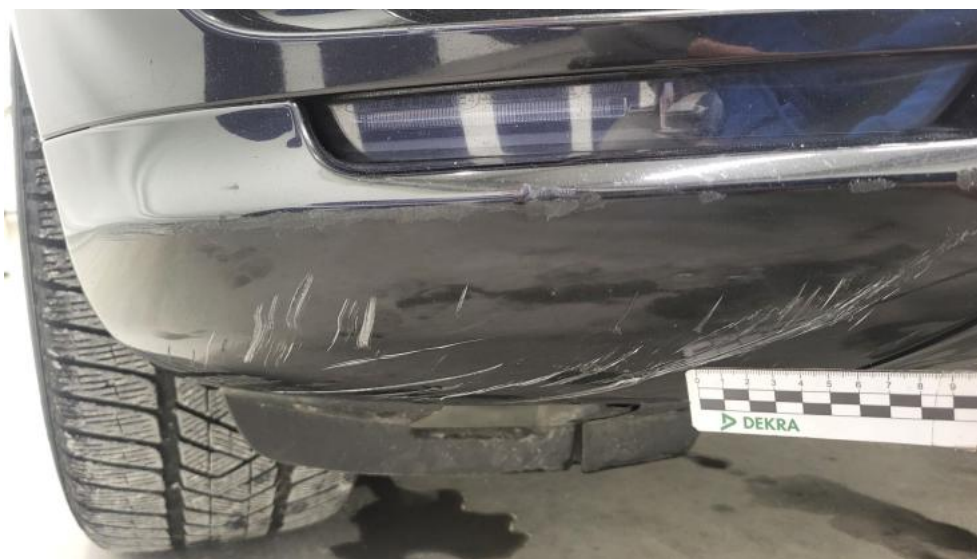
**Photo 41.**  
Zderzak - Rysa/odprysk 2

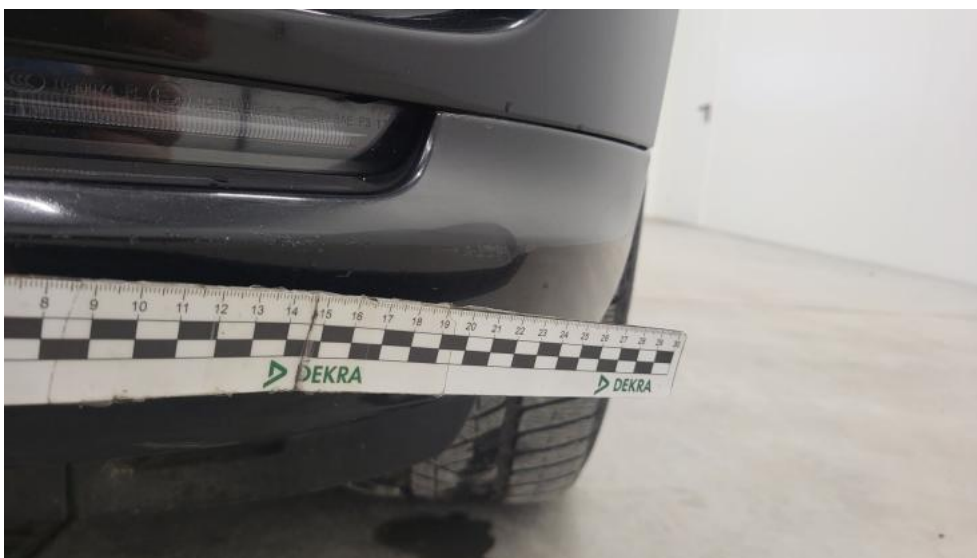
**Photo 42.**  
Zderzak - Wgniecenie/odkształcenie 1

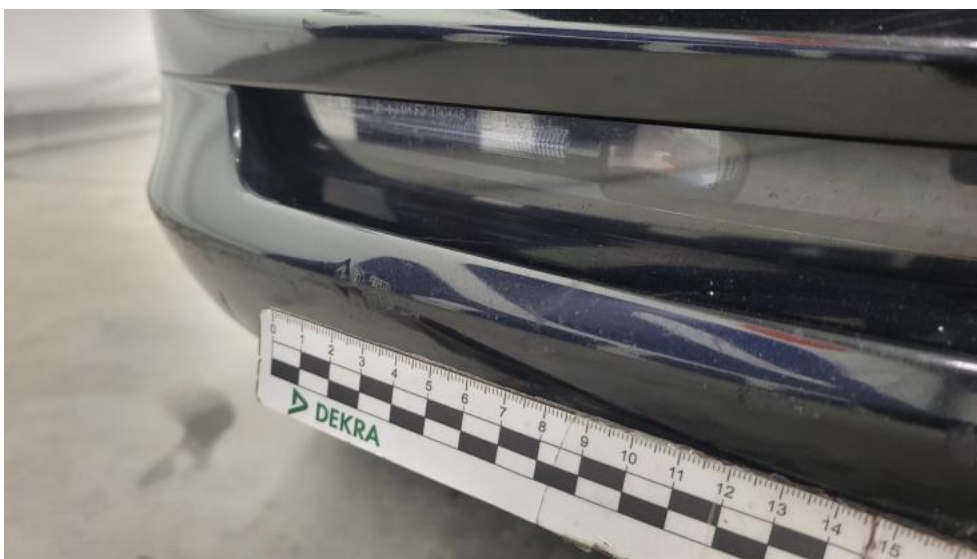
**Photo 43.**  
Zderzak - Wgniecenie/odkształcenie 2

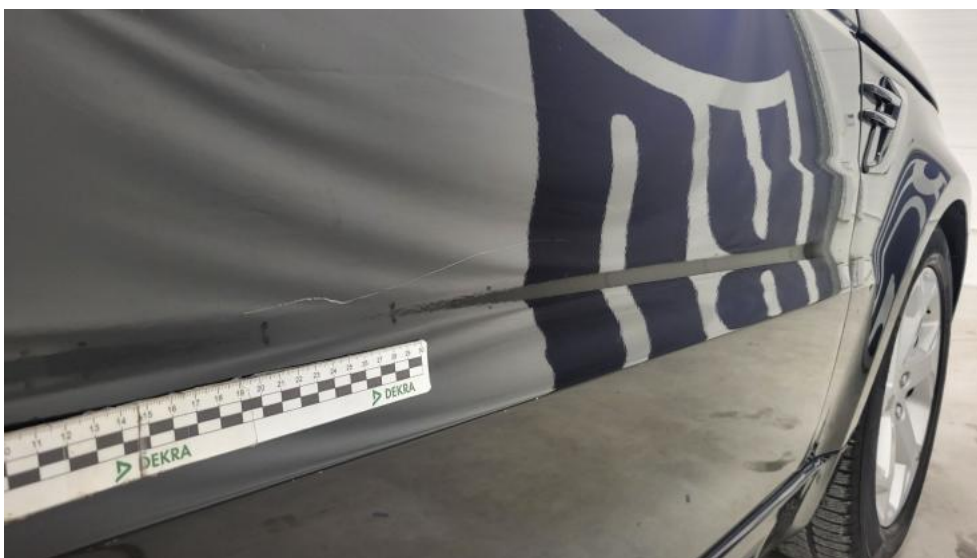
**Photo 44.**  
Drzwi przednie P - Rysa/odprysk 1

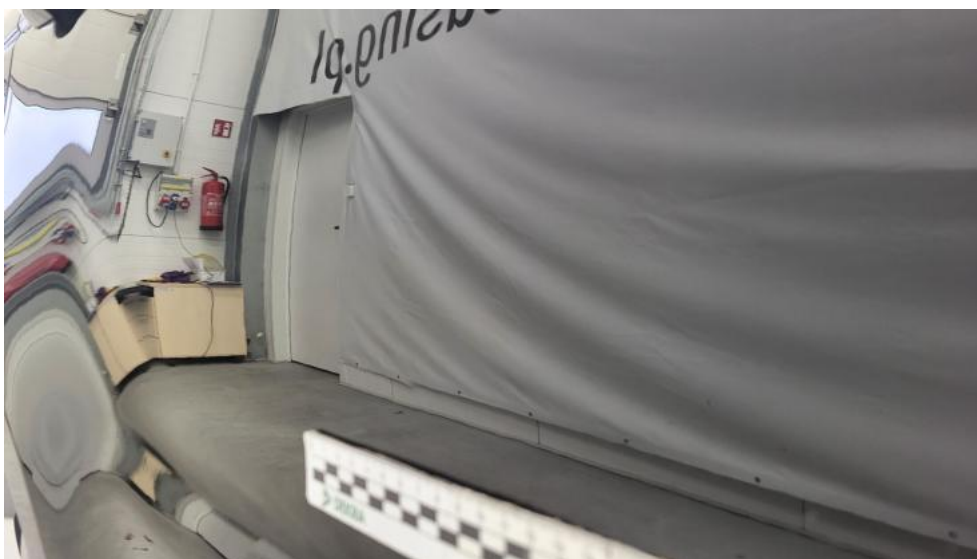
**Photo 45.**  
Drzwi tylne P - Wgniecenie/odkształcenie 1

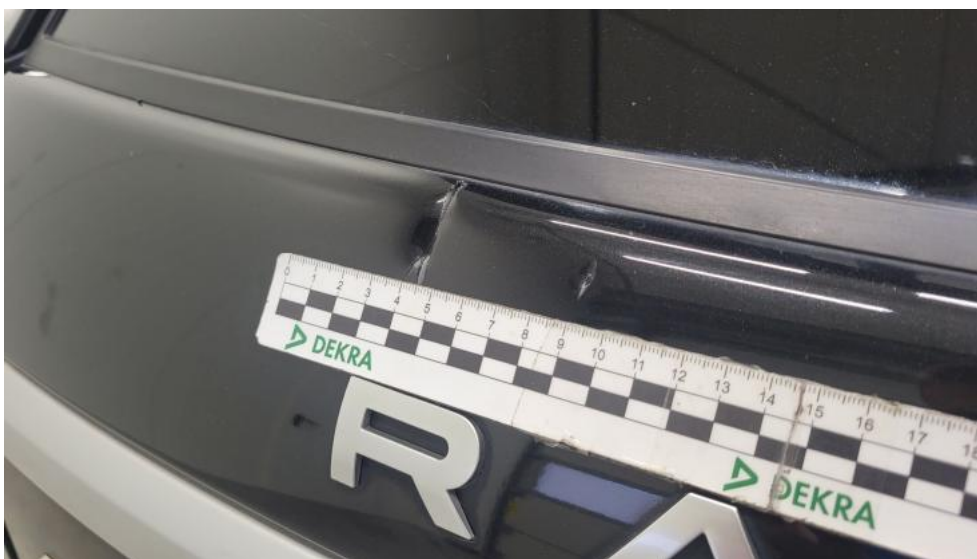
**Photo 47.**  
Pokrywy bagażnika - Rysa/odprysk 1

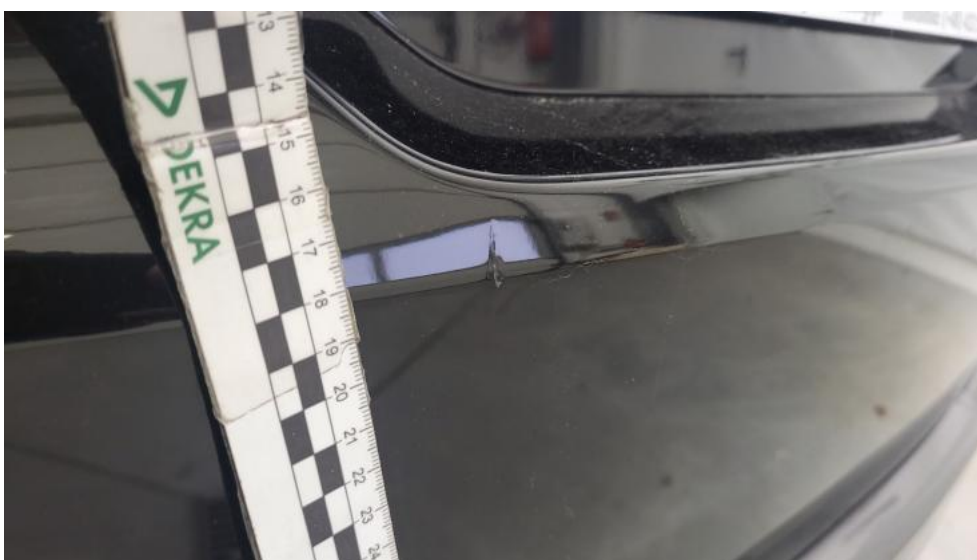
**Photo 48.**  
Pokrywy bagażnika - Rysa/odprysk 2

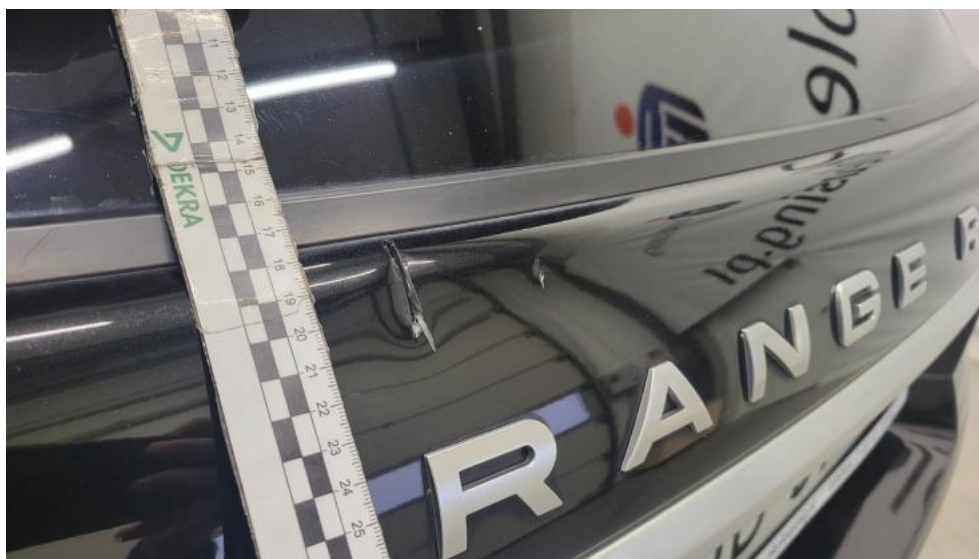
**Photo 49.**

Pokrywy bagażnika - Wgniecenie/odkształcenie 1

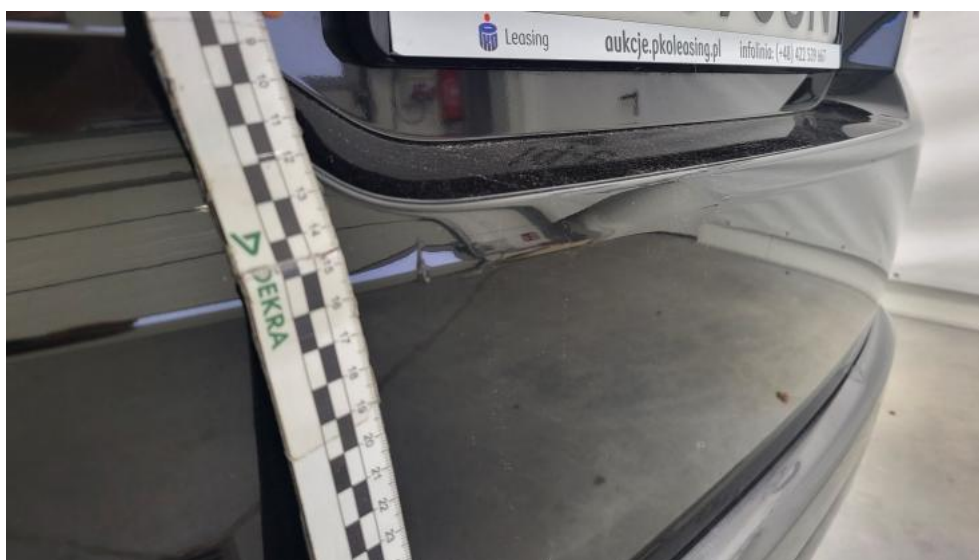
**Photo 50.**

Pokrywy bagażnika - Wgniecenie/odkształcenie 2

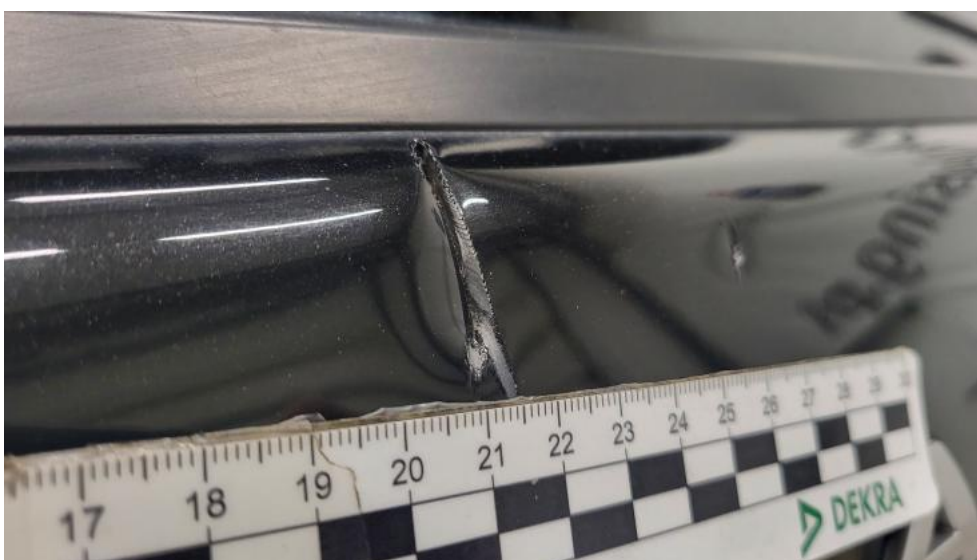
**Photo 52.**  
Pokrywy bagażnika - Pęknięcie/rozerwanie 1

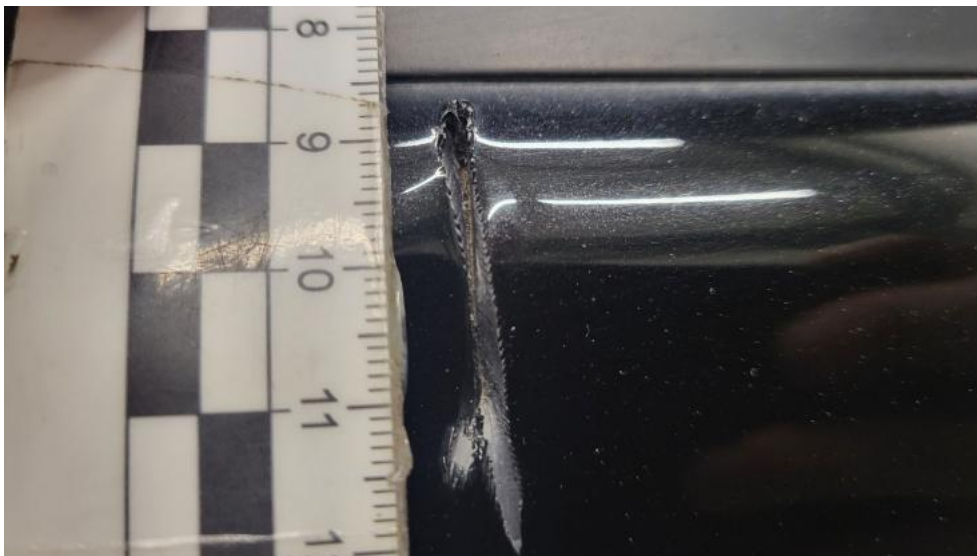
**Photo 53.**  
Pokrywy bagażnika - Pęknięcie/rozerwanie 2

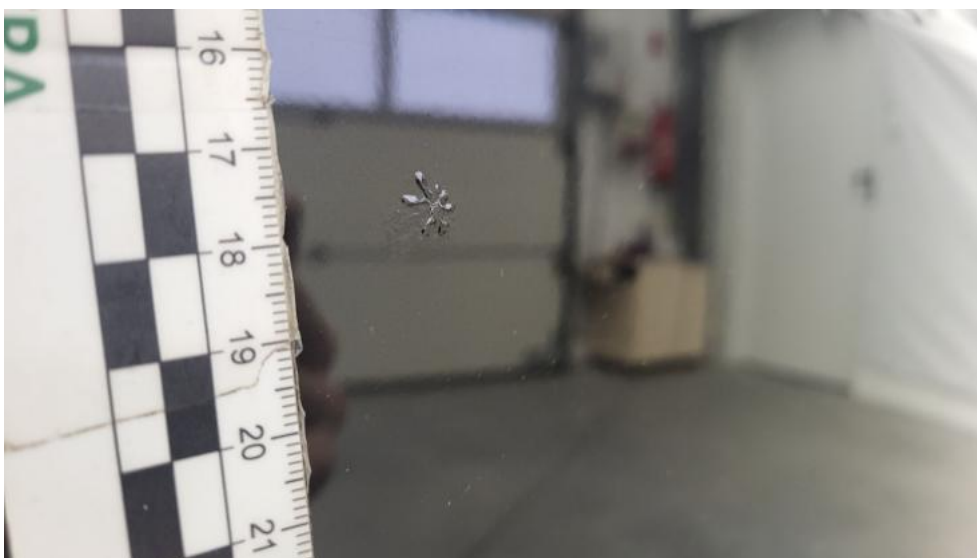
**Photo 54.**  
Pokrywy bagażnika - Inne 1

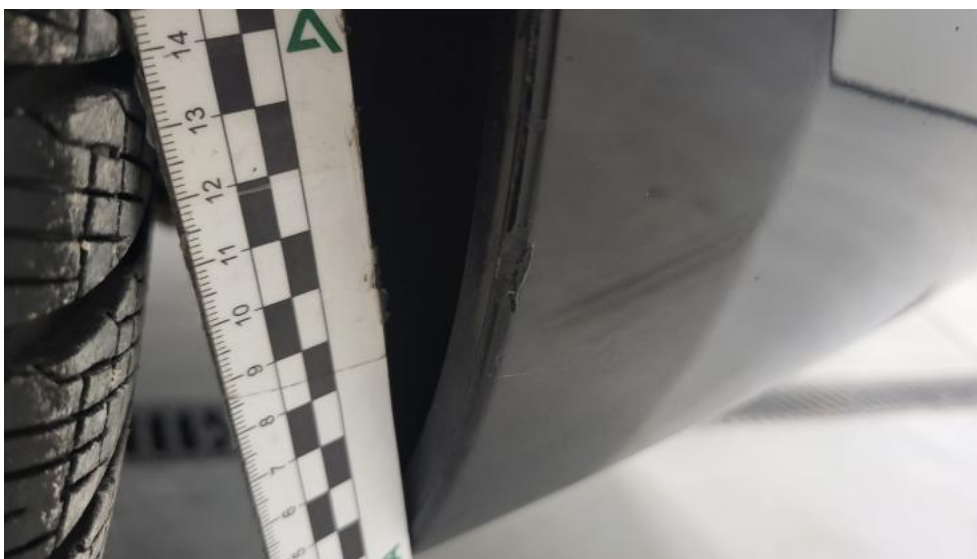
**Photo 55.**

Zderzak tylny - Rysa/odprysk 1

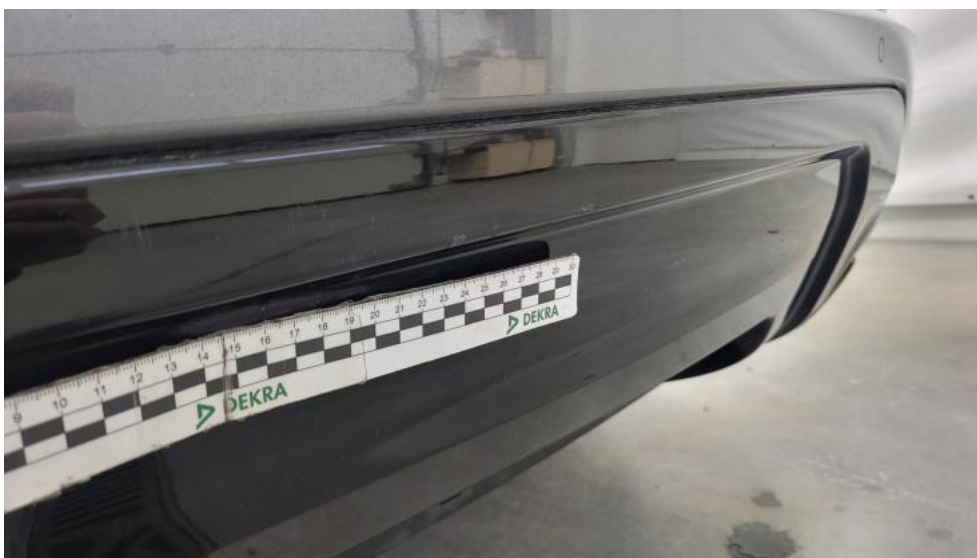
**Photo 56.**

Zderzak tylny - Rysa/odprysk 2

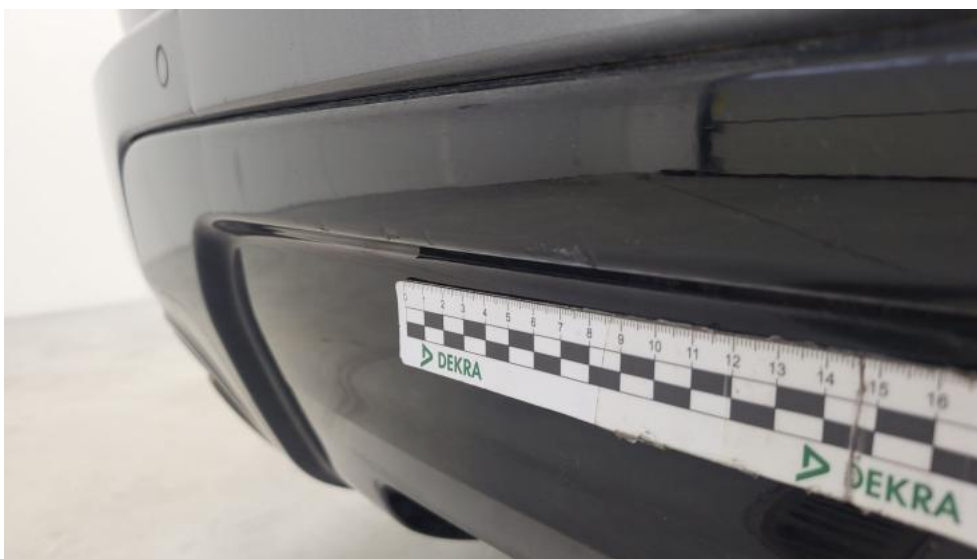
**Photo 57.**  
Zderzak tylny - Wgniecenie/odkształcenie 1

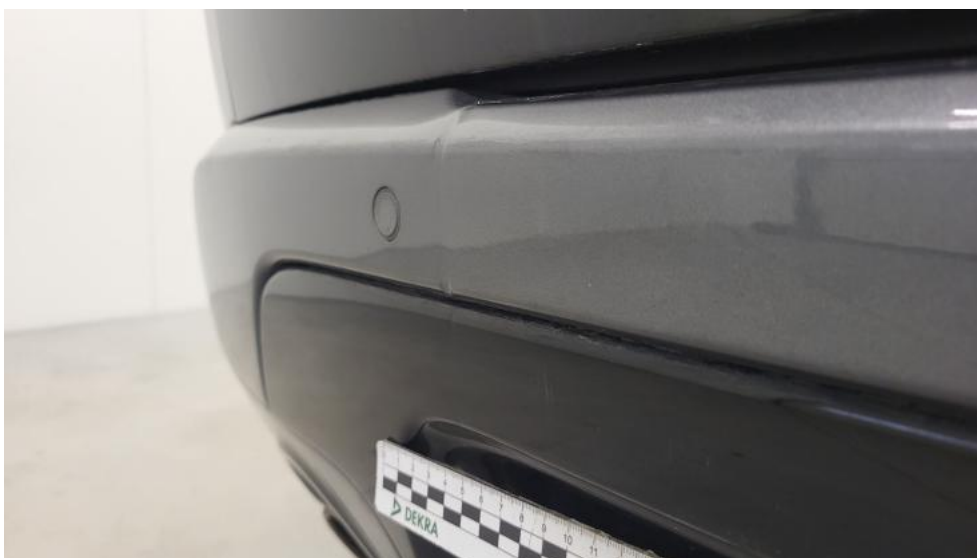
**Photo 58.**  
Zderzak tylny - Wgniecenie/odkształcenie 2

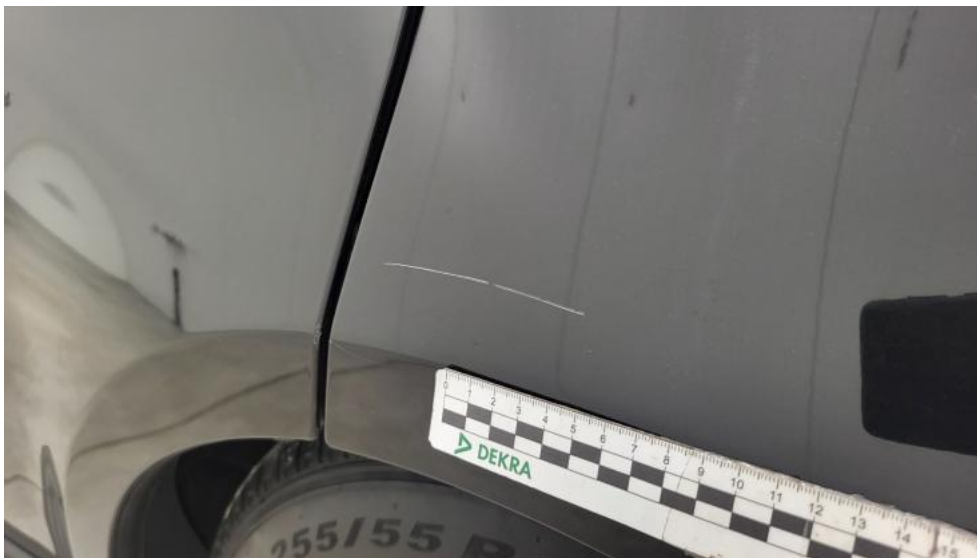
**Photo 59.**

Błotnik tylny L / Ściana boczna L - Rysa/odprysk 1

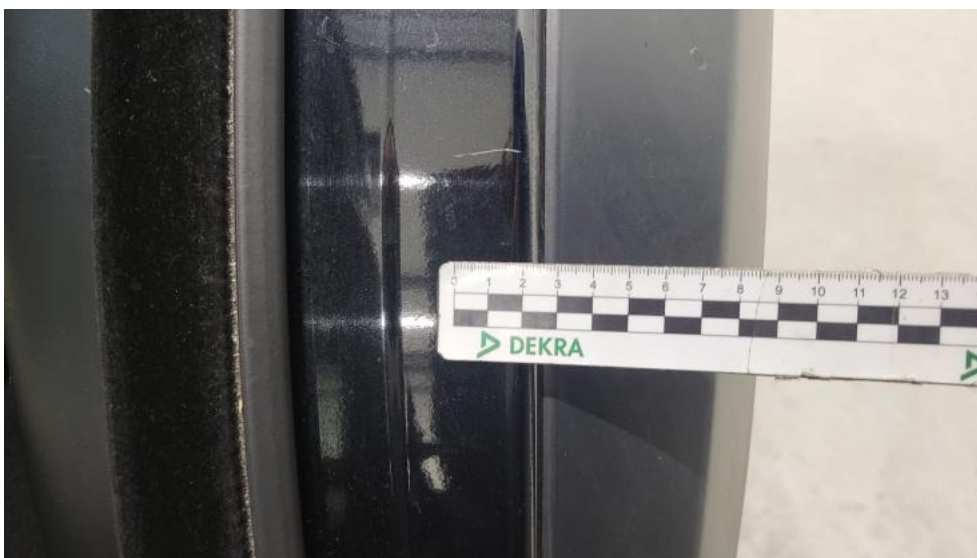
**Photo 60.**

Błotnik tylny L / Ściana boczna L - Rysa/odprysk 2

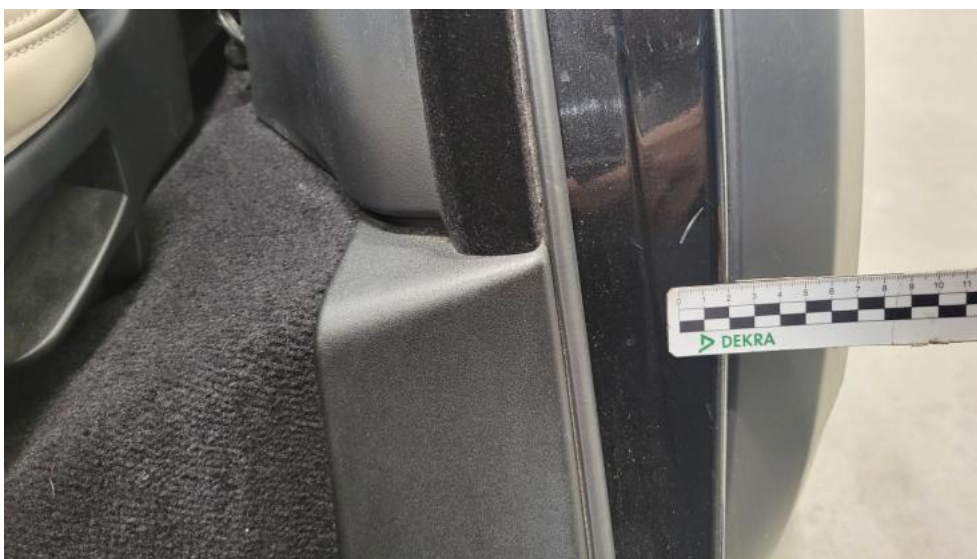
**Photo 61.**  
Błotnik tylny L / Ściana boczna L() - Rysa/odprysk 3

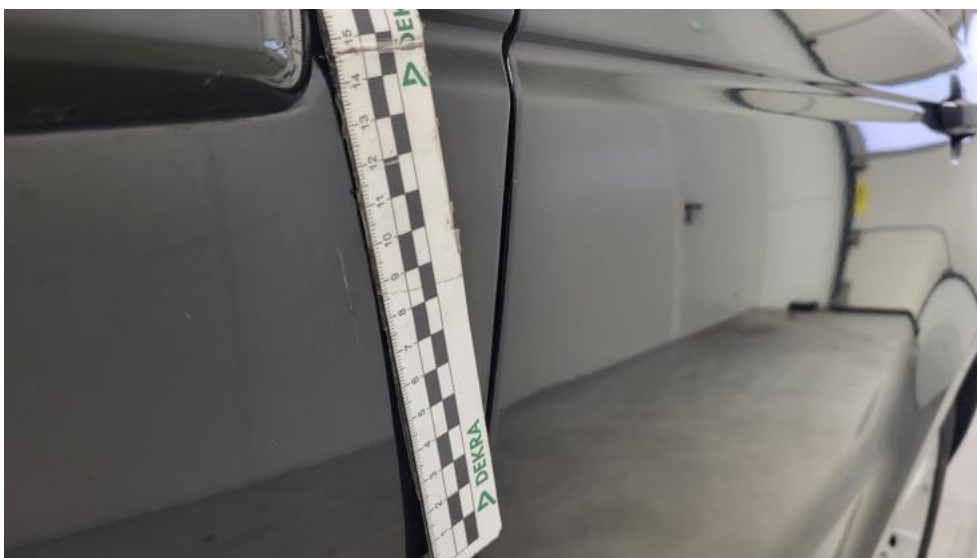
**Photo 62.**  
Drzwi przed L - Rysa/odprysk 1

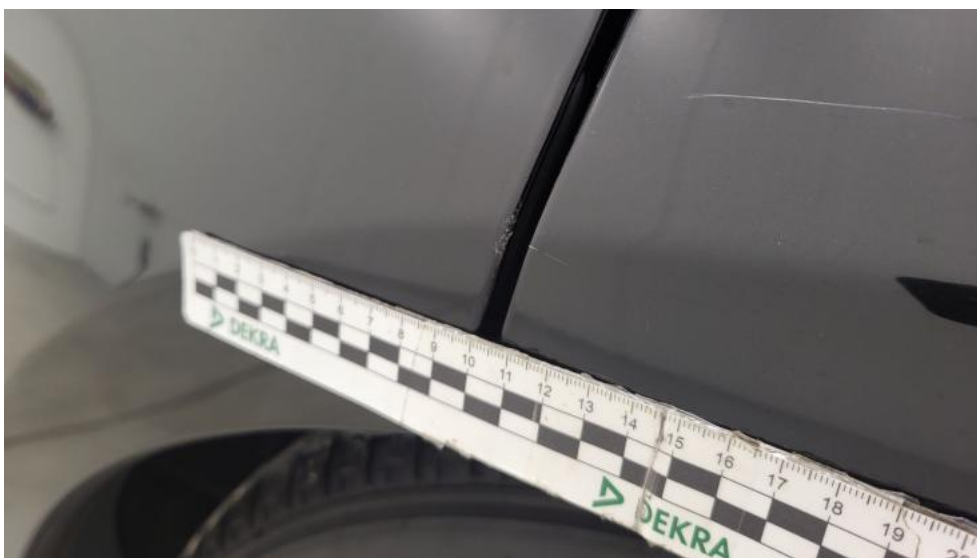
**Photo 64.**  
Drzwi tylne L - Rysa/odprysk 1

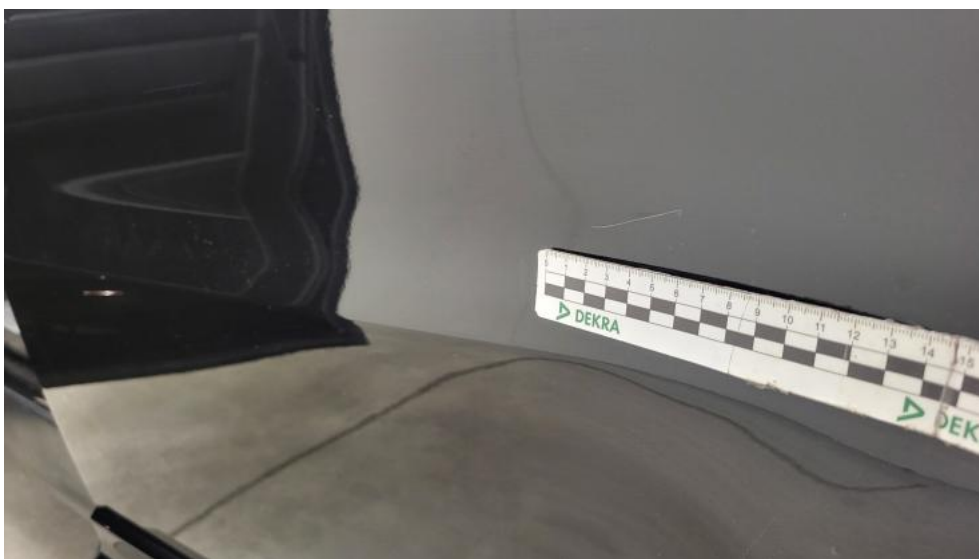
**Photo 65.**  
Drzwi tylne L - Rysa/odprysk 2

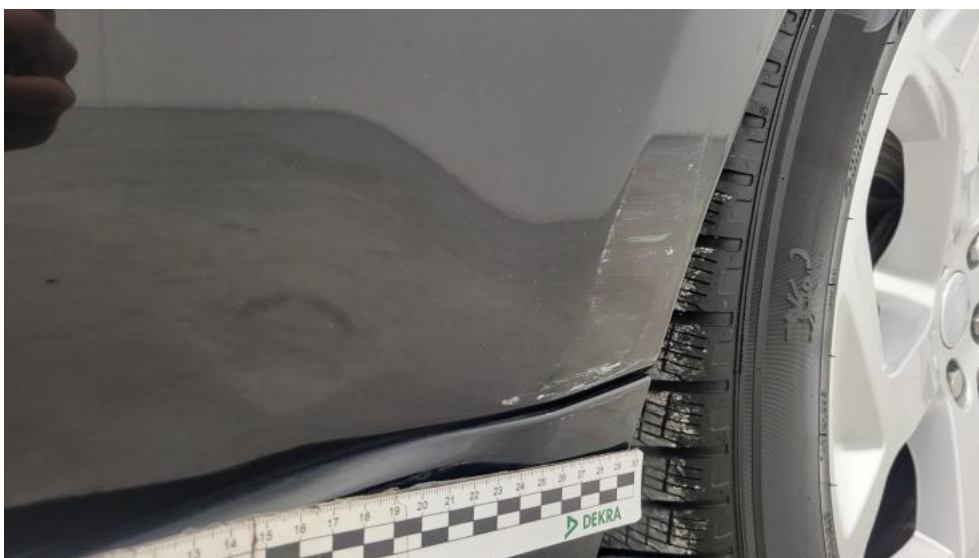
**Photo 66.**  
Drzwi tylne L() - Rysa/odprysk 3

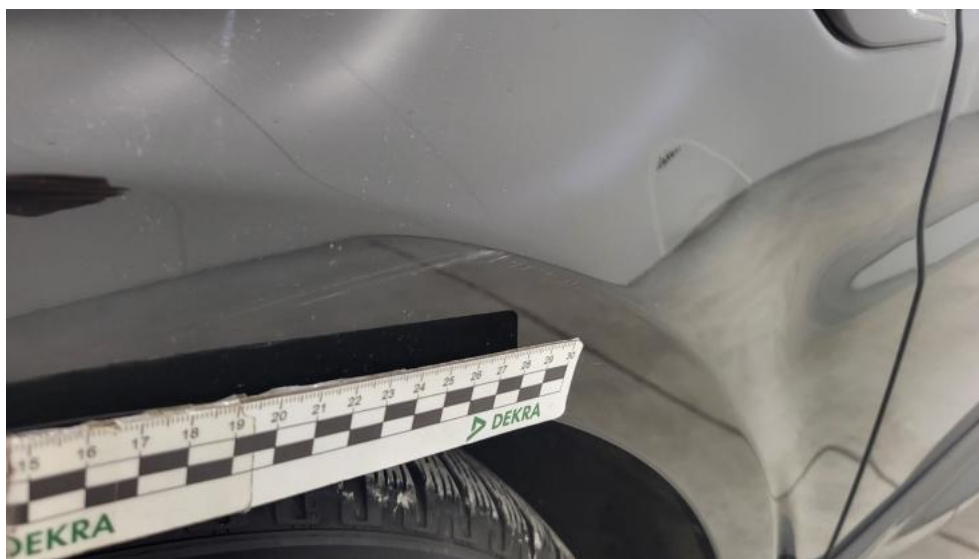
**Photo 67.**  
Błotnik przedni L - Rysa/odprysk 1

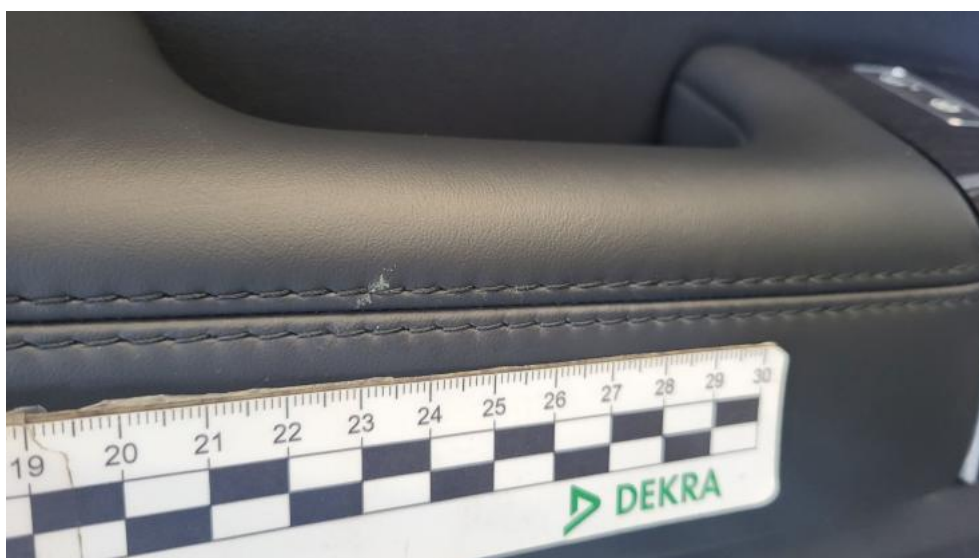
**Photo 68.**  
Tapicerka drzwi tylnych L - Rysa/odprysk 1

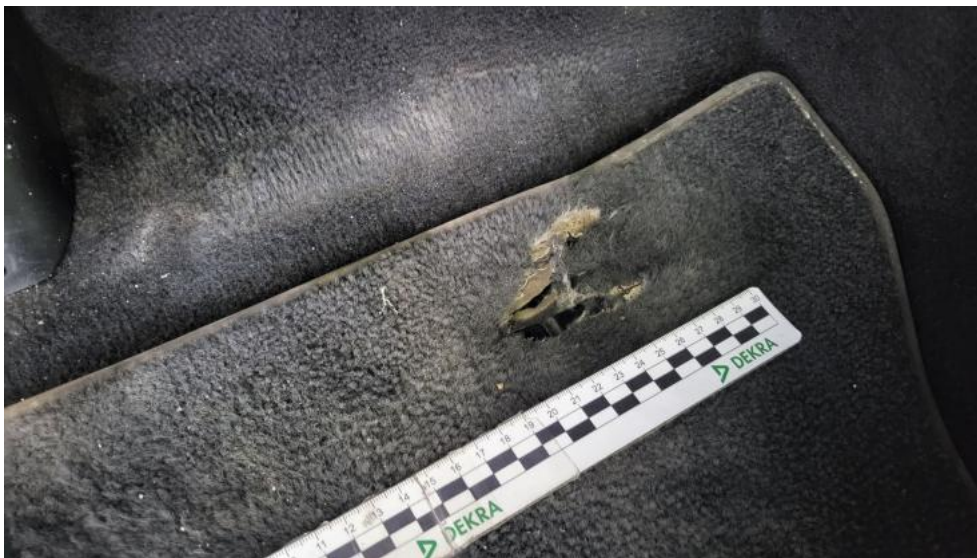
**Photo 69.**

Dywanik prze L - Pęknięcie/rozerwanie 1

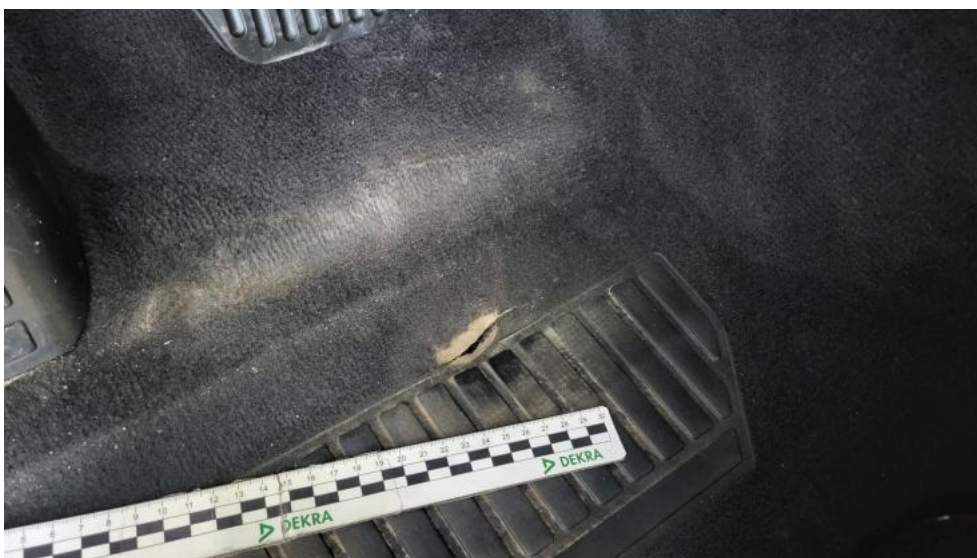
**Photo 70.**

Wykładzina podłogi - Pęknięcie/rozerwanie 1
