DEKRA's commission No. : PKOL(W)/LODZ/87920/24/11/14
commission/ damage No. : 22/035104
Date of commission: 14-11-2024

Vehicle data

Group of objects (Eurotax)	cars
EC code (Eurotax)	0149202
Manufacturer	FIAT
Model	500 3+1 21-
Type / version	500 3+1 42 kWh Icon
Body type	hatchback
Number of doors / seats	4/4
Curb weight [kg]	1325
Gross vehicle weight [kg]	1725
Wheelbase 1/2	2322
Engine type	elektryczny
Pollution reduction system	-
Engine capacity [ccm]	0
Engine Power [hp/kW]	118/87
Gearbox	automatic
Registration /record No.	PY00227
VIN / serial number	ZFAEFAR47NX096957
Date of first registration	18-11-2022
Date of next. tech. test	18-11-2025
Year of manufacture	2022
Readout [km]	30 342 (read)
Body color / type of coating	różowy/beżowy/double-layered, metallized

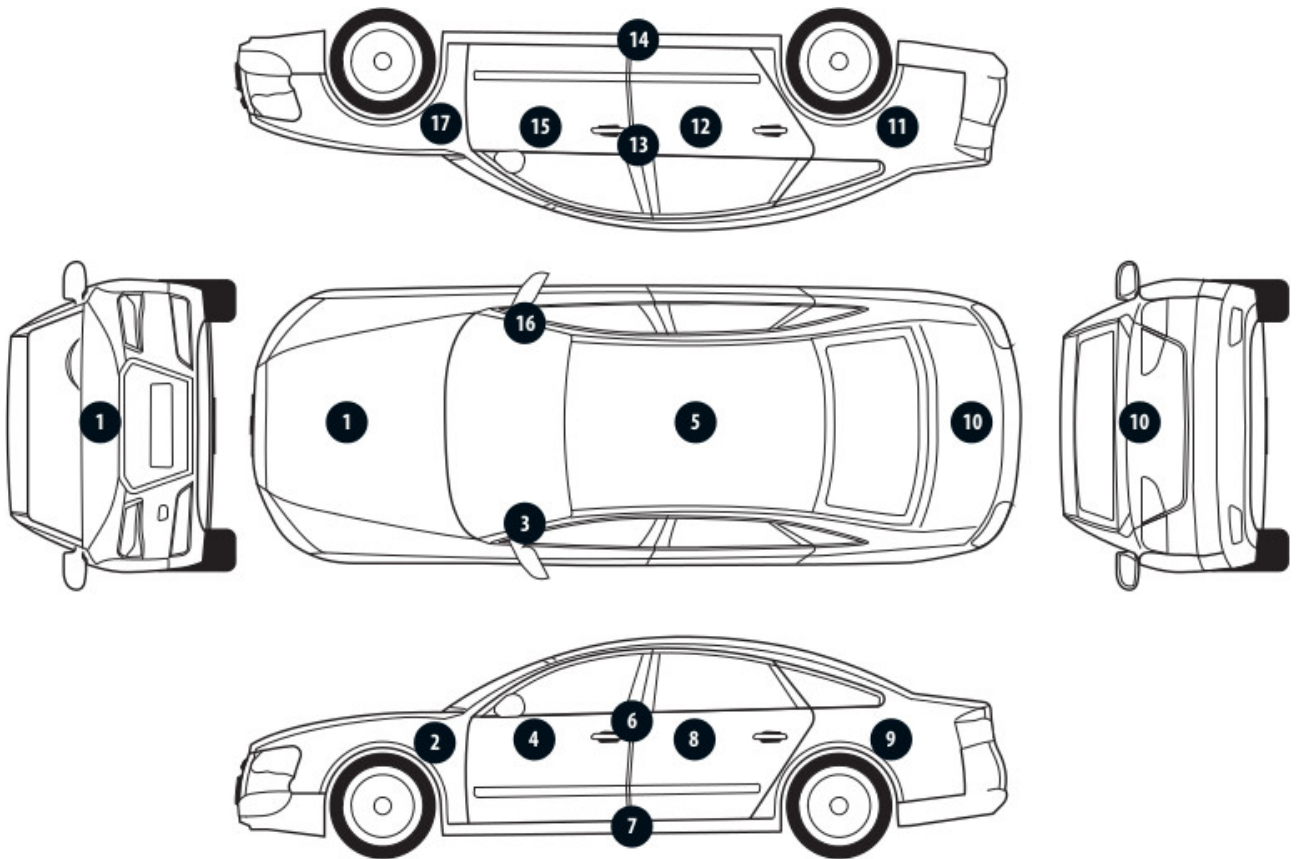
Measurement of thickness of the vehicle lacquer coating

No. of controlled item	Controlled item	Measured range of thickness of the lacquer coat [μm]
1	Front cover	to 150
2	Front left fender	to 150
3	Left front pillar	to 150
4	Front left door	to 150
5	Roof	to 150
6	Left middle pillar	to 150
7	Right side sill	to 150
9	Rear left fender	to 150
10	Cover/lid	to 150
11	Right rear fender	150 - 300
13	Right middle pillar	to 150
14	Right side sill	to 150
15	Front right door	to 150
16	Right front pillar	to 150
17	Front right fender	150 - 300

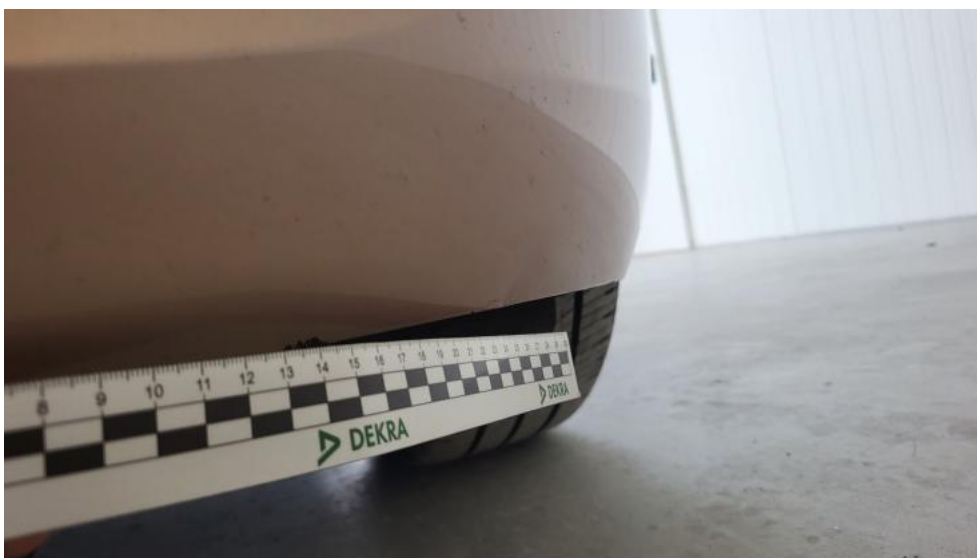
Photo 52.
Zderzak - Wgniecenie/odkształcenie 1

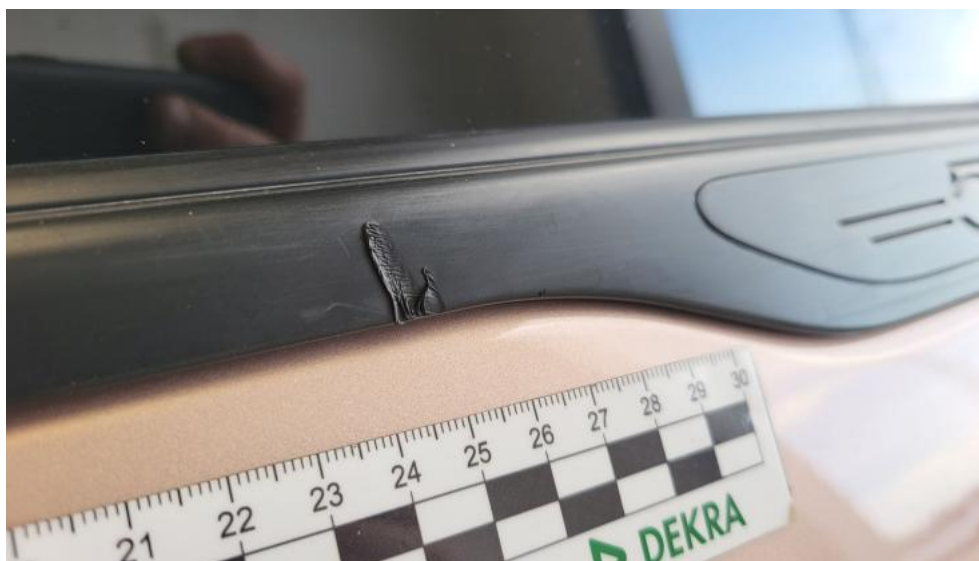
Photo 57.

Uszczelka szyby bocznej tyl L - Rysa/odprysk 1

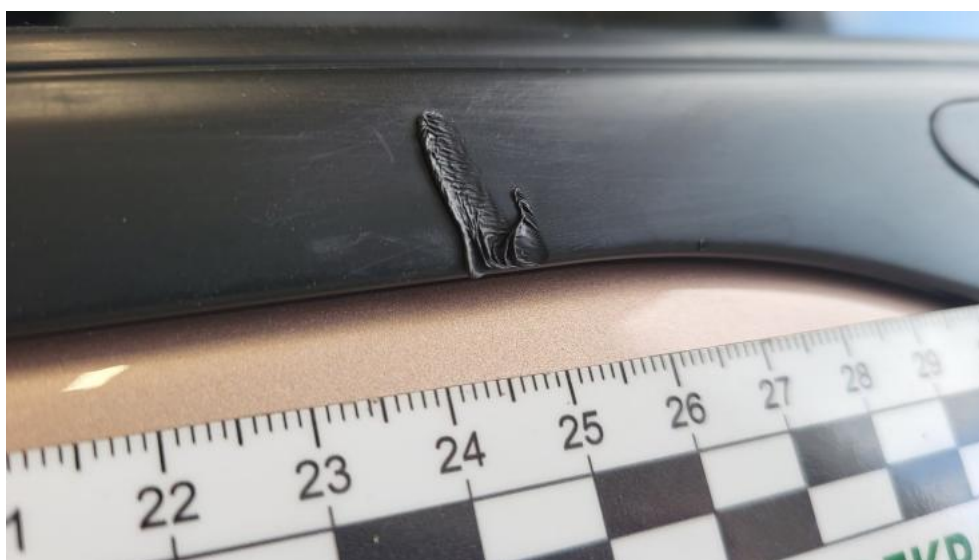
Photo 58.

Uszczelka szyby bocznej tyl L - Wgniecenie/odkształcenie 1
