DEKRA's commission No. : PKOL(W)/LODZ/101841/25/12/22  
commission/ damage No. : 23/045730  
Date of commission: 22-12-2025

| Manufacturer | NISSAN |
| Type / version | Qashqai 1.3 DIG-T mHEV Acenta Xtronic |
| Registration /record No. | DW7XC31 |

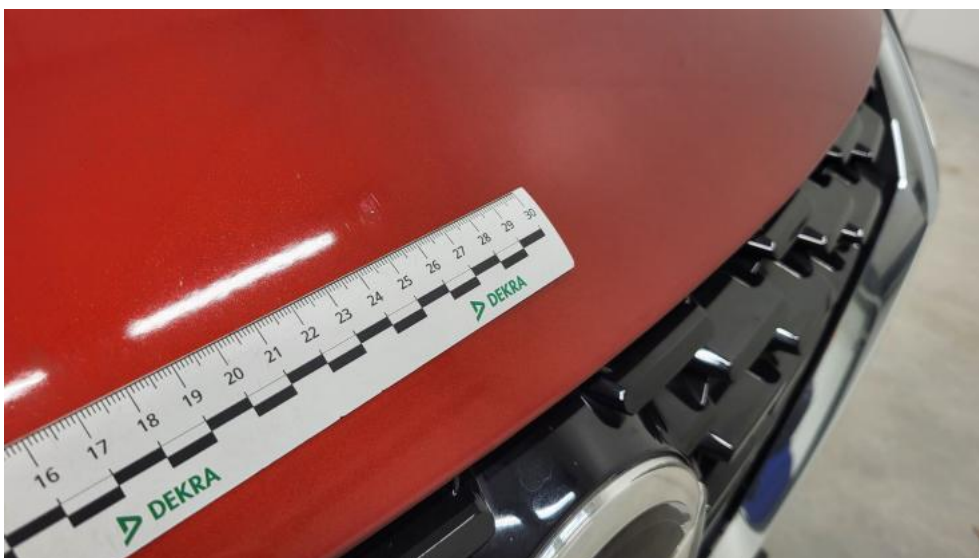
**Photo 38.**

Pokrywa komory silnika - Rysa/odprysk 1

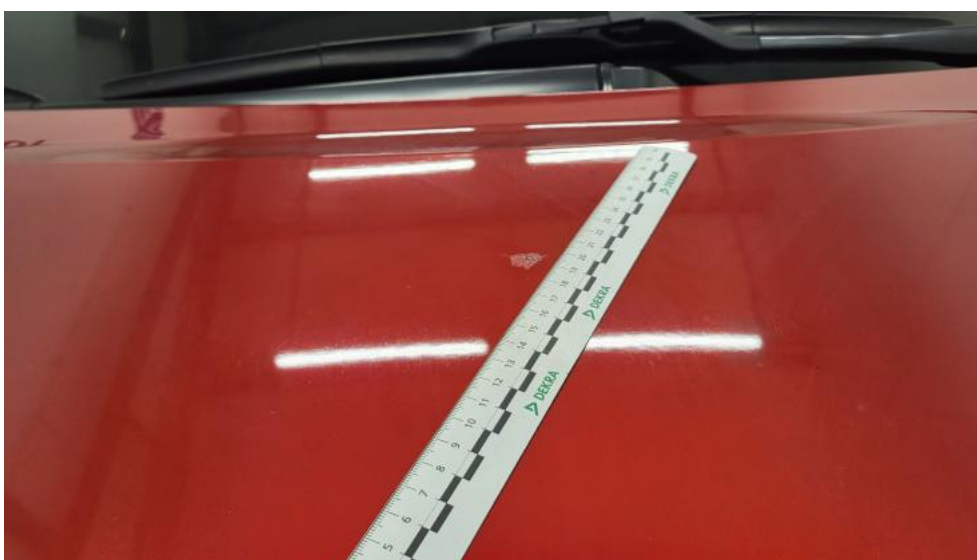
**Photo 40.**

Pokrywa komory silnika - Inne 1

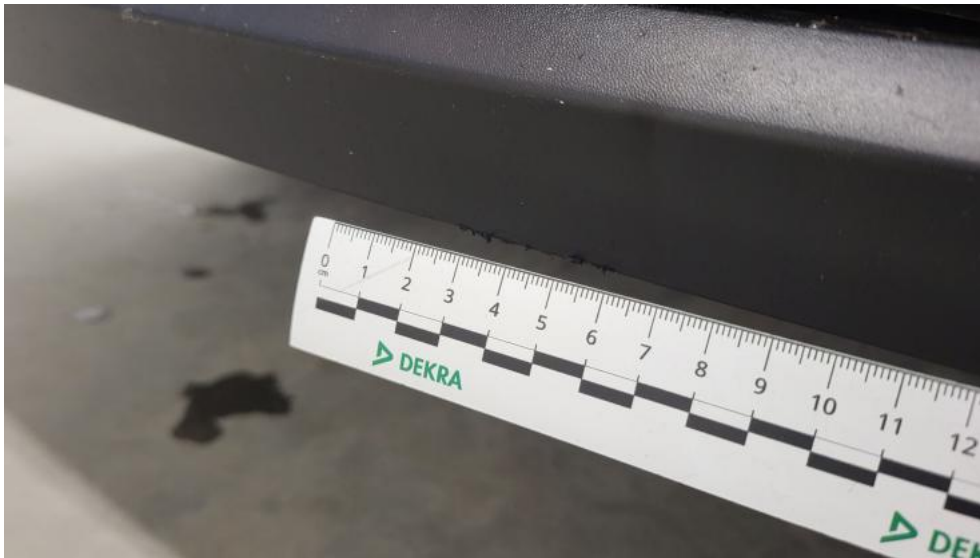
**Photo 41.**

Spoiler zderzaka przedniego - Rysa/odprysk 1

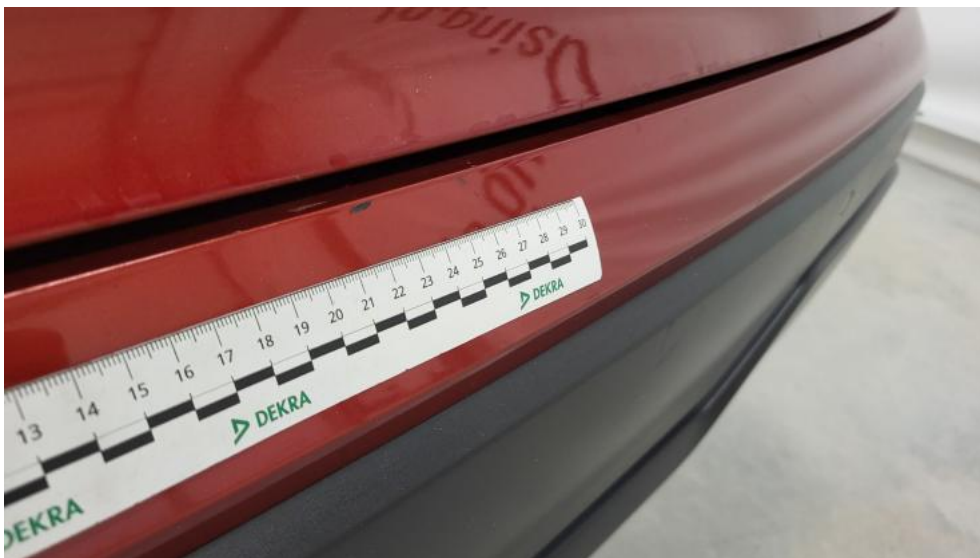
**Photo 42.**

Zderzak tylny - Rysa/odprysk 1

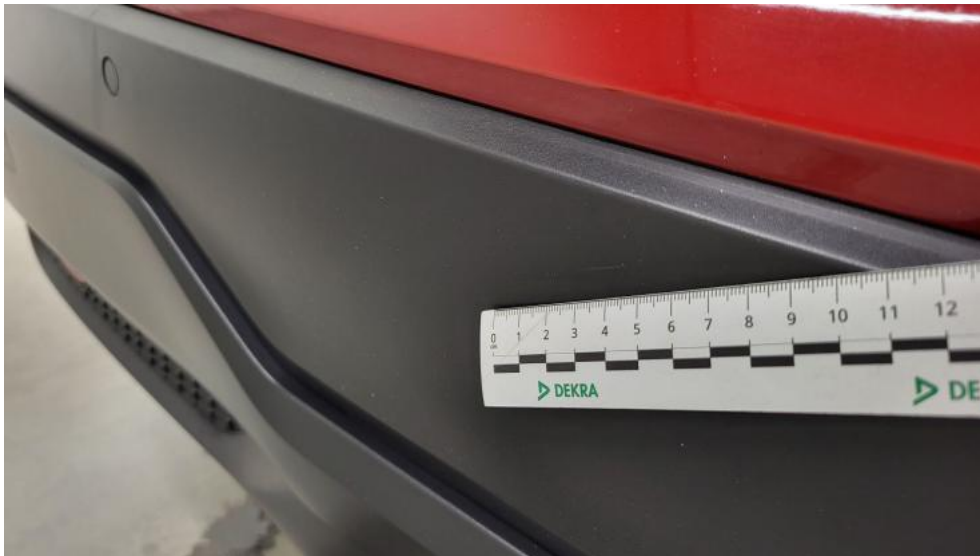
**Photo 43.**

Zderzak tylny cz dolna - Rysa/odprysk 1

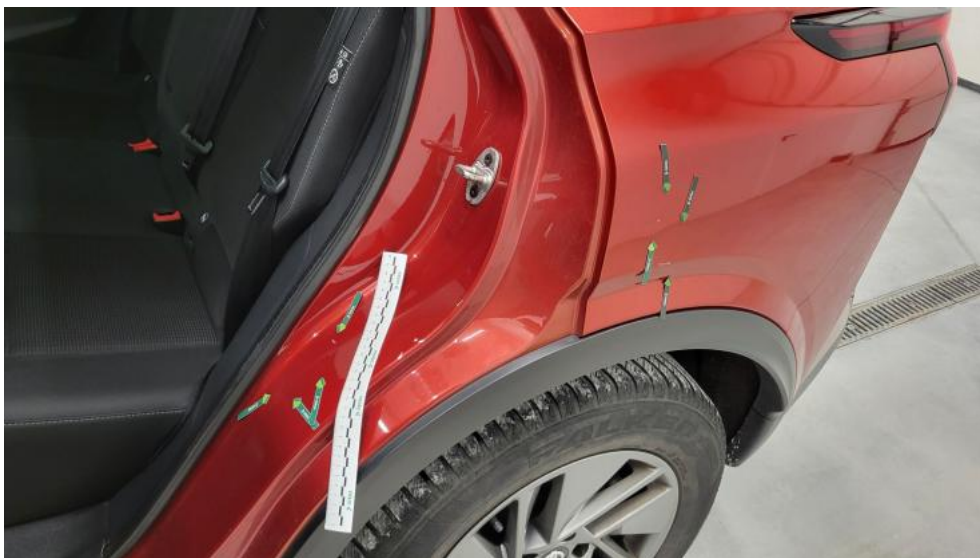
**Photo 44.**

Błotnik tylny L / Ściana boczna L - Wgniecenie/odkształcenie 1

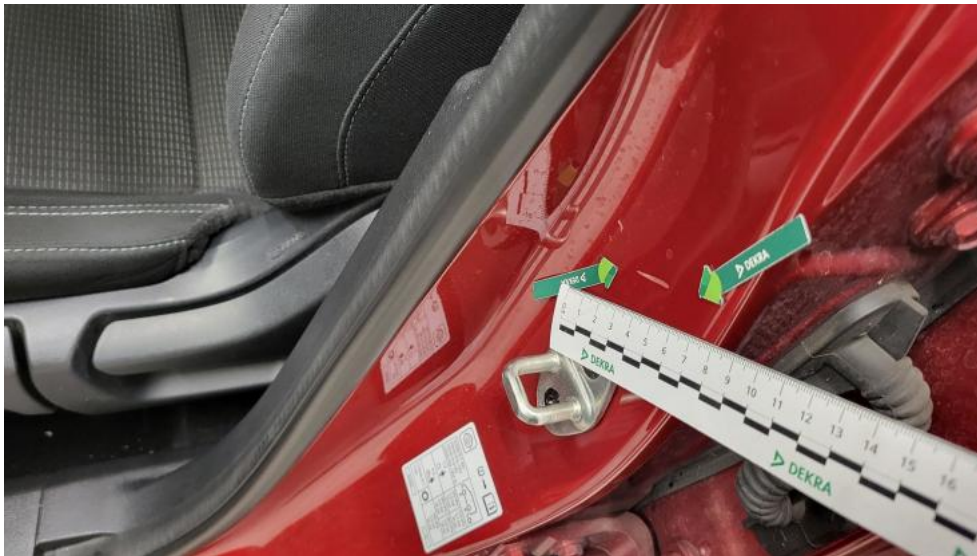
**Photo 47.**

Słupek środkowy L - Wgniecenie/odkształcenie 1

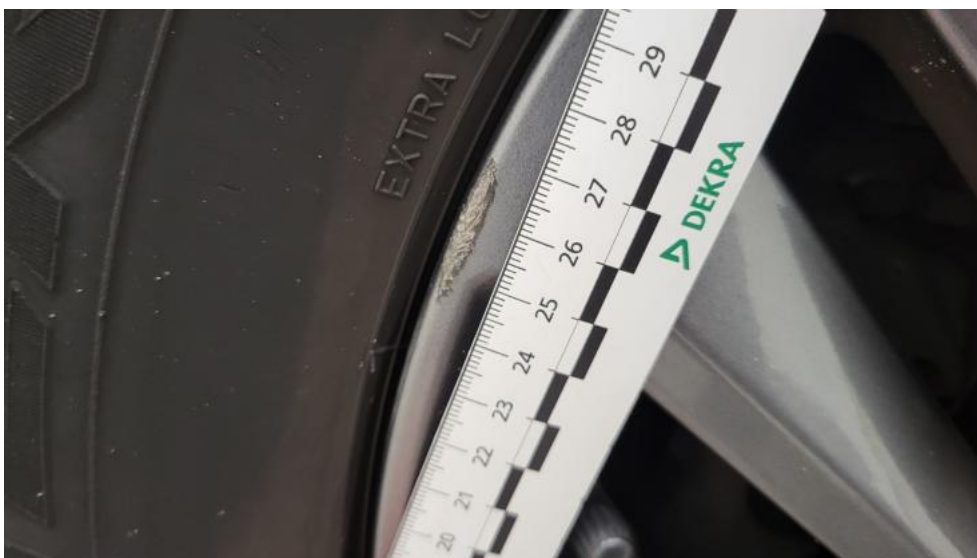
**Photo 48.**

Felga Aluminiowa przednia L - Rysa/odprysk 1

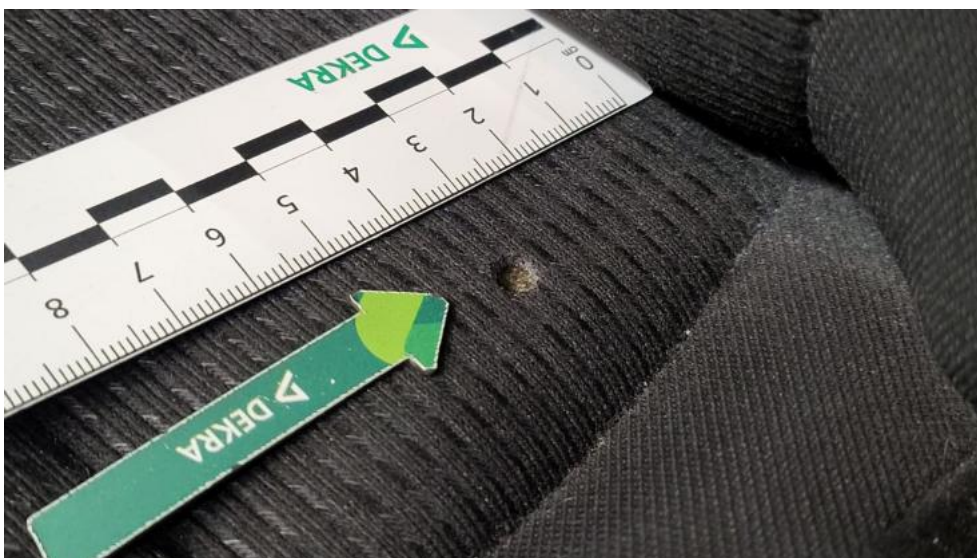
**Photo 50.**

Fotel prz. lew. - Inne 1

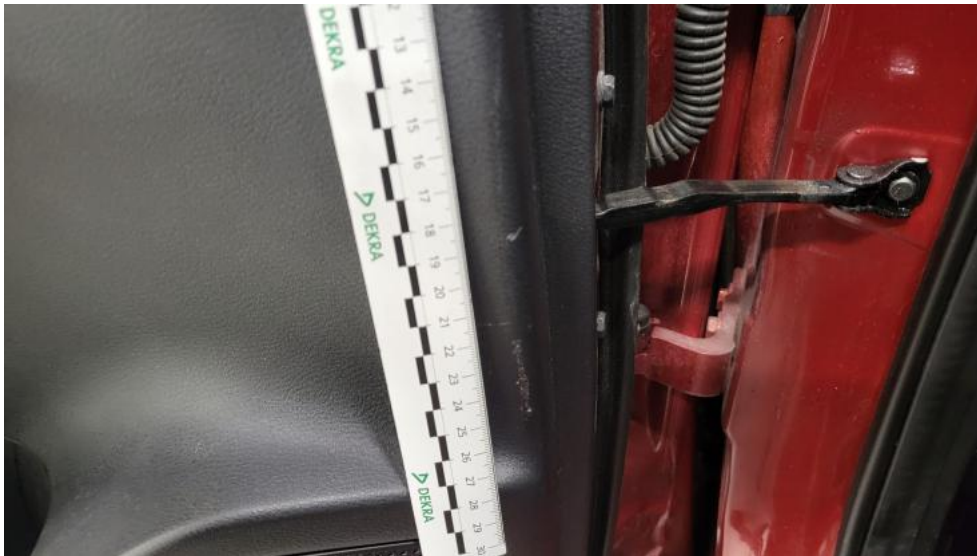
**Photo 53.**

Tapicerka drzwi tylnych L - Rysa/odprysk 1

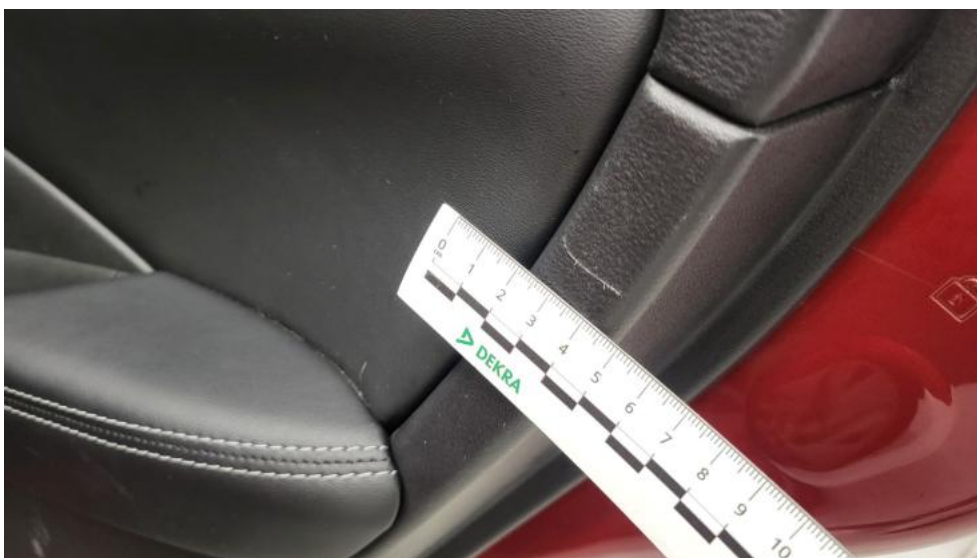
**Photo 54.**

Tapicerka drzwi tylnych P - Rysa/odprysk 1

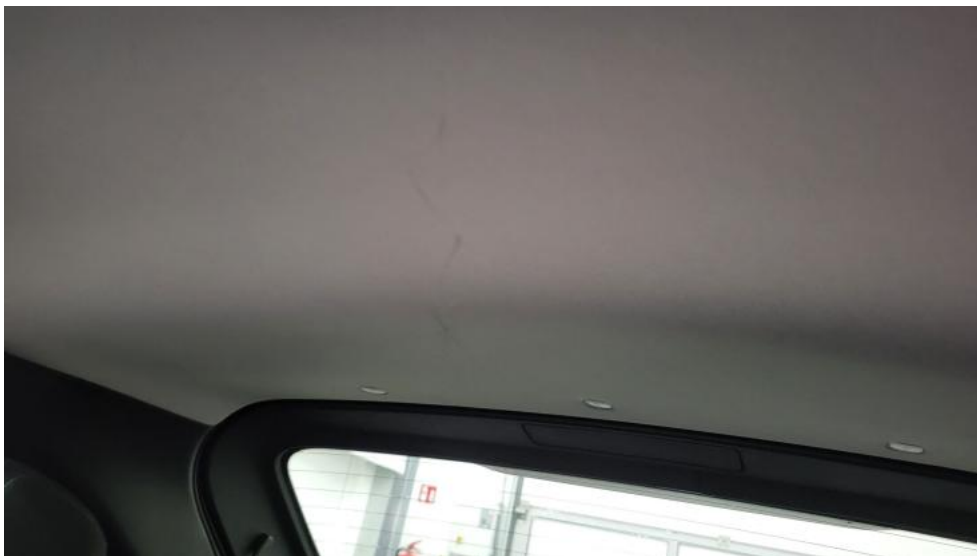
**Photo 55.**

Podsufitka - Inne 1
