DEKRA's commission No. : PKOL(W)/LODZ/03715/26/01/16  
commission/ damage No. : 03477/EO/22  
Date of commission: 16-01-2026

| Manufacturer | BMW |
| Model | X7 [G07] 18-22 |
| Registration /record No. | ZK5721J |

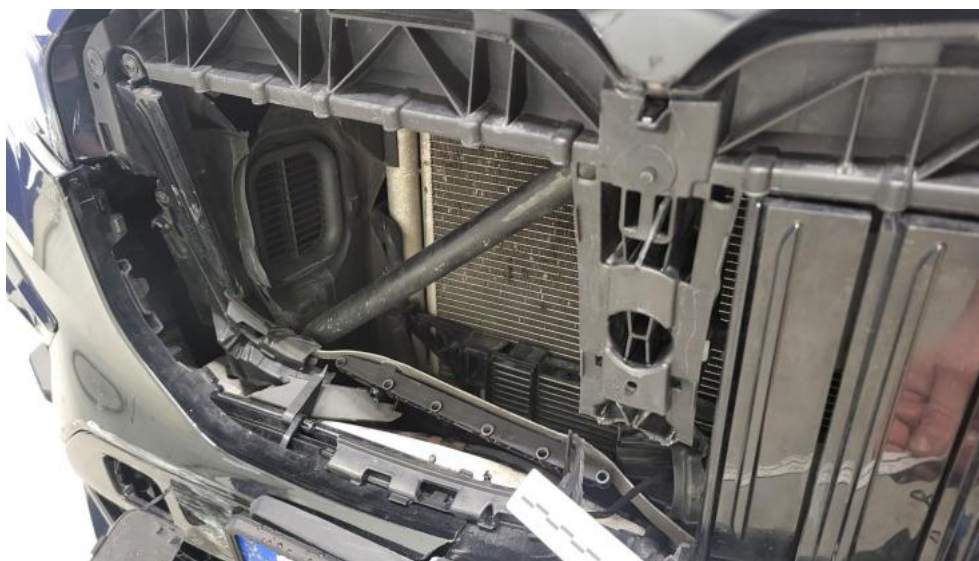
Rysy na samochodzie. Plastikowy element w bagażniku. Informacja uzupełnij AdBlue. Informacja awaria automatycznej aktywacji PDC. Awaria kamery parkowania przód i tył. Pojazd oklejony folią. Pomiar lakieru wykonany na folii oprócz elementów próg lewy/prawy, słupek środkowy lewy/prawy. Lusterka i reflektory oklejone folią. Odpryski na szybie czołowej. Uszkodzony przód, zakres uszkodzeń do weryfikacji. Elektryczne i podgrzewane tylne fotele.

Atrapa przednia - Pęknięcie/rozerwanie 1

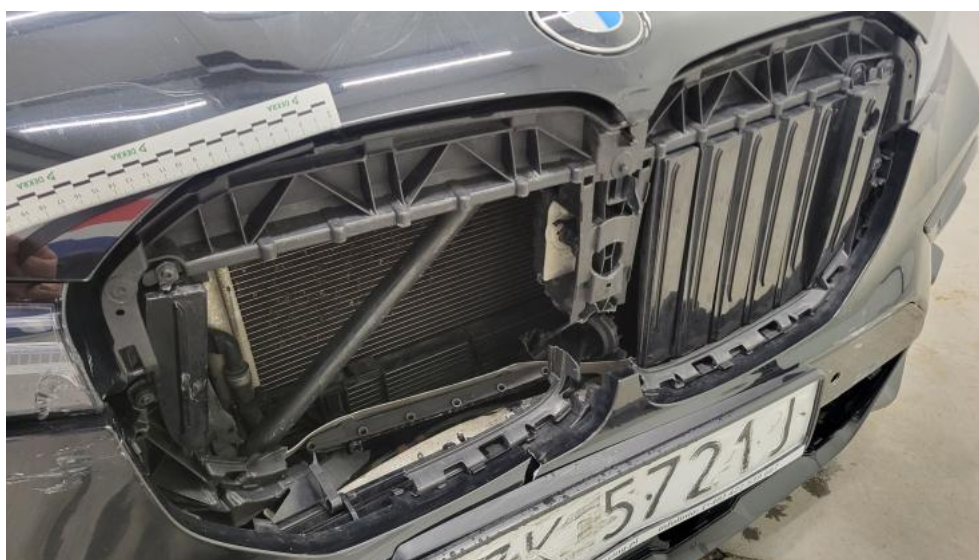
Atrapa przednia - Inne 1

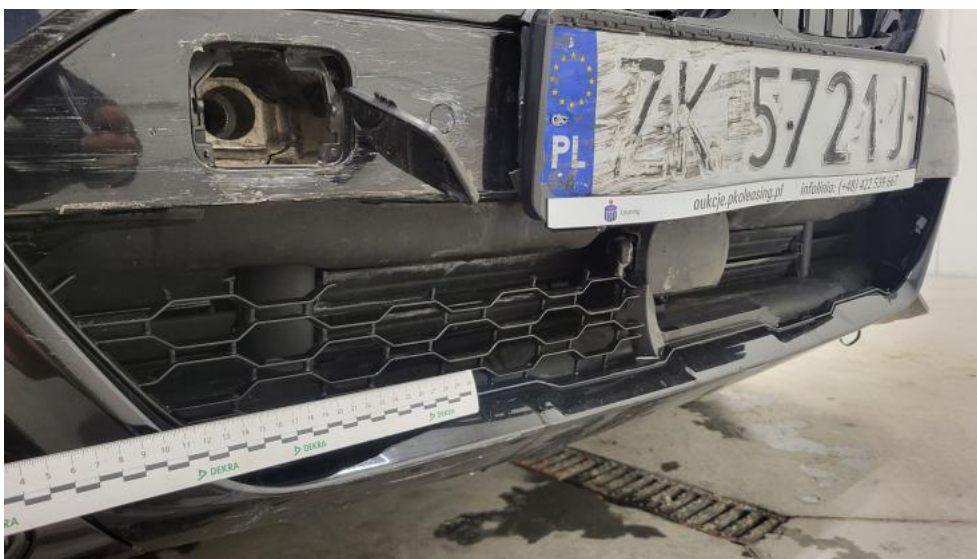
Krata zderzaka prz. - Pęknięcie/rozerwanie 1

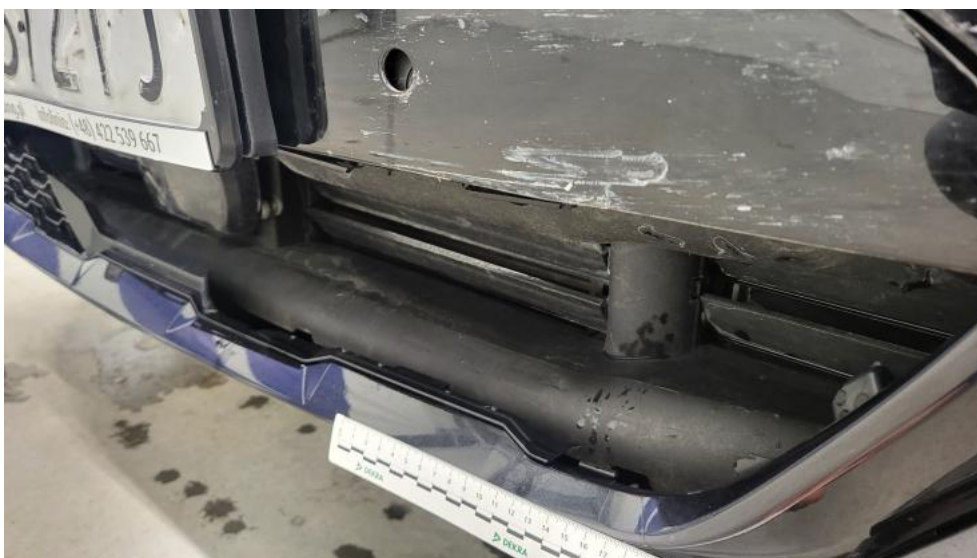
Krata zderzaka prz. - Pęknięcie/rozerwanie 2

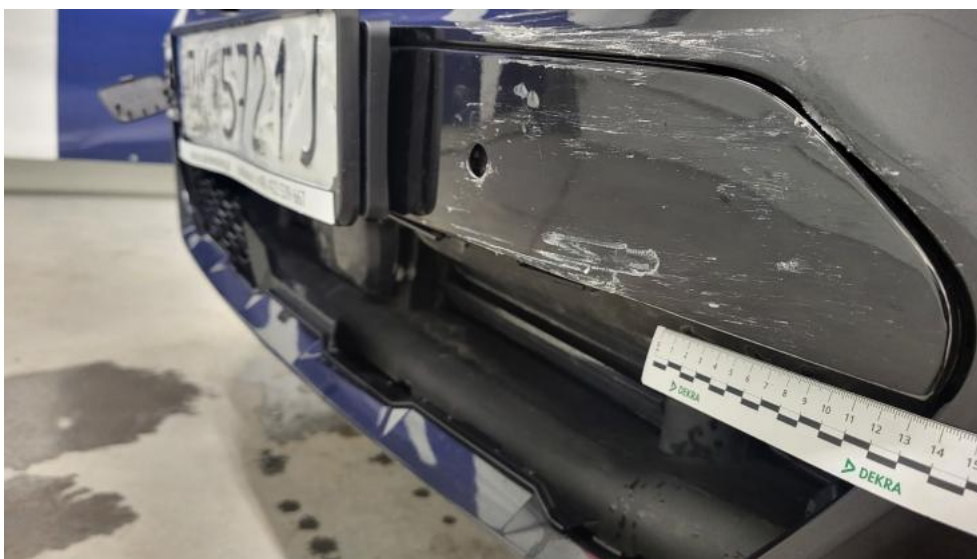
Listwa śr zderzaka przedniego - Rysa/odprysk 1

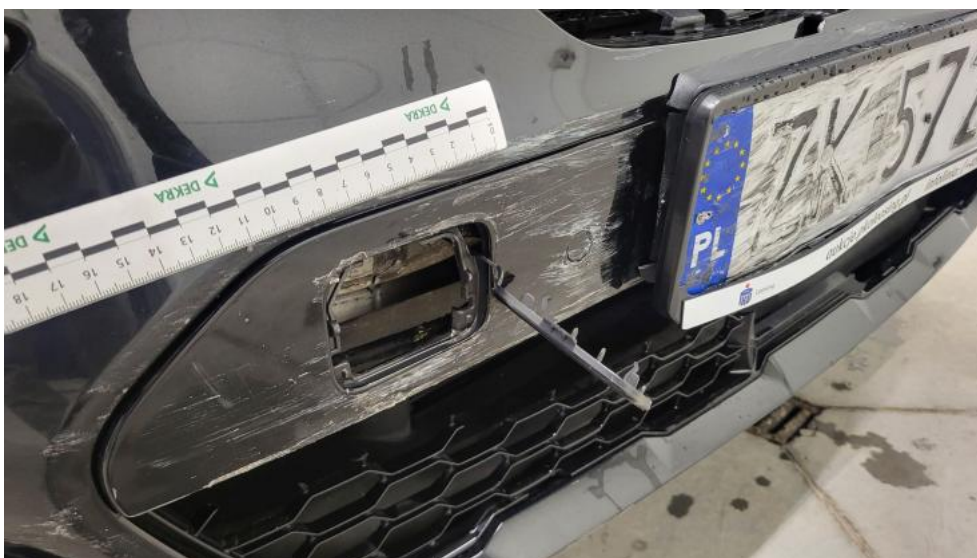
Listwa śr zderzaka przedniego - Rysa/odprysk 2

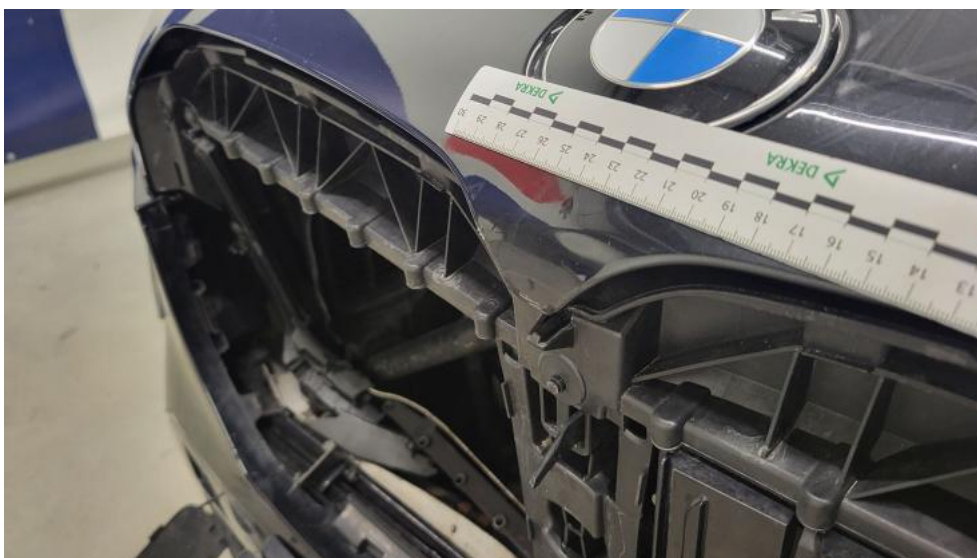
Pokrywa komory silnika - Wgniecenie/odkształcenie 1

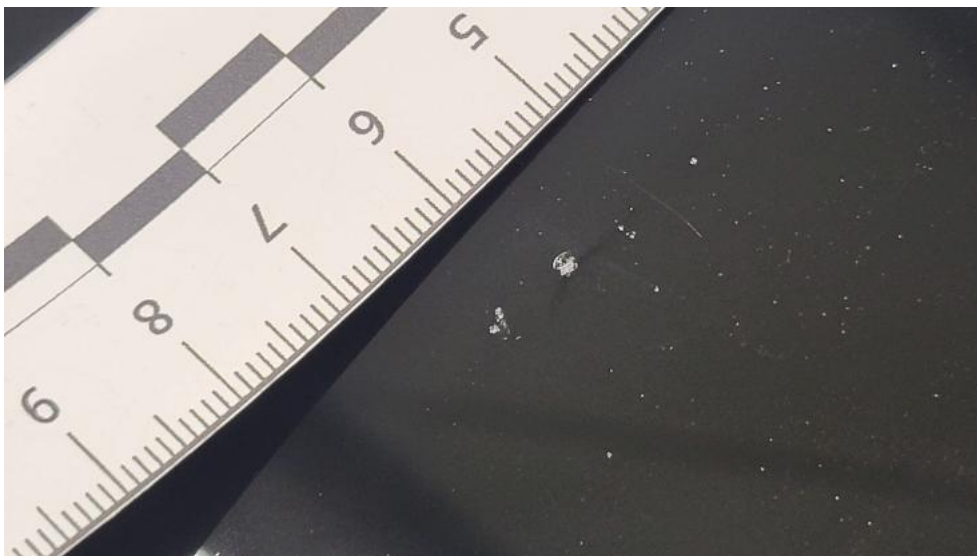
Szyba czołowa - Pęknięcie/rozerwanie 1

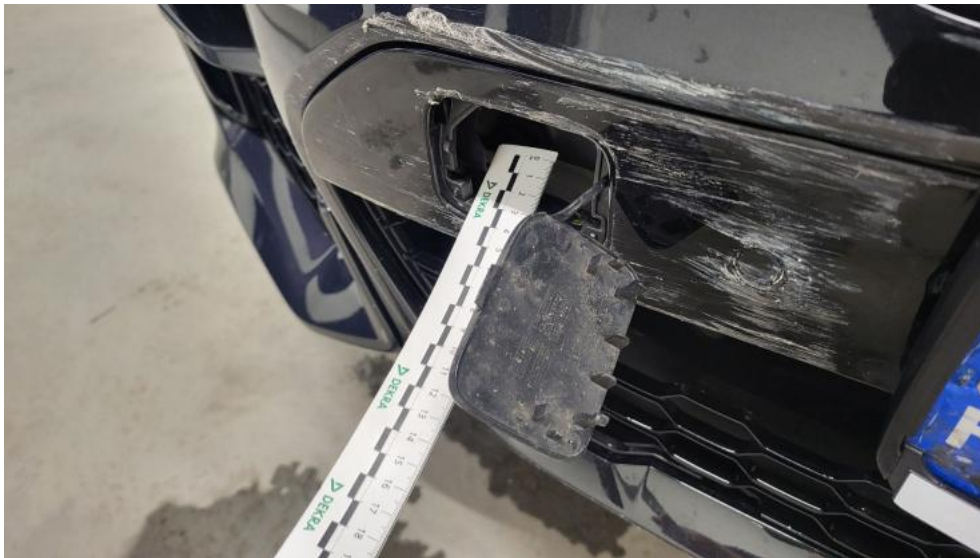
Zaślepka prz haka hol. - Inne 1

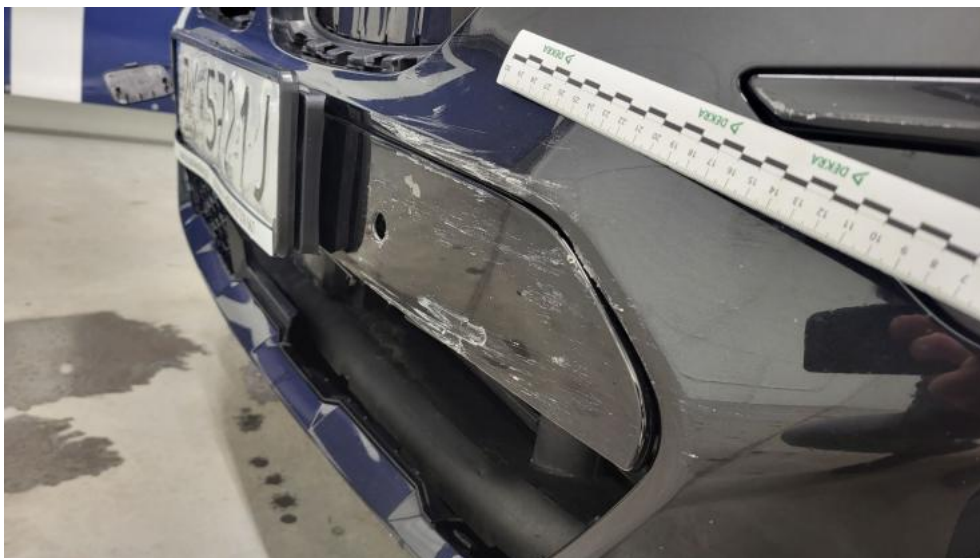
Zderzak - Rysa/odprysk 1

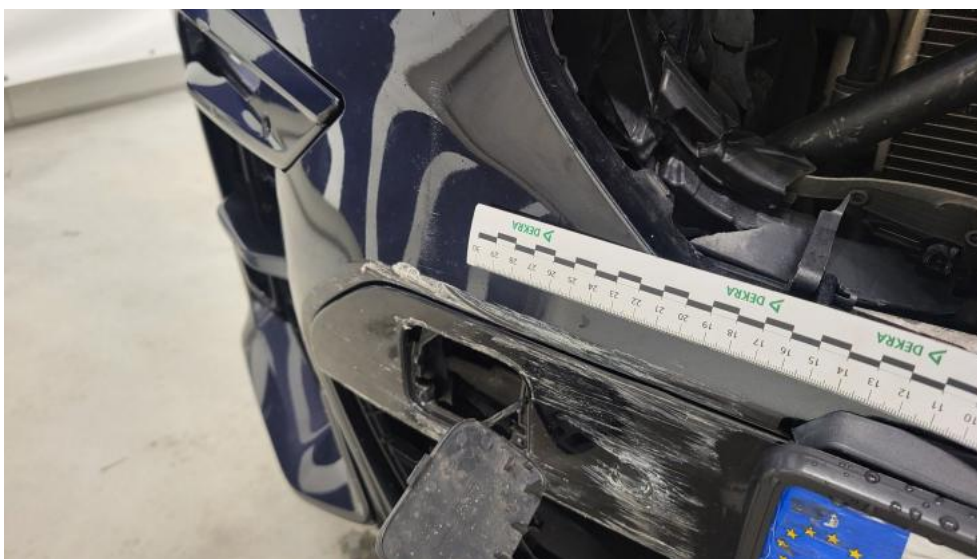
Zderzak - Rysa/odprysk 2

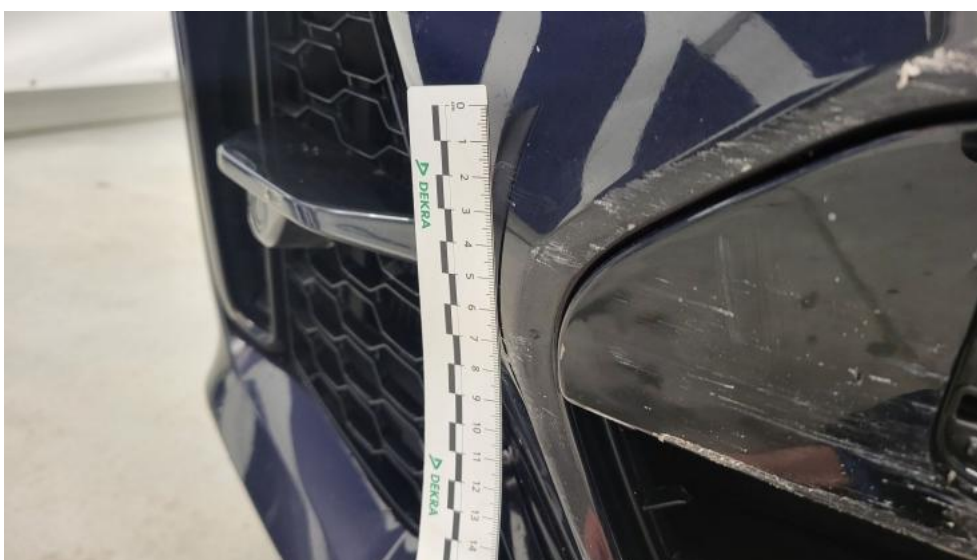
Zderzak - Wgniecenie/odkształcenie 1

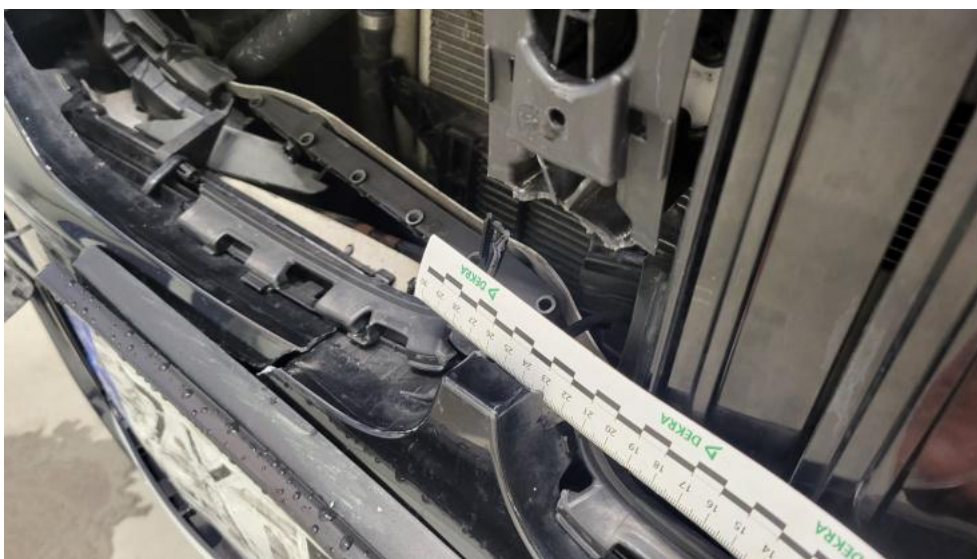
Zderzak - Pęknięcie/rozerwanie 1

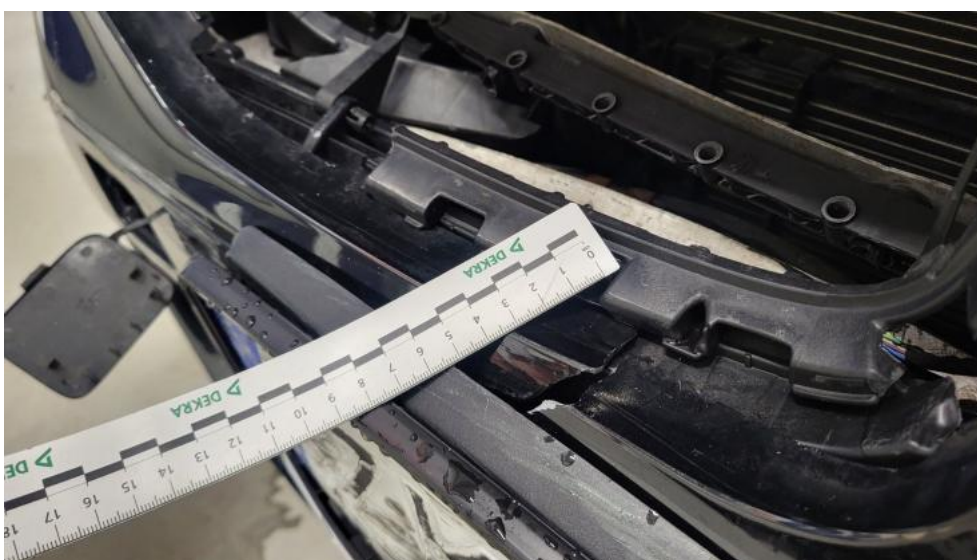
Zderzak - Pęknięcie/rozerwanie 2

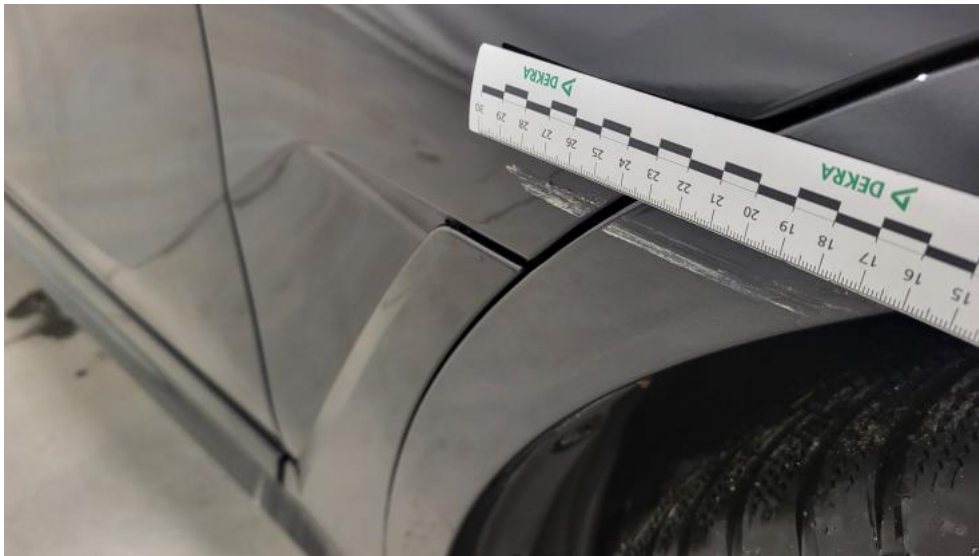
Błotnik przedni P - Rysa/odprysk 1

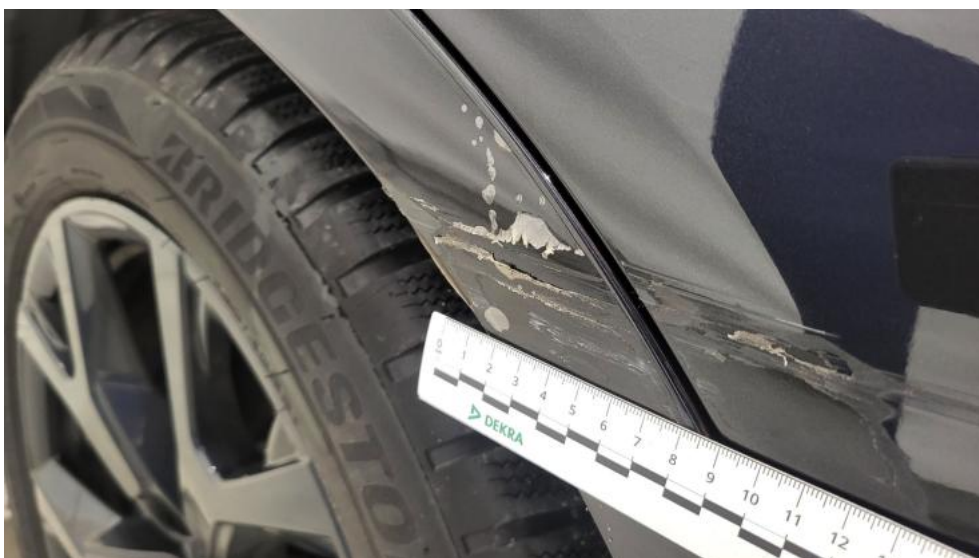
Listwa błotnika przedniego P - Rysa/odprysk 1

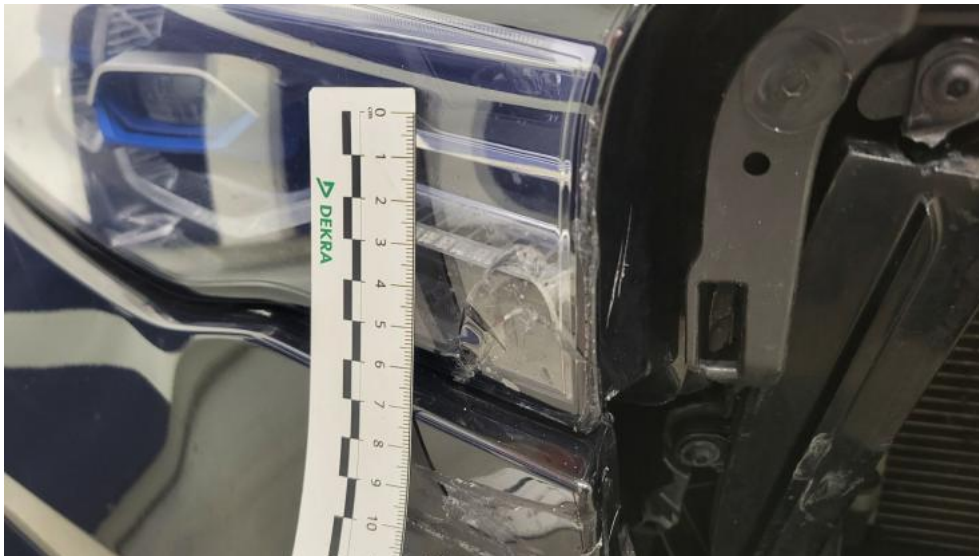
Reflektor P - Pęknięcie/rozerwanie 1

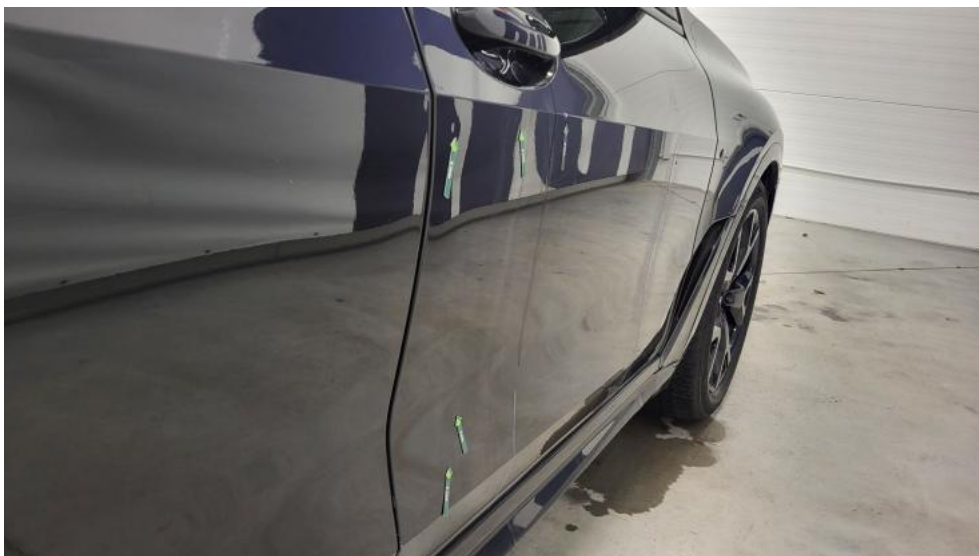
Drzwi przednie P - Wgniecenie/odkształcenie 1

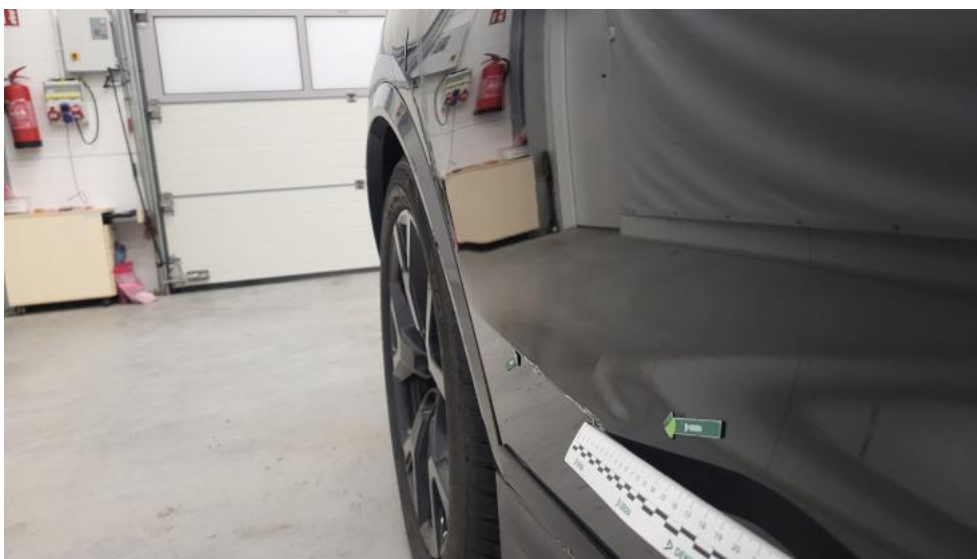
Drzwi tylne P - Wgniecenie/odkształcenie 1

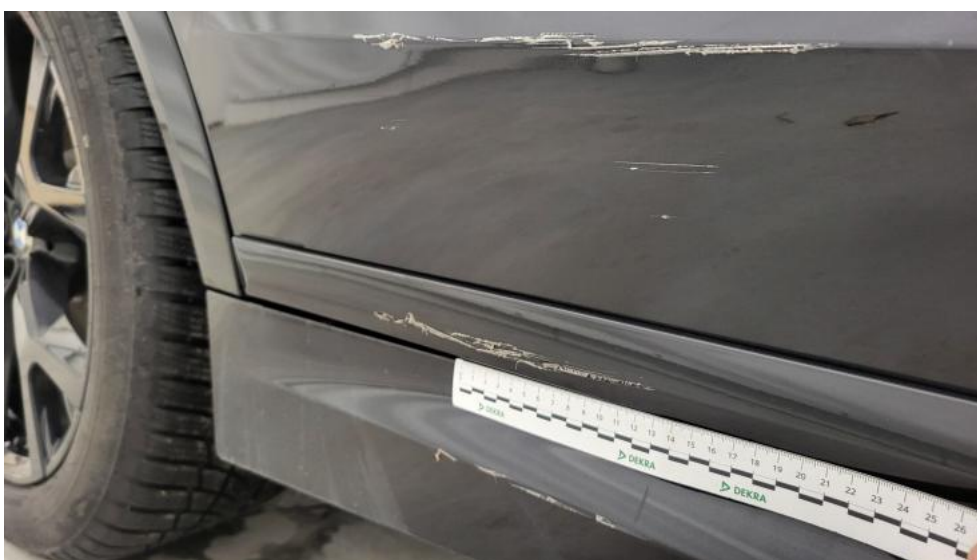
Listwa drzwi tylnych P - Rysa/odprysk 1

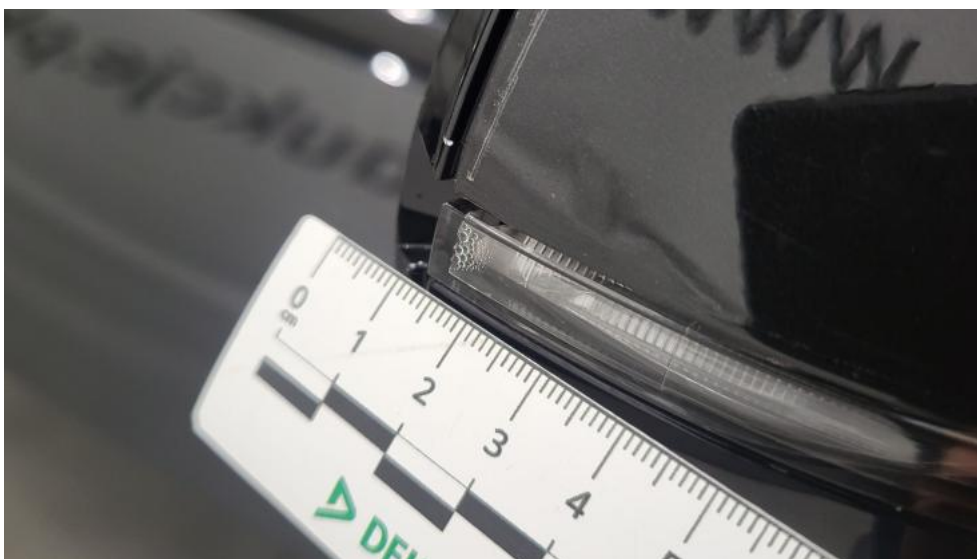
Lusterko zew P - Inne 1

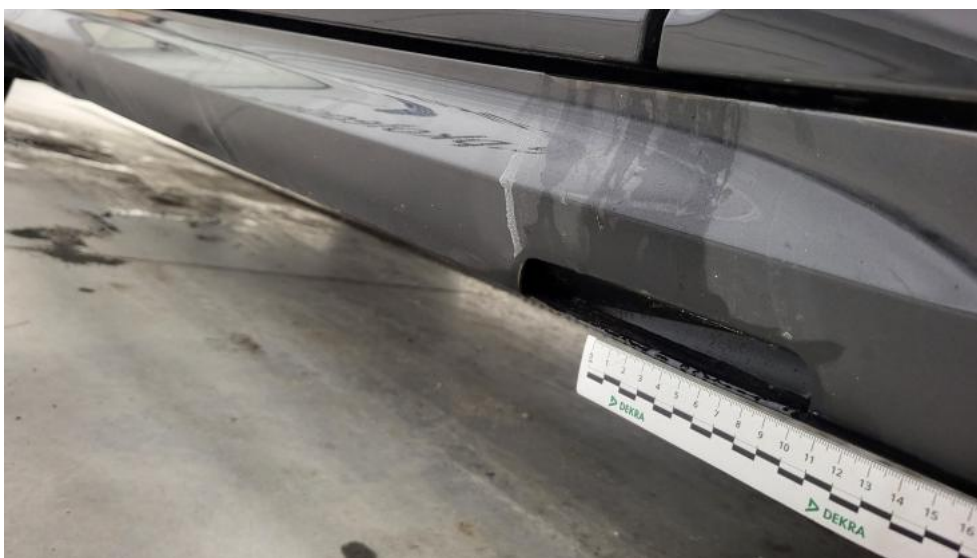
Próg P - Inne 1

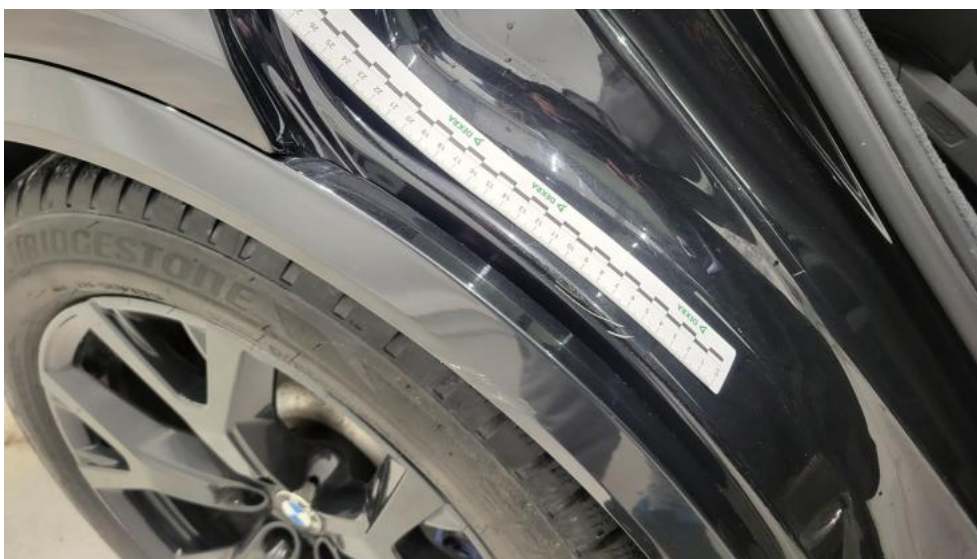
Ścianka tylna P / Ścianka boczna P - Rysa/odprysk 1

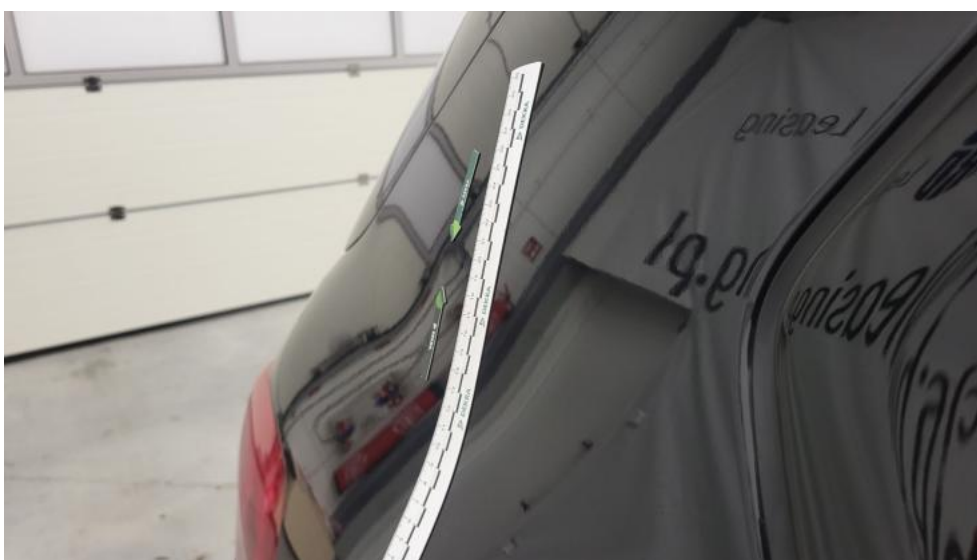
Ścianka tylna P / Ścianka boczna P - Wgniecenie/odkształcenie 1

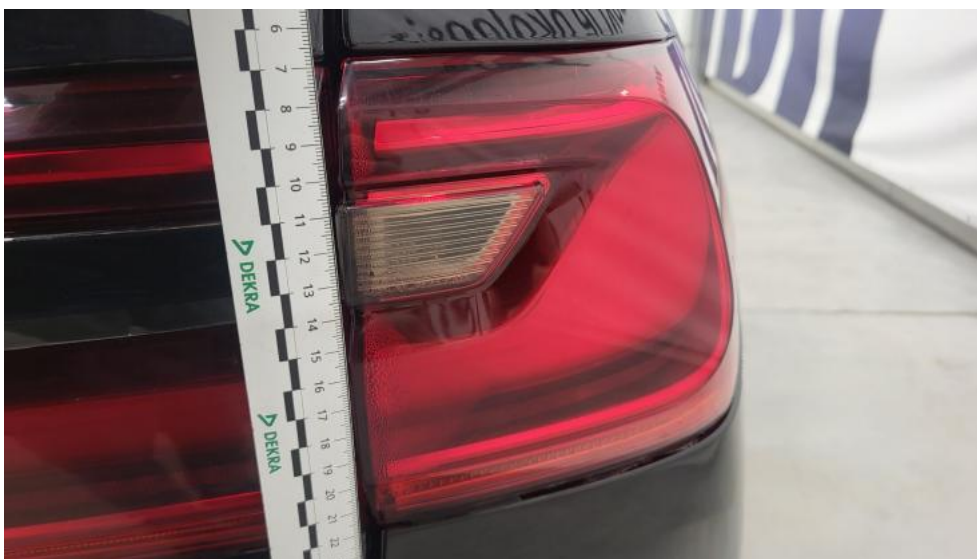
Lampa tylna zew P - Inne 1

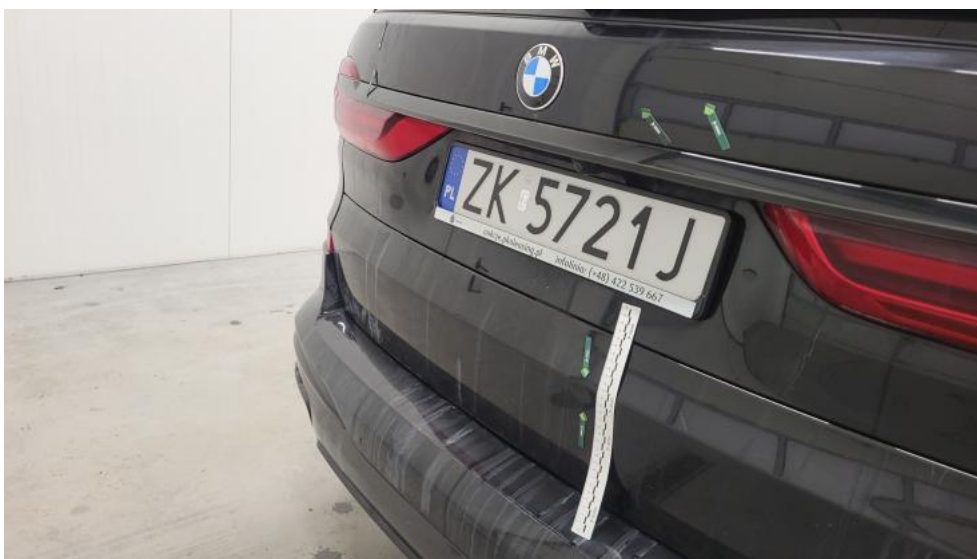
Pokrywy bagażnika - Wgniecenie/odkształcenie 1

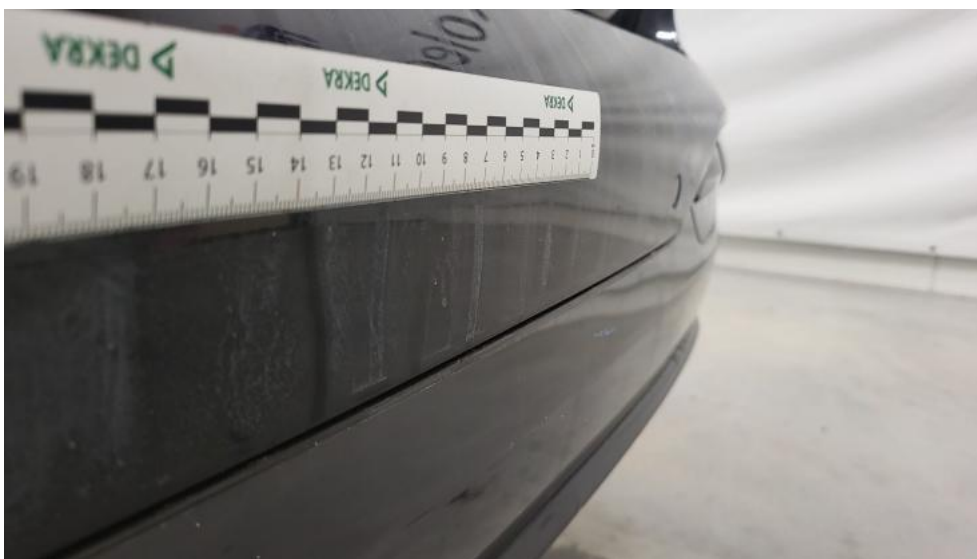
Zderzak tylny - Wgniecenie/odkształcenie 1

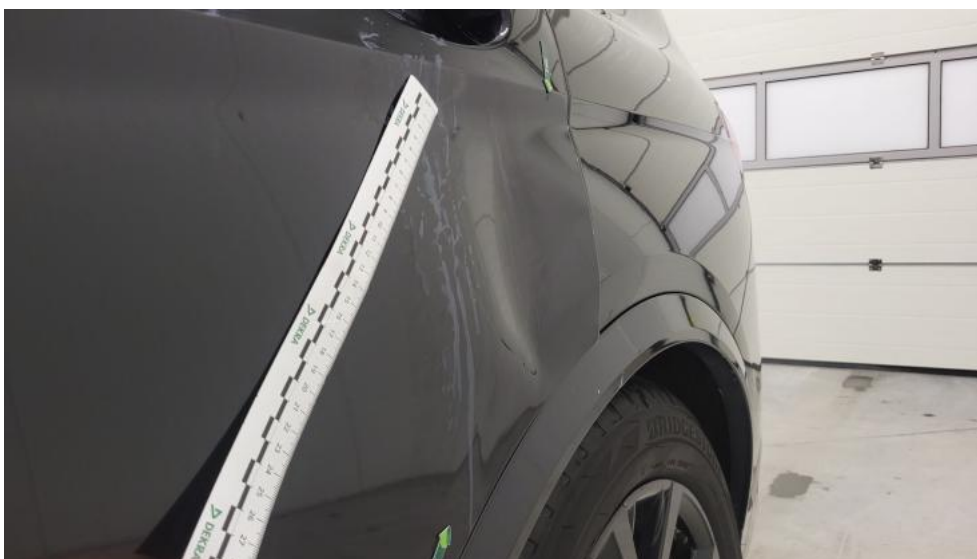
Drzwi tylne L - Wgniecenie/odkształcenie 1

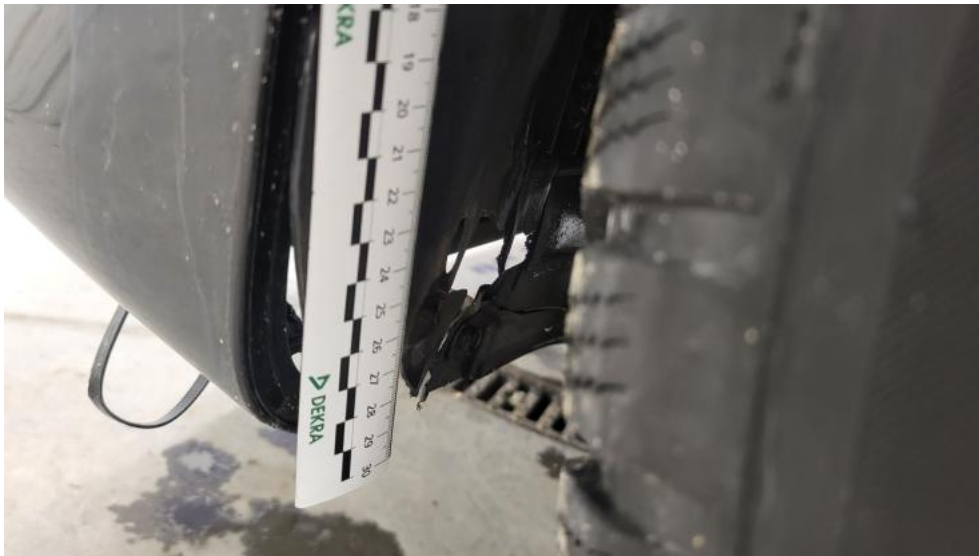
Nadkole przednie L - Pęknięcie/rozerwanie 1

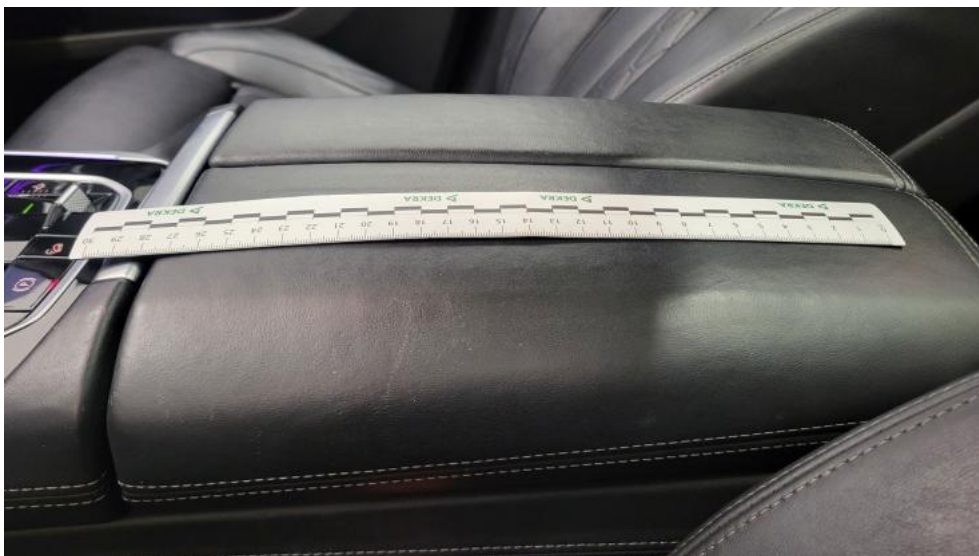
Podłokietnik środkowy przedni - Rysa/odprysk 1

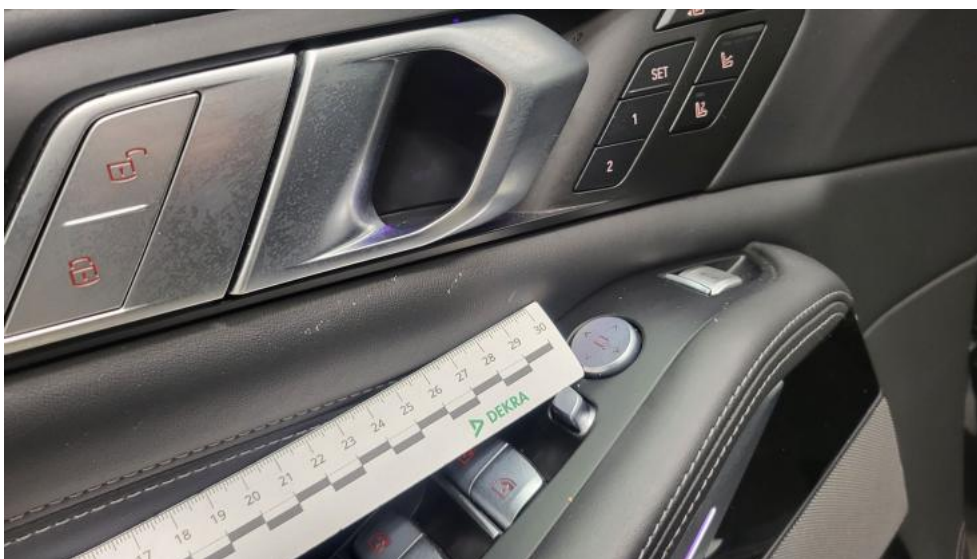
Tapicerka drzwi przednich L - Rysa/odprysk 1

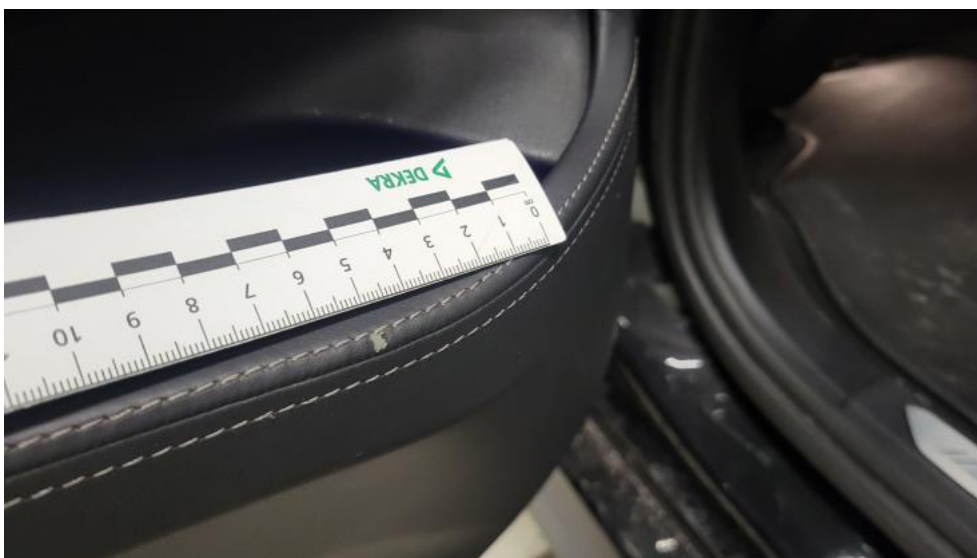
Tapicerka drzwi tylnych L - Pęknięcie/rozerwanie 1

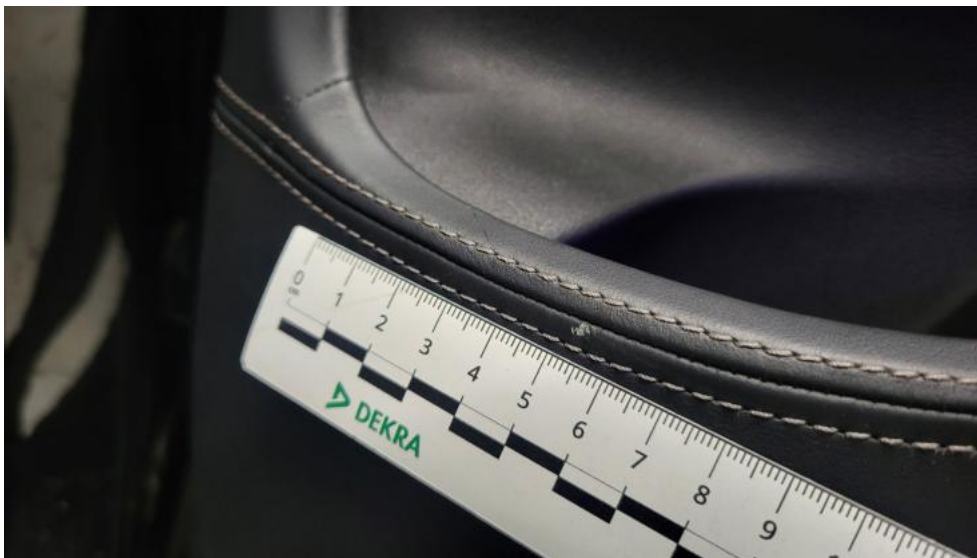
Tapicerka drzwi tylnych P - Pęknięcie/rozerwanie 1
