DEKRA's commission No. : PKOL(W)/LODZ/77042/26/08/18  
commission/ damage No. : 21/044114  
Date of commission: 18-08-2026

| Manufacturer | OPEL |
| Model | Corsa F Hatchback 19-23 |
| Registration /record No. | WZ114EG |

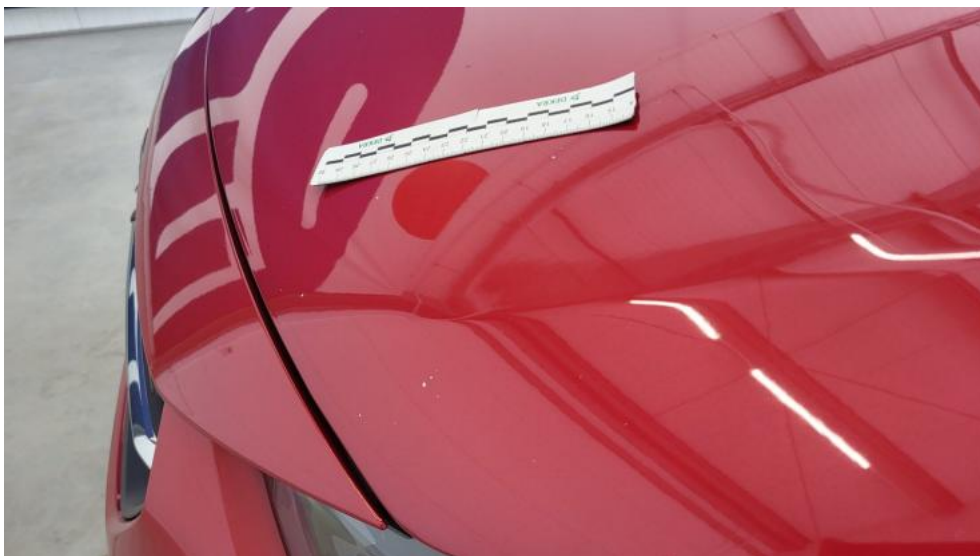
**Photo 40.**

Pokrywa komory silnika - Rysa/odprysk 1

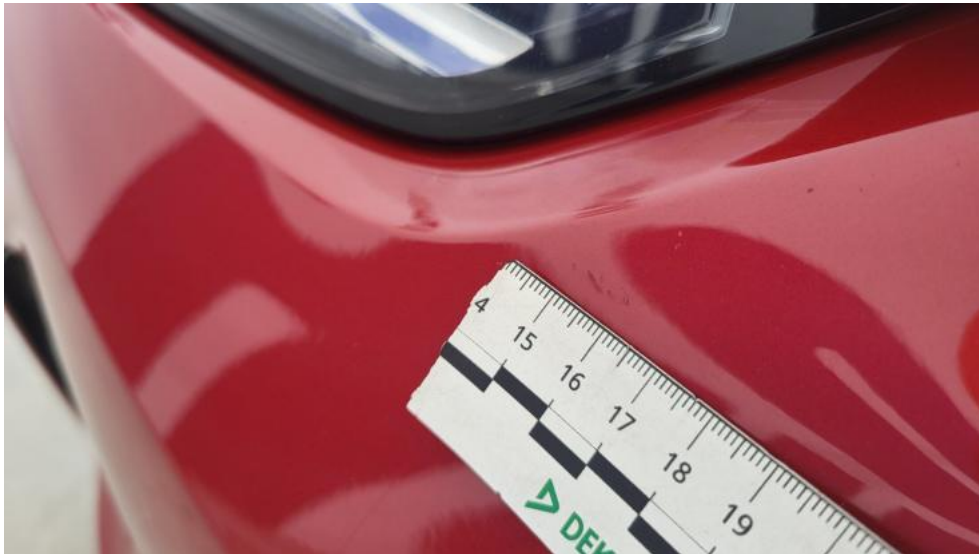
**Photo 41.**

Zderzak - Rysa/odprysk 1

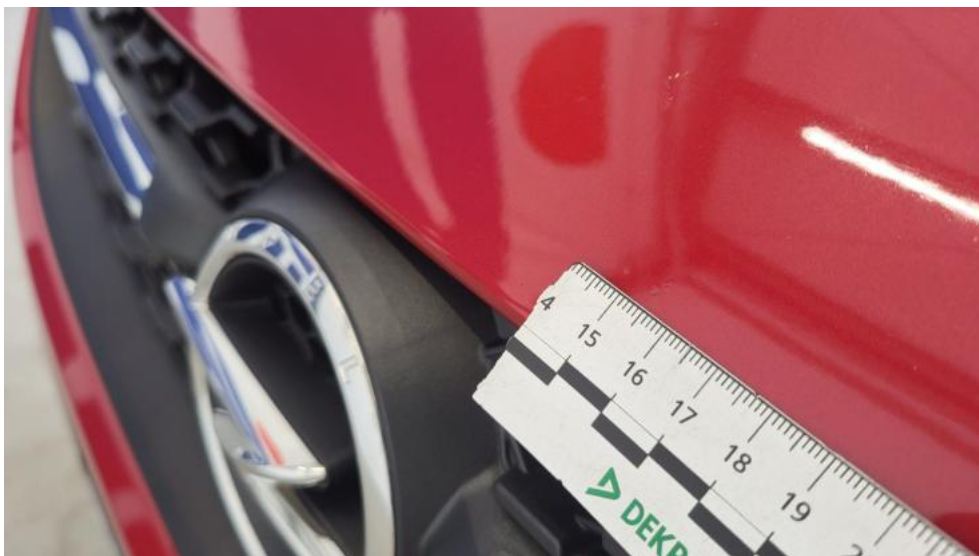
**Photo 42.**

Zderzak przedni cz górna - Rysa/odprysk 1

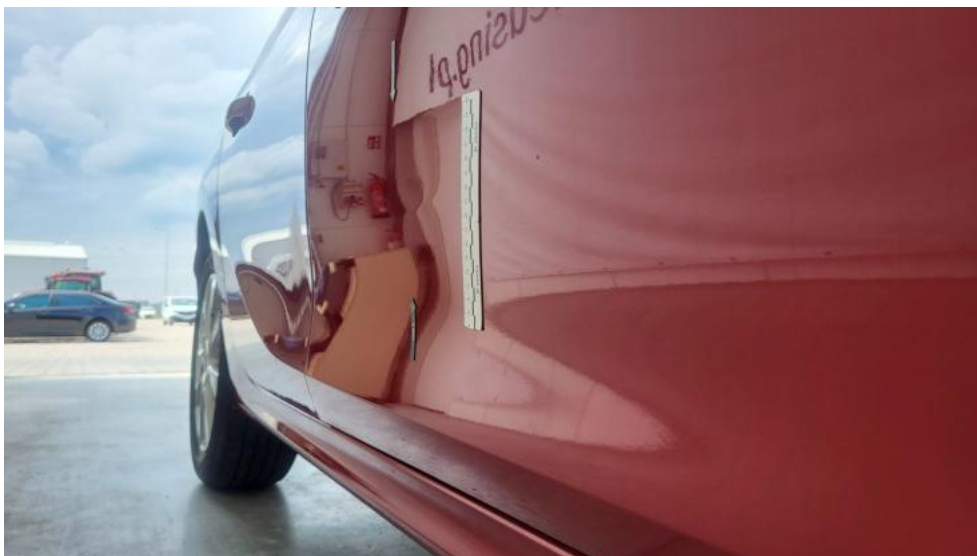
**Photo 46.**

Drzwi przednie P - Wgniecenie/odkształcenie 1

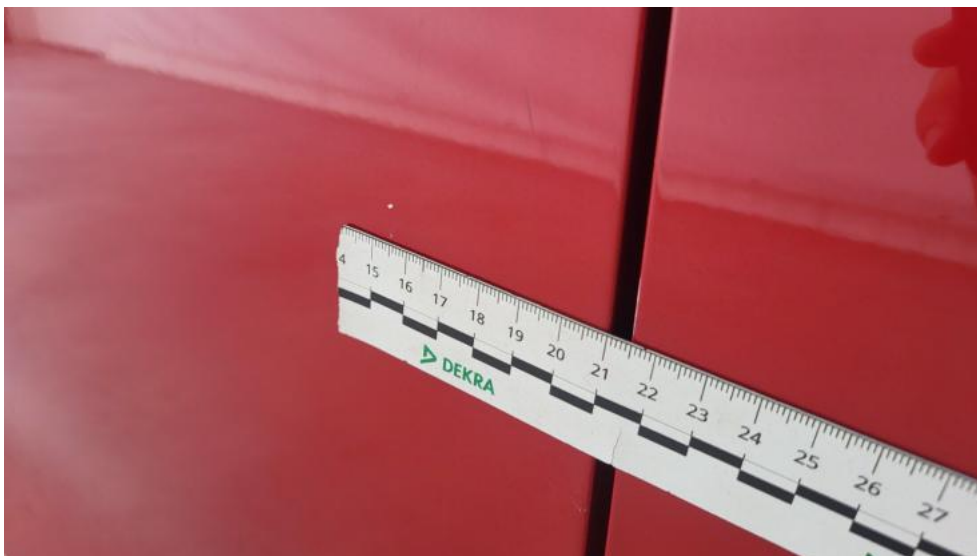
**Photo 47.**

Drzwi tylne P - Rysa/odprysk 1

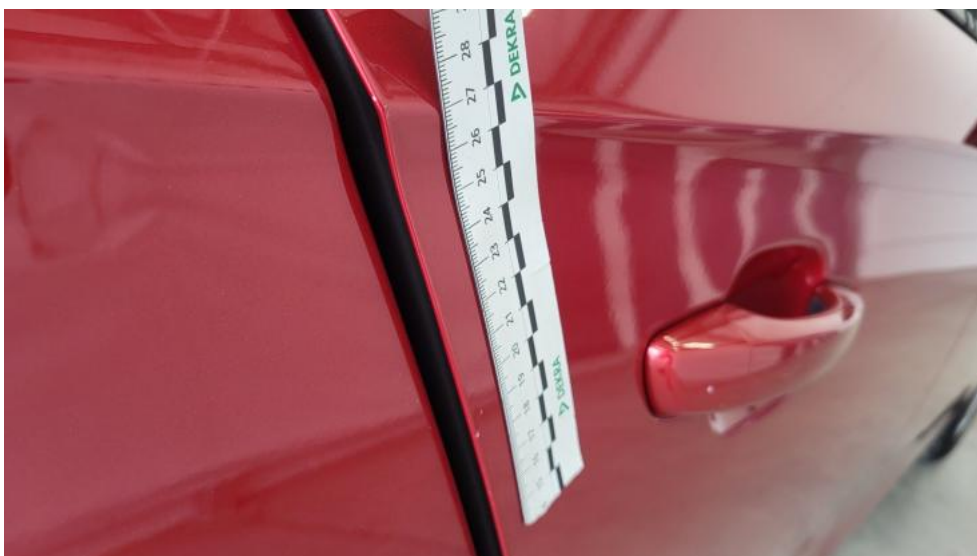
**Photo 48.**

Drzwi tylne P - Rysa/odprysk 2

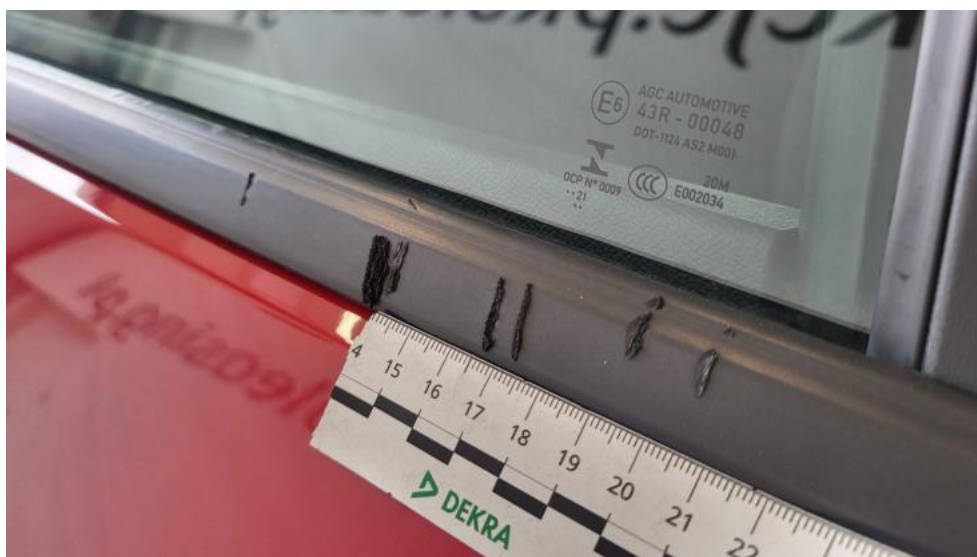
**Photo 51.**

Listwa drzwi tylnych P - Rysa/odprysk 1

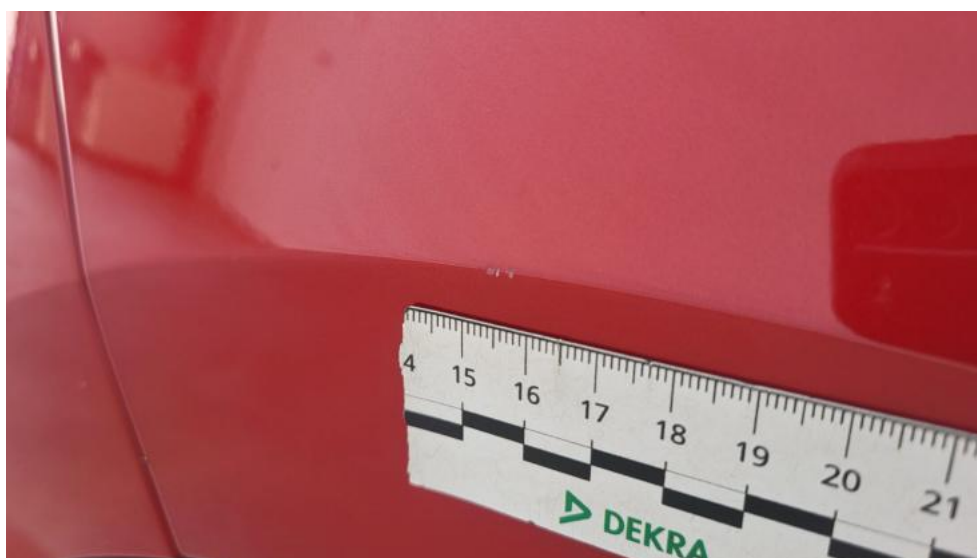
**Photo 52.**

Błotnik tylny P / Ściana boczna P - Rysa/odprysk 1

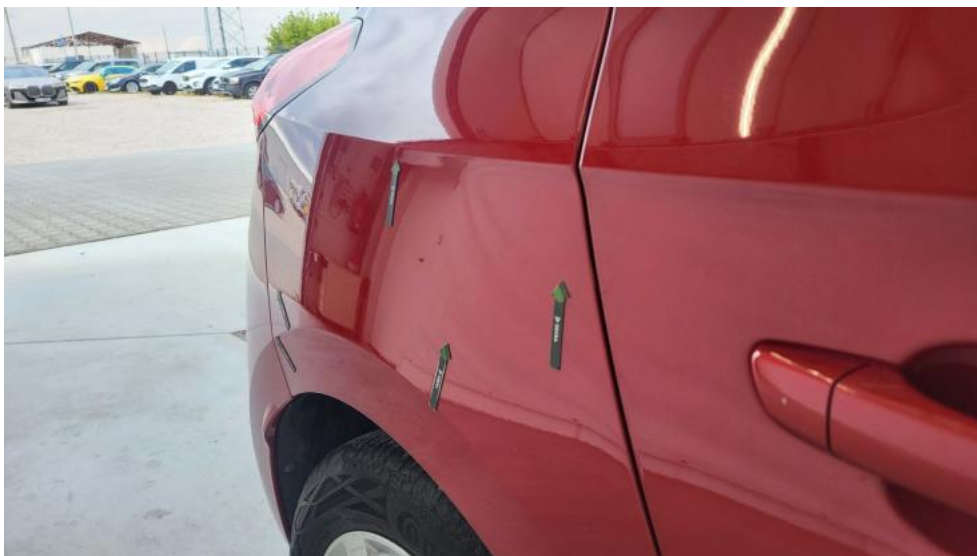
**Photo 53.**

Błotnik tylny P / Ściana boczna P - Wgniecenie/odkształcenie 1

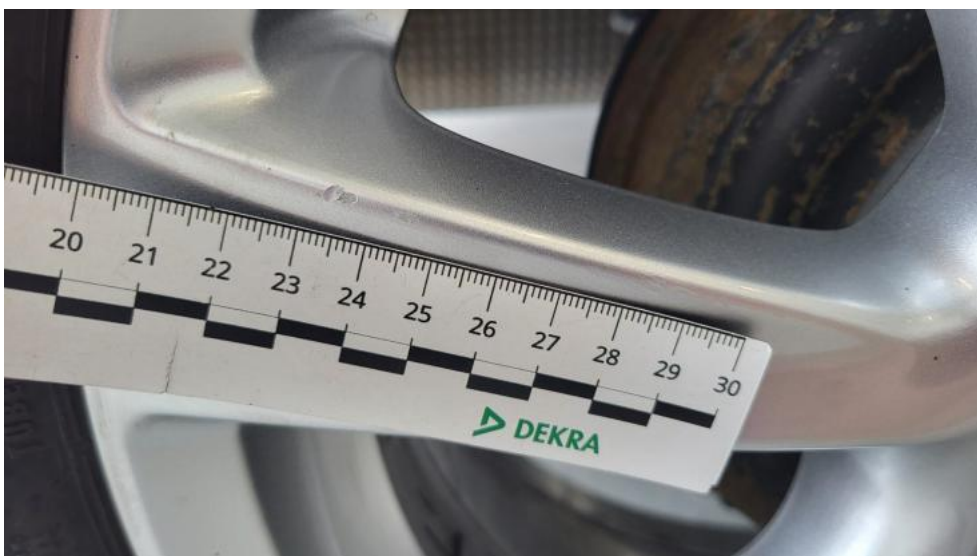
**Photo 54.**

Felga aluminiowa tylna P - Rysa/odprysk 1

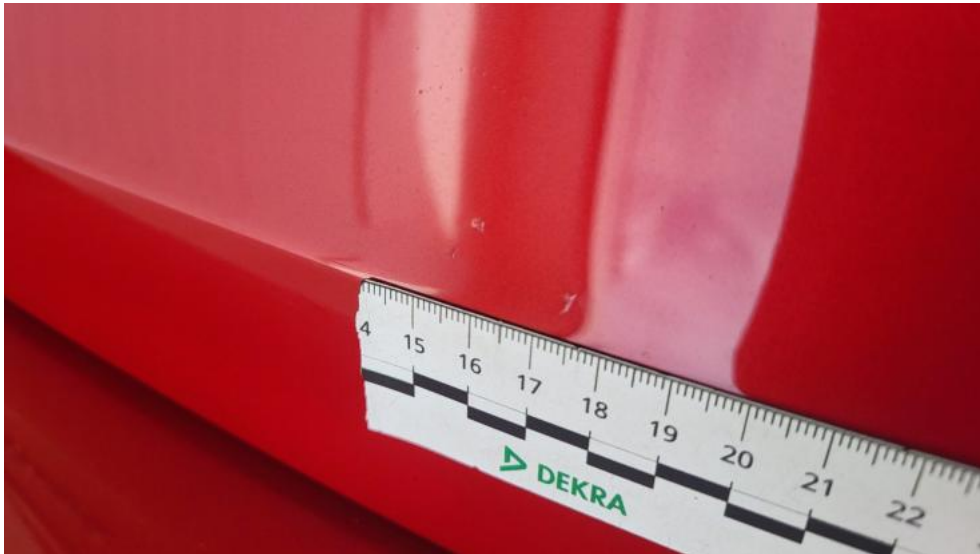
**Photo 55.**

Pokrywy bagażnika - Rysa/odprysk 1

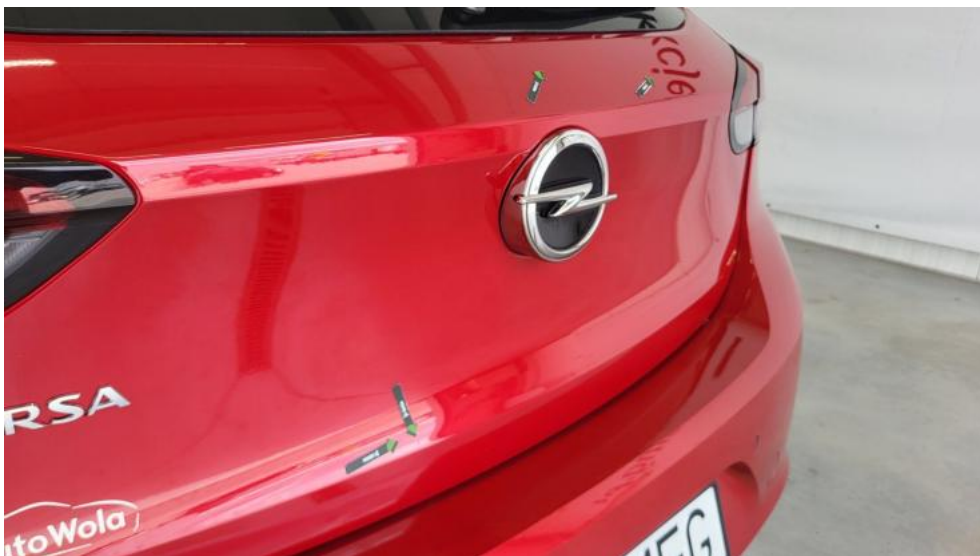
**Photo 56.**

Pokrywy bagażnika - Wgniecenie/odkształcenie 1

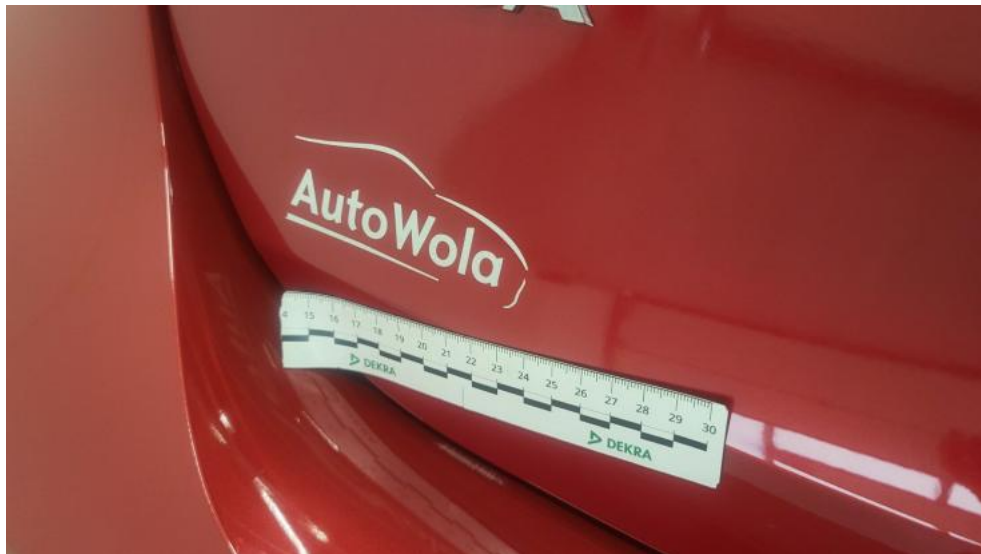
**Photo 57.**  
Pokrywy bagażnika - Inne 1

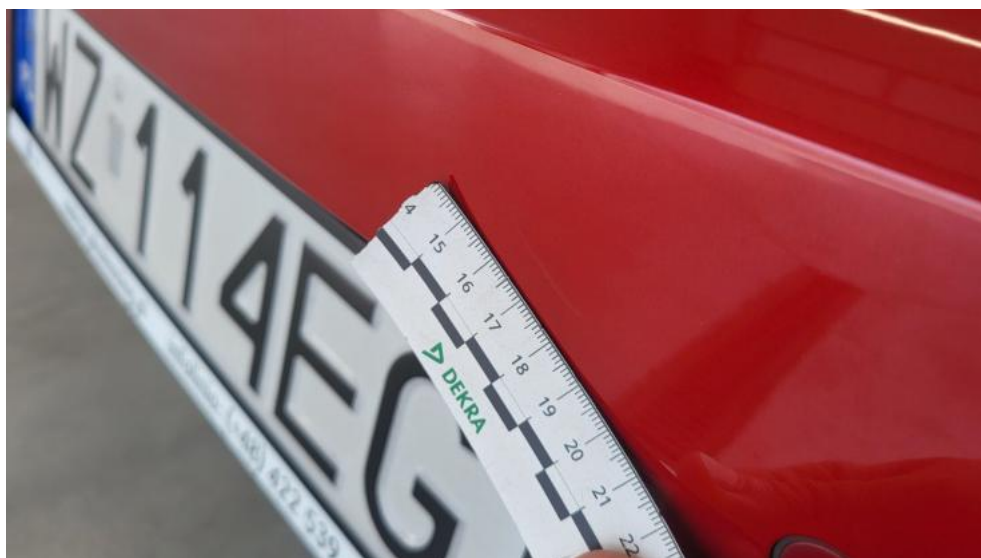
**Photo 58.**  
Zderzak tylny - Rysa/odprysk 1

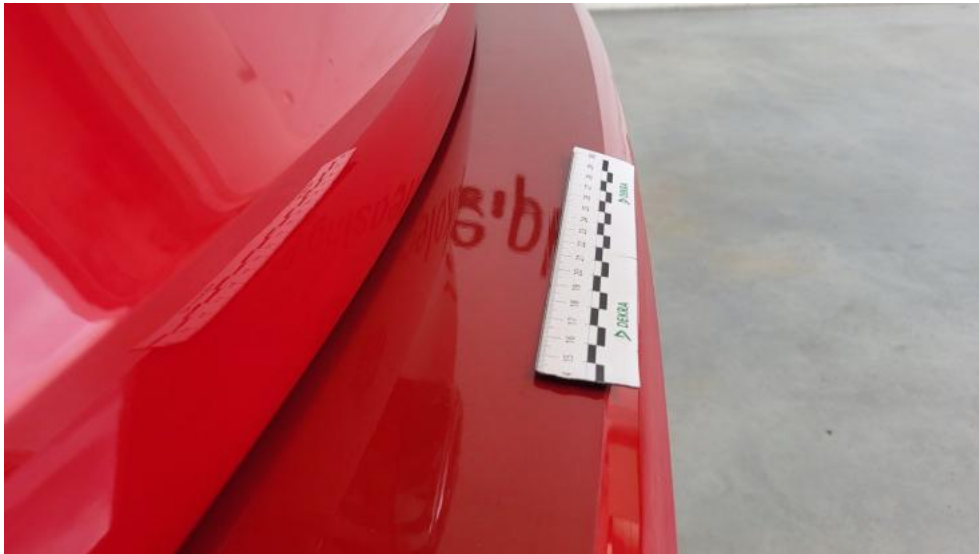
**Photo 59.**

Zderzak tylny - Wgniecenie/odkształcenie 1

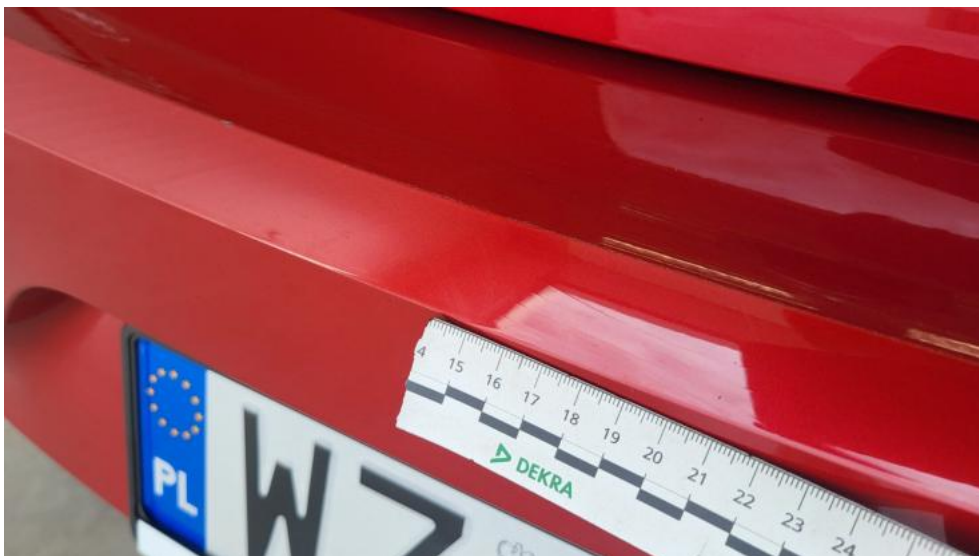
**Photo 60.**

Zderzak tylny - Pęknięcie/rozerwanie 1

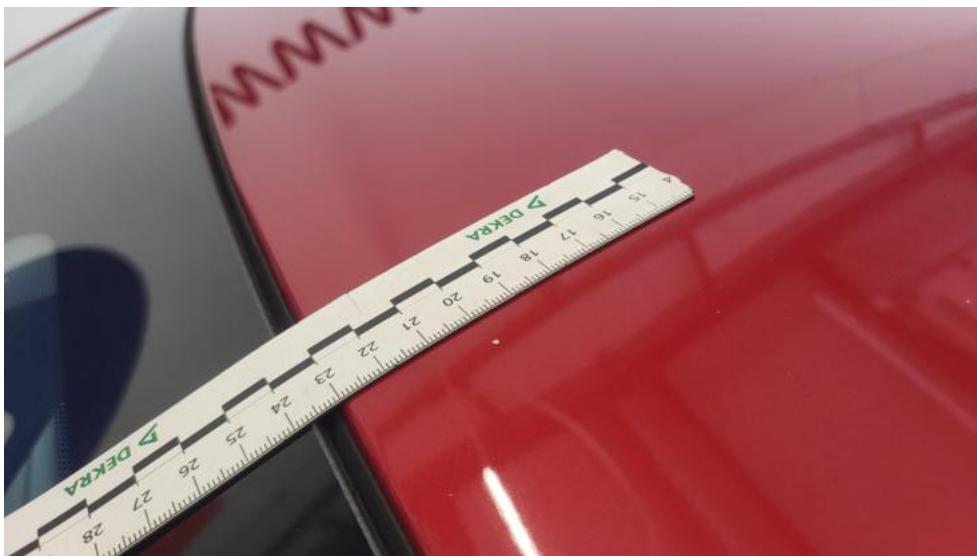
**Photo 61.**

Dach - Rysa/odprysk 1

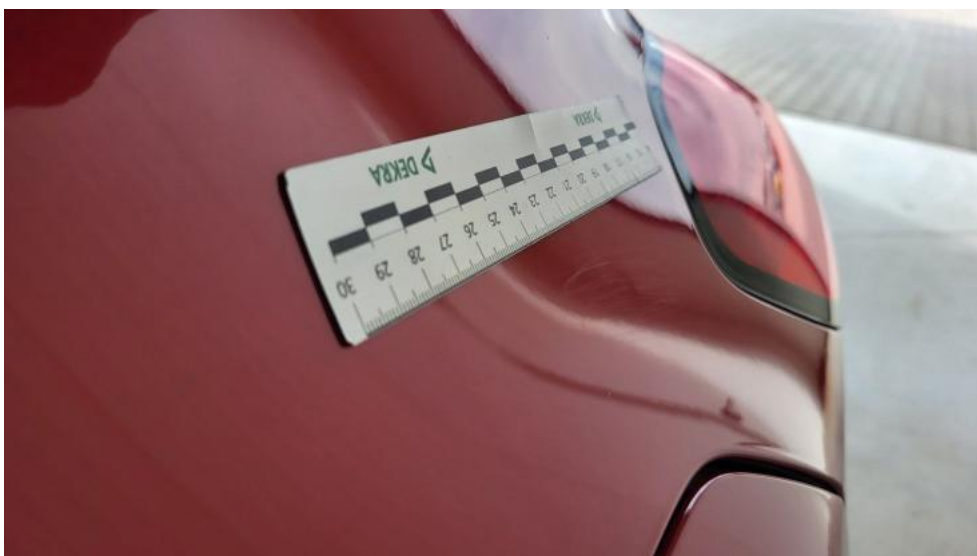
**Photo 62.**

Łotnik tylny L / Ściana boczna L - Rysa/odprysk 1

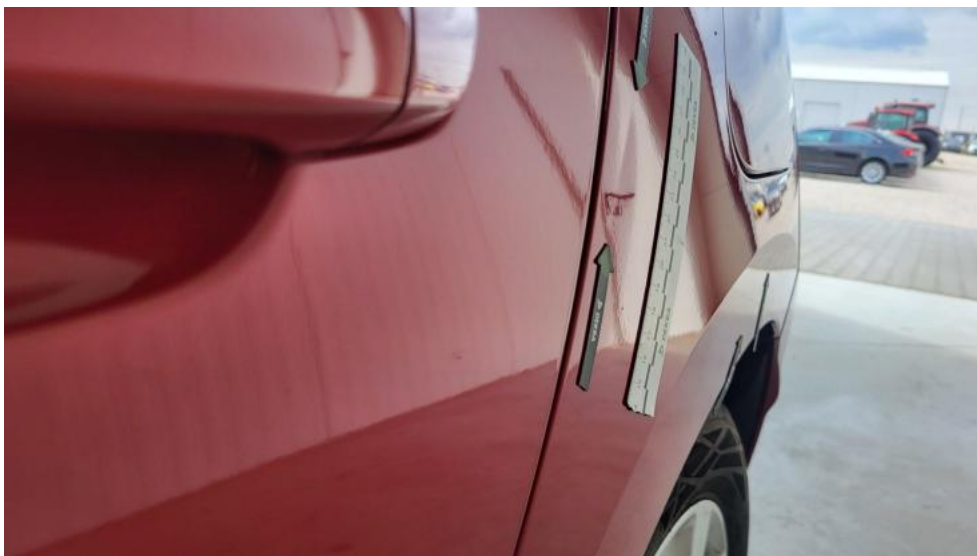
**Photo 63.**

Błotnik tylny L / Ściana boczna L - Wgniecenie/odkształcenie 1

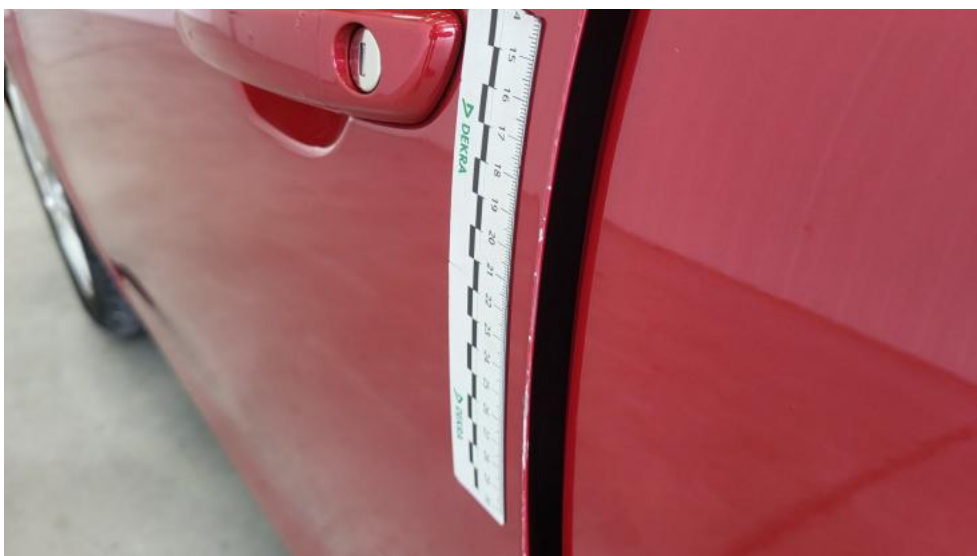
**Photo 64.**

Drzwi przed L - Rysa/odprysk 1

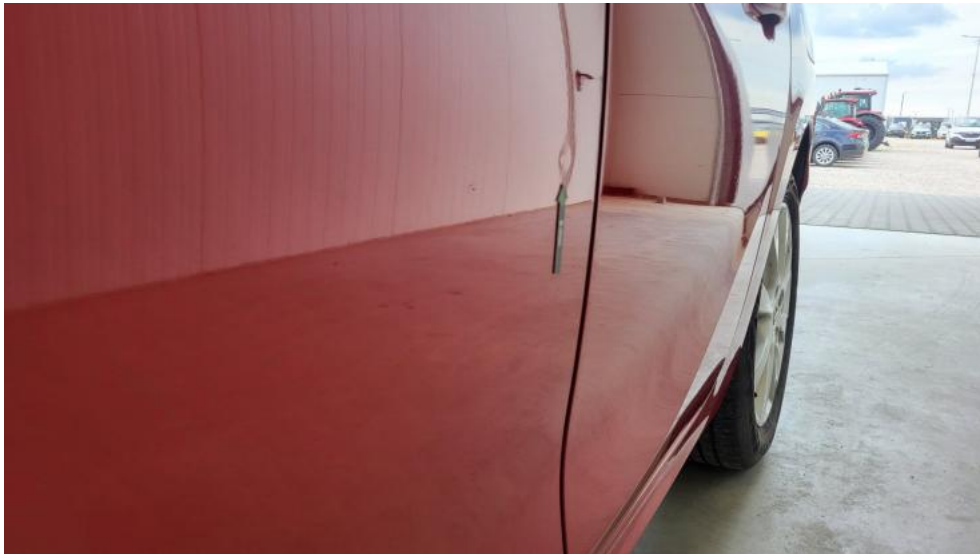
**Photo 65.**

Drzwi przed L - Wgniecenie/odkształcenie 1

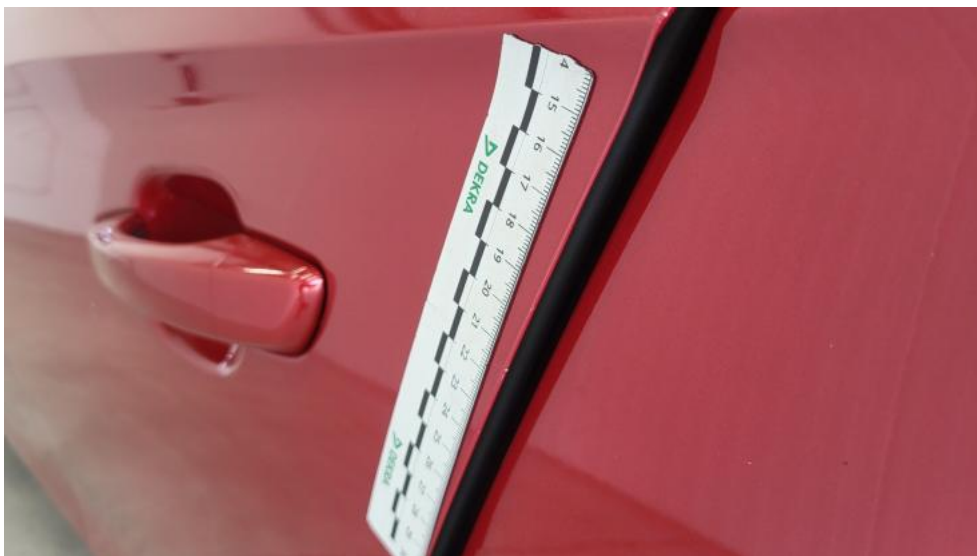
**Photo 67.**

Drzwi tylne L - Rysa/odprysk 1

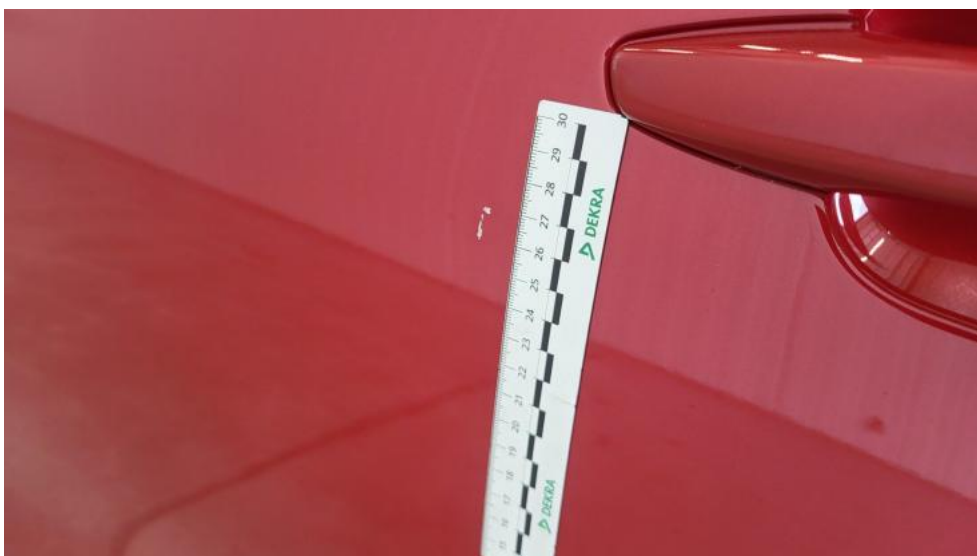
**Photo 68.**

Drzwi tylne L - Rysa/odprysk 2

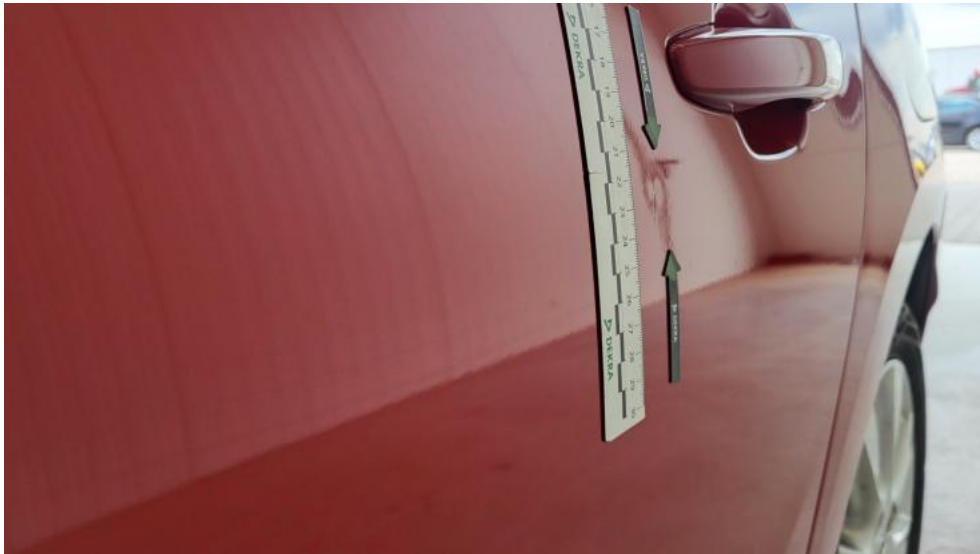
**Photo 69.**

Drzwi tylne L - Wgniecenie/odkształcenie 1

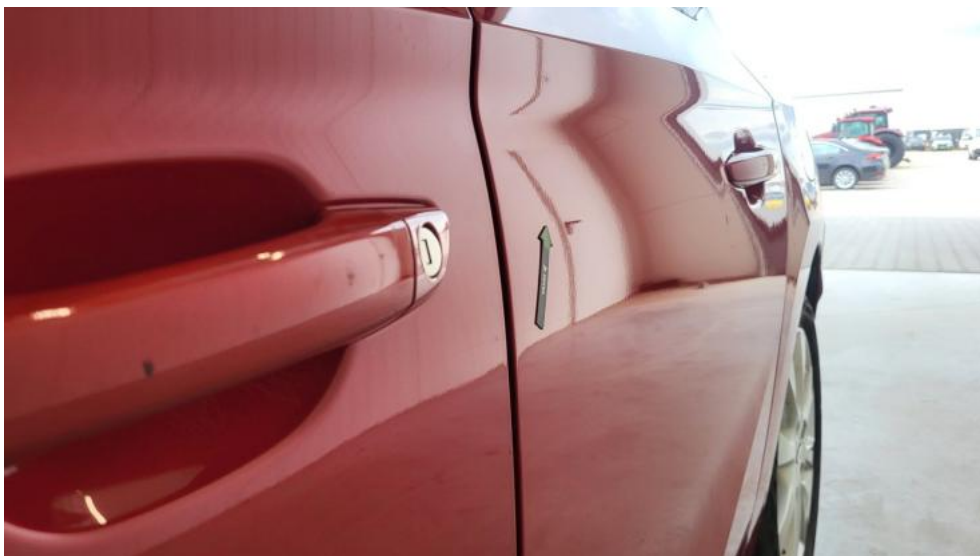
**Photo 70.**

Drzwi tylne L - Wgniecenie/odkształcenie 2

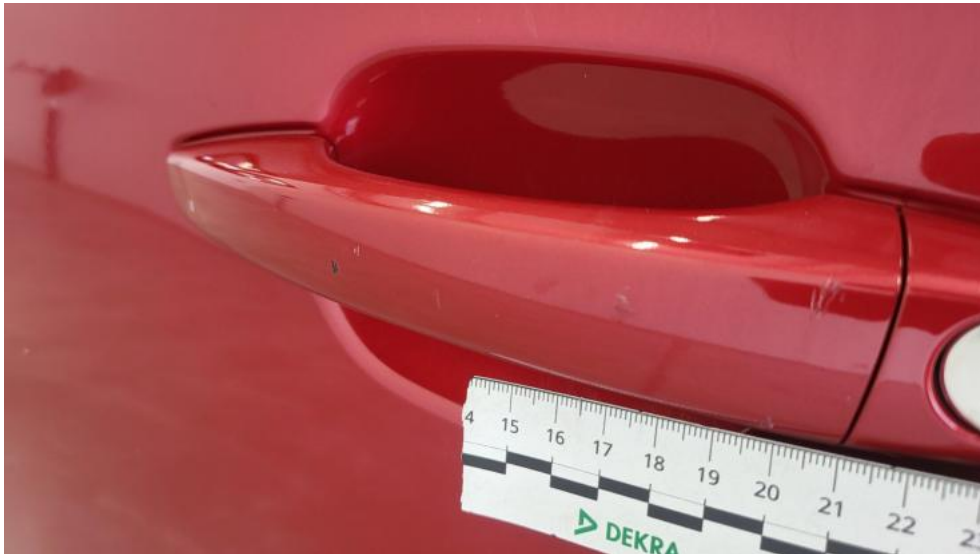
**Photo 71.**

Klamka drzwi prz L - Rysa/odprysk 1

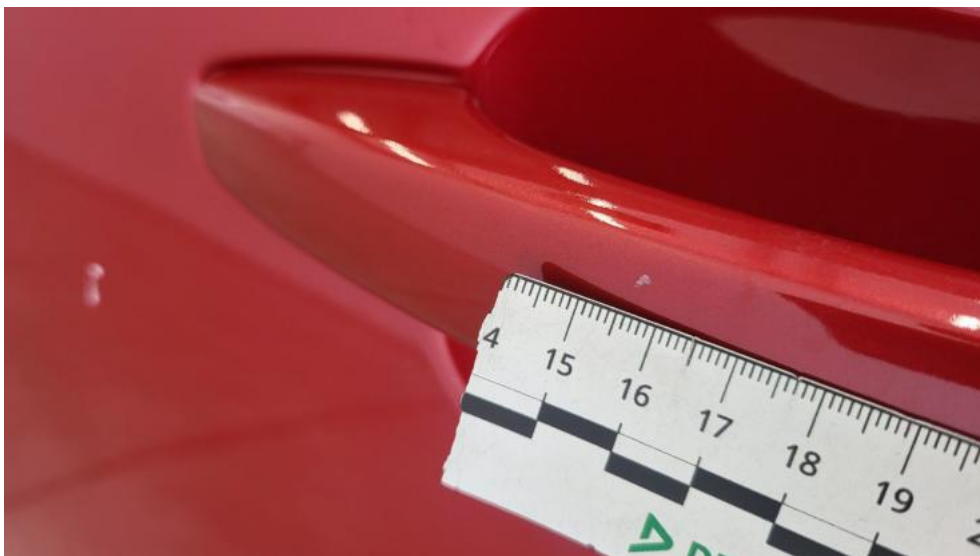
**Photo 72.**

Klamka drzwi tyl L - Rysa/odprysk 1

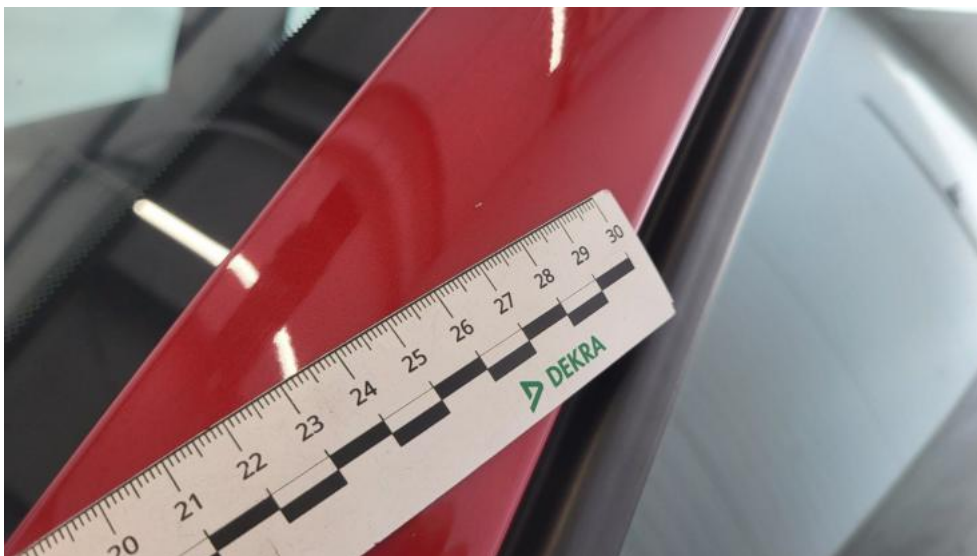
**Photo 73.**

Słupek przedni L - Rysa/odprysk 1

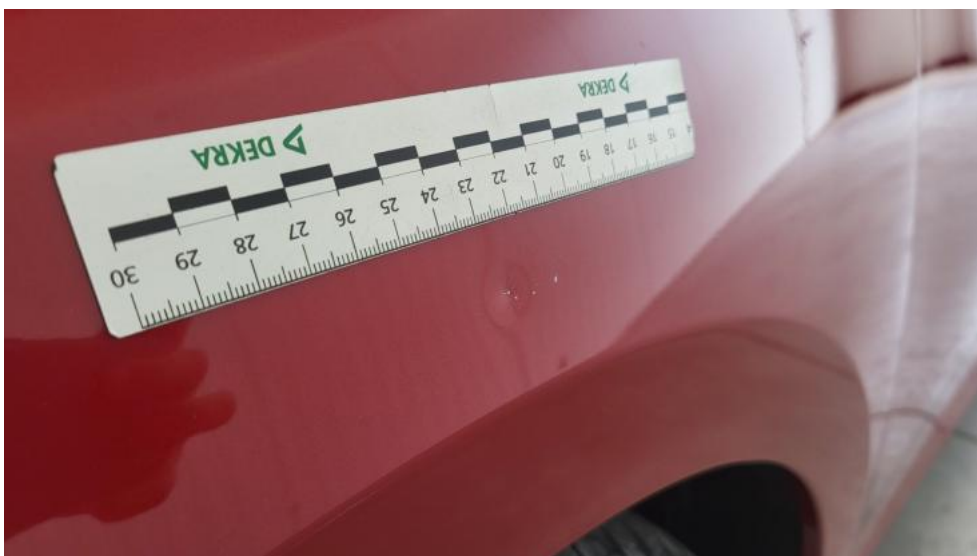
**Photo 74.**

Ślotnik przedni L - Rysa/odprysk 1

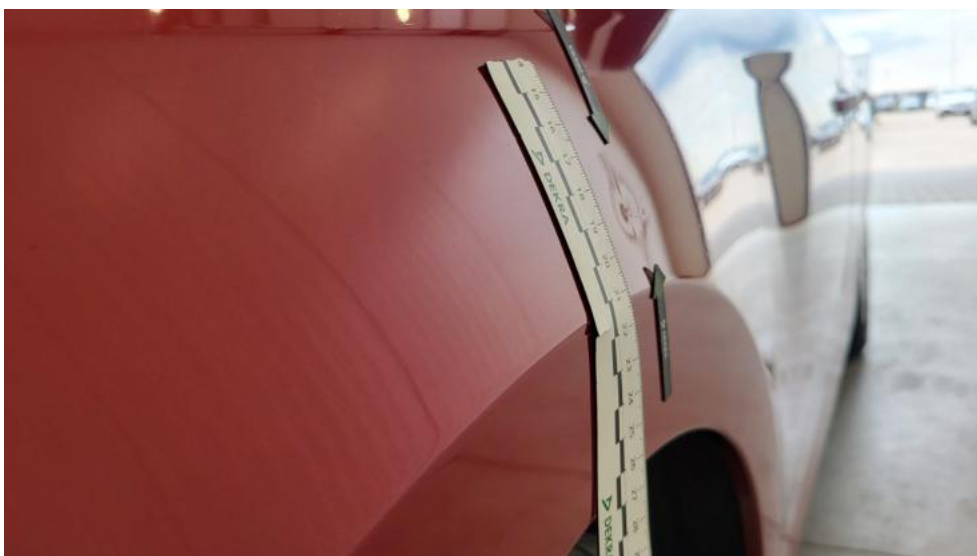
**Photo 76.**

Błotnik przedni L - Wgniecenie/odkształcenie 1

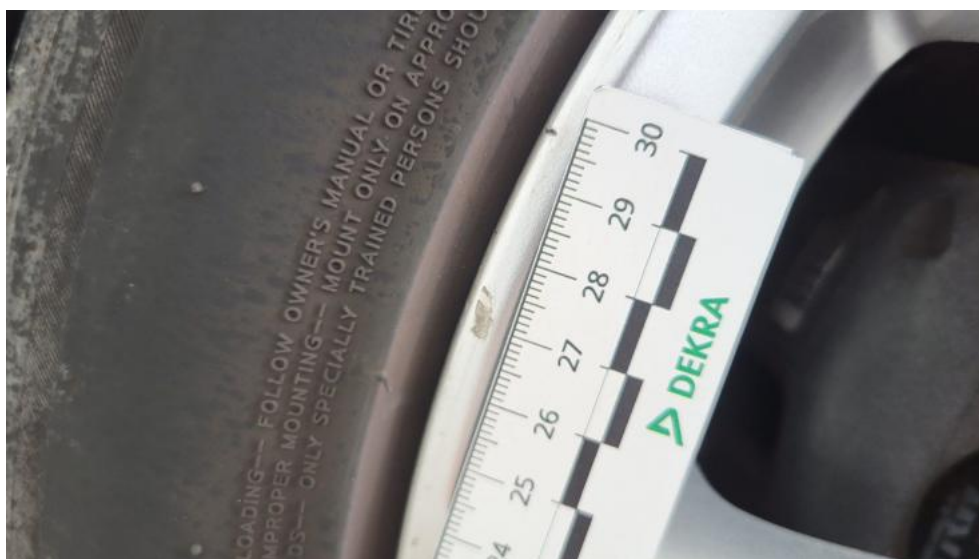
**Photo 77.**

Felga Aluminiowa przednia L - Rysa/odprysk 1

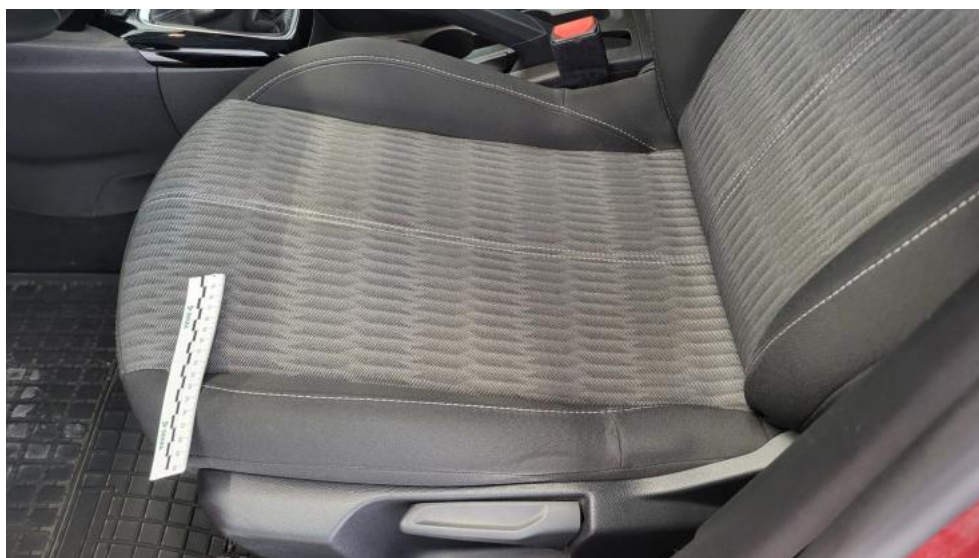
**Photo 78.**

Fotel prz. lew. - Inne 1

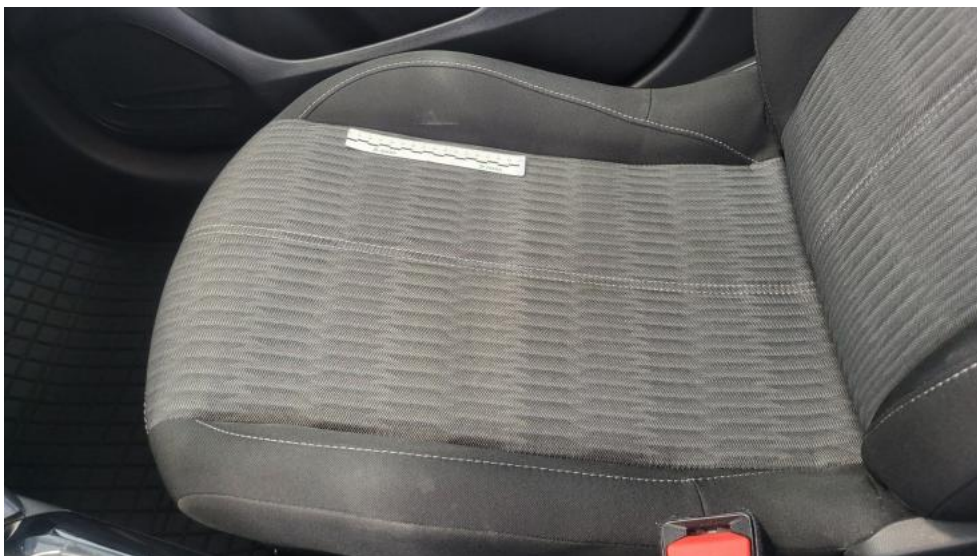
**Photo 79.**

Fotel prz. praw. - Inne 1

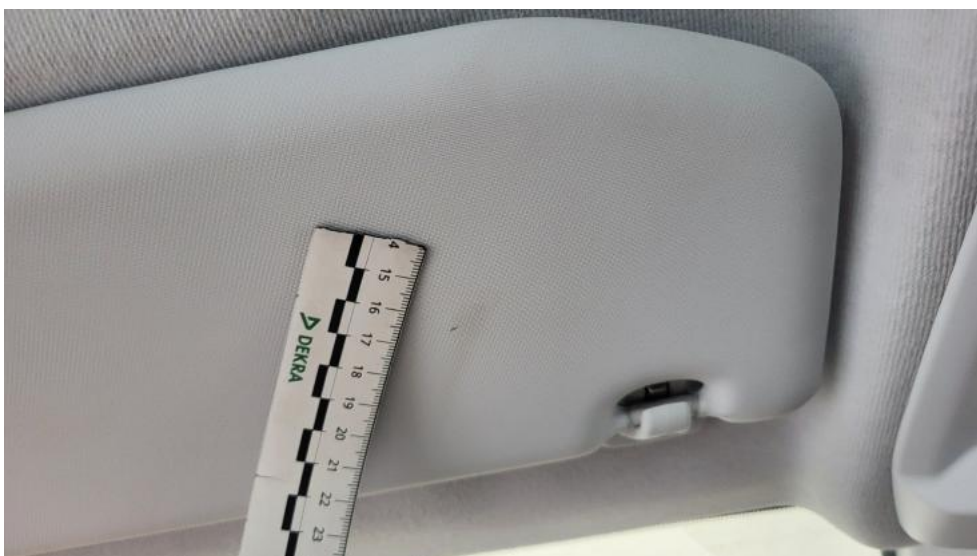
**Photo 80.**

Osłona p/słoneczna lewa - Inne 1
