DEKRA's commission No. : PKOL(W)/LODZ/80667/26/08/28  
commission/ damage No. : 20/043739  
Date of commission: 28-08-2026

**DEKRA Poland - Headquarters**  
02-673 Warszawa, ul. Konstruktorska 12A

PKO Leasing SA  
Świętokrzyska 36  
00-116 Warszawa

| Type / version | Edge 2.0 EcoBlue Twin-Turbo 4WD Vignale aut |

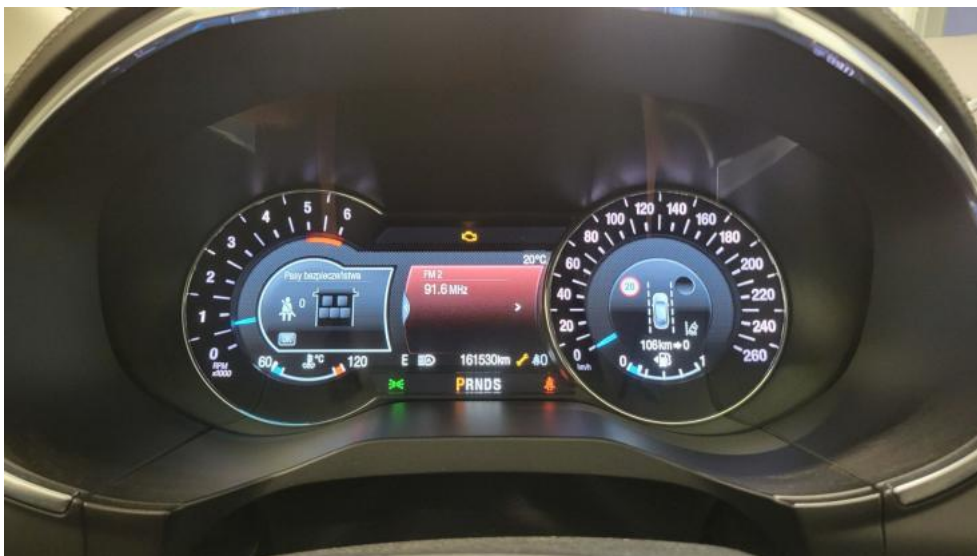
**Photo 25.**

Aktywna kontrolka wezwania do serwisu.

Zestaw wskaźników - serwis

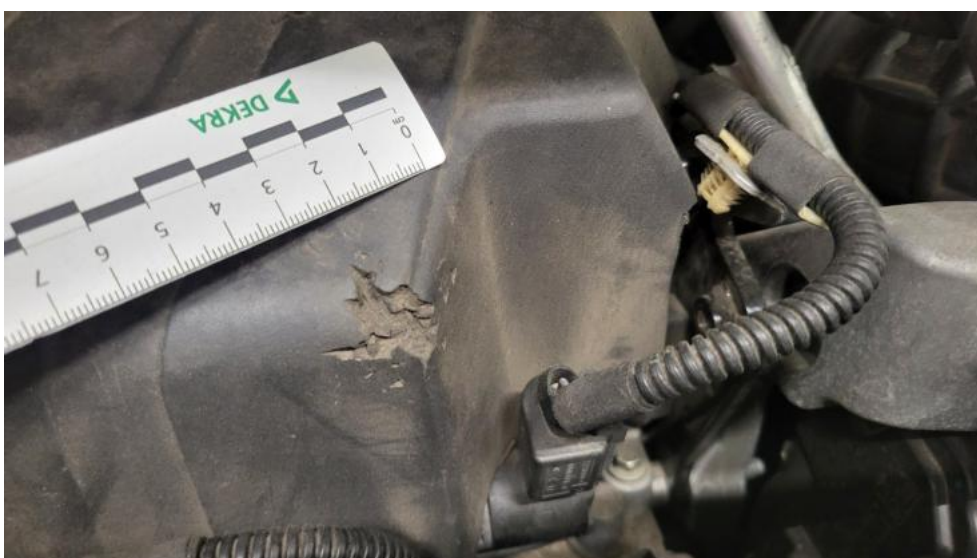
**Photo 40.**

Ośłona silnika - ubytki materiału

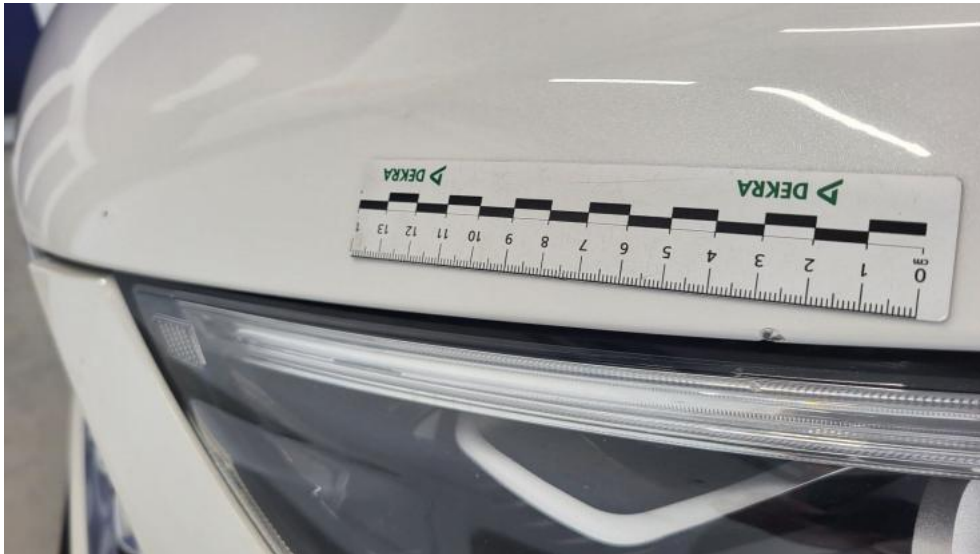
**Photo 41.**

Pokrywa komory silnika - Rysa/odprysk 1

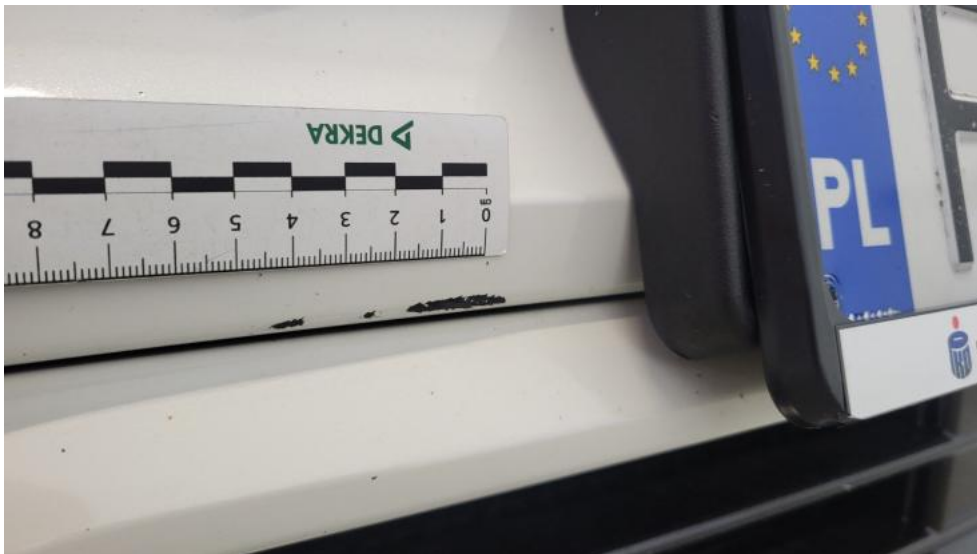
**Photo 45.**

Zderzak - Rysa/odprysk 1

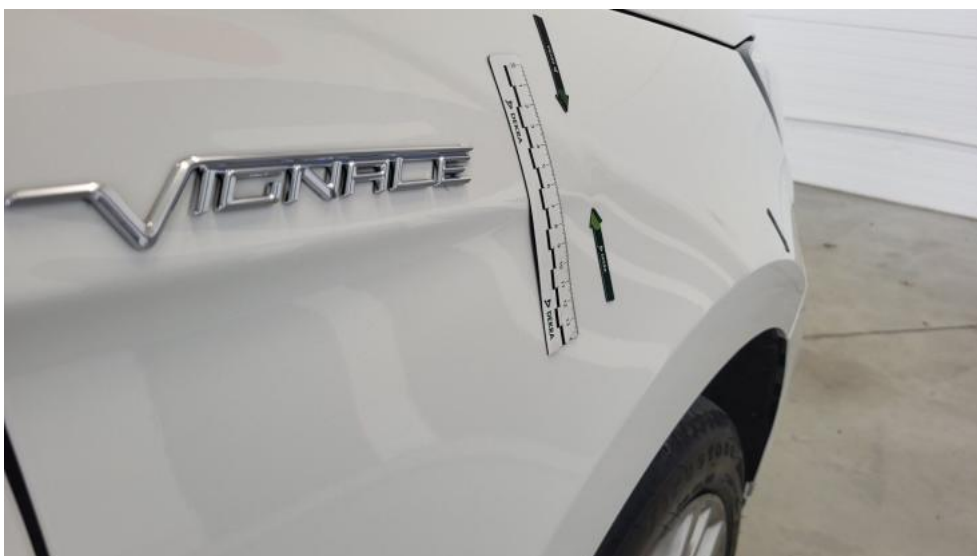
**Photo 46.**

Łotnik przedni P - Wgniecenie/odkształcenie 1

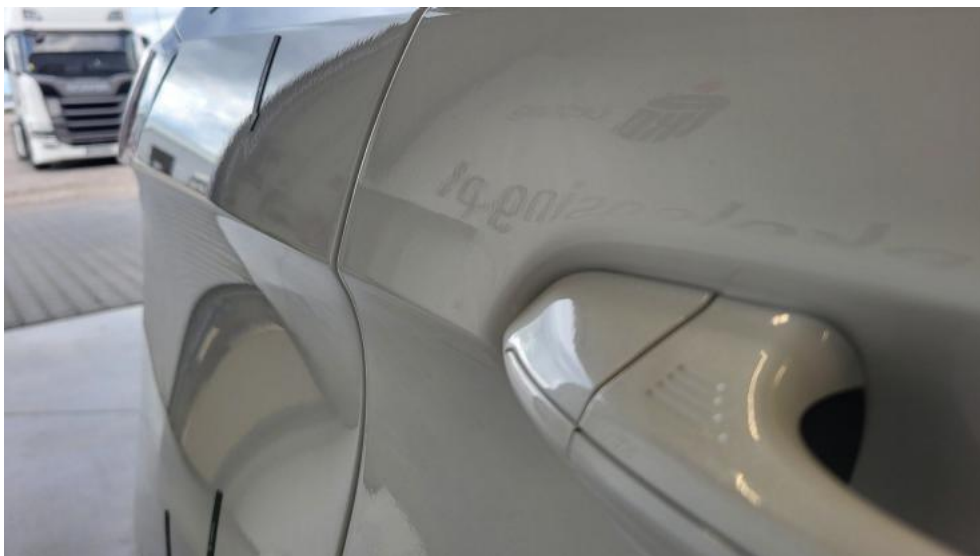
**Photo 50.**

Błotnik tylny P / Ściana boczna P - Wgniecenie/odkształcenie 1

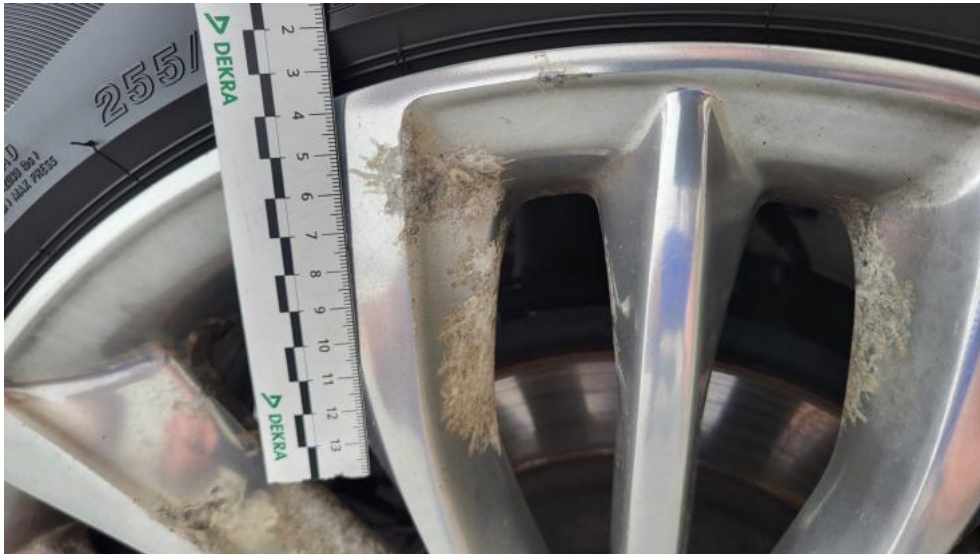
**Photo 51.**

Felga aluminiowa tylna P - Rysa/odprysk 1

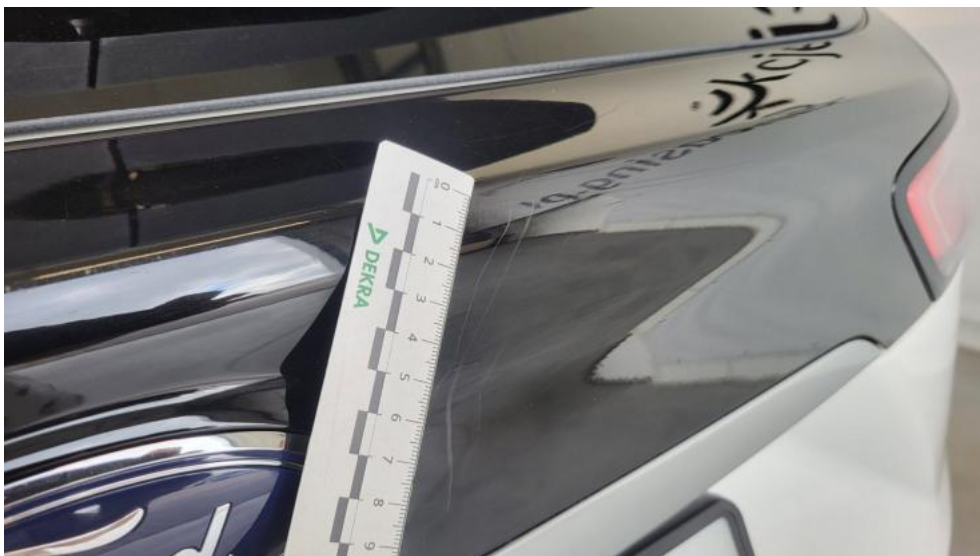
**Photo 52.**

Pokrywy bagażnika - Rysa/odprysk 1

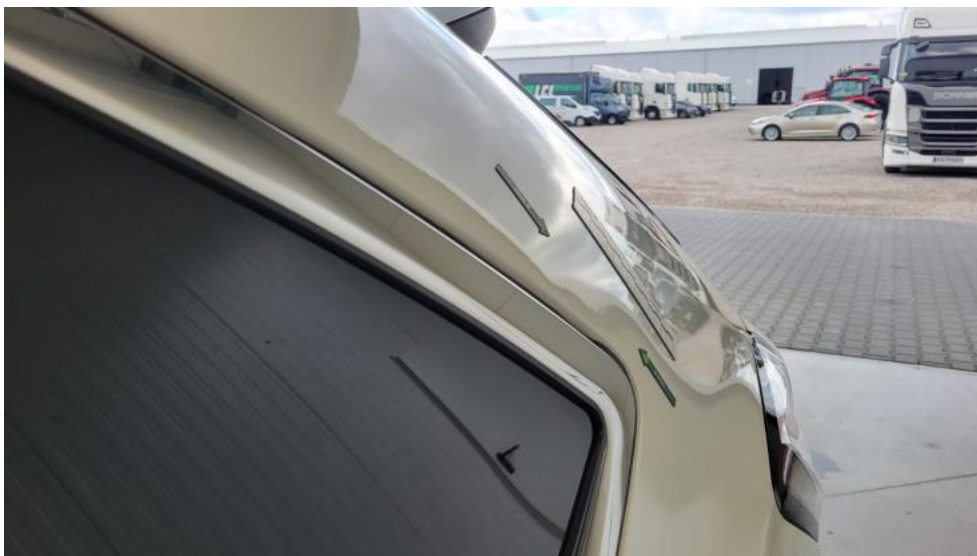
**Photo 53.**

Błotnik tylny L / Ściana boczna L - Wgniecenie/odkształcenie 1

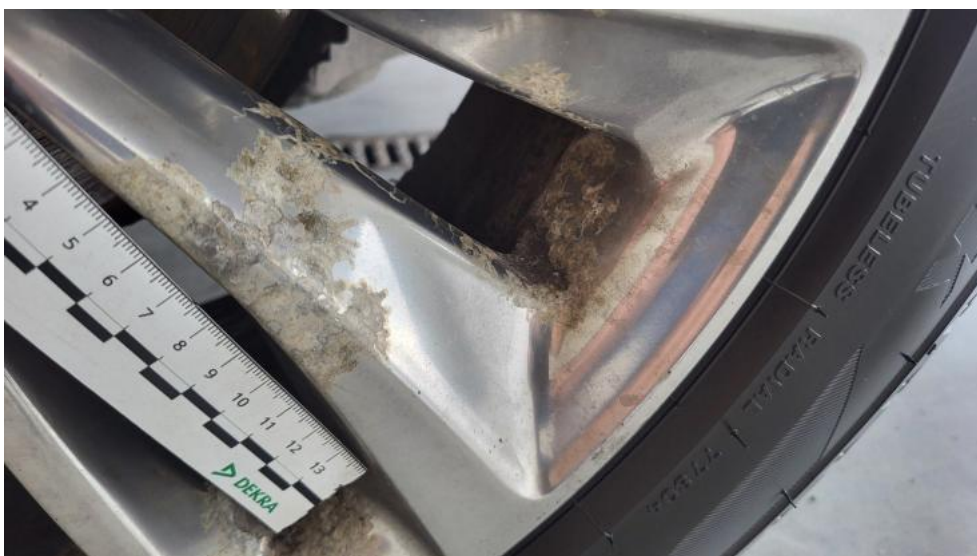
**Photo 54.**

Felga aluminiowa tylna L - Rysa/odprysk 1

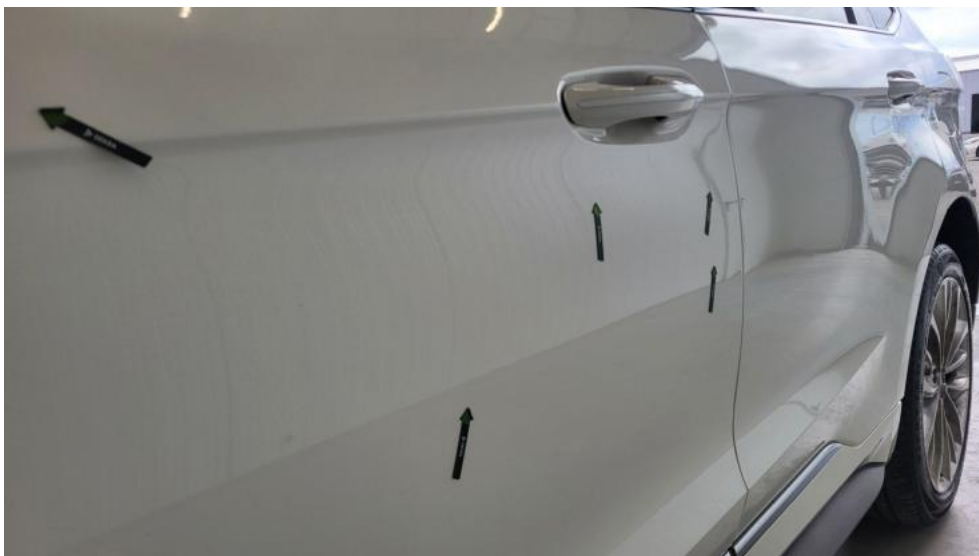
**Photo 56.**

Drzwi tylna L - Wgniecenie/odkształcenie 1

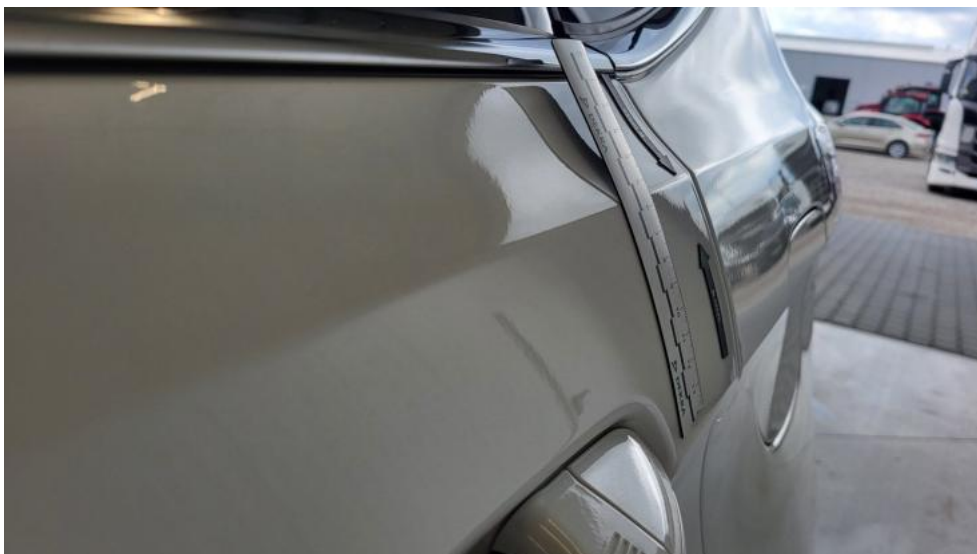
**Photo 58.**

Drzwi tylne L - Wgniecenie/odkształcenie 1

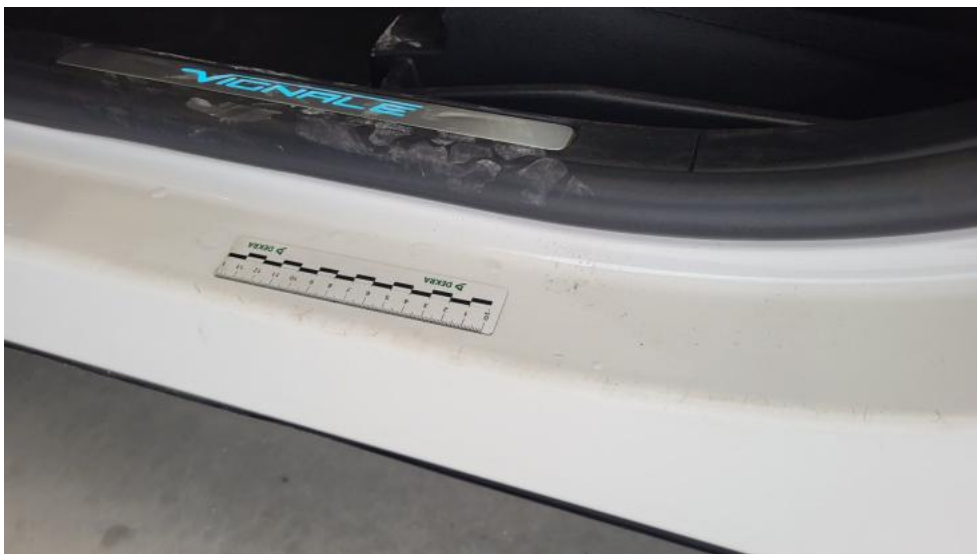
**Photo 59.**  
Próg L - Rysa/odprysk 1

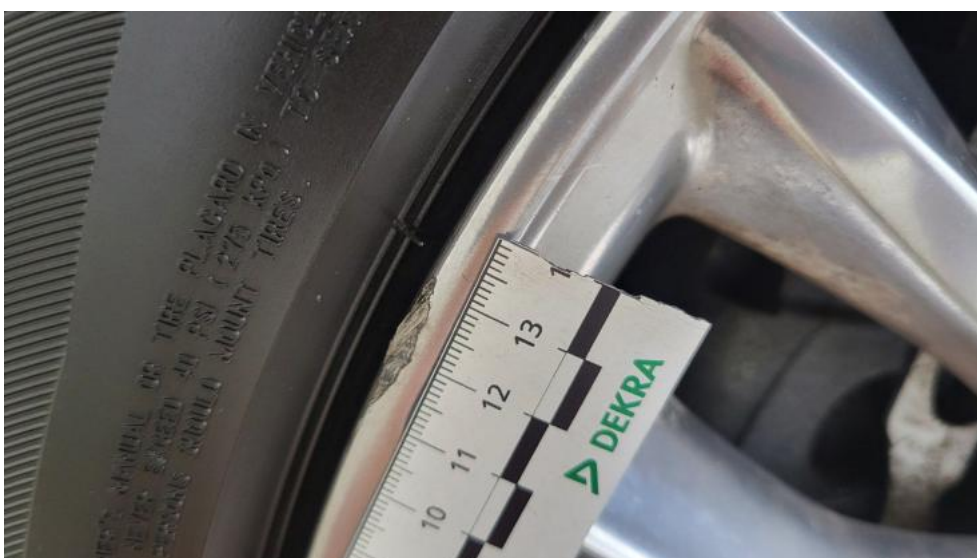
**Photo 60.**  
Felga Aluminiowa przednia L - Rysa/odprysk 1

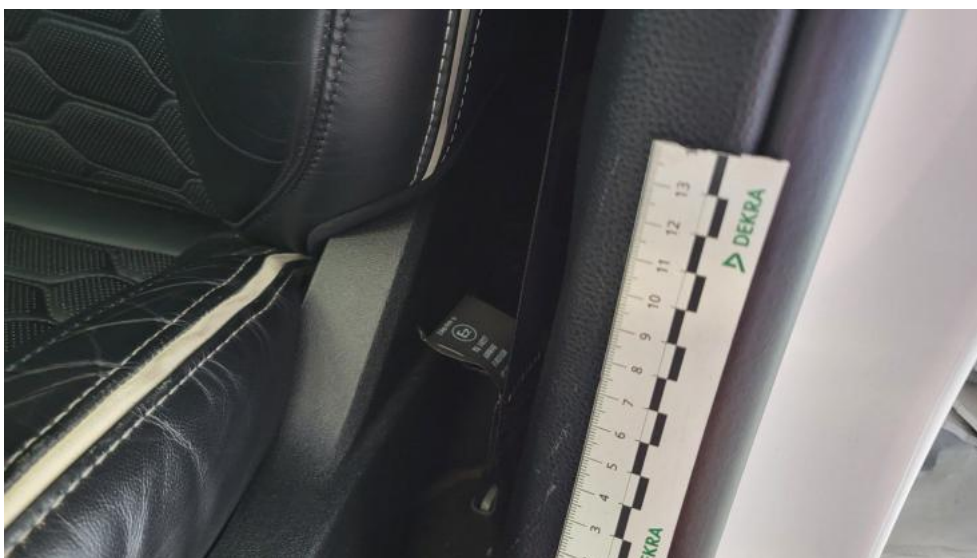
**Photo 70.**

Wykładzina(y) słupka środkowego L - Rysa/odprysk 1
