DEKRA's commission No. : PKOL(W)/LODZ/41786/26/05/14
commission/ damage No. : PS22/00731
Date of commission: 14-05-2026

Group of objects (Eurotax)	cars
EC code (Eurotax)	0128688
Manufacturer	AUDI
Model	A8 [4N] 17-21
Type / version	A8 L 50 TDI mHEV Quattro Tiptr.
Body type	sedan
Number of doors / seats	4/5
Curb weight [kg]	2000
Gross vehicle weight [kg]	2700
Wheelbase 1/2	3128
Engine type	Automatic ignition
Pollution reduction system	KSC
Engine capacity [ccm]	2967
Engine Power [hp/kW]	286/210
Gearbox	automatic 8- gear
Registration /record No.	KR2KE77
VIN / serial number	WAUZZZF83KN011558
Date of first registration	31-01-2019
Date of next. tech. test	31-01-2027
Year of manufacture	2019 (year has been verified with the manufacturer's base)
Readout [km]	151 675 (read)
Body color / type of coating	grafitowy/METALIK

PHOTOGRAPHIC DOCUMENTATION

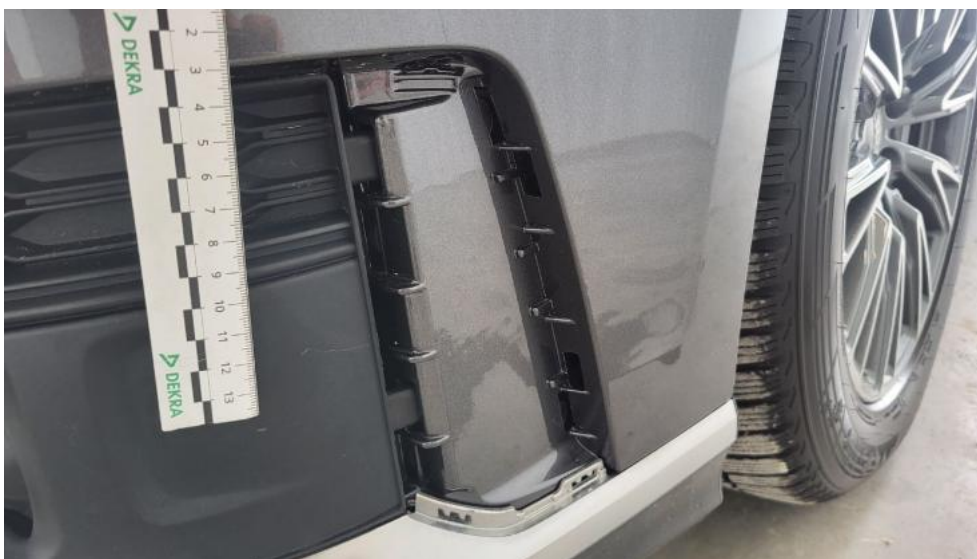
Photo 51.
Kratka/zaślepka halogenu L - Inne 1

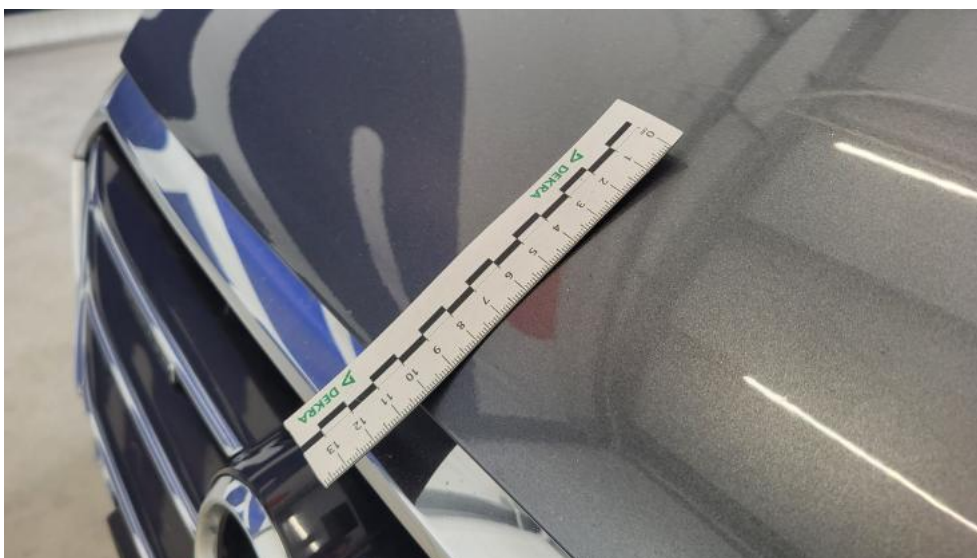
Photo 52.
Pokrywa komory silnika - Rysa/odprysk 1

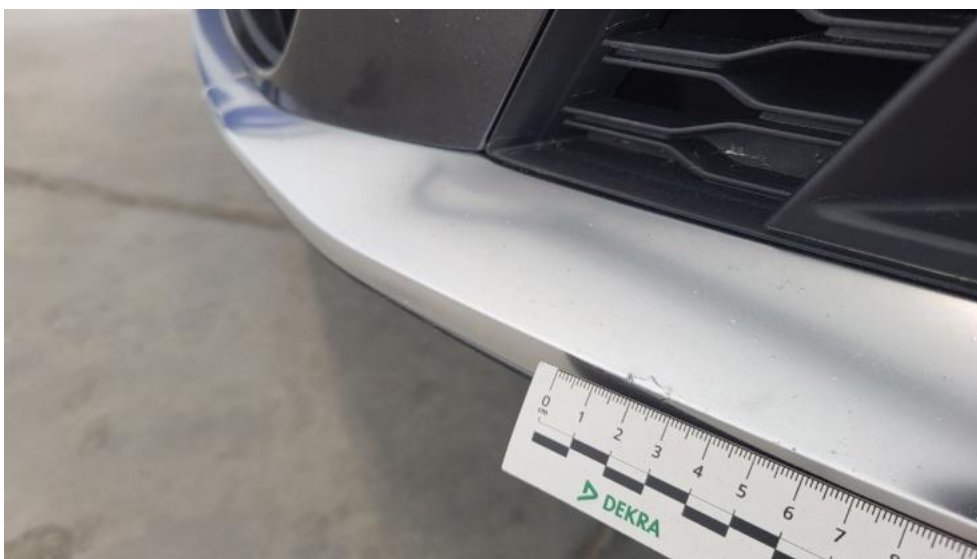
Photo 53.
Spoiler zderzaka przedniego - Rysa/odprysk 1

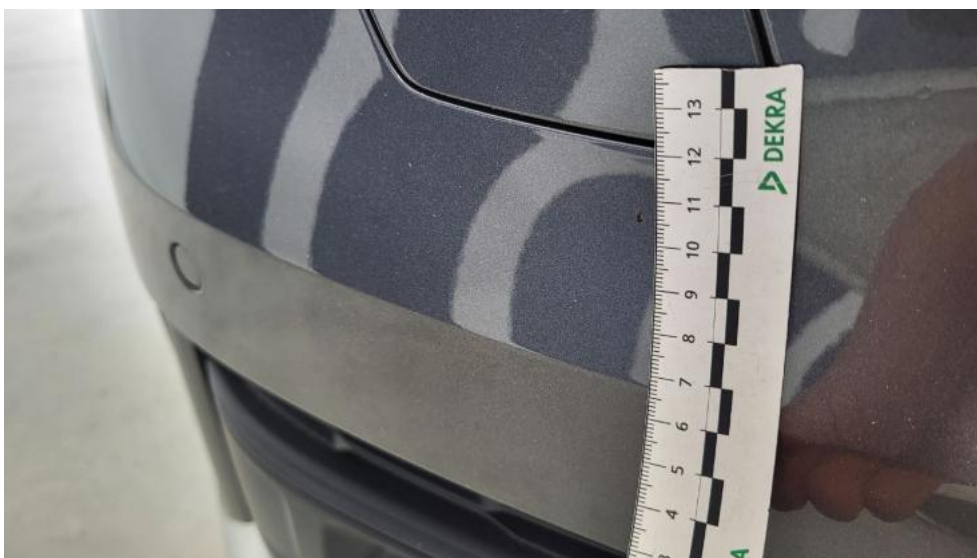
Photo 54.
Zderzak - Rysa/odprysk 1

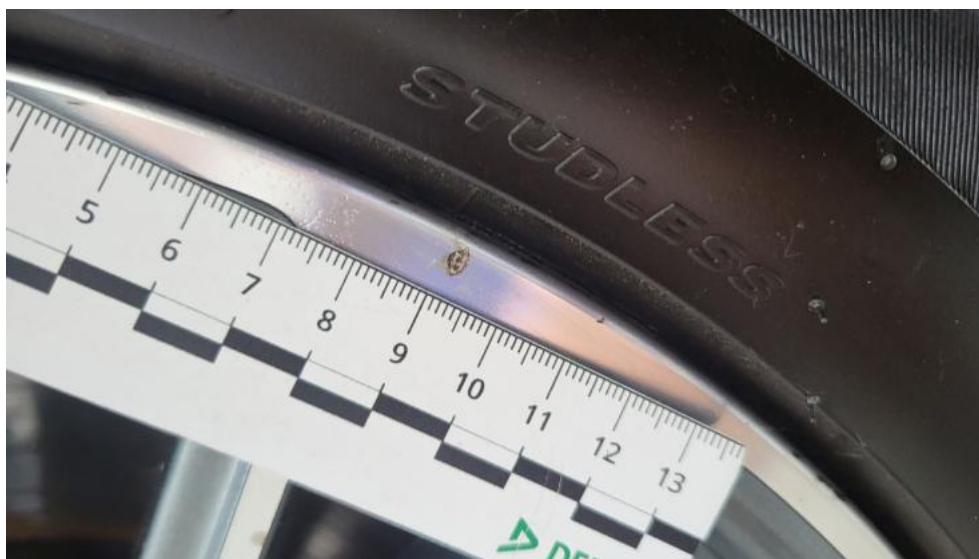
Photo 55.

Felga aluminiowa przednia P - Rysa/odprysk 1

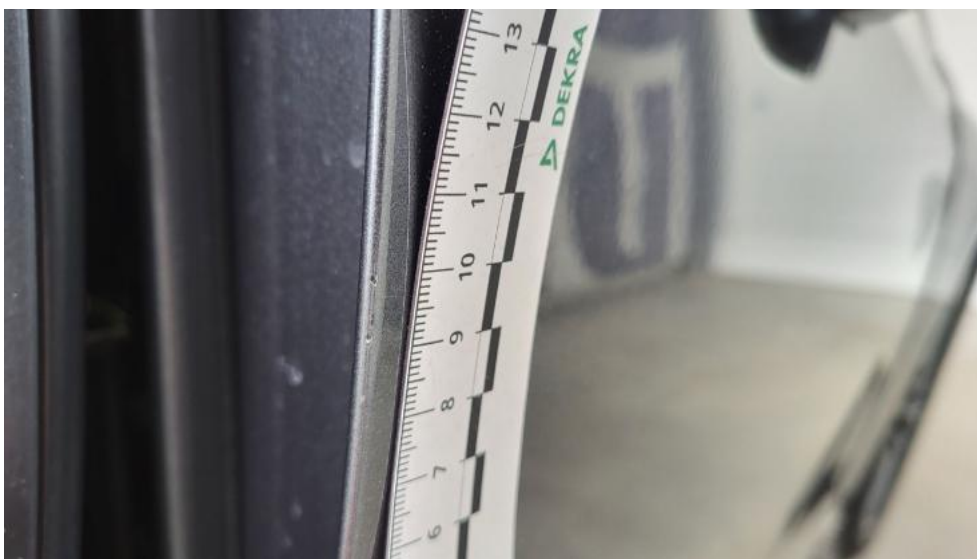
Photo 57.

Drzwi przednie P - Rysa/odprysk 1

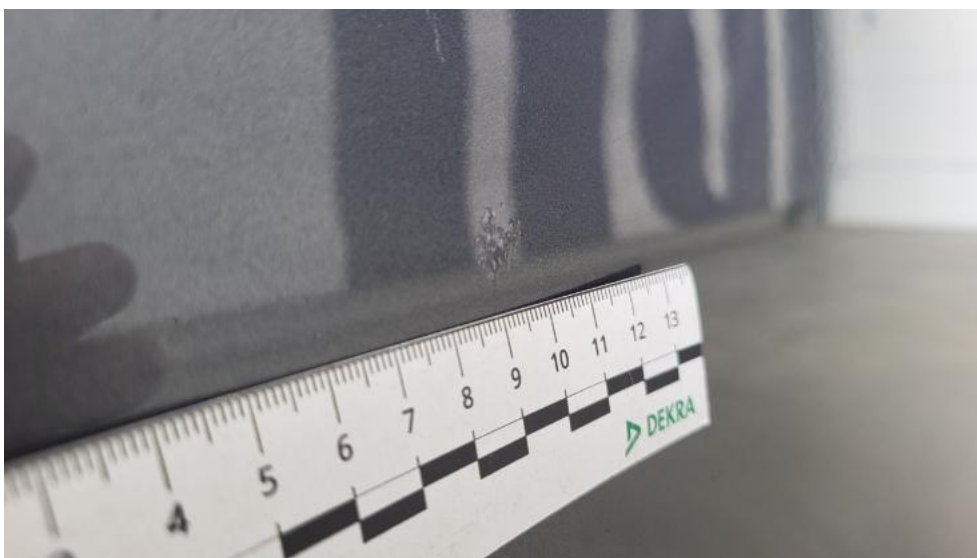
Photo 58.

Drzwi przednie P - Inne 1

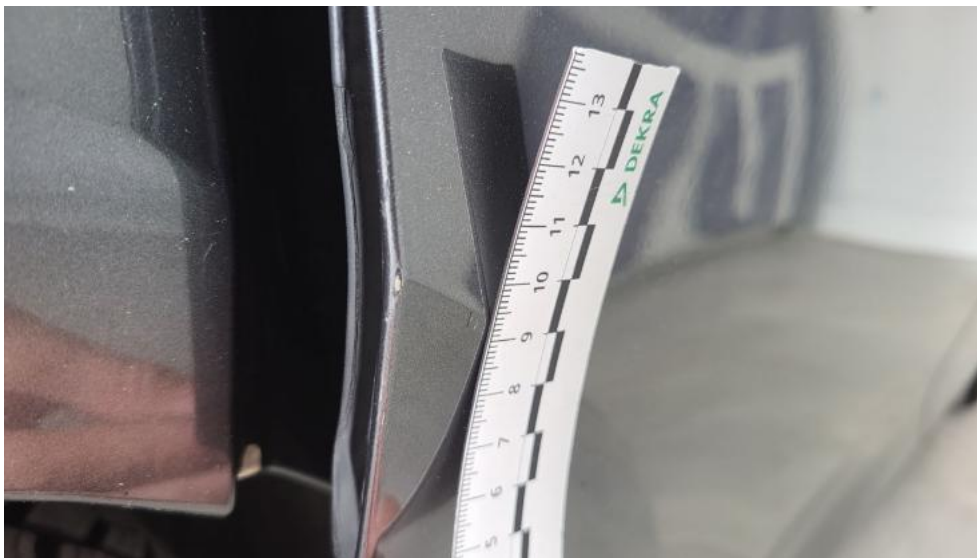
Photo 59.
Drzwi tylne P - Rysa/odprysk 1

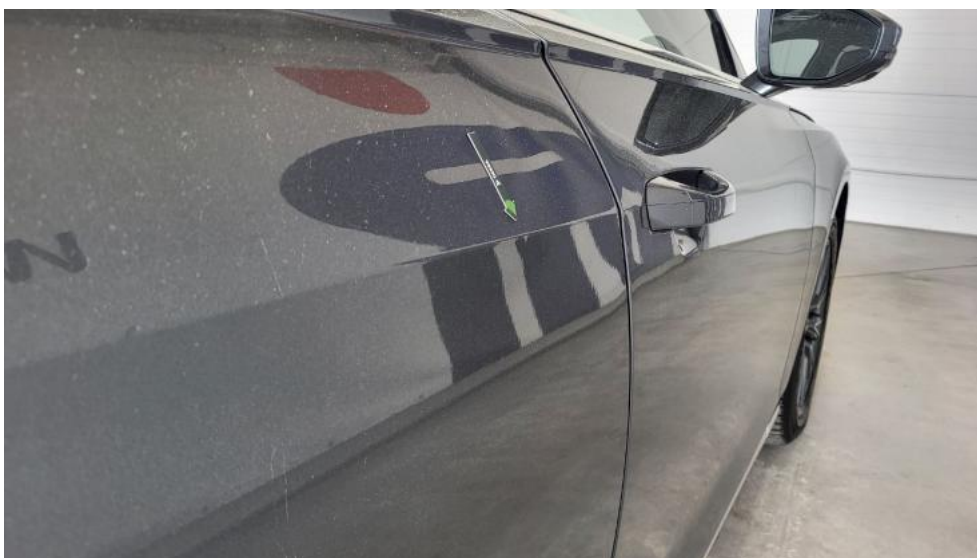
Photo 60.
Drzwi tylne P - Wgniecenie/odkształcenie 1

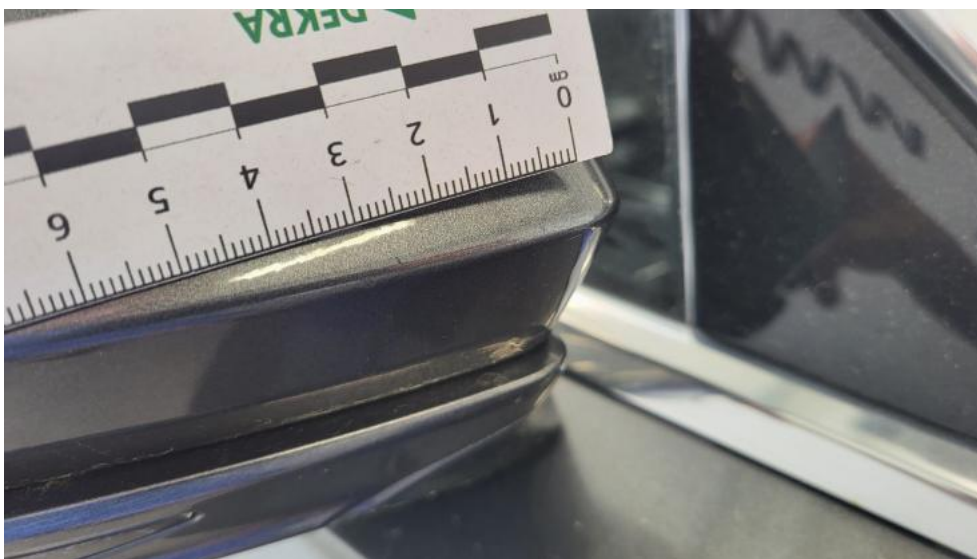
Photo 61.
Lusterko zew P - Rysa/odprysk 1

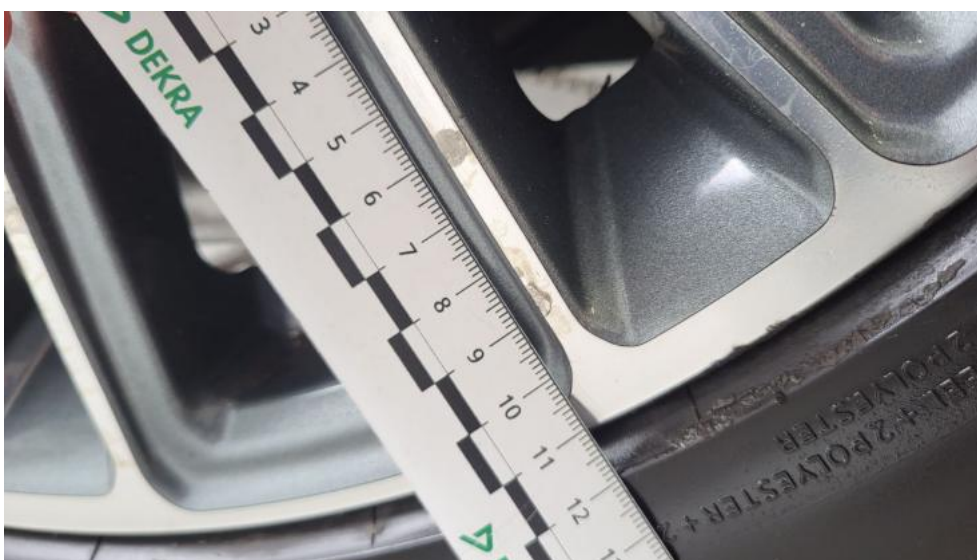
Photo 62.
Felga aluminiowa tylna P - Rysa/odprysk 1

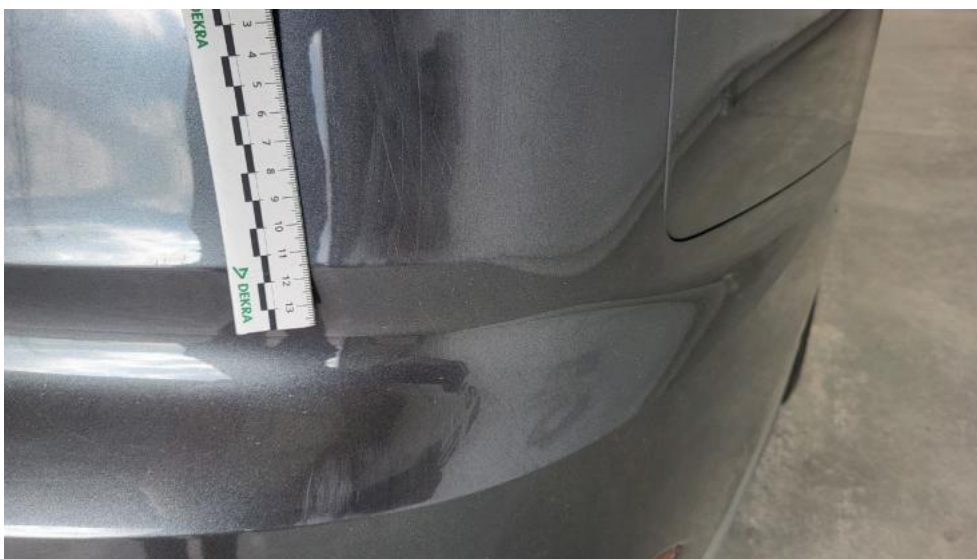
Photo 63.
Zderzak tylny - Rysa/odprysk 1

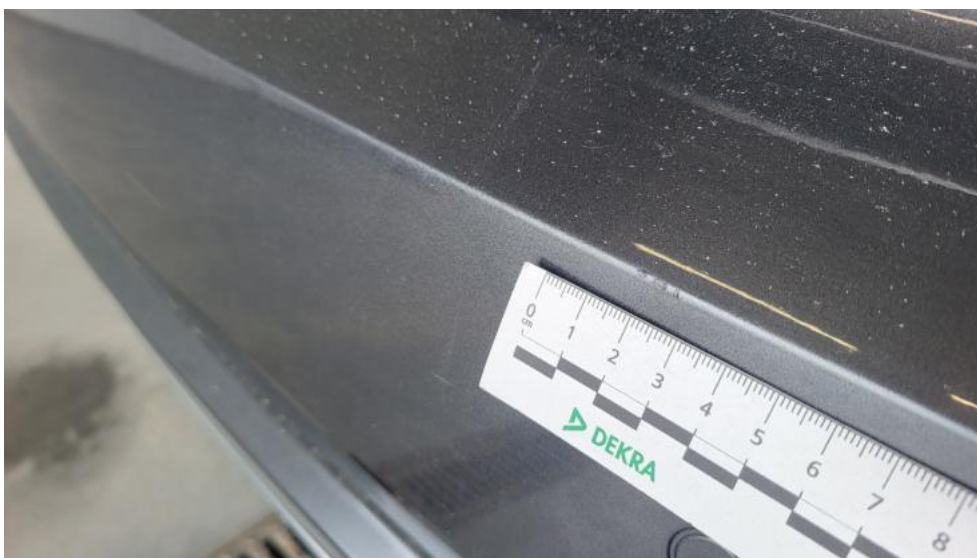
Photo 64.
Zderzak tylny - Rysa/odprysk 2

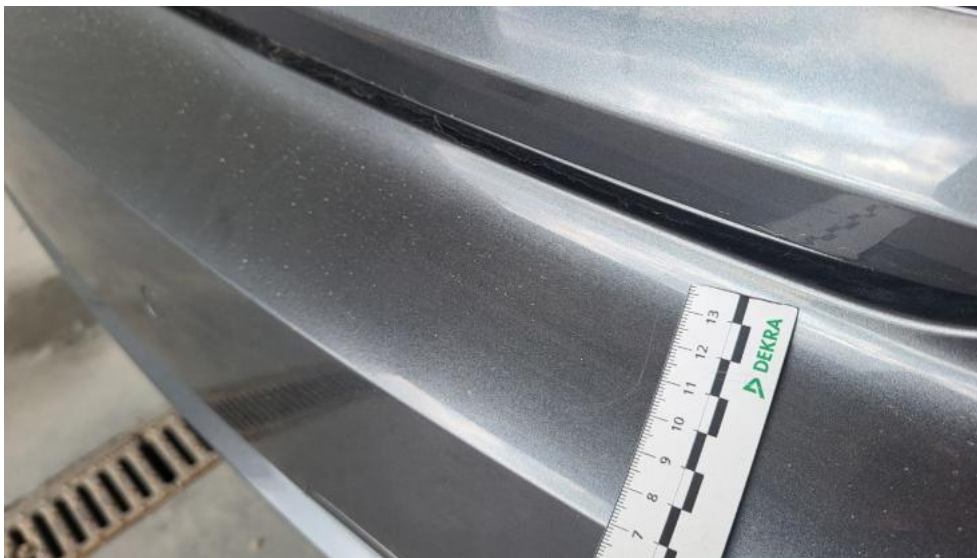
Photo 65.
Zderzak tylny() - Rysa/odprysk 3

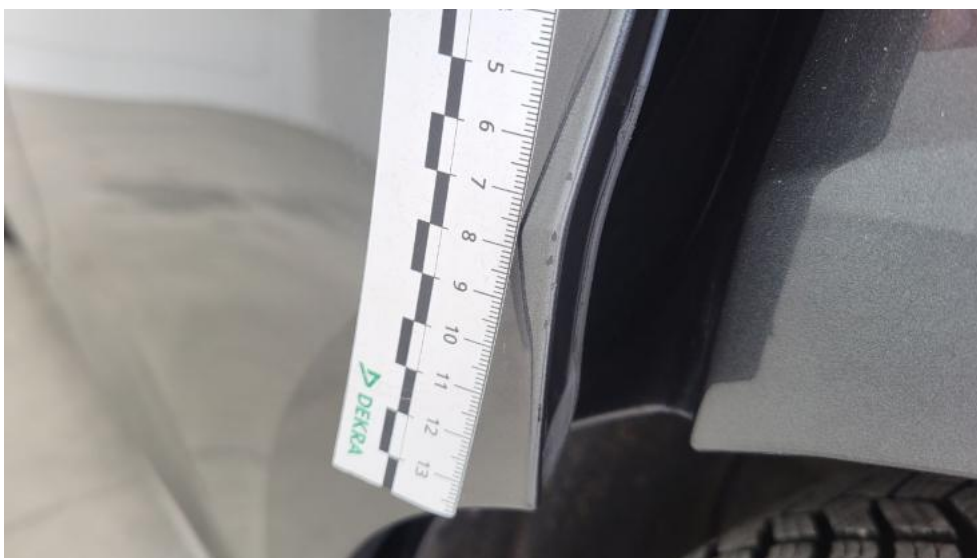
Photo 66.
Drzwi tylne L - Rysa/odprysk 1

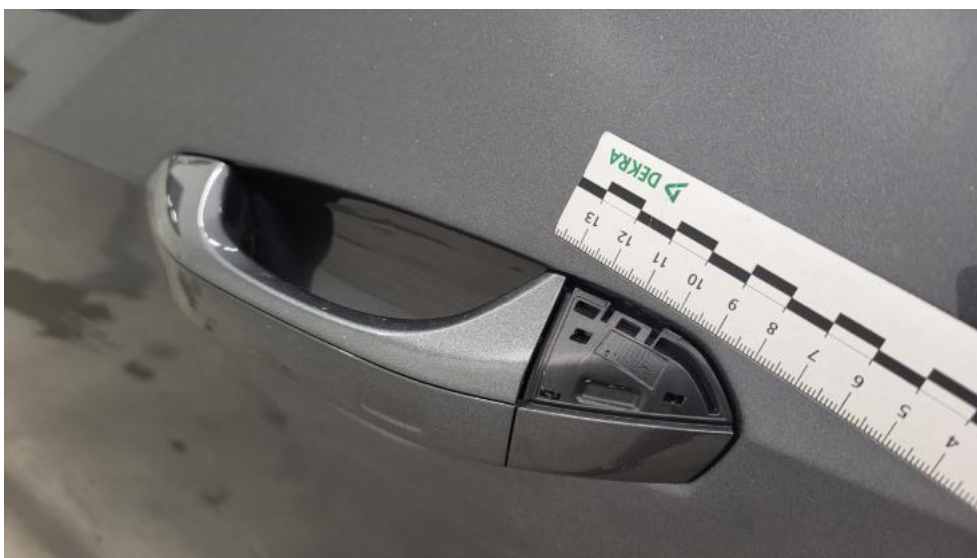
Photo 68.
Zamek drzwi przednich L - Inne 1

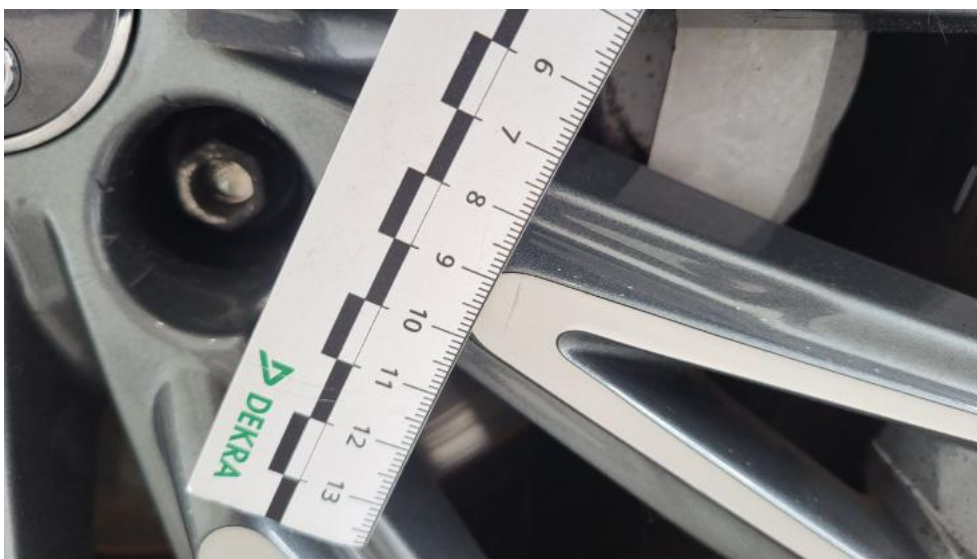
Photo 69.
Felga Aluminiowa przednia L - Rysa/odprysk 1

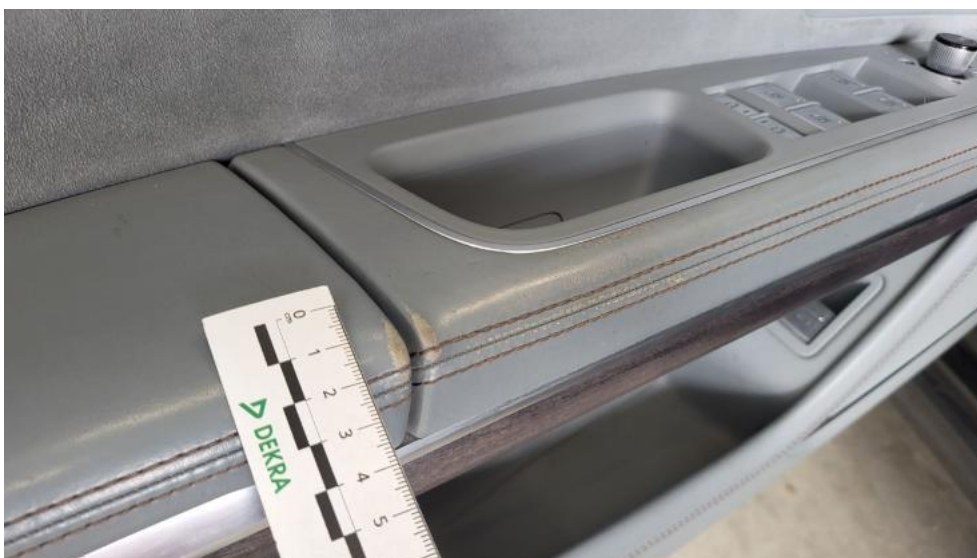
Photo 70.
Tapicerka drzwi przednich L - Rysa/odprysk 1

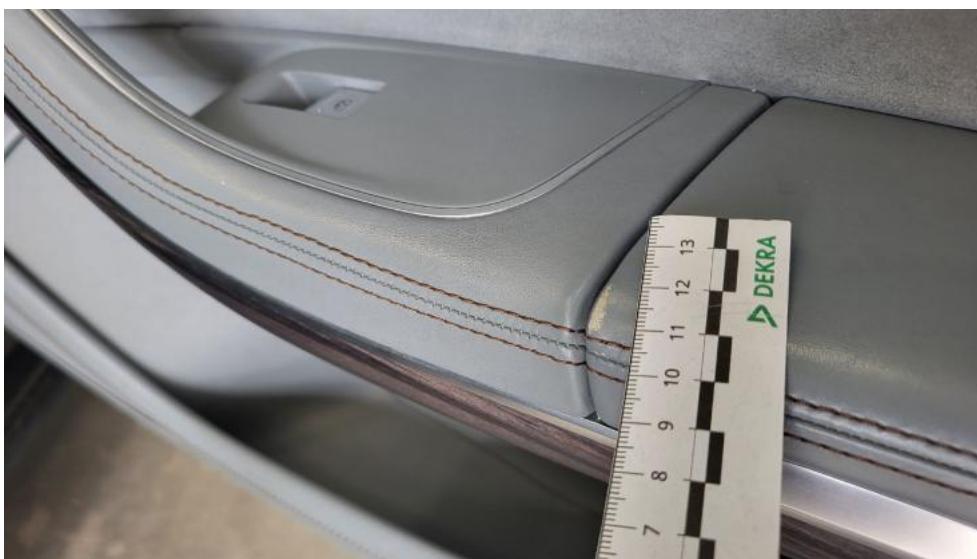
Photo 71.
Tapicerka drzwi przednich P - Rysa/odprysk 1

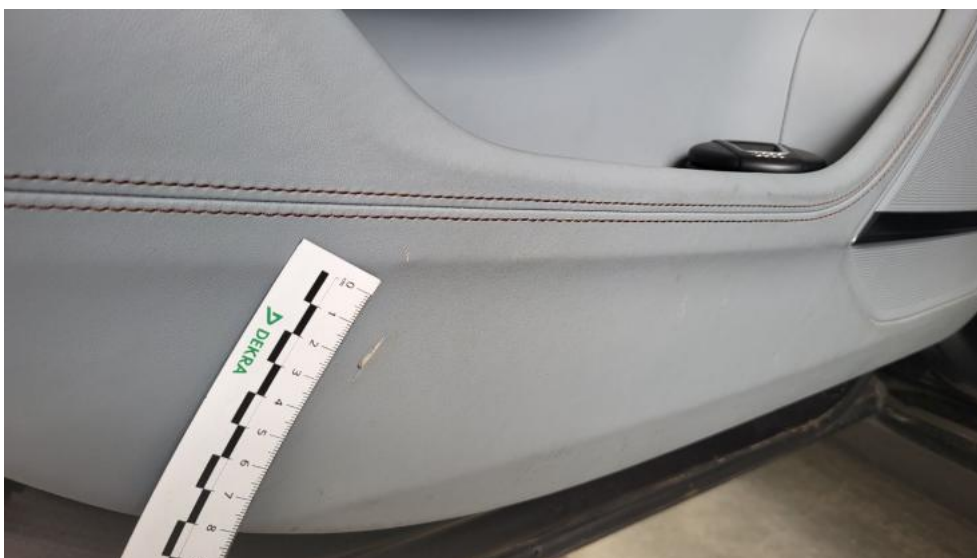
Photo 72.
Tapicerka drzwi tylnych L - Pęknięcie/rozerwanie 1

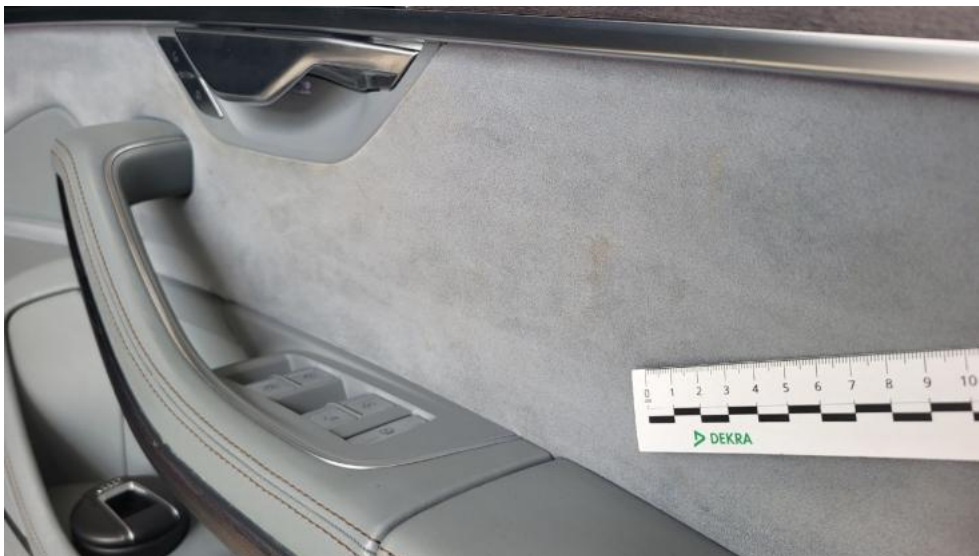
Photo 73.
Tapicerka drzwi tylnych P - Inne 1

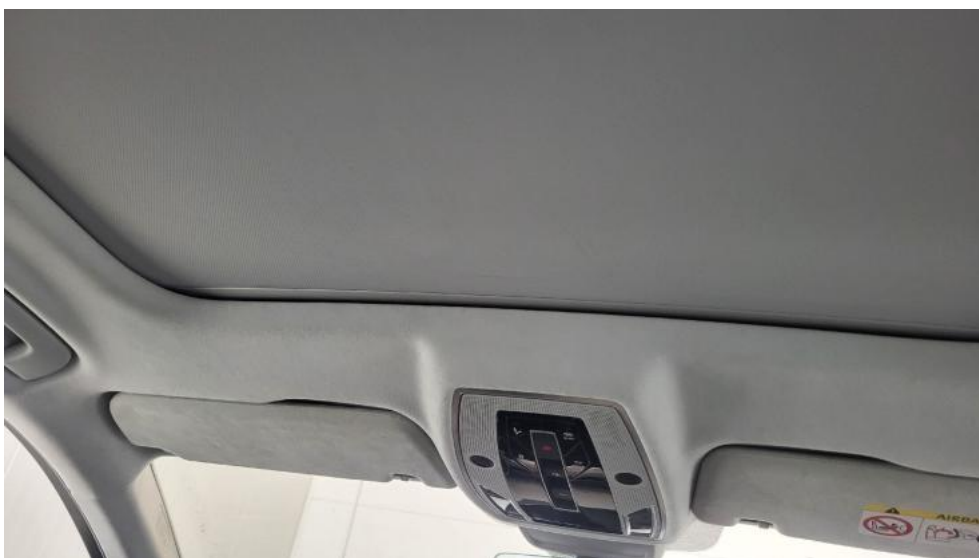
Photo 74.
Podsufitka - Inne 1

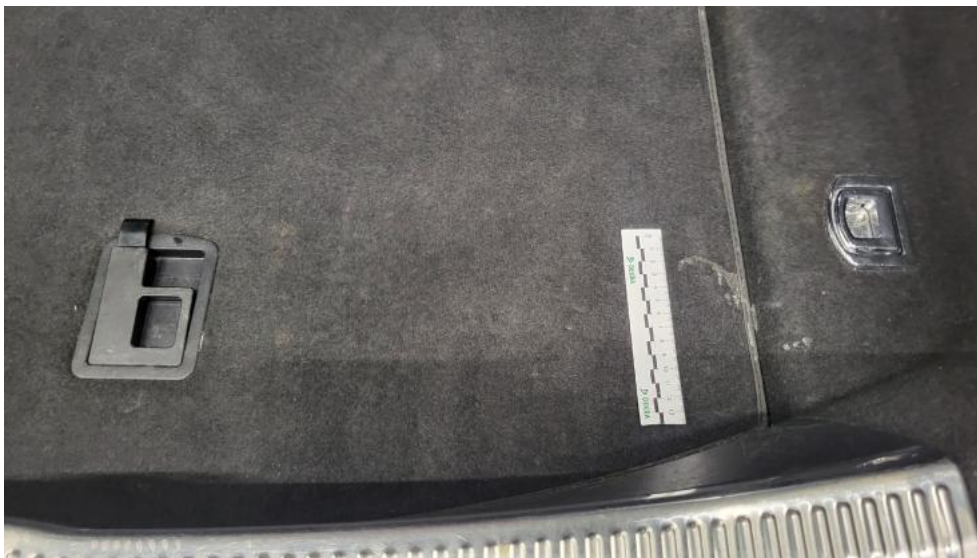
Photo 75.

Wykładzina podłogi bagażnika - Inne 1
