DEKRA's commission No. : PKOL(W)/LODZ/56391/25/07/31  
commission/ damage No. : 20/002083  
Date of commission: 31-07-2025

| Model | Grand Cherokee 16-20 |
| Type / version | Gr. Cherokee 6.4 V8 SRT8 |
| Registration /record No. | WZ6228Y |

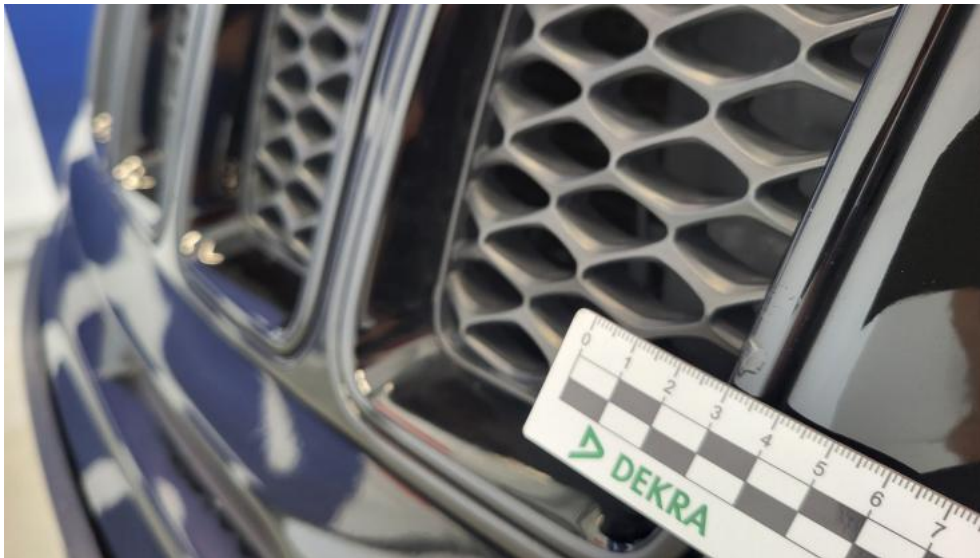
**Photo 43.**

Atrapa przednia - Rysa/odprysk 1

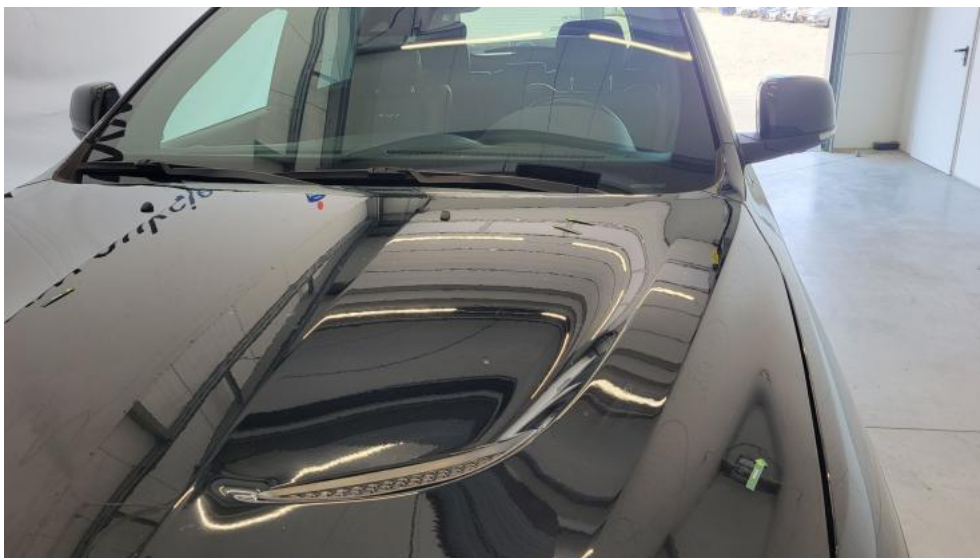
**Photo 44.**

Pokrywa komory silnika - Wgniecenie/odkształcenie 1

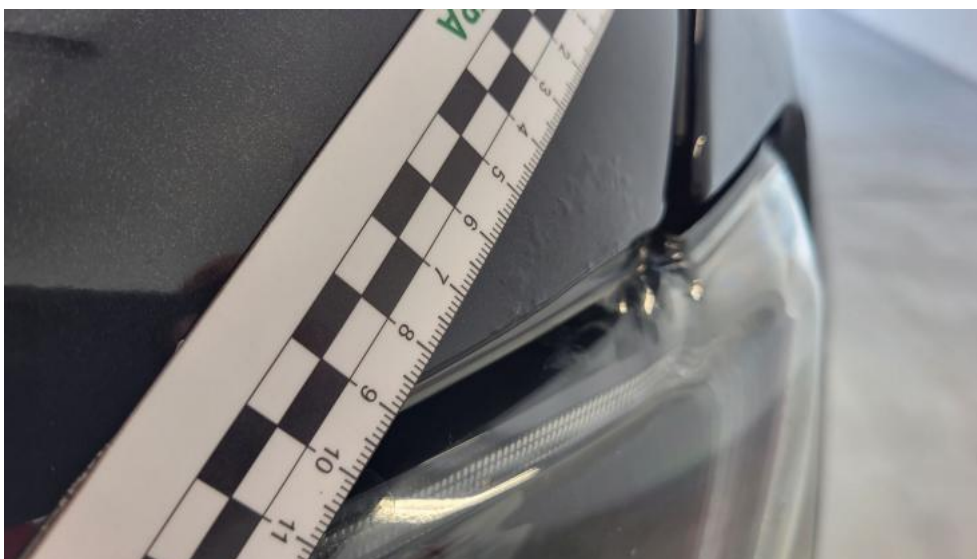
**Photo 45.**

Pokrywa komory silnika - Inne 1

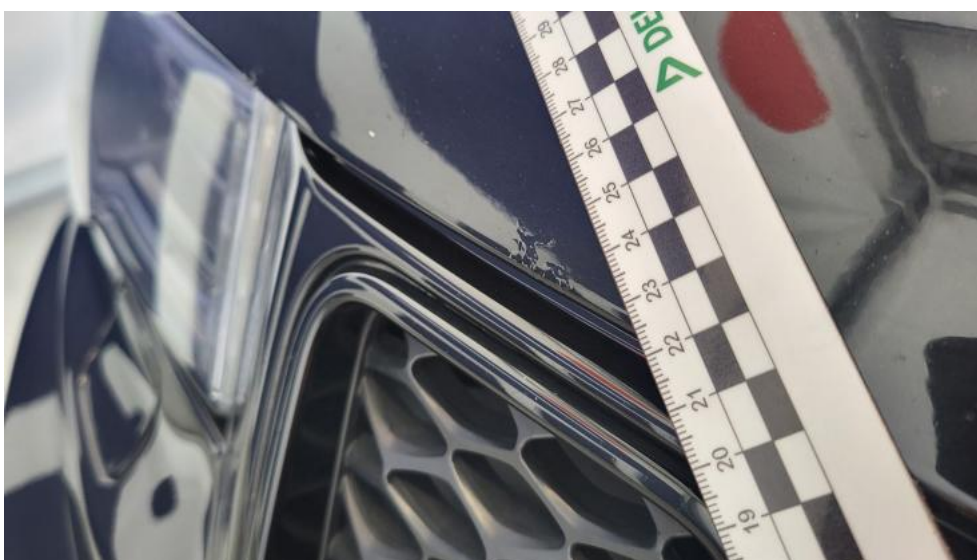
**Photo 46.**

Pokrywa komory silnika - Inne 2

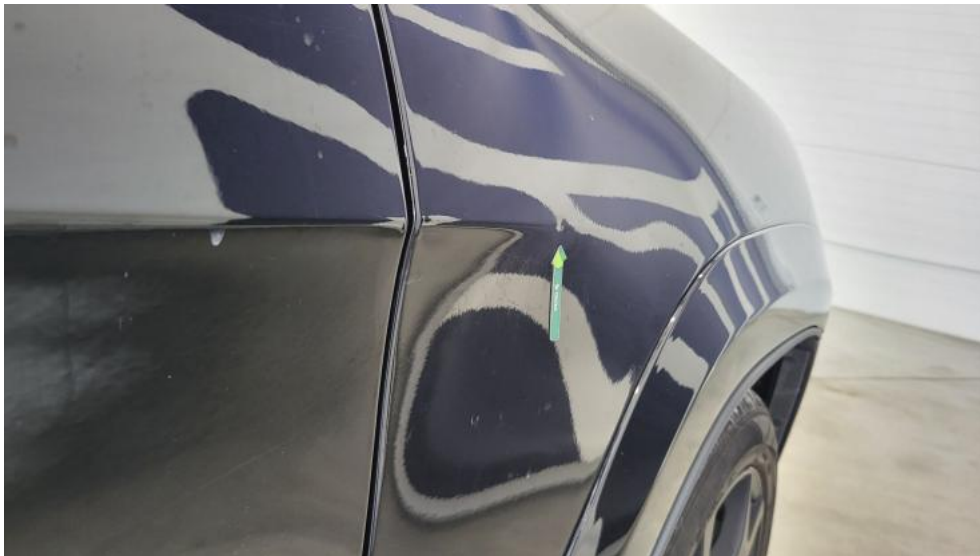
**Photo 47.**

| No. of controlled item | Controlled item | Measured range of thickness of the lacquer coat [µm] |
|---|---|---|
| 17 | Right front fender | 150 - 1000 |

Błotnik przedni P - Wgniecenie/odkształcenie 1

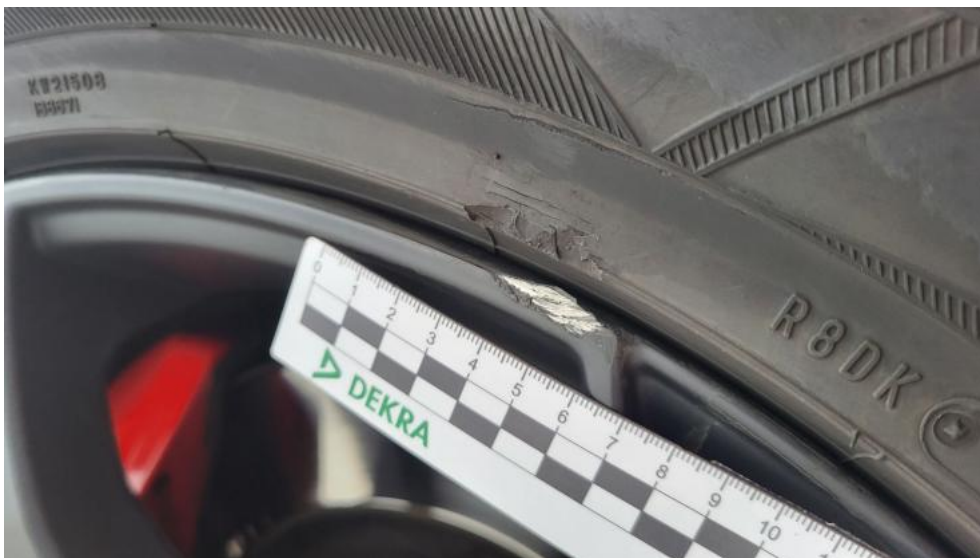
**Photo 48.**

Felga aluminiowa przednia P - Rysa/odprysk 1

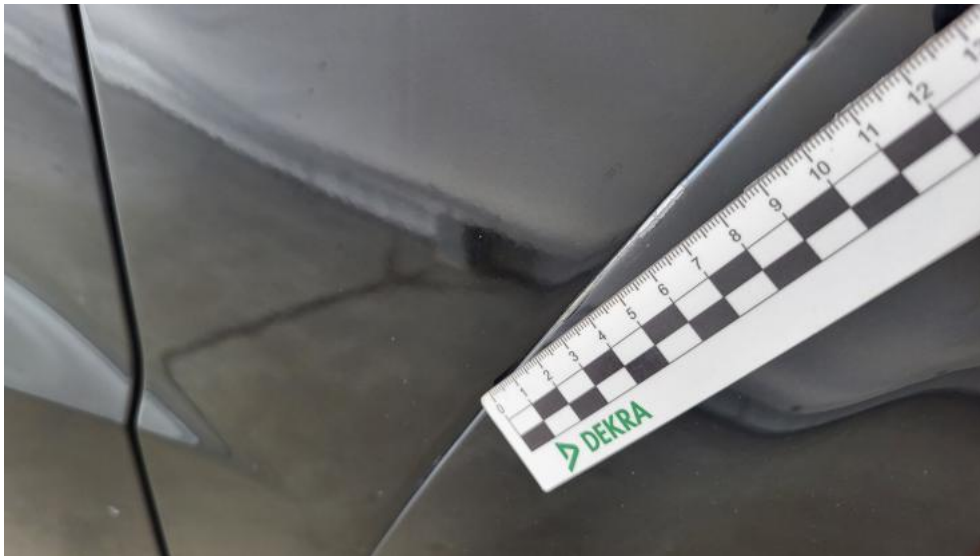
**Photo 49.**

Listwa błotnika przedniego P - Rysa/odprysk 1

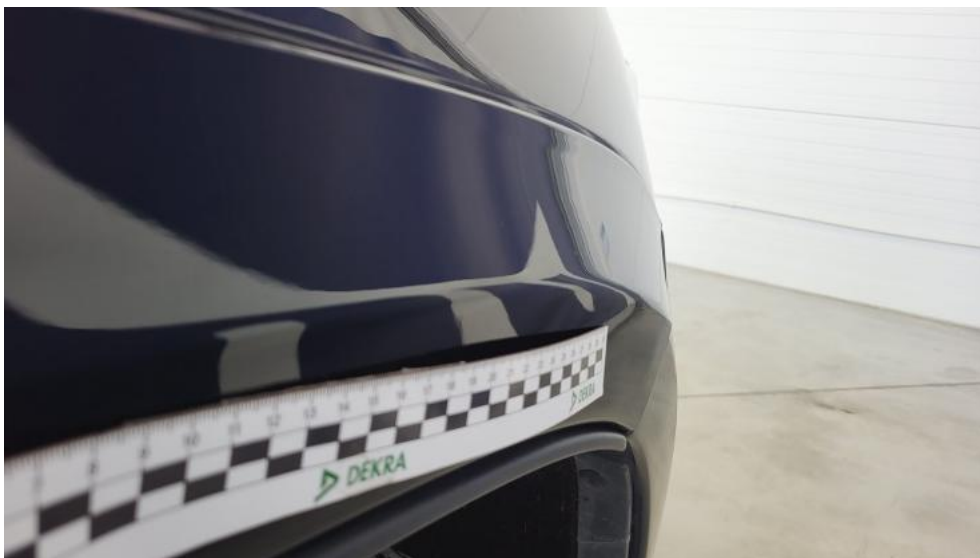
**Photo 50.**

Listwa błotnika przedniego P - Wgniecenie/odkształcenie 1

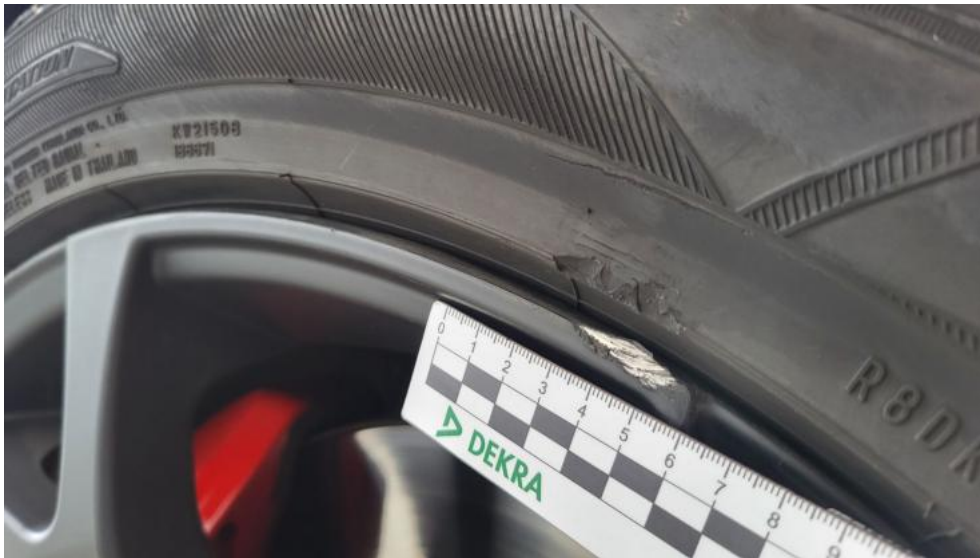
**Photo 51.**

Opona przednia P - Pęknięcie/rozerwanie 1

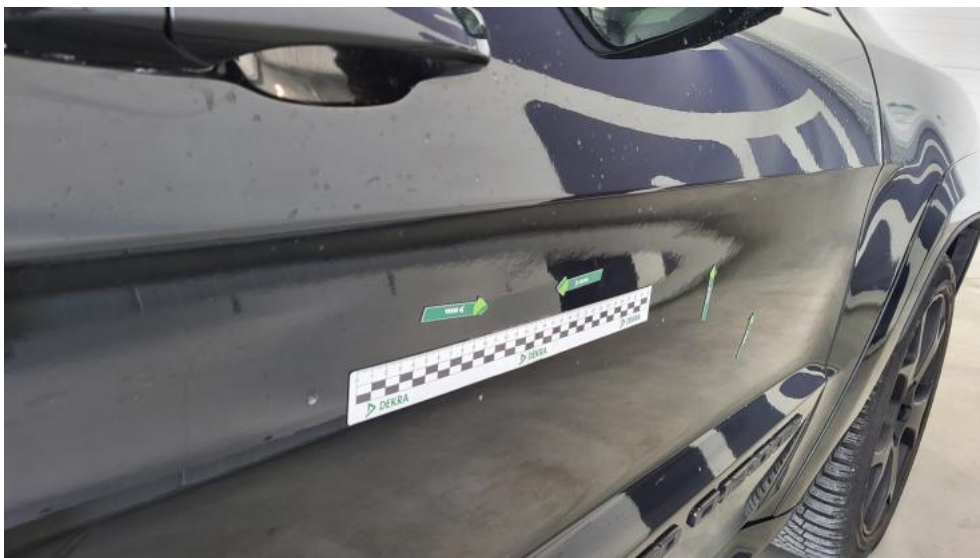
**Photo 52.**

| No. of controlled item | Controlled item | Measured range of thickness of the lacquer coat [µm] |
|---|---|---|
| 14 | Front right door | 150 - 500 |

Drzwi przednie P - Wgniecenie/odkształcenie 1

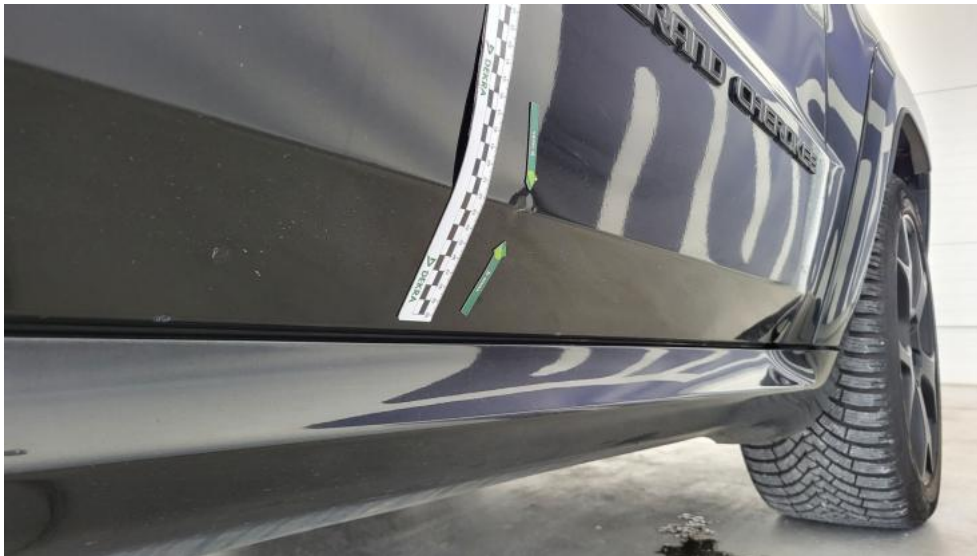
**Photo 53.**

Drzwi przednie P - Wgniecenie/odkształcenie 2

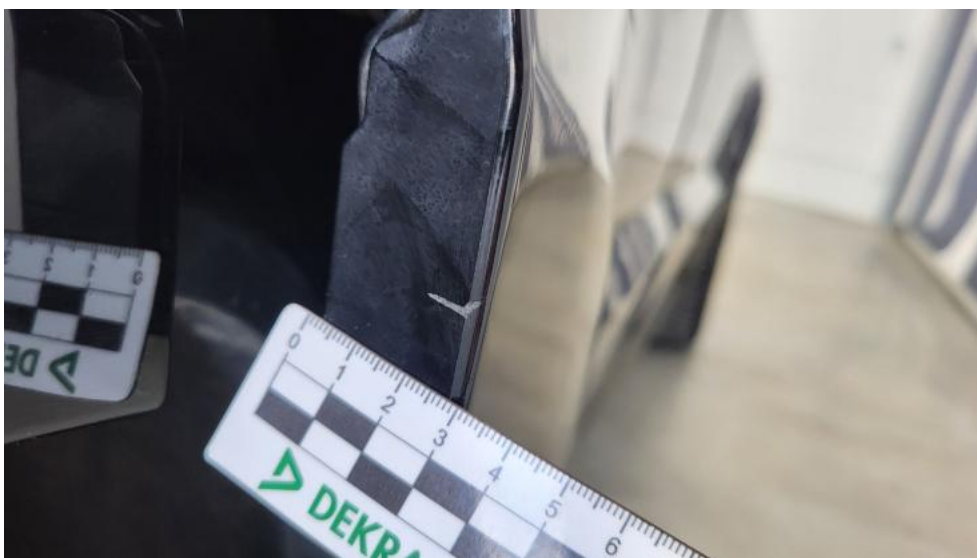
**Photo 54.**

Listwa drzwi tylnych P - Rysa/odprysk 1

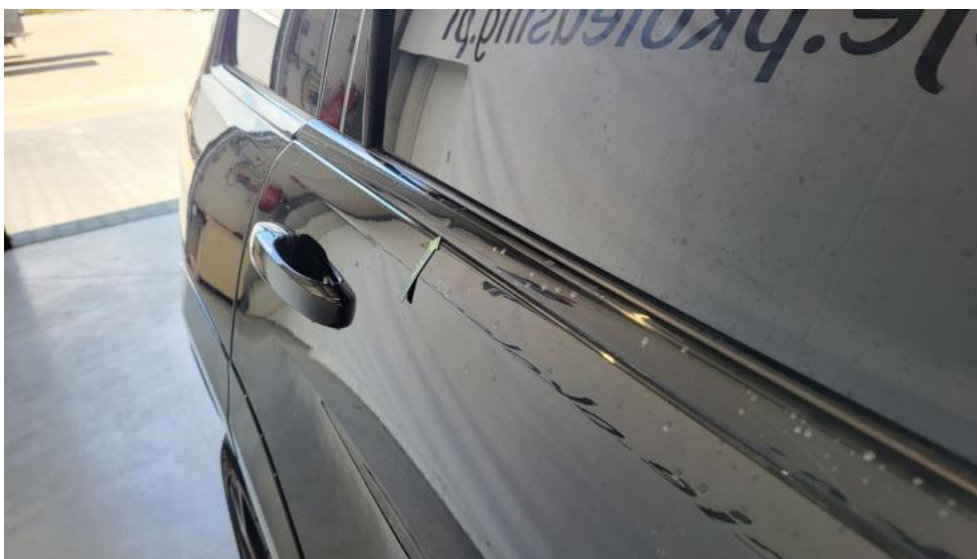
**Photo 55.**

Listwa drzwi tylnych P - Wgniecenie/odkształcenie 1

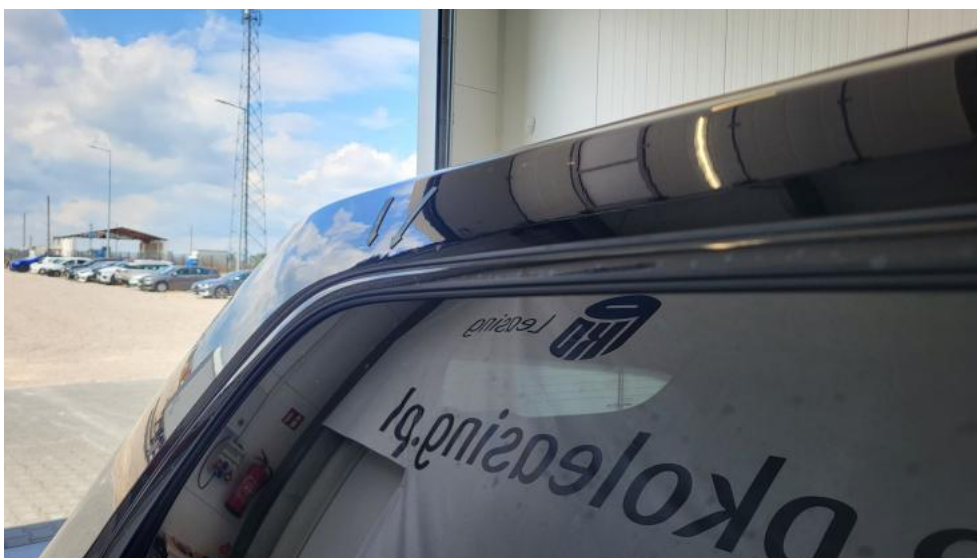
**Photo 56.**

Ścianka tylna P / Ścianka boczna P - Wgniecenie/odkształcenie 1

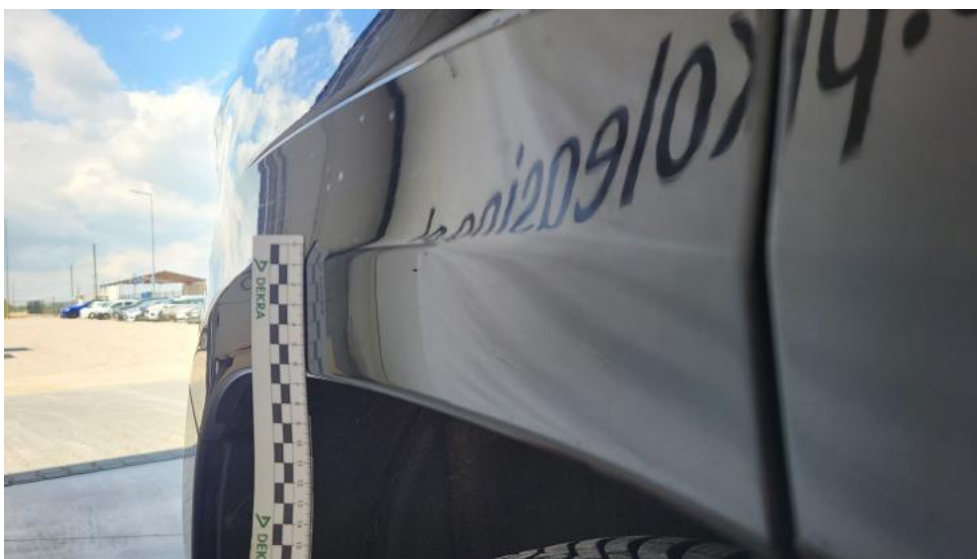
**Photo 57.**

Listwa krawędzi błotnika tyl P - Wgniecenie/odkształcenie 1

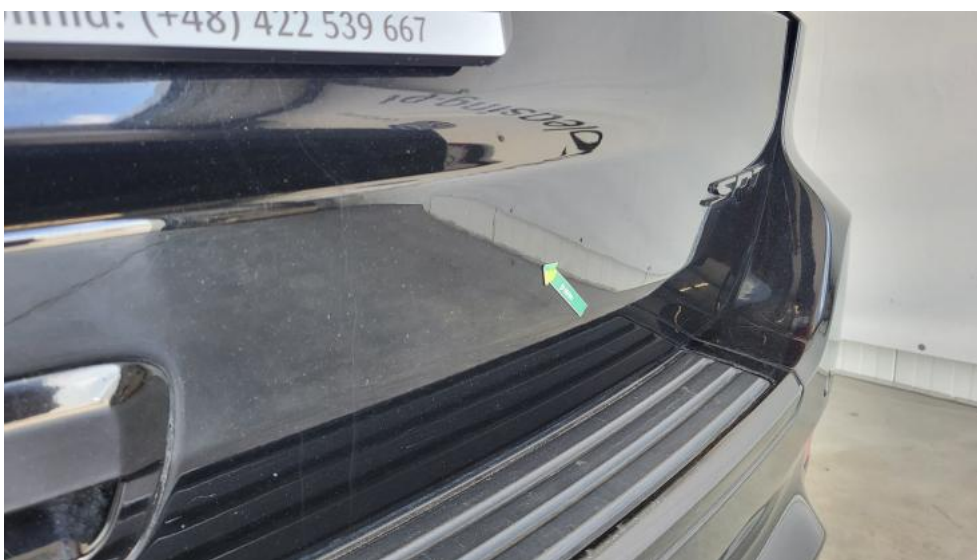
**Photo 58.**

Pokrywy bagażnika - Wgniecenie/odkształcenie 1

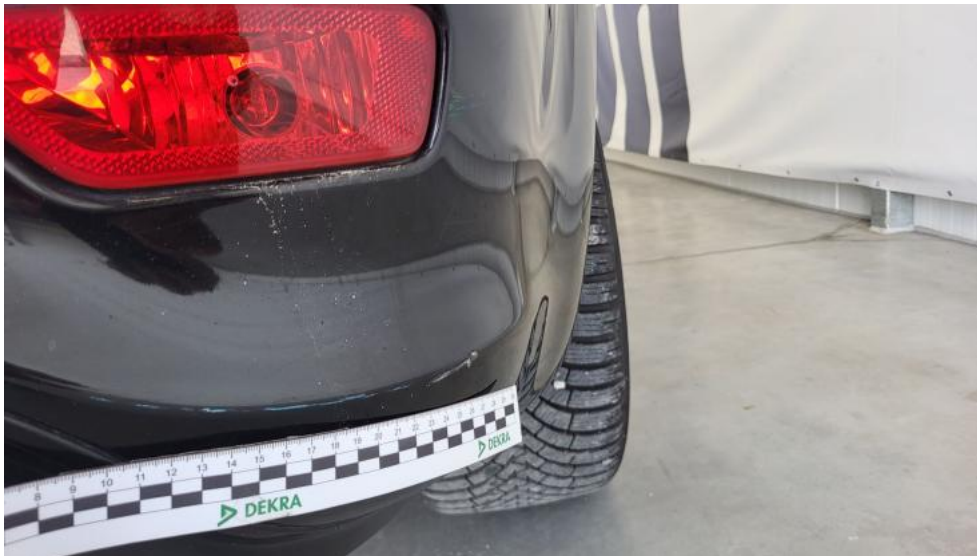
**Photo 59.**

Zderzak tylny - Rysa/odprysk 1

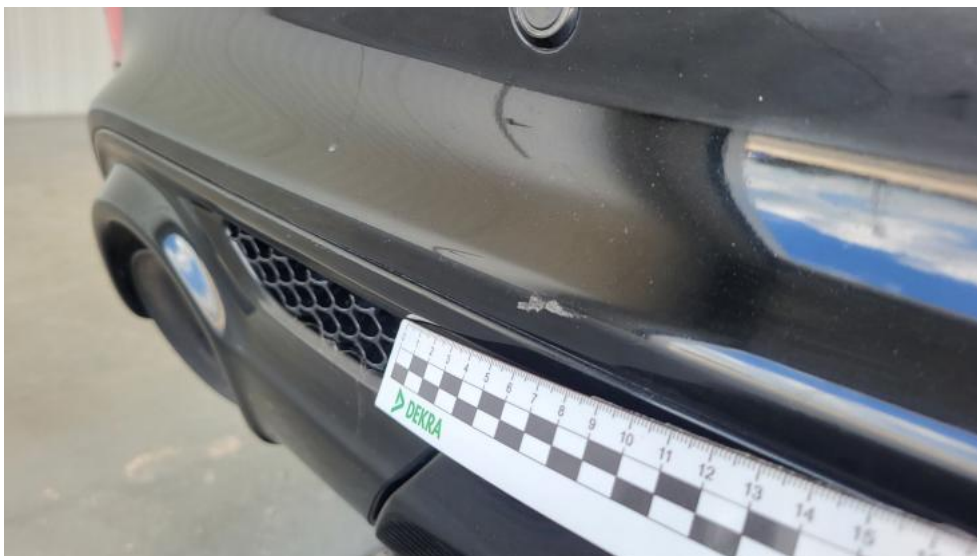
**Photo 60.**

Zderzak tylny - Rysa/odprysk 2

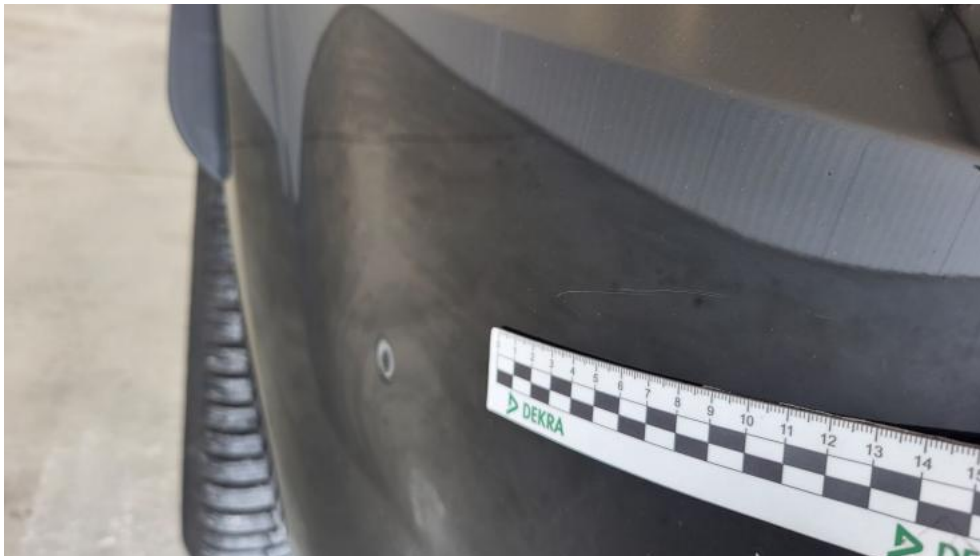
**Photo 61.**

Zderzak tylny() - Rysa/odprysk 3

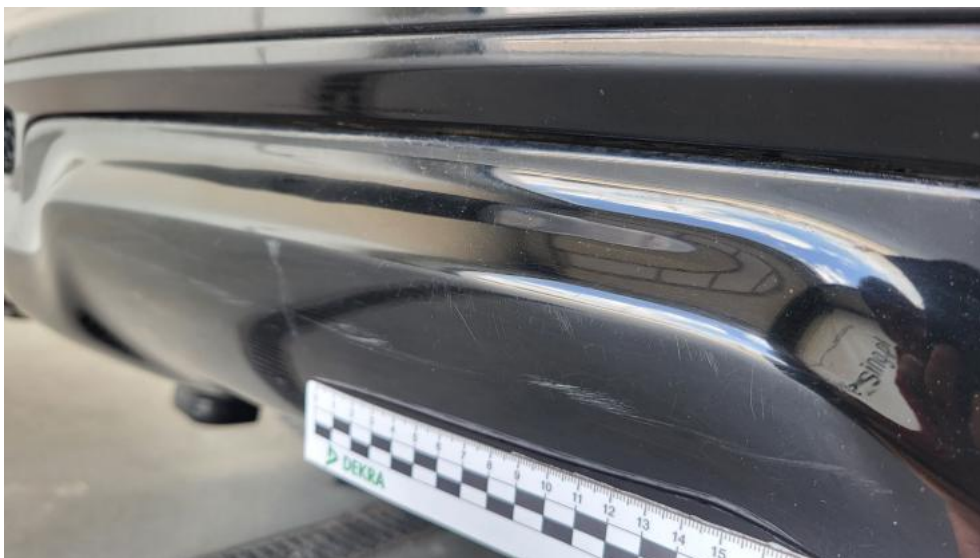
**Photo 62.**

Zderzak tylny cz dolna - Rysa/odprysk 1

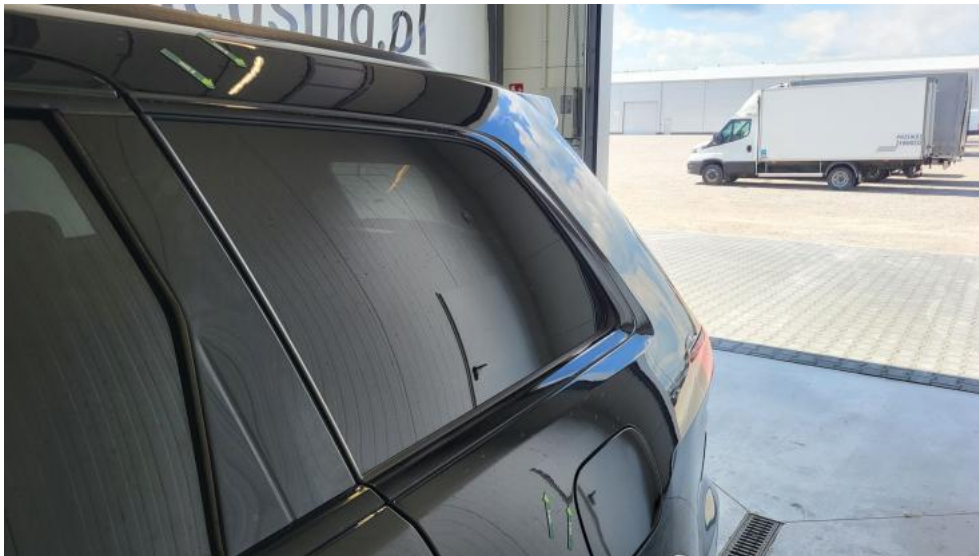
**Photo 63.**

Błotnik tylny L / Ściana boczna L - Wgniecenie/odkształcenie 1

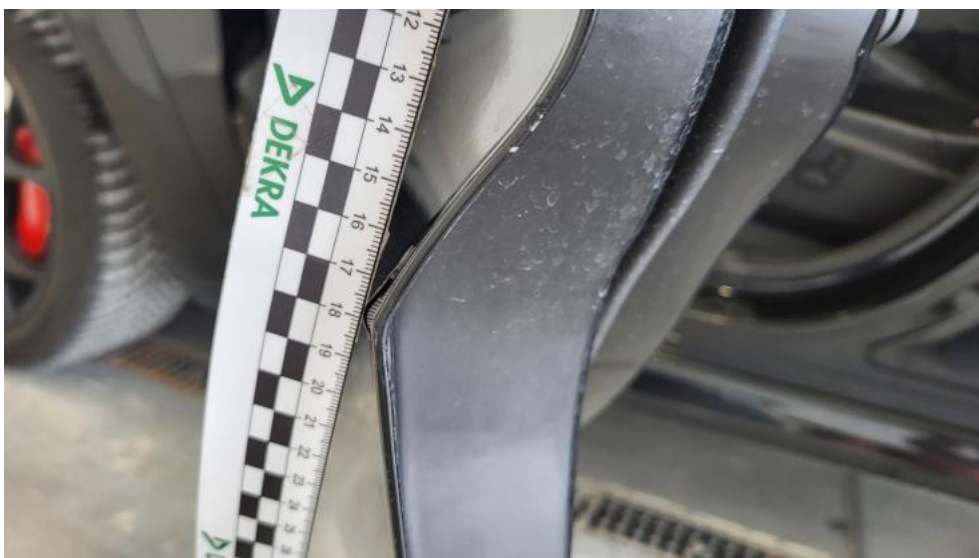
**Photo 64.**

Drzwi przed L - Rysa/odprysk 1

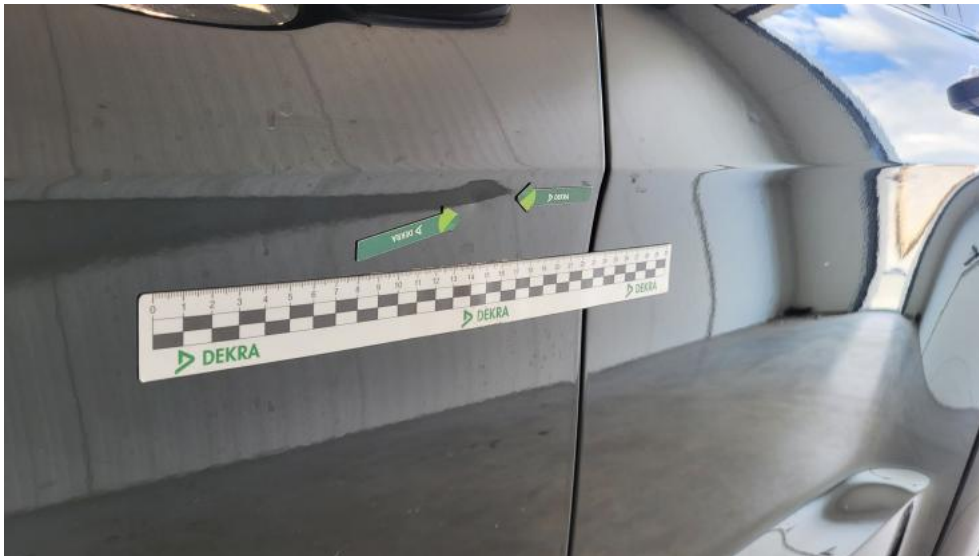
**Photo 65.**

Drzwi przed L - Wgniecenie/odkształcenie 1

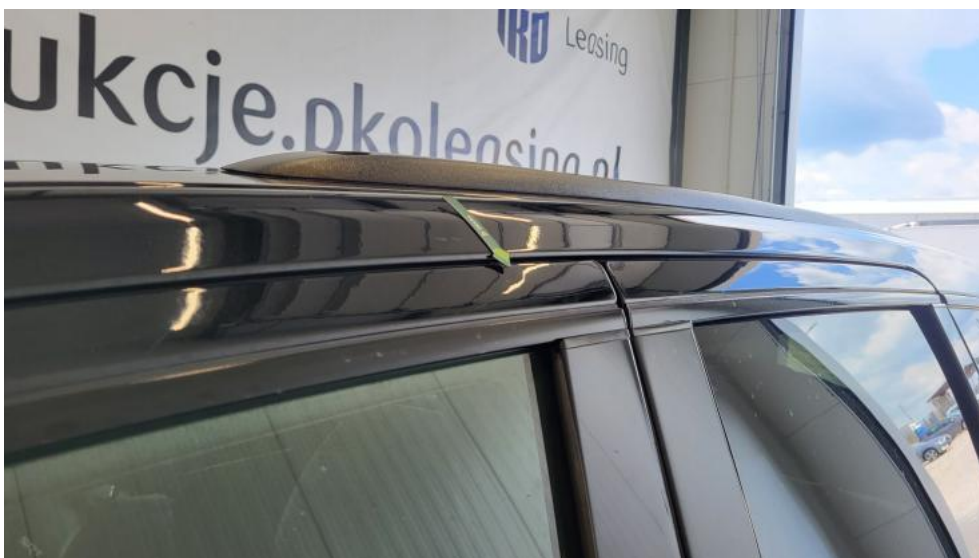
**Photo 66.**

Listwa drzwi przednich L - Wgniecenie/odkształcenie 1

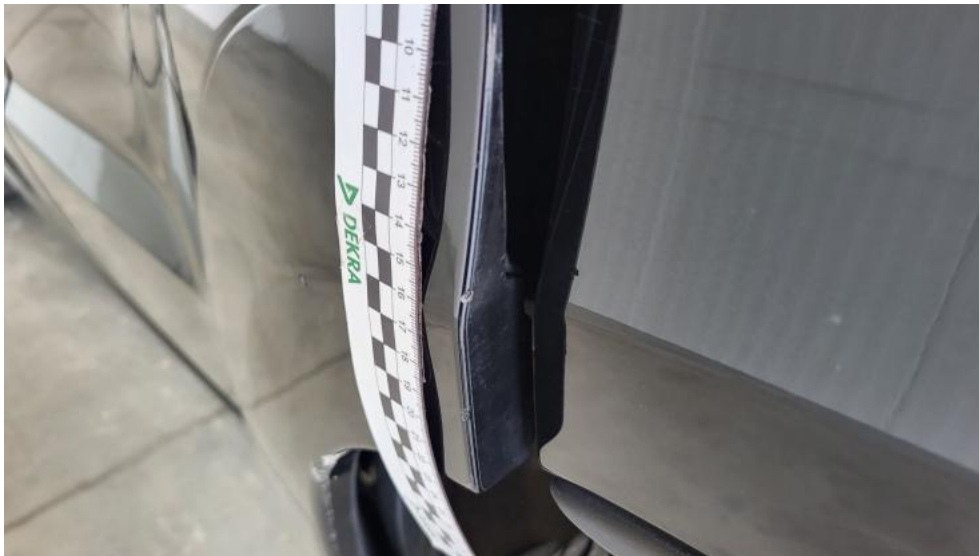
**Photo 67.**

Listwa drzwi tylnych L - Rysa/odprysk 1

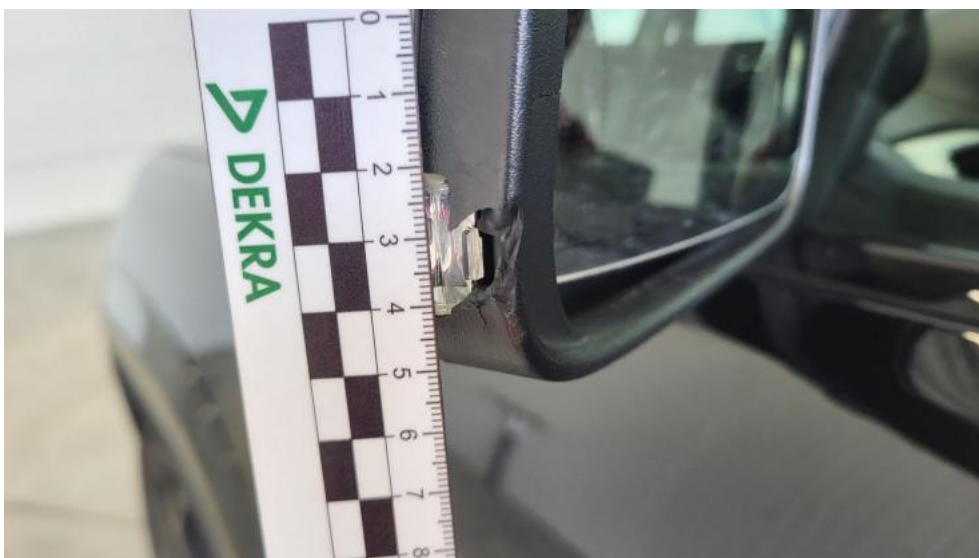
**Photo 68.**

Lusterko zew L - Pęknięcie/rozerwanie 1

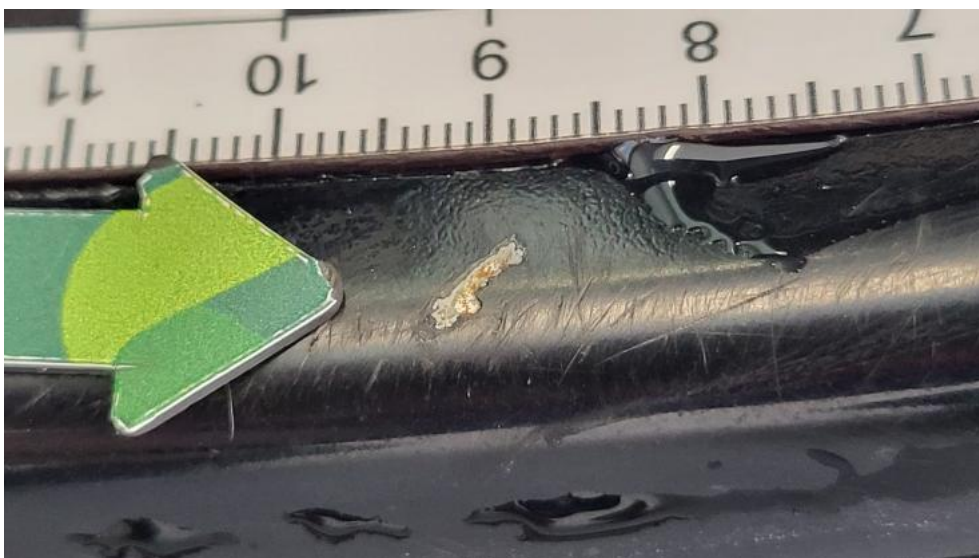
**Photo 70.**

Próg L - Inne 1

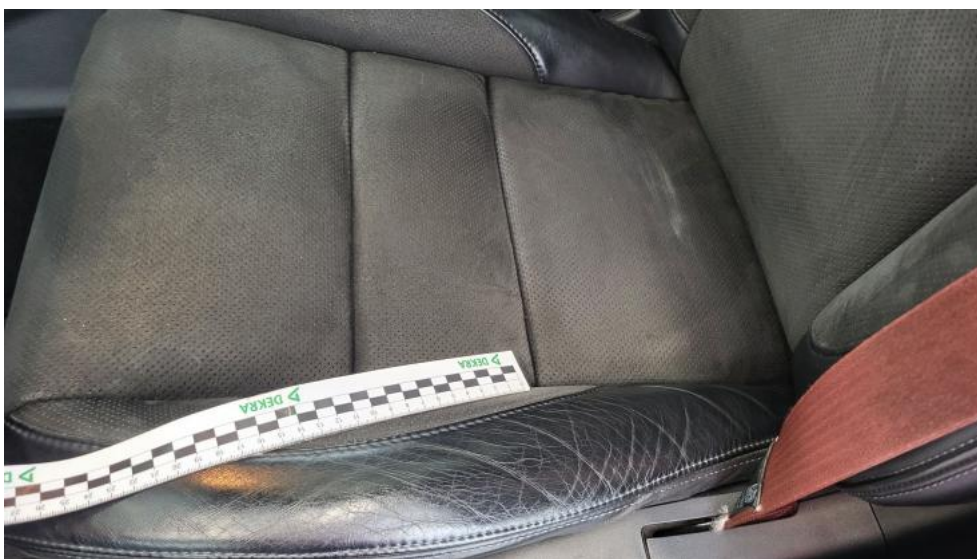
**Photo 73.**

Fotel prz. lew. - Inne 1

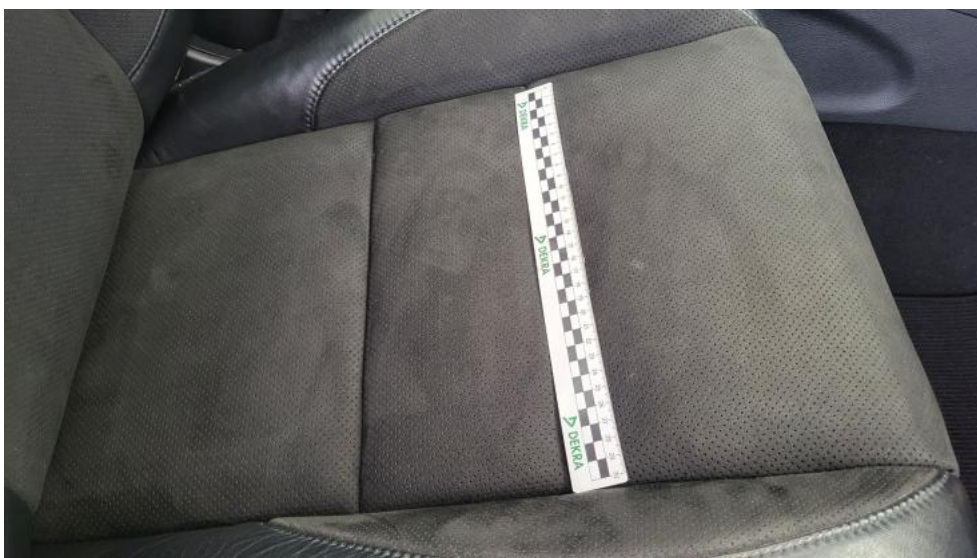
**Photo 74.**

Fotel prz. praw. - Inne 1
