DEKRA's commission No. : PKOL(W)/LODZ/19273/25/03/17  
commission/ damage No. : FUTURA  
Date of commission: 17-03-2025

| Manufacturer | MERCEDES-BENZ |
| Type / version | GLS 350 d 4-Matic |
| Registration /record No. | WD3069M |

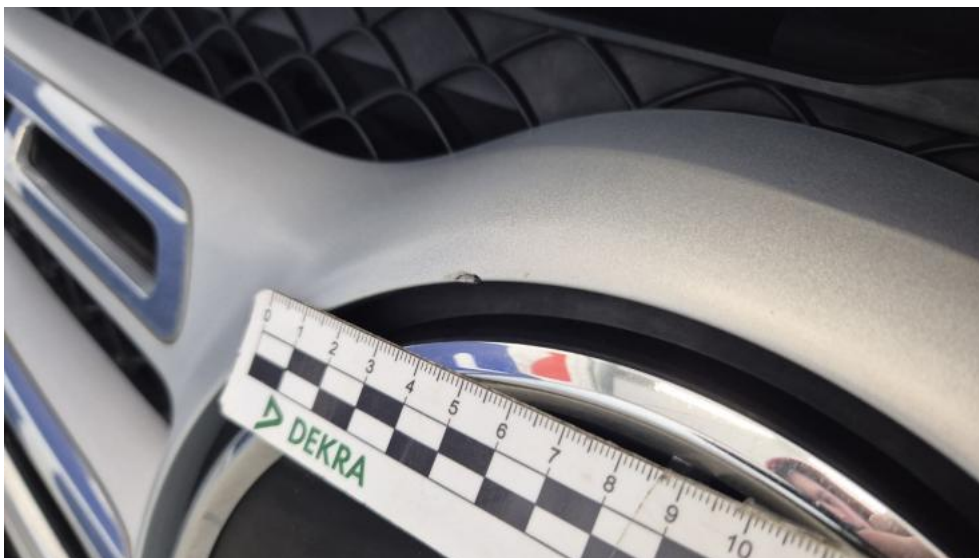
**Photo 40.**

Atrapa przednia - Rysa/odprysk 1

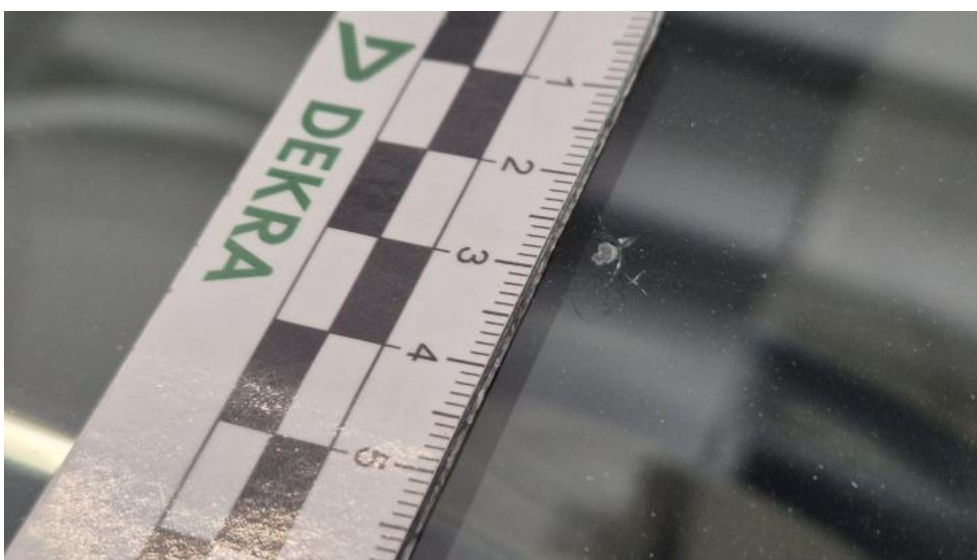
**Photo 44.**

Szyba czołowa - Pęknięcie/rozerwanie 1

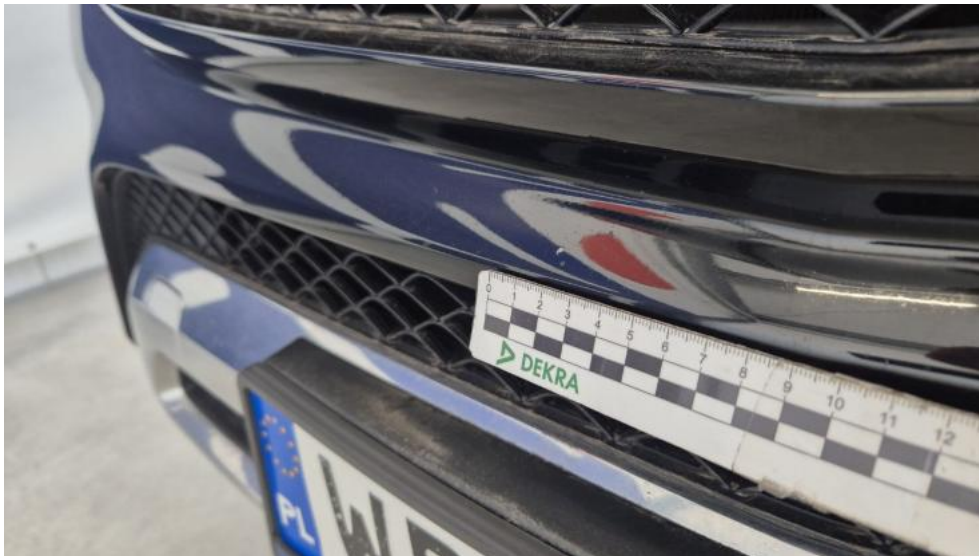
**Photo 45.**

Zderzak - Rysa/odprysk 1

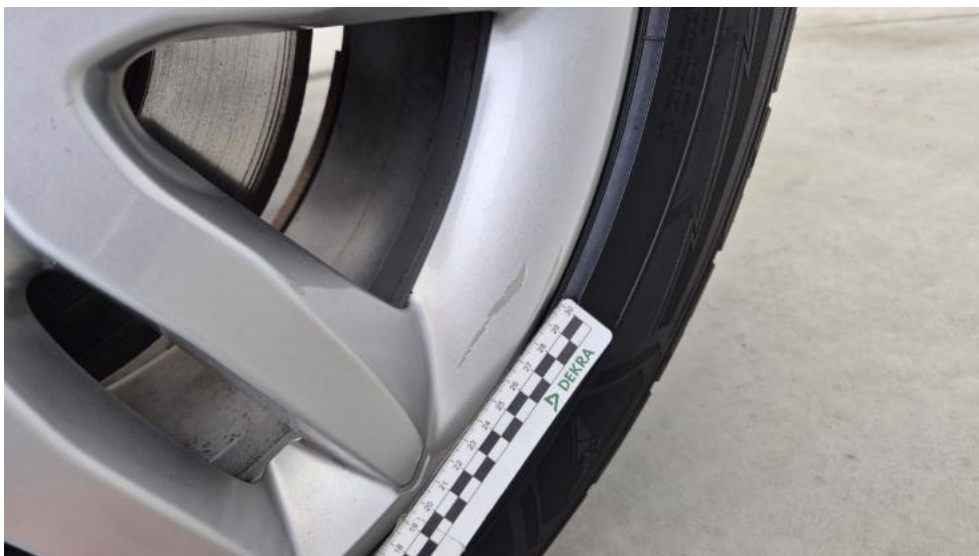
**Photo 46.**

Felga aluminiowa przednia P - Rysa/odprysk 1

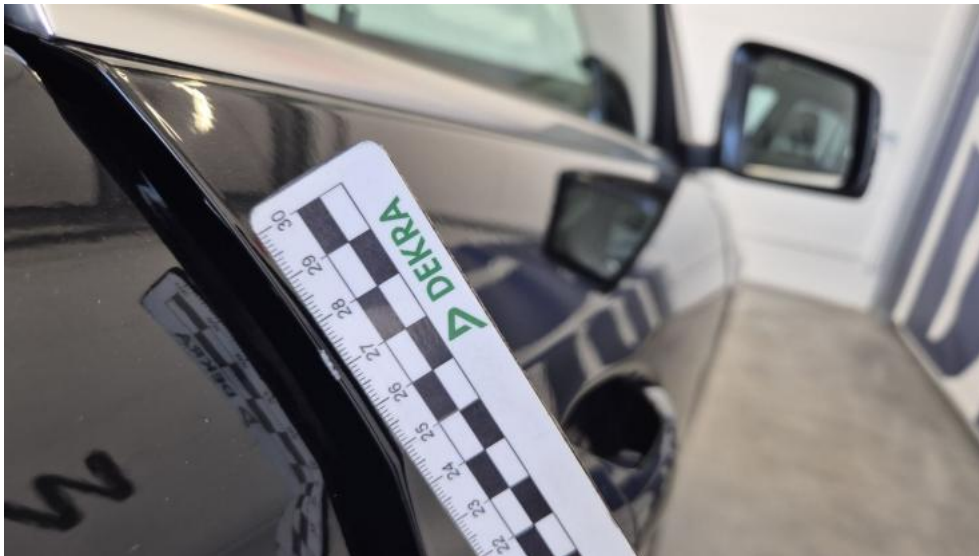
**Photo 47.**

Drzwi przednie P - Rysa/odprysk 1

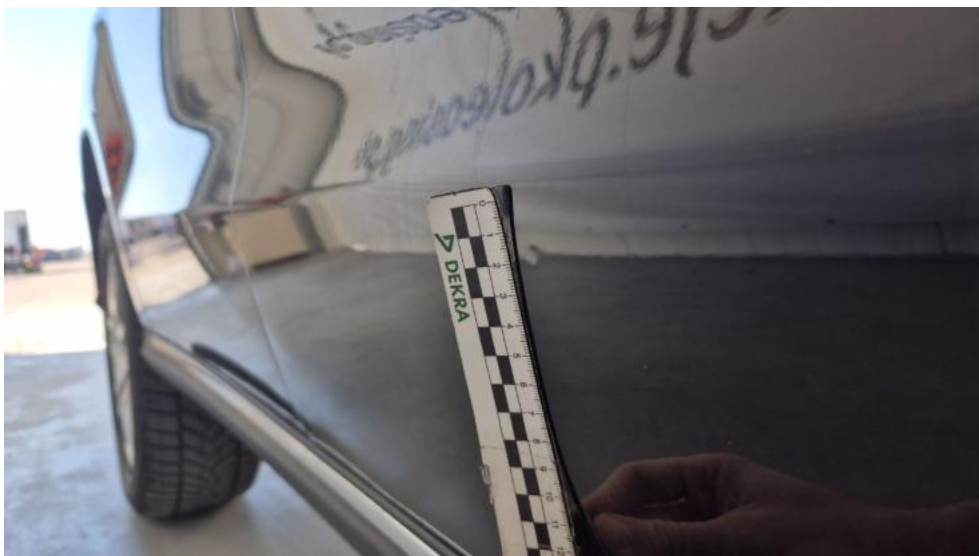
**Photo 48.**

Drzwi przednie P - Wgniecenie/odkształcenie 1

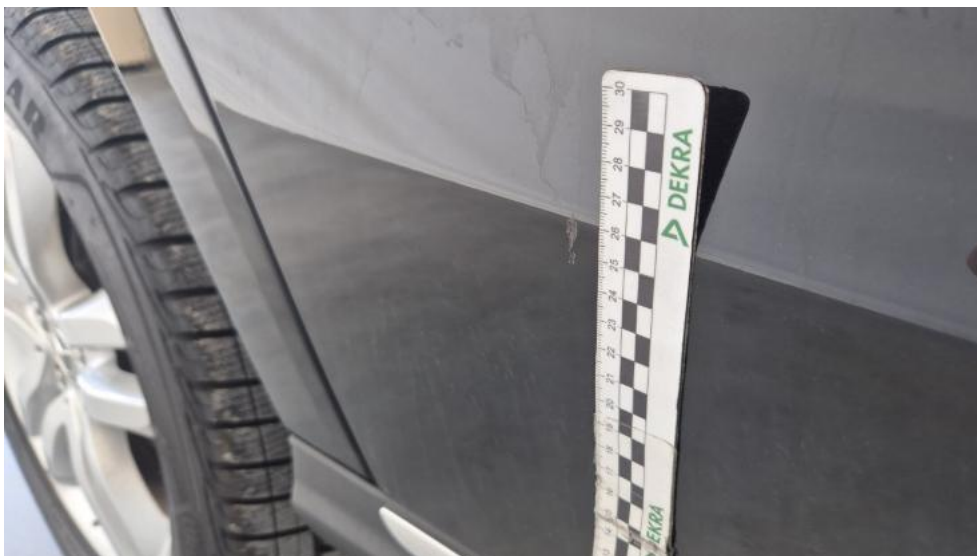
**Photo 50.**

Drzwi tylne P - Rysa/odprysk 1

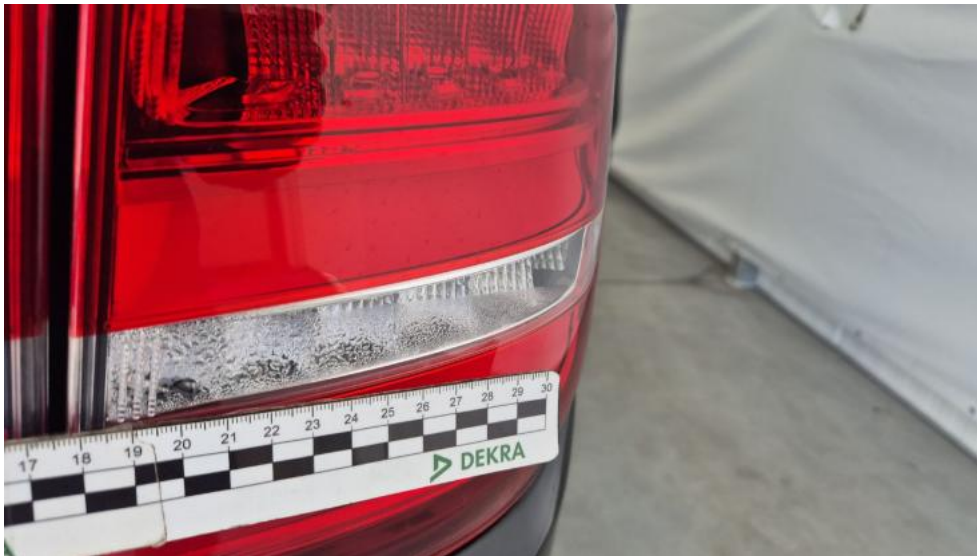
**Photo 53.**

Lampa tylna zew P - Inne 1

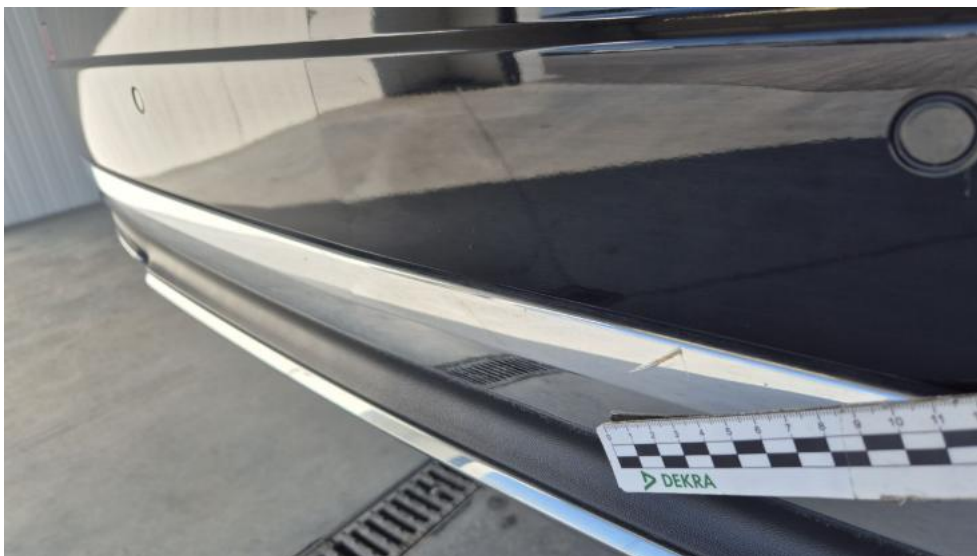
**Photo 54.**

Listwa śr zderzaka tylnego - Rysa/odprysk 1

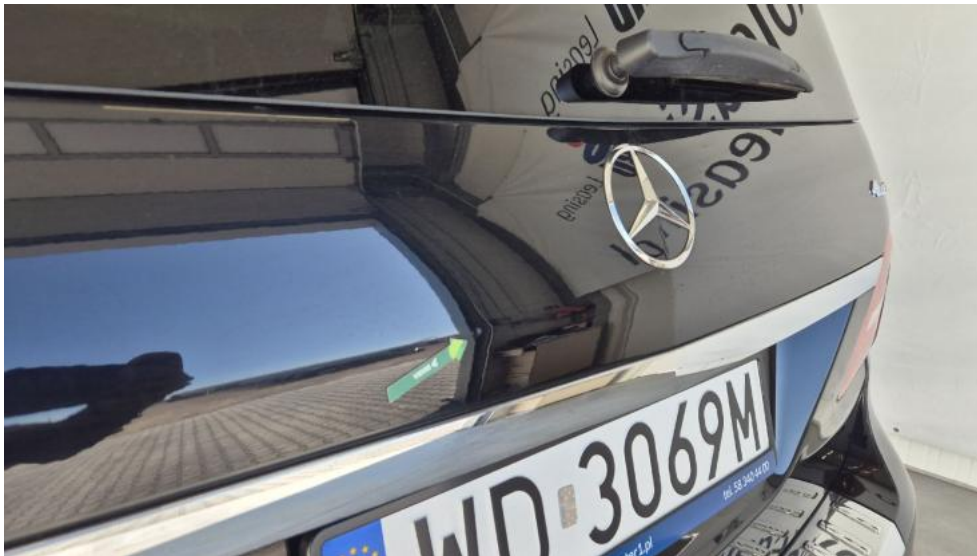
**Photo 55.**

Pokrywy bagażnika - Wgniecenie/odkształcenie 1

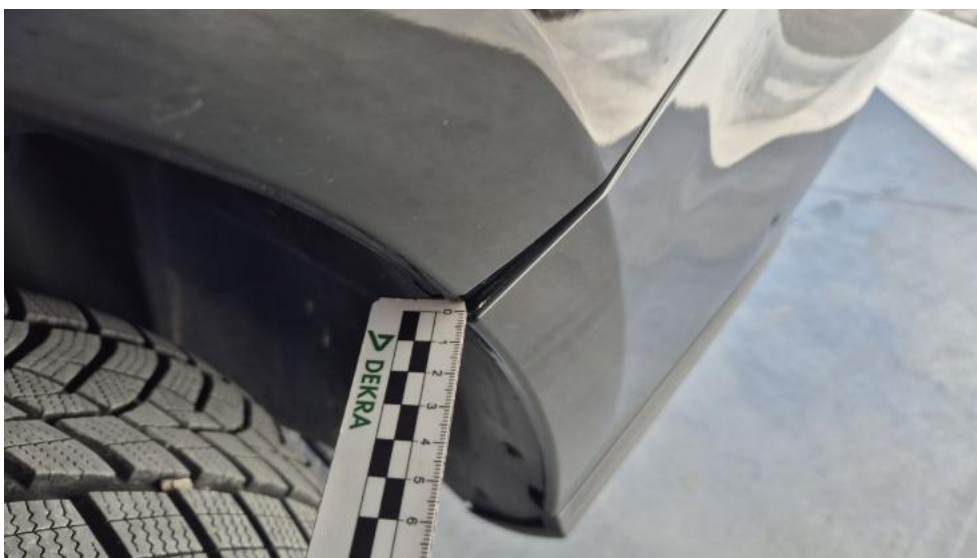
**Photo 56.**

Zderzak tylny - Inne 1

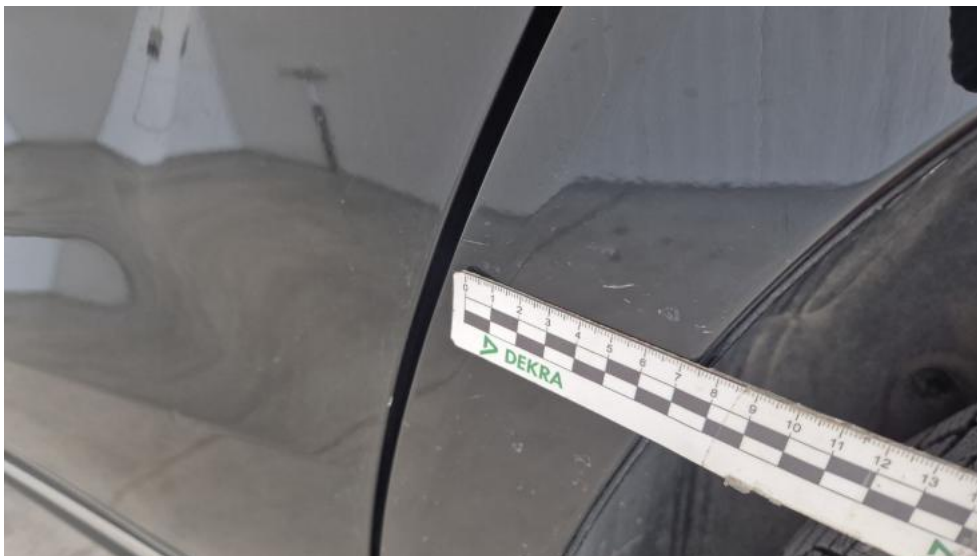
**Photo 57.**

Błotnik tylny L / Ściana boczna L - Rysa/odprysk 1

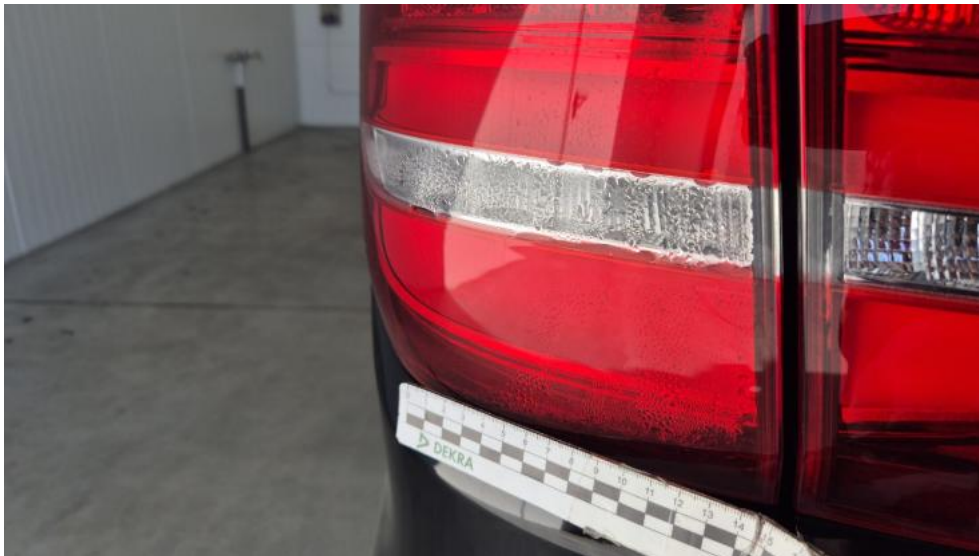
**Photo 59.**

Lampa tylna zew L - Inne 1

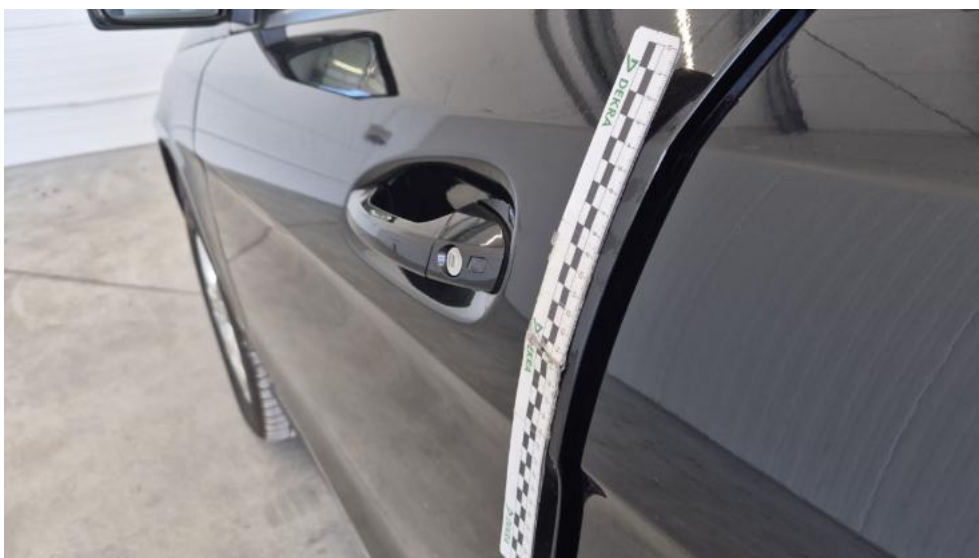
**Photo 60.**

Drzwi przed L - Rysa/odprysk 1

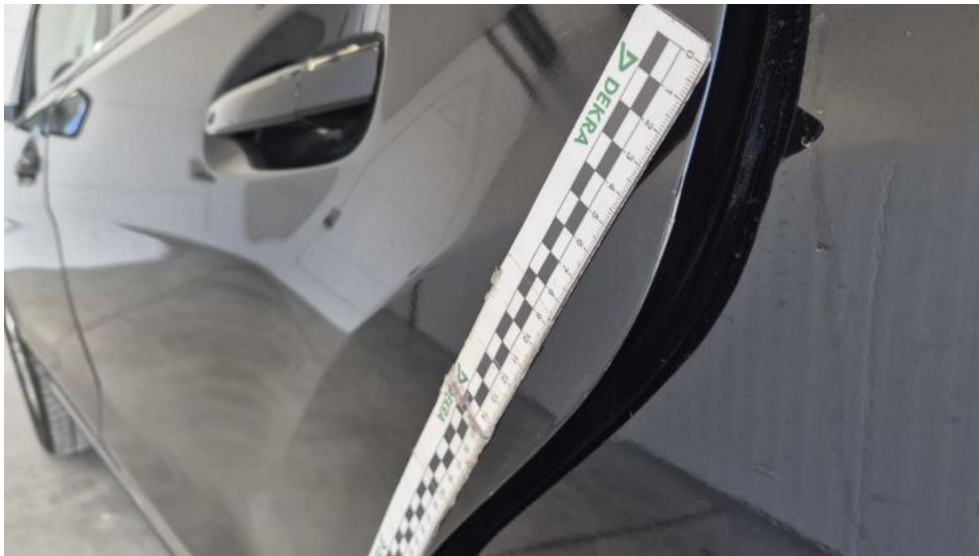
**Photo 61.**

Drzwi tylne L - Rysa/odprysk 1

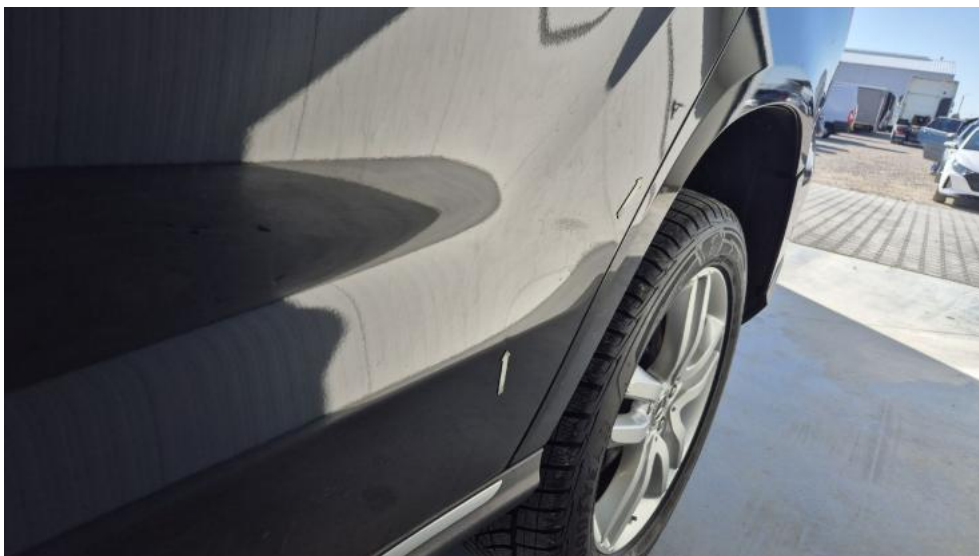
**Photo 62.**

Drzwi tylne L - Wgniecenie/odkształcenie 1

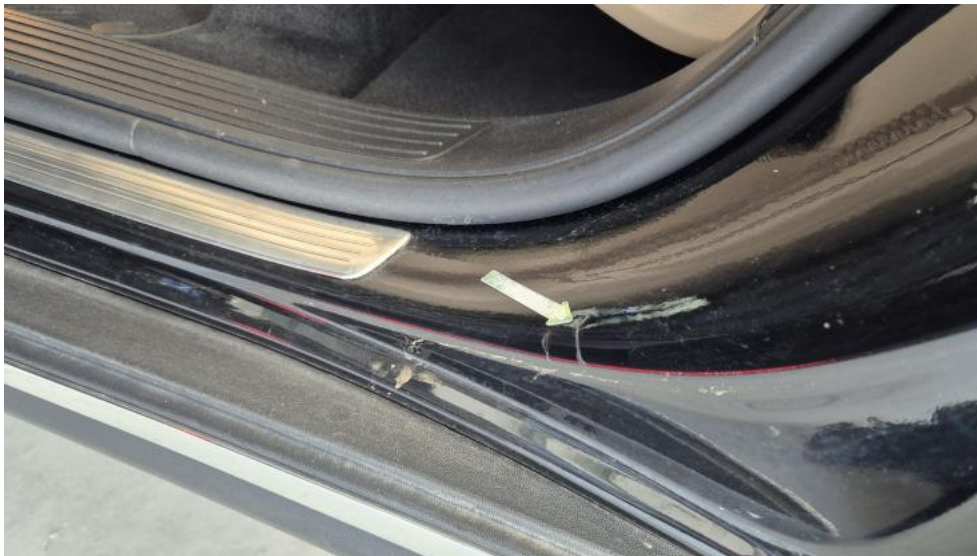
**Photo 63.**

Próg L - Wgniecenie/odkształcenie 1

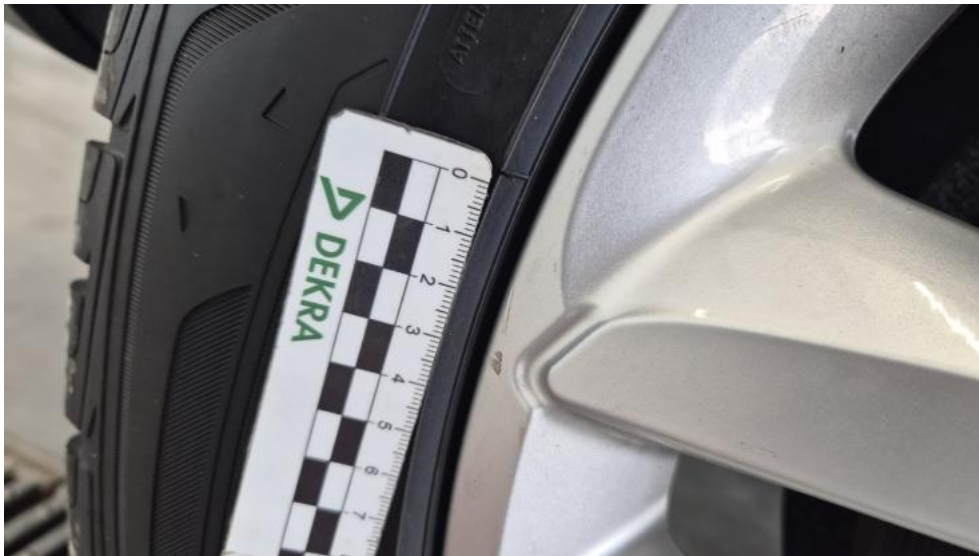
**Photo 65.**

Felga Aluminiowa przednia L - Rysa/odprysk 1

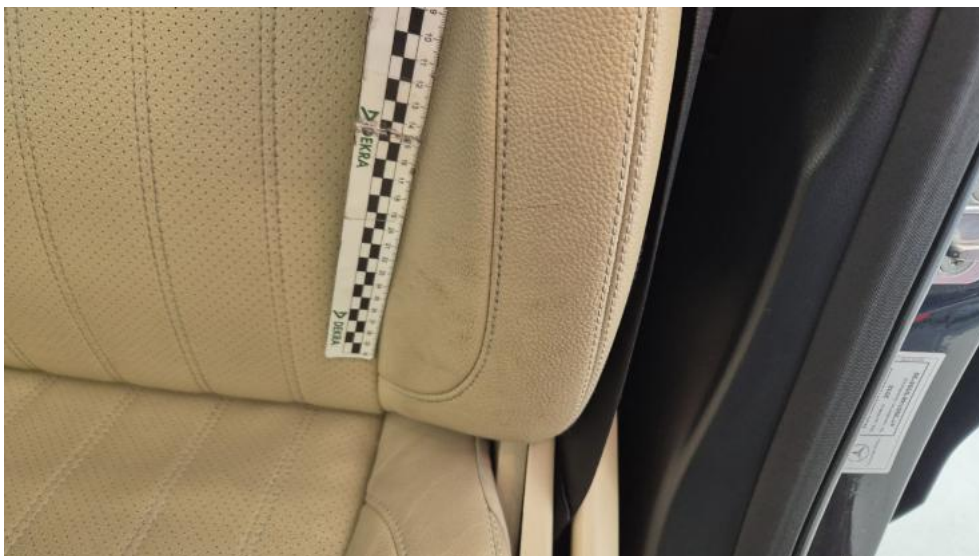
**Photo 66.**

Fotel prz. lew. - Inne 1

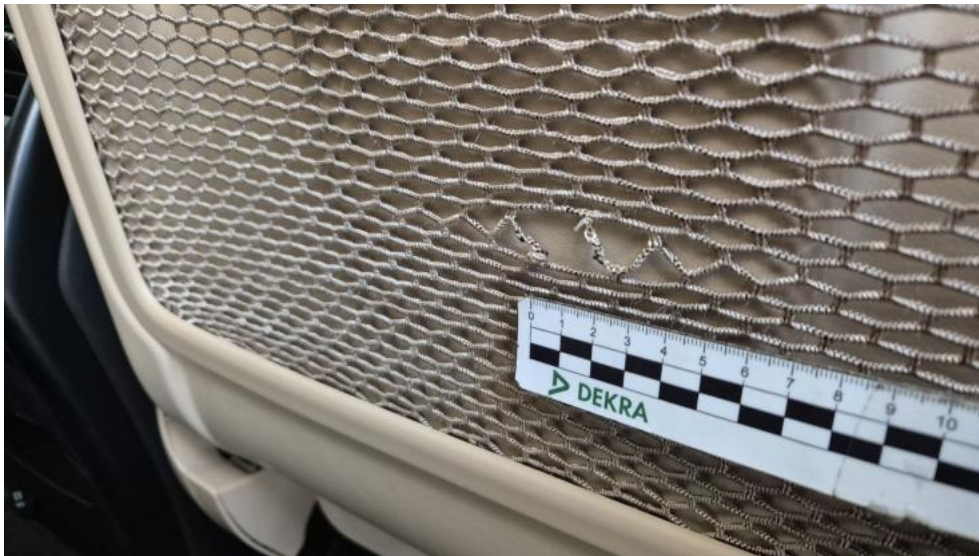
**Photo 67.**

Fotel prz. praw. - Pęknięcie/rozerwanie 1

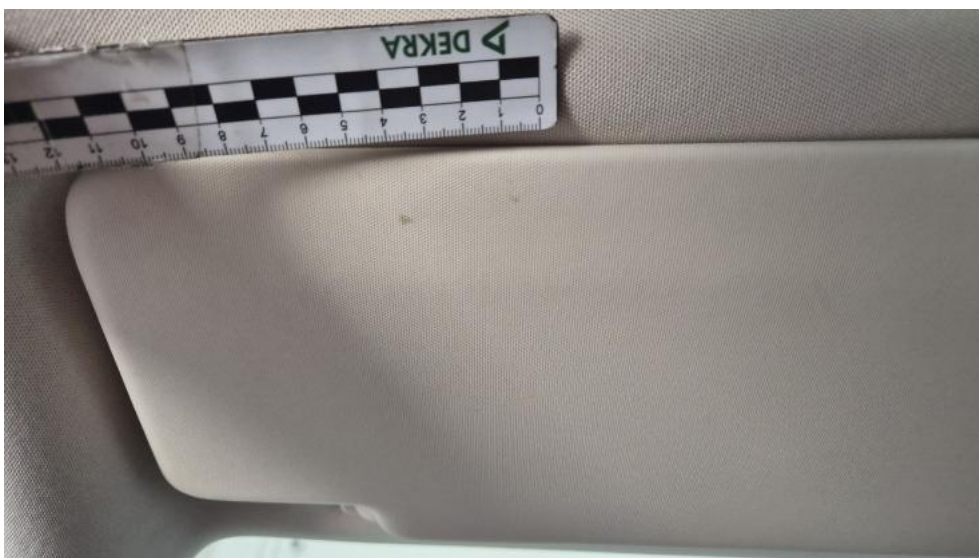
**Photo 68.**

Osłona p/słoneczna lewa - Inne 1
