DEKRA's commission No. : PKOL(W)/LODZ/67179/25/09/09  
commission/ damage No. : 23/003740  
Date of commission: 09-09-2025

**DEKRA Poland - Headquarters**  
02-673 Warszawa, ul. Konstruktorska 12A

| Manufacturer | AUDI |
| Type / version | Q7 55 TFSI mHEV Quattro Tiptr. |

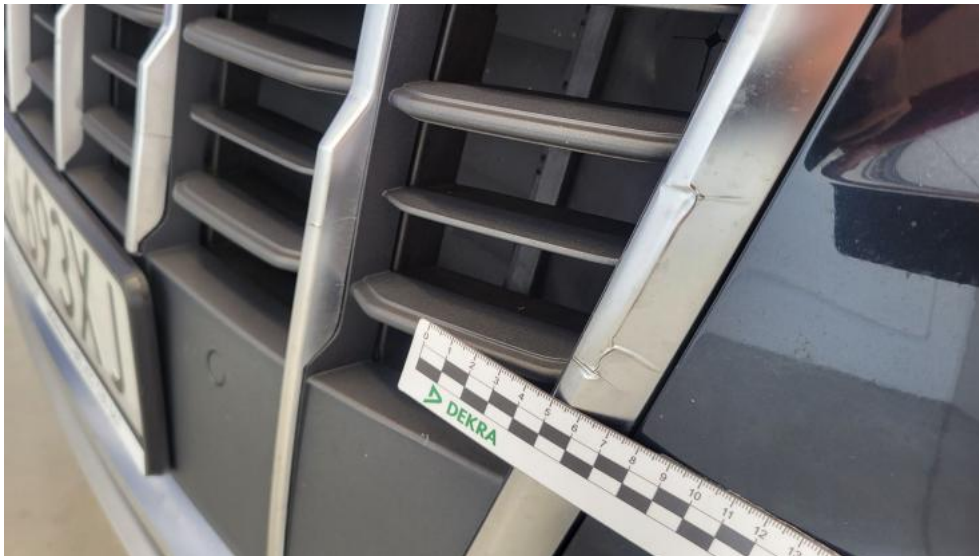
**Photo 39.**

Listwa śr zderzaka przedniego - Pęknięcie/rozerwanie 1

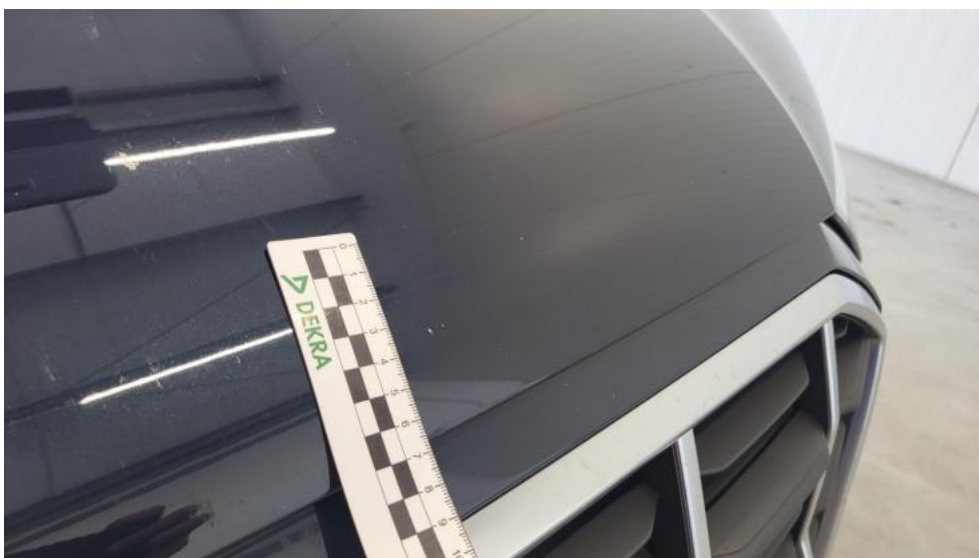
**Photo 40.**

Pokrywa komory silnika - Rysa/odprysk 1

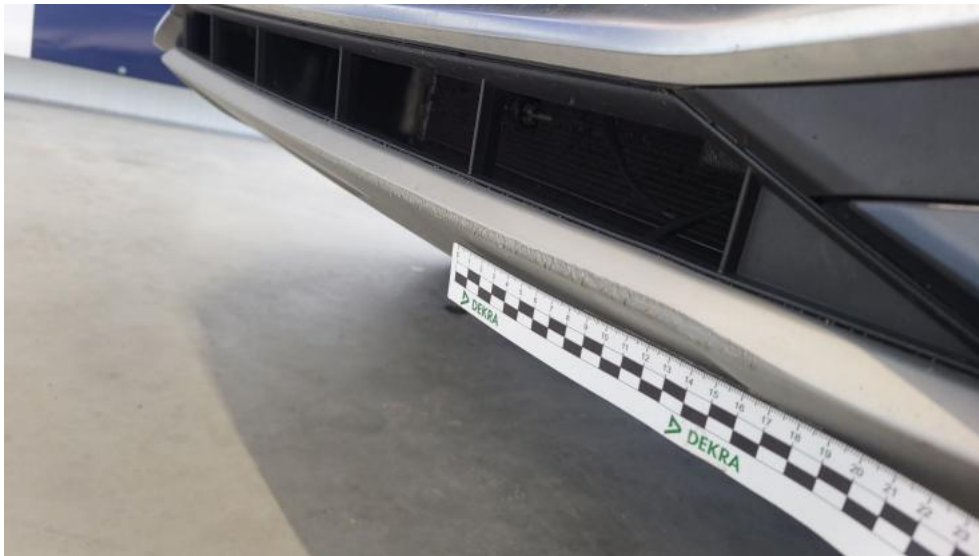
**Photo 41.**

Spoiler zderzaka przedniego - Rysa/odprysk 1

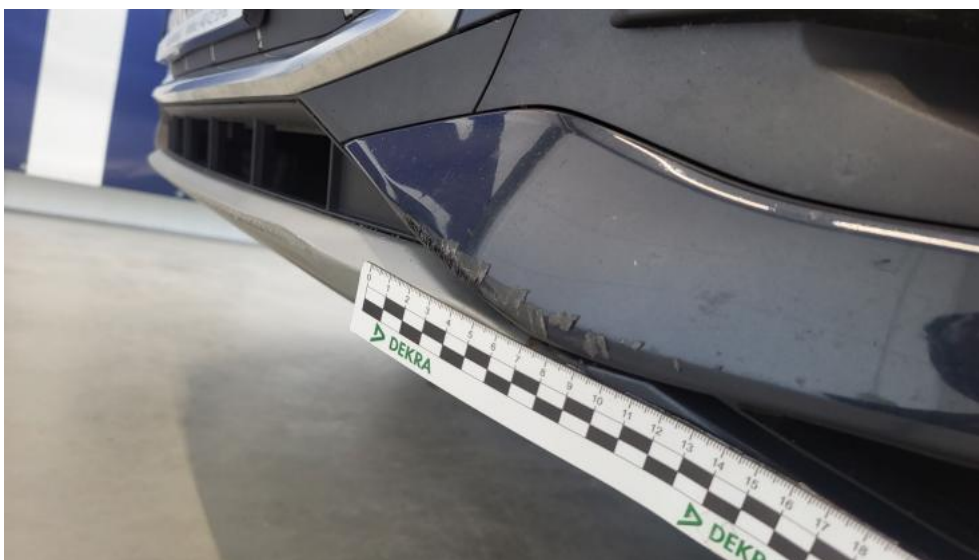
**Photo 42.**

Zderzak - Rysa/odprysk 1

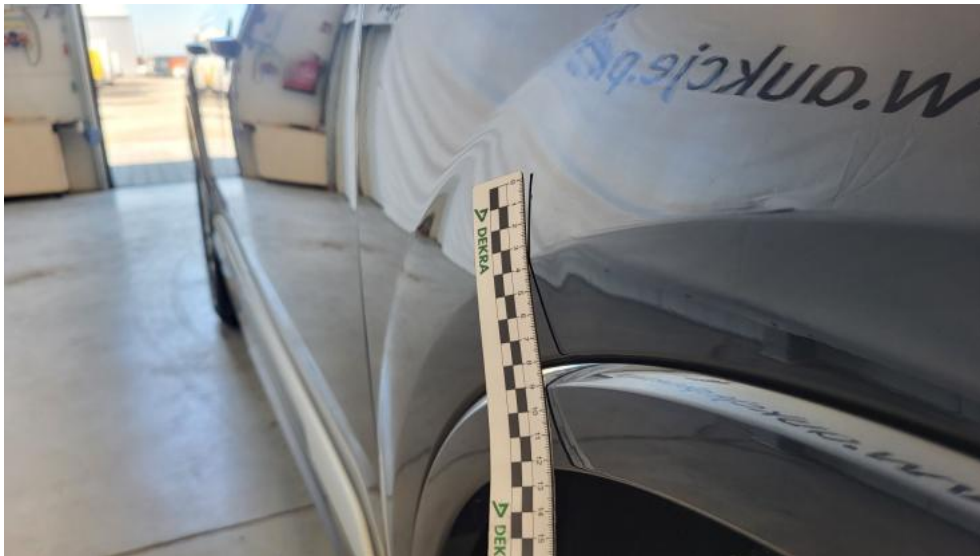
**Photo 43.**

Błotnik przedni P - Wgniecenie/odkształcenie 1

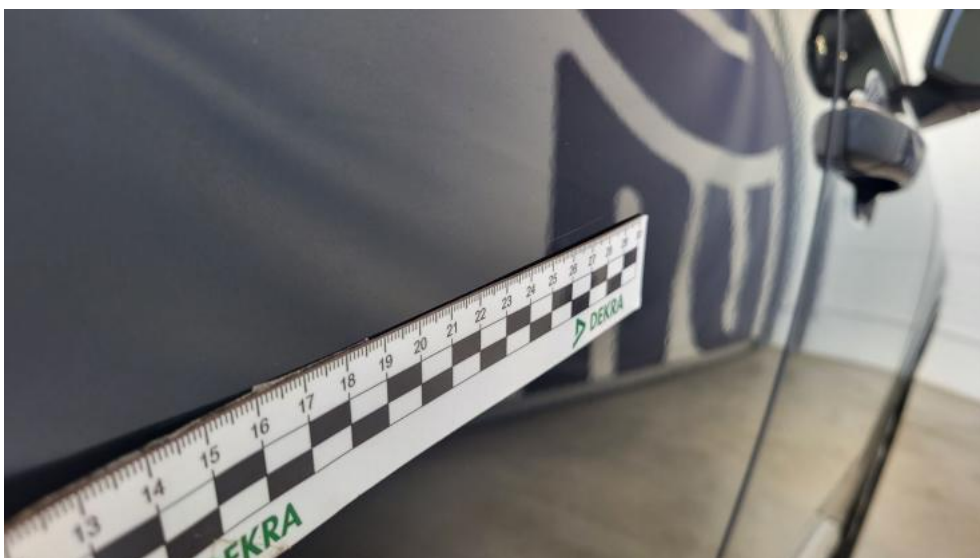
**Photo 44.**

Drzwi tylne P - Rysa/odprysk 1

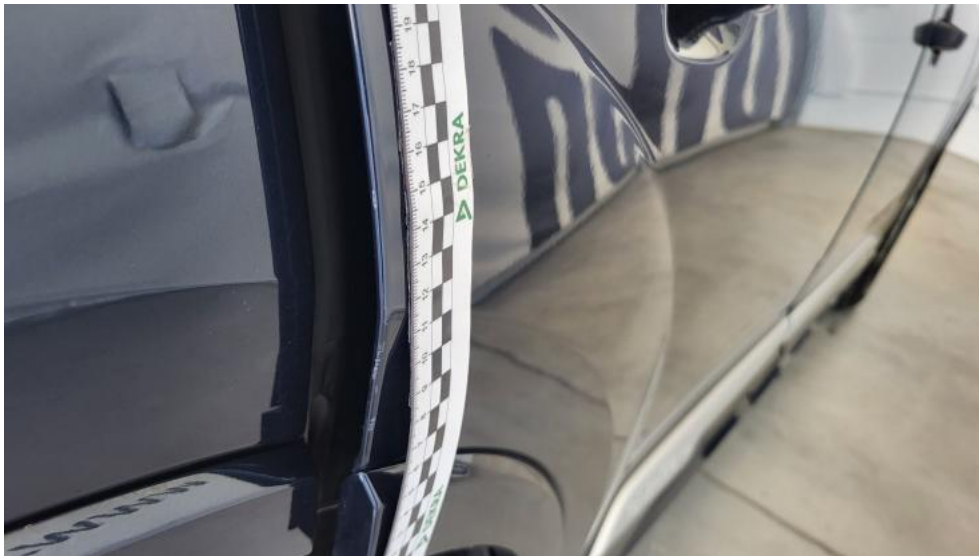
**Photo 45.**

Drzwi tylne P - Rysa/odprysk 2

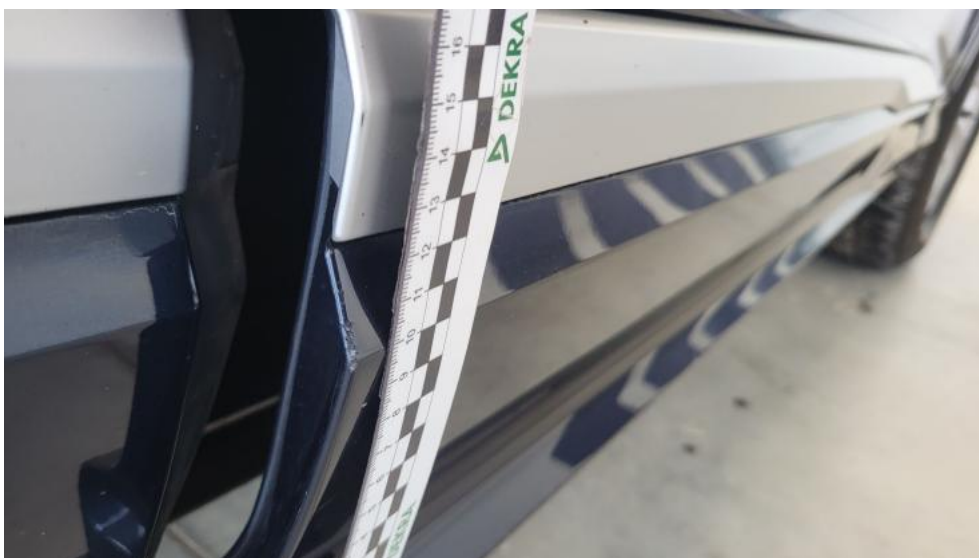
**Photo 46.**

Listwa drzwi przednich P - Rysa/odprysk 1

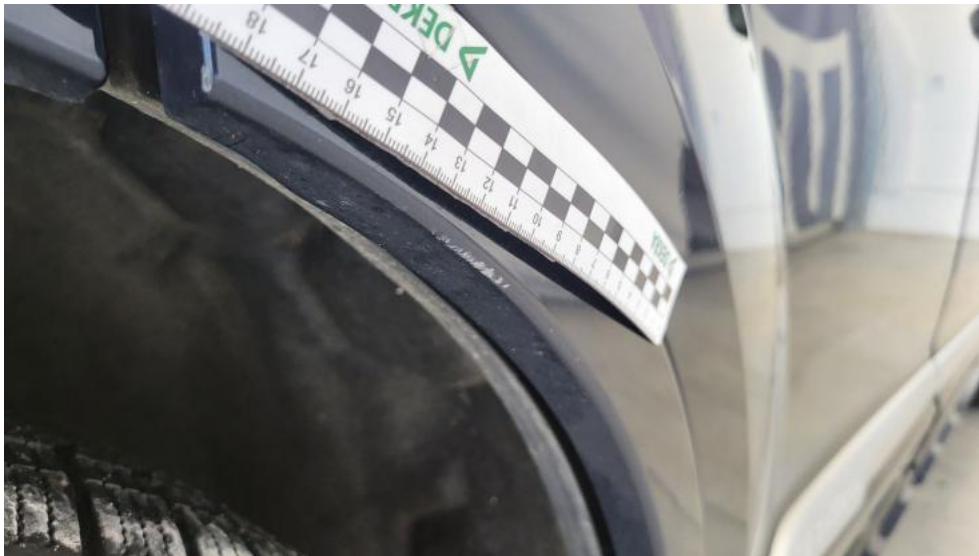
**Photo 47.**

Listwa drzwi tylnych P - Rysa/odprysk 1

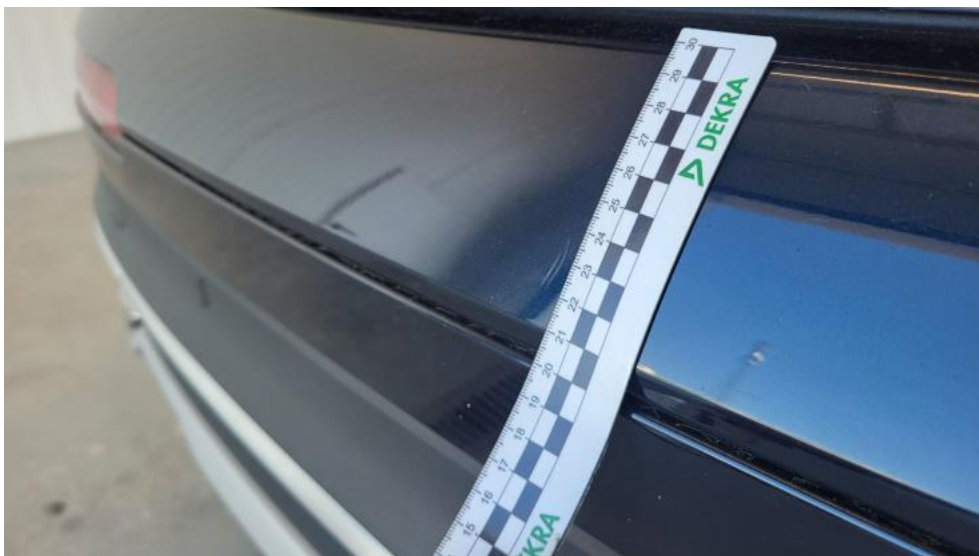
**Photo 48.**

Zderzak tylny - Rysa/odprysk 1

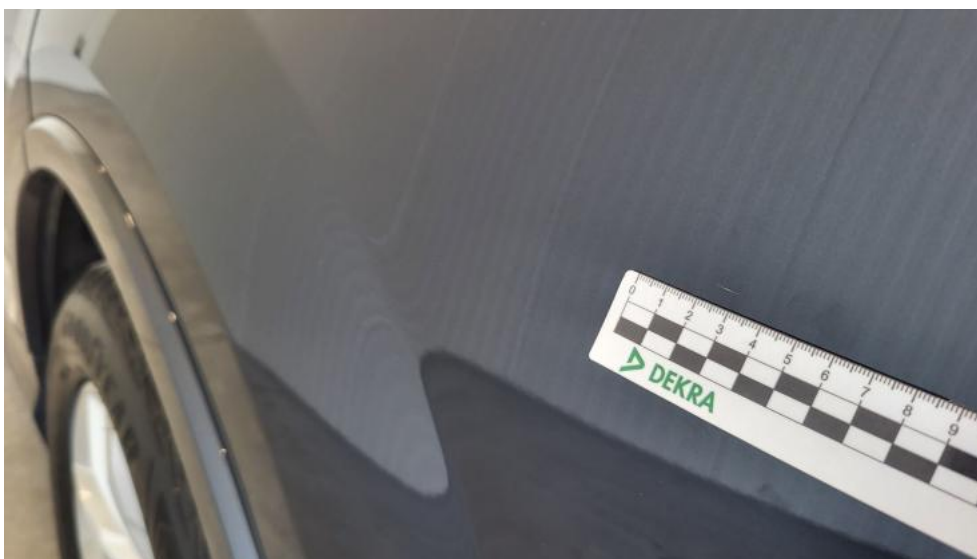
**Photo 49.**

Błotnik tylny L / Ściana boczna L - Rysa/odprysk 1

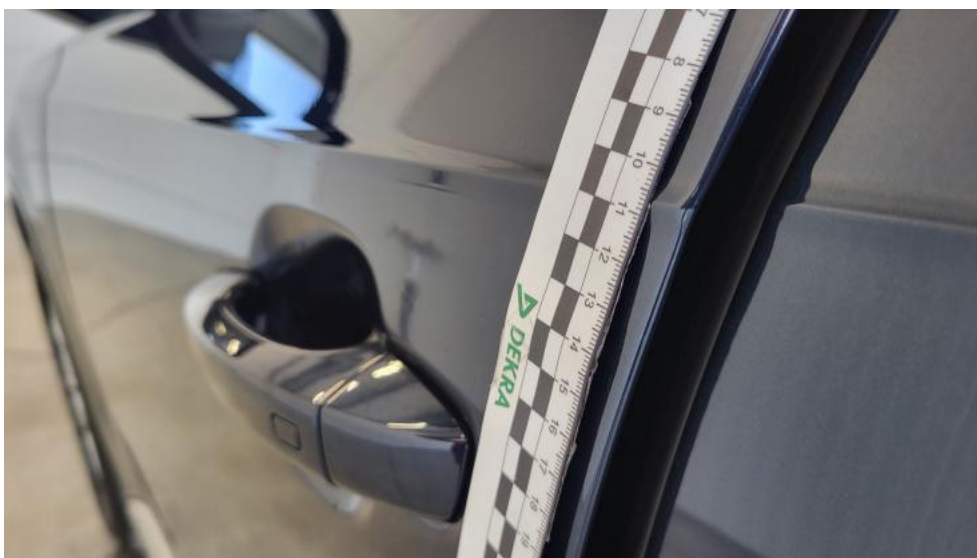
**Photo 50.**

Drzwi przed L - Rysa/odprysk 1

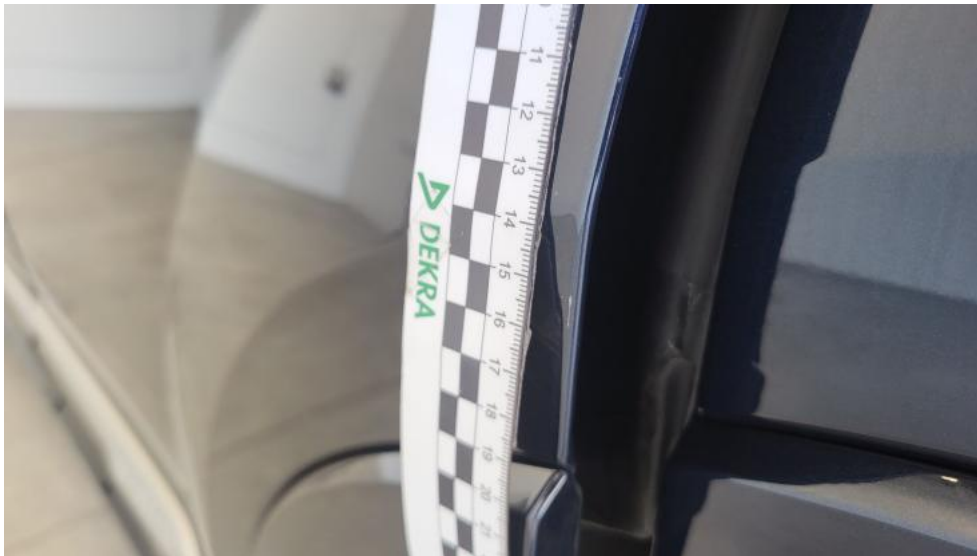
**Photo 51.**

Drzwi tylne L - Rysa/odprysk 1

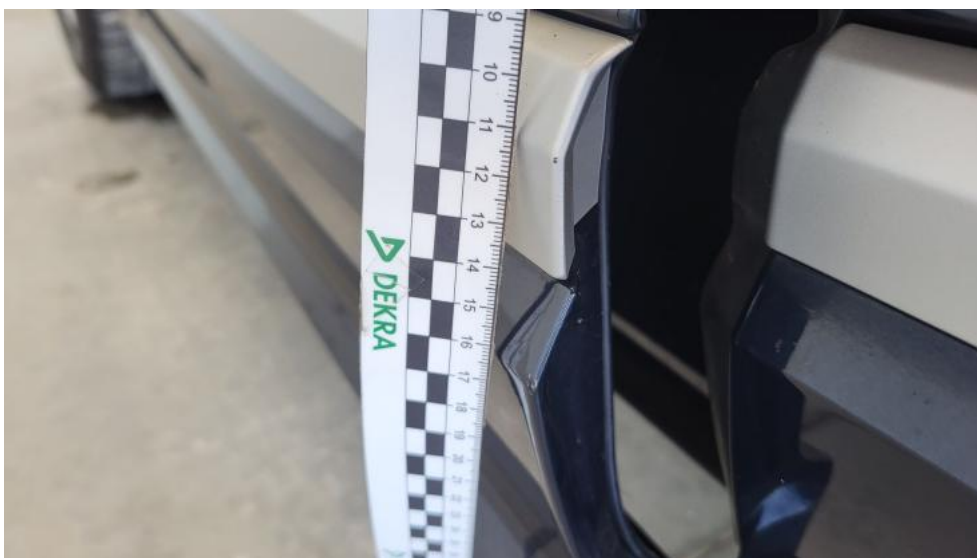
**Photo 52.**

Listwa drzwi przednich L - Rysa/odprysk 1

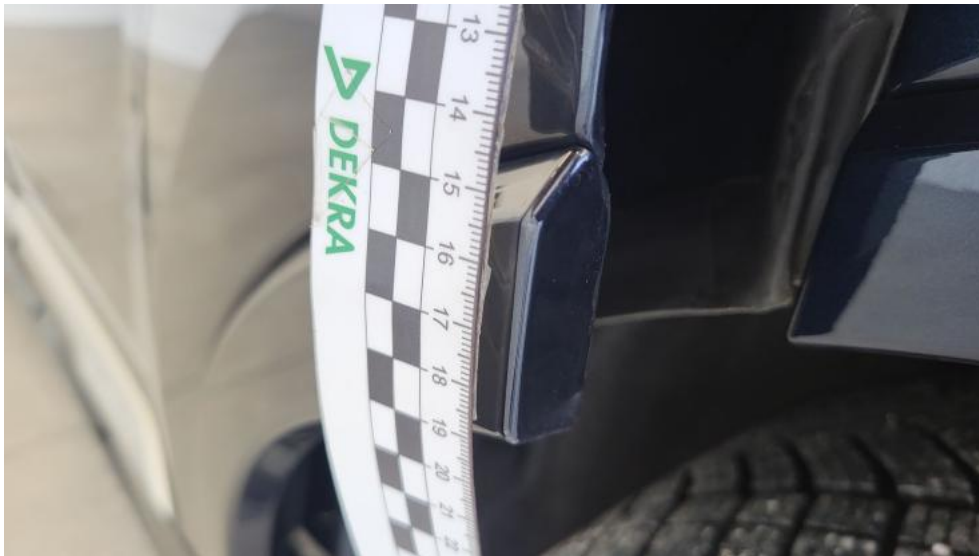
**Photo 53.**

Listwa drzwi tylnych L - Rysa/odprysk 1

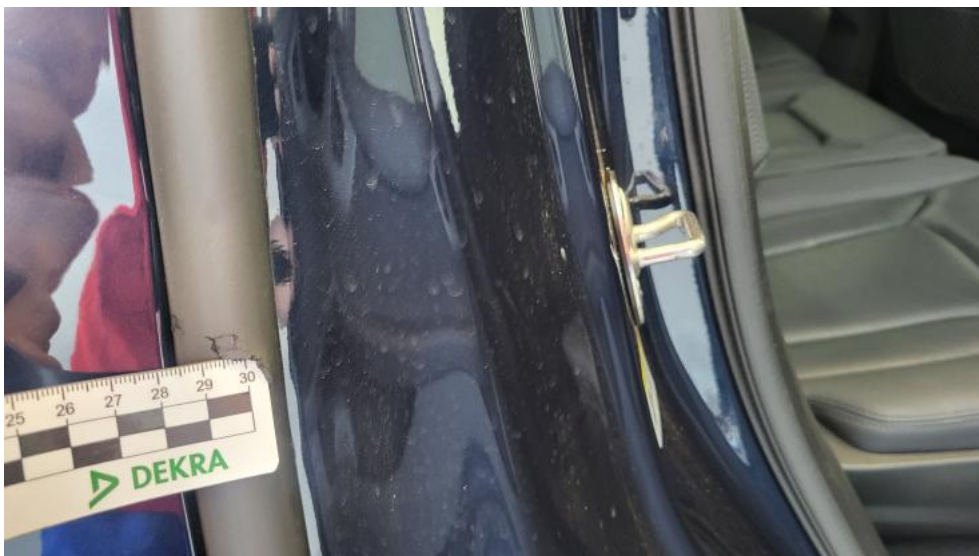
**Photo 54.**

Uszczelka drzwi tylnych P - Pęknięcie/rozerwanie 1
