DEKRA's commission No. : PKOL(W)/LODZ/61020/25/08/19  
commission/ damage No. : 24/056115  
Date of commission: 19-08-2025

**DEKRA Poland - Headquarters**  
02-673 Warszawa, ul. Konstruktorska 12A

| Manufacturer | CUPRA |
| Type / version | Formentor 2.0 TSI 4Drive VZ DSG |

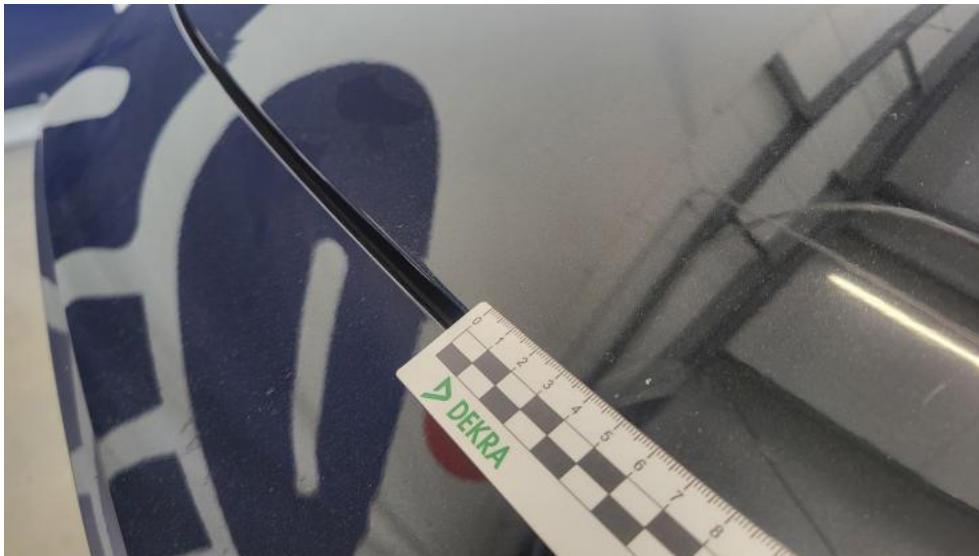
**Photo 37.**

Pokrywa komory silnika - Rysa/odprysk 1

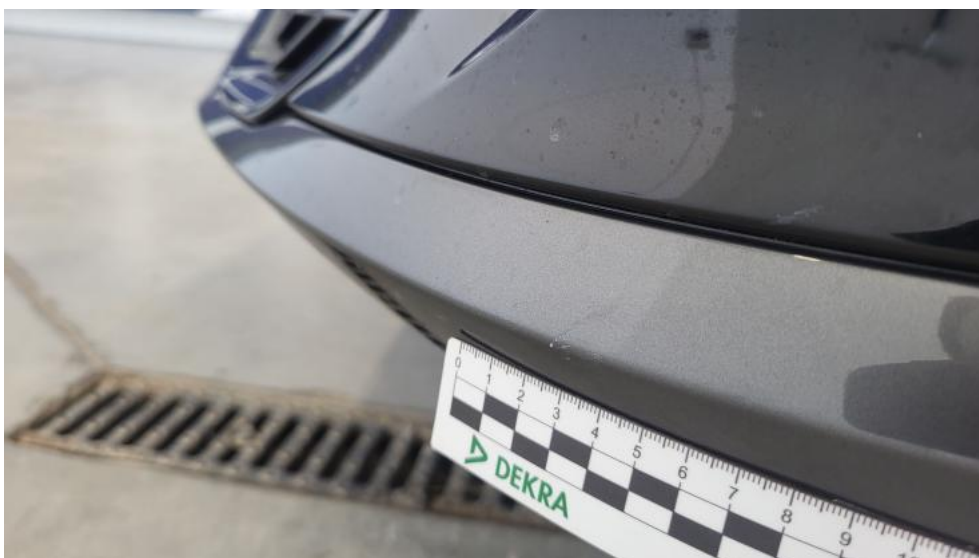
**Photo 38.**

Spoiler zderzaka przedniego - Rysa/odprysk 1

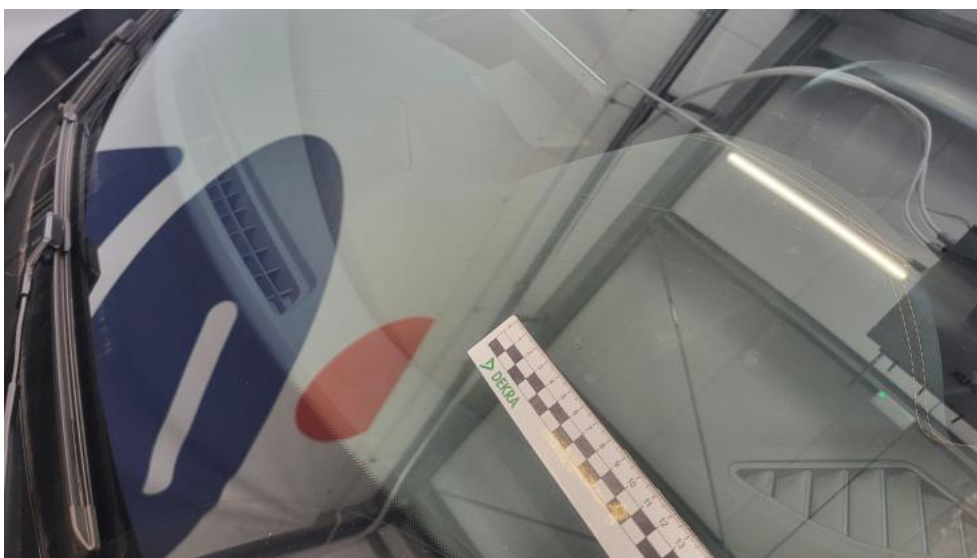
**Photo 40.**

Dostarczono ksero pozwolenia czasowego. Rysy na samochodzie. Odpryski na szybie czołowej.

Szyba czołowa - zdjęcie poglądowe 1

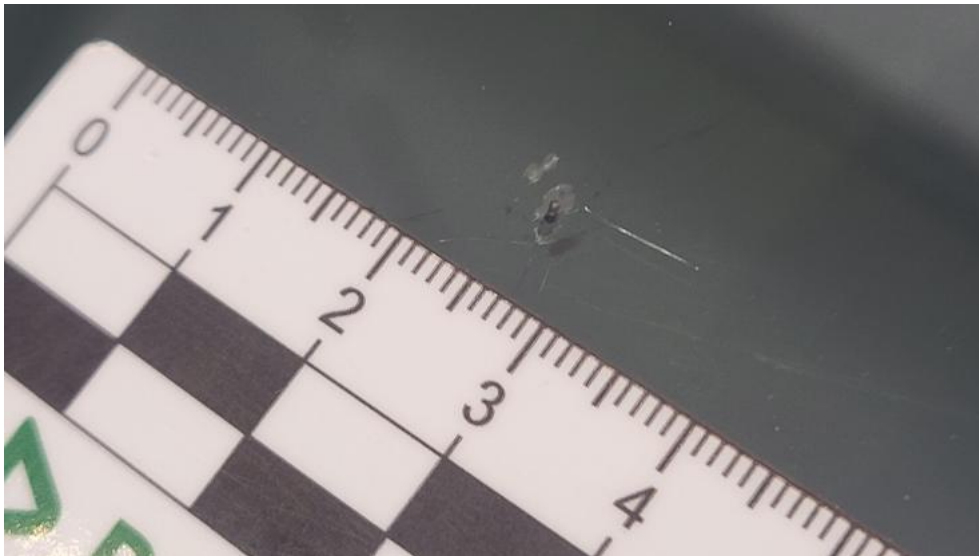
**Photo 41.**

Szyba czołowa - Pęknięcie/rozerwanie 1

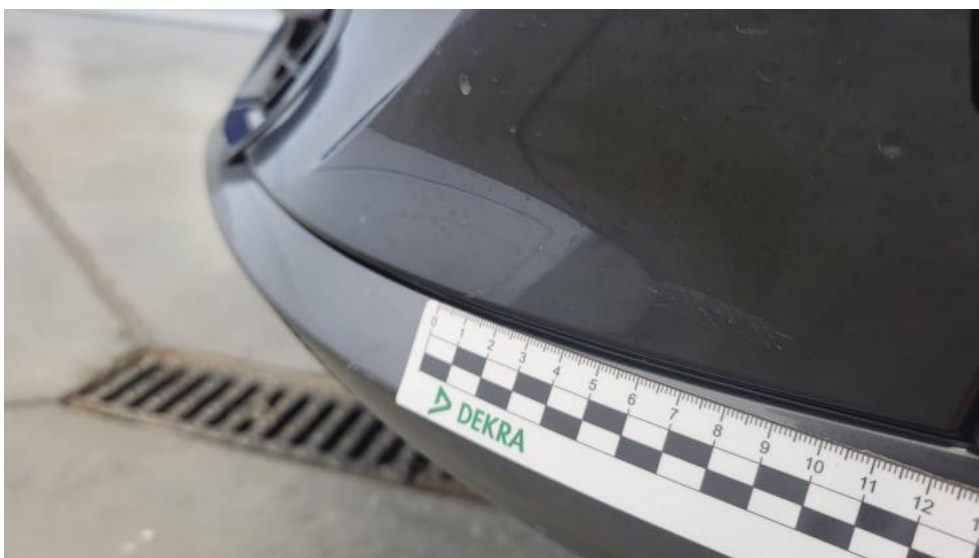
**Photo 42.**

Zderzak - Rysa/odprysk 1

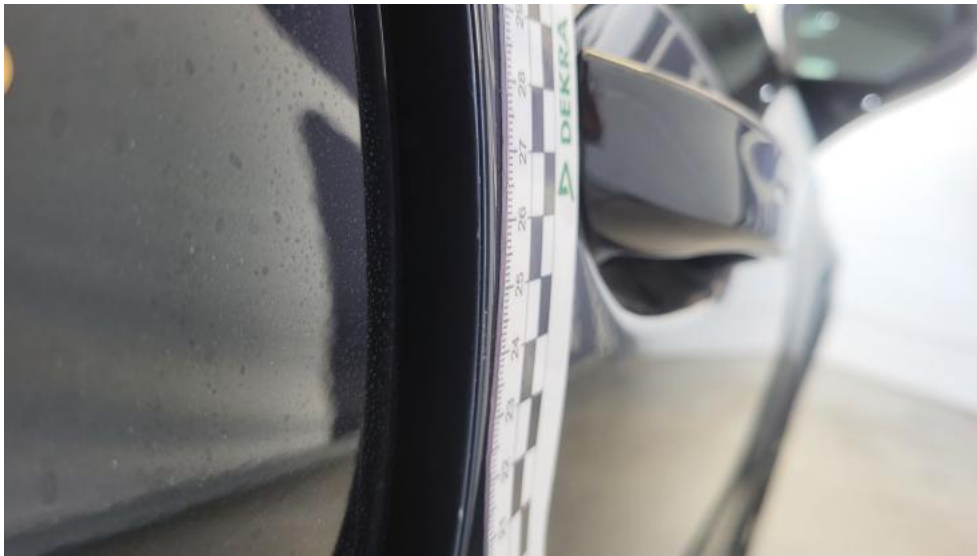
**Photo 45.**

Drzwi przednie P - Rysa/odprysk 1

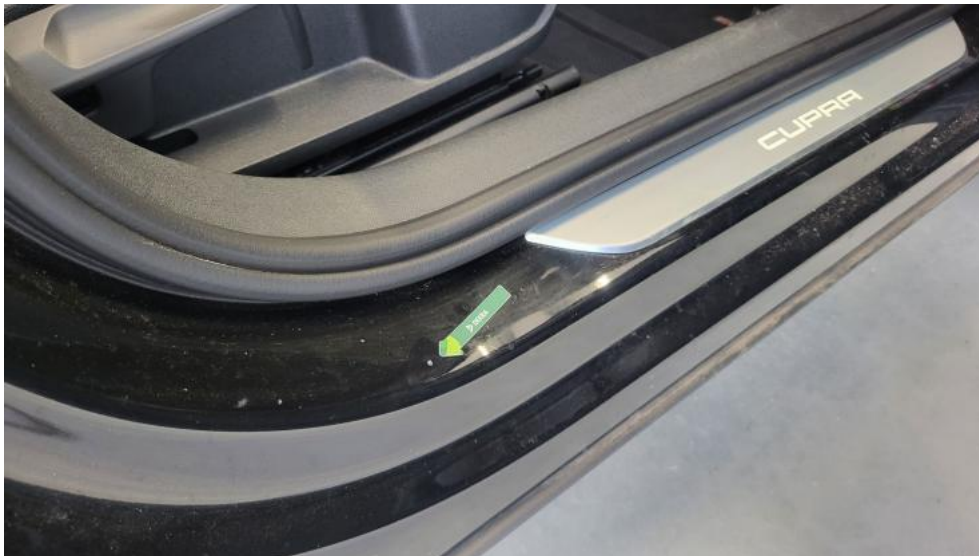
**Photo 47.**

Próg P - Wgniecenie/odkształcenie 1

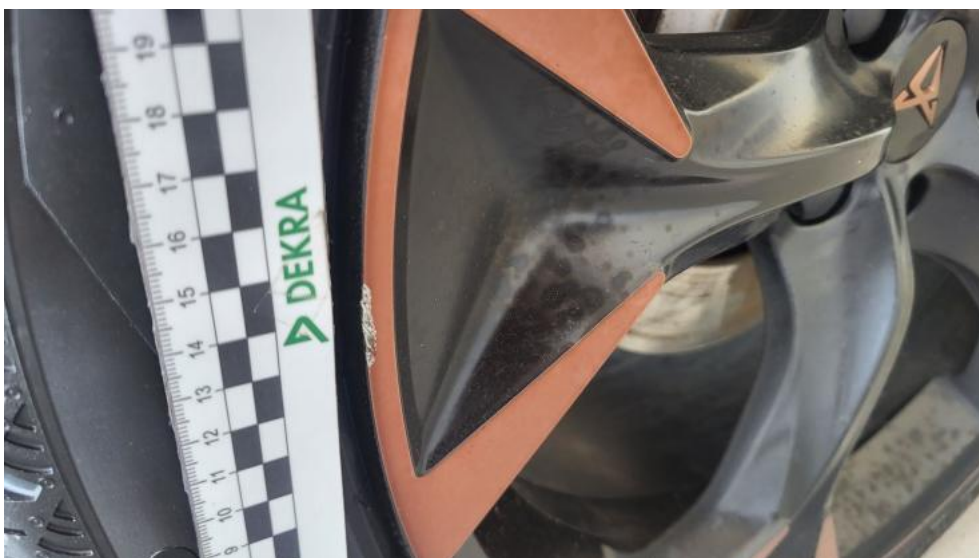
**Photo 48.**

Felga aluminiowa tylna P - Rysa/odprysk 1

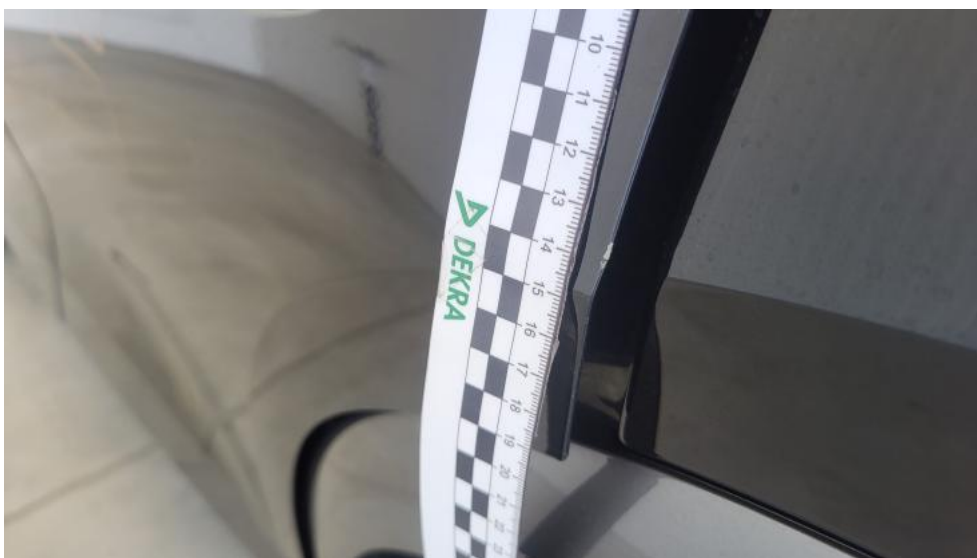
**Photo 52.**

Drzwi tylne L - Rysa/odprysk 1

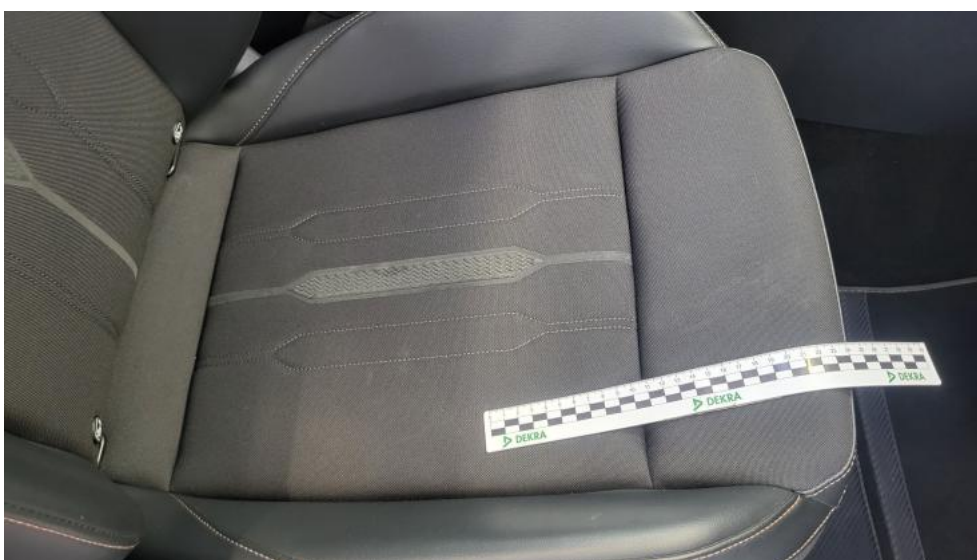
**Photo 56.**

Fotel prz. praw. - Inne 1

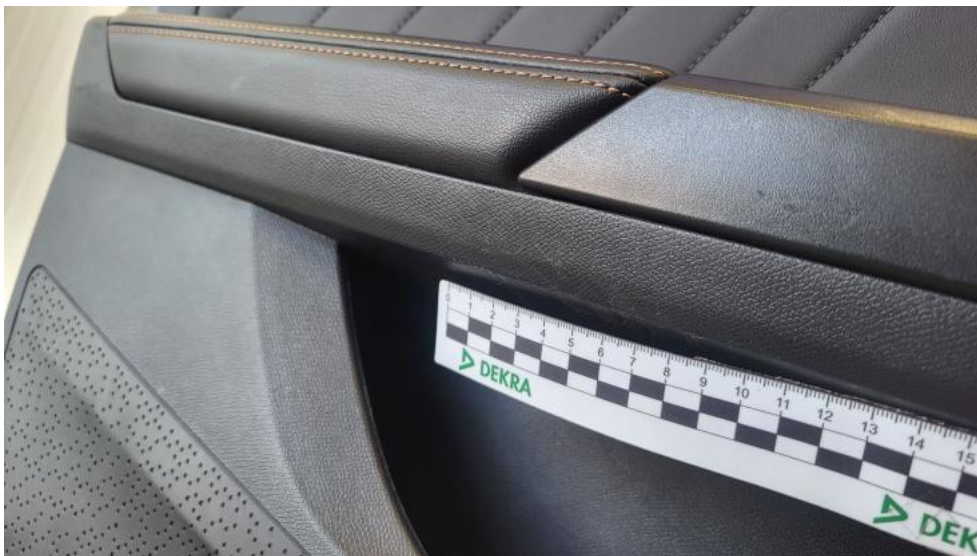
**Photo 57.**

Tapicerka drzwi przednich L - Rysa/odprysk 1

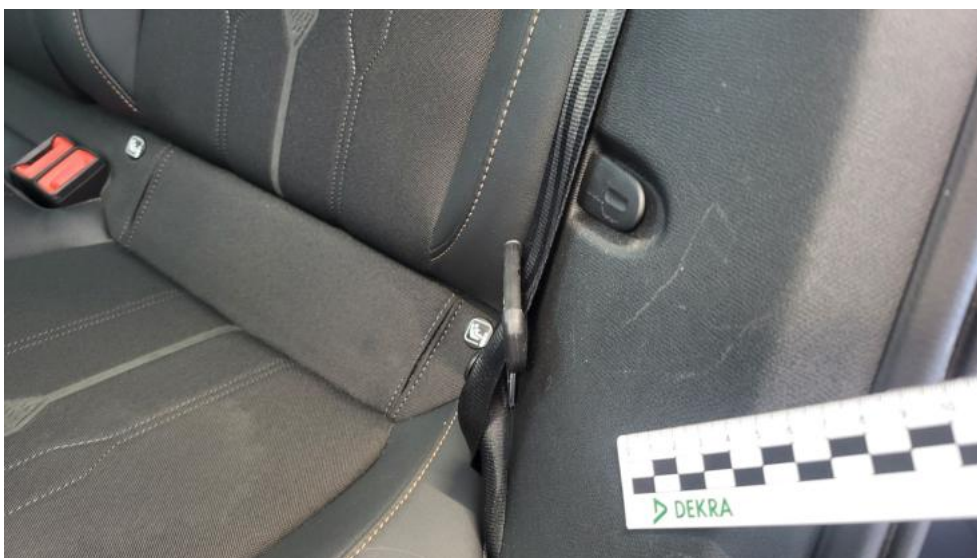
**Photo 58.**

Wykładzina(y) słupka tylnego L - Rysa/odprysk 1
