DEKRA's commission No. : PKOL(W)/LODZ/79923/24/10/15  
 commission/ damage No. : 22/010866  
 Date of commission: 15-10-2024

Group of objects (Eurotax)	cars
EC code (Eurotax)	0126753
Manufacturer	MERCEDES-BENZ
Model	S Klasa [W 222] 17-20
Type / version	AMG S 63 4-Matic+ L
Body type	sedan
Number of doors / seats	4/5
Curb weight [kg]	2185
Gross vehicle weight [kg]	2745
Wheelbase 1/2	3165
Engine type	spark ignition
Supercompression	turbocompressor with intercooler
Pollution reduction system	three-way catalytic converter
Emission standard	EURO 6
Engine capacity [ccm]	3982
Engine Power [hp/kW]	612/450
Gearbox	automatic 9- gear
Registration /record No.	E1TRAKO
VIN / serial number	WDD2221881A401225
Date of first registration	13-03-2018
Date of next. tech. test	28-06-2025
Year of manufacture	2018 (year has been verified with the manufacturer's base)
Readout [km]	102 778 (read)
Body color / type of coating	white/INNY

Description of the technical condition

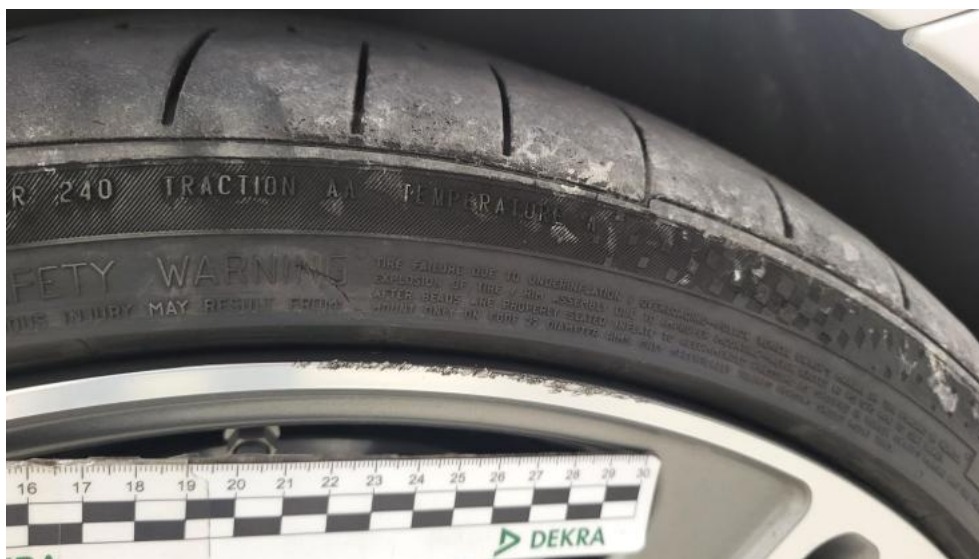
**Photo 65.**  
Felga aluminiowa przednia P - Rysa/odprysk 1

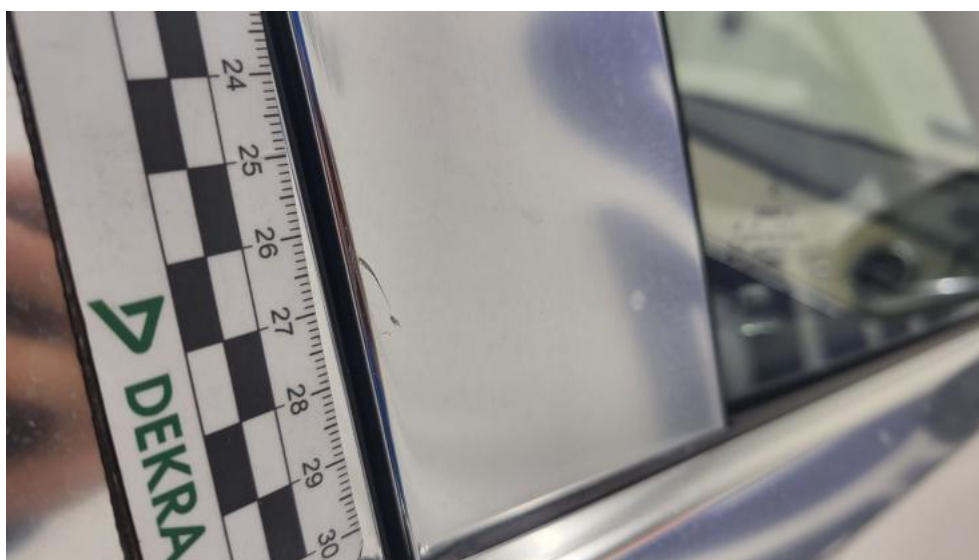
**Photo 66.**  
Drzwi przednie P - Rysa/odprysk 1

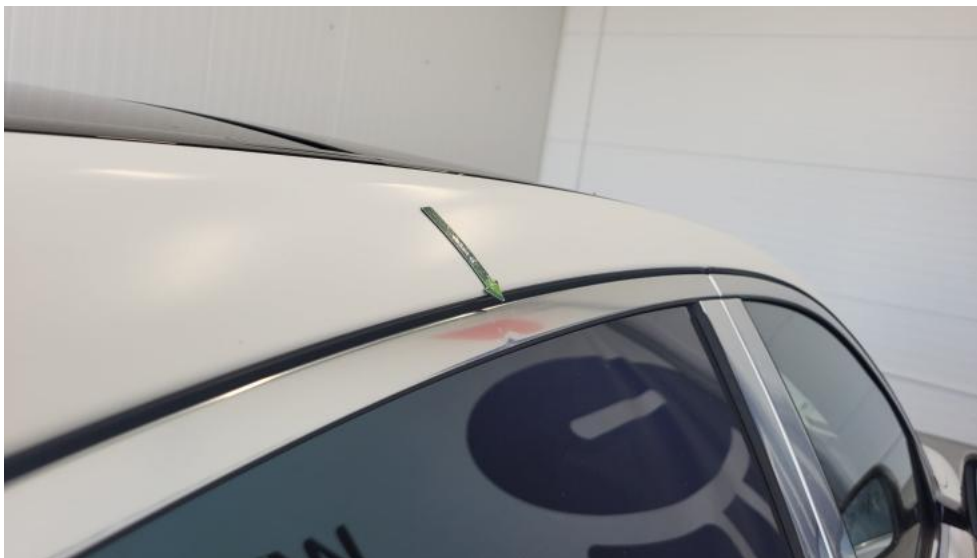
**Photo 67.**  
Drzwi tylne P - Wgniecenie/odkształcenie 1

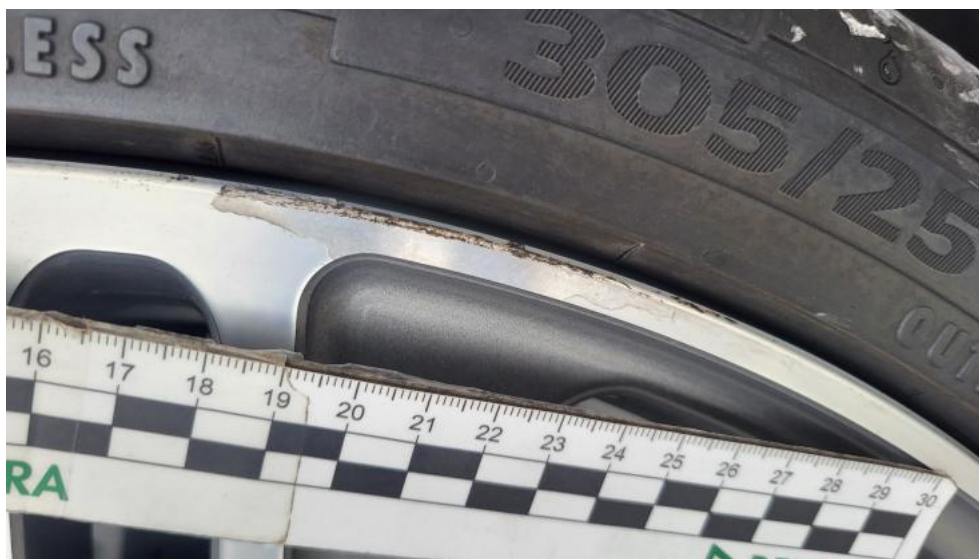
**Photo 69.**

Felga aluminiowa tylna P - Rysa/odprysk 1

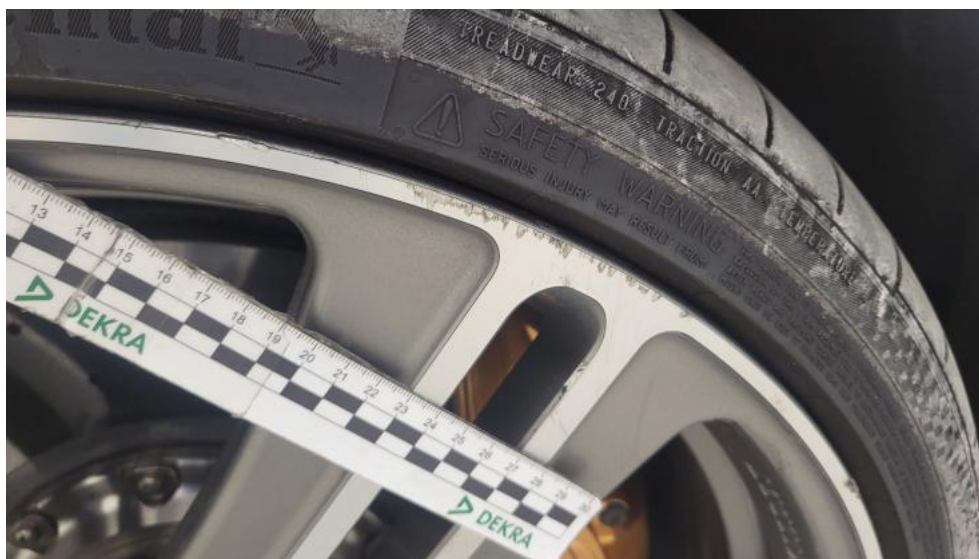
**Photo 71.**  
Felga Aluminiowa przednia L - Rysa/odprysk 1

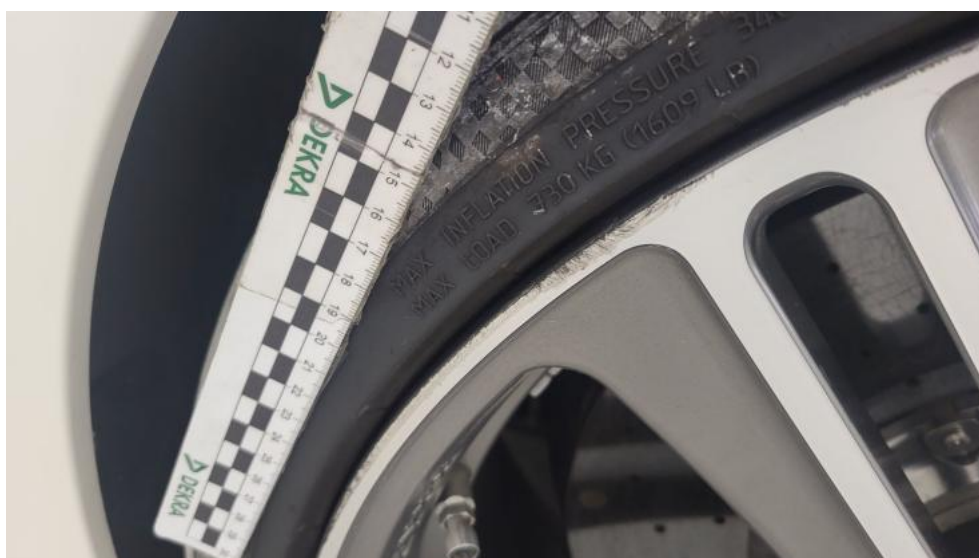
**Photo 72.**  
Felga Aluminiowa przednia L - Rysa/odprysk 2
