DEKRA's commission No. : PKOL(W)/LODZ/82058/24/10/23
 commission/ damage No. : 01285/EO/21
 Date of commission: 23-10-2024

PKO Leasing SA
 Świętokrzyska 36
 00-116 Warszawa

Group of objects (Eurotax)	jeeps
EC code (Eurotax)	0157973
Manufacturer	MASERATI
Model	Levante 16-21
Type / version	Levante Trofeo
Body type	hatchback
Number of doors / seats	5/5
Curb weight [kg]	2245
Gross vehicle weight [kg]	2825
Wheelbase 1/2	3004
Engine type	spark ignition
Supercompression	turbocompressor with intercooler
Pollution reduction system	GPF
Emission standard	EURO 6
Engine capacity [ccm]	3798
Engine Power [hp/kW]	580/427
Gearbox	automatic 8- gear
Registration /record No.	ZS373NJ
VIN / serial number	ZN6ZU61B00X371660
Date of first registration	29-03-2021
Date of next. tech. test	29-03-2026
Year of manufacture	2021 (year has been verified with the manufacturer's base)
Readout [km]	72 952 (read)
Body color / type of coating	white/INNY

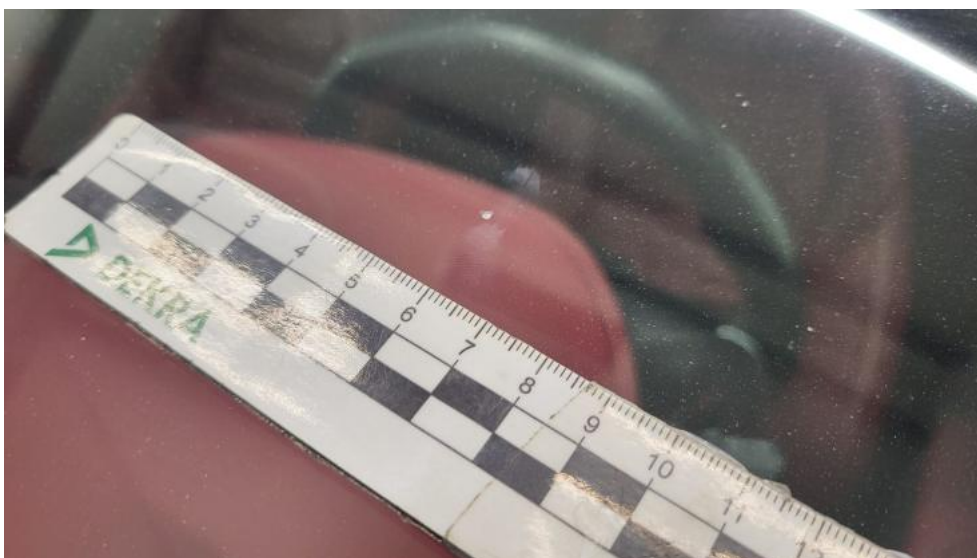
Photo 52.
Szyba czołowa - Rysa/odprysk 1

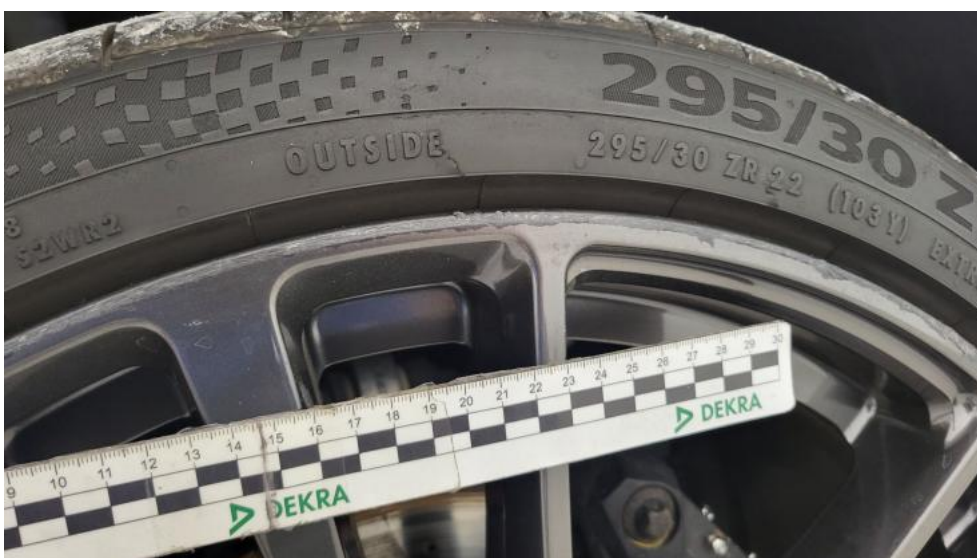
Photo 58.
Felga aluminiowa tylna P - Rysa/odprysk 2

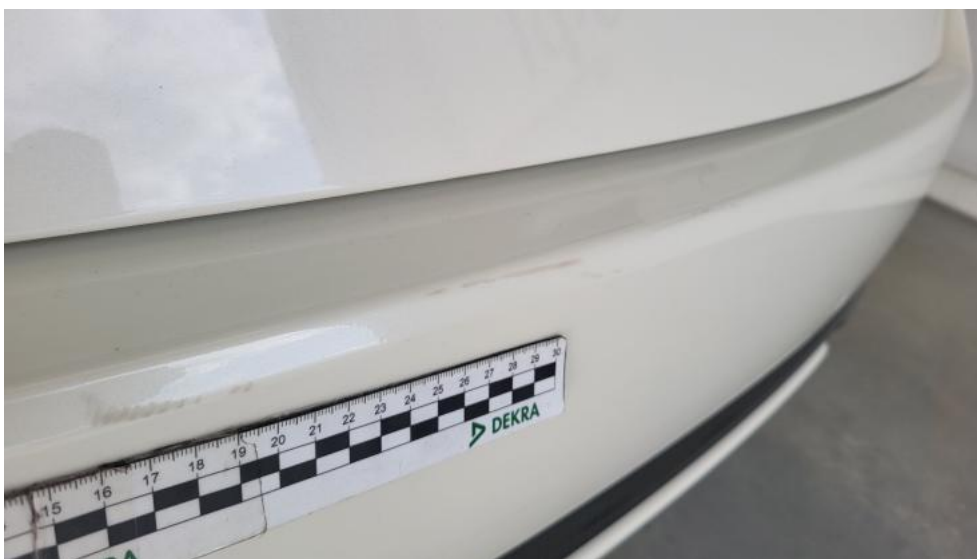
Niesprawne przyciski funkcyjne w jednym z kluczyków. Aktywna kontrolka ciśnienia w oponach. Rysy na samochodzie. Pojazd oklejony folią. Pomiar lakieru wykonany na folii elementy: pokrywa silnika, błotnik przedni lewy, błotnik przedni prawy, słupek przedni lewy, słupek przedni prawy, fragment dachu, próg lewy I, próg prawy, błotnik tylny lewy, błotnik tylny prawy.

Photo 63.
Zderzak tylny - Rysa/odprysk 1

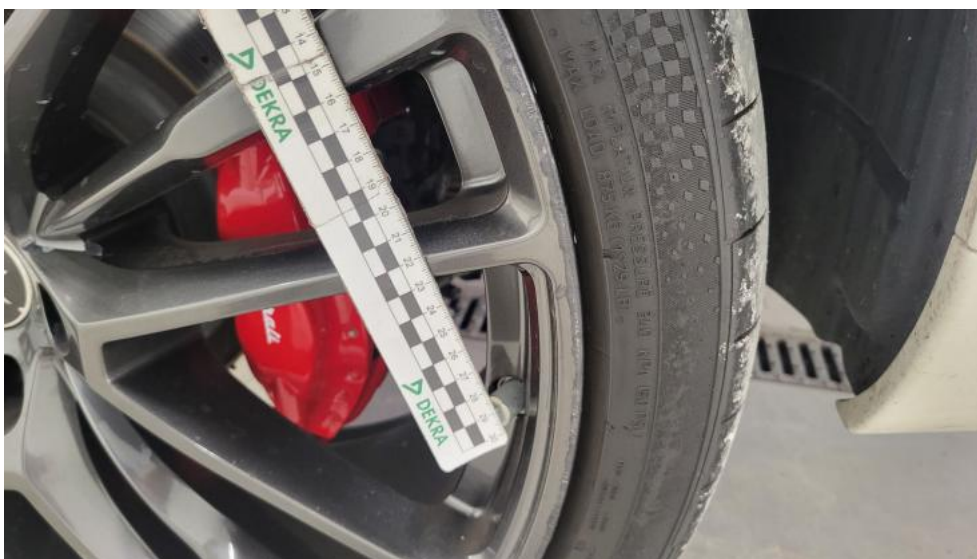
Photo 69.
Felga aluminiowa tylna L - Rysa/odprysk 2

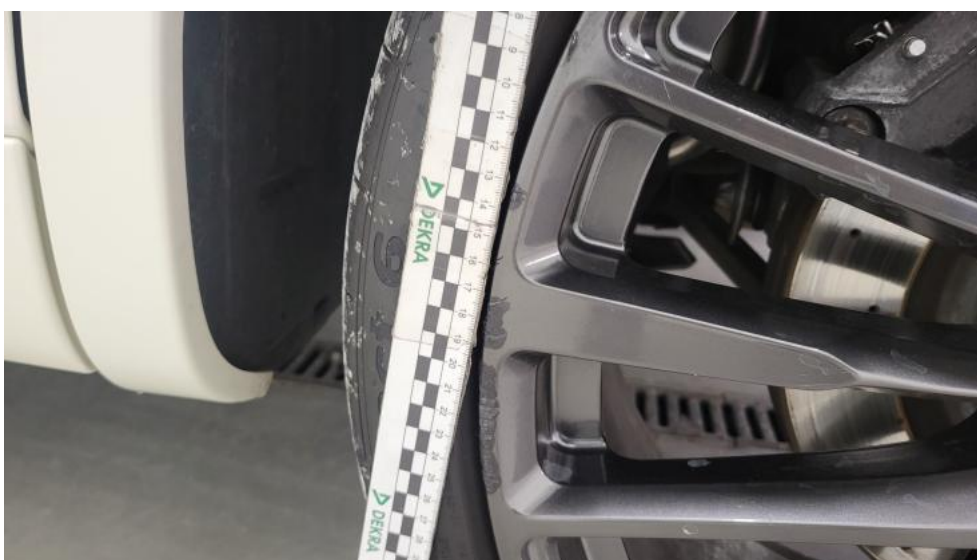
Photo 70.
Felga aluminiowa tylna L() - Rysa/odprysk 3

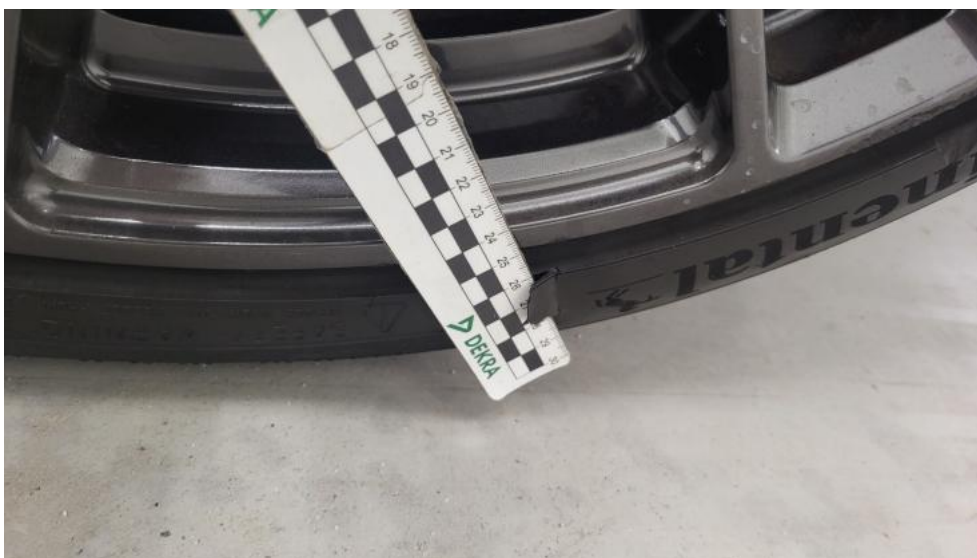
Photo 72.

Opona tylna L - Pęknięcie/rozerwanie 1
