DEKRA's commission No. : PKOL(W)/LODZ/03559/26/01/15  
commission/ damage No. : 21/061842  
Date of commission: 15-01-2026

**DEKRA Poland - Headquarters**  
02-673 Warszawa, ul. Konstruktorska 12A

| Manufacturer | BMW |
| Type / version | 118i M Sport aut |

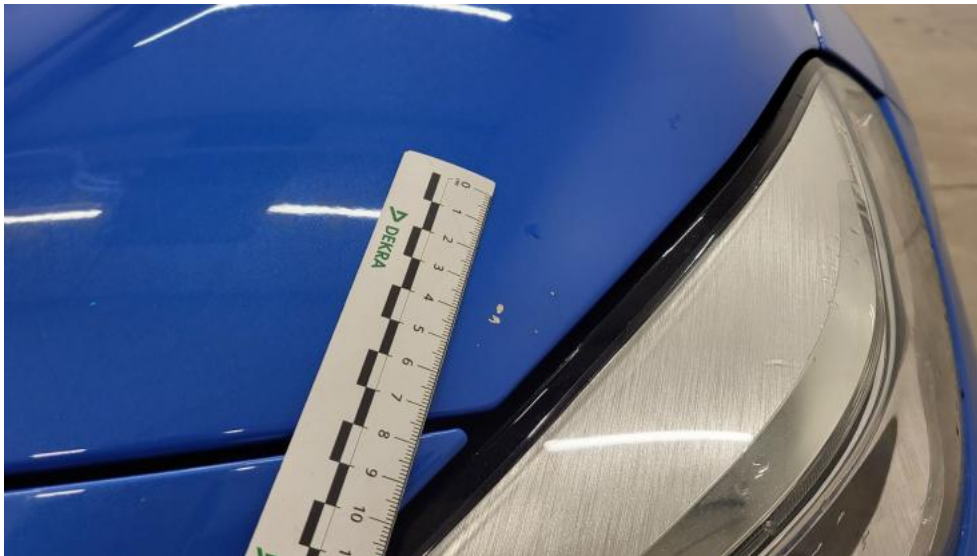
**Photo 39.**

Pokrywa komory silnika - Rysa/odprysk 1

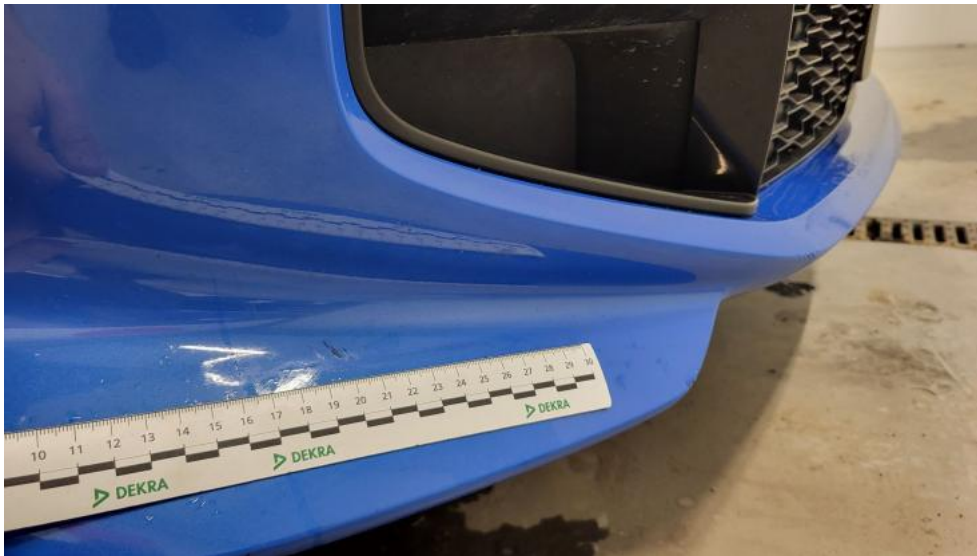
**Photo 43.**

Zderzak() - Rysa/odprysk 3

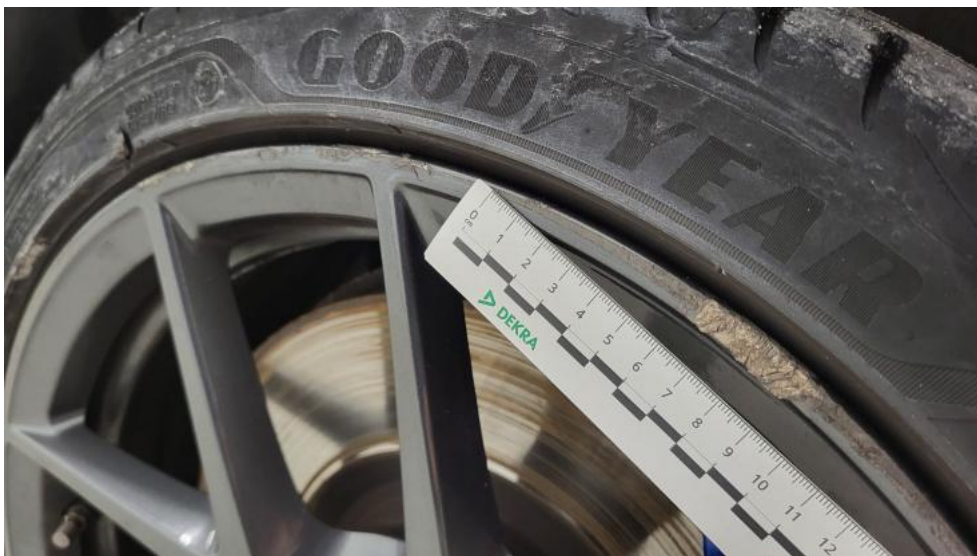
**Photo 44.**

Felga aluminiowa przednia P - Rysa/odprysk 1

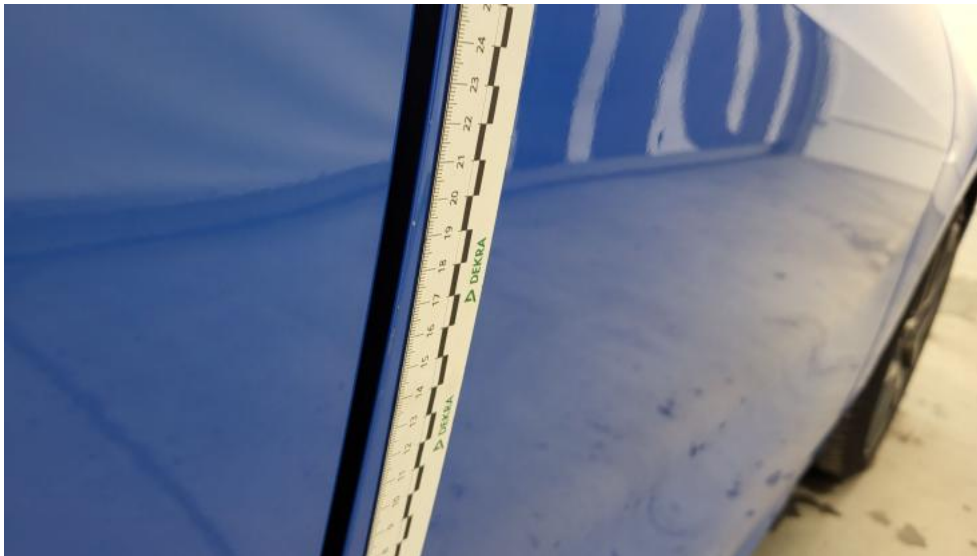
**Photo 47.**

Drzwi przednie P - Rysa/odprysk 2

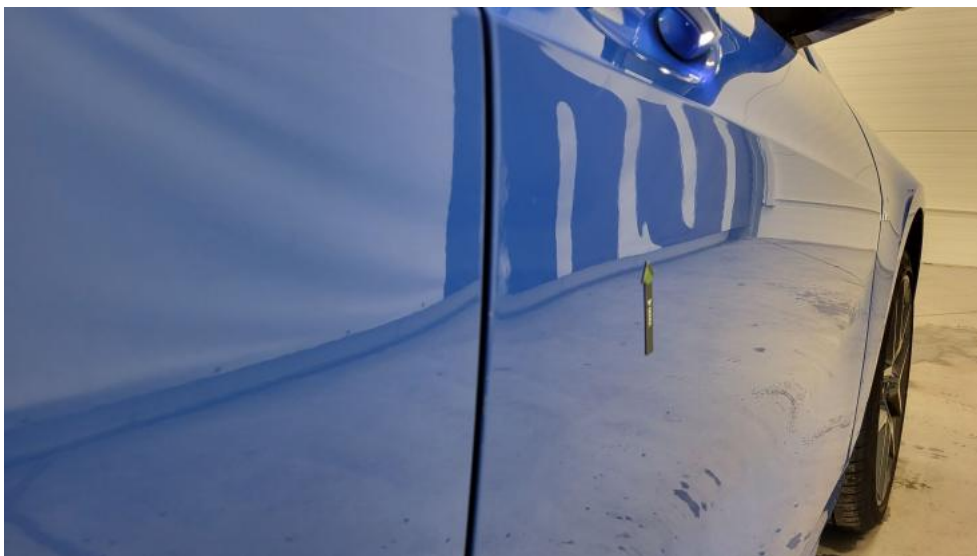
**Photo 48.**

Drzwi przednie P - Wgniecenie/odkształcenie 1

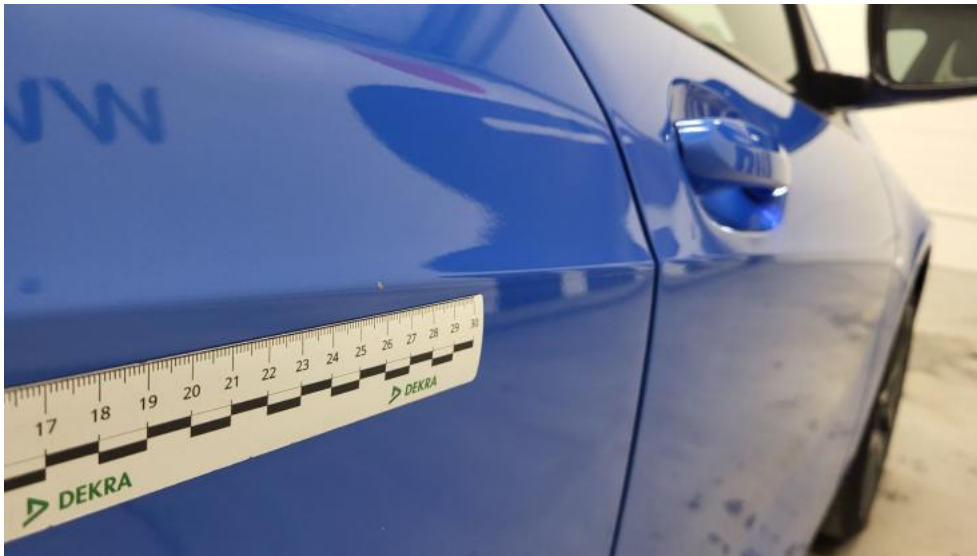
**Photo 49.**

Drzwi tylne P - Rysa/odprysk 1

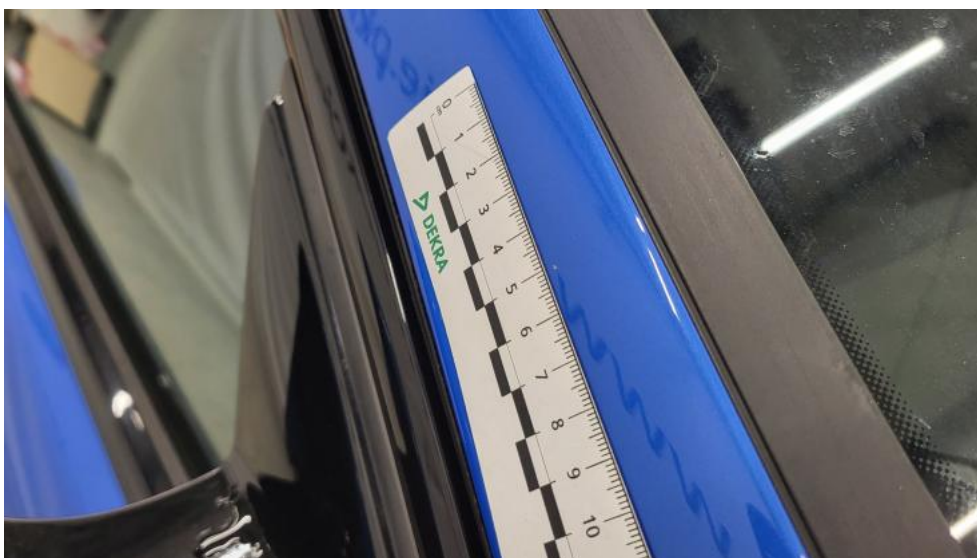
**Photo 50.**

Słupek przedni P - Rysa/odprysk 1

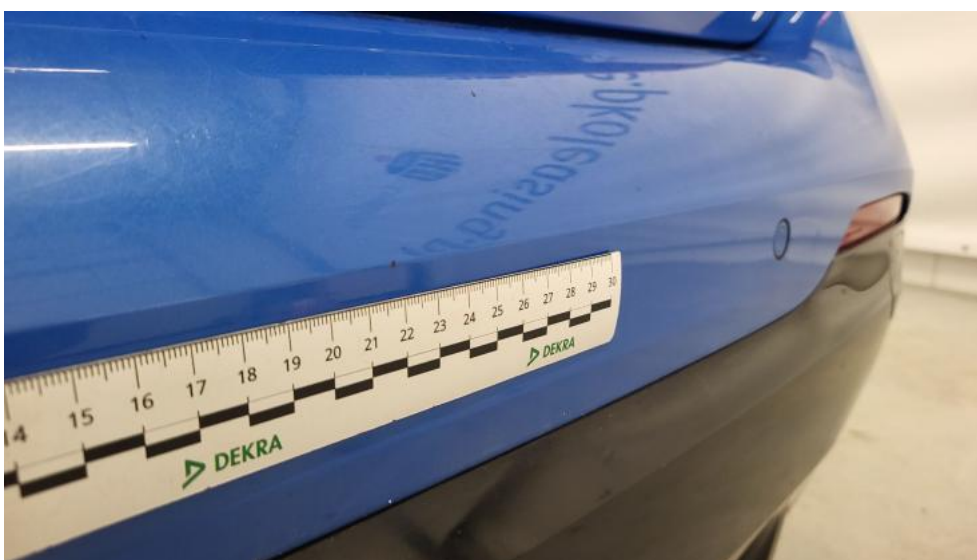
**Photo 54.**

Zderzak tylny - Rysa/odprysk 1

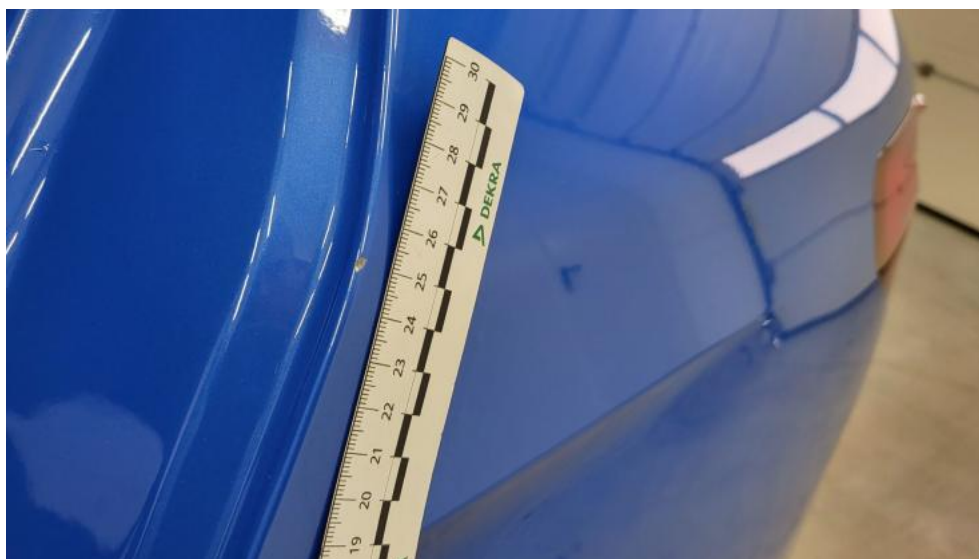
**Photo 55.**

Błotnik tylny L / Ściana boczna L - Rysa/odprysk 1

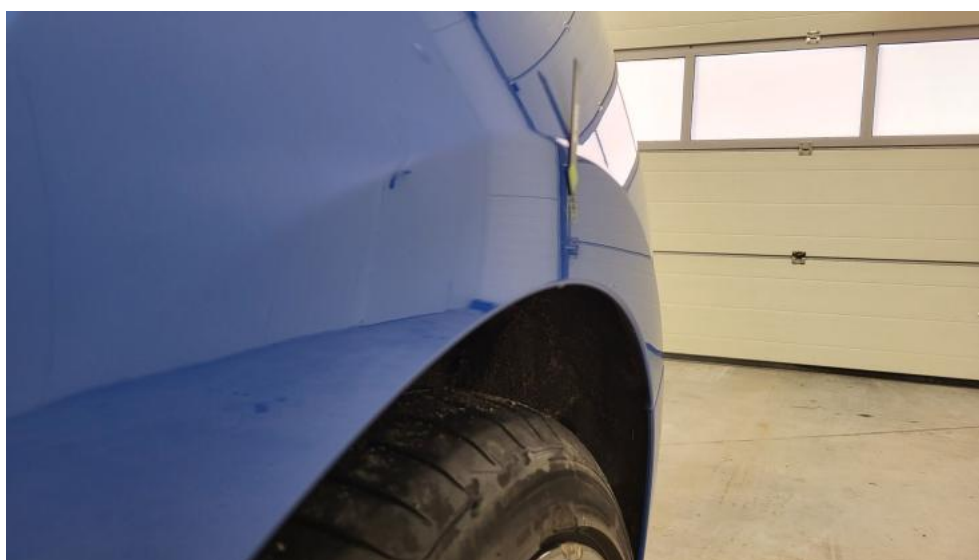
**Photo 56.**

Błotnik tylny L / Ściana boczna L - Wgniecenie/odkształcenie 1

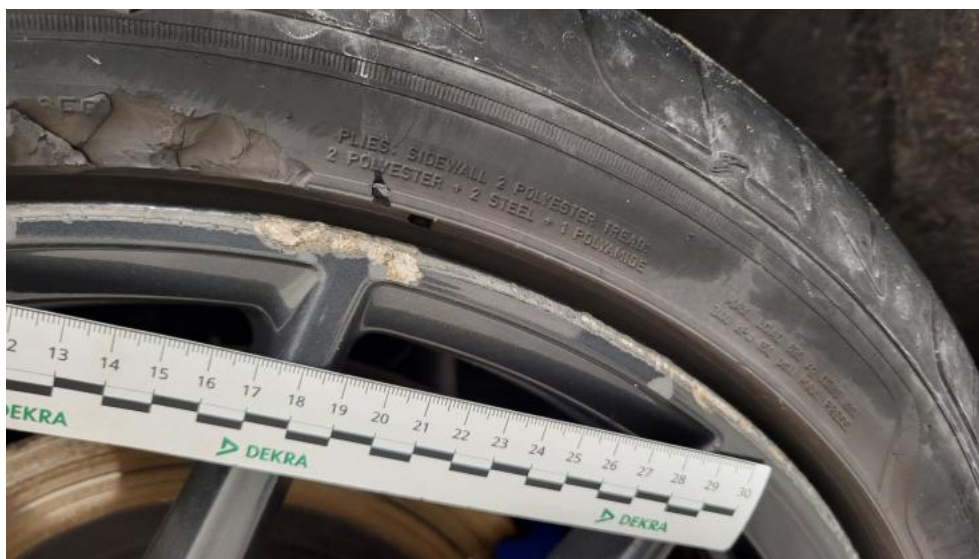
**Photo 57.**

Felga aluminiowa tylna L - Rysa/odprysk 1

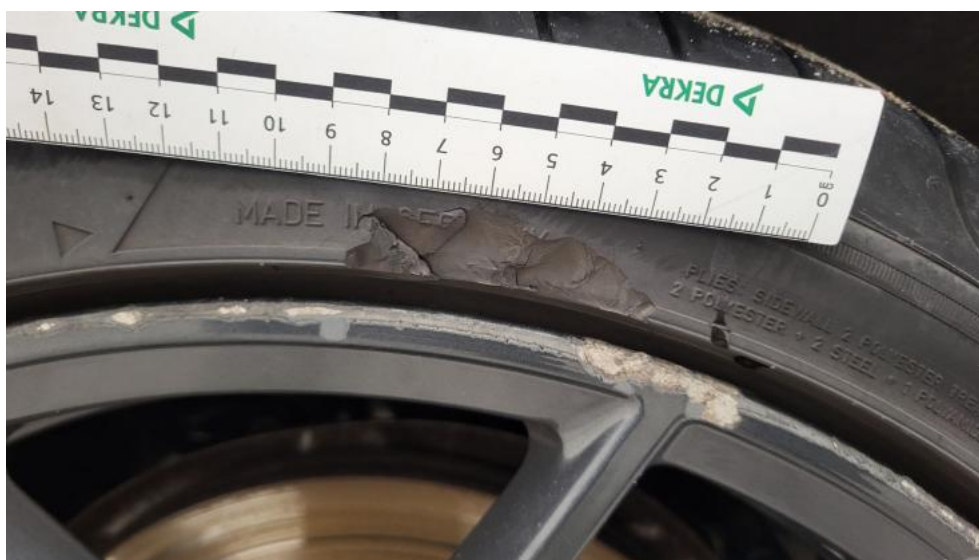
**Photo 58.**

Opona tylna L - Pęknięcie/rozerwanie 1

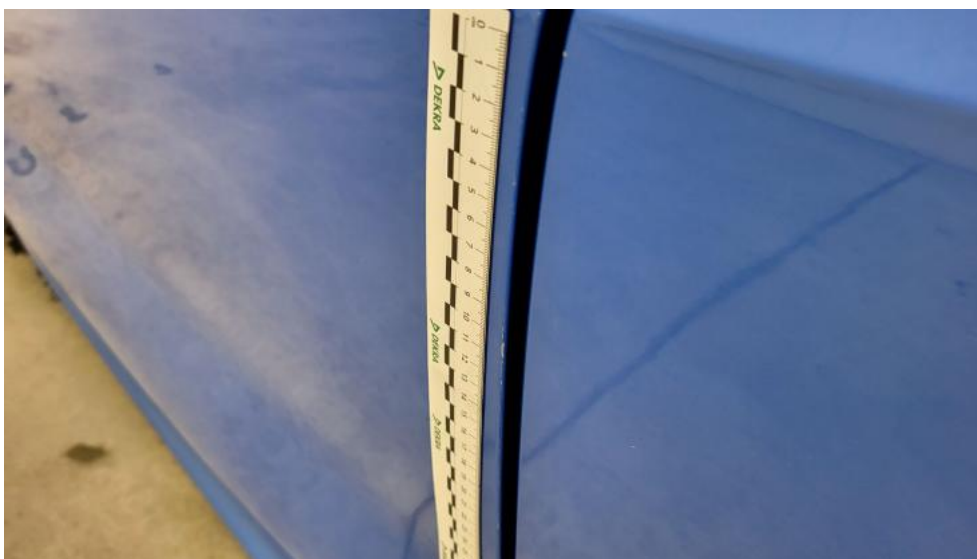
**Photo 59.**

Drzwi przed L - Rysa/odprysk 1

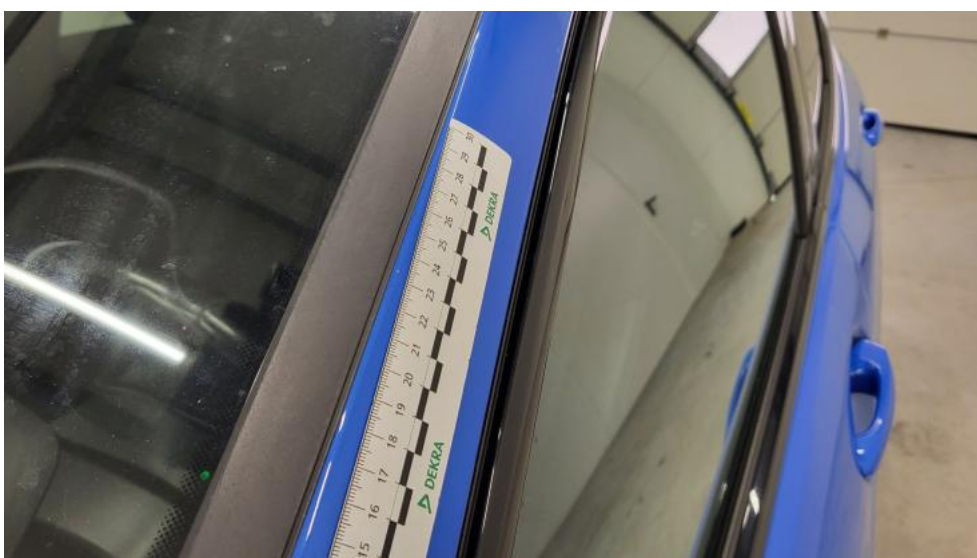
**Photo 64.**

Słupek przedni L - Rysa/odprysk 1

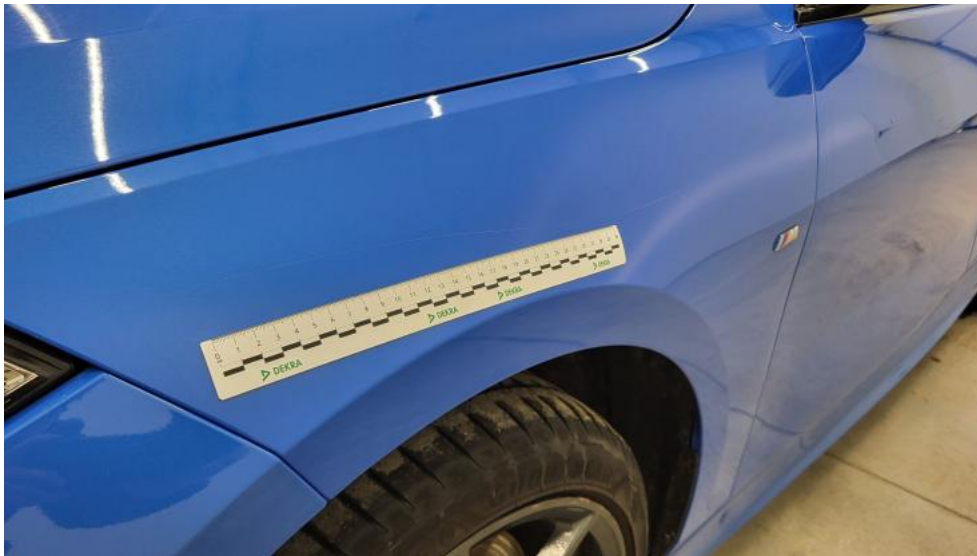
**Photo 65.**

Błotnik przedni L - Rysa/odprysk 1

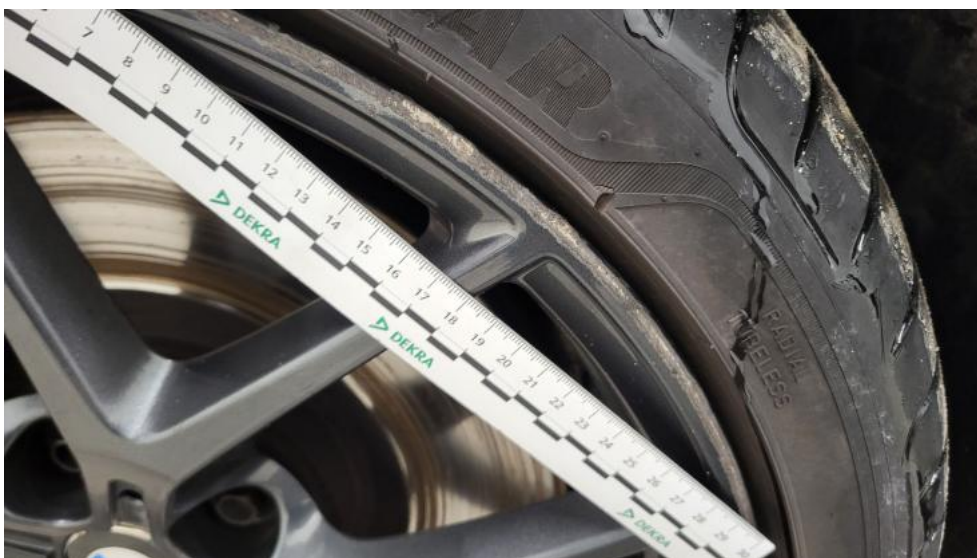
**Photo 66.**

Felga Aluminiowa przednia L - Rysa/odprysk 1

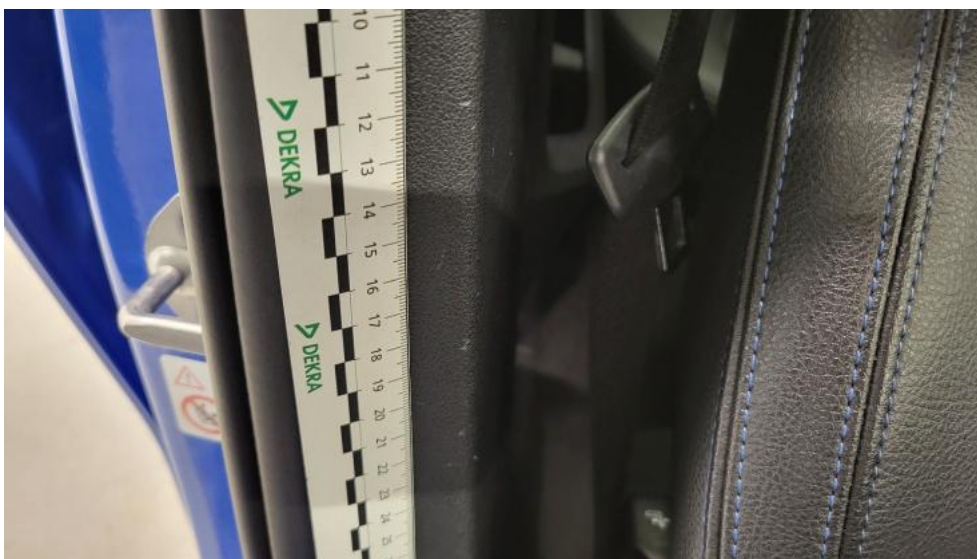
**Photo 69.**

Wykładzina(y) słupka środkowego P - Rysa/odprysk 1
