DEKRA's commission No. : PKOL(W)/LODZ/84479/25/11/03  
commission/ damage No. : 21/046227  
Date of commission: 03-11-2025

| Manufacturer | AUDI |
| Model | A6 [C8] 18-23 |
| Registration /record No. | CT0461Y |

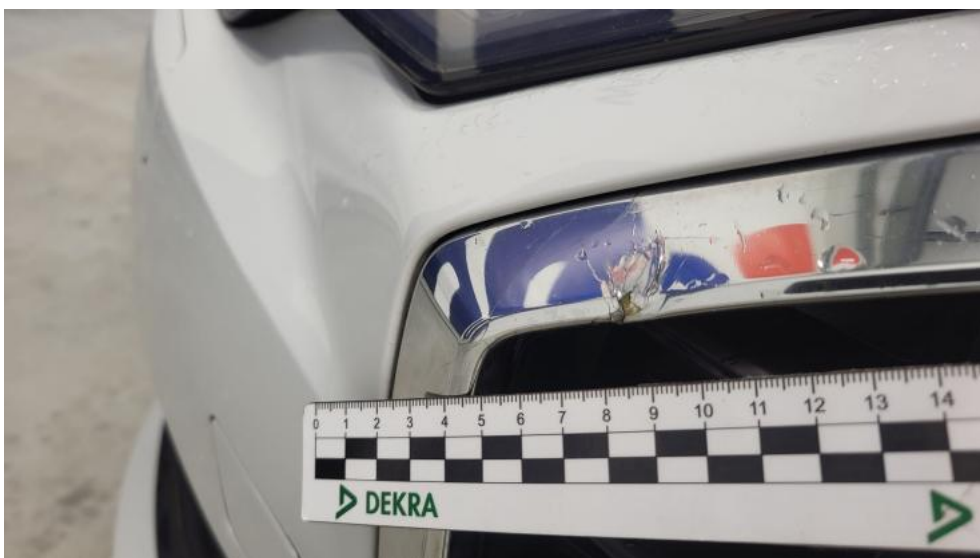
**Photo 38.**

Listwa śr zderzaka przedniego - Pęknięcie/rozerwanie 1

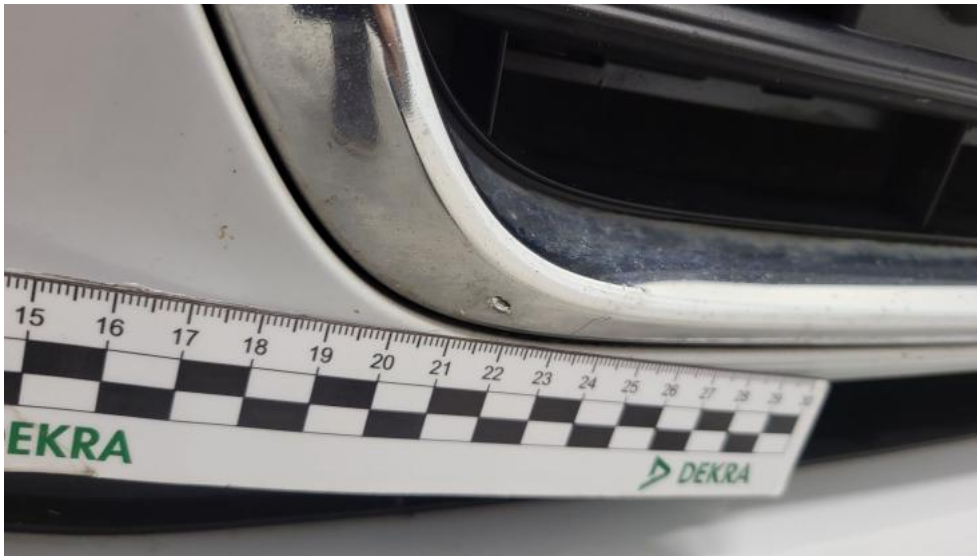
**Photo 39.**

Listwa śr zderzaka przedniego - Pęknięcie/rozerwanie 2

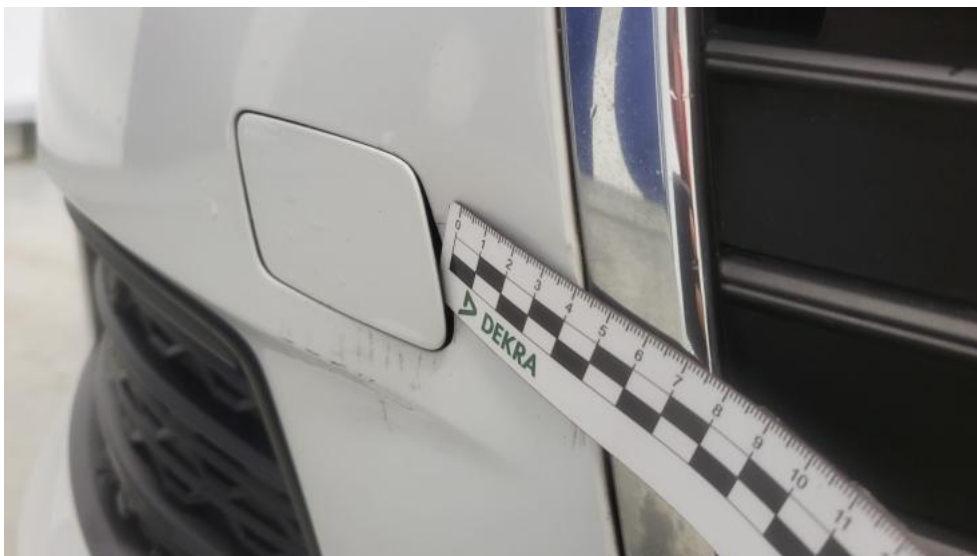
**Photo 40.**

Zaślepka prz haka hol. - Inne 1

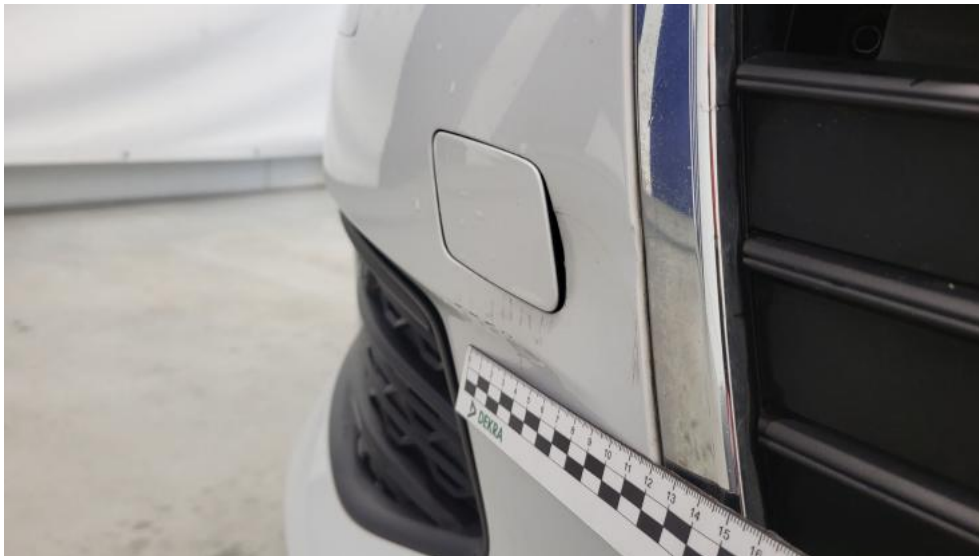
**Photo 43.**

Zderzak - Wgniecenie/odkształcenie 1

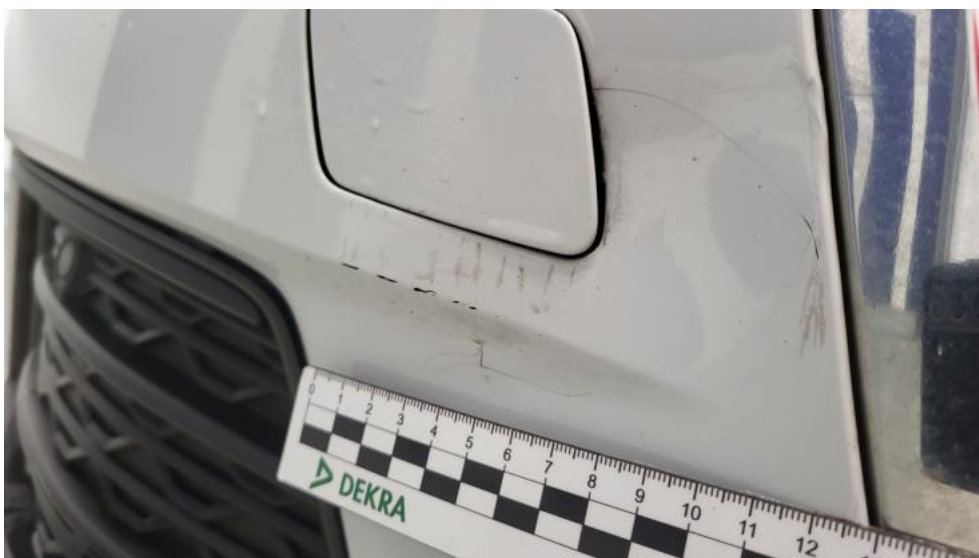
**Photo 44.**

Zderzak - Pęknięcie/rozerwanie 1

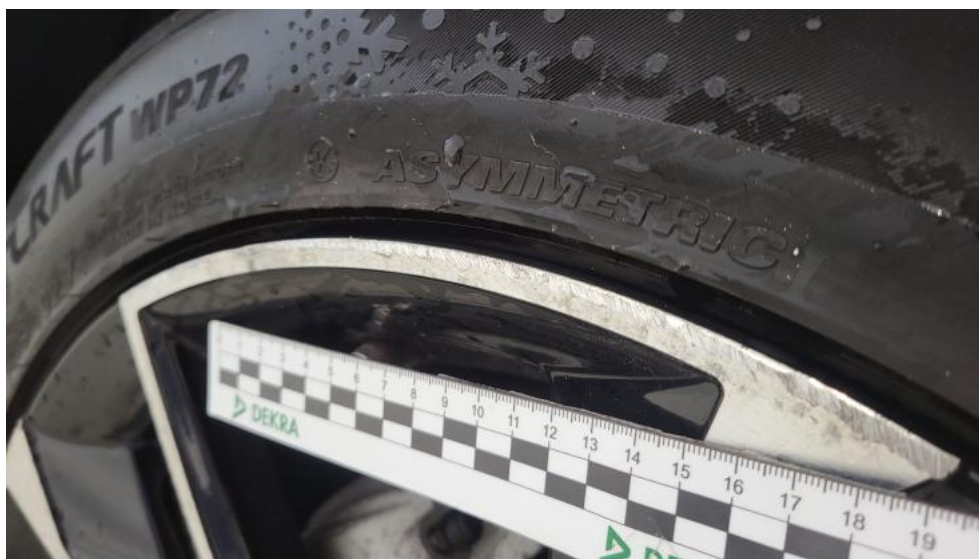
**Photo 45.**

Felga aluminiowa przednia P - Rysa/odprysk 1

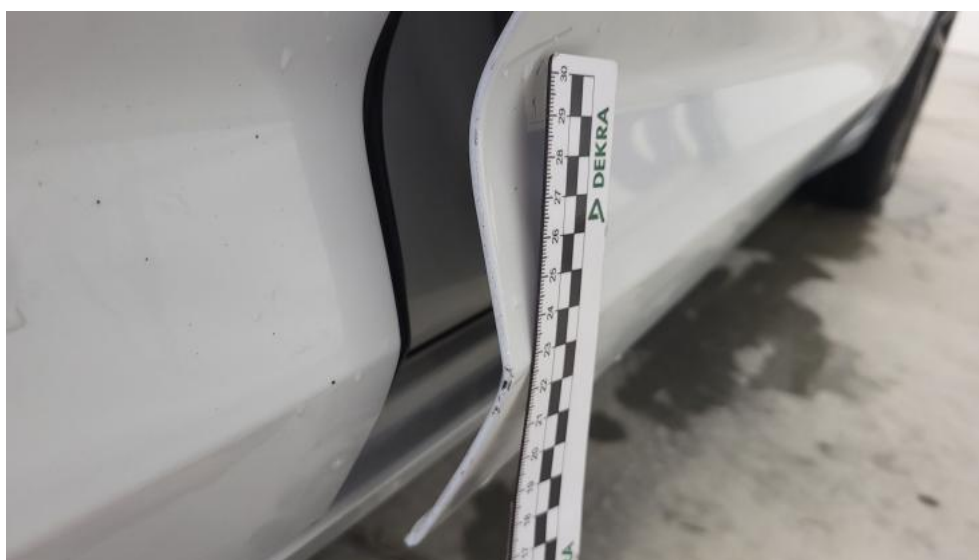
**Photo 46.**

Drzwi przednie P - Rysa/odprysk 1

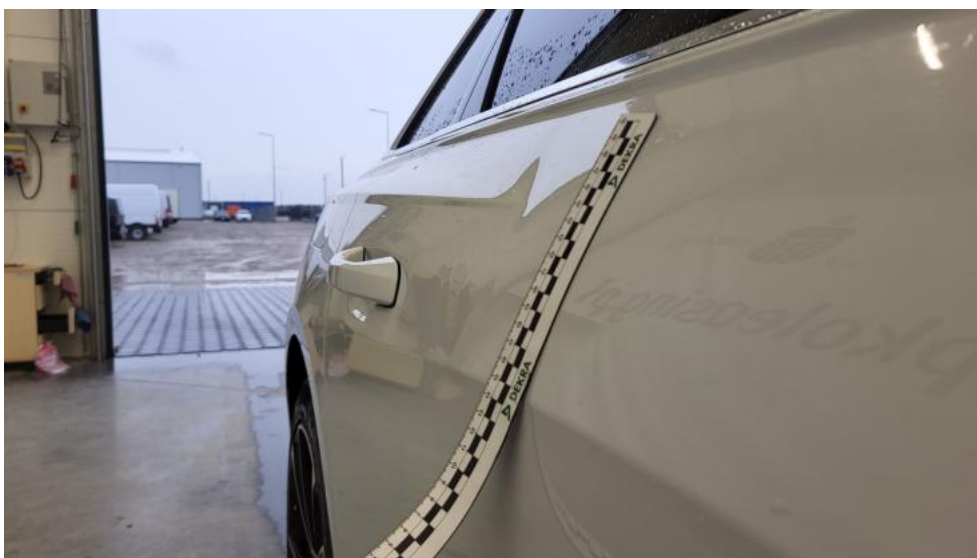
**Photo 48.**

Drzwi tylne P - Wgniecenie/odkształcenie 1

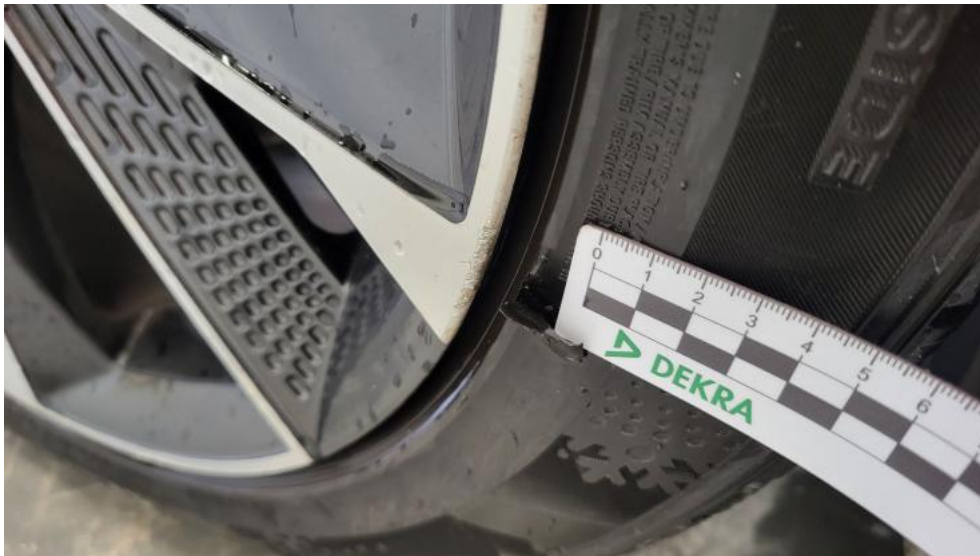
**Photo 55.**

Opona tylna P - Pęknięcie/rozerwanie 1

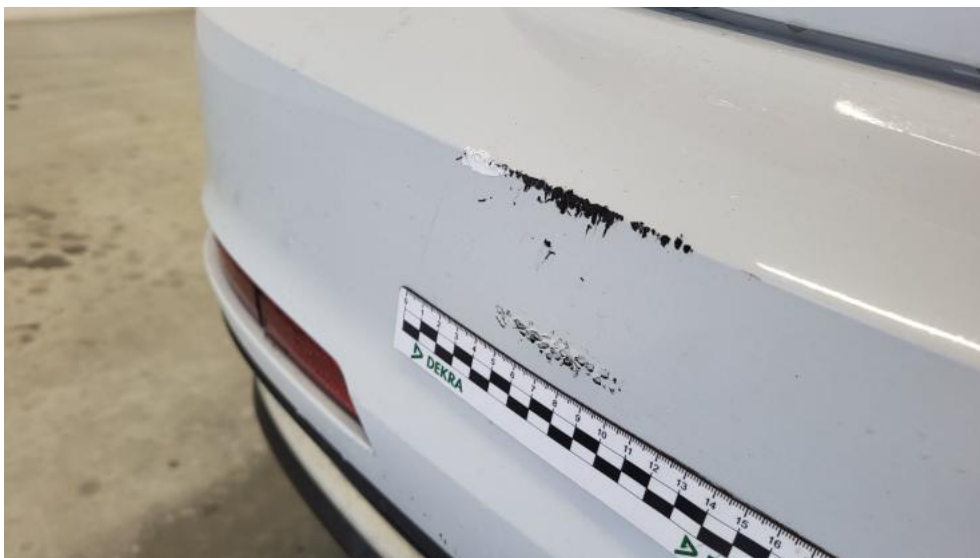
**Photo 56.**

Zderzak tylny - Rysa/odprysk 1

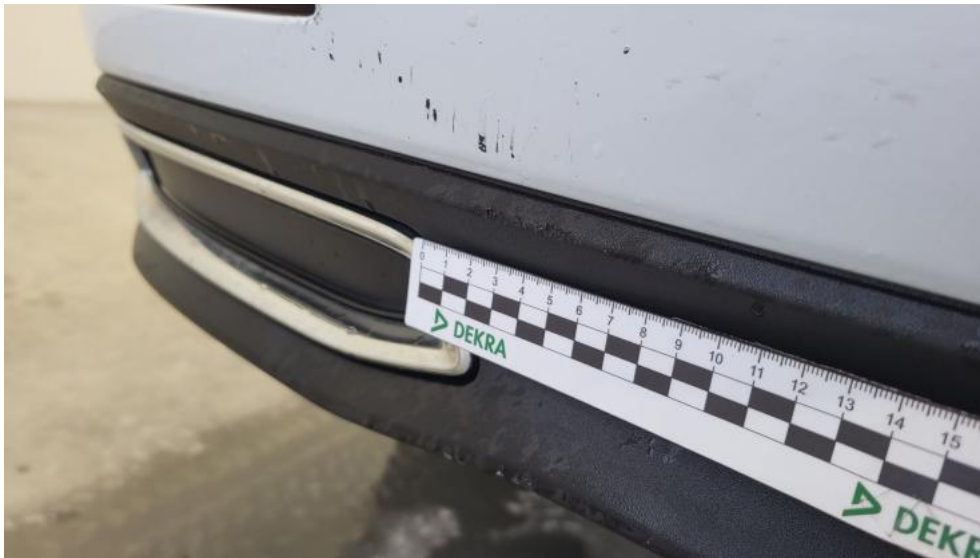
**Photo 59.**

Zderzak tylny cz dolna - Rysa/odprysk 1

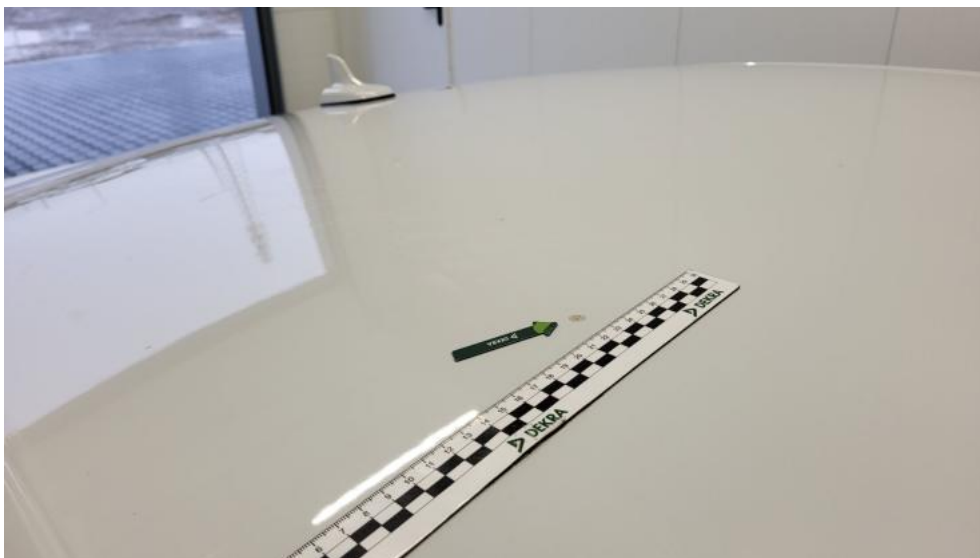
**Photo 60.**

Dach - Inne 1

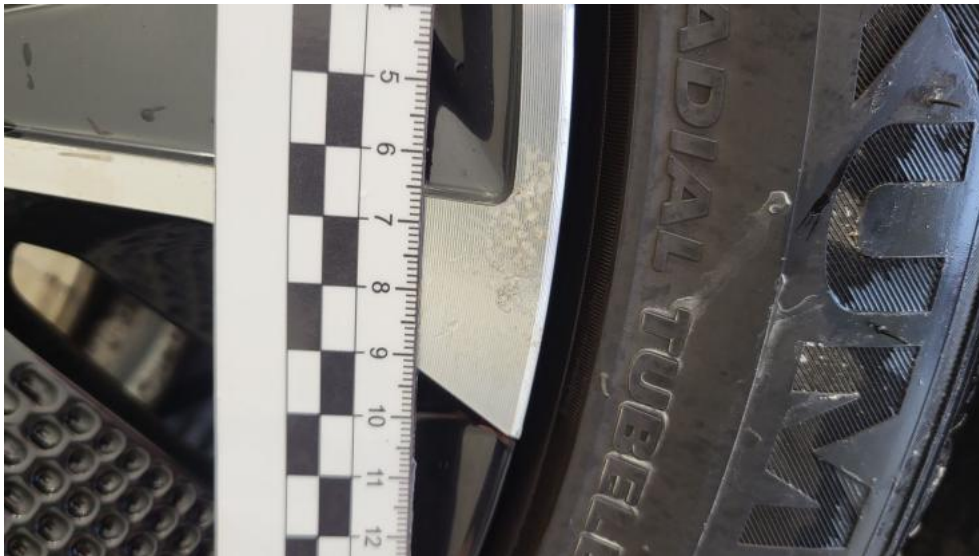
**Photo 61.**

Felga aluminiowa tylna L - Rysa/odprysk 1

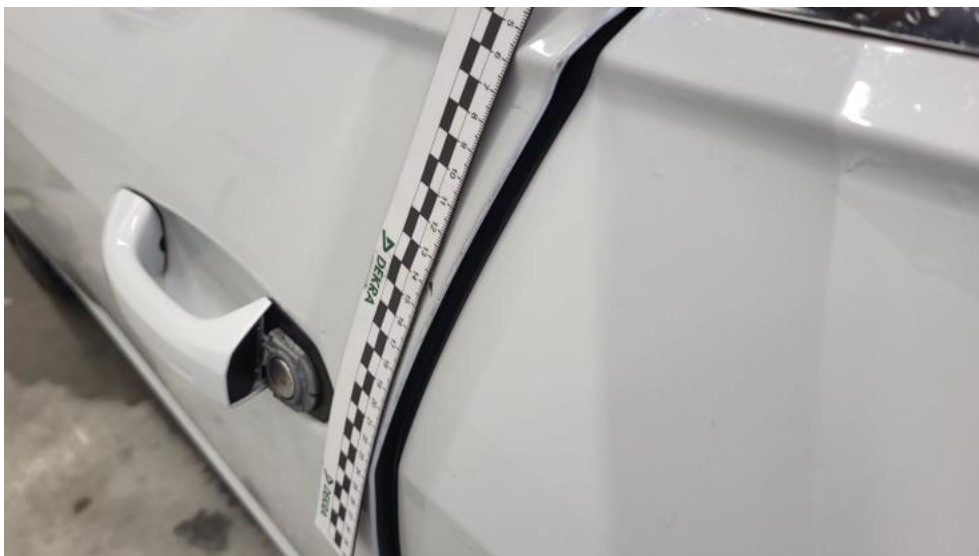
**Photo 62.**

Drzwi przed L - Rysa/odprysk 1

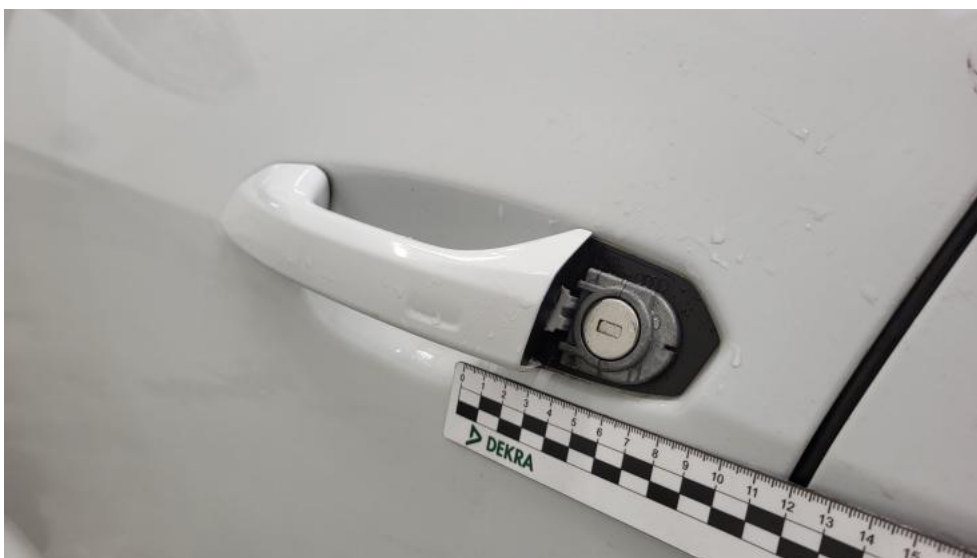
**Photo 64.**

Klamka drzwi prz L - Inne 1

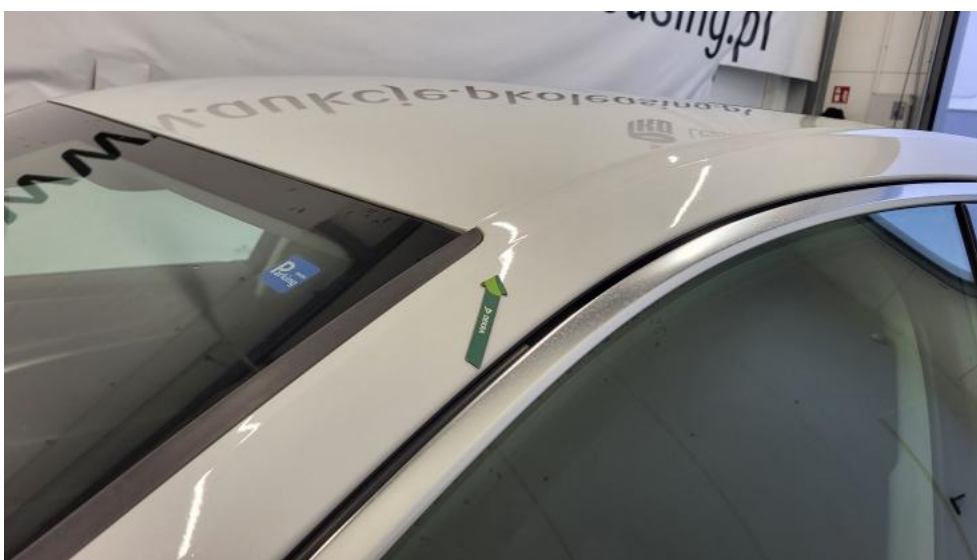
**Photo 66.**

Słupek przedni L - Wgniecenie/odkształcenie 1

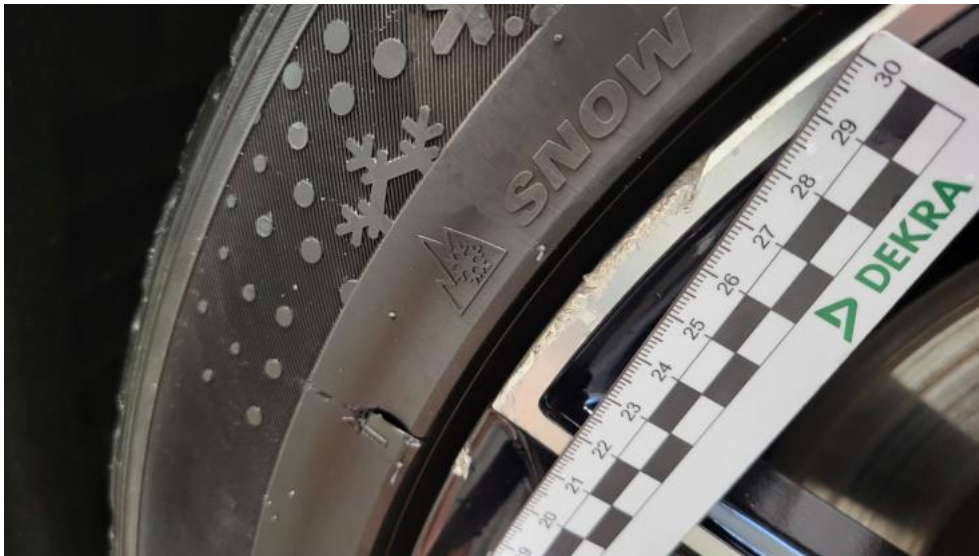
**Photo 67.**

Felga Aluminiowa przednia L - Rysa/odprysk 1

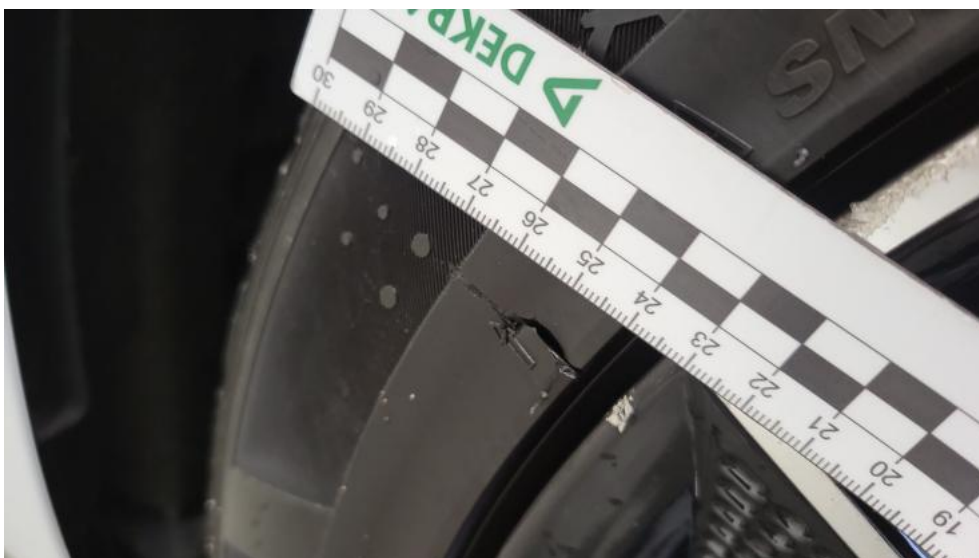
**Photo 68.**

Opona przednia L - Pęknięcie/rozerwanie 1

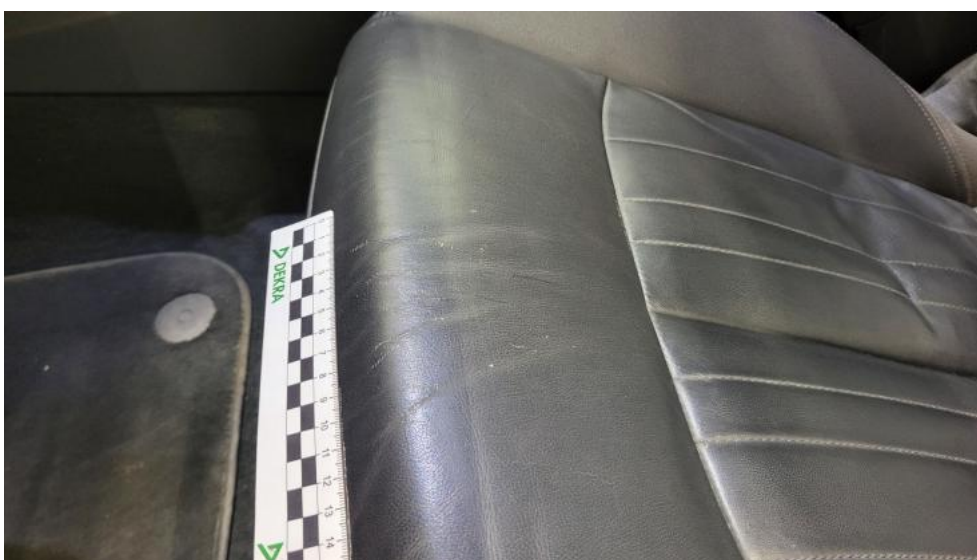
**Photo 70.**

Fotel prz. lew. - Inne 1

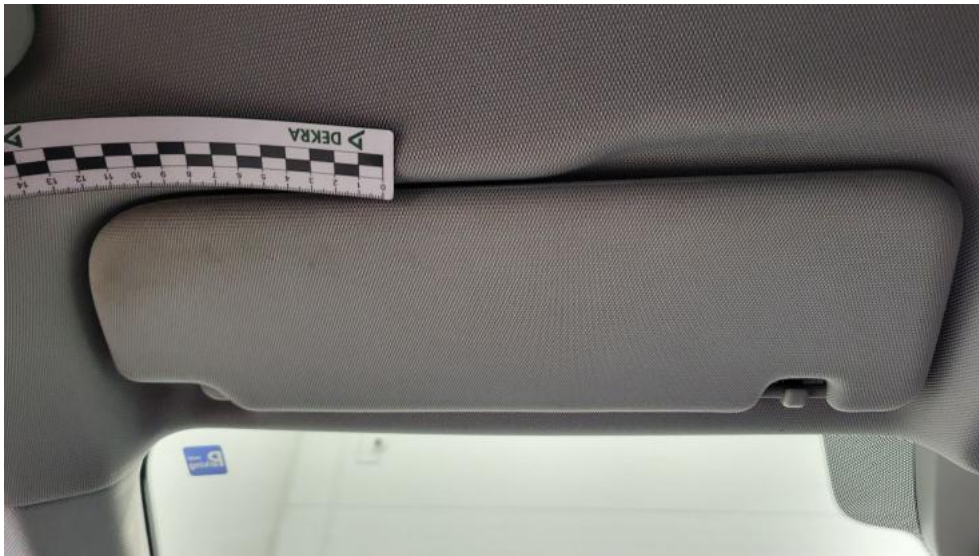
**Photo 71.**

Osłona p/słoneczna lewa - Inne 1

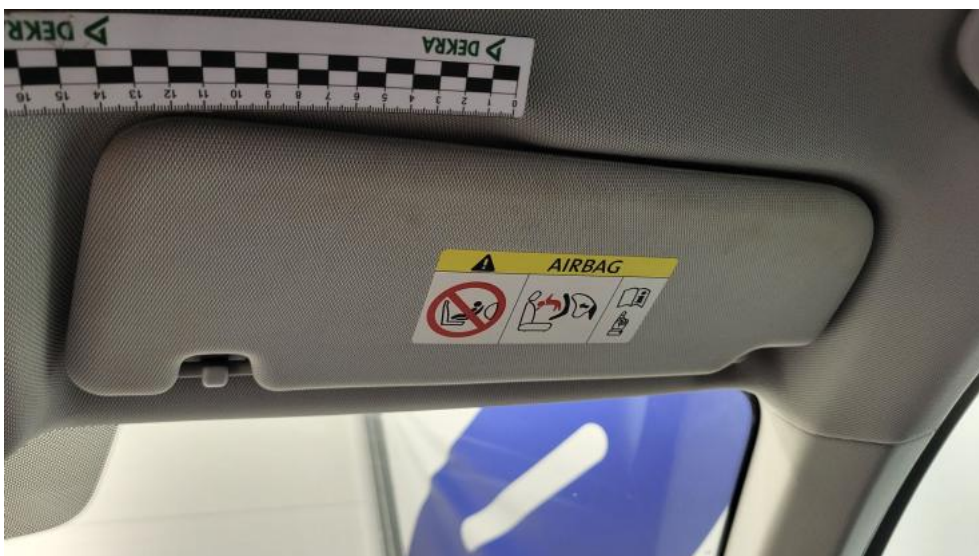
**Photo 72.**

Osłona p/słoneczna prawa - Inne 1

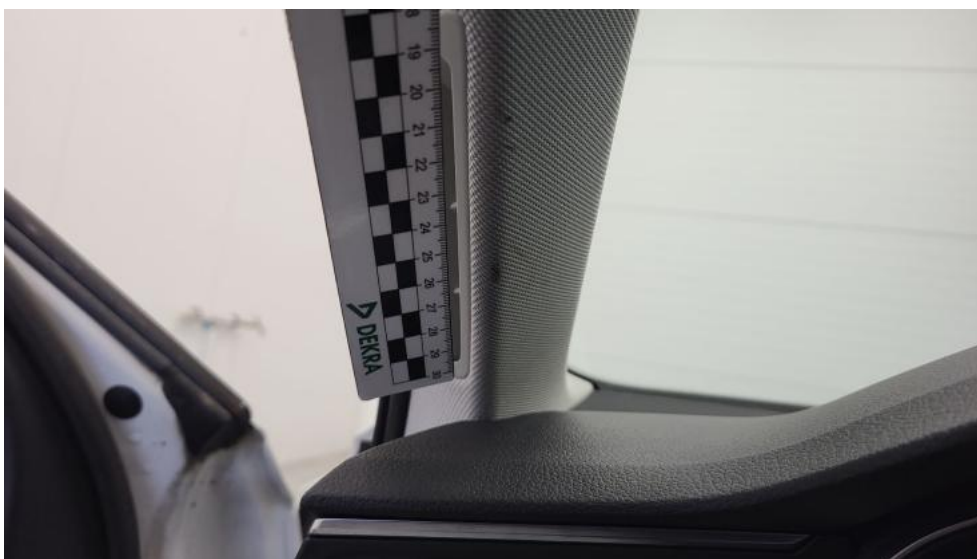
**Photo 75.**

Wykładzina(y) słupka przedniego L - Inne 1
