DEKRA's commission No. : PKOL(W)/LODZ/53965/26/06/11
commission/ damage No. : PS25/02978
Date of commission: 11-06-2026

Vehicle data

Measurement of thickness of the vehicle lacquer coating

PHOTOGRAPHIC DOCUMENTATION

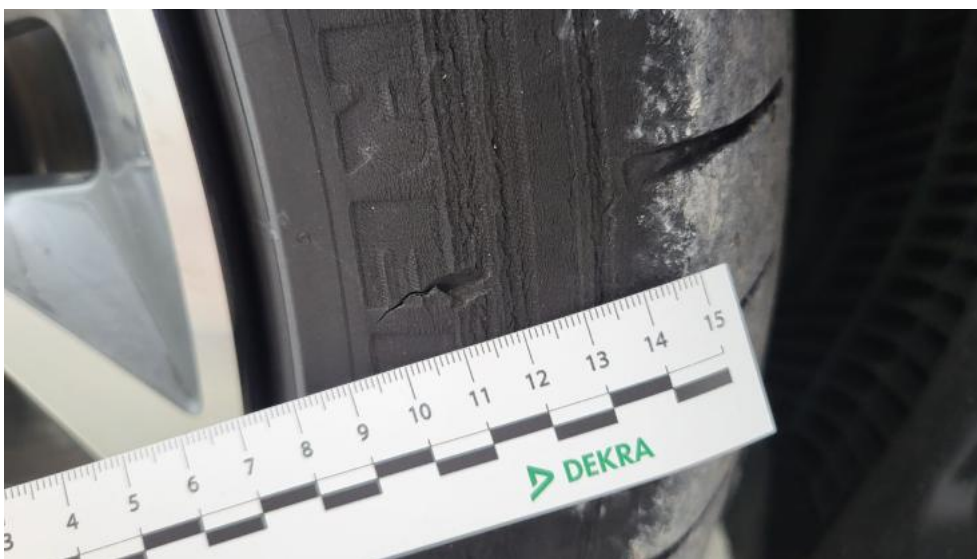
Photo 43.

Opona przednia P - Pęknięcie/rozerwanie 1

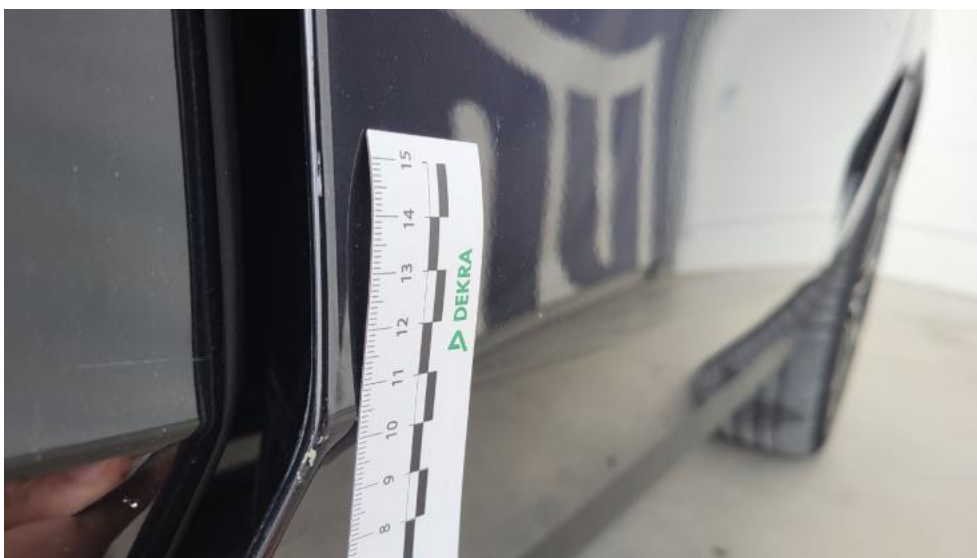
Photo 44.

Drzwi przednie P - Rysa/odprysk 1

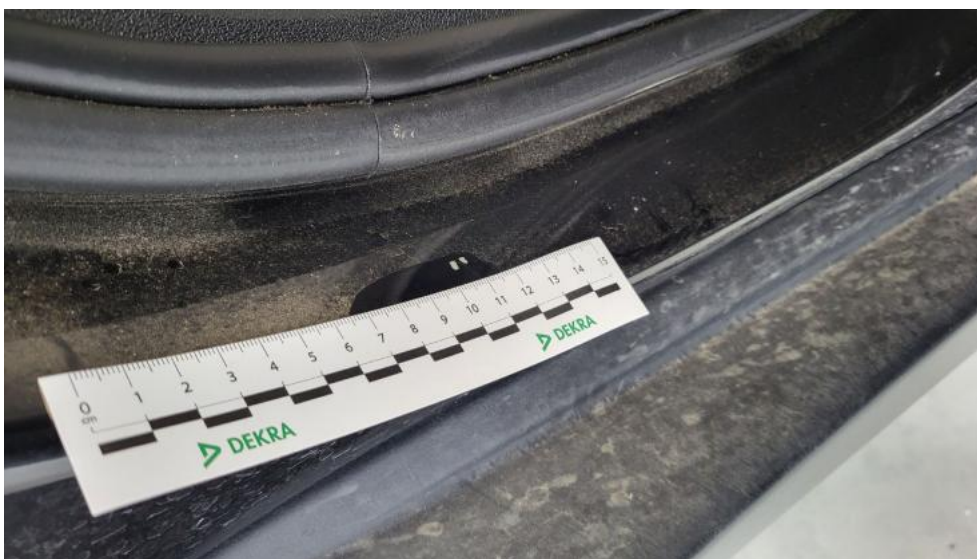
Photo 47.
Próg P - Rysa/odprysk 1

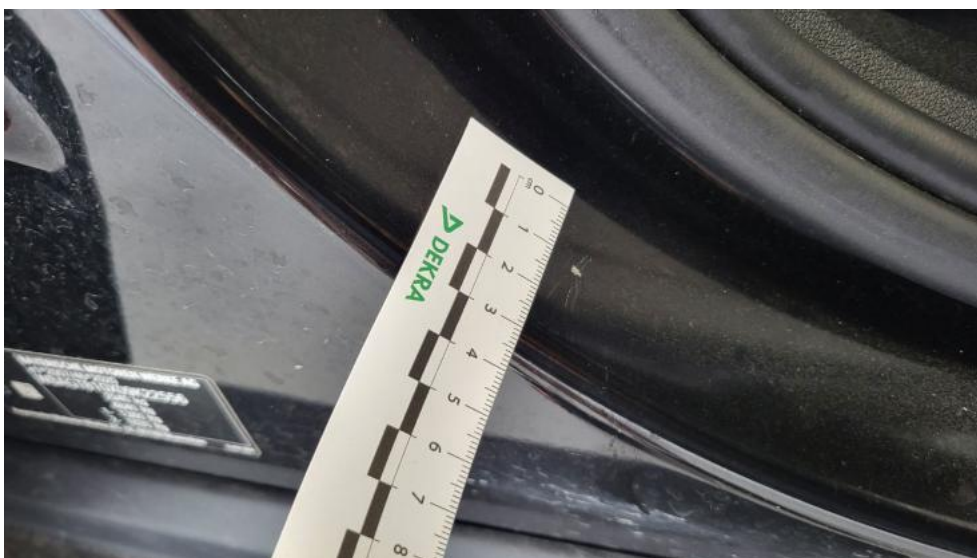
Photo 48.
Słupek środkowy P - Rysa/odprysk 1

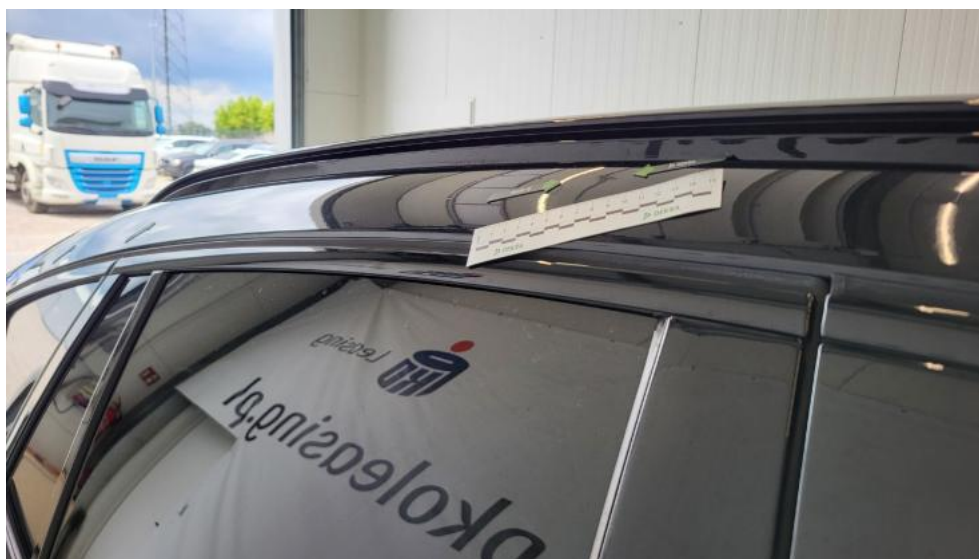
Photo 49.
Błotnik tylny P / Ściana boczna P - Wgniecenie/odkształcenie 1

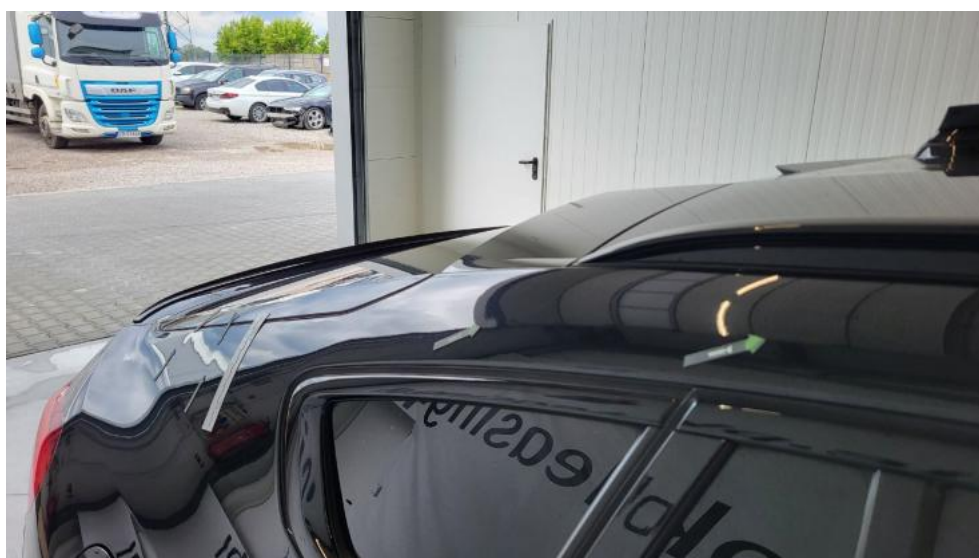
Photo 50.
Błotnik tylny P / Ściana boczna P - Wgniecenie/odkształcenie 2

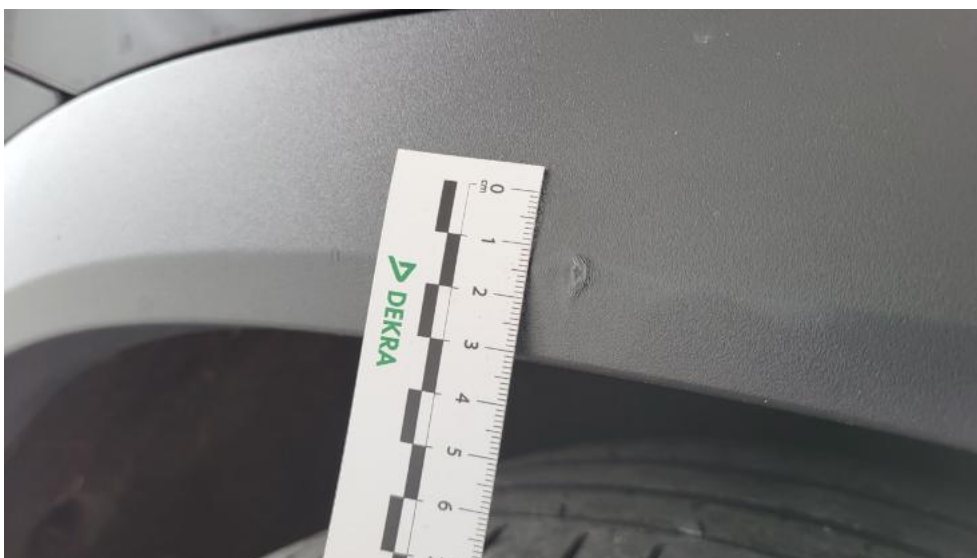
Photo 52.
Listwa krawędzi błotnika tył P - Rysa/odprysk 1

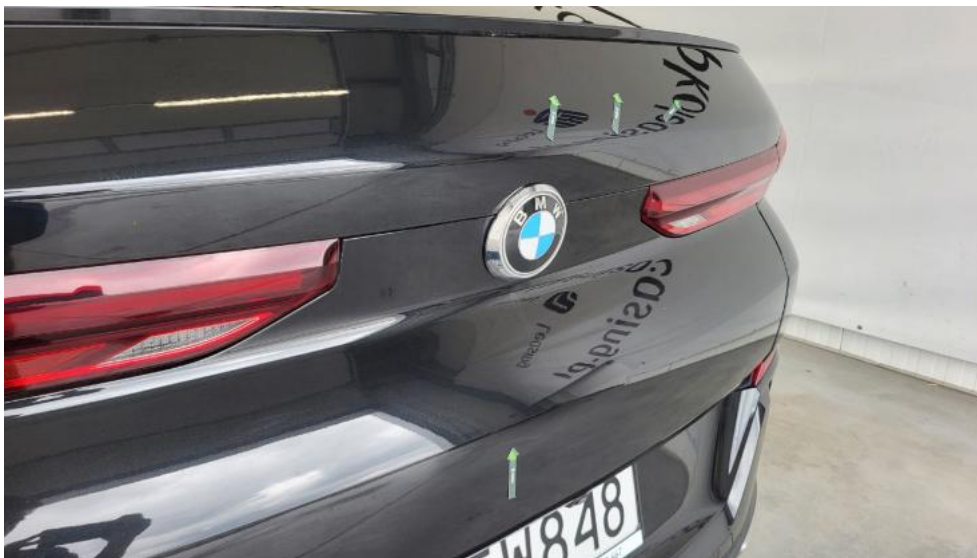
Photo 53.
Pokrywy bagażnika - Wgniecenie/odkształcenie 1

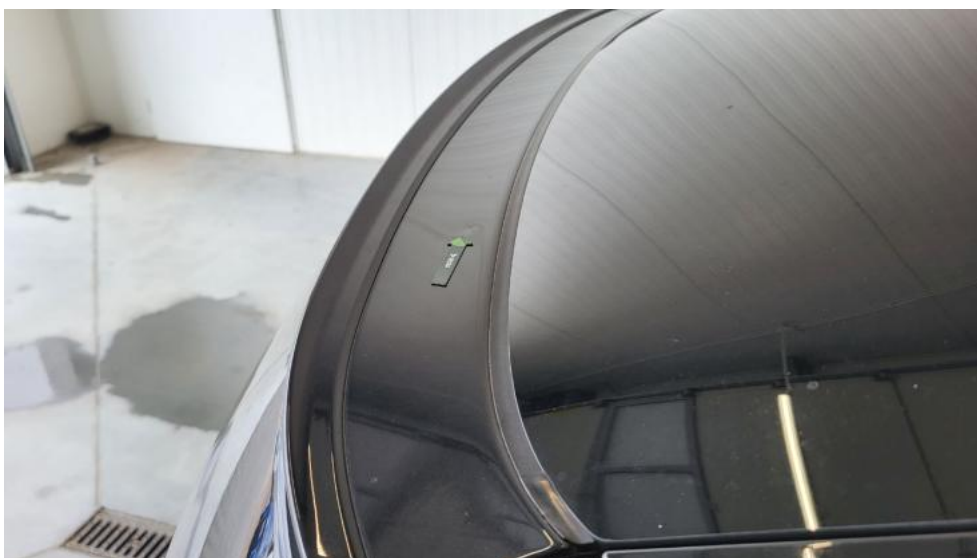
Photo 54.
Pokrywy bagażnika - Wgniecenie/odkształcenie 2

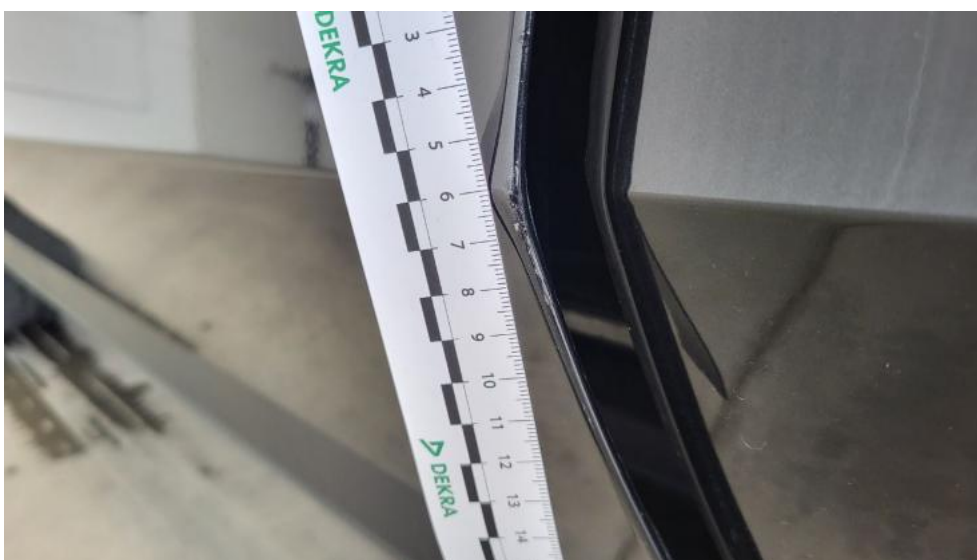
Photo 56.
Drzwi przed L - Rysa/odprysk 1

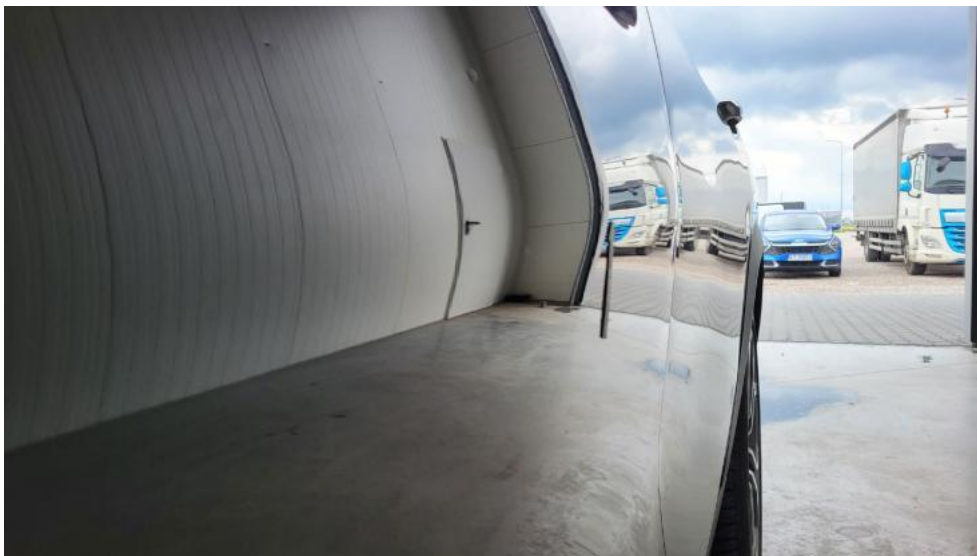
Photo 57.
Drzwi przed L - Wgniecenie/odkształcenie 1

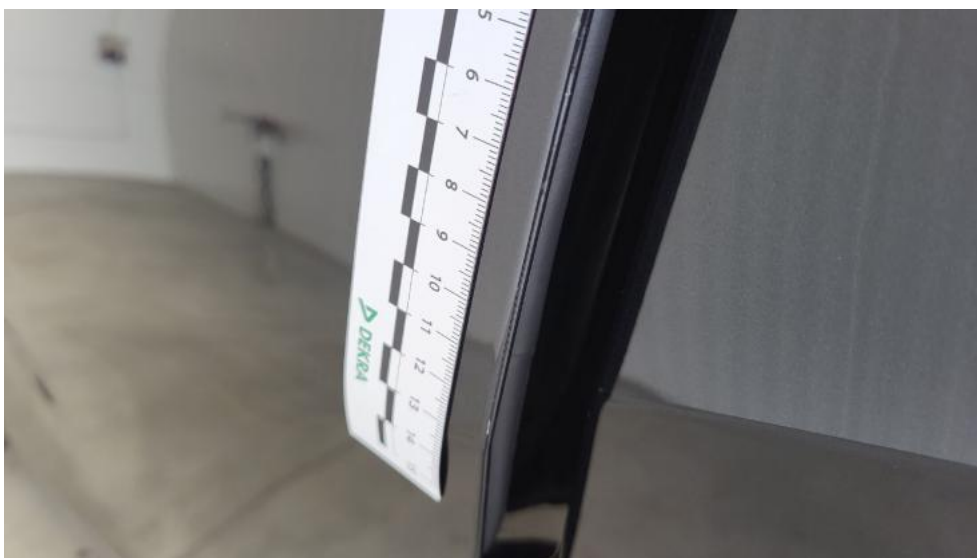
Photo 58.
Drzwi tylne L - Rysa/odprysk 1

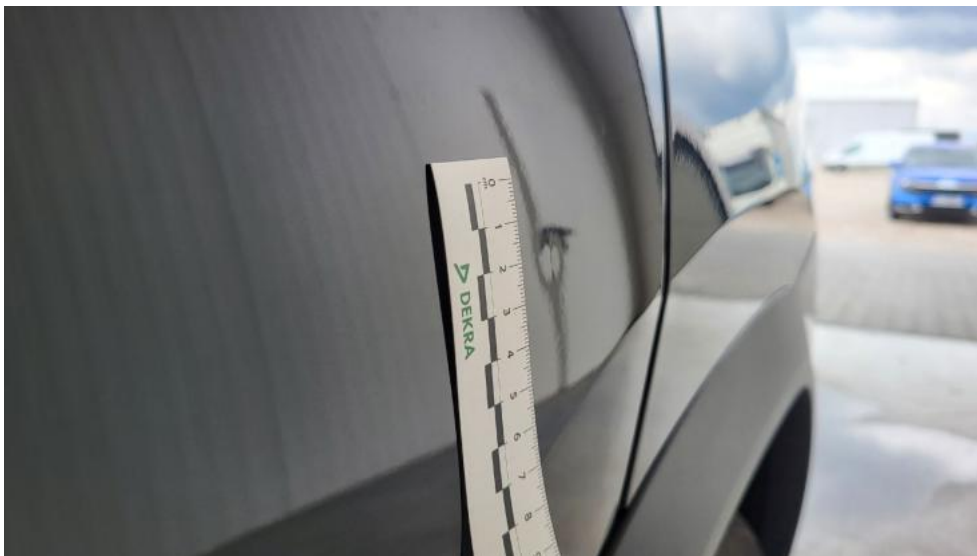
Photo 59.
Drzwi tylne L - Wgniecenie/odkształcenie 1

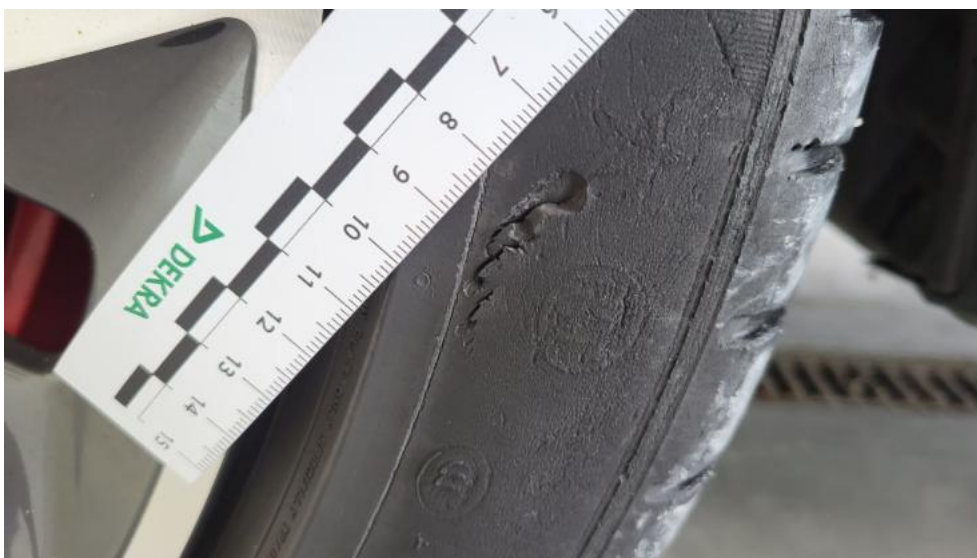
Photo 60.
Opona przednia L - Pęknięcie/rozerwanie 1

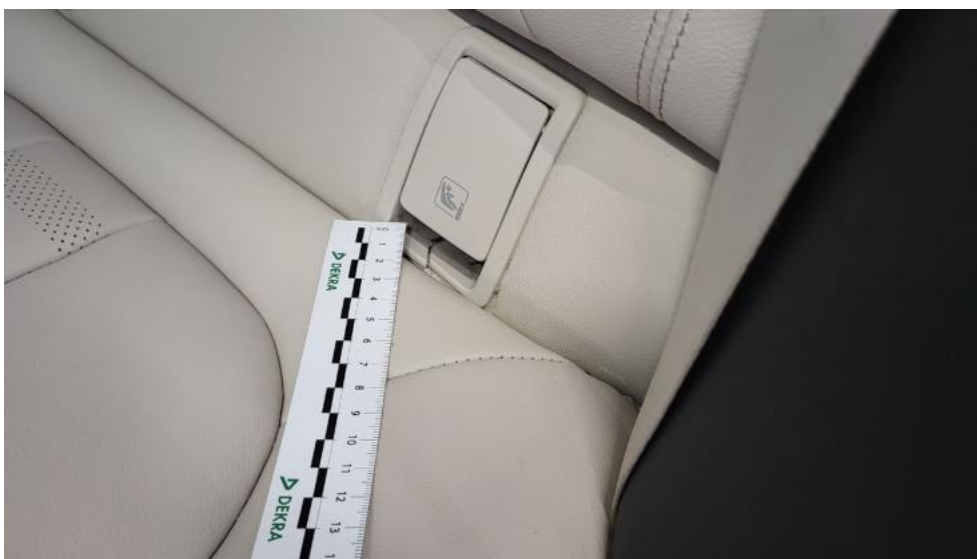
Photo 63.

Kanapa tyl. - Pęknięcie/rozerwanie 1
