DEKRA's commission No. : PKOL(W)/LODZ/13677/25/02/24  
commission/ damage No. : 22/008782  
Date of commission: 24-02-2025

**Vehicle data**

Group of objects (Eurotax)	cars
EC code (Eurotax)	0126688
Manufacturer	SKODA
Model	Rapid Spaceback 17-19
Type / version	Rapid Spb. 1.0 TSI Active
Body type	hatchback
Number of doors / seats	5/5
Curb weight [kg]	1090
Gross vehicle weight [kg]	1625
Wheelbase 1/2	2602
Engine type	spark ignition
Pollution reduction system	three-way catalytic converter
Engine capacity [ccm]	999
Engine Power [hp/kW]	95/70
Gearbox	manual 5- gear
Registration /record No.	PO3XE81
VIN / serial number	TMBEP6NH1J4524013
Date of first registration	10-11-2017
Date of next. tech. test	07-11-2025
Year of manufacture	2017 (year has been verified with the manufacturer's base)
Readout [km]	138 935 (read)
Body color / type of coating	white/UNI

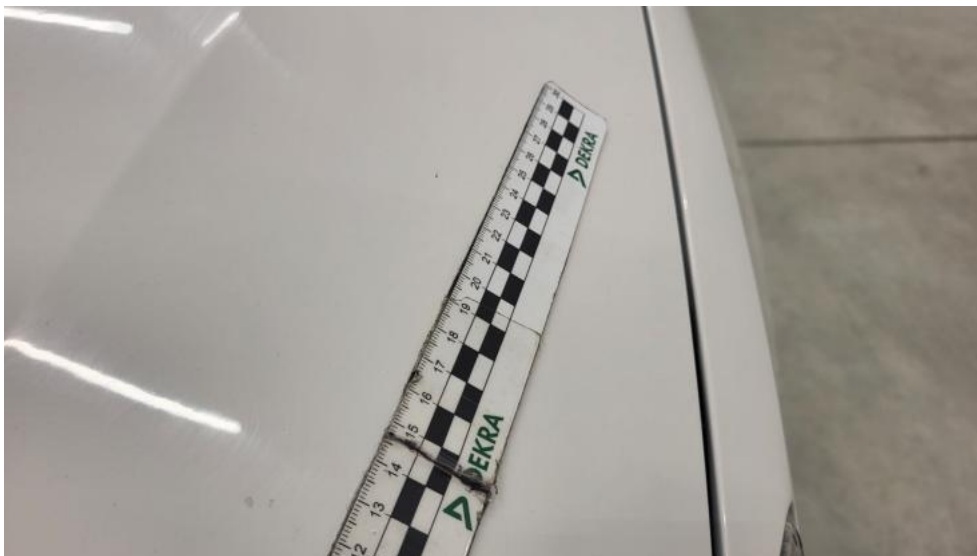
**Photo 31.**  
Pokrywa komory silnika - Rysa/odprysk 1

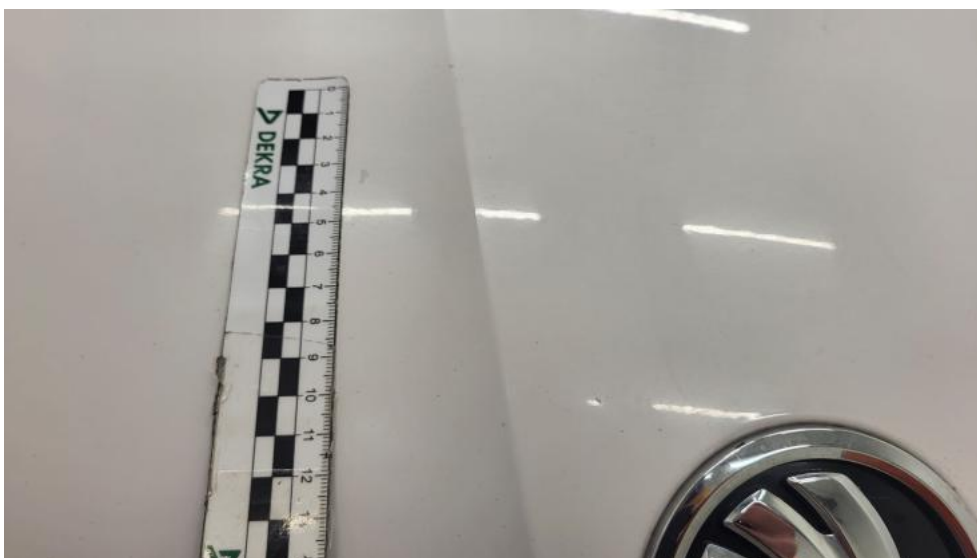
**Photo 32.**  
Pokrywa komory silnika - Rysa/odprysk 2

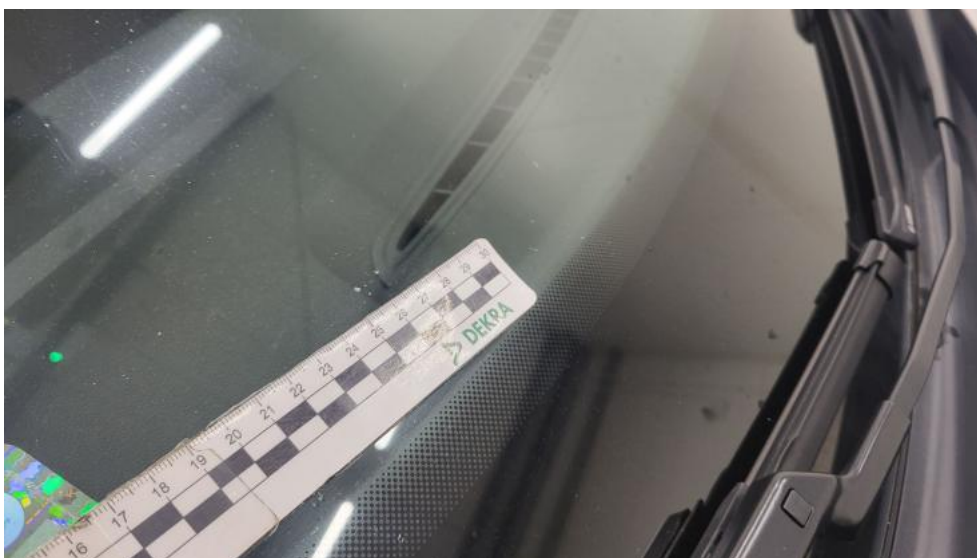
**Photo 34.**  
Szyba czołowa - Rysa/odprysk 2

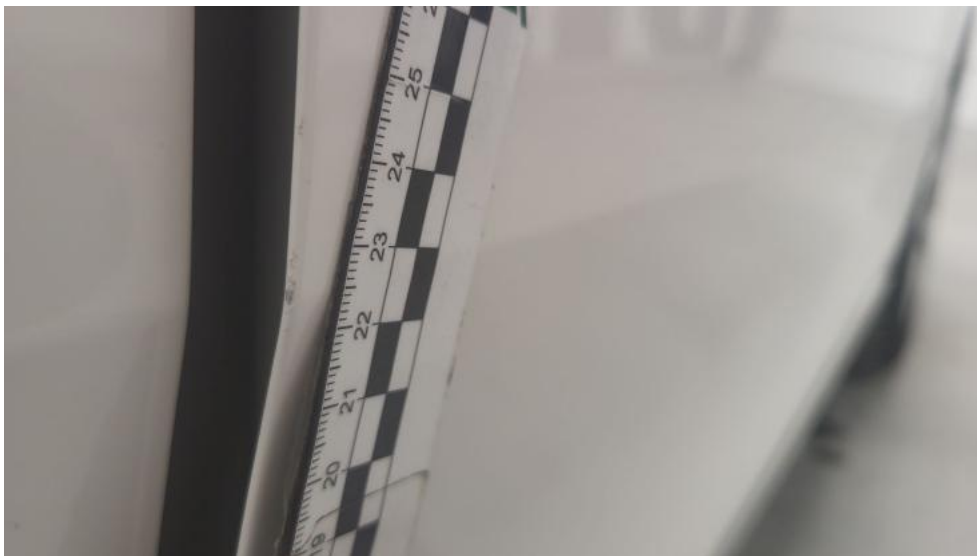
**Photo 37.**

Drzwi przednie P - Rysa/odprysk 1

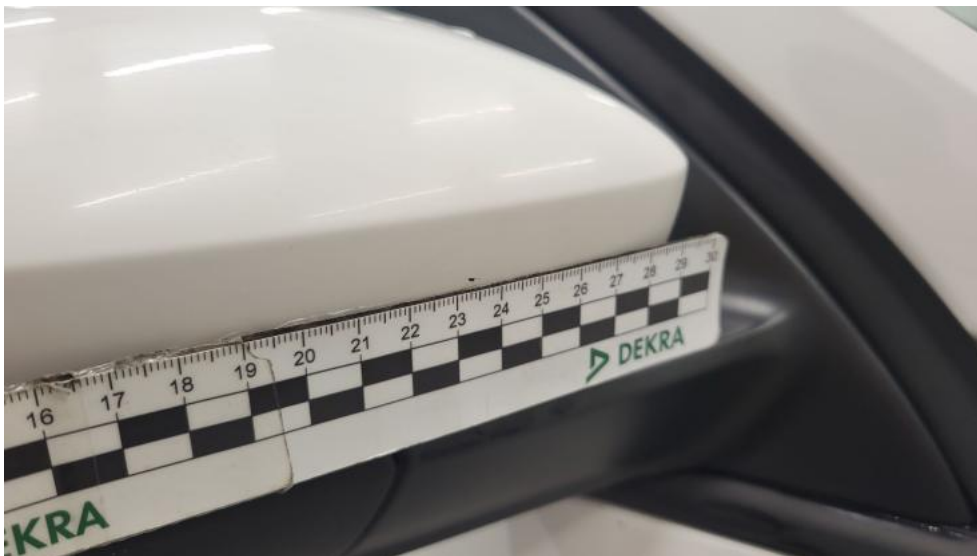
**Photo 39.**

Lusterko zew P - Rysa/odprysk 1

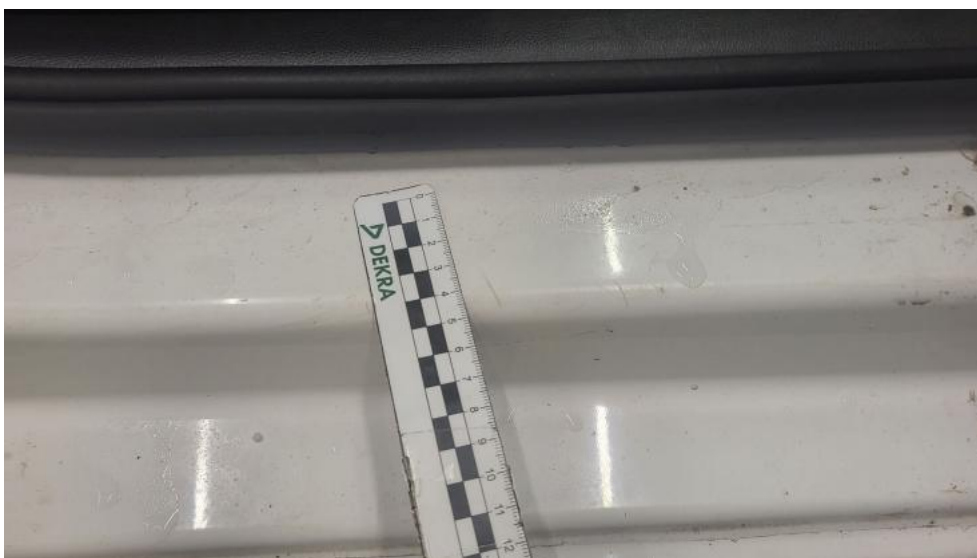
**Photo 40.**

Próg P - Rysa/odprysk 1

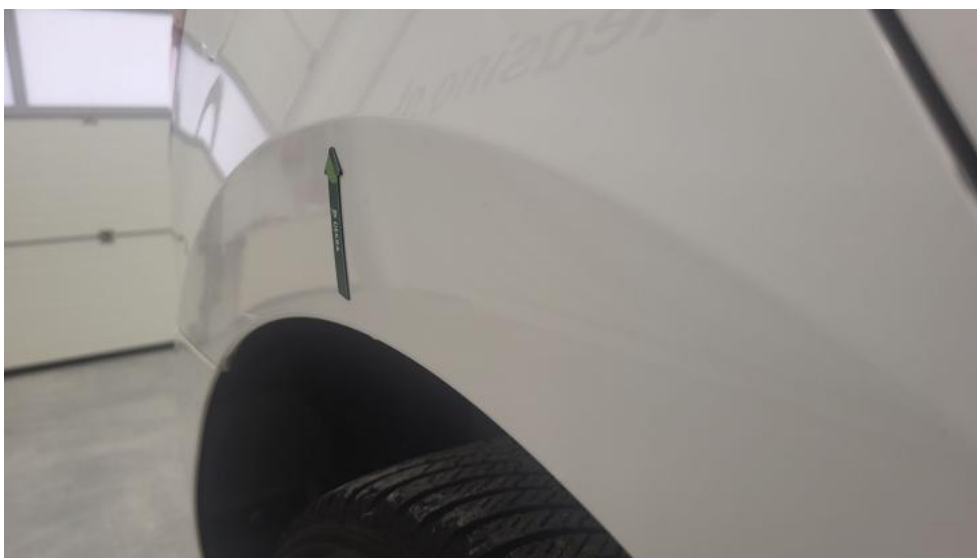
**Photo 42.**  
Błotnik tylny P / Ściana boczna P - Wgniecenie/odkształcenie 1

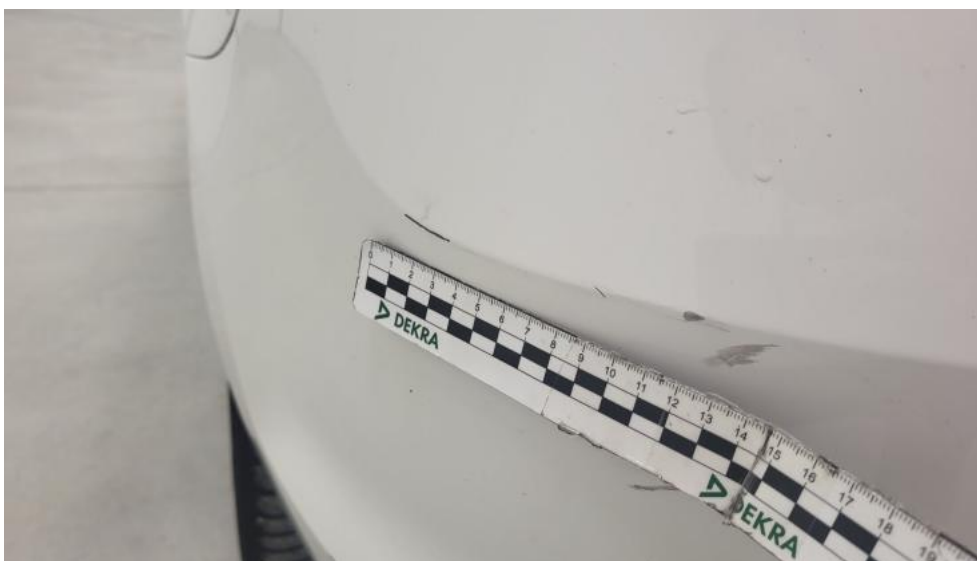
**Photo 45.**

Zderzak tylny - Rysa/odprysk 2

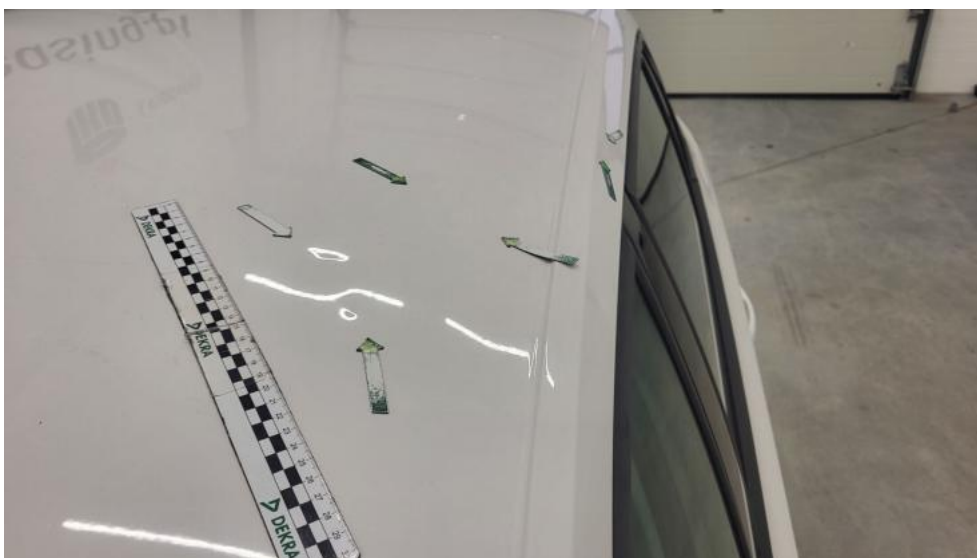
**Photo 46.**

Dach - Wgniecenie/odkształcenie 1

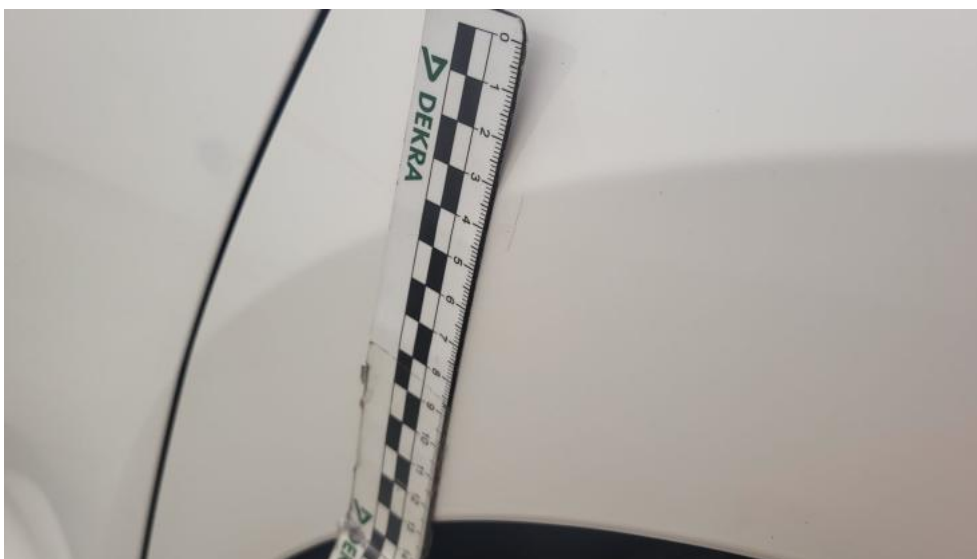
**Photo 49.**  
Błotnik tylny L / Ściana boczna L - Rysa/odprysk 1

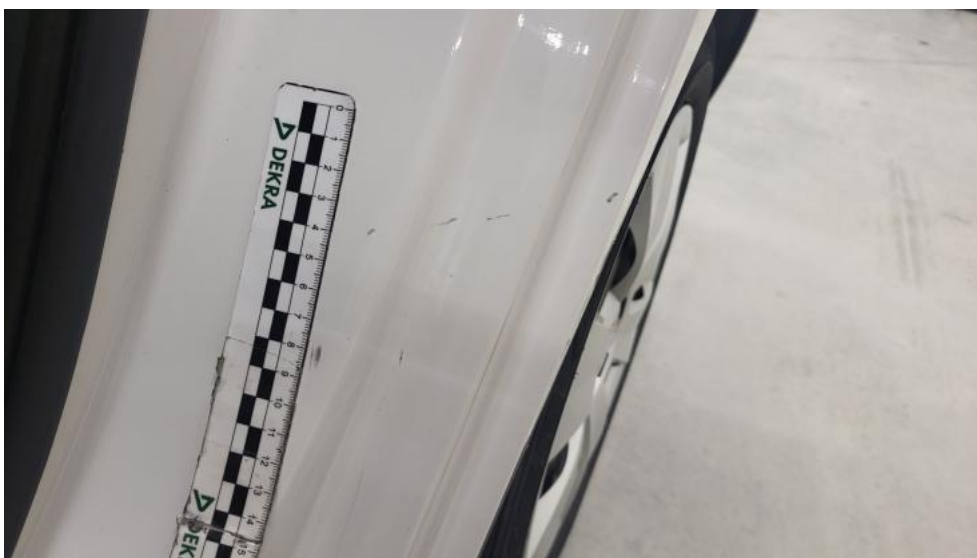
**Photo 50.**  
Błotnik tylny L / Ściana boczna L - Rysa/odprysk 2

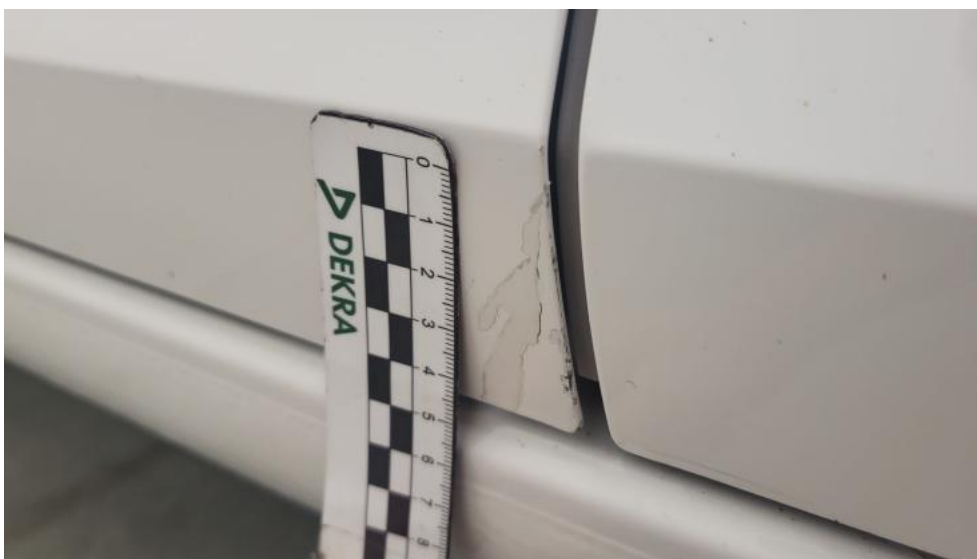
**Photo 51.**

Drzwi przed L - Rysa/odprysk 1

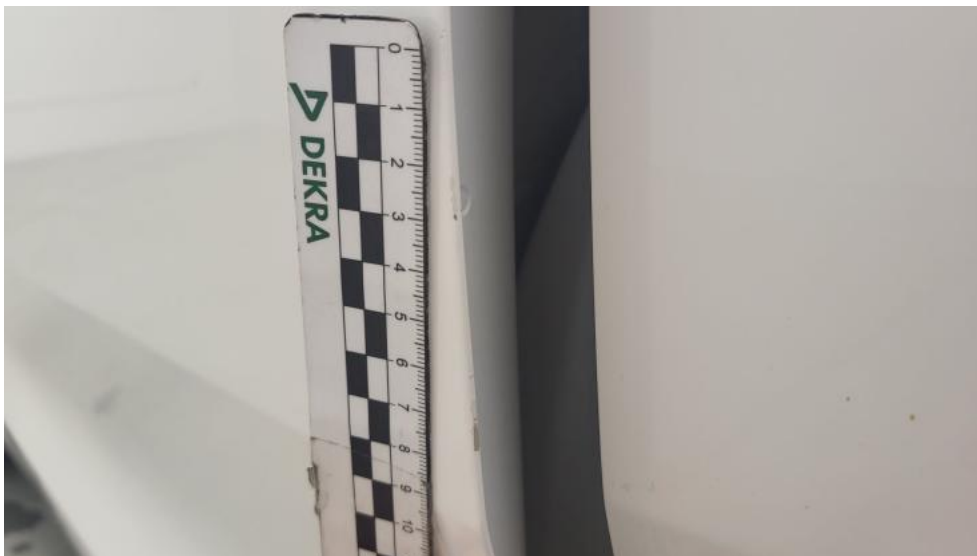
**Photo 53.**

Drzwi przed L() - Rysa/odprysk 3

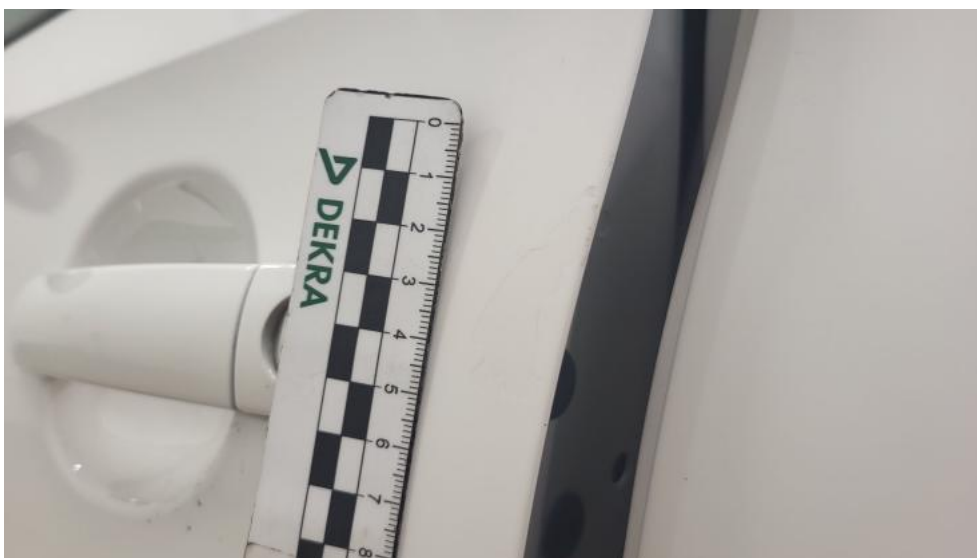
**Photo 54.**

Drzwi przed L - Inne 1

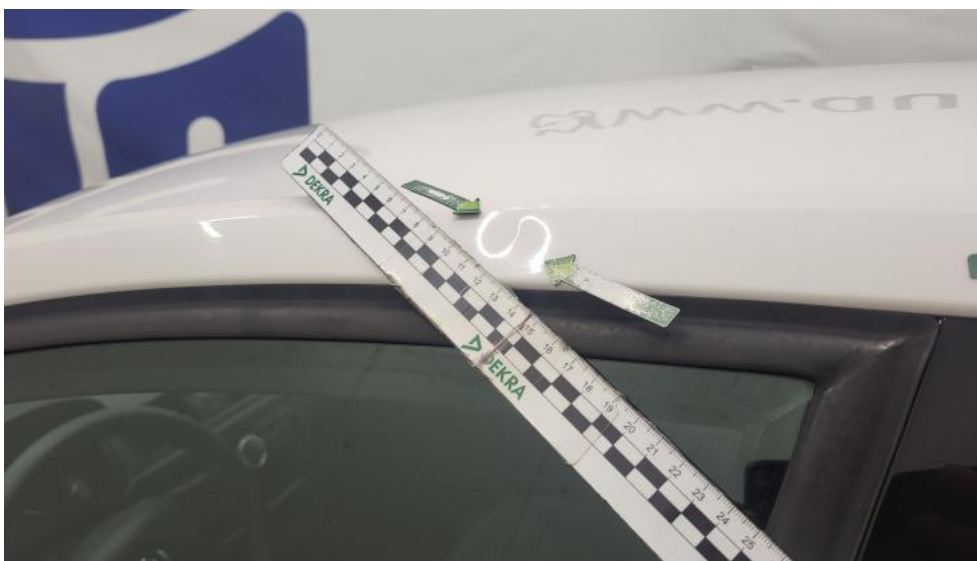
**Photo 59.**  
Stupek przedni L - Wgniecenie/odkształcenie 2

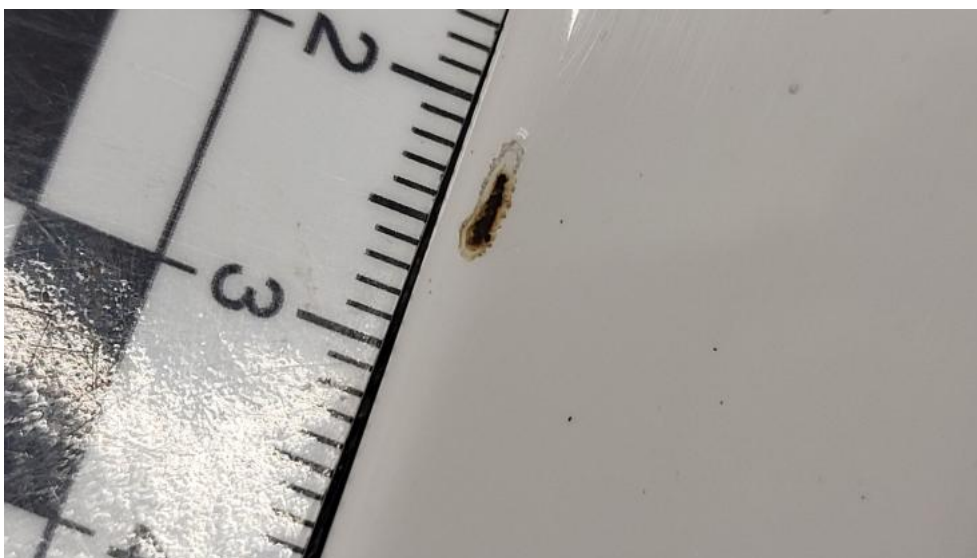
Rysy na samochodzie. Wystający przewód przy lewym przednim słupku.

**Photo 60.**  
Stupek przedni L - Inne 1

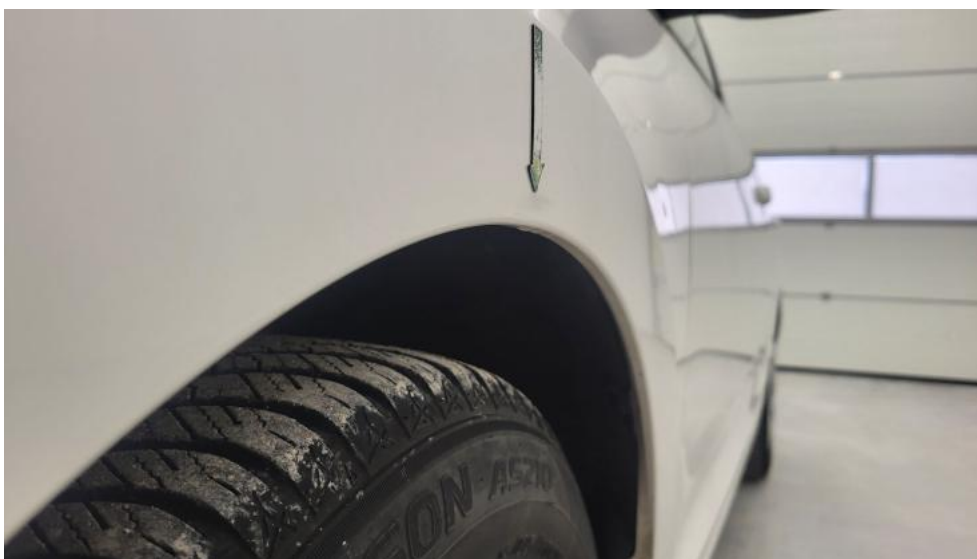
**Photo 61.**  
Błotnik przedni L - Wgniecenie/odkształcenie 1

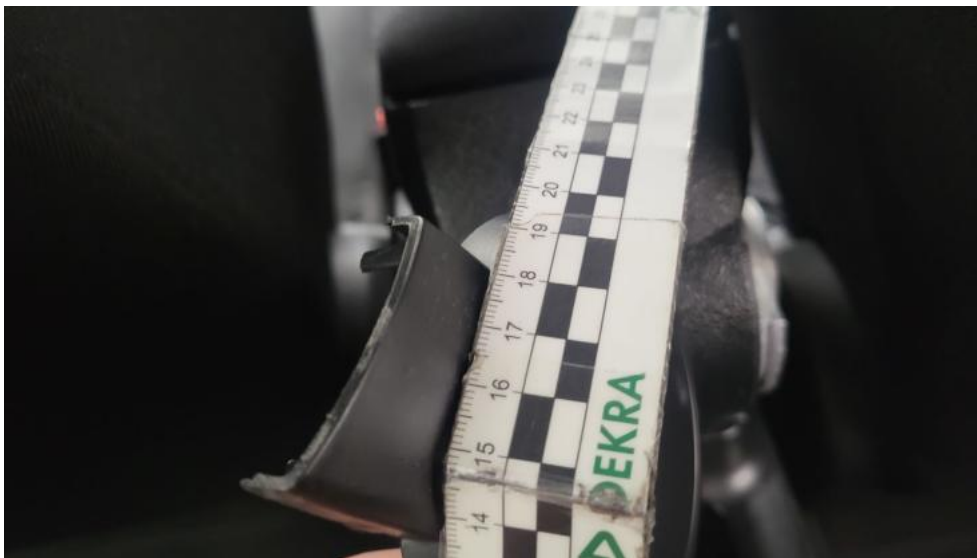
**Photo 63.**

Podłokietnik środkowy przedni - Pęknięcie/rozerwanie 1

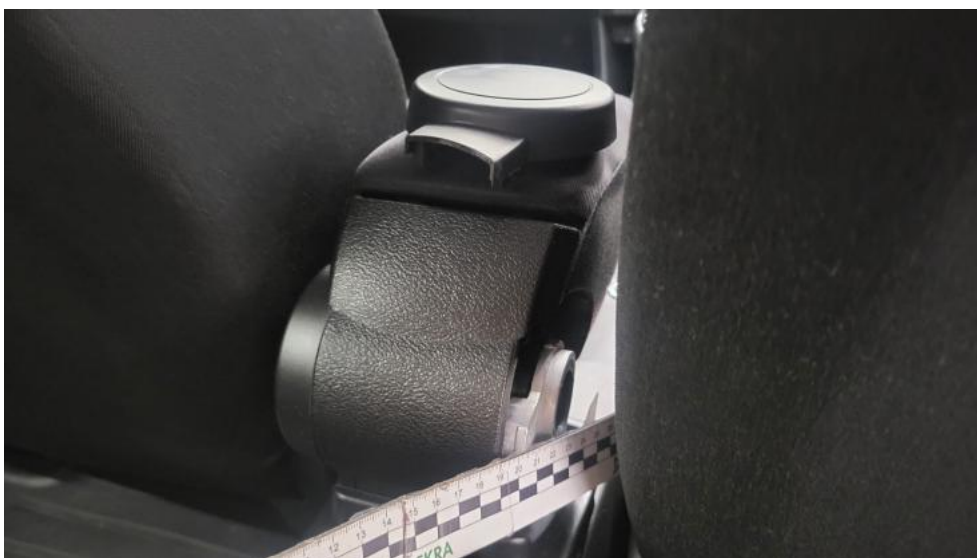
**Photo 64.**

Podłokietnik środkowy przedni - Inne 1

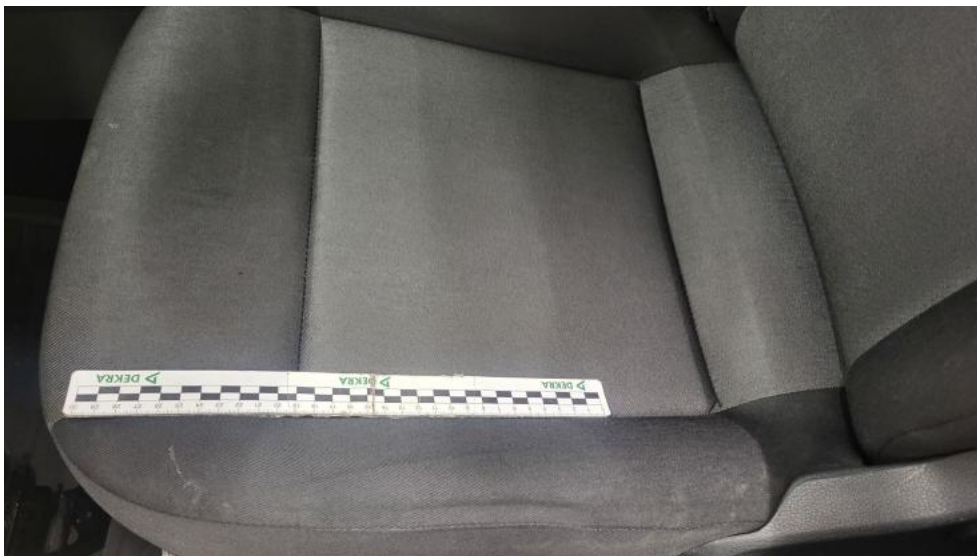
**Photo 65.**  
Fotel prz. lew. - Inne 1

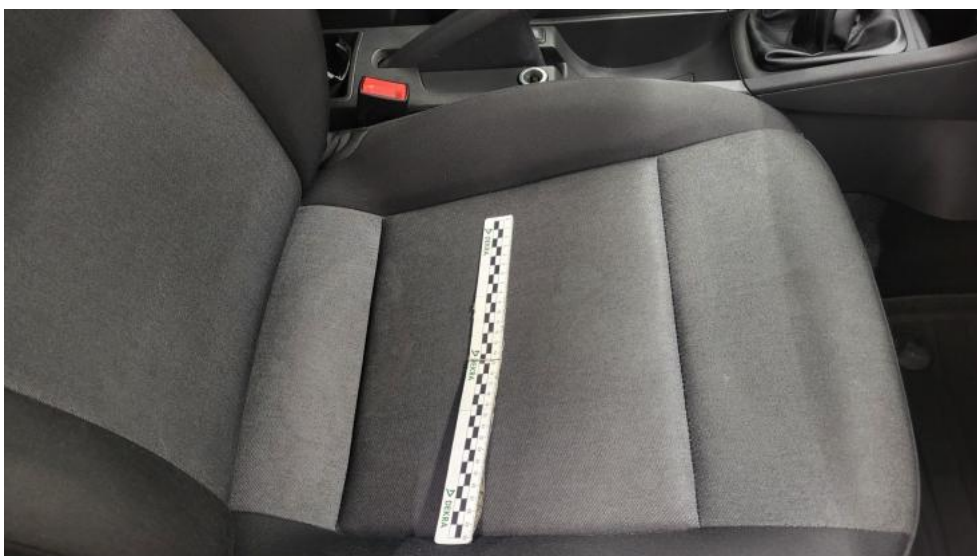
**Photo 66.**  
Fotel prz. praw. - Inne 1

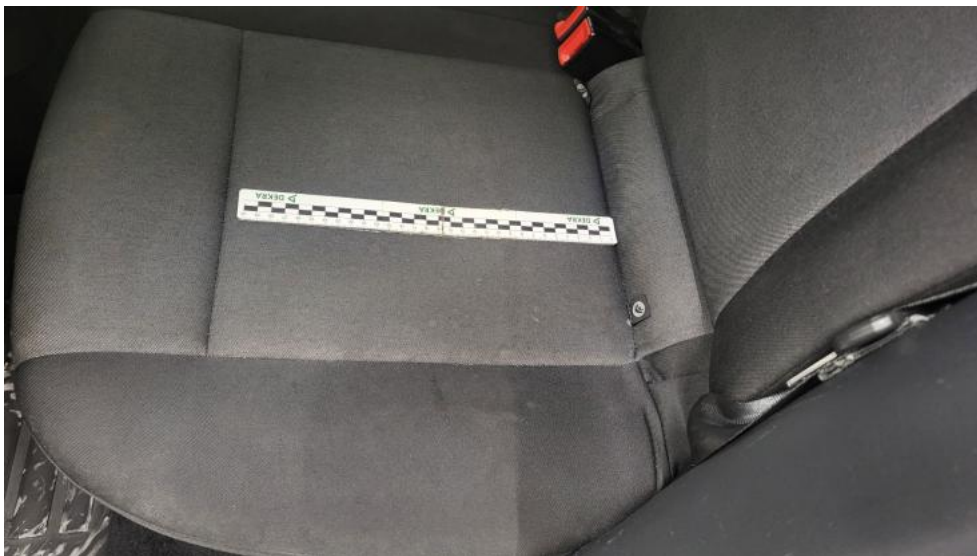
**Photo 67.**  
Kanapa tyl. - Inne 1

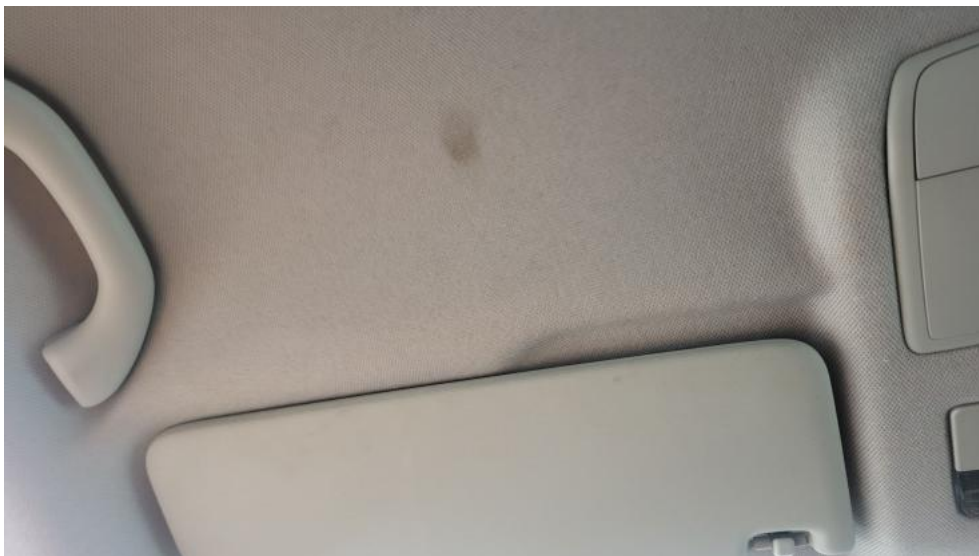
**Photo 71.**  
Podsufitka - Inne 1

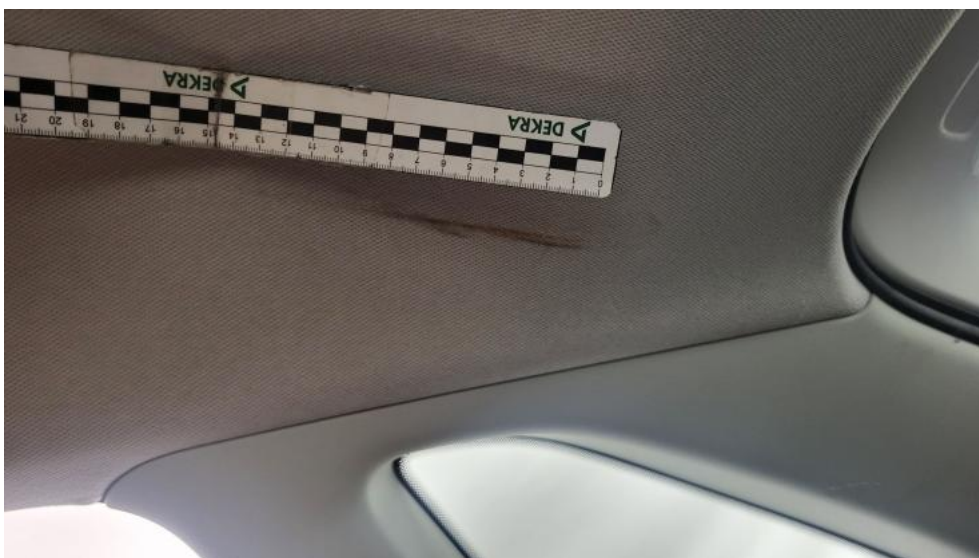
**Photo 72.**  
Podsufitka - Inne 2

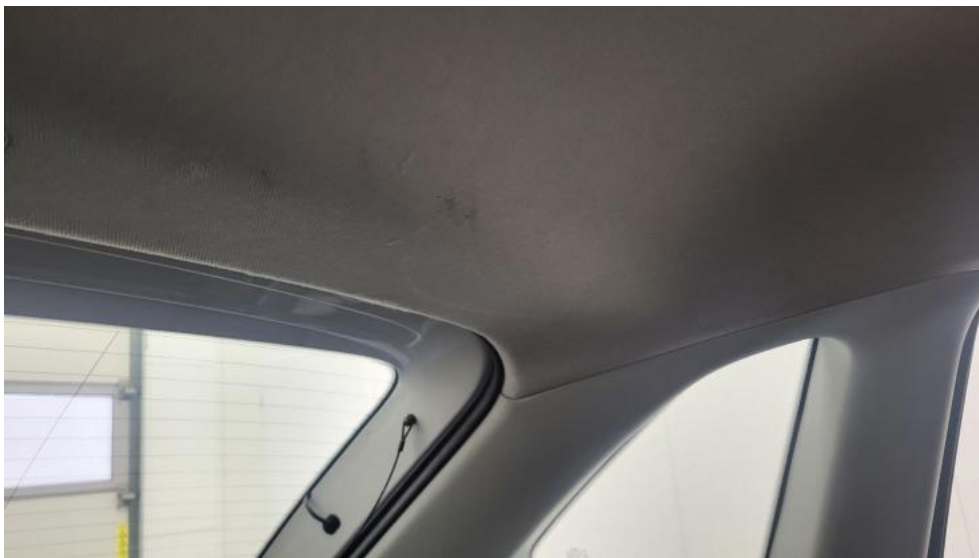
**Photo 73.**  
Podsufitka() - Inne 3
