DEKRA's commission No. : PKOL(W)/LODZ/98690/26/10/21  
commission/ damage No. : 21/040822  
Date of commission: 21-10-2026

| Manufacturer | KIA |
| Model | ProCeed 21-25 |
| Registration /record No. | KR5WU33 |

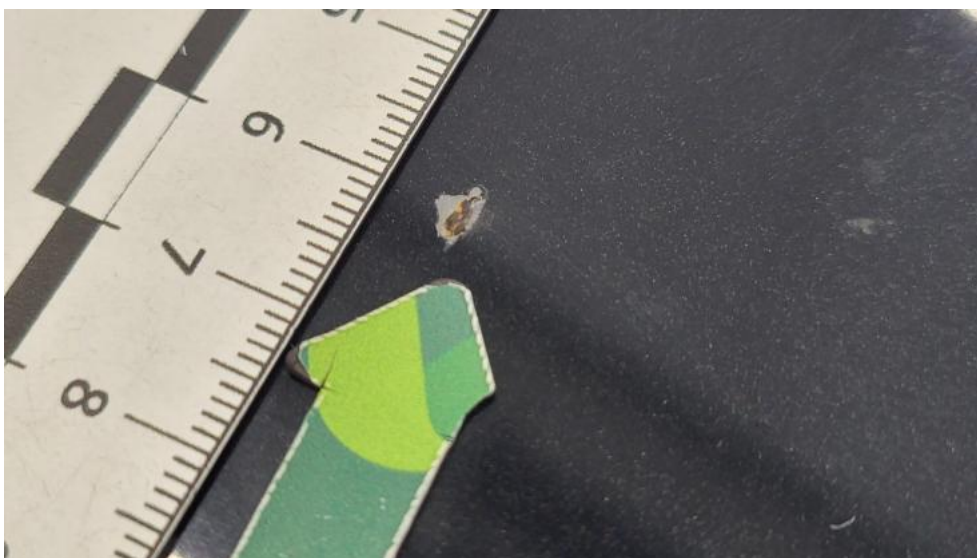
Pokrywa komory silnika - Inne 1

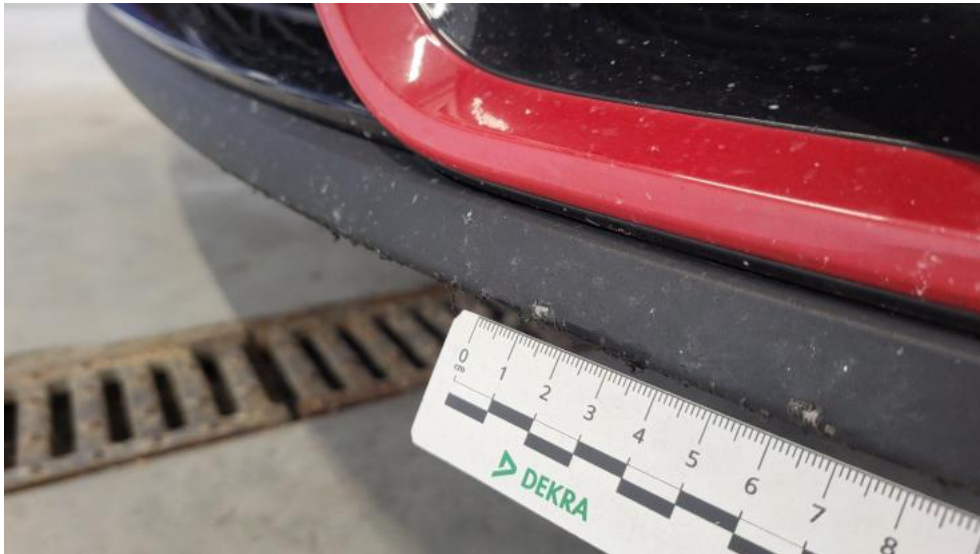
Spoiler zderzaka przedniego - Rysa/odprysk 1

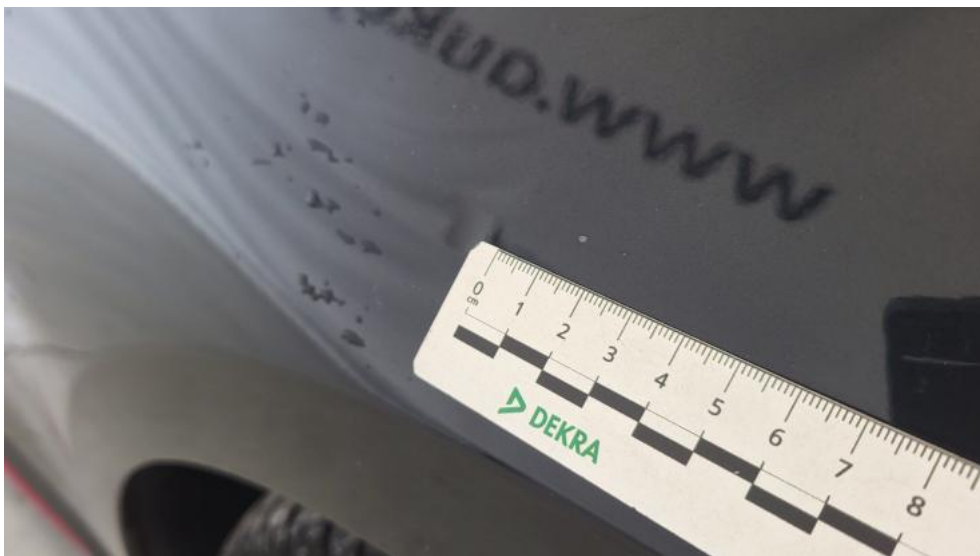
Łotnik przedni P - Rysa/odprysk 1

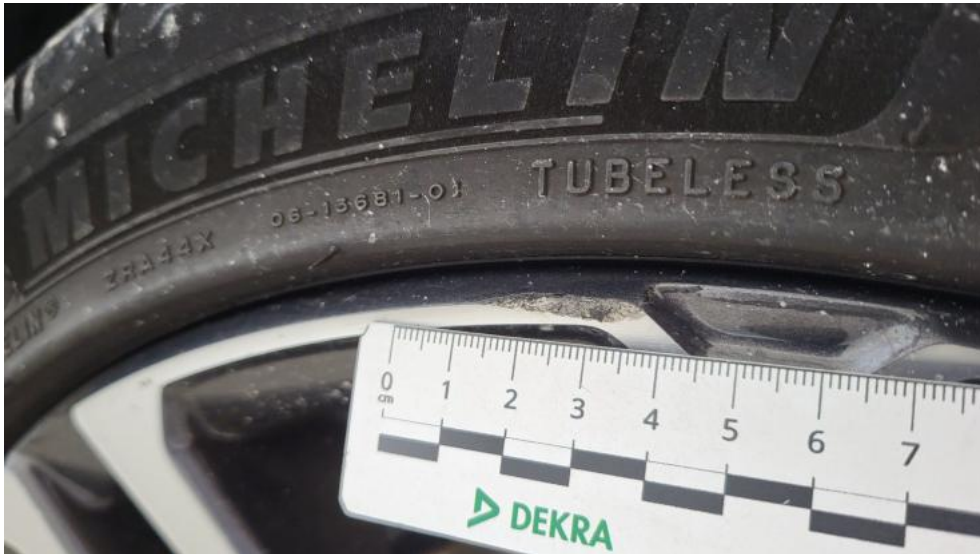
Felga aluminiowa przednia P - Rysa/odprysk 1

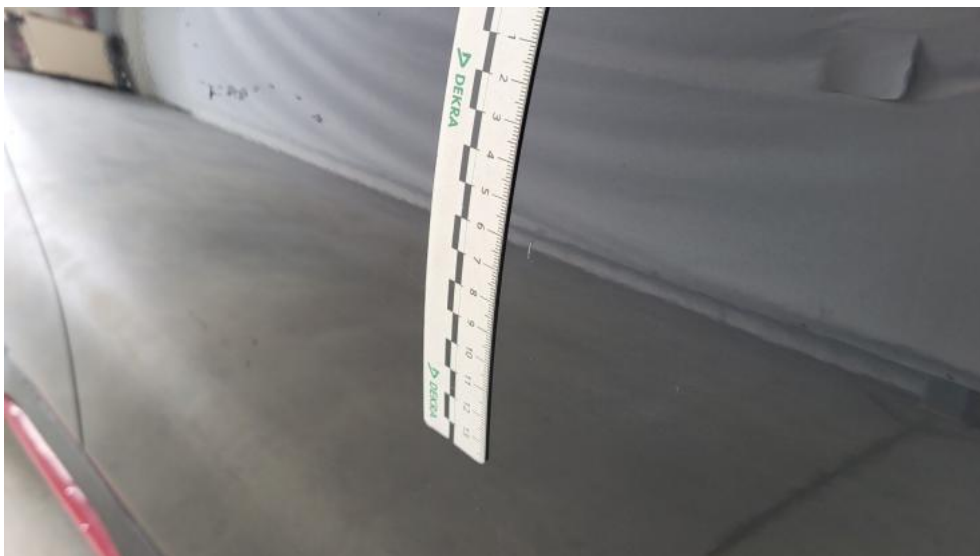
Drzwi przednie P - Rysa/odprysk 1

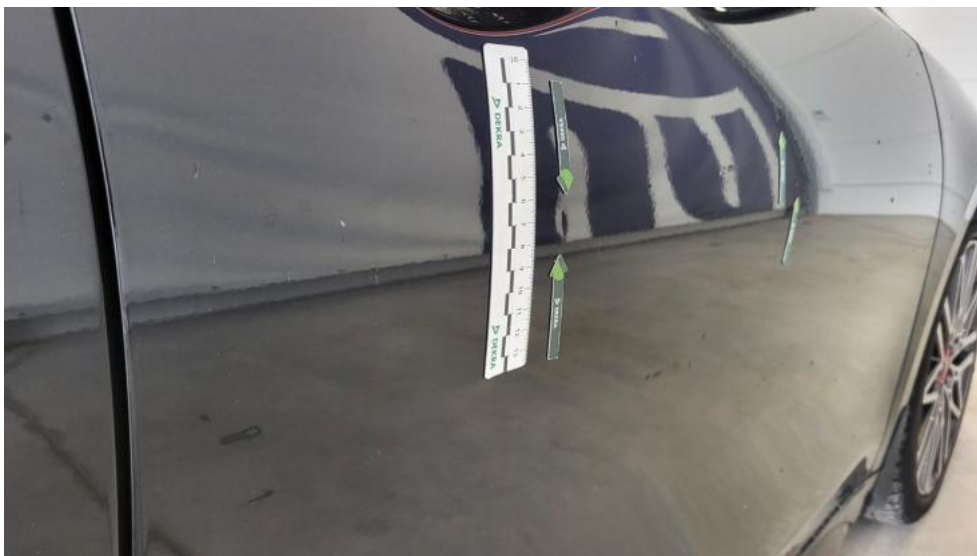
Drzwi przednie P - Wgniecenie/odkształcenie 1

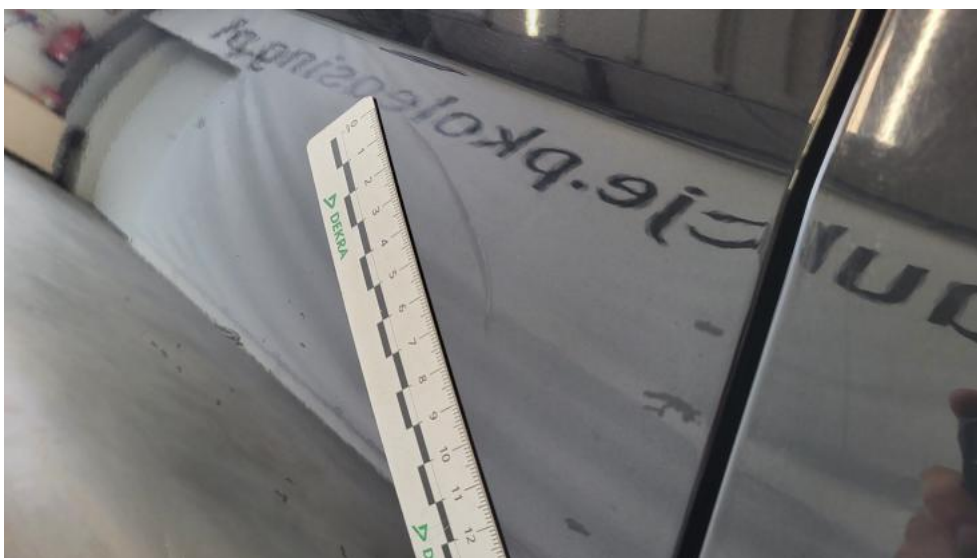
Drzwi tylne P - Rysa/odprysk 1

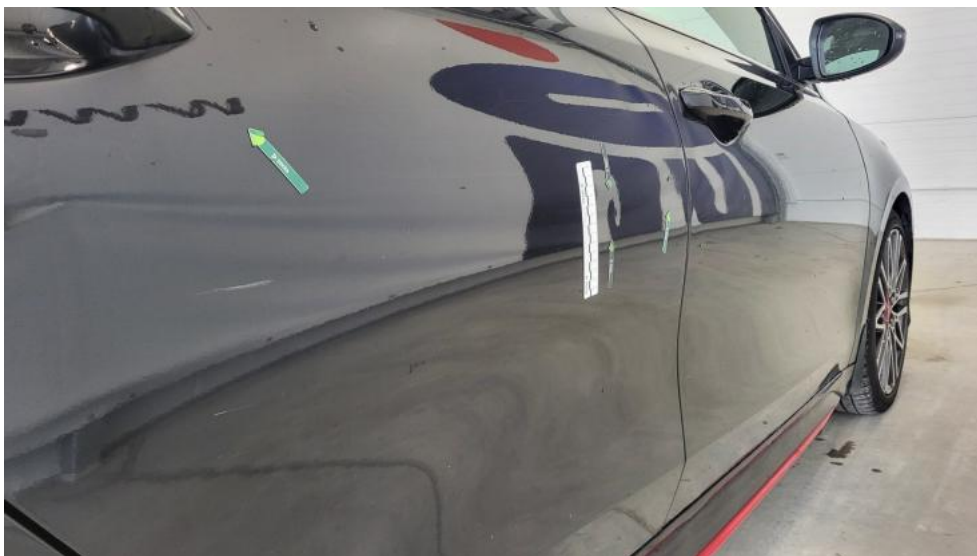
Drzwi tylne P - Wgniecenie/odkształcenie 1

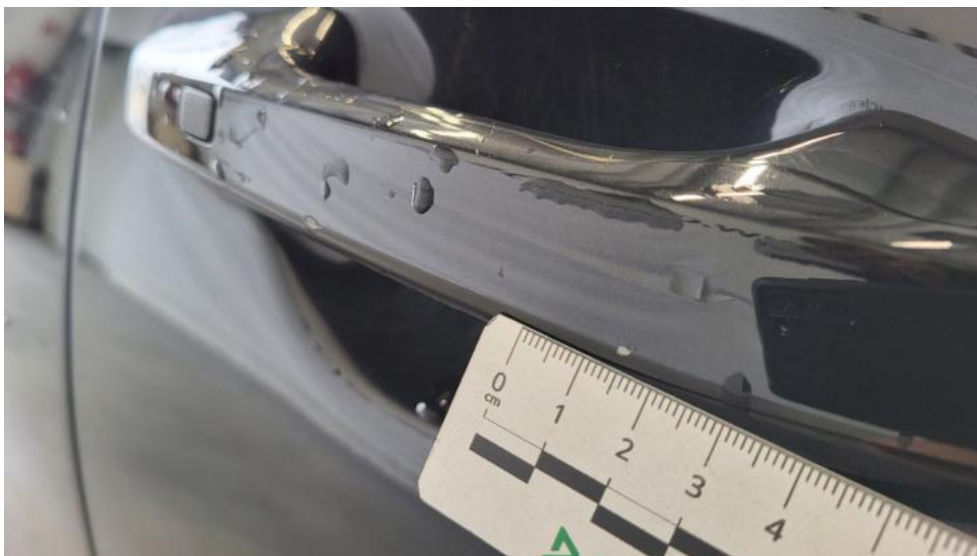
Klamka drzwi prz P - Rysa/odprysk 1

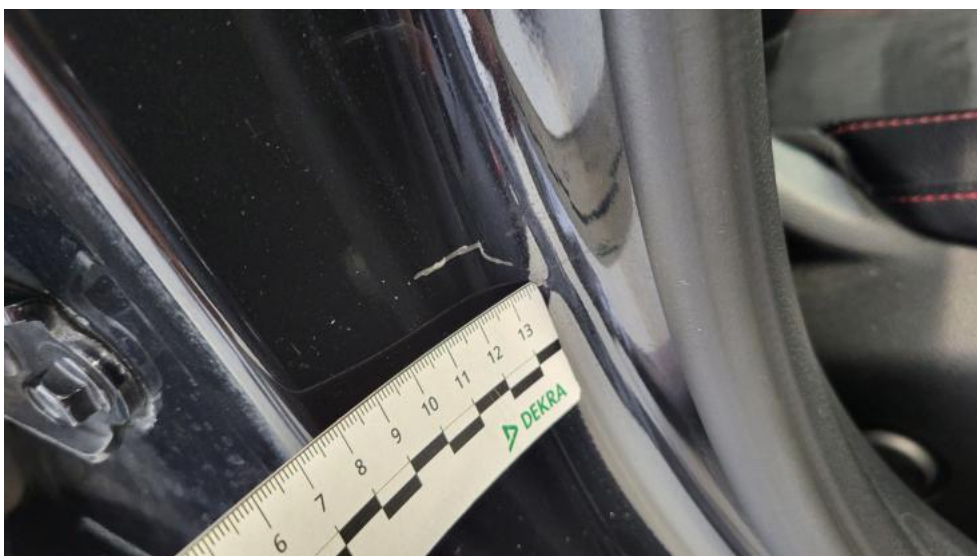
Słupek środkowy P - Rysa/odprysk 1

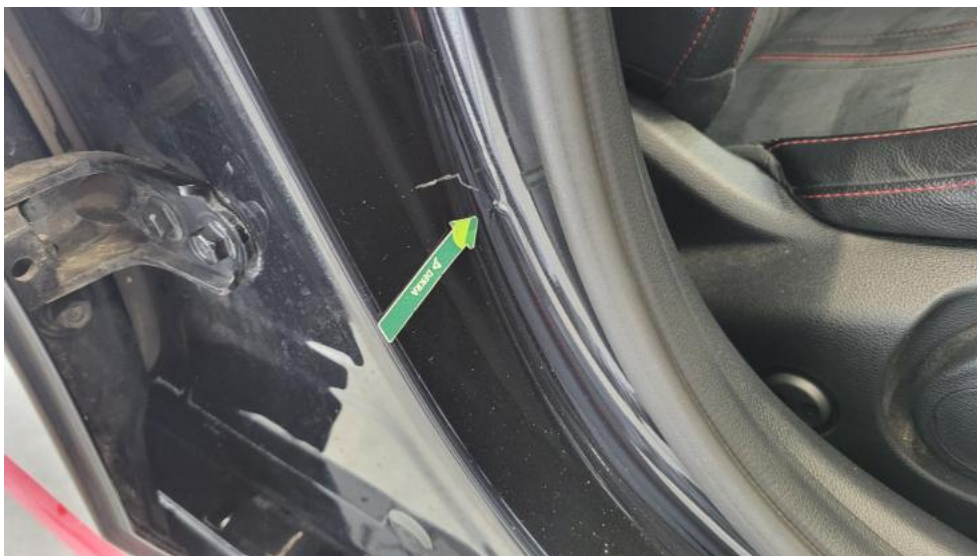
Stupek środkowy P - Wgniecenie/odkształcenie 1

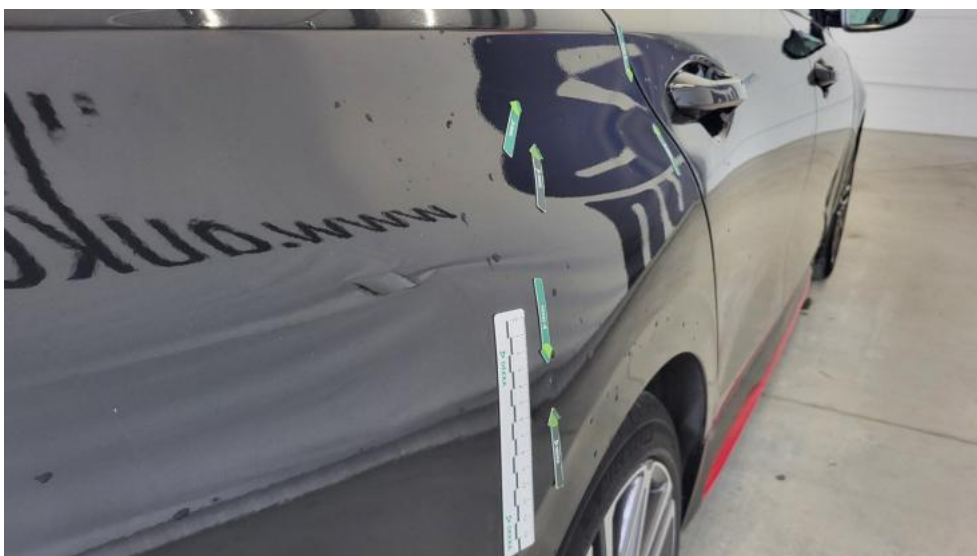
Błotnik tylny P / Ściana boczna P - Wgniecenie/odkształcenie 1

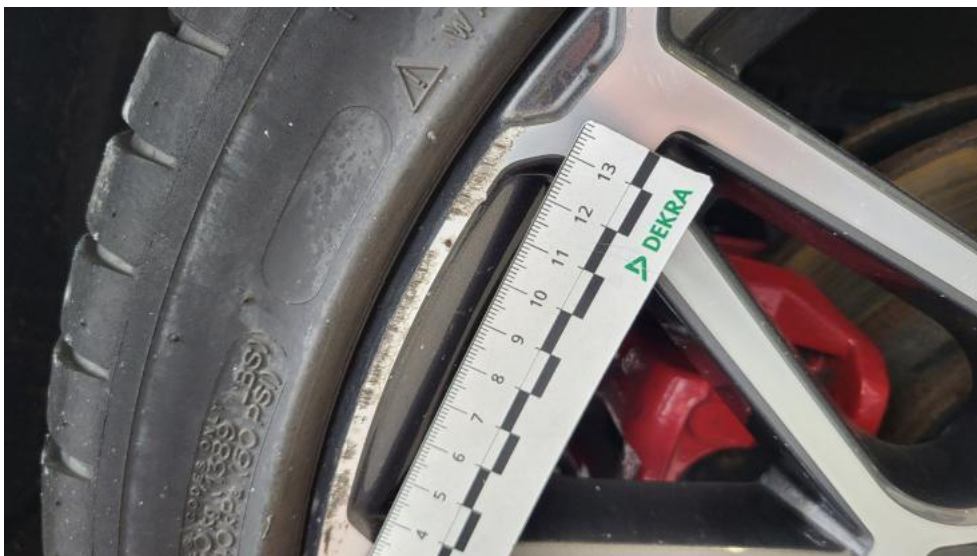
Felga aluminiowa tylna P - Rysa/odprysk 1

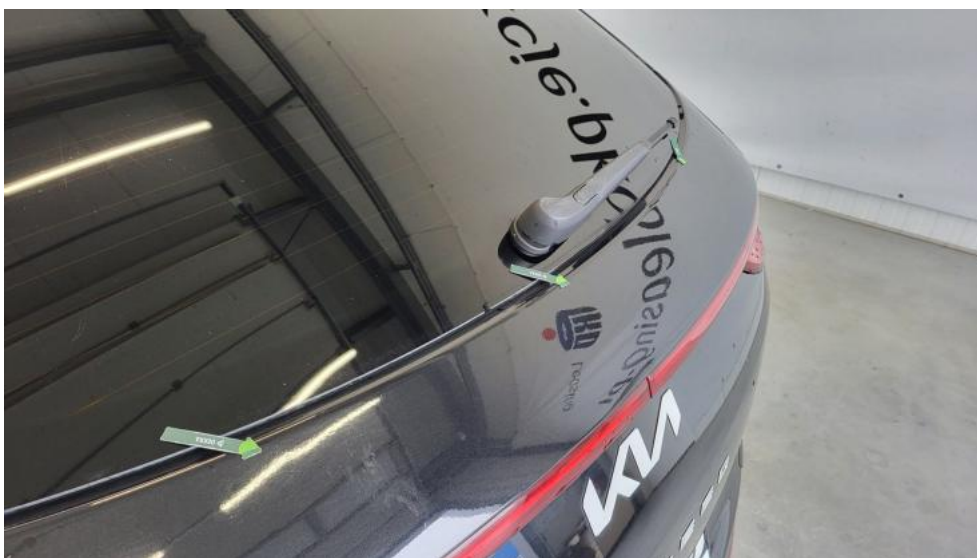
Pokrywy bagażnika - Wgniecenie/odkształcenie 1

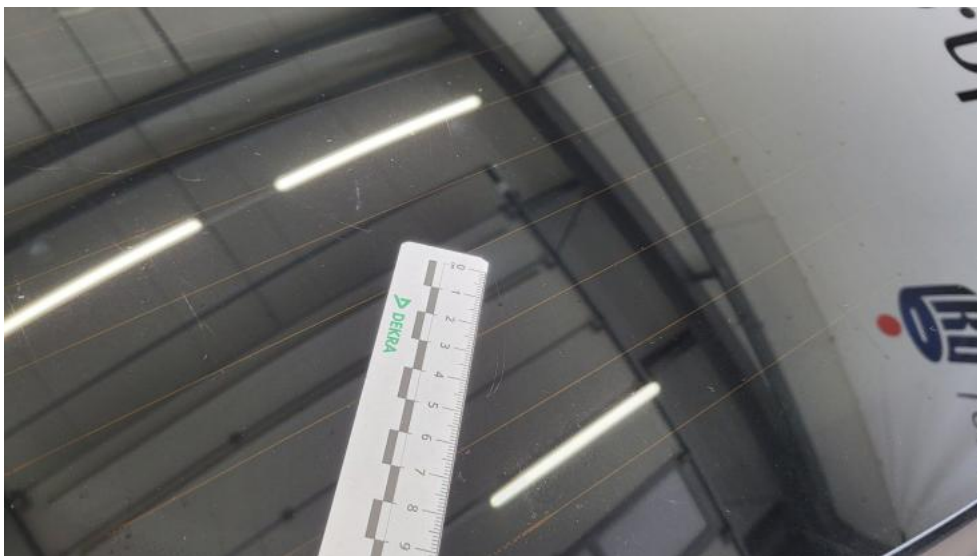
Szyba tylna - Rysa/odprysk 1

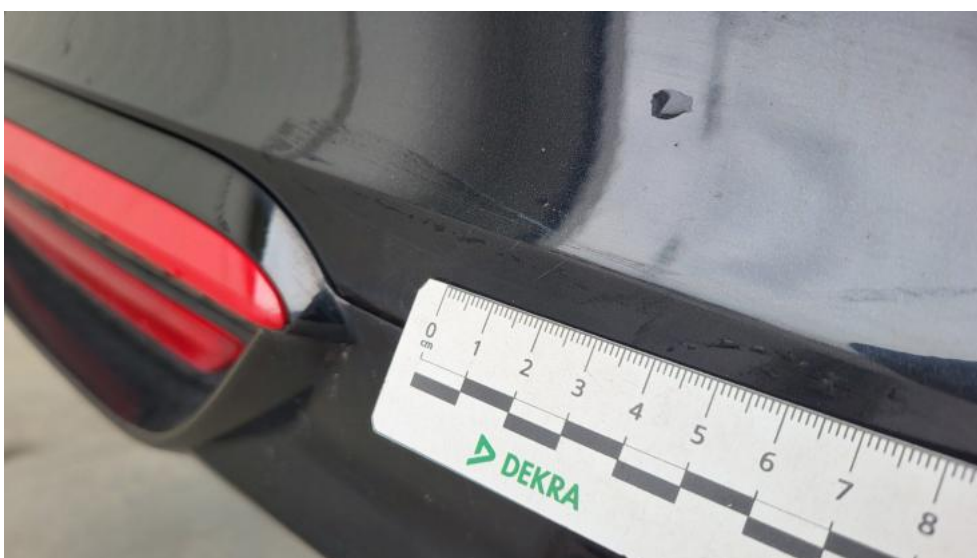
Zderzak tylny - Rysa/odprysk 1

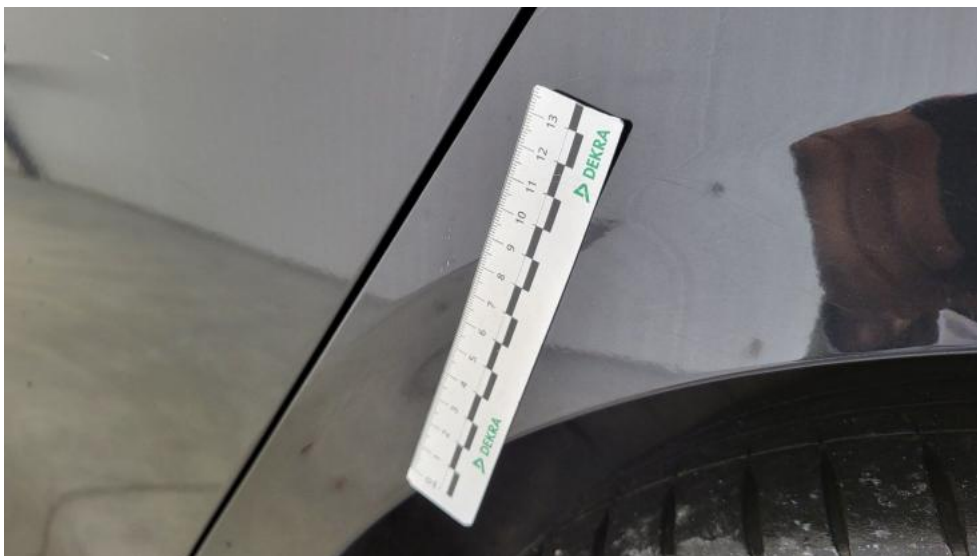
Błotnik tylny L / Ściana boczna L - Rysa/odprysk 1

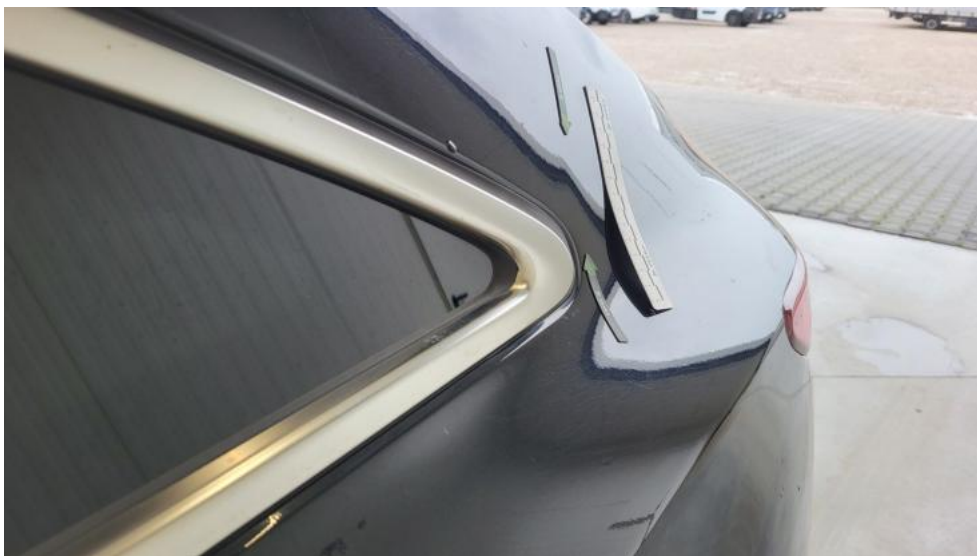
Błotnik tylny L / Ściana boczna L - Wgniecenie/odkształcenie 1

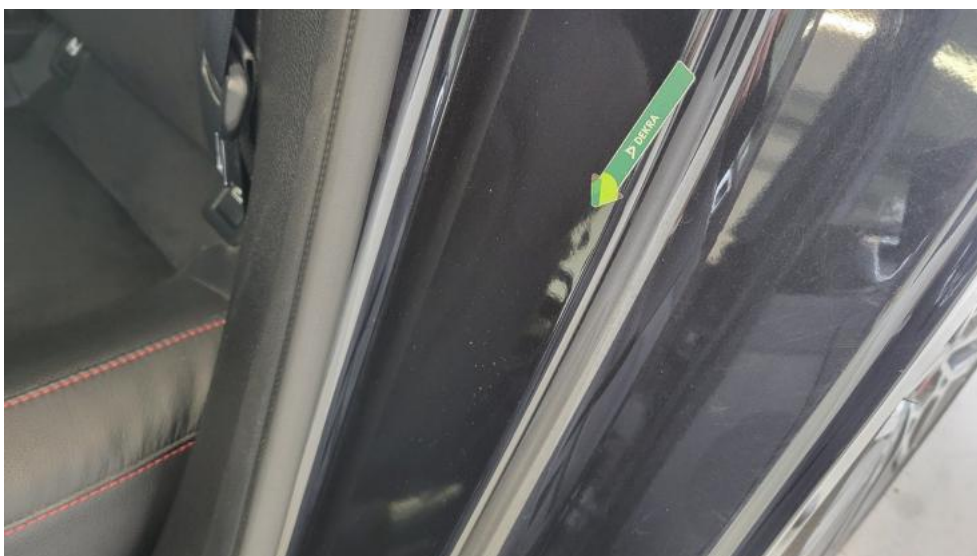
Błotnik tylny L / Ściana boczna L - Wgniecenie/odkształcenie 2

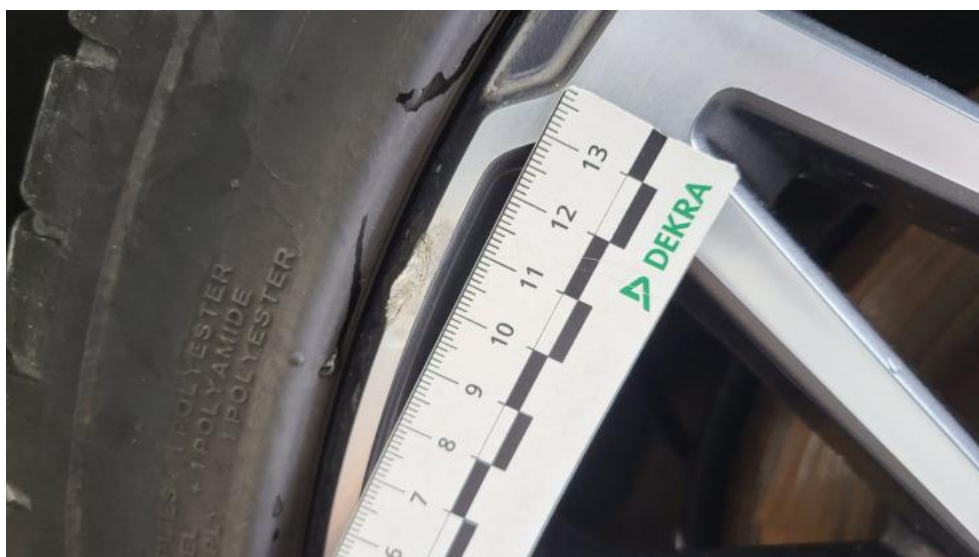
Felga aluminiowa tylna L - Rysa/odprysk 1

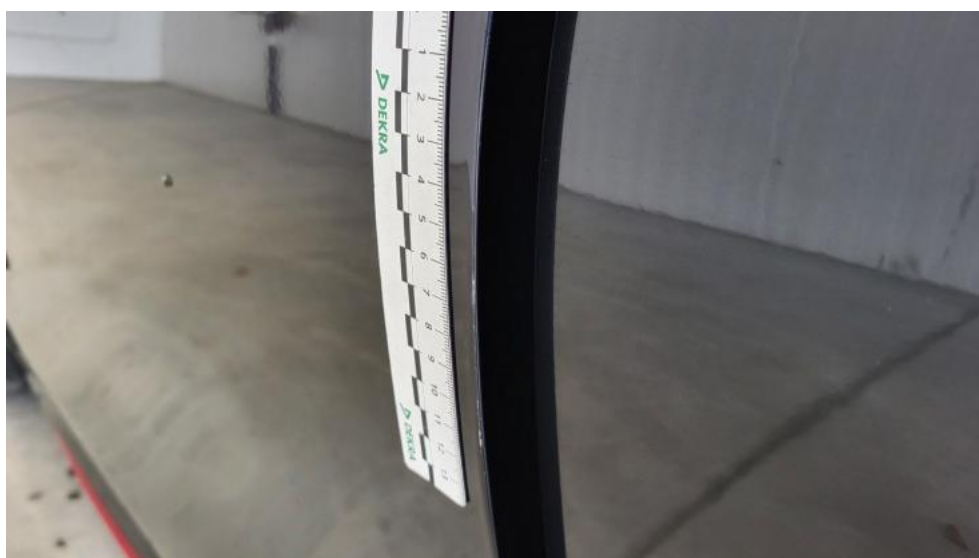
Drzwi przed L - Rysa/odprysk 1

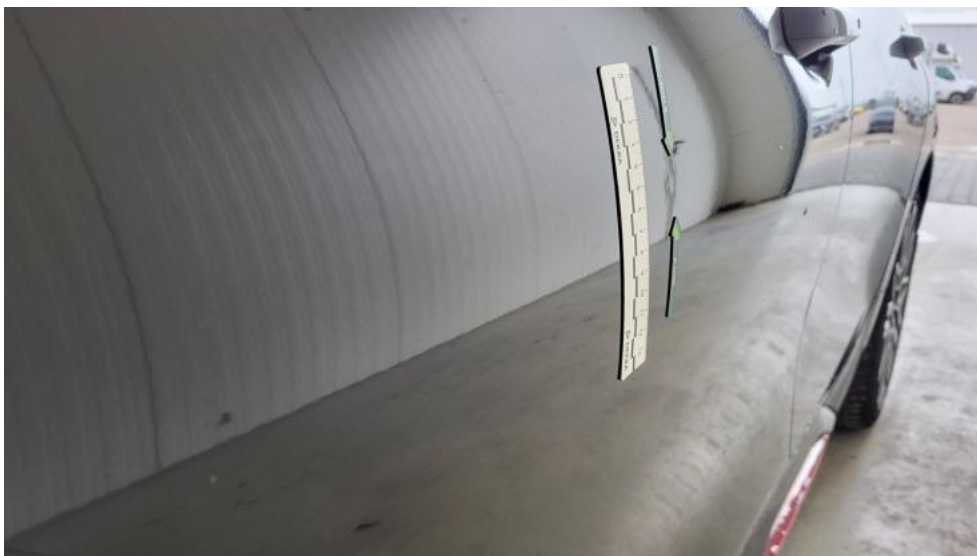
Drzwi przed L - Wgniecenie/odkształcenie 1

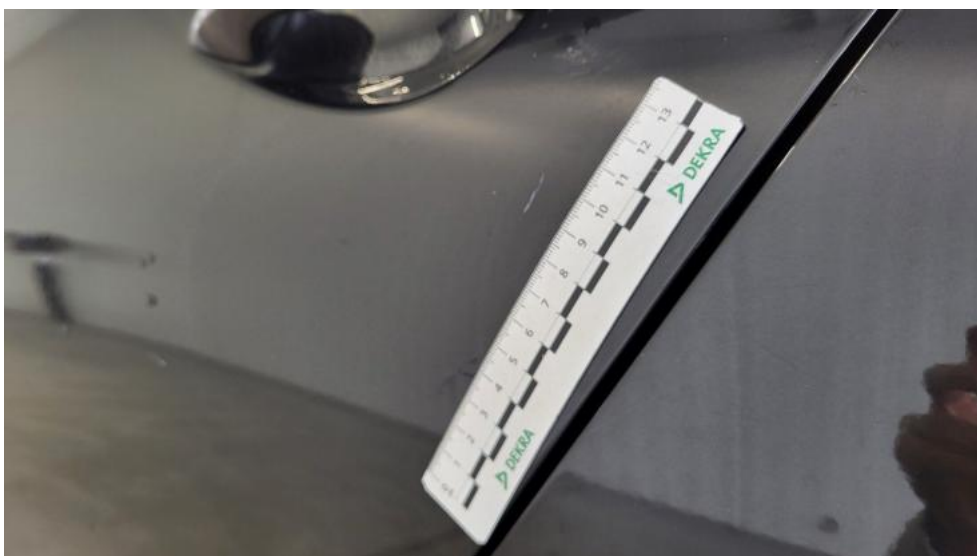
Drzwi tylne L - Rysa/odprysk 1

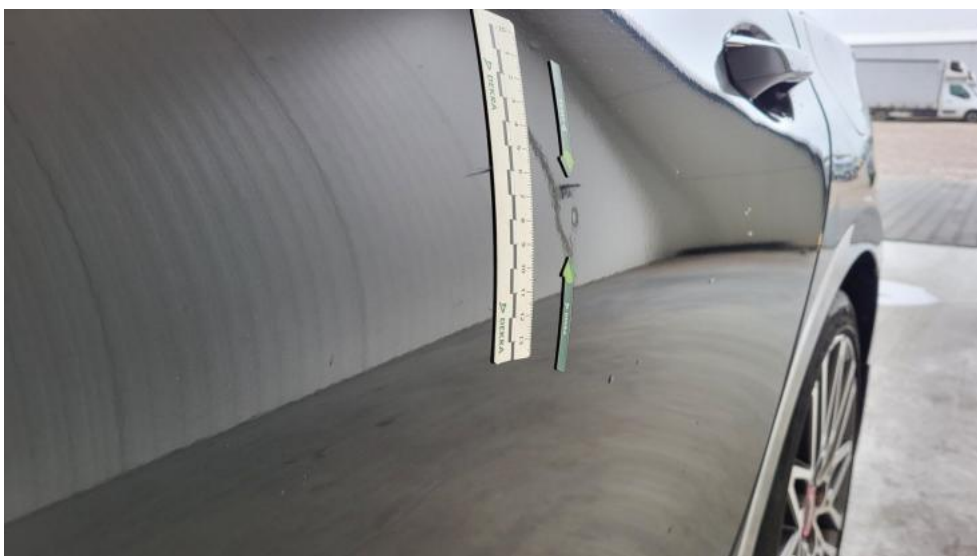
Drzwi tylne L - Wgniecenie/odkształcenie 1

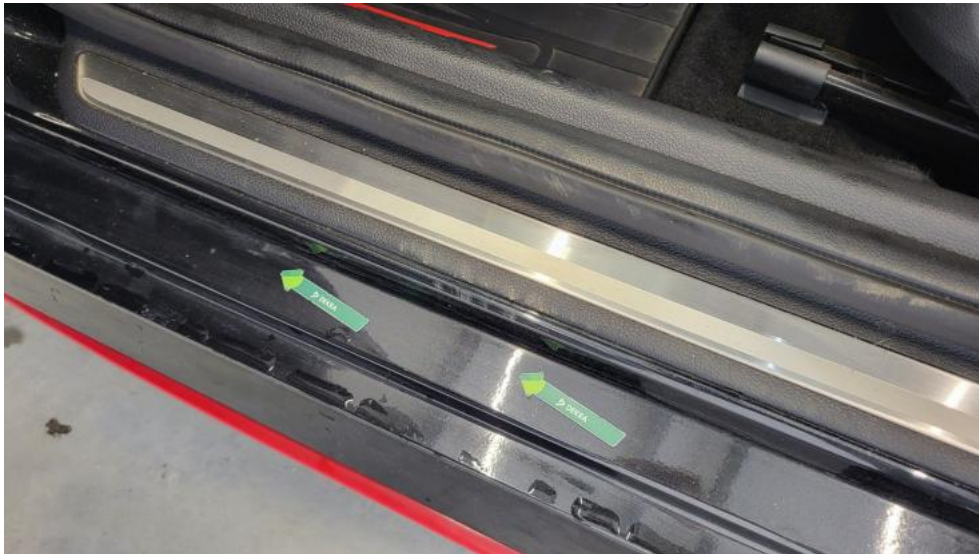
Próg L - Wgniecenie/odkształcenie 1

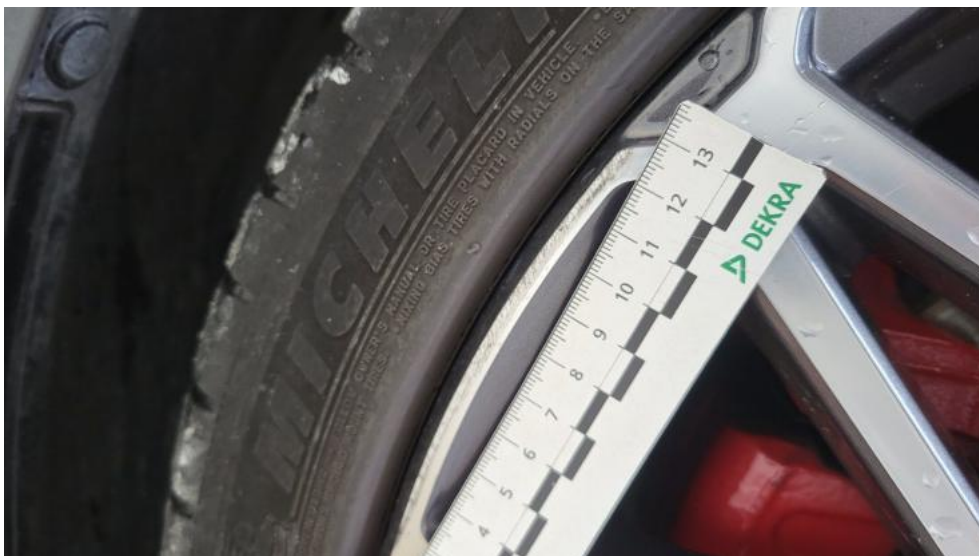
Felga Aluminiowa przednia L - Rysa/odprysk 1

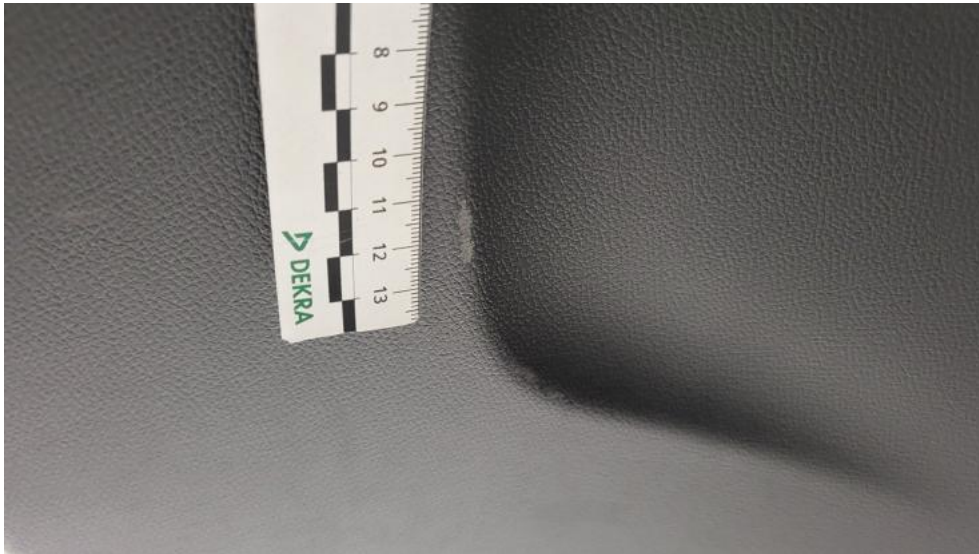
Pokrywa schowka deski rozdzielczej - Rysa/odprysk 1

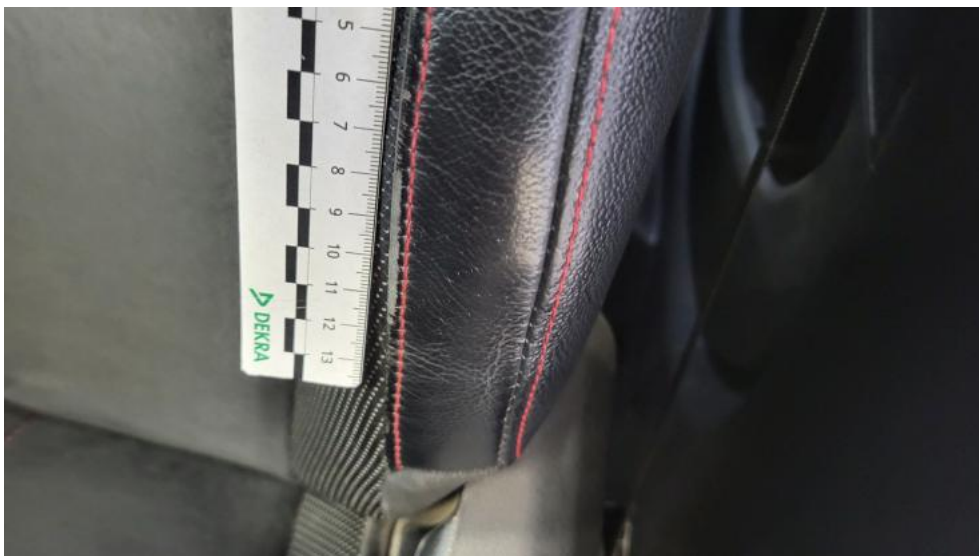
Fotel prz. lewy - Rysa/odprysk 1

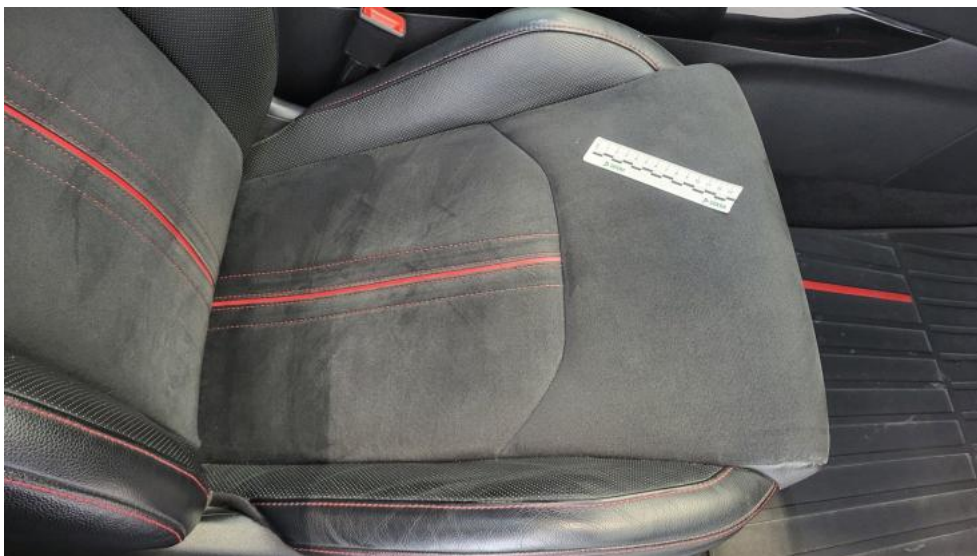
Fotel prz. praw. - Inne 1

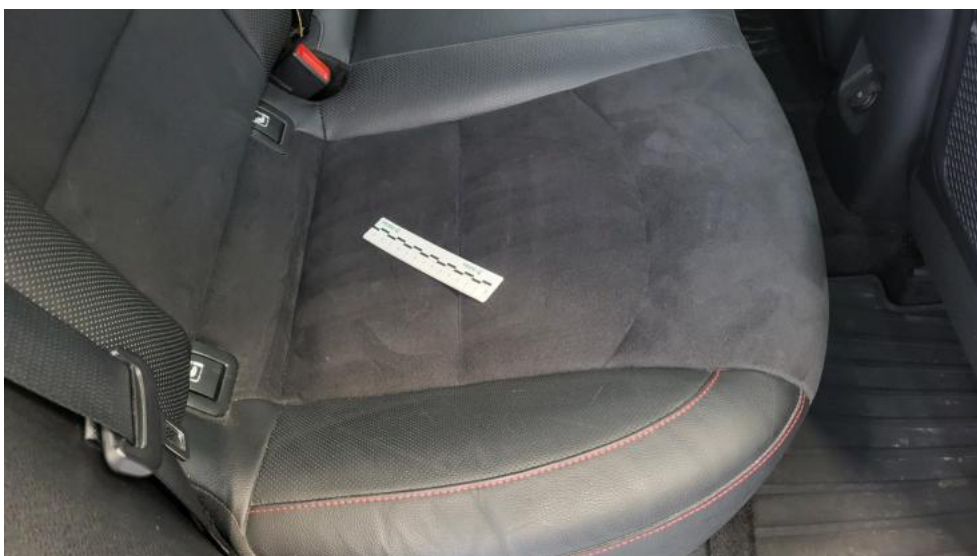
Kanapa tyl. - Inne 1

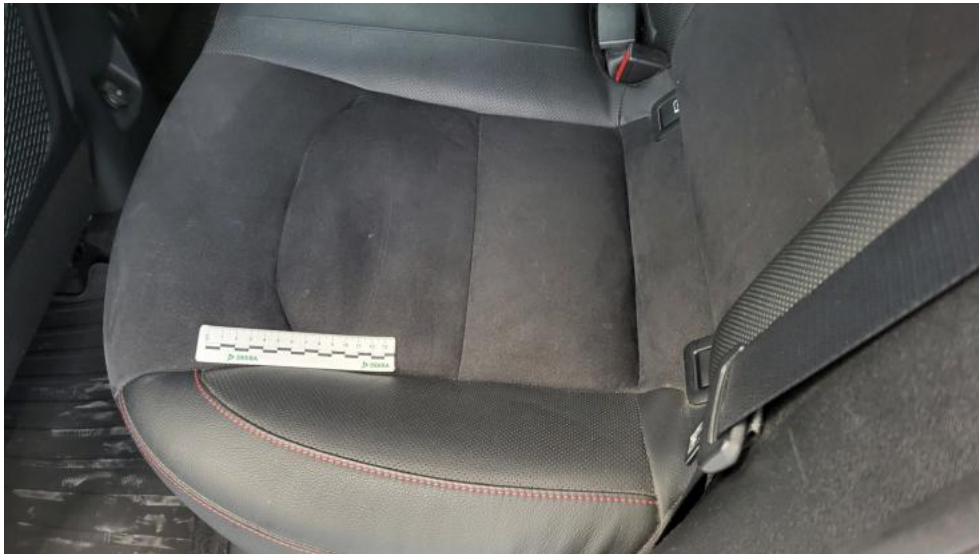
**Photo 75.**  
Kanapa tyl. - Inne 2

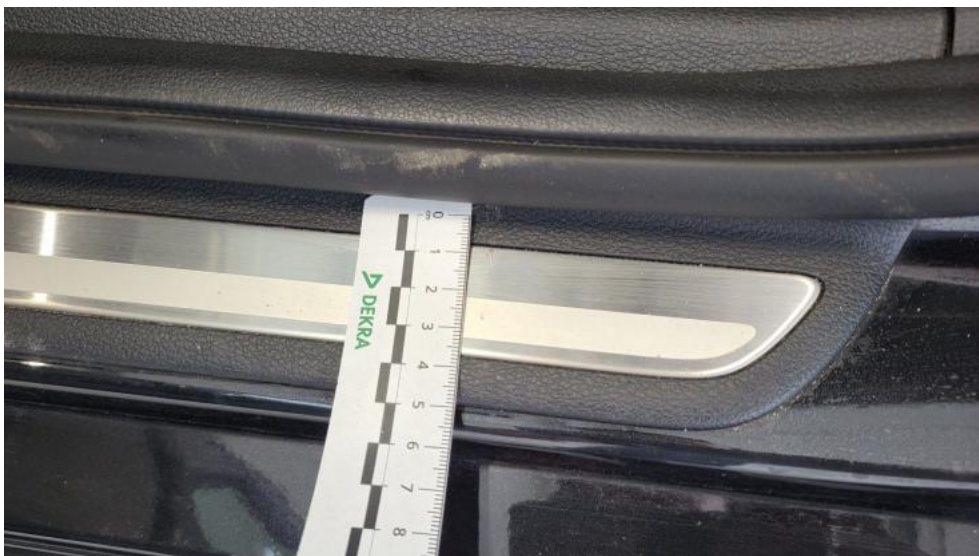
**Photo 76.**  
Listwy progowe lew. - Rysa/odprysk 1
