DEKRA's commission No. : PKOL(W)/LODZ/39775/25/06/02  
commission/ damage No. : 21/058052  
Date of commission: 02-06-2025

| Manufacturer | LAND ROVER |
| Model | Range Rover Sport 17-22 |
| Registration /record No. | WU1410N |

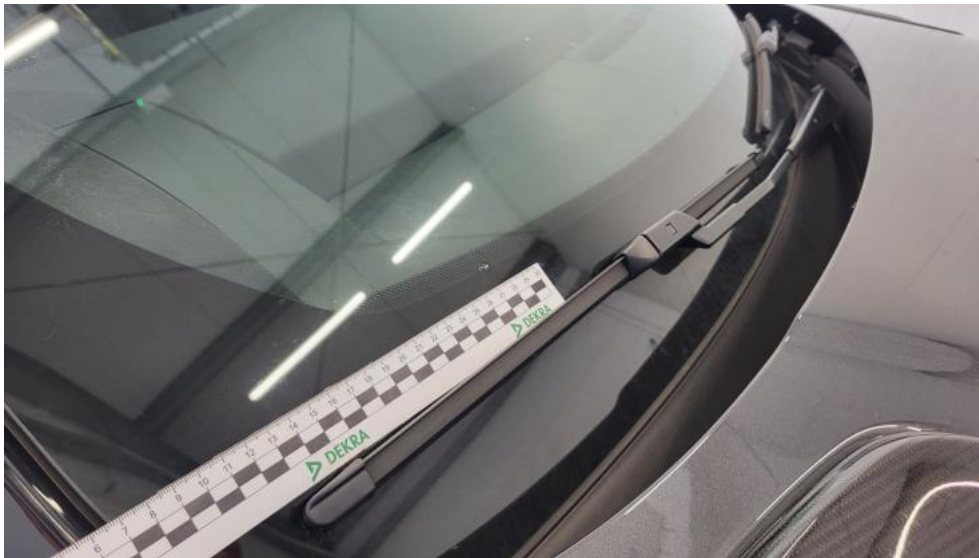
**Photo 51.**

Szyba czołowa ogrzewana - zdjęcie poglądowe 1

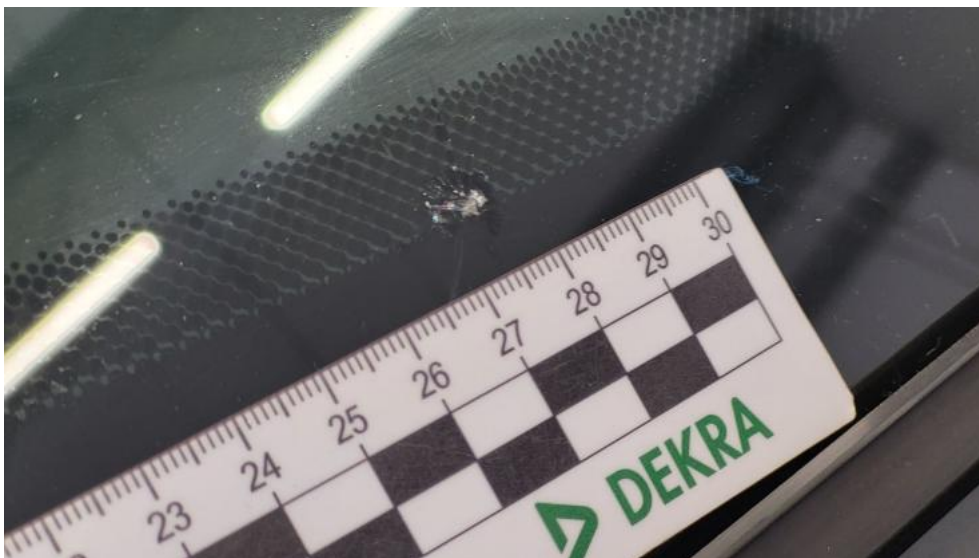
**Photo 52.**

Rysy na samochodzie. Pojazd posiada hak. Pojazd oklejony folią. Pomiar lakieru wykonany na folii oprócz elementów: słupek przedni prawy/lewy, słupek środkowy prawy/lewy, próg prawy/lewy. Odpryski na szybie czołowej.

Szyba czołowa ogrzewana - Pęknięcie/rozerwanie 1

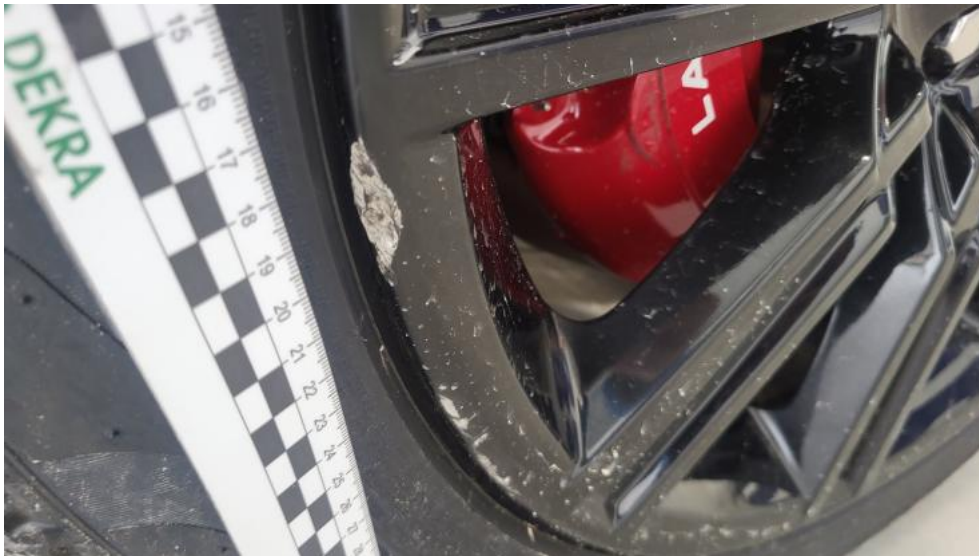
**Photo 53.**

Felga aluminiowa przednia P - Rysa/odprysk 1

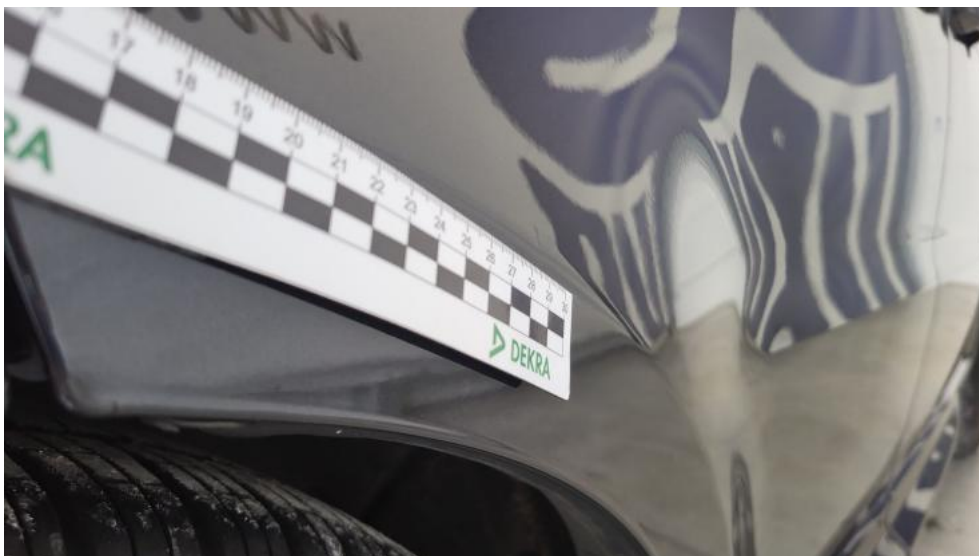
**Photo 54.**

Drzwi tylne P - Wgniecenie/odkształcenie 1

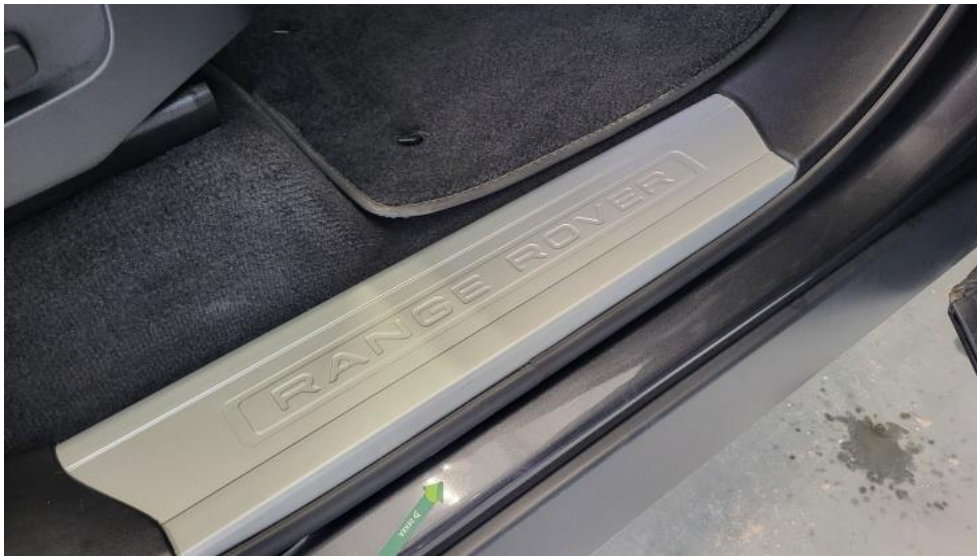
**Photo 55.**

Próg P - Wgniecenie/odkształcenie 1

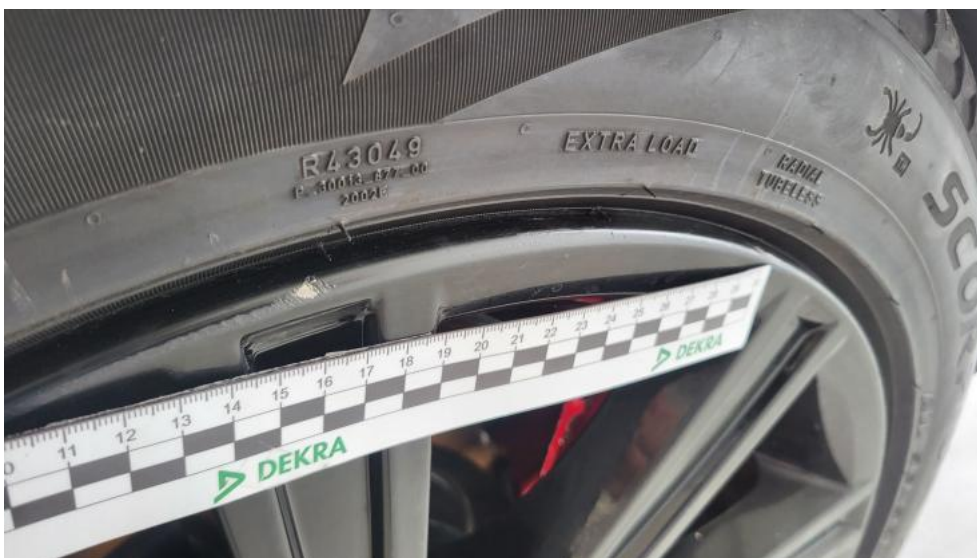
**Photo 56.**

Felga aluminiowa tylna L - Rysa/odprysk 1

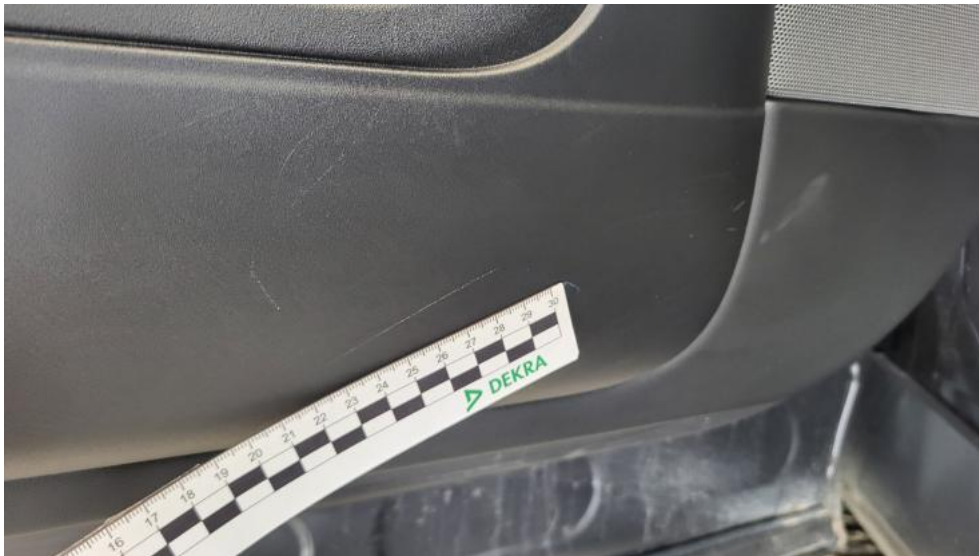
**Photo 57.**

Tapicerka drzwi przednich L - Rysa/odprysk 1

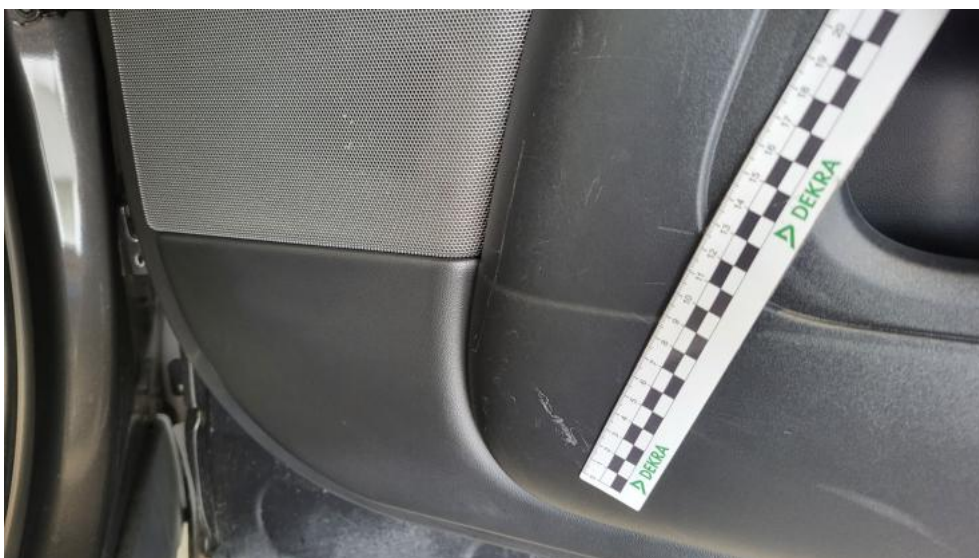
**Photo 58.**

Tapicerka drzwi przednich P - Rysa/odprysk 1
