DEKRA's commission No. : PKOL(W)/LODZ/18912/25/03/14  
commission/ damage No. : 21/060437  
Date of commission: 14-03-2025

**DEKRA Poland - Headquarters**  
02-673 Warszawa, ul. Konstruktorska 12A

| Type / version | 520d xDrive mHEV M Sport sport-aut |
| Registration /record No. | DW3RE59 |

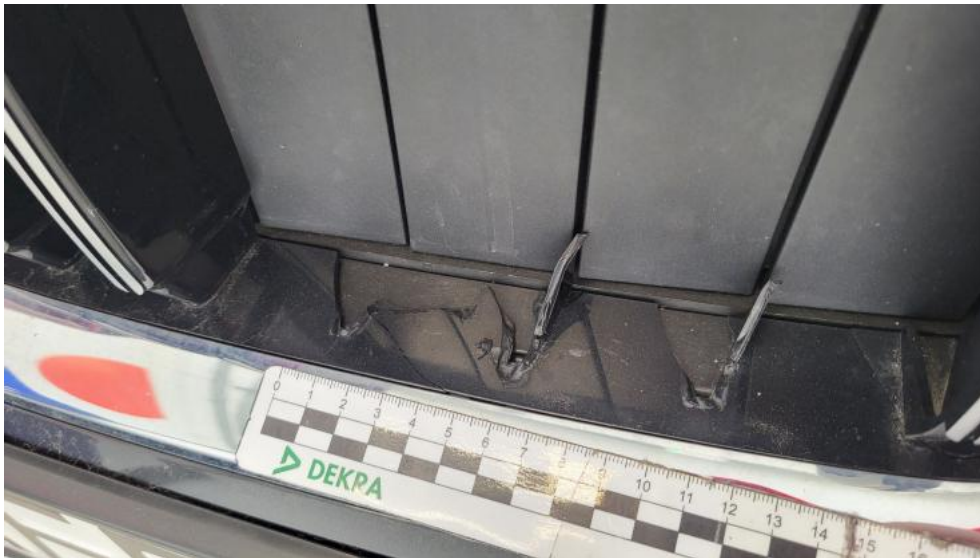
**Photo 41.**

Atrapa przednia - Pęknięcie/rozerwanie 1

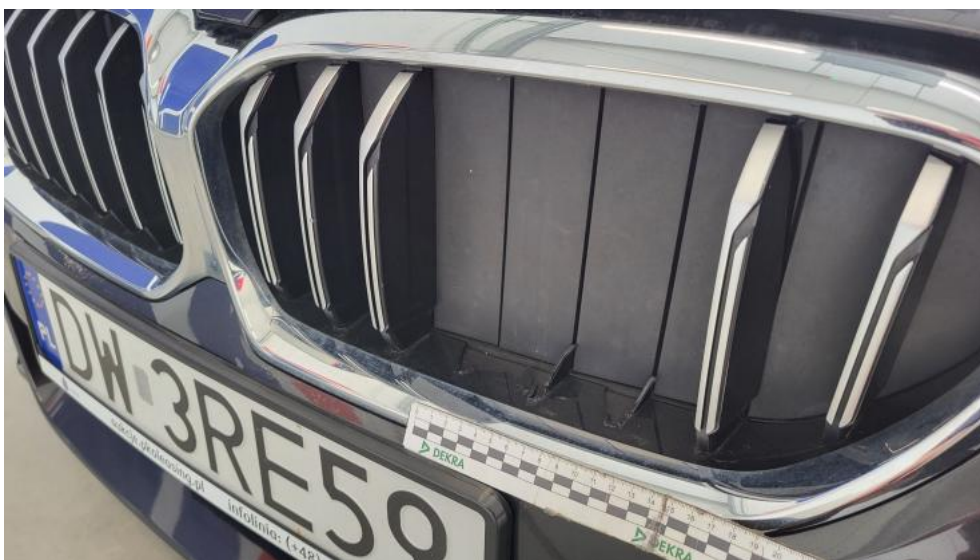
**Photo 42.**

Atrapa przednia - Inne 1

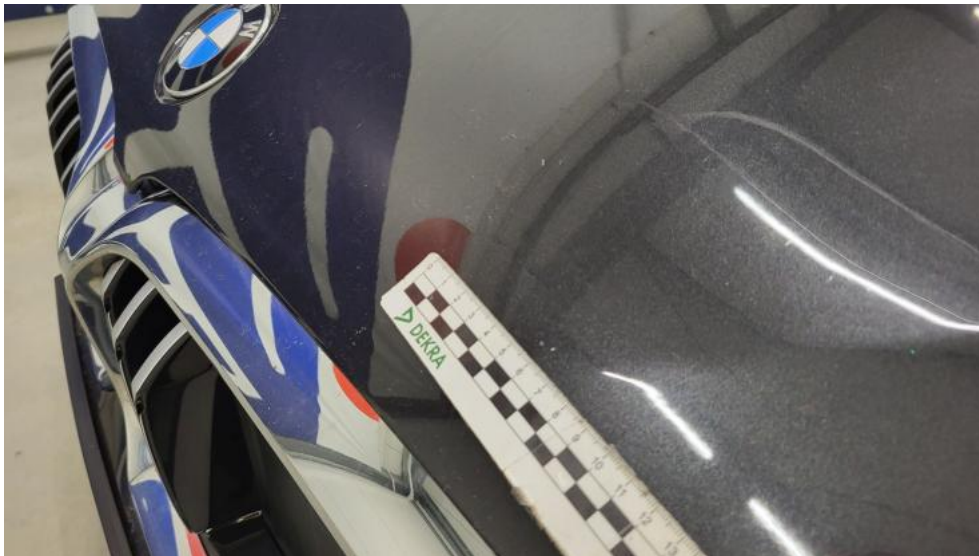
**Photo 43.**

Pokrywa komory silnika - Rysa/odprysk 1

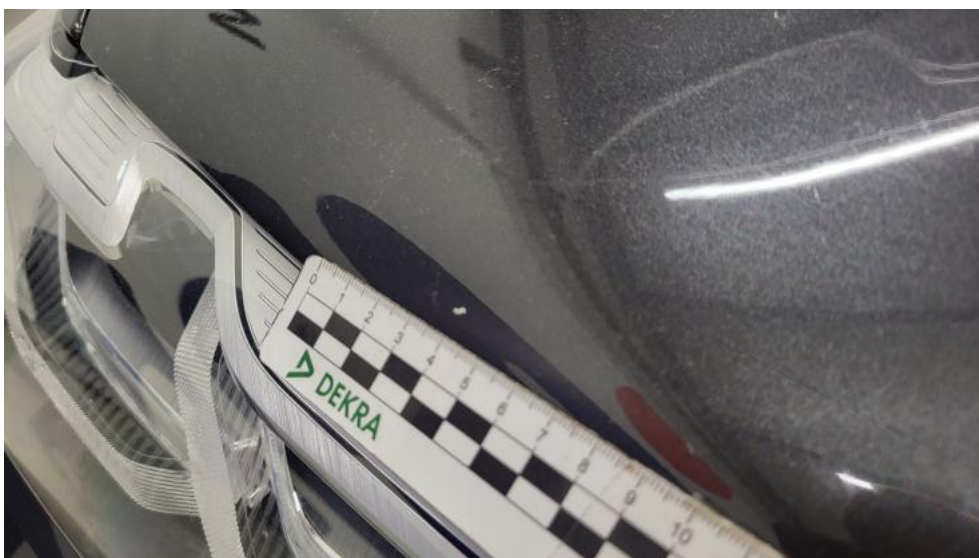
**Photo 44.**

Pokrywa komory silnika - Rysa/odprysk 2

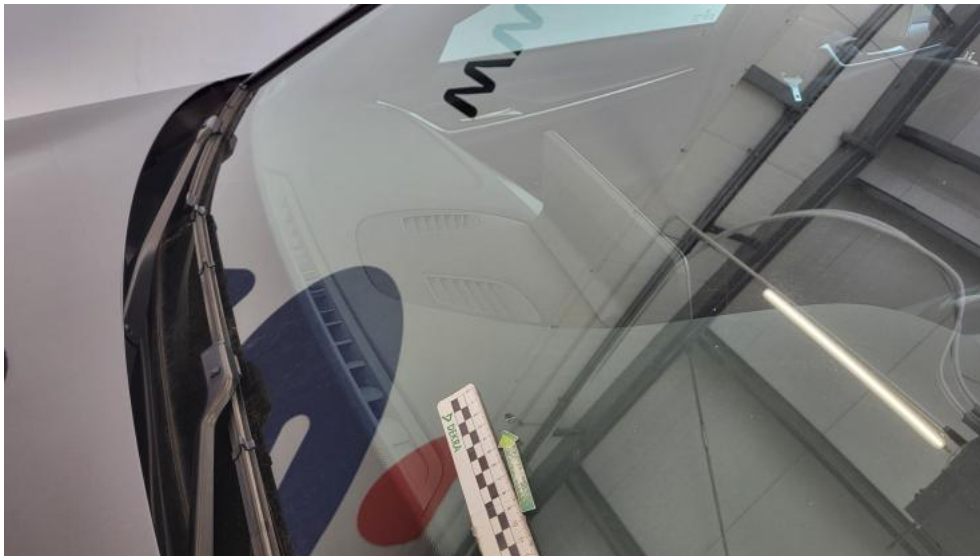
**Photo 45.**

W samochodzie nieprzyjemny zapach po papierosach. Nietypowe odgłosy z komory silnika do weryfikacji serwisowej. Dywanik prawy przód przepalony. Roleta chłodnicy do weryfikacji. Brak płynu zestawu naprawczego. Termin przeglądu minął 210km temu. Aktywna kontrolka serwisu. Rysy na samochodzie. Odpryski na szybie czołowej.

Szyba czołowa - zdjęcie poglądowe 1

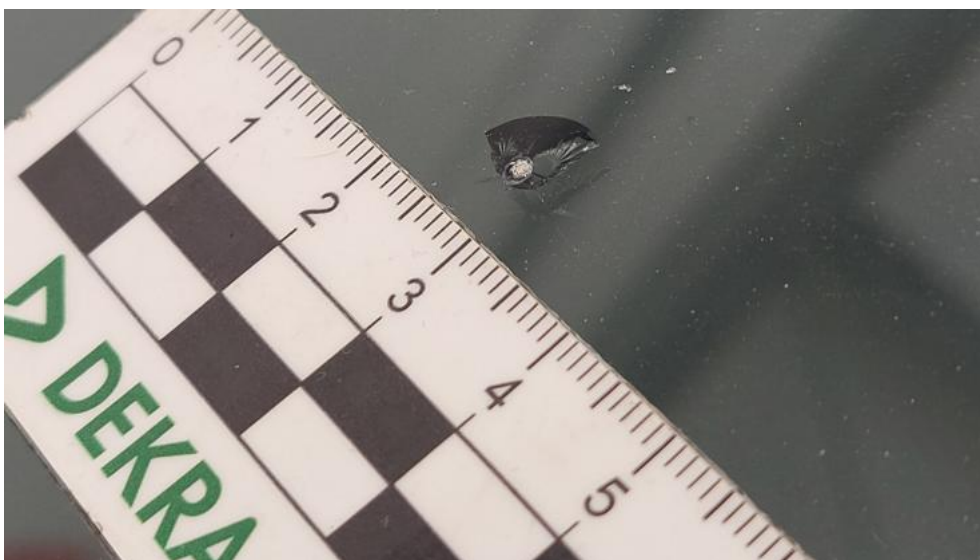
**Photo 46.**

Szyba czołowa - Pęknięcie/rozerwanie 1

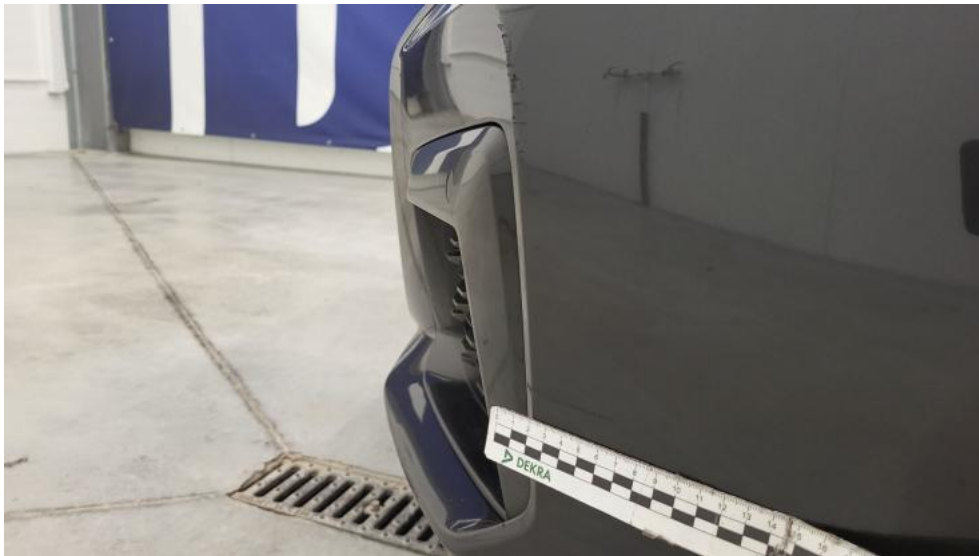
**Photo 47.**

Zderzak - Rysa/odprysk 1

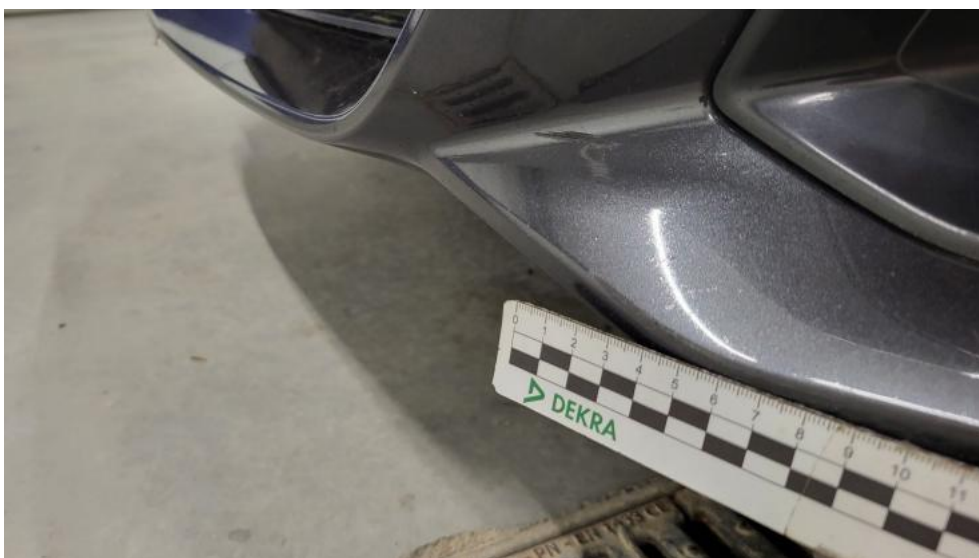
**Photo 48.**

Zderzak - Rysa/odprysk 2

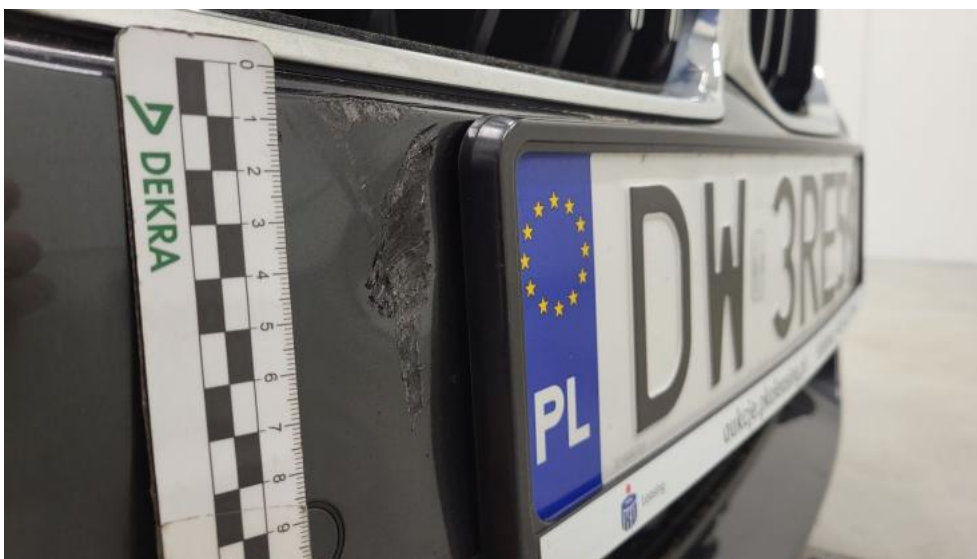
**Photo 49.**

Zderzak() - Rysa/odprysk 3

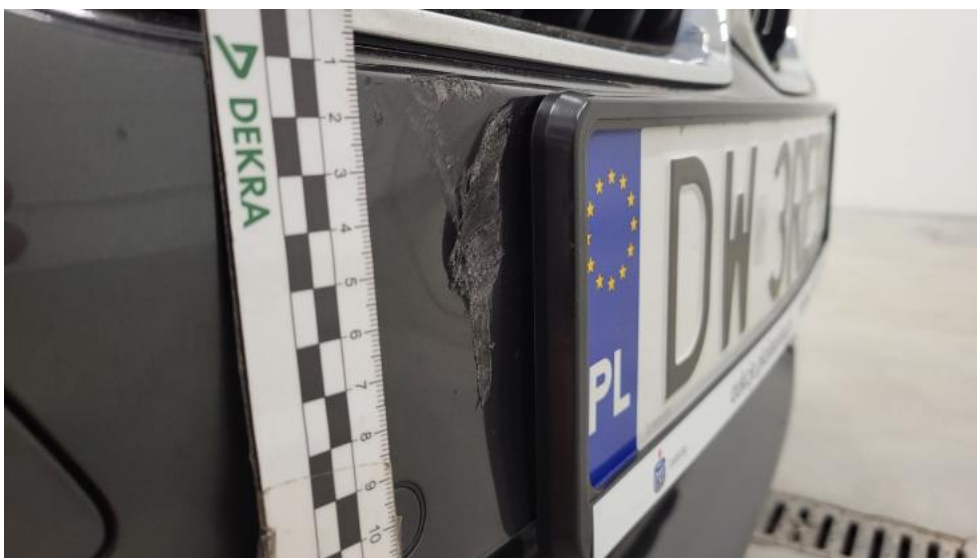
**Photo 50.**

Zderzak - Wgniecenie/odkształcenie 1

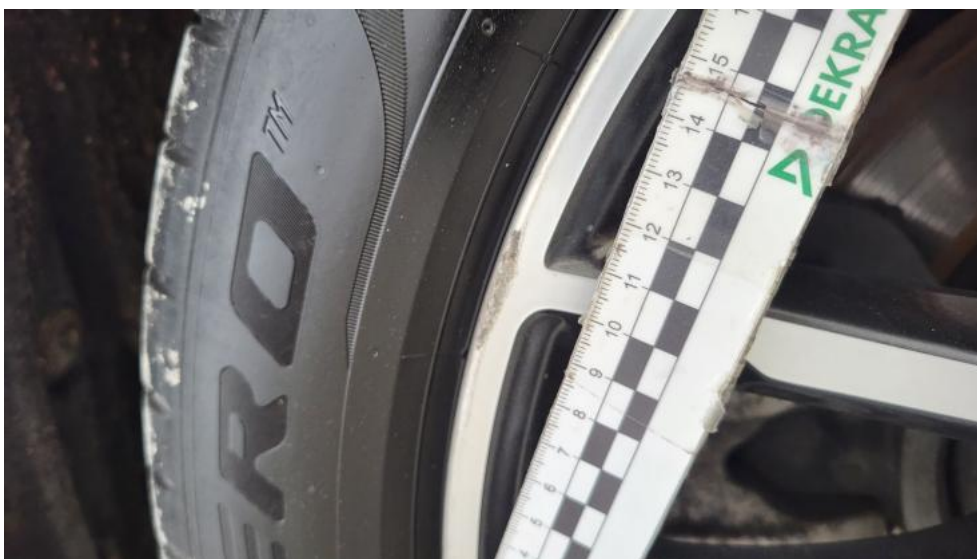
**Photo 51.**

Felga aluminiowa przednia P - Rysa/odprysk 1

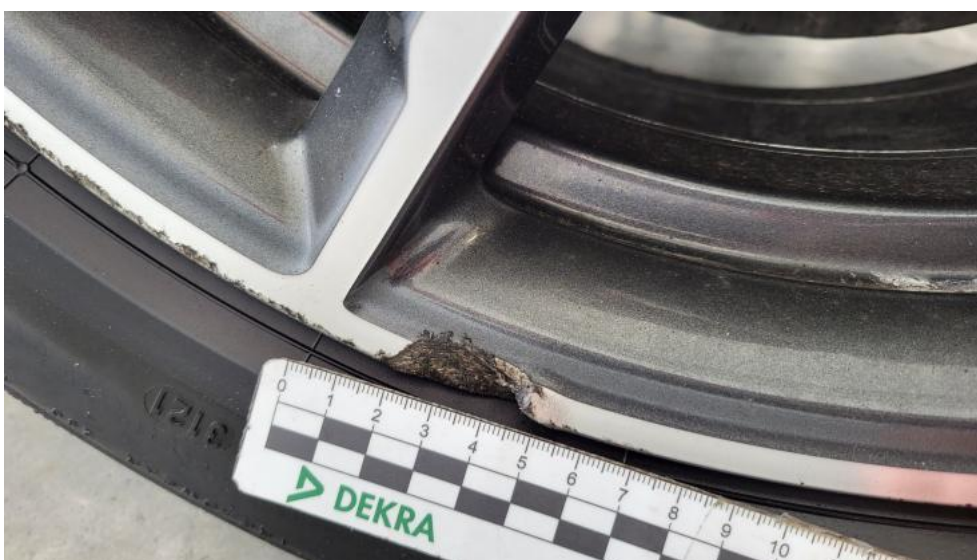
**Photo 52.**

Felga aluminiowa przednia P - Wgniecenie/odkształcenie 1

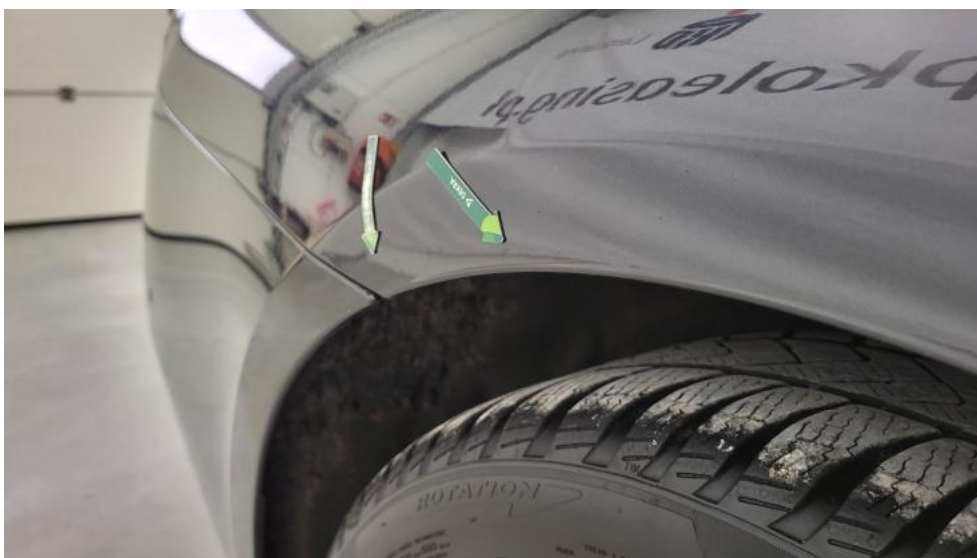
**Photo 54.**

Łotnik tylny P / Ściana boczna P - Wgniecenie/odkształcenie 1

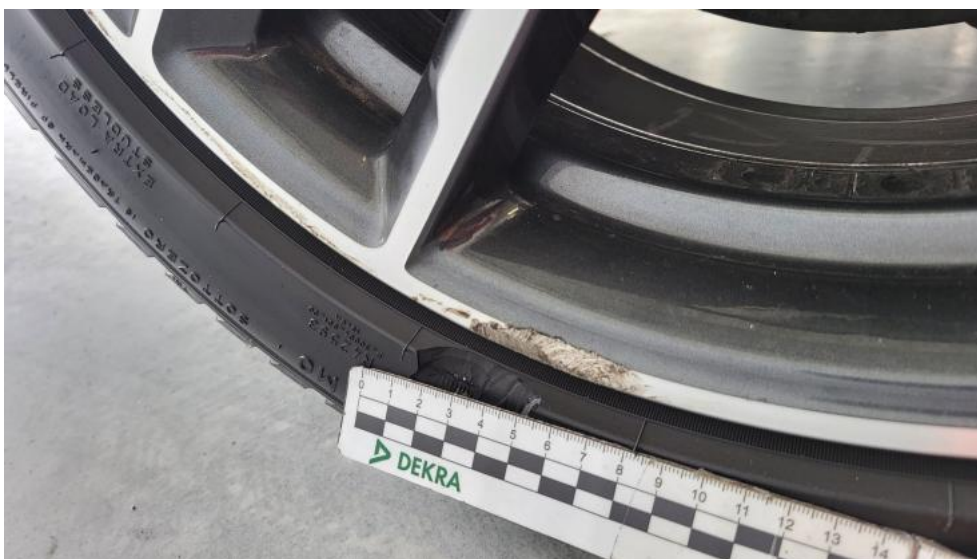
**Photo 55.**

Felga aluminiowa tylna P - Rysa/odprysk 1

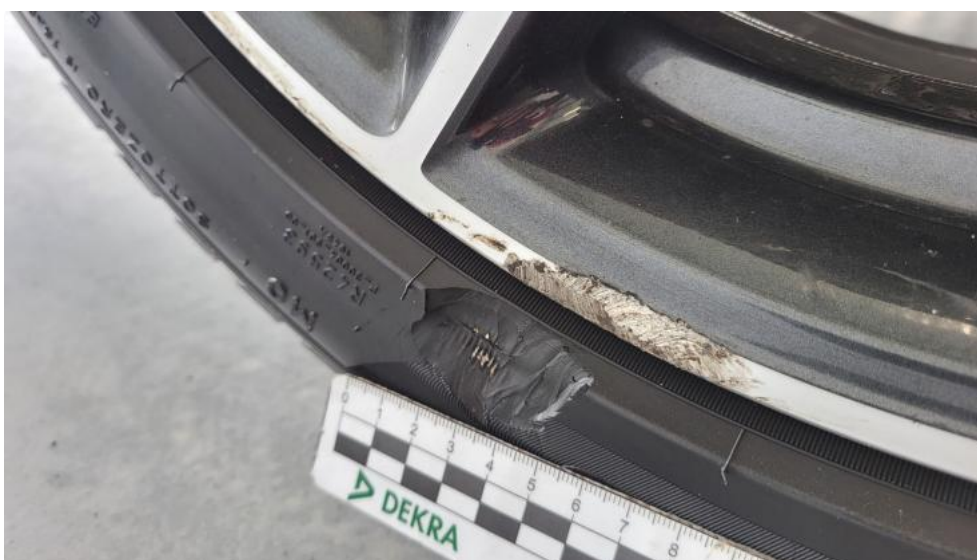
**Photo 56.**

Opona tylna P - Pęknięcie/rozerwanie 1

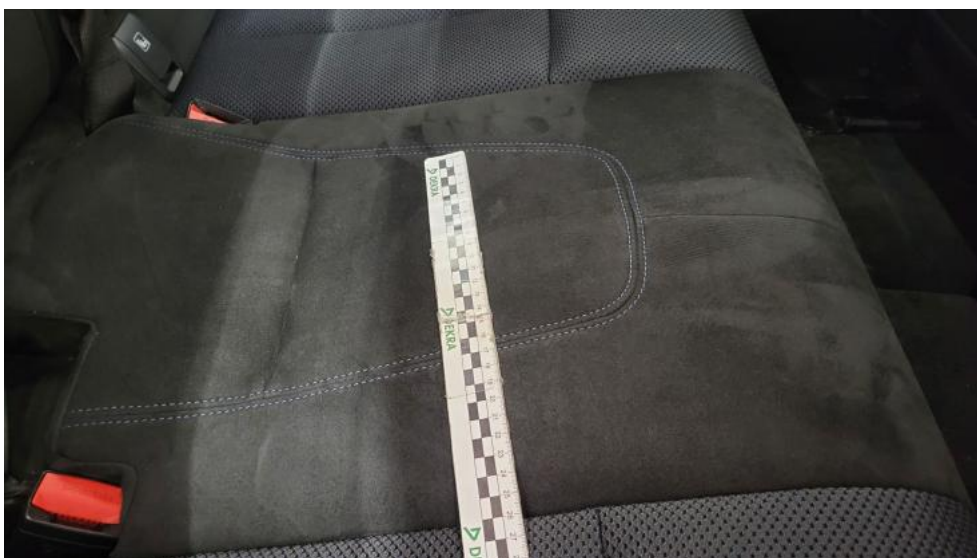
**Photo 58.**

Kanapa tyl. - Inne 1

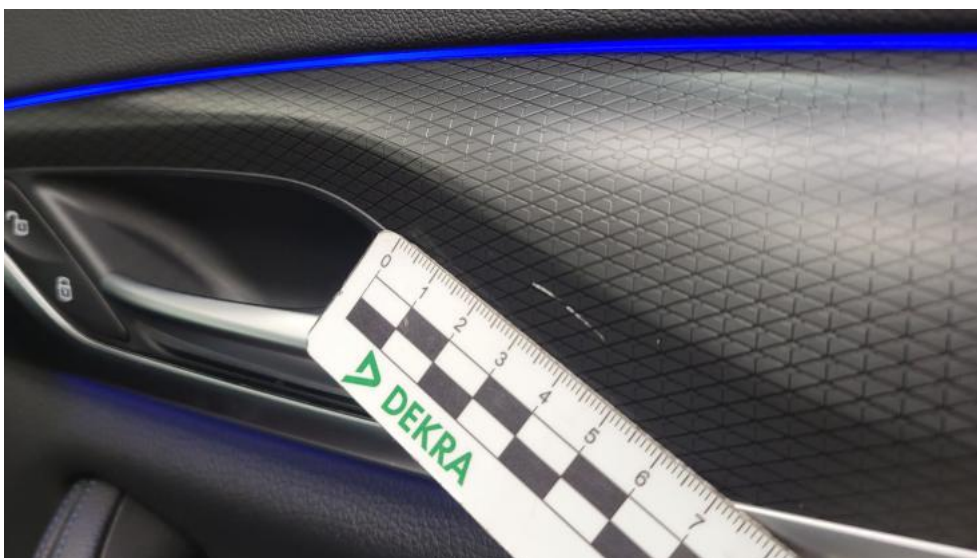
**Photo 60.**

Tapicerka drzwi przednich P - Rysa/odprysk 1

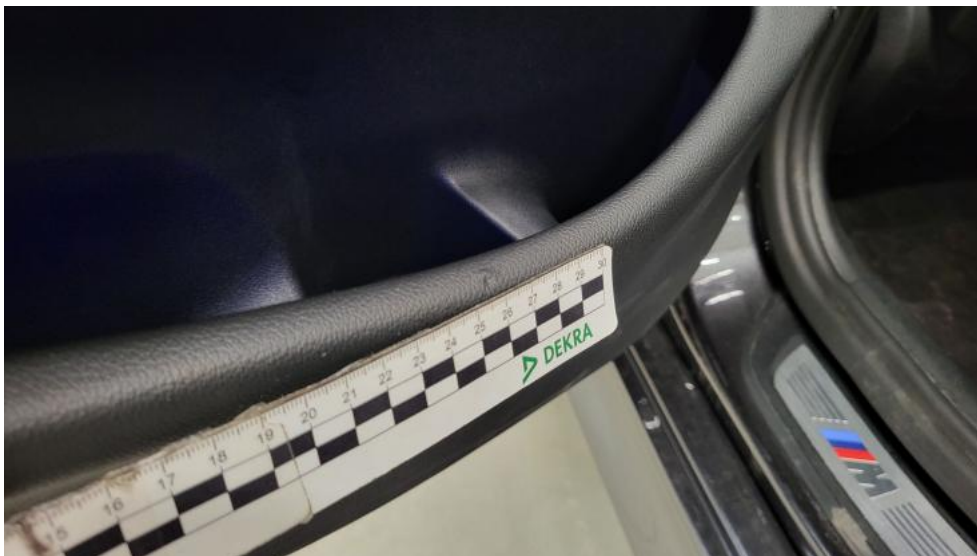
**Photo 61.**

Tapicerka drzwi tylnych L - Wgniecenie/odkształcenie 1

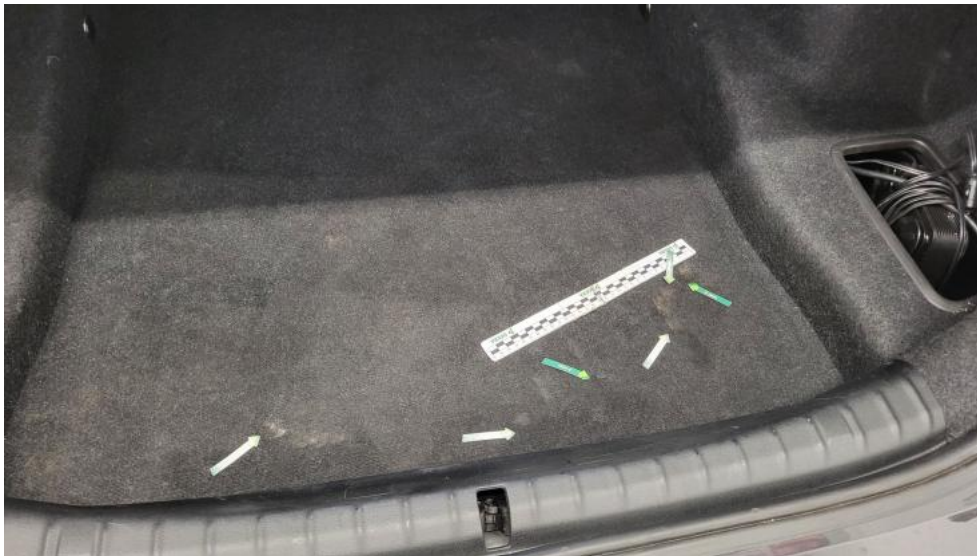
**Photo 63.**

Wykładzina podłogi bagażnika - Wgniecenie/odkształcenie 1
