DEKRA's commission No. : PKOL(W)/LODZ/25006/26/03/20  
commission/ damage No. : 24/008329  
Date of commission: 20-03-2026

PKO Leasing SA  
Świętokrzyska 36  
00-116 Warszawa

Group of objects (Eurotax)	cars
EC code (Eurotax)	0154674
Manufacturer	PORSCHE
Model	Taycan Sport Turismo 22-24
Type / version	Taycan Turbo Sport Turismo
Body type	KOM
Number of doors / seats	5/5
Curb weight [kg]	2402
Gross vehicle weight [kg]	2880
Wheelbase 1/2	2900
Engine type	elektryczny
Pollution reduction system	-
Engine capacity [ccm]	0
Engine Power [hp/kW]	625/460
Gearbox	automatic
Registration /record No.	KK0729E
VIN / serial number	WP0ZZZY1ZNSA86167
Date of first registration	16-08-2022
Date of next. tech. test	16-08-2025
Year of manufacture	2022
Readout [km]	52 480 (read)
Body color / type of coating	black/double-layered, metallized

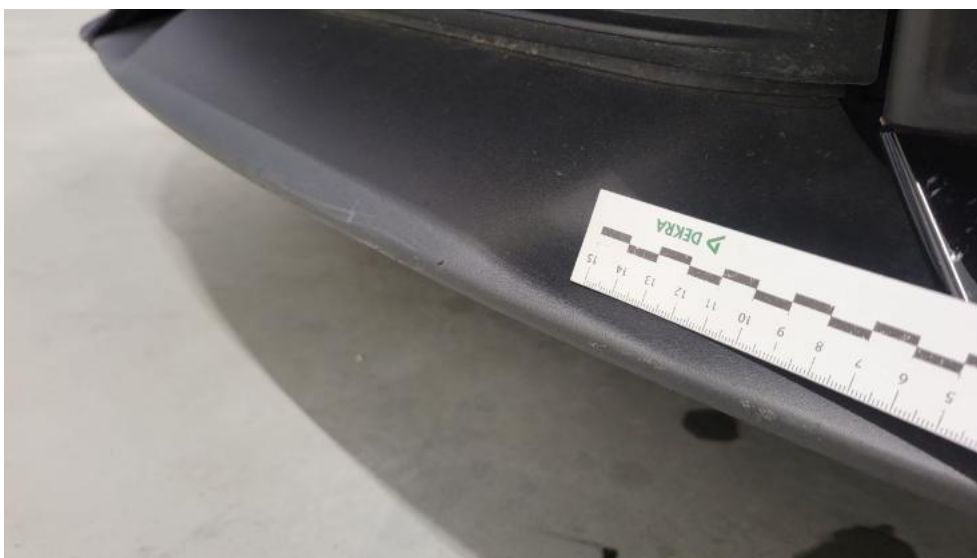
**Photo 58.**  
Spoiler zderzaka przedniego - Rysa/odprysk 1

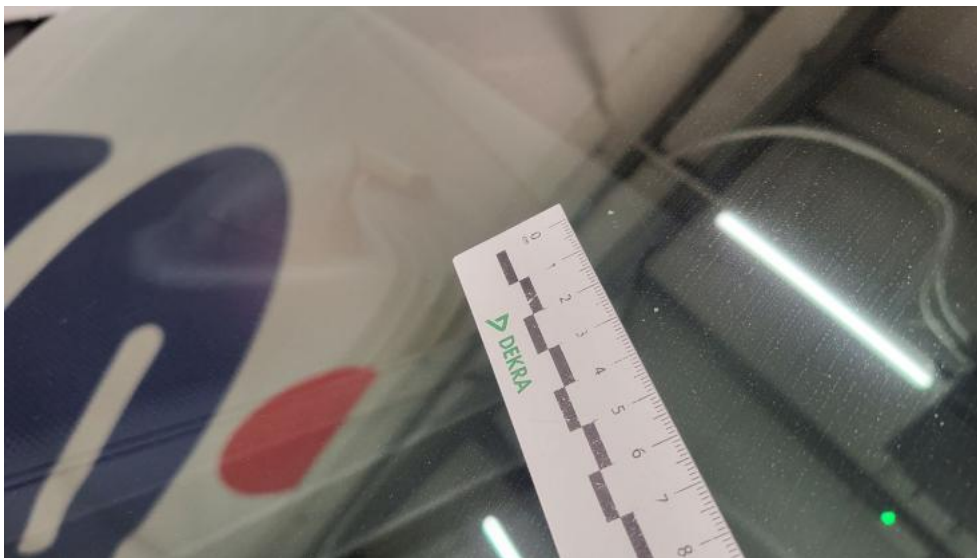
Dostarczono ksero pozwolenia czasowego. Pojazd elektryczny. Dwie opony w bagażniku letnie MICHELIN pilot sport 4s 305/30 R21 104Y 2x5.0mm. Jedna opona w bagażniku letnia GOODYEAR EAGLE F1 ASYMETRIC5 265/35 21 101Y 5.0mm. Brak aktualnych badań technicznych. Pojazd oklejony folią, pomiar lakieru wykonany na folii oprócz elementów: próg lewy/prawy, słupek środkowy lewy/prawy. Reflektory, lusterka i lampy tylne oklejone folią. Rysy na samochodzie. Odpryski na szybie czołowej.

**Photo 59.**  
Szyba czołowa - Rysa/odprysk 1

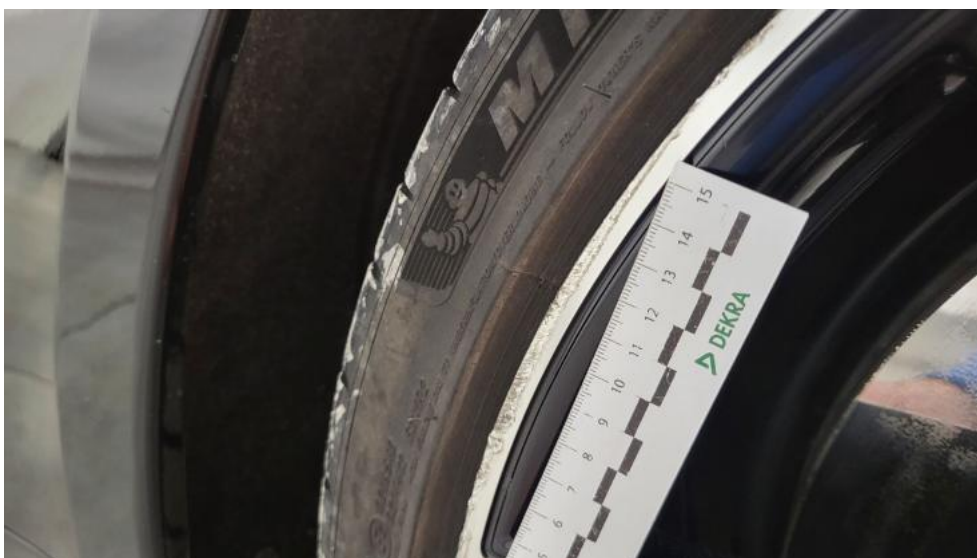
**Photo 60.**  
Felga aluminiowa przednia P - Rysa/odprysk 1

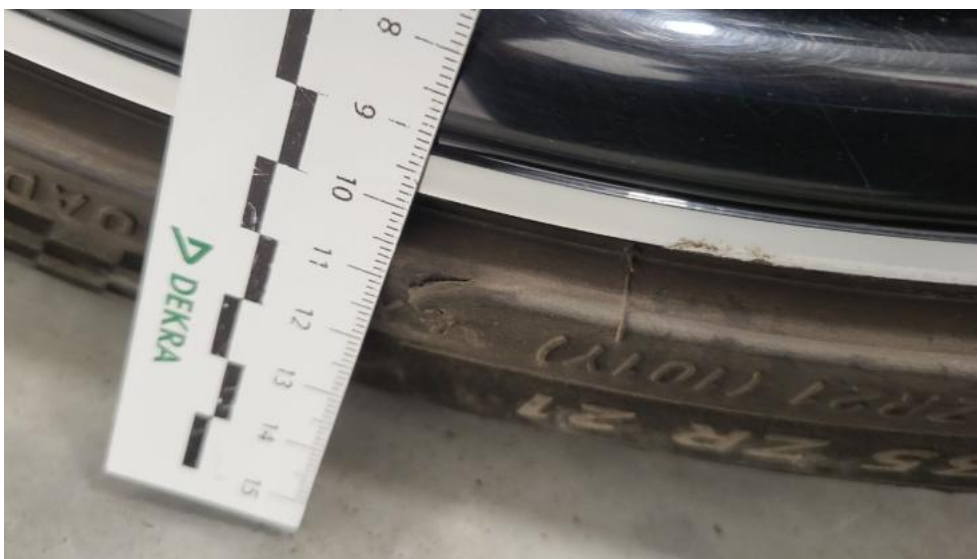
**Photo 61.**

Opona przednia P - Pęknięcie/rozerwanie 1

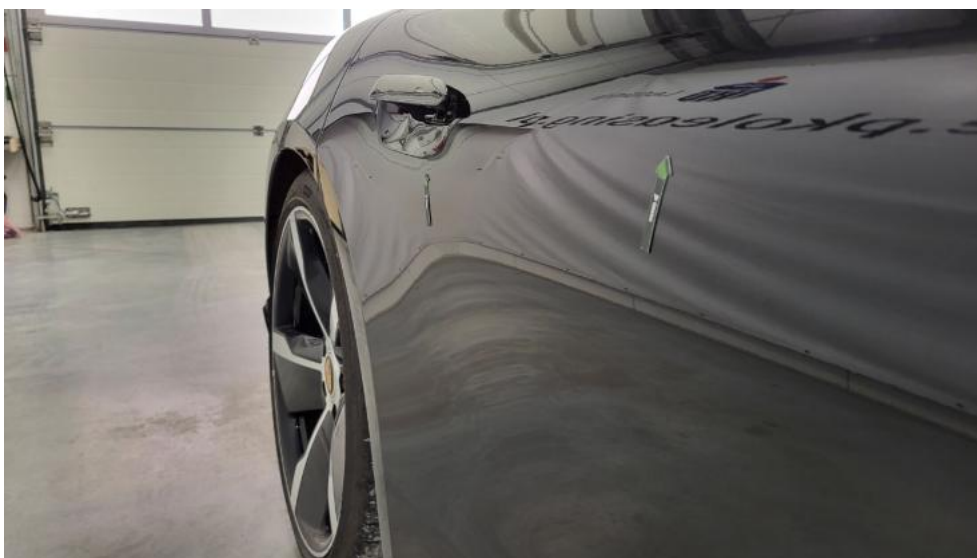
**Photo 62.**

Drzwi tylne P - Wgniecenie/odkształcenie 1

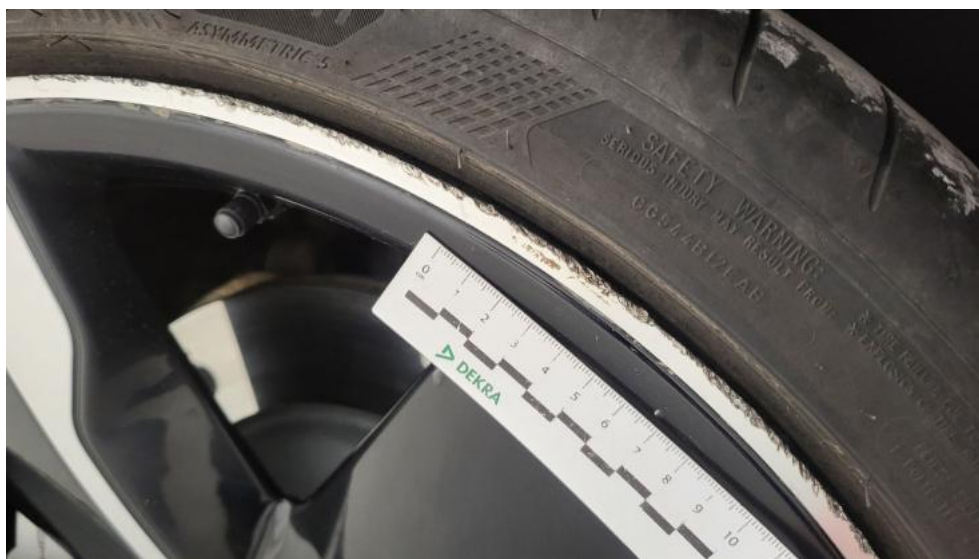
**Photo 63.**  
Felga aluminiowa tylna P - Rysa/odprysk 1

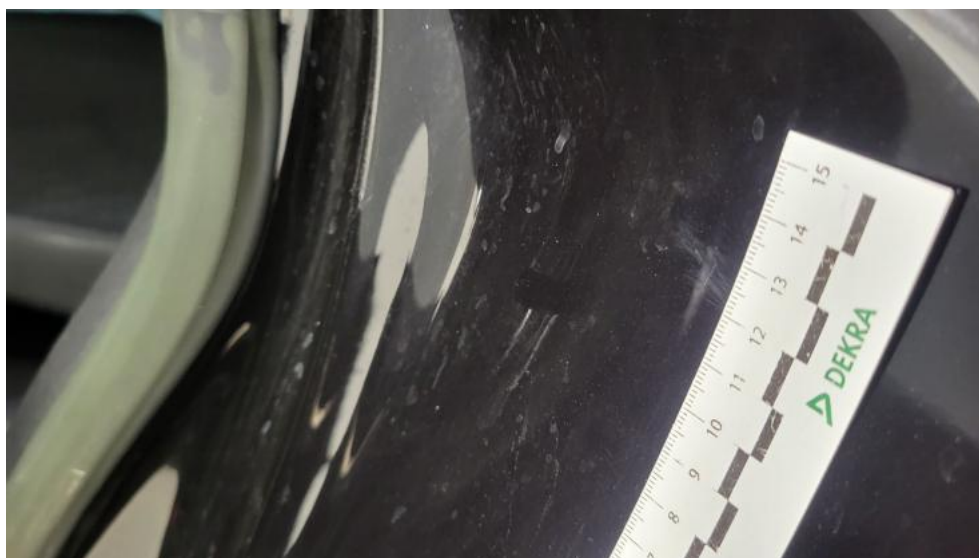
**Photo 64.**  
Błotnik tylny L / Ściana boczna L - Rysa/odprysk 1

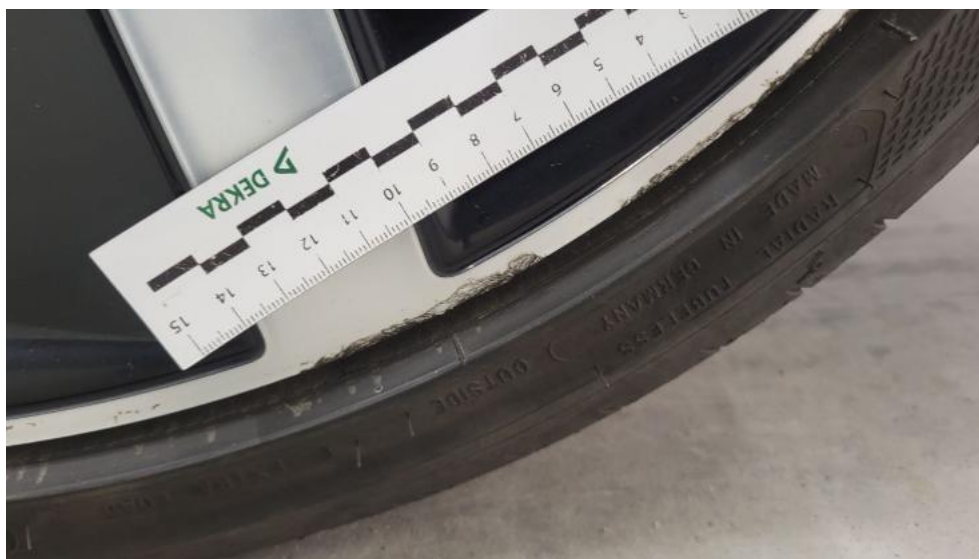
**Photo 65.**  
Felga aluminiowa tylna L - Rysa/odprysk 1

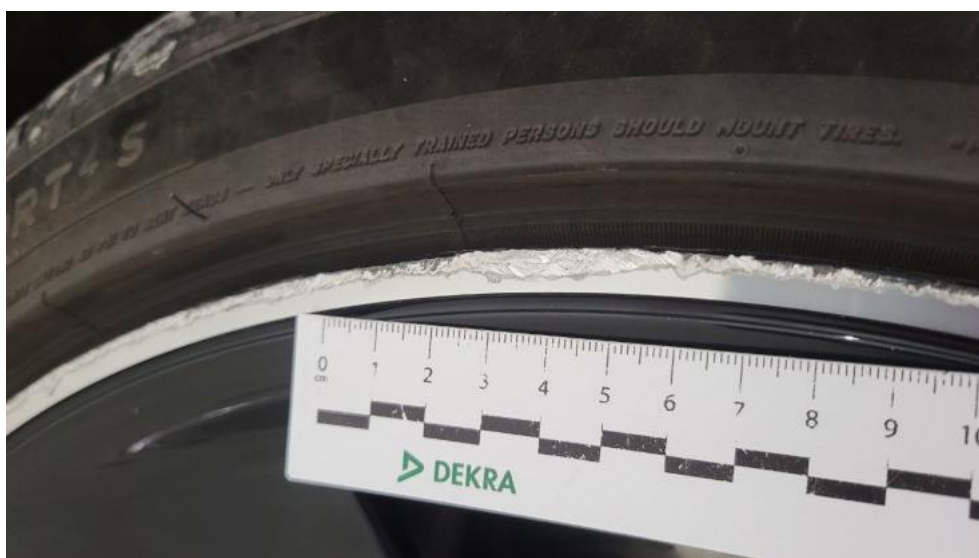
**Photo 66.**  
Felga Aluminiowa przednia L - Rysa/odprysk 1

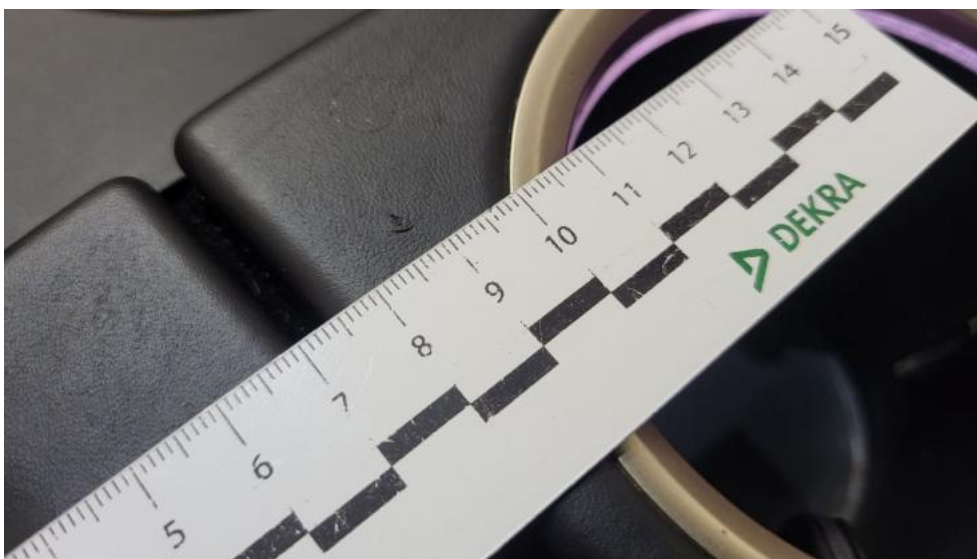
**Photo 67.**  
Podłokietnik środkowy przedni - Rysa/odprysk 1

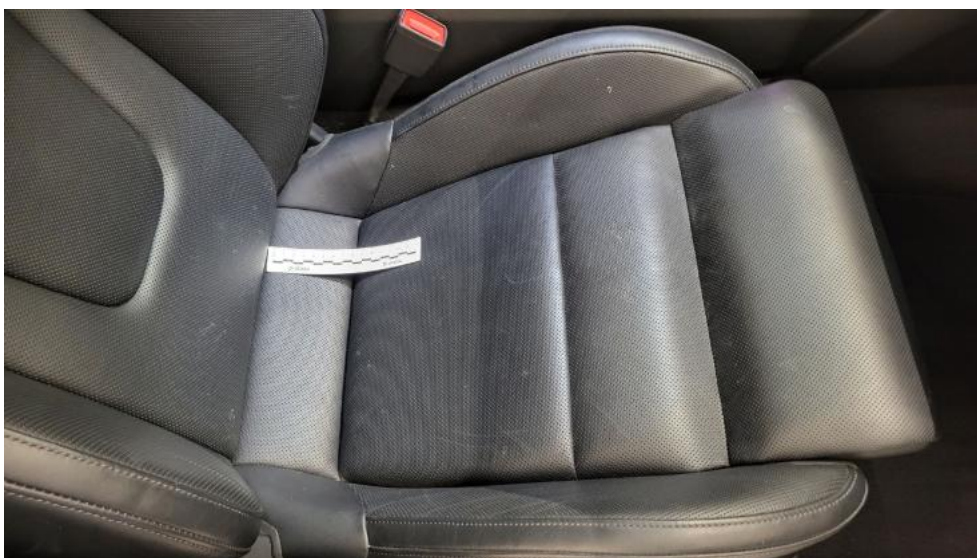
**Photo 68.**  
Fotel prz. praw. - Inne 1

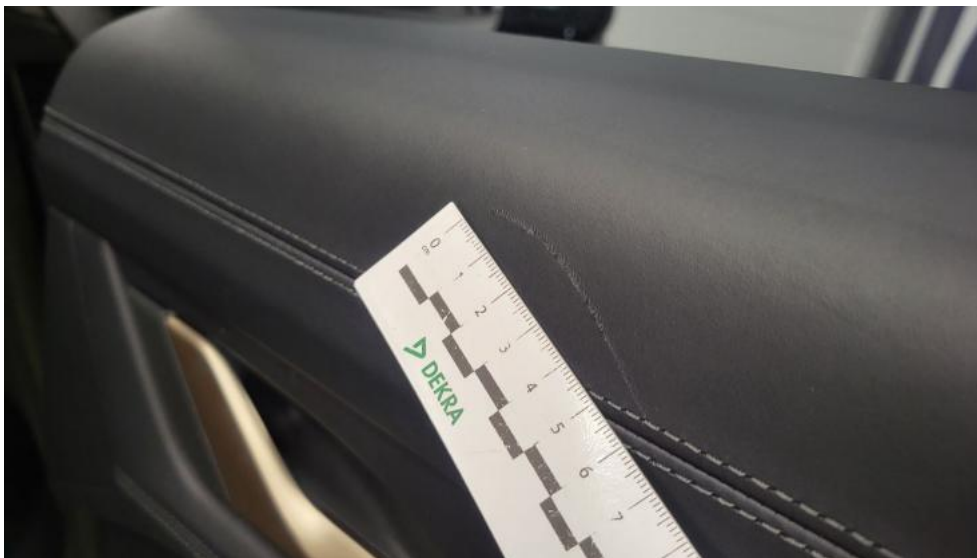
**Photo 69.**

Tapicerka drzwi tylnych P - Rysa/odprysk 1

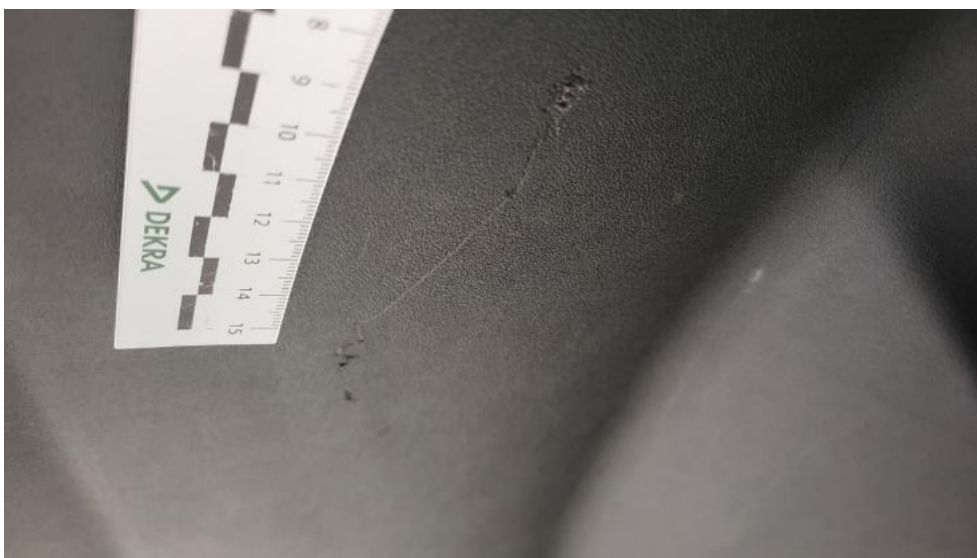
**Photo 70.**

Wykładzina pokrywy tylnej - Rysa/odprysk 1
