DEKRA's commission No. : PKOL(W)/LODZ/36409/26/04/27  
 commission/ damage No. : 22/026782  
 Date of commission: 27-04-2026

**DEKRA Poland - Headquarters**  
 02-673 Warszawa, ul. Konstruktorska 12A

PKO Leasing SA  
 Świętokrzyska 36  
 00-116 Warszawa

Group of objects (Eurotax)	jeeps
EC code (Eurotax)	146108
Manufacturer	TOYOTA
Model	Highlander 20-25
Type / version	Highlander 2.5 Hybrid Executive
Body type	KOM
Number of doors / seats	5/7
Curb weight [kg]	2105
Gross vehicle weight [kg]	2720
Wheelbase 1/2	2850
Engine type	spark ignition
Engine capacity [ccm]	2487
Engine Power [hp/kW]	190/140
Gearbox	automatic
Registration /record No.	NO319AC
VIN / serial number	5TDLB3CH10S092937
Date of first registration	30-08-2022
Date of next. tech. test	30-08-2027
Year of manufacture	2022 (year has been verified with the manufacturer's base)
Readout [km]	160 412 (read)
Body color / type of coating	black/double-layered, metallized

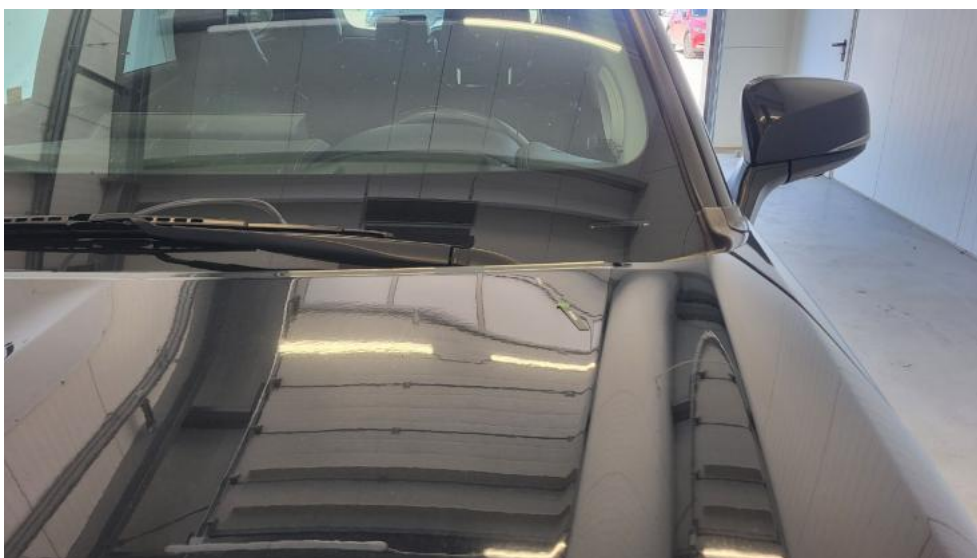
**Photo 44.**  
Pokrywa komory silnika - Wgniecenie/odkształcenie 1

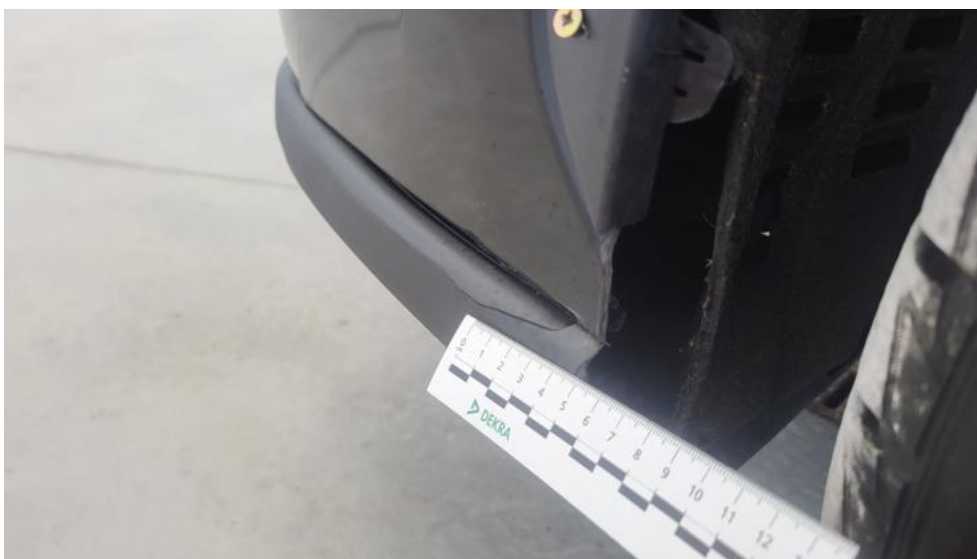
**Photo 45.**  
Spoiler zderzaka przedniego - Pęknięcie/rozerwanie 1

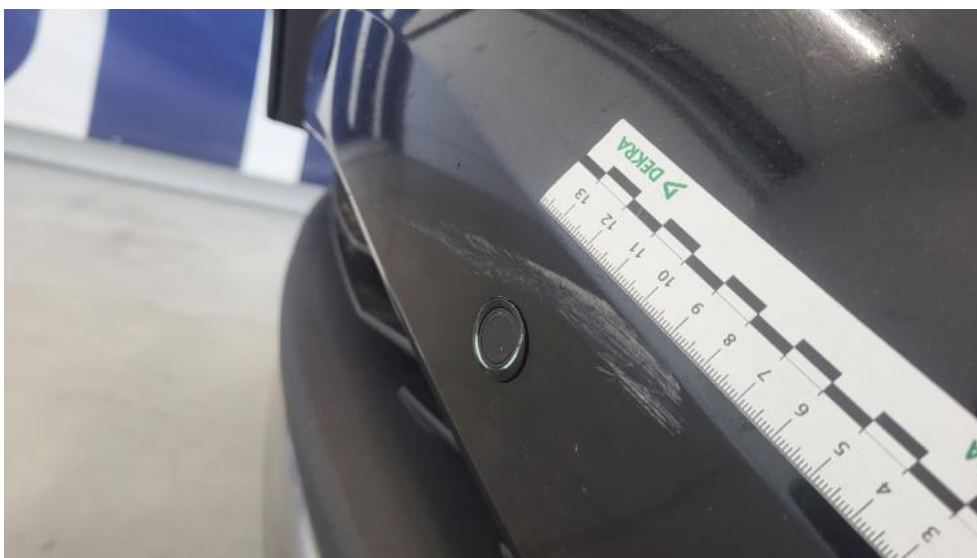
**Photo 46.**  
Zderzak - Rysa/odprysk 1

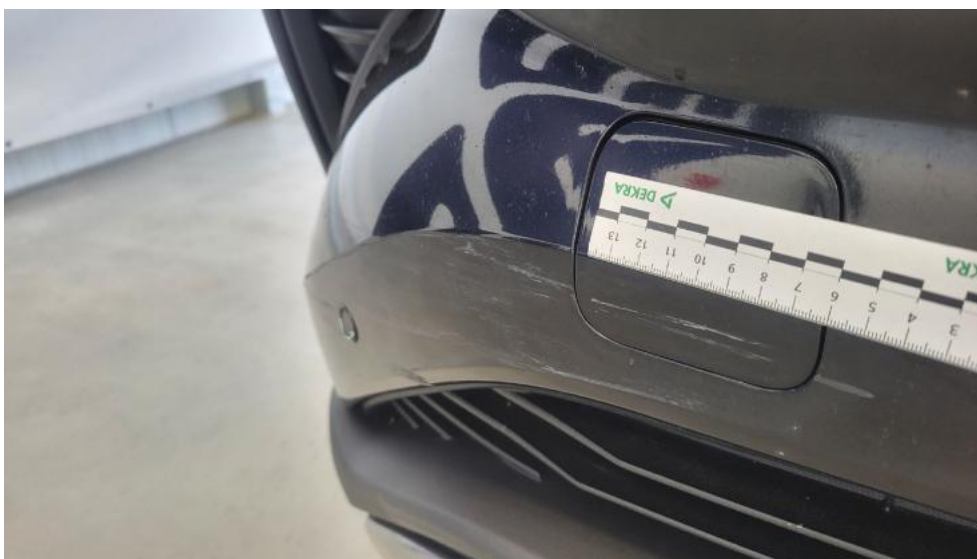
**Photo 47.**

Zderzak - Rysa/odprysk 2

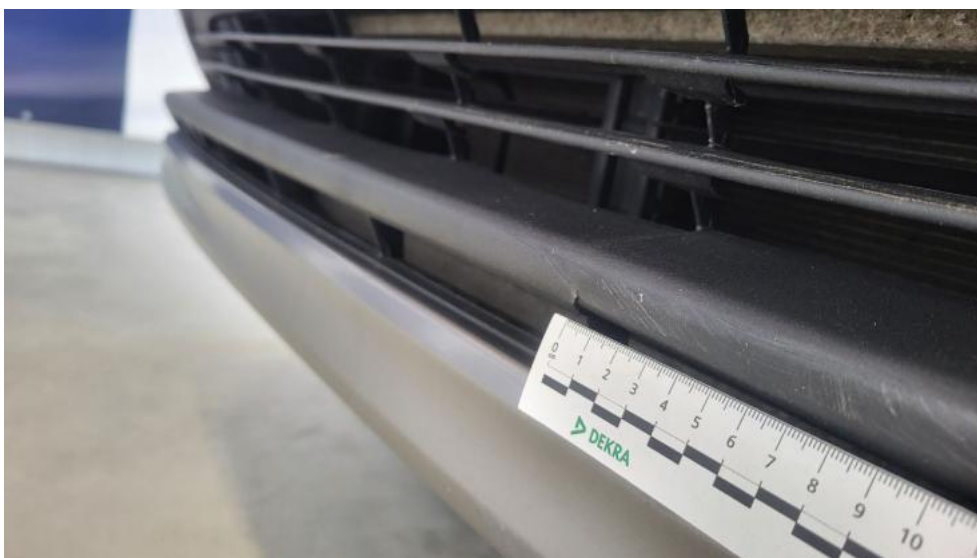
**Photo 48.**

Zderzak przedni cz dolna - Wgniecenie/odkształcenie 1

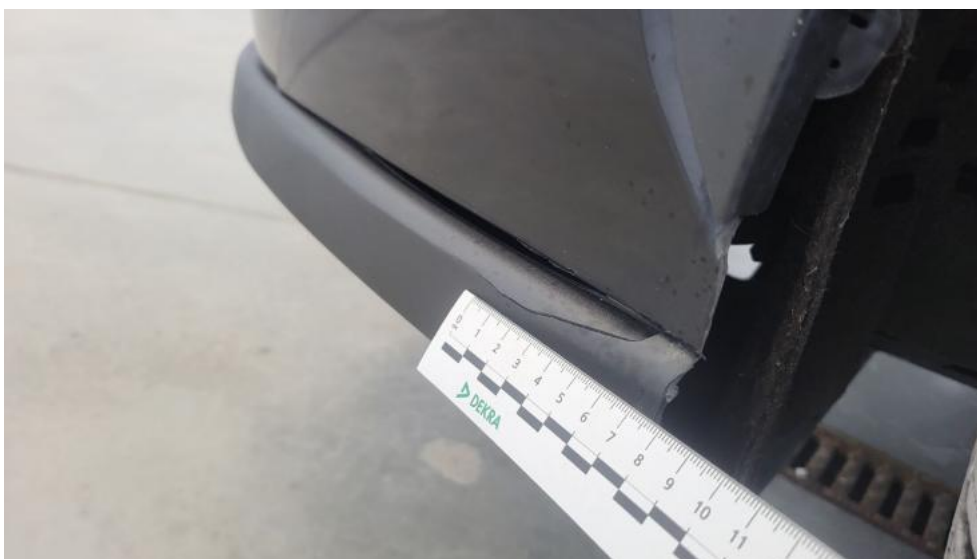
Zderzak przedni cz dolna - Pęknięcie/rozerwanie 1

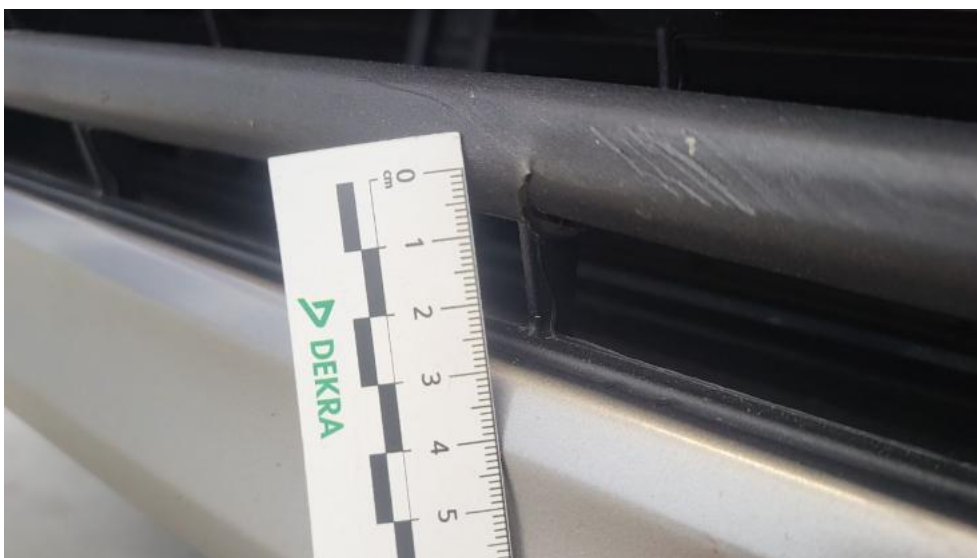
**Photo 50.**

Zderzak przedni cz dolna - Pęknięcie/rozerwanie 2

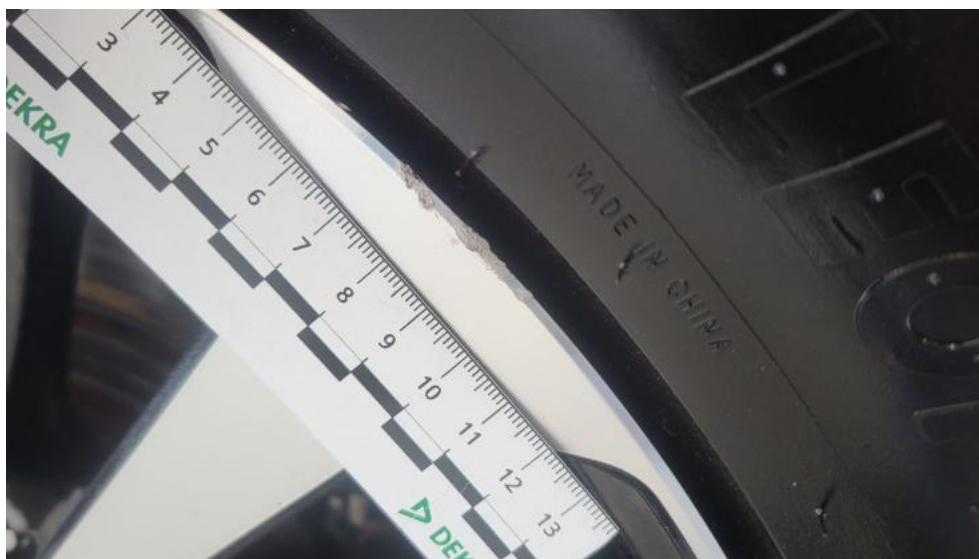
**Photo 51.**

Felga aluminiowa przednia P - Rysa/odprysk 1

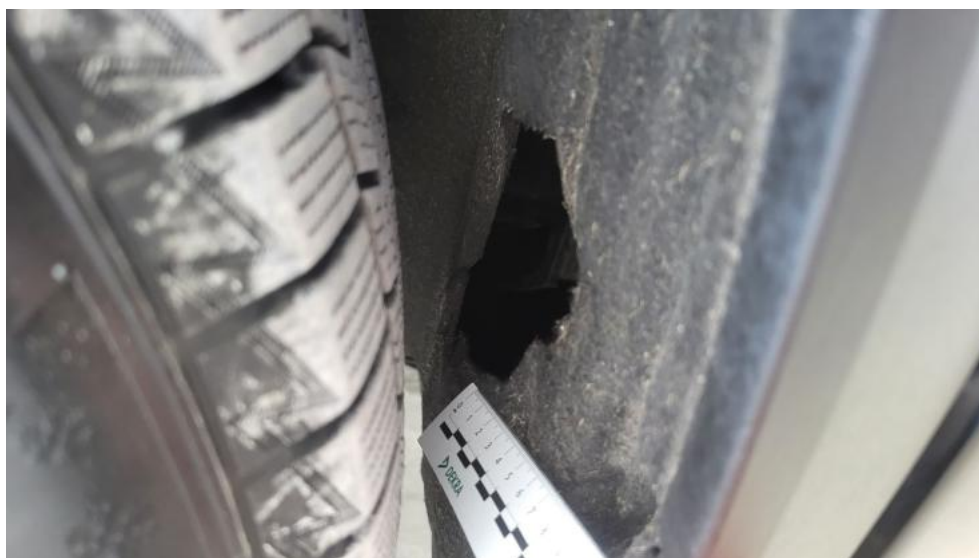
**Photo 52.**

Nadkole przednie P - Pęknięcie/rozerwanie 1

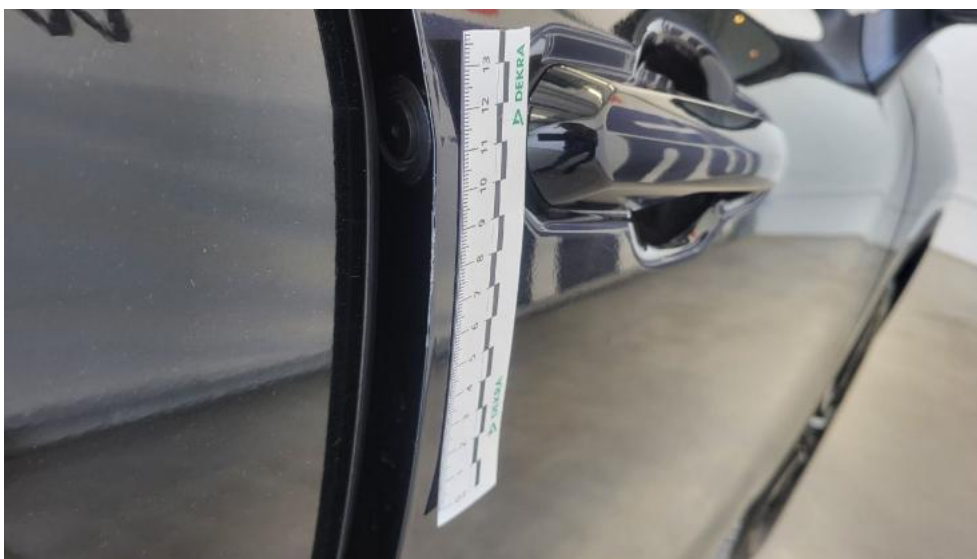
**Photo 53.**

Drzwi przednie P - Rysa/odprysk 1

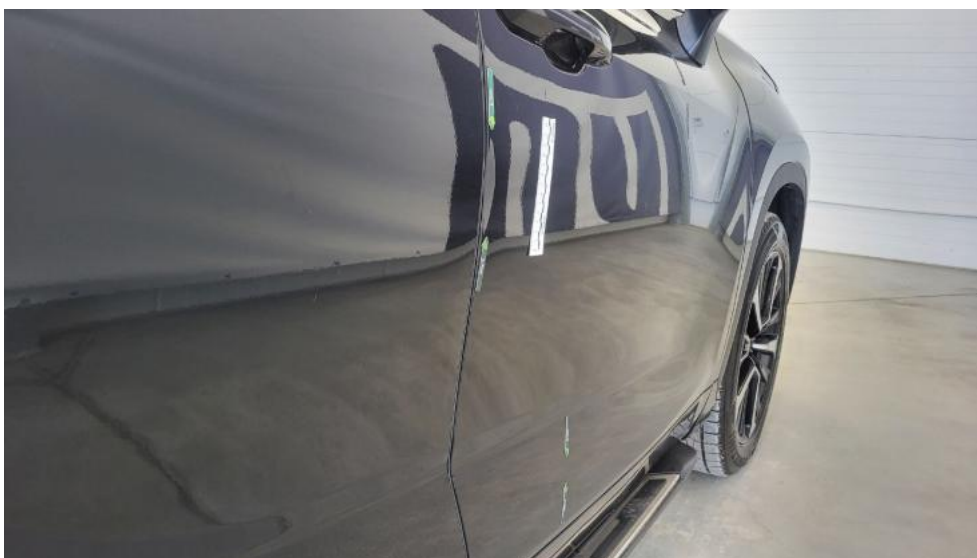
**Photo 54.**

Drzwi przednie P - Wgniecenie/odkształcenie 1

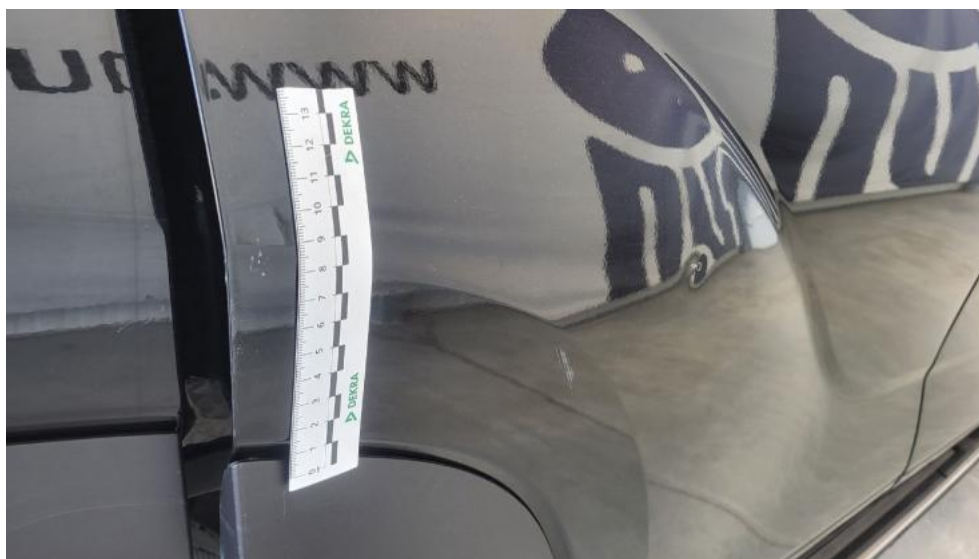
**Photo 55.**  
Drzwi tylne P - Rysa/odprysk 1

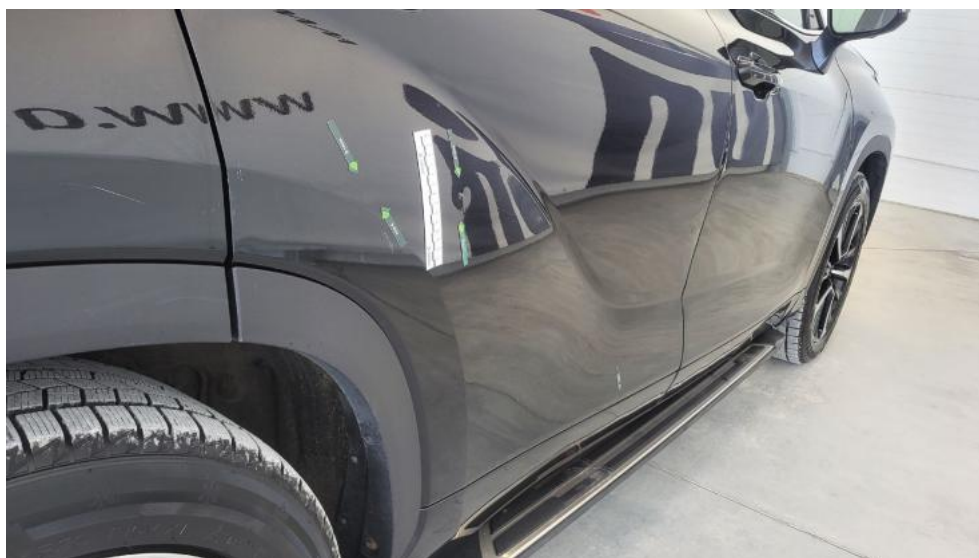
**Photo 56.**  
Drzwi tylne P - Wgniecenie/odkształcenie 1

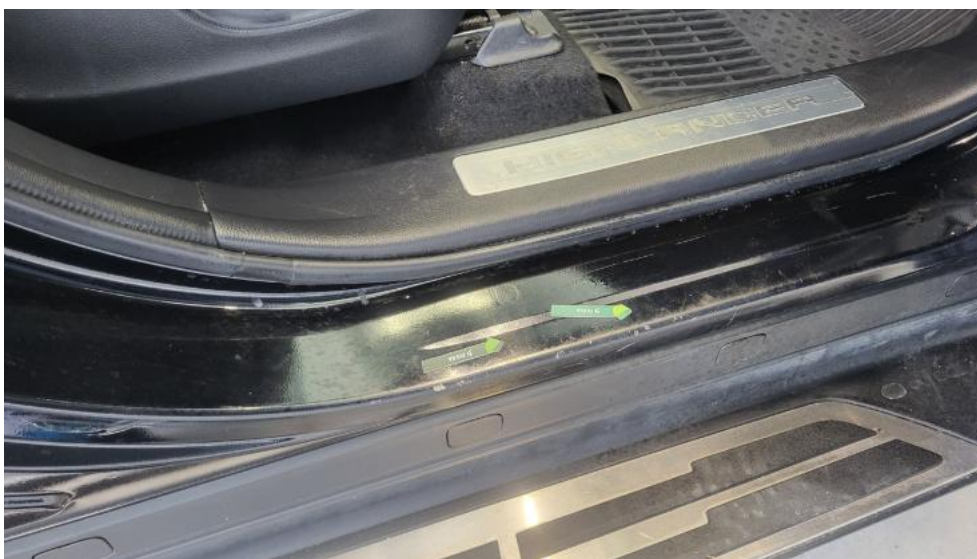
**Photo 57.**  
Próg P - Wgniecenie/odkształcenie 1

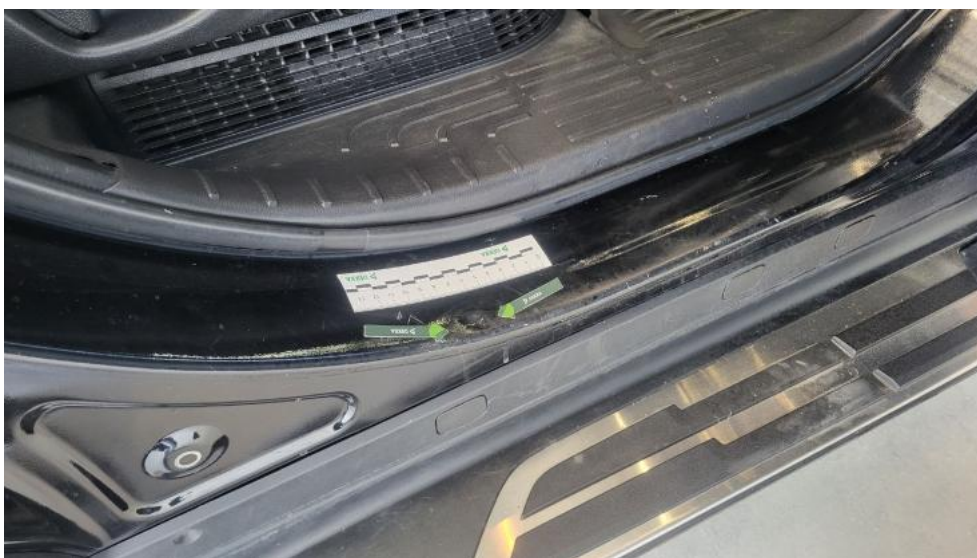
**Photo 58.**  
Próg P - Wgniecenie/odkształcenie 2

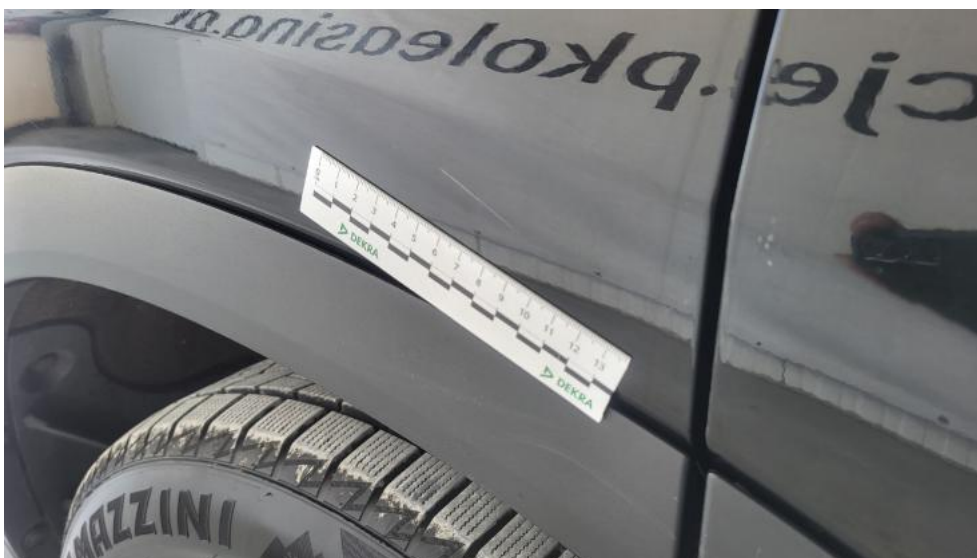
**Photo 60.**

Łotnik tylny P / Ściana boczna P - Rysa/odprysk 1

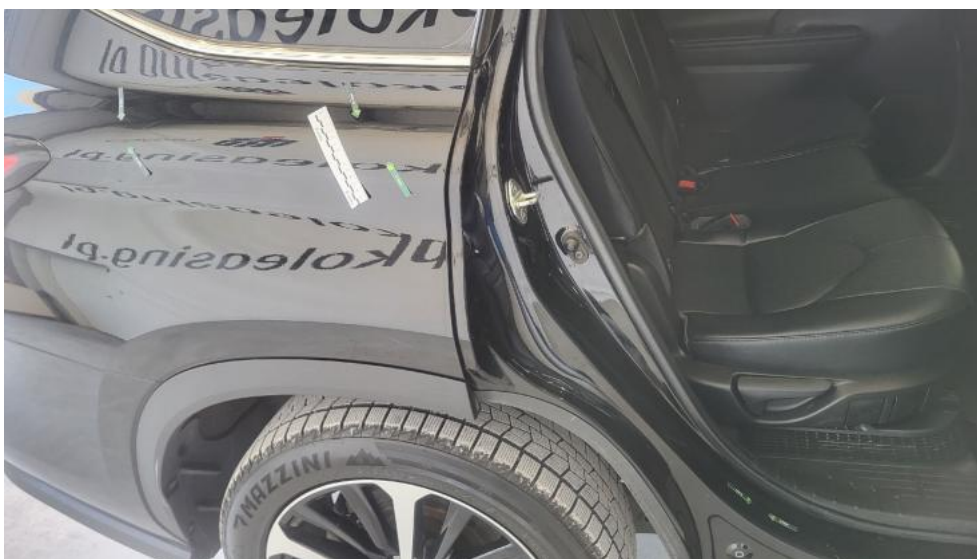
**Photo 61.**  
Błotnik tylny P / Ściana boczna P - Wgniecenie/odkształcenie 1

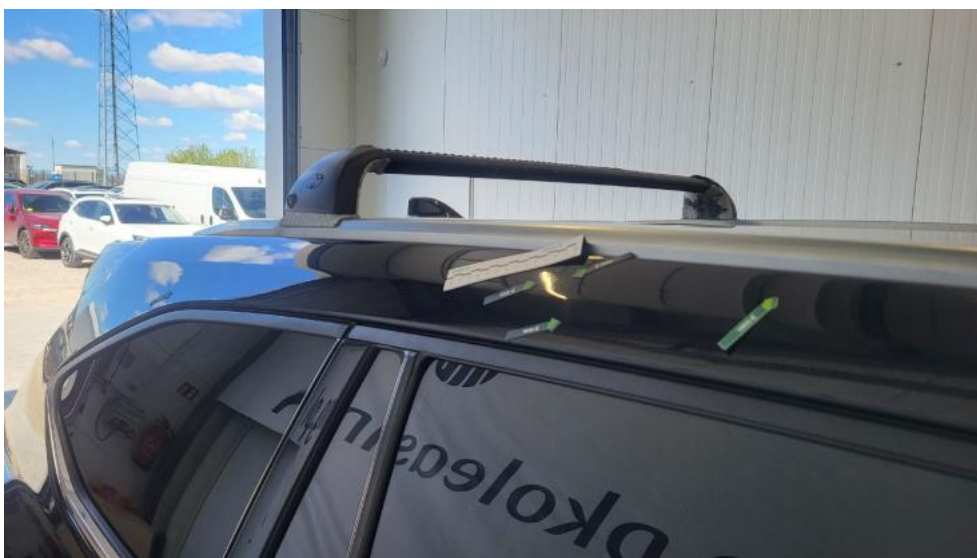
**Photo 62.**  
Błotnik tylny P / Ściana boczna P - Wgniecenie/odkształcenie 2

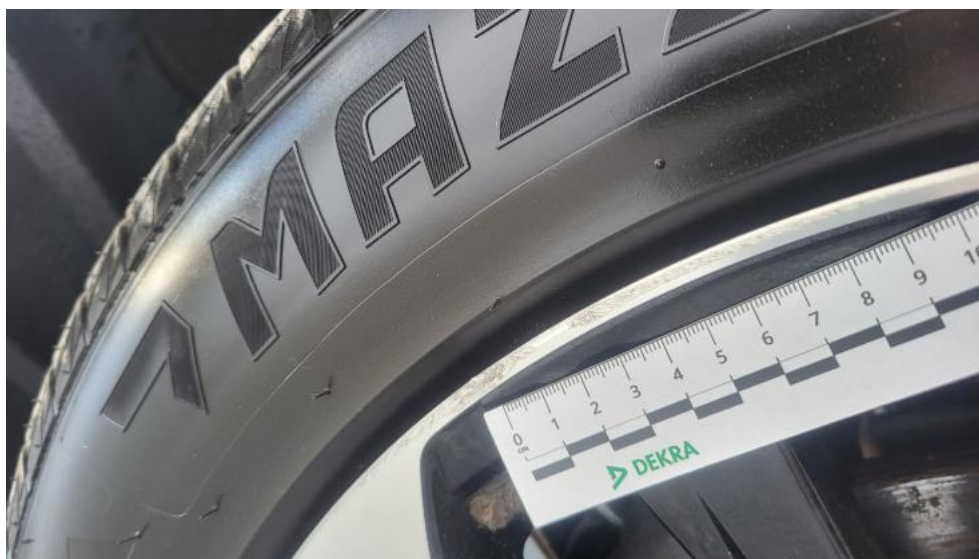
**Photo 63.**  
Felga aluminiowa tylna P - Rysa/odprysk 1

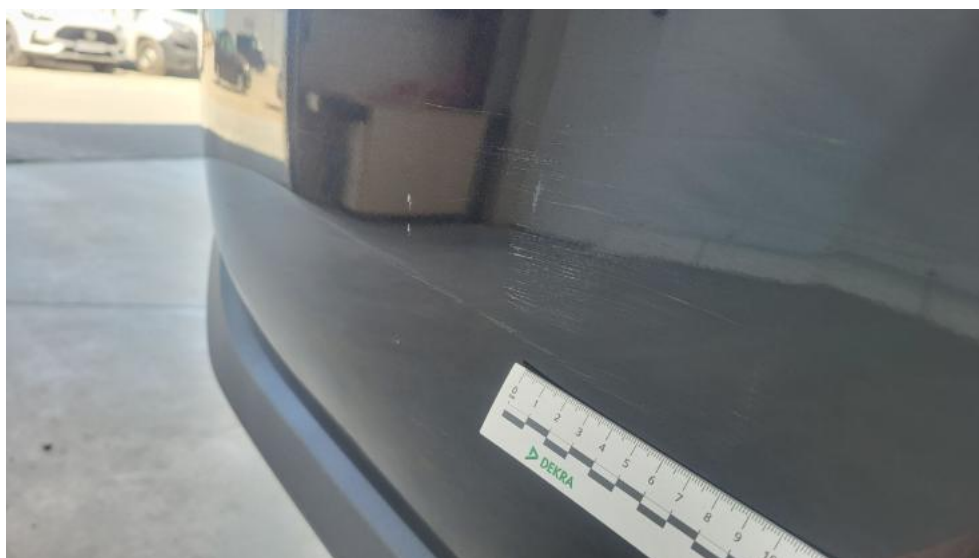
**Photo 64.**  
Zderzak tylny - Rysa/odprysk 1

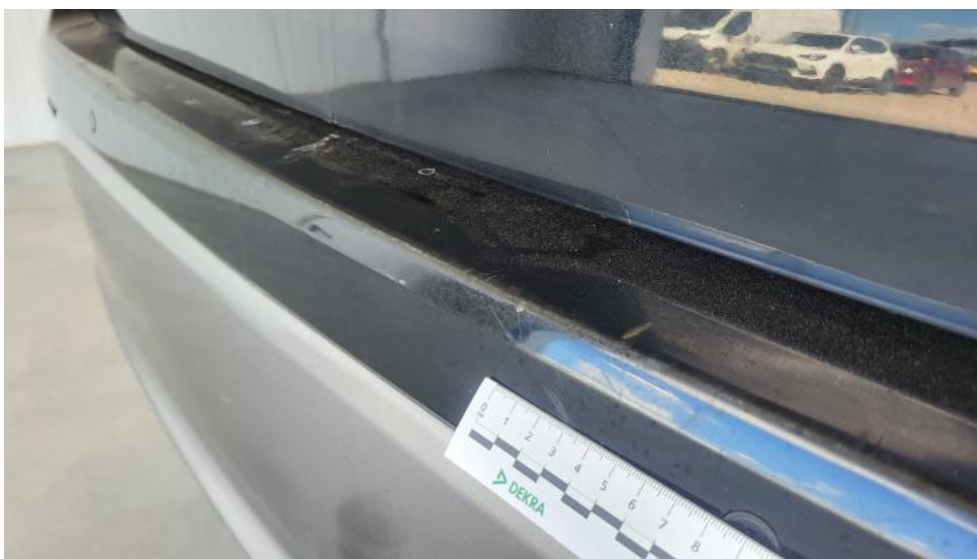
**Photo 65.**  
Zderzak tylny - Rysa/odprysk 2

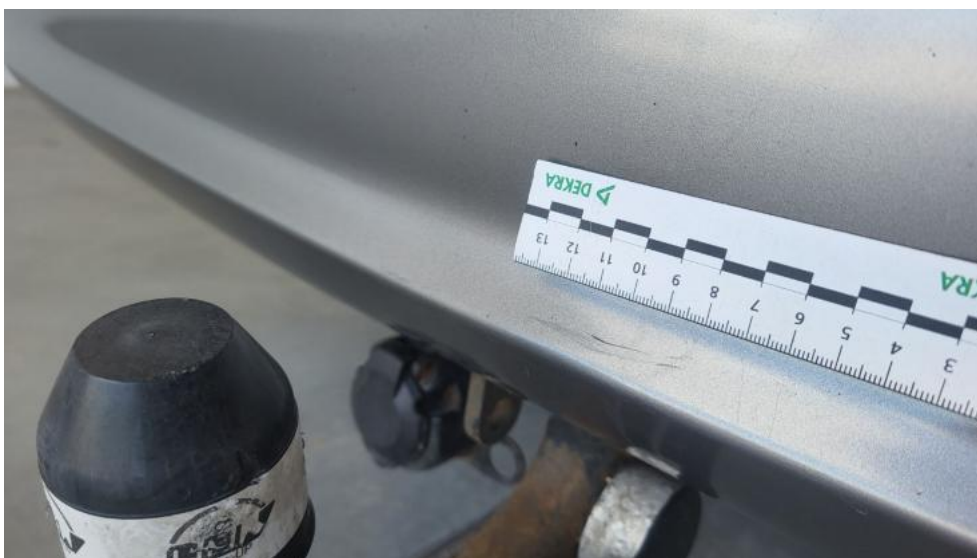
**Photo 66.**  
Zderzak tylny cz dolna - Rysa/odprysk 1

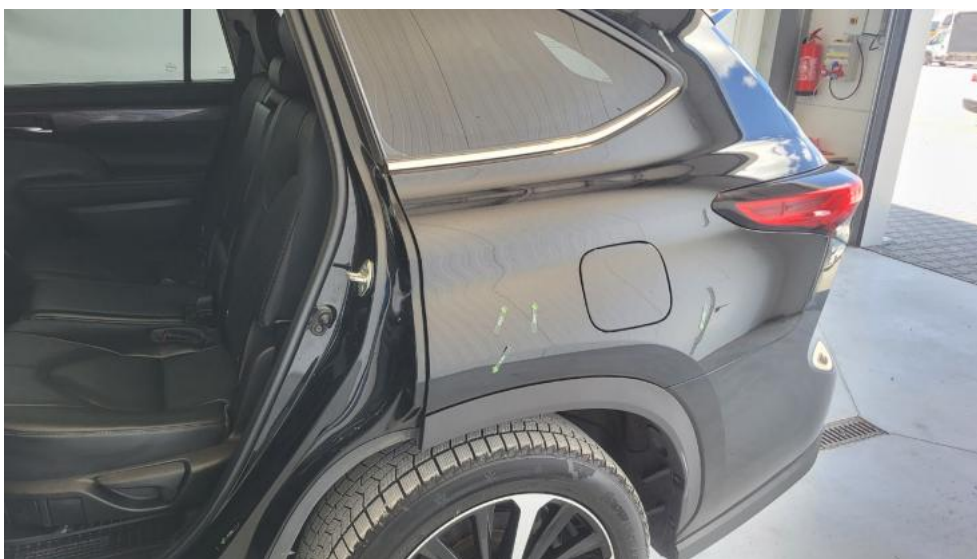
**Photo 67.**  
Błotnik tylny L / Ściana boczna L - Wgniecenie/odkształcenie 1

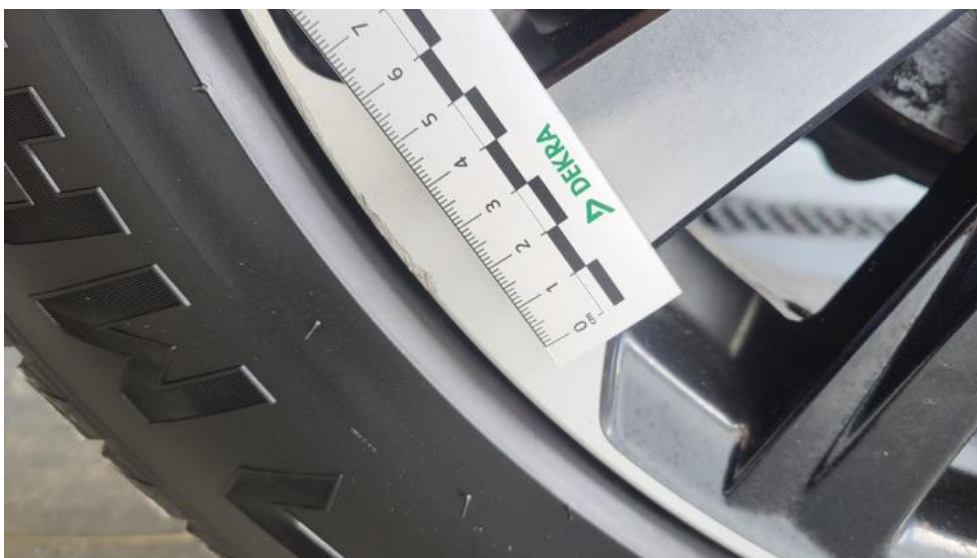
**Photo 68.**  
Felga aluminiowa tylna L - Rysa/odprysk 1

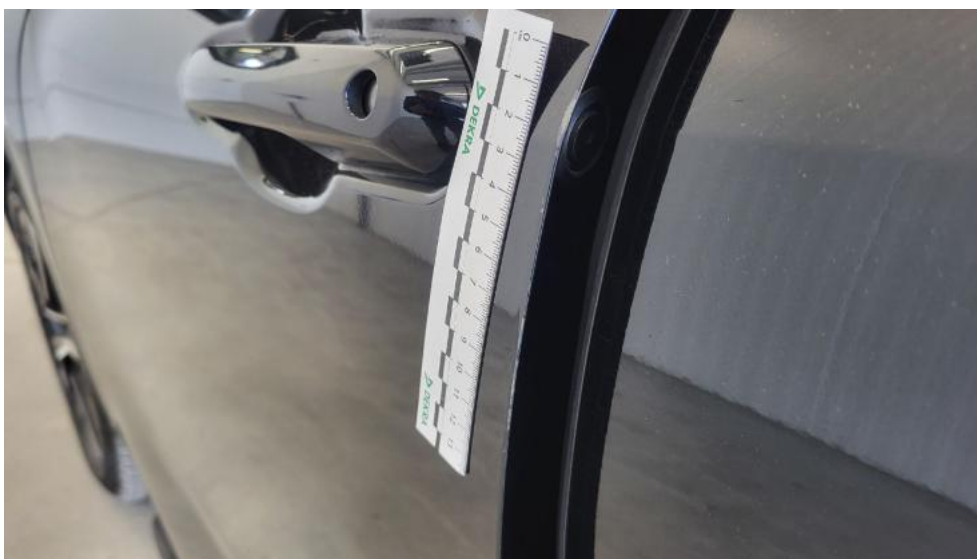
**Photo 69.**

Drzwi przed L - Rysa/odprysk 1

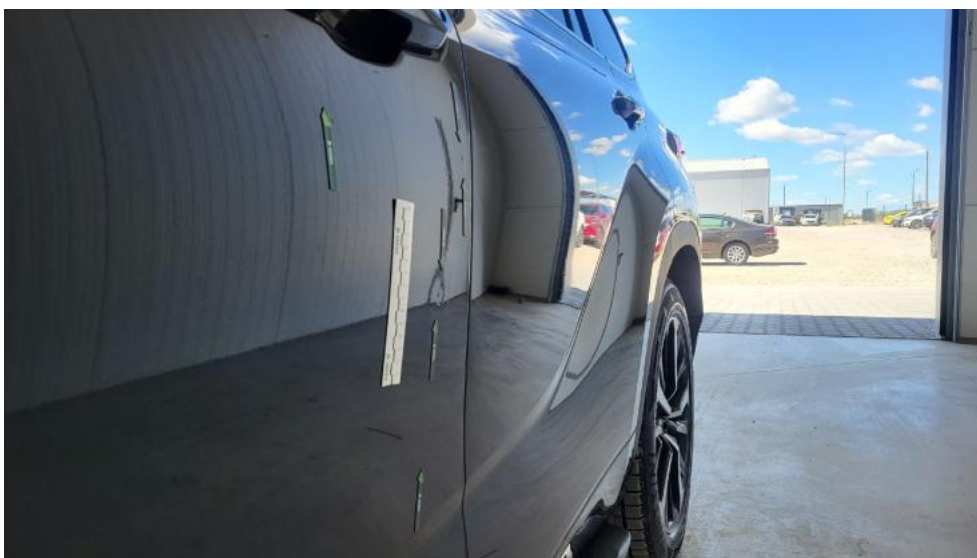
**Photo 70.**

Drzwi przed L - Wgniecenie/odkształcenie 1

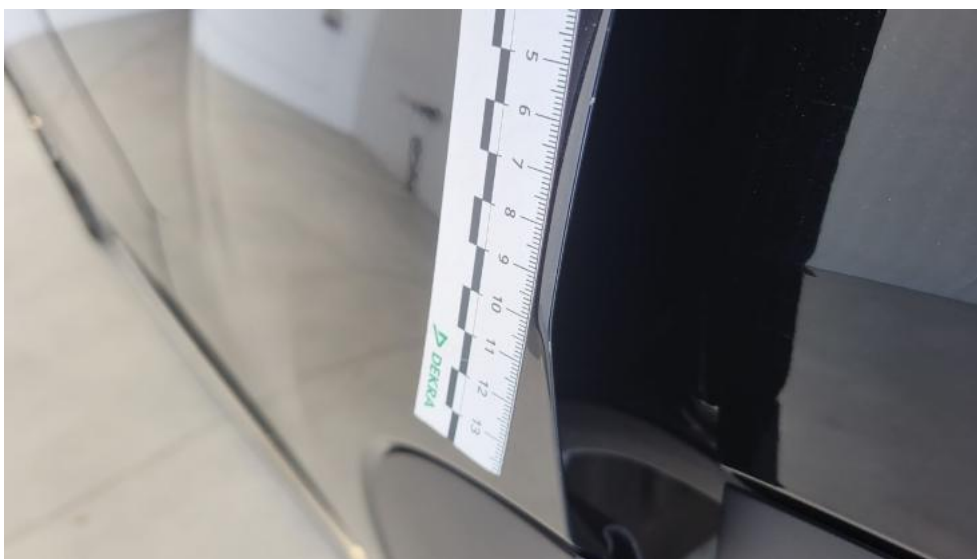
**Photo 71.**

Drzwi tylne L - Rysa/odprysk 1

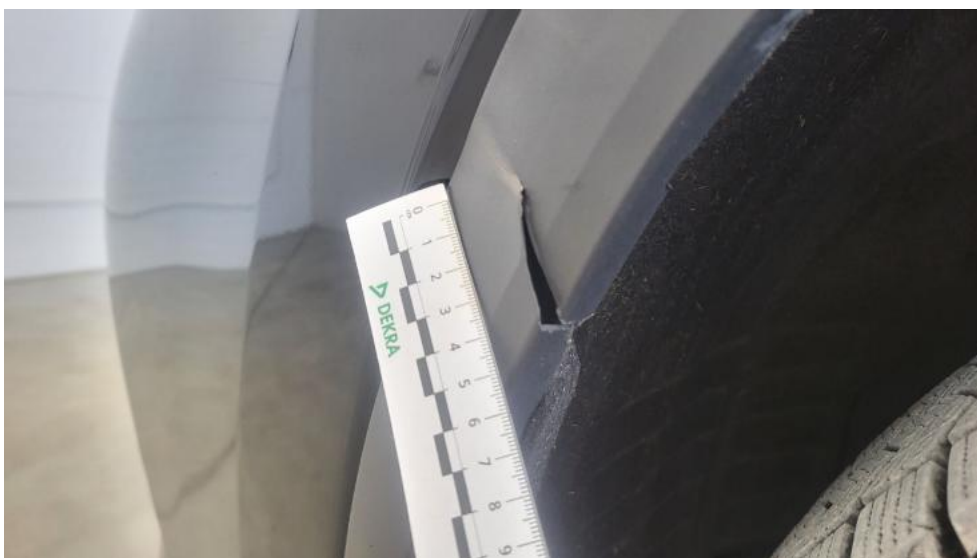
**Photo 72.**

Listwa błotnika przedniego L - Pęknięcie/rozerwanie 1

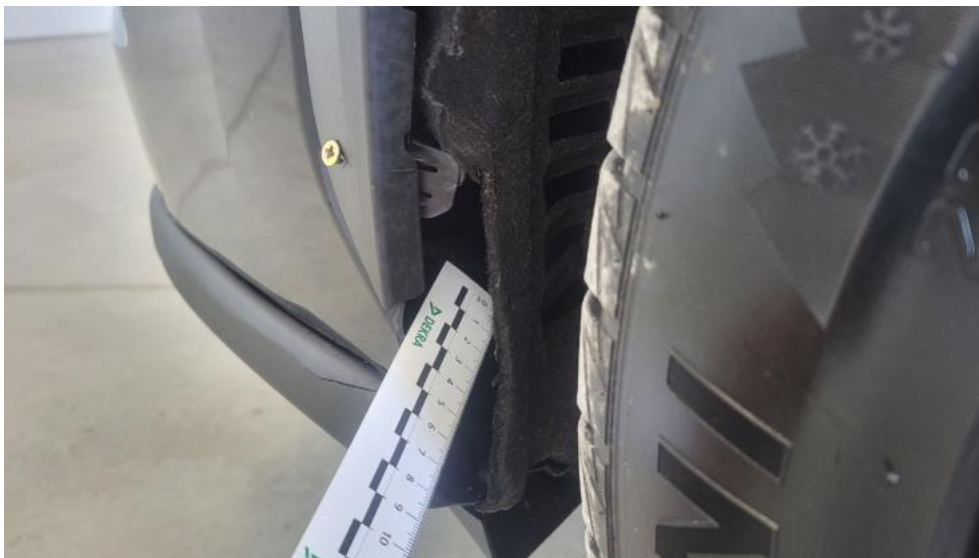
**Photo 73.**  
Nadkole przednie L - Inne 1

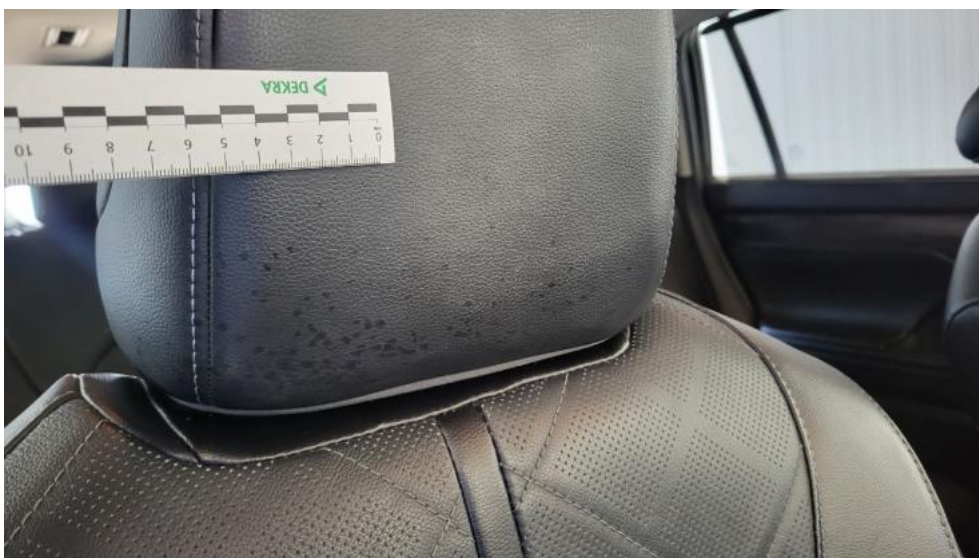
**Photo 74.**  
Zaglówek fotela prz. P - Inne 1

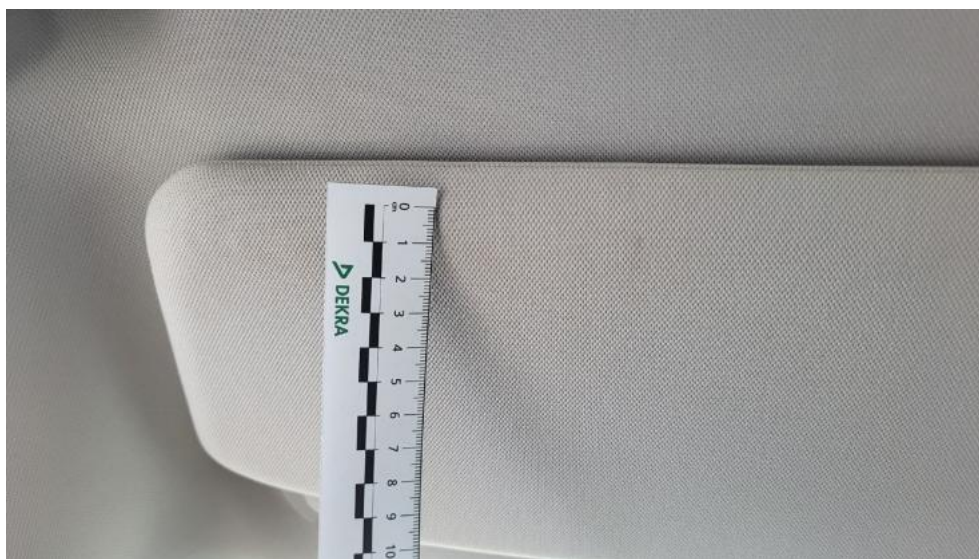
**Photo 75.**

Osłona p/słoneczna lewa - Inne 1

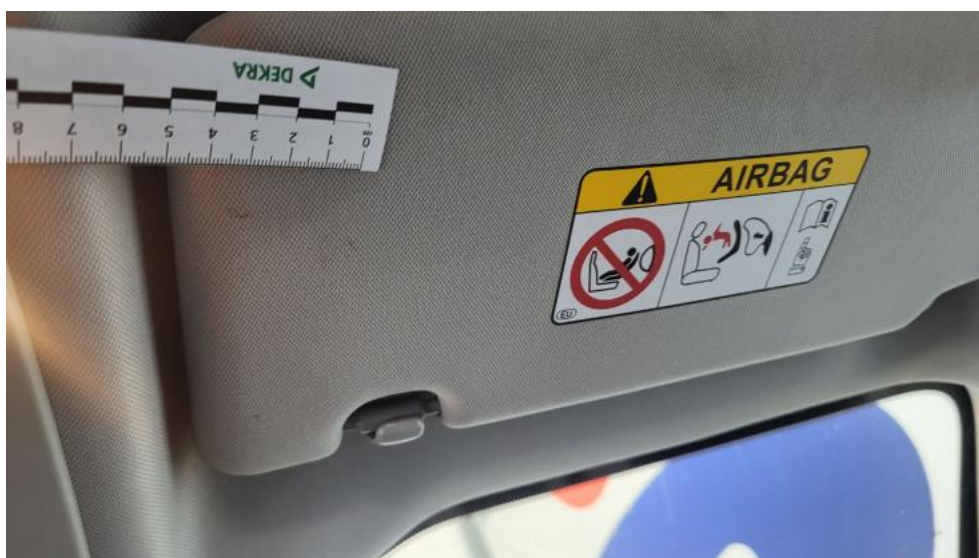
**Photo 76.**

Osłona p/słoneczna prawa - Inne 1

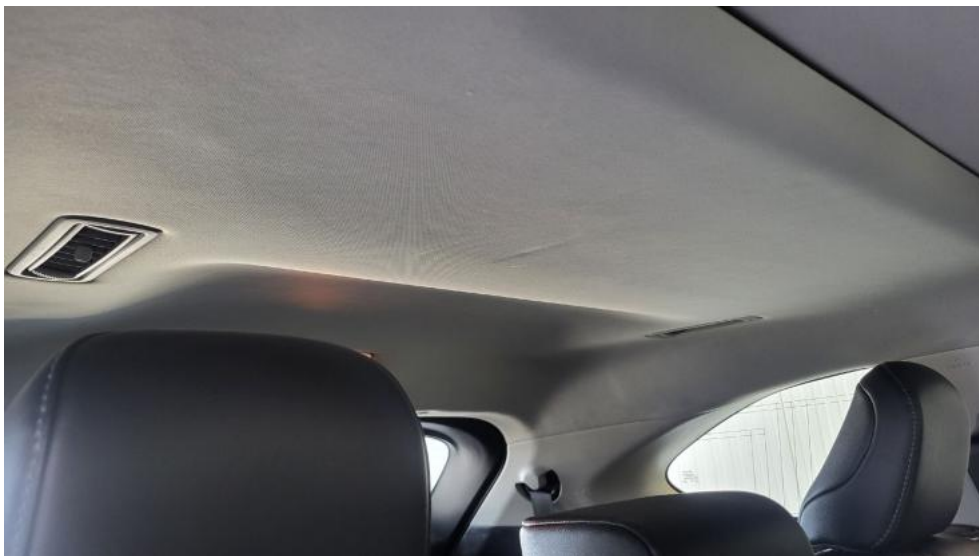
**Photo 77.**  
Podsufitka - Inne 1

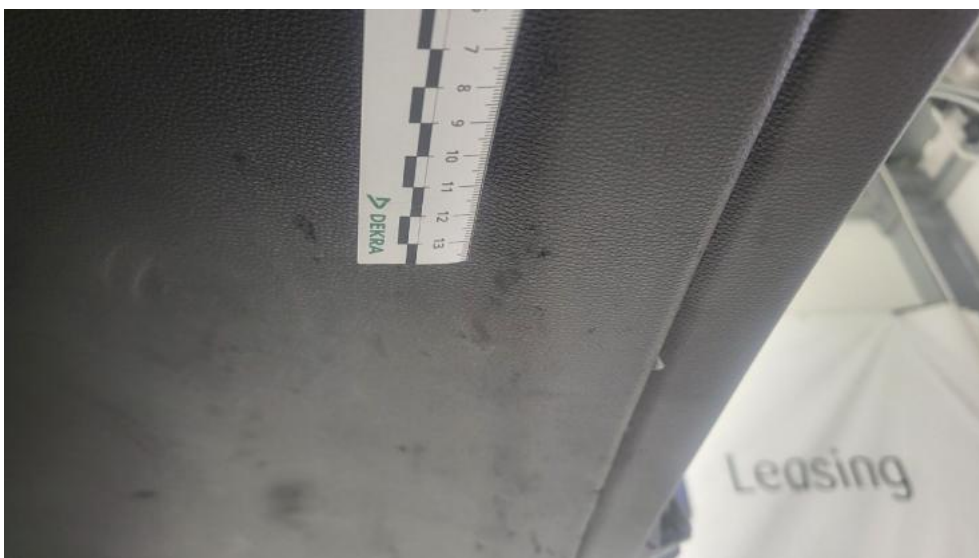
**Photo 78.**  
Wykładzina pokrywy tylnej - Rysa/odprysk 1

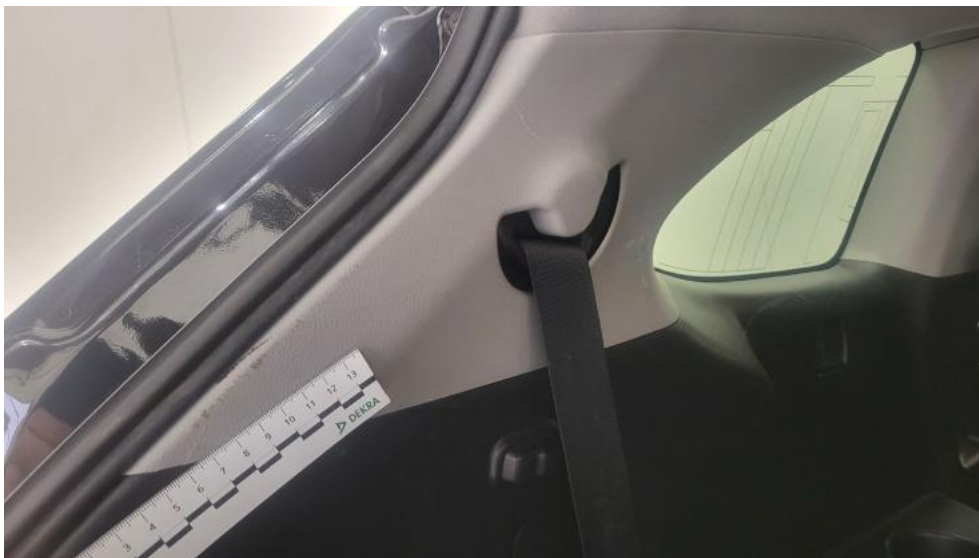
**Photo 79.**

Wykładzina przestrzeni bagażowej - Rysa/odprysk 1
