DEKRA's commission No. : PKOL(W)/LODZ/15782/26/02/19
 commission/ damage No. : PS24/01207
 Date of commission: 19-02-2026

Vehicle data

Group of objects (Eurotax)	cars
EC code (Eurotax)	0130729
Manufacturer	FORD
Model	Focus Hatchback 18-21
Type / version	Focus 1.5 EcoBlue ST-Line Business
Body type	hatchback
Number of doors / seats	5/5
Curb weight [kg]	1288
Gross vehicle weight [kg]	1895
Wheelbase 1/2	2650
Engine type	Automatic ignition
Pollution reduction system	DPF
Engine capacity [ccm]	1498
Engine Power [hp/kW]	120/88
Gearbox	manual
Registration /record No.	WU9765R
VIN / serial number	WF0NXXGCHNLB27053
Date of first registration	16-10-2020
Date of next. tech. test	16-10-2026
Year of manufacture	2020 (year has been verified with the manufacturer's base)
Readout [km]	105 494 (read)
Body color / type of coating	silver/double-layered, metallized

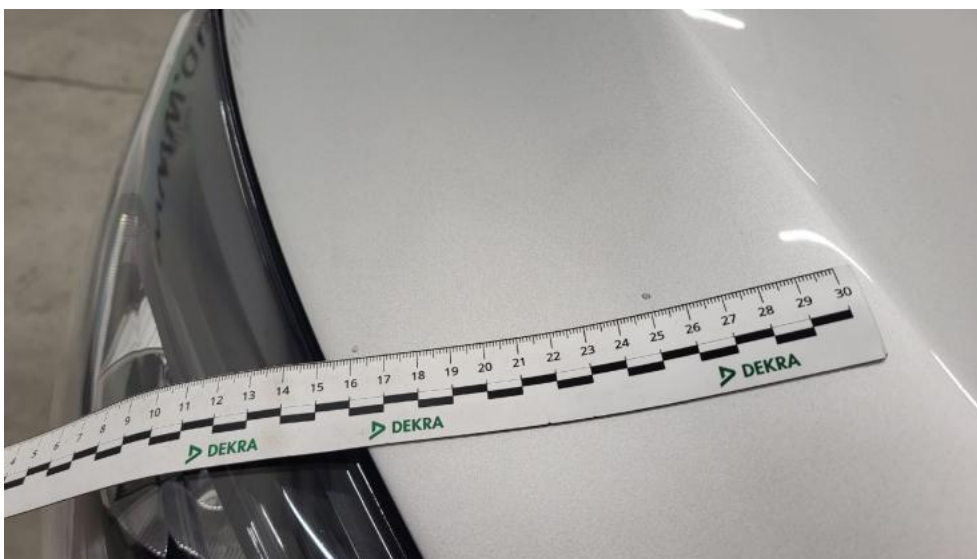
Photo 41.
Pokrywa komory silnika - Rysa/odprysk 1

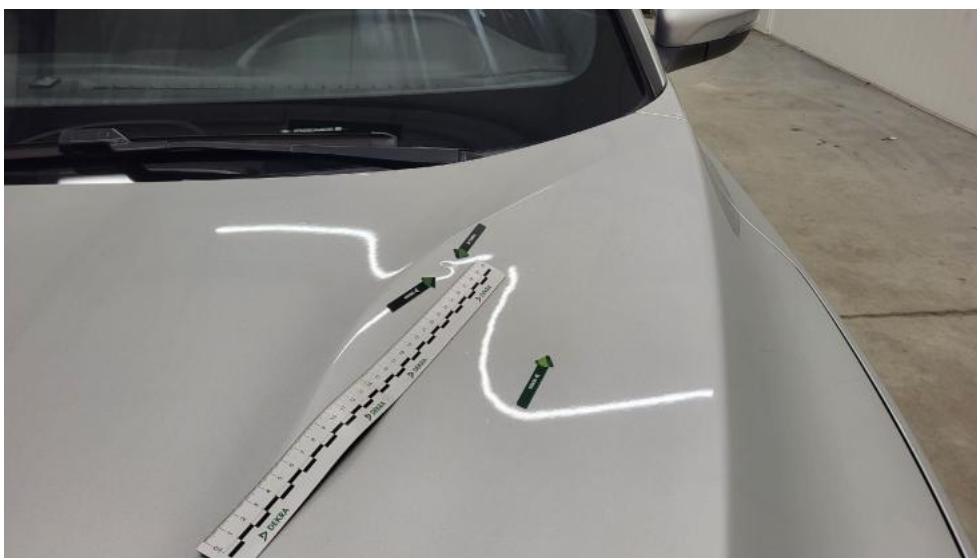
Photo 42.
Pokrywa komory silnika - Wgniecenie/odkształcenie 1

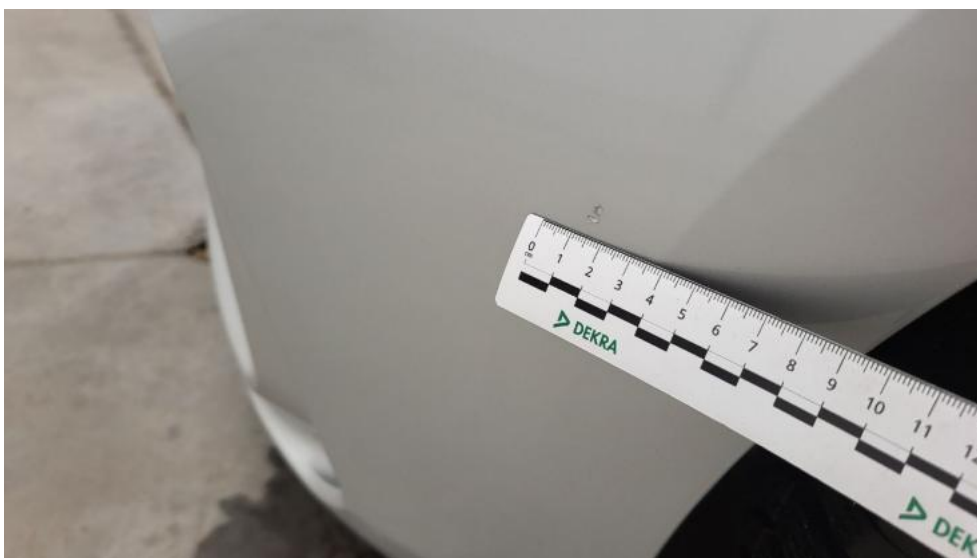
Photo 44.

Zderzak - Rysa/odprysk 1

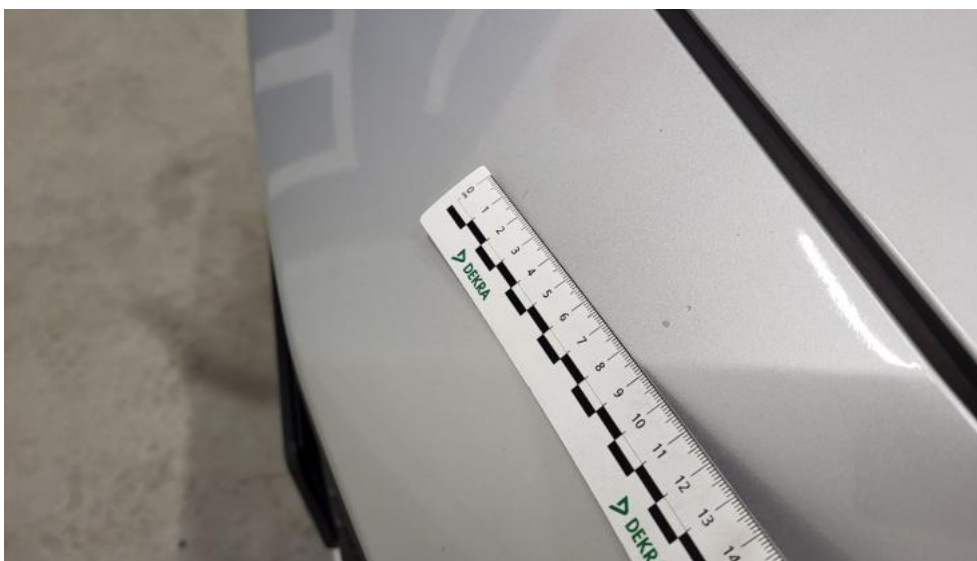
Photo 45.
Zderzak - Rysa/odprysk 2

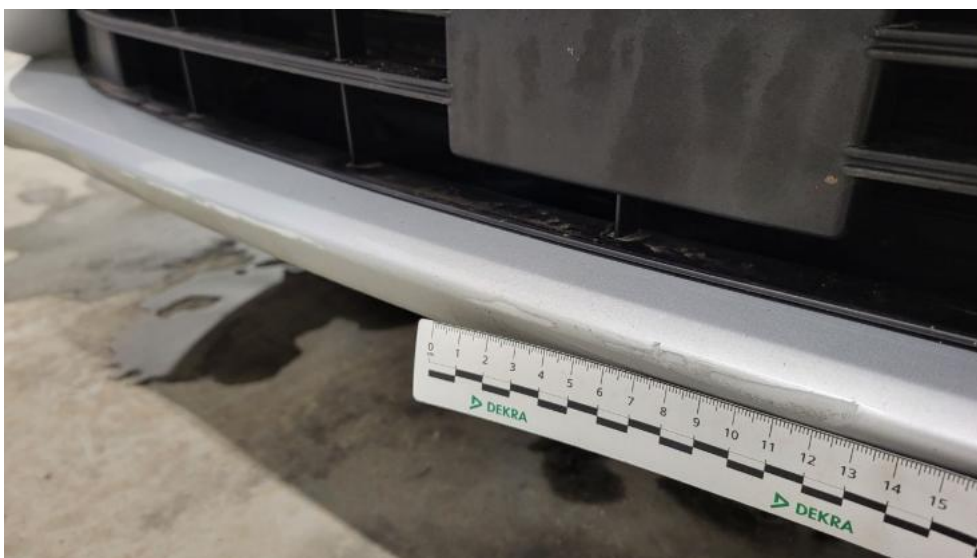
Photo 46.
Zderzak() - Rysa/odprysk 3

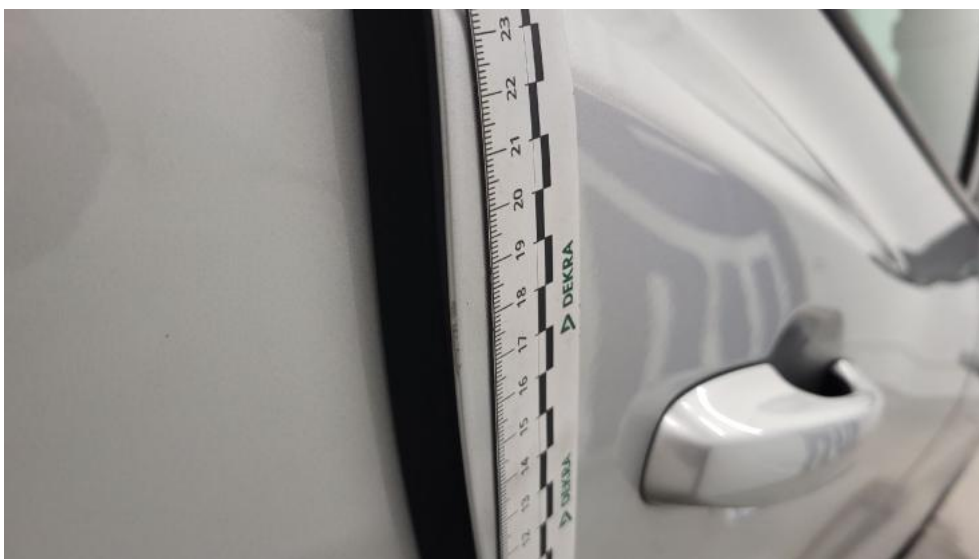
Photo 51.

Drzwi tylne P - Rysa/odprysk 1

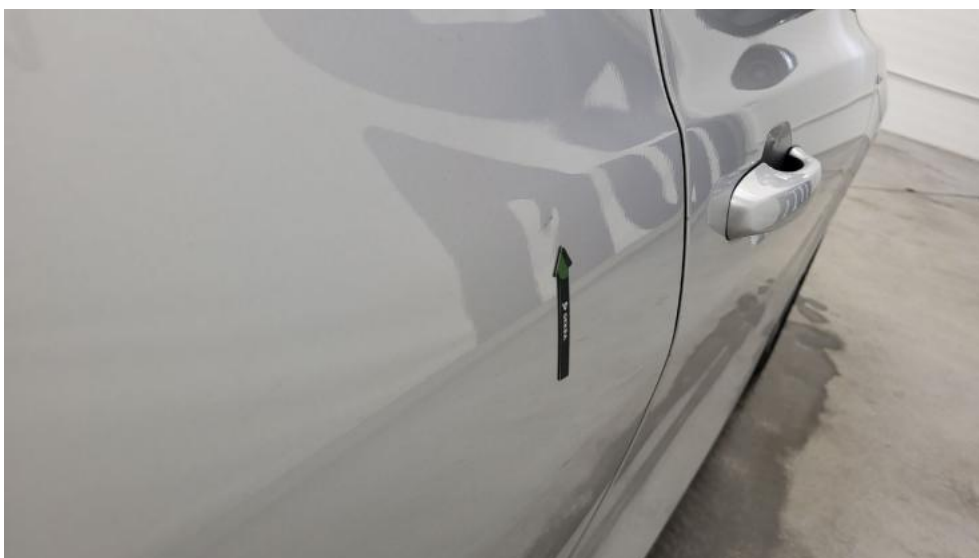
Photo 52.

Drzwi tylne P - Wgniecenie/odkształcenie 1

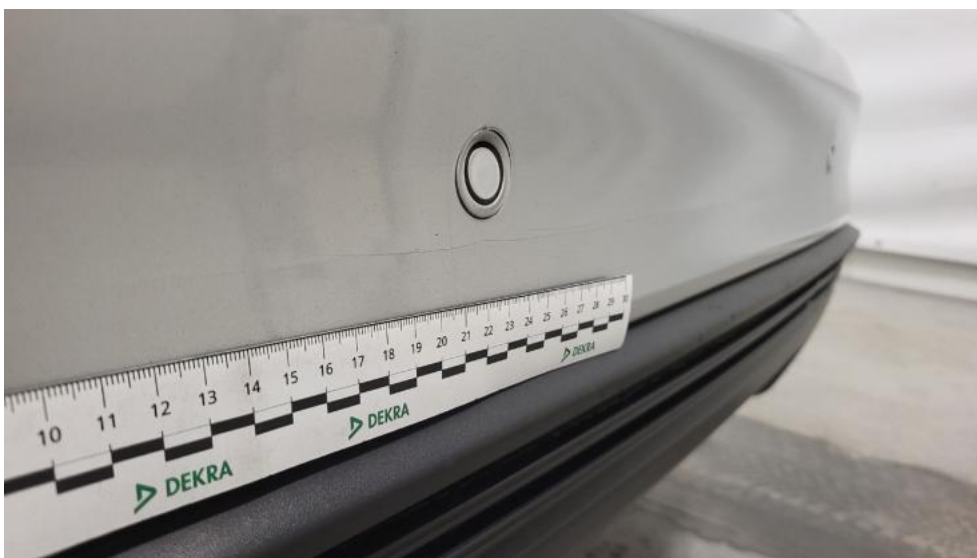
Photo 58.

Zderzak tylny - Pęknięcie/rozerwanie 2

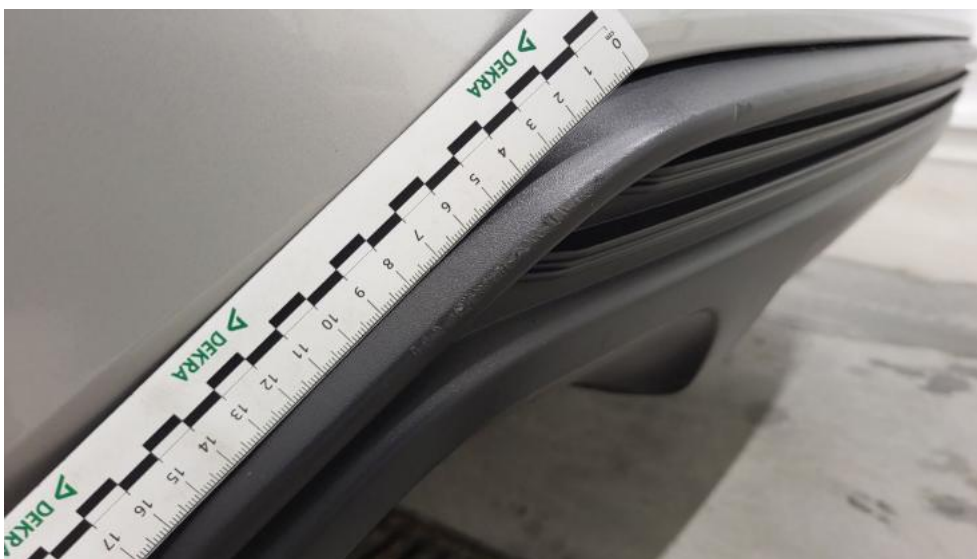
Photo 59.
Zderzak tylny cz dolna - Rysa/odprysk 1

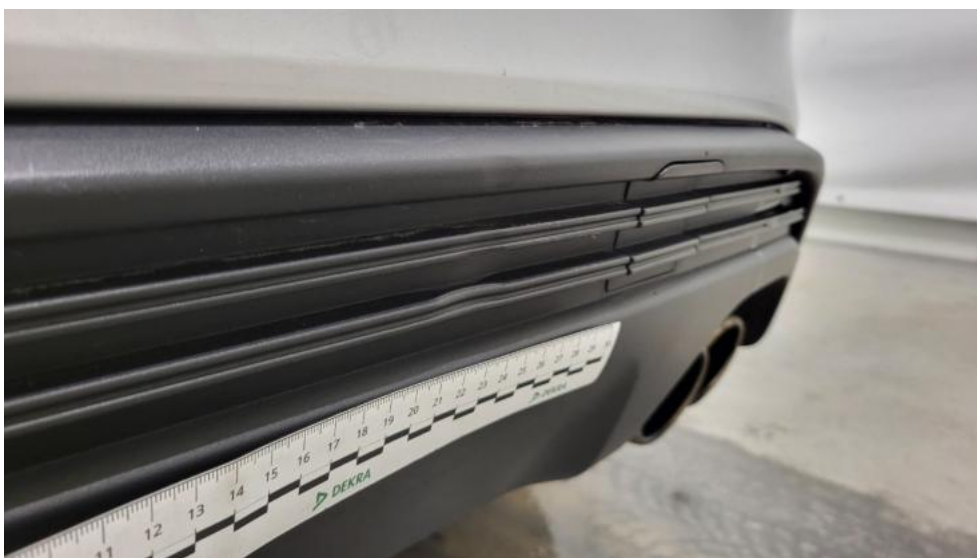
Photo 60.
Zderzak tylny cz dolna - Wgniecenie/odkształcenie 1

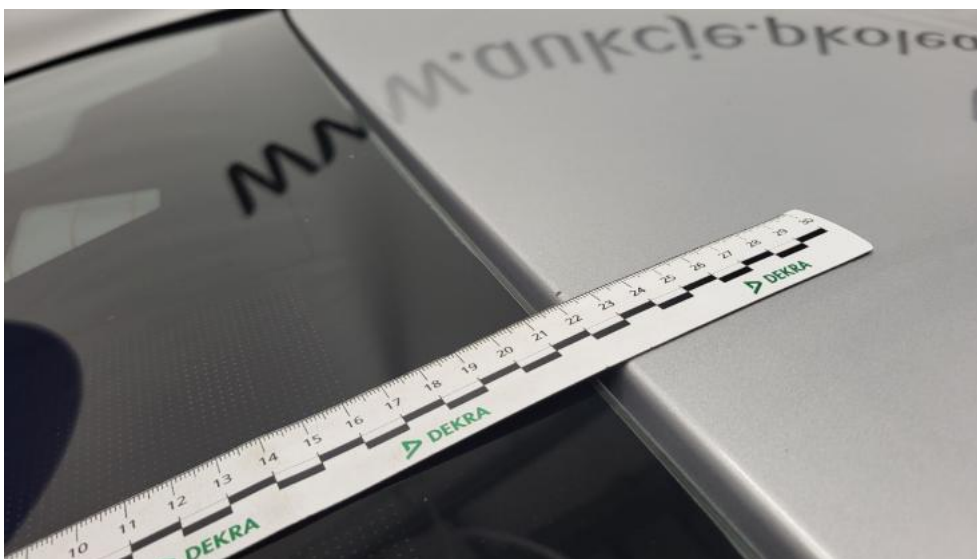
Photo 61.
Dach - Rysa/odprysk 1

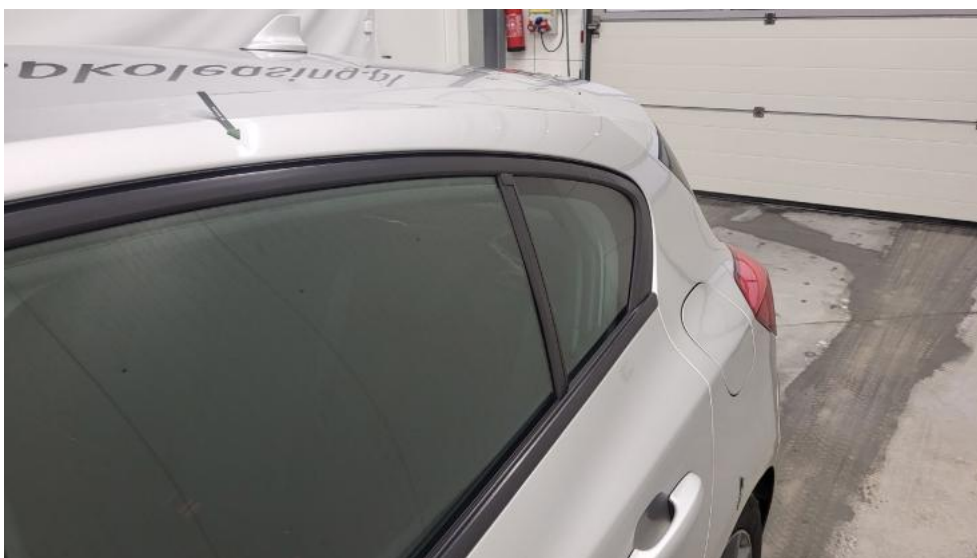
Photo 62.
Błotnik tylny L / Ściana boczna L - Wgniecenie/odkształcenie 1

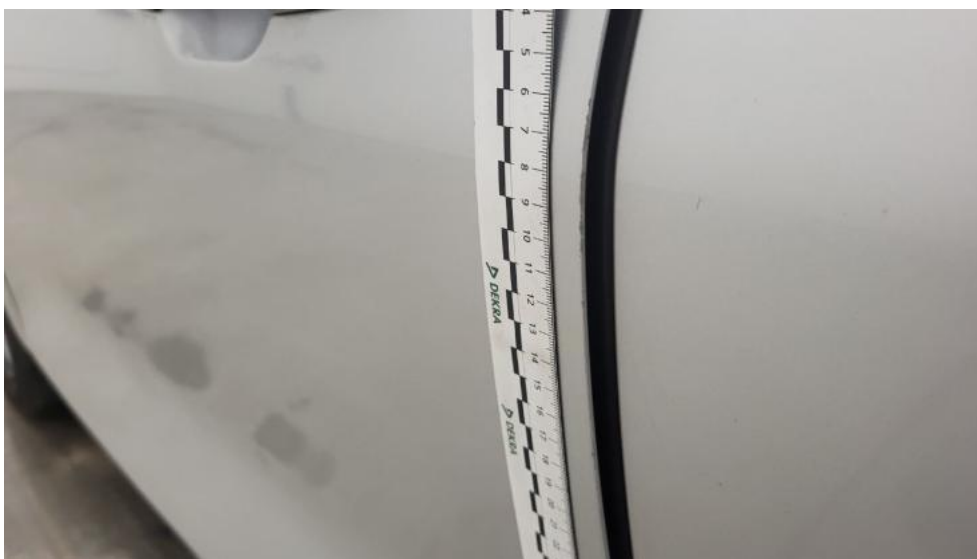
Photo 63.

Drzwi przed L - Rysa/odprysk 1

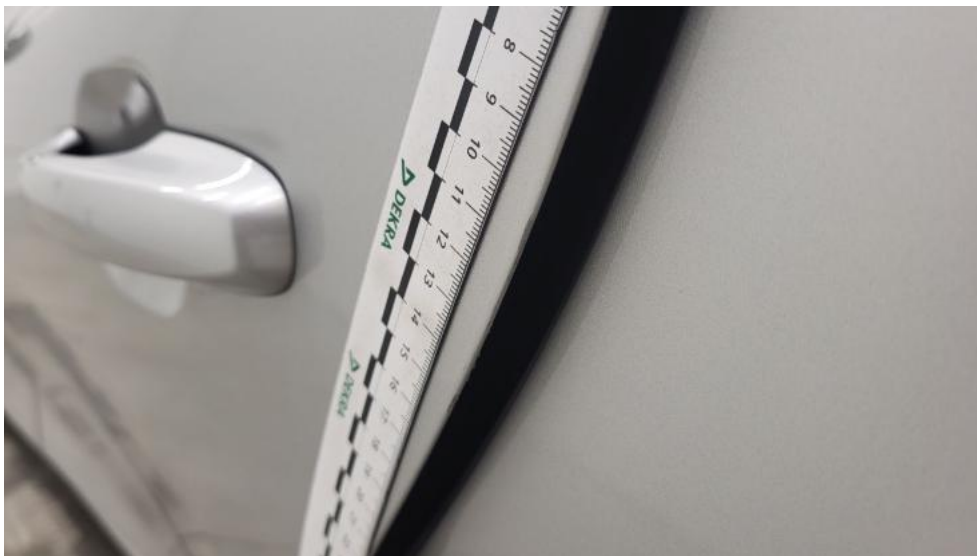
Photo 65.
Drzwi tylne L - Rysa/odprysk 1

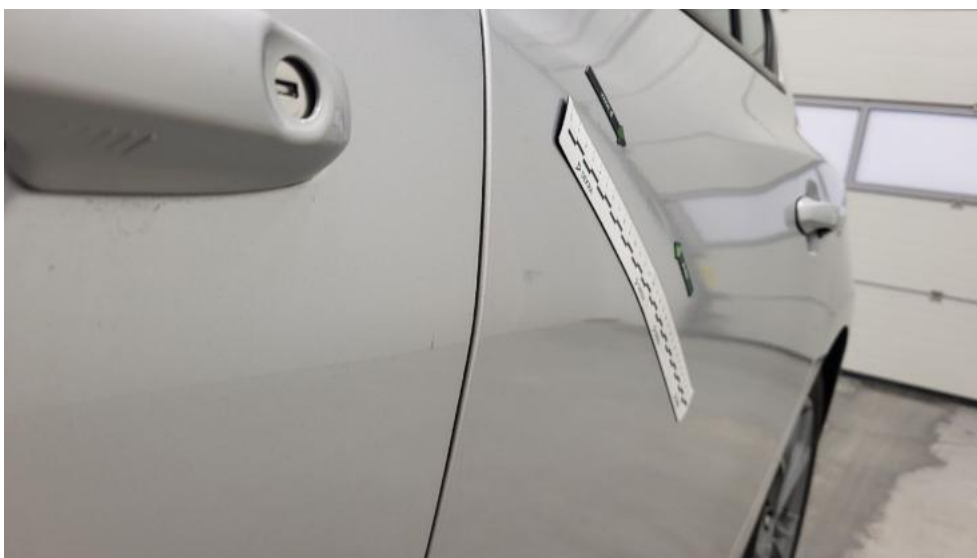
Photo 66.
Drzwi tylne L - Wgniecenie/odkształcenie 1

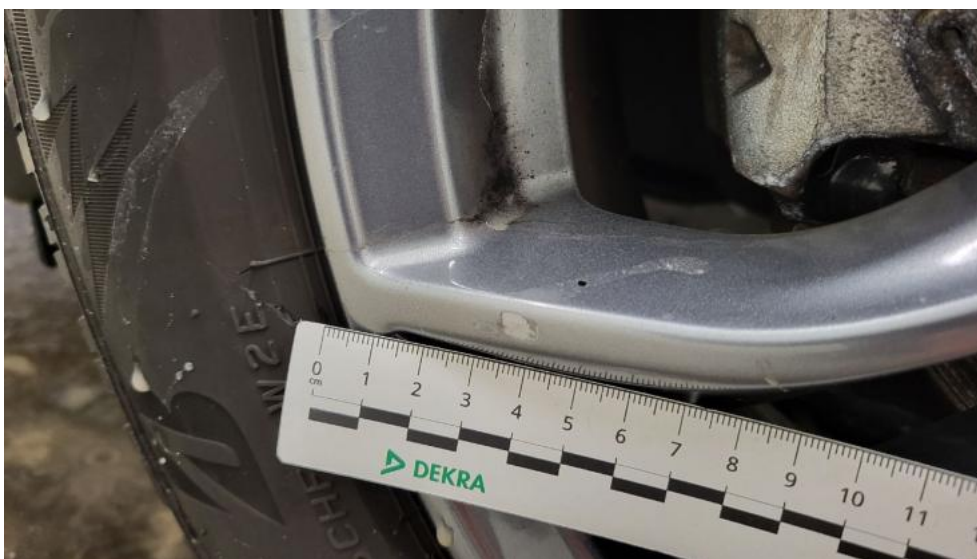
Photo 67.
Felga Aluminiowa przednia L - Rysa/odprysk 1

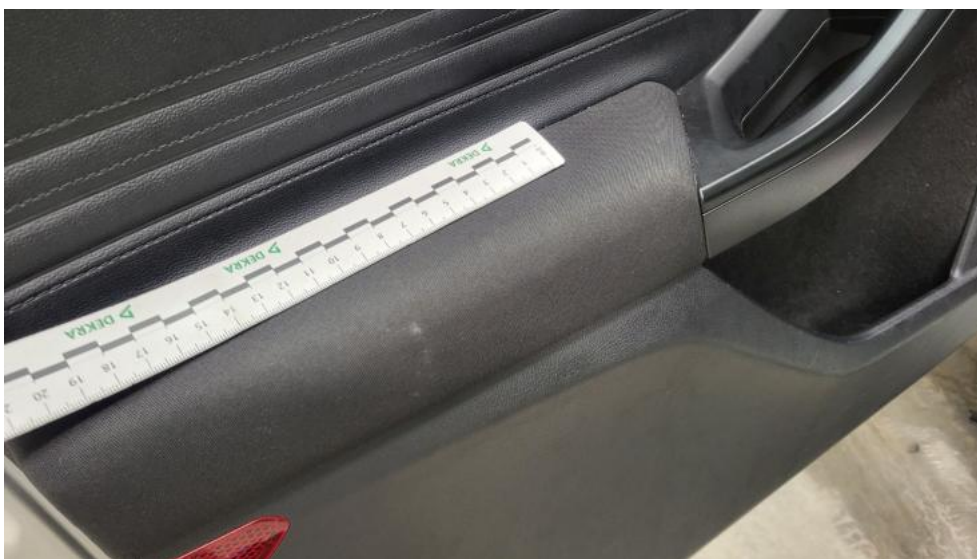
Photo 71.
Tapicerka drzwi przednich L - Inne 1

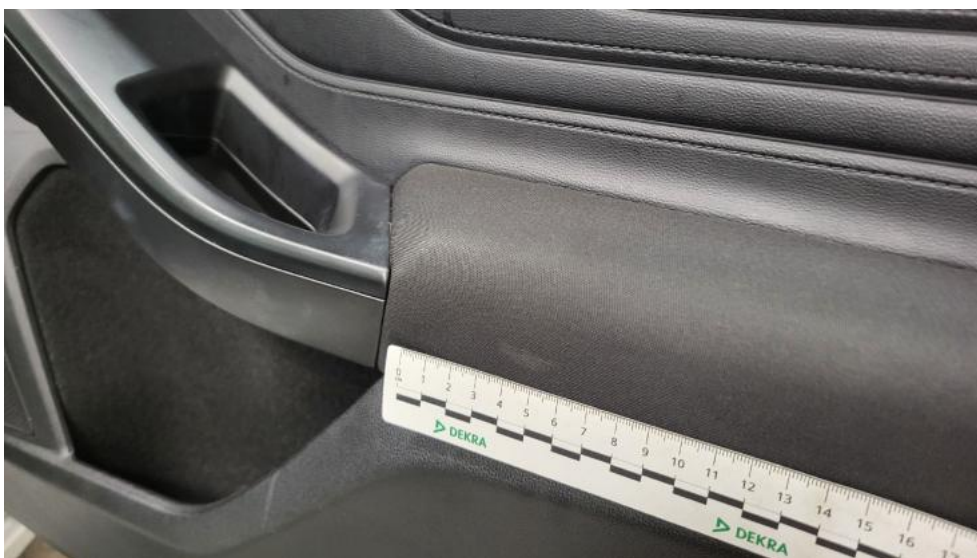
Photo 72.
Tapicerka drzwi przednich P - Inne 1
