DEKRA's commission No. : PKOL(W)/LODZ/24045/26/03/18  
commission/ damage No. : 24/044131  
Date of commission: 18-03-2026

**DEKRA Poland - Headquarters**  
02-673 Warszawa, ul. Konstruktorska 12A

| Model | Corolla Sedan 18-22 |
| Type / version | Corolla 1.8 Hybrid GPF Comfort |

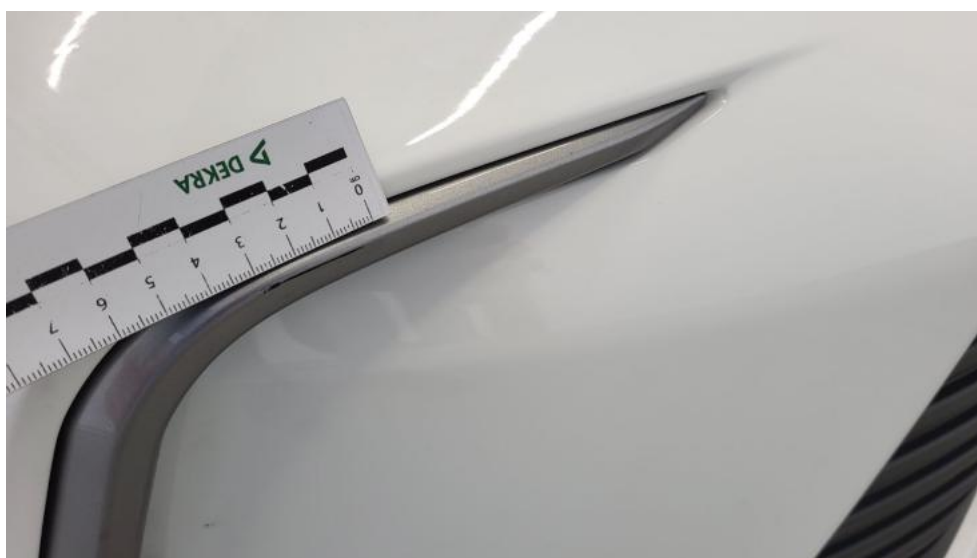
**Photo 42.**

Kratka/zaślepka halogenu P - Rysa/odprysk 1

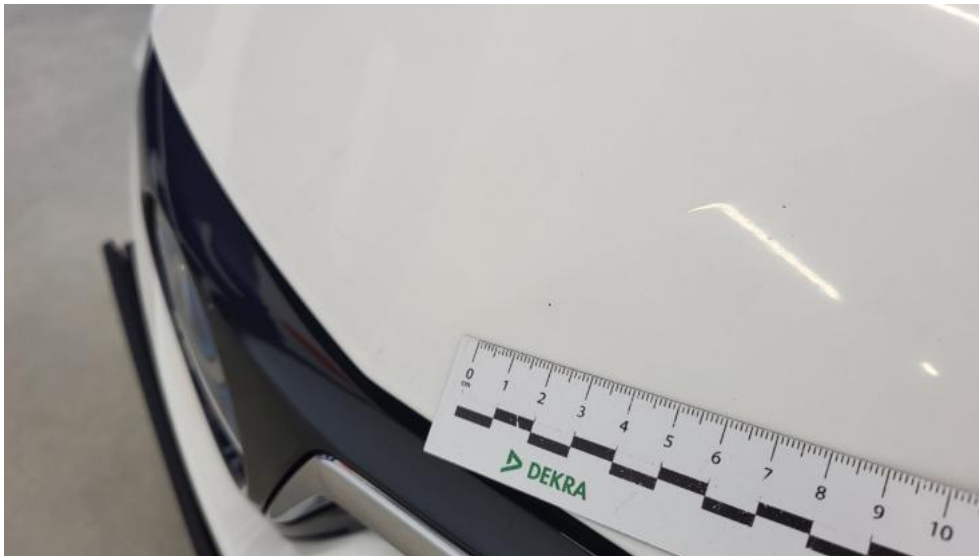
**Photo 43.**

Pokrywa komory silnika - Rysa/odprysk 1

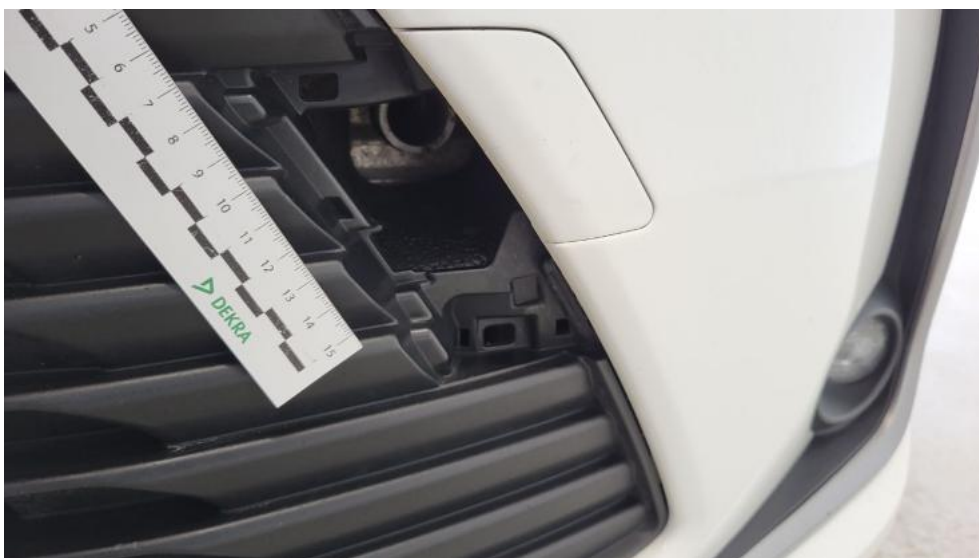
**Photo 44.**

Zaślepka prz haka hol. - Inne 1

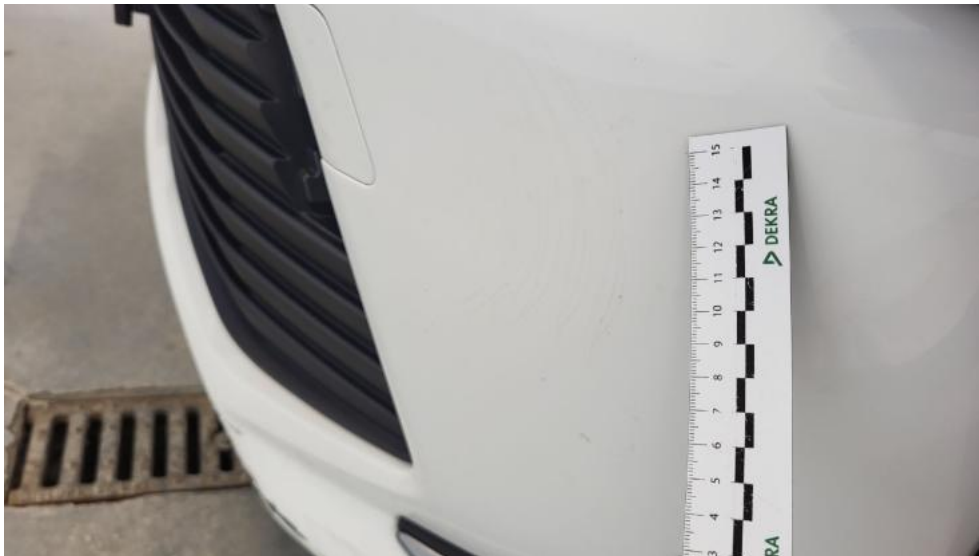
**Photo 49.**

Zderzak - Pęknięcie/rozerwanie 2

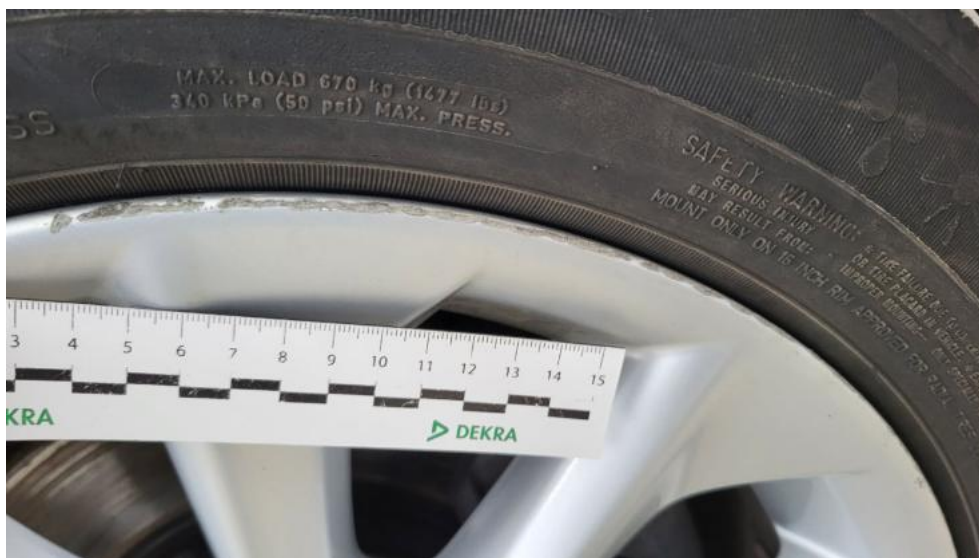
**Photo 50.**

Felga aluminiowa przednia P - Rysa/odprysk 1

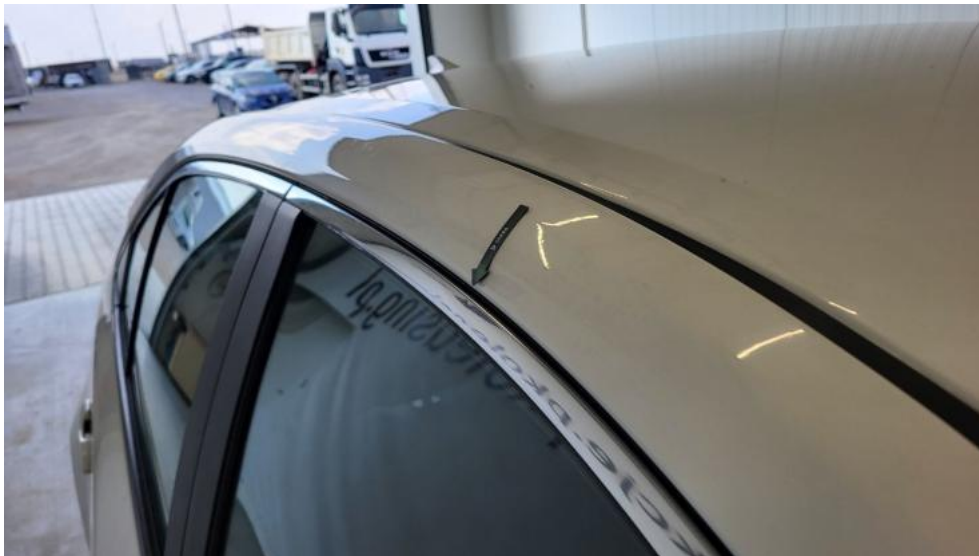
**Photo 53.**

Listwa drzwi przednich P - Wgniecenie/odkształcenie 1

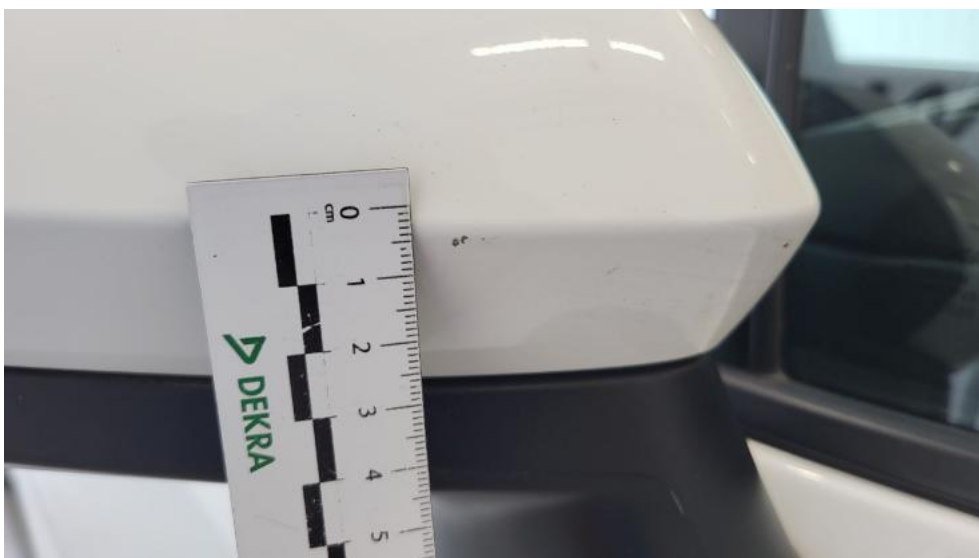
**Photo 54.**

Lusterko zew P - Rysa/odprysk 1

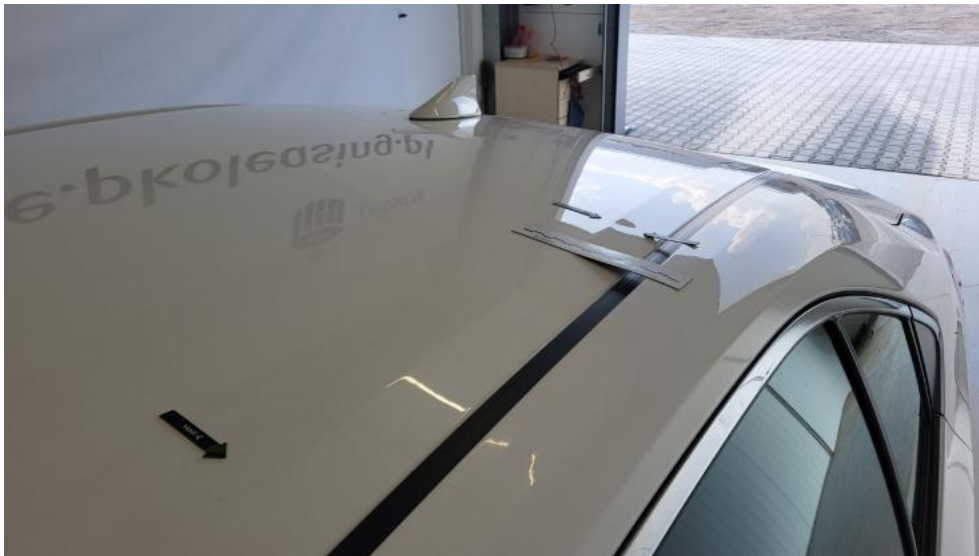
**Photo 55.**

Dach - Wgniecenie/odkształcenie 1

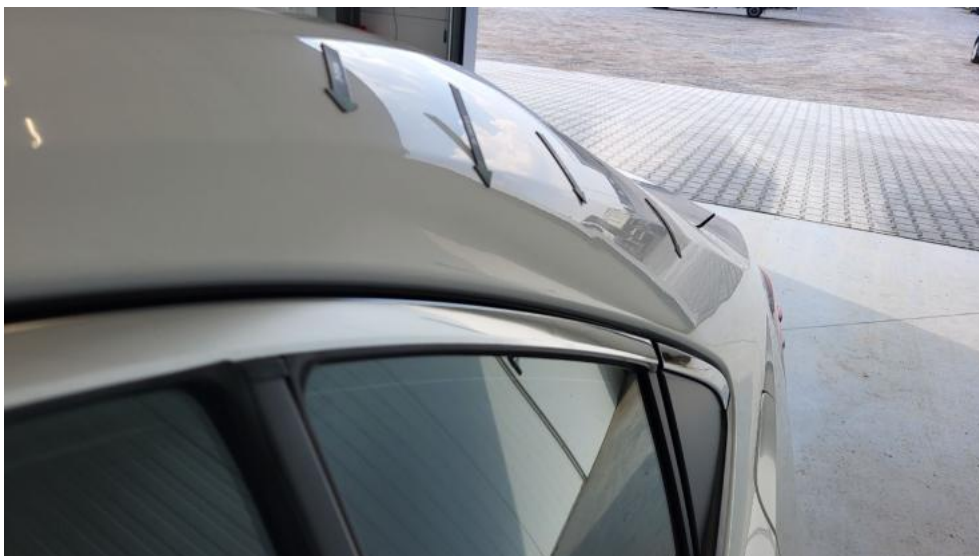
**Photo 56.**

Łotnik tylny L / Ściana boczna L - Wgniecenie/odkształcenie 1

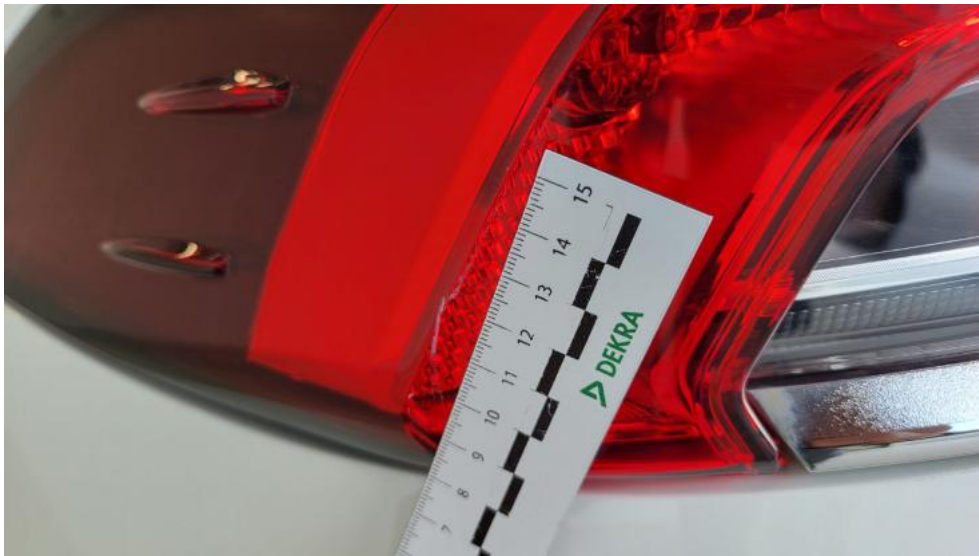
**Photo 57.**

Lampa tylna zew L - Rysa/odprysk 1

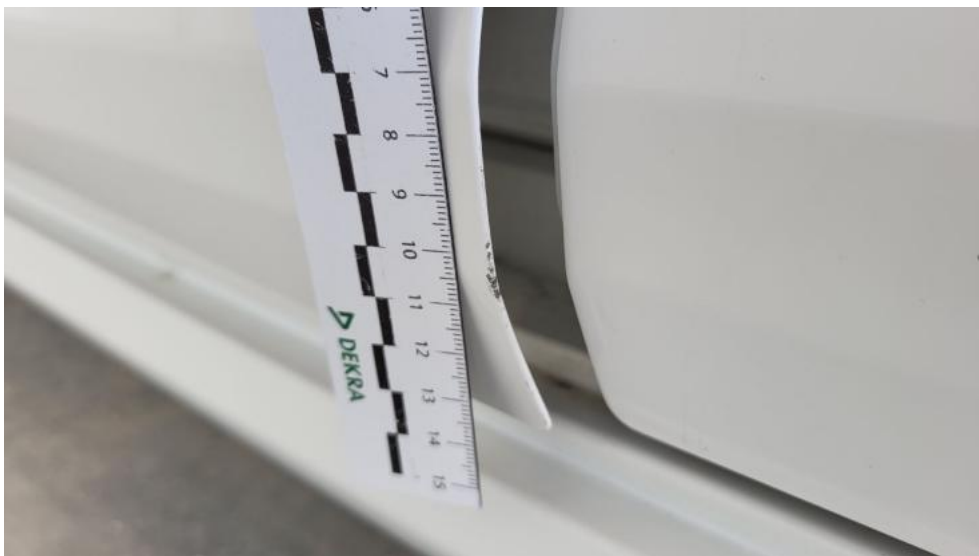
**Photo 58.**

Drzwi przed L - Rysa/odprysk 1

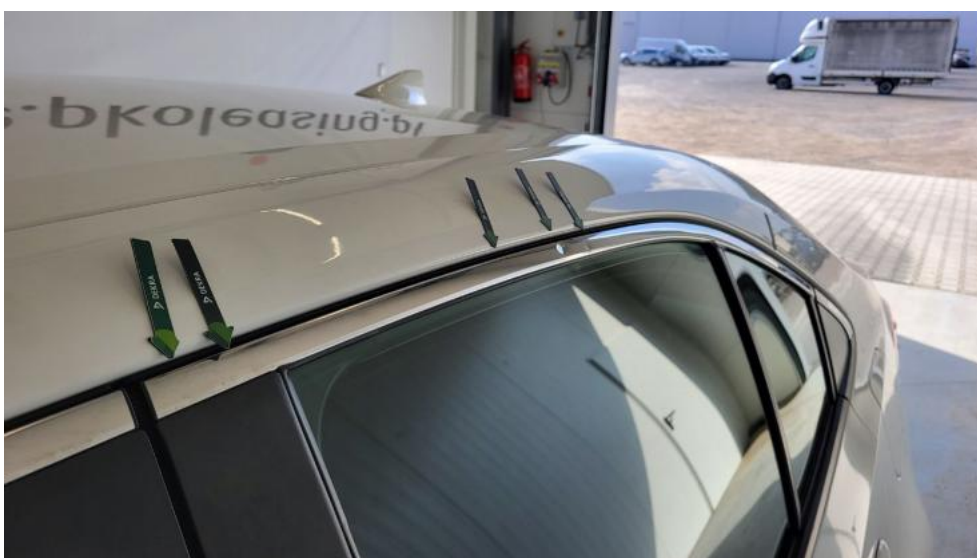
**Photo 62.**

Listwa drzwi tylnych L - Wgniecenie/odkształcenie 1

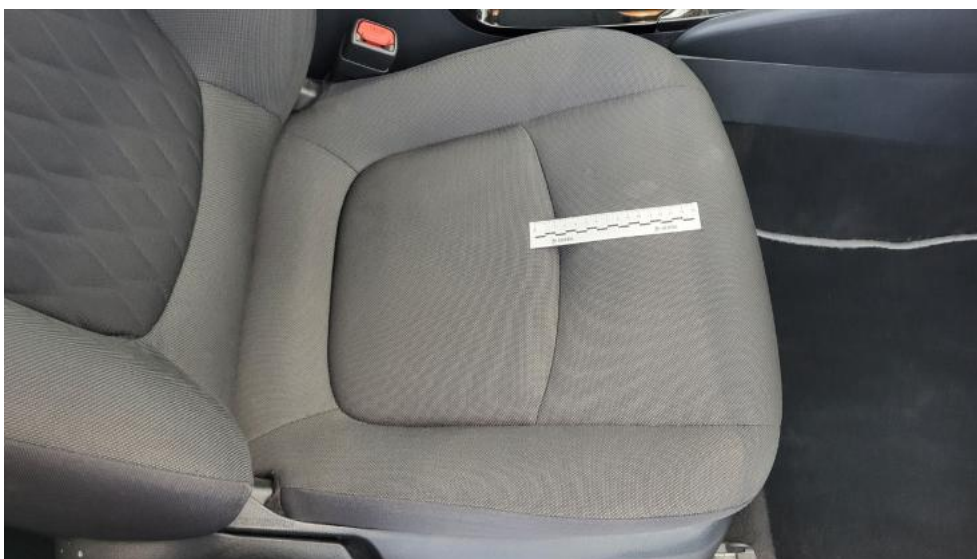
**Photo 65.**

Fotel prz. praw. - Inne 1

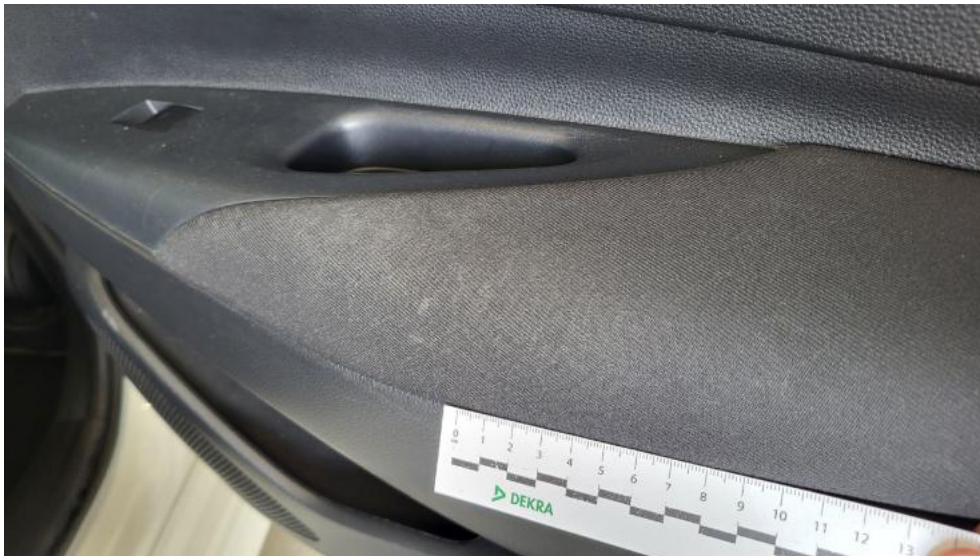
**Photo 69.**

Tapicerka drzwi tylnych P - Inne 1

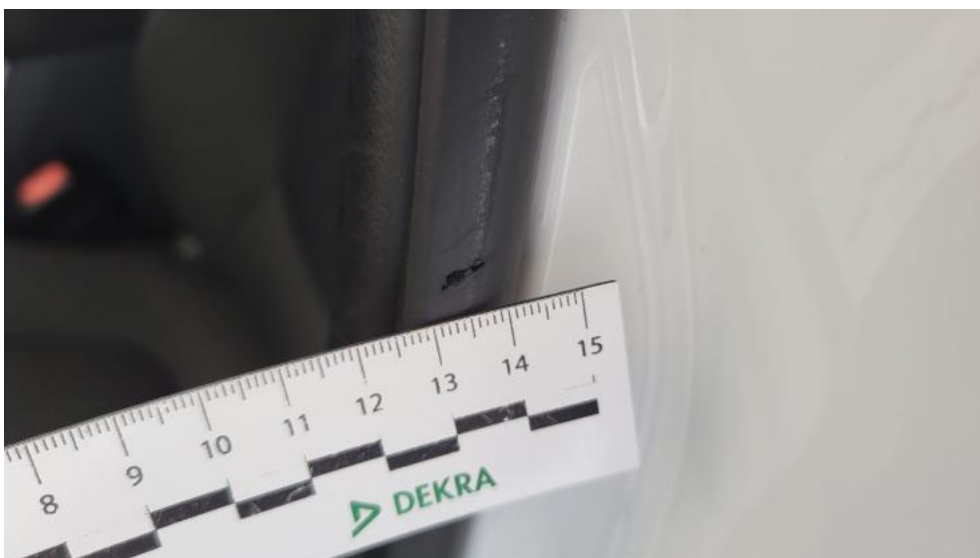
**Photo 70.**

Uszczelka drzwi przednich L - Pęknięcie/rozerwanie 1
