DEKRA's commission No. : PKOL(W)/LODZ/28988/26/04/01
 commission/ damage No. : 25/049849
 Date of commission: 01-04-2026

Vehicle data

Group of objects (Eurotax)	jeeps
EC code (Eurotax)	0161866
Manufacturer	AUDI
Model	Q7 24-
Type / version	Q7 45 TDI mHEV Quattro S Line
Body type	KOM
Number of doors / seats	5/5
Curb weight [kg]	2218
Gross vehicle weight [kg]	2850
Wheelbase 1/2	2995
Engine type	Automatic ignition
Pollution reduction system	KSC
Engine capacity [ccm]	2967
Engine Power [hp/kW]	231/170
Gearbox	automatic
Registration /record No.	PY1966M
VIN / serial number	WAUZZZ4M0SD012222
Date of first registration	24-10-2024
Date of next. tech. test	24-10-2027
Year of manufacture	2024
Readout [km]	24 863 (read)
Body color / type of coating	black/double-layered, metallized

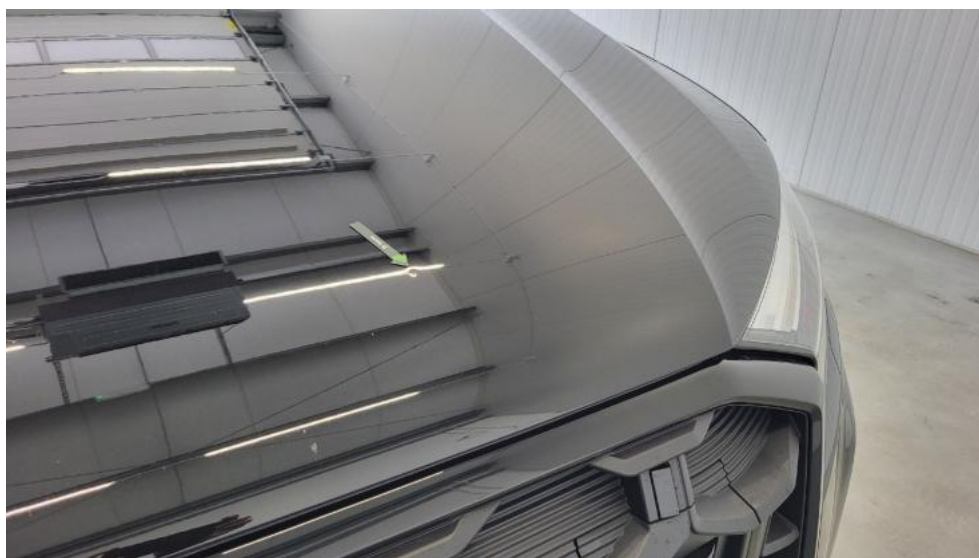
Photo 42.
Pokrywa komory silnika - Wgniecenie/odkształcenie 1

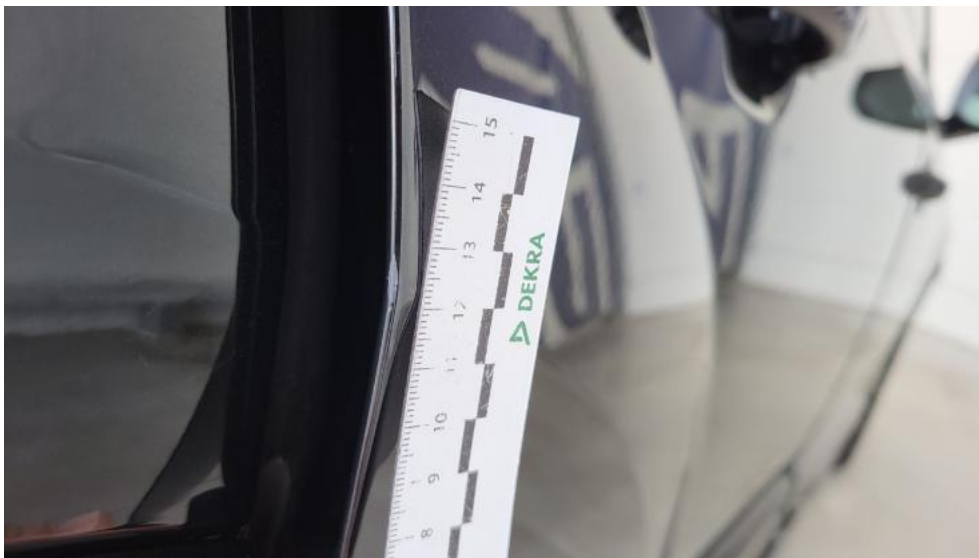
Photo 43.

Drzwi tylne P - Rysa/odprysk 1

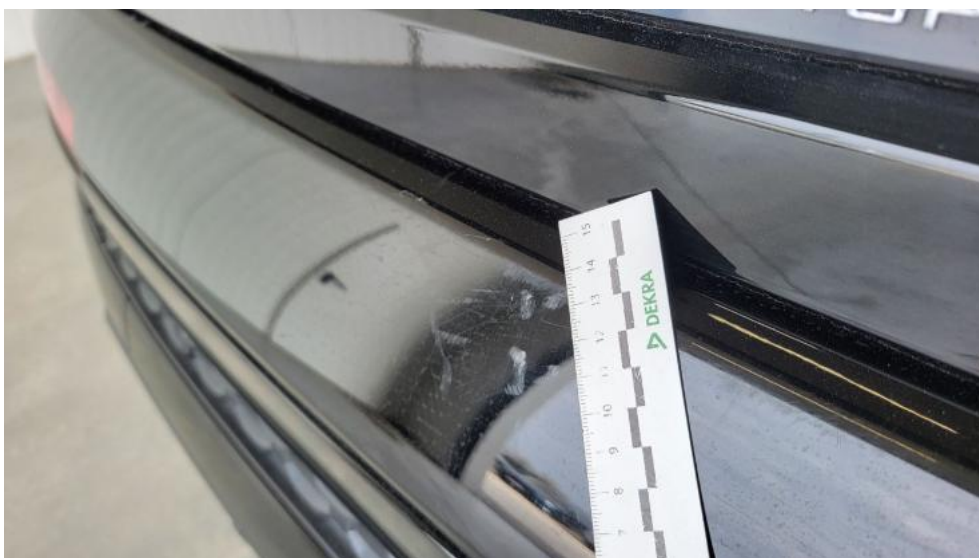
Photo 44.

Zderzak tylny - Rysa/odprysk 1

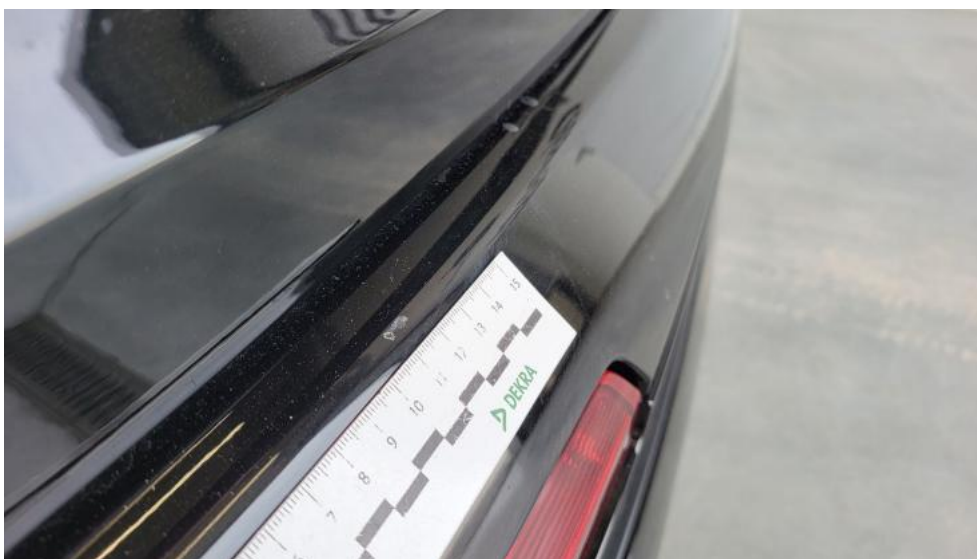
Photo 45.

Zderzak tylny - Rysa/odprysk 2

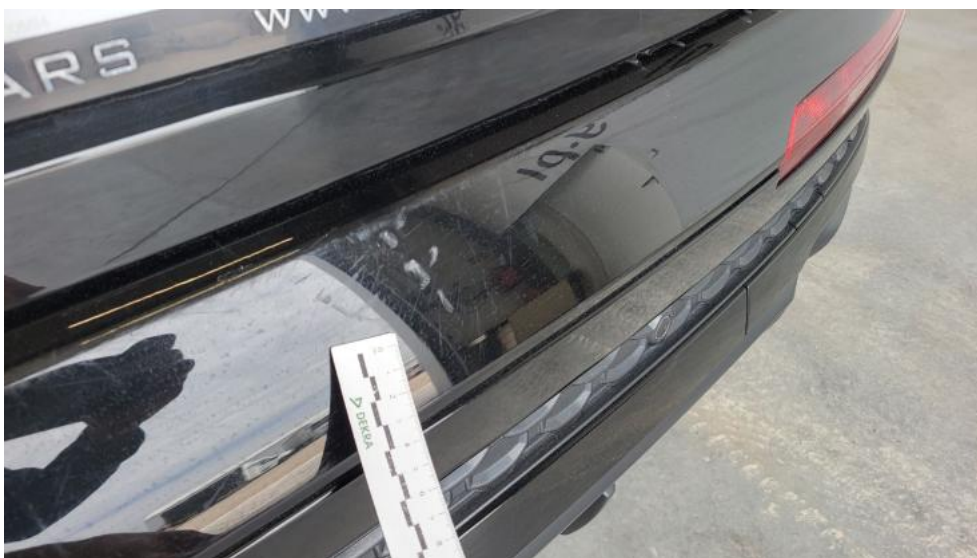
Photo 46.

Zderzak tylny - Wgniecenie/odkształcenie 1

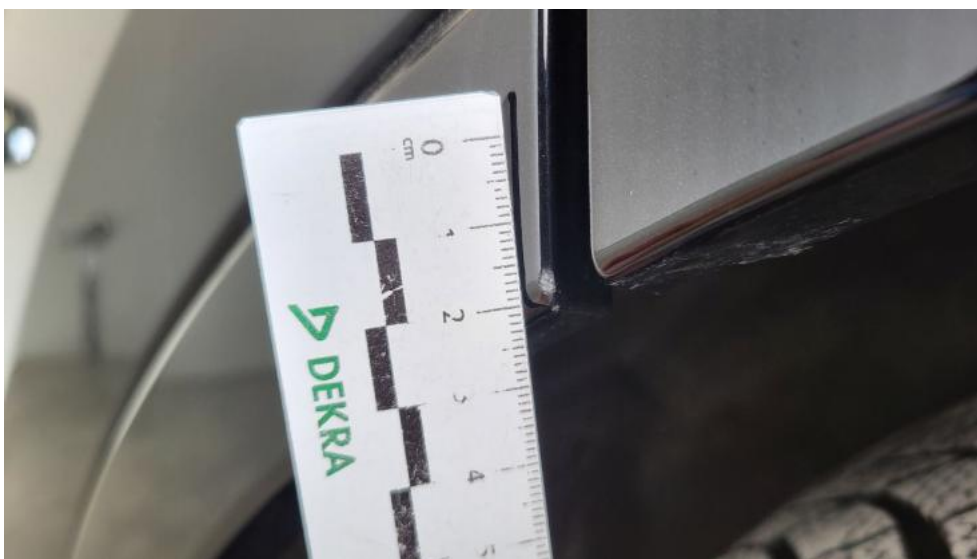
Photo 47.
Listwa drzwi tylnych L - Rysa/odprysk 1

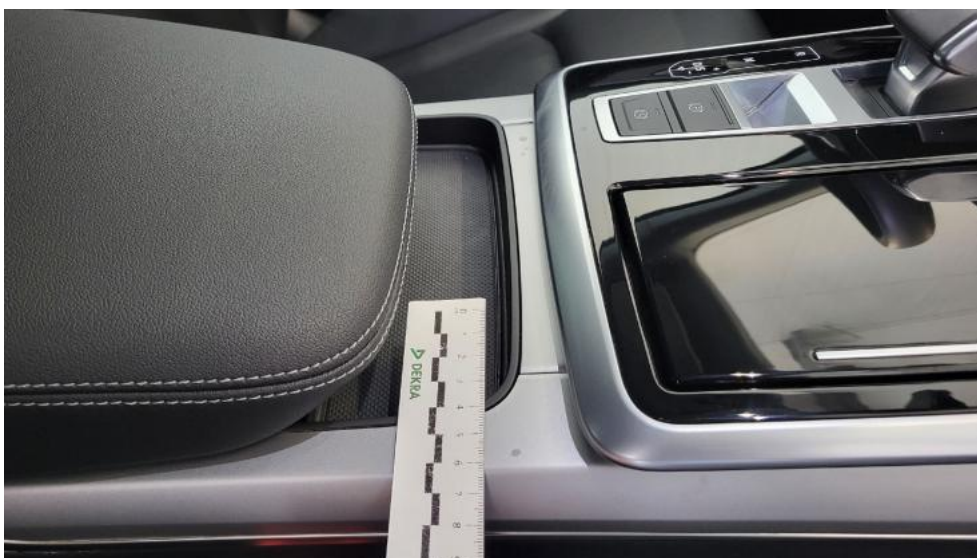
Photo 48.
Konsola tunelu śr. - Rysa/odprysk 1

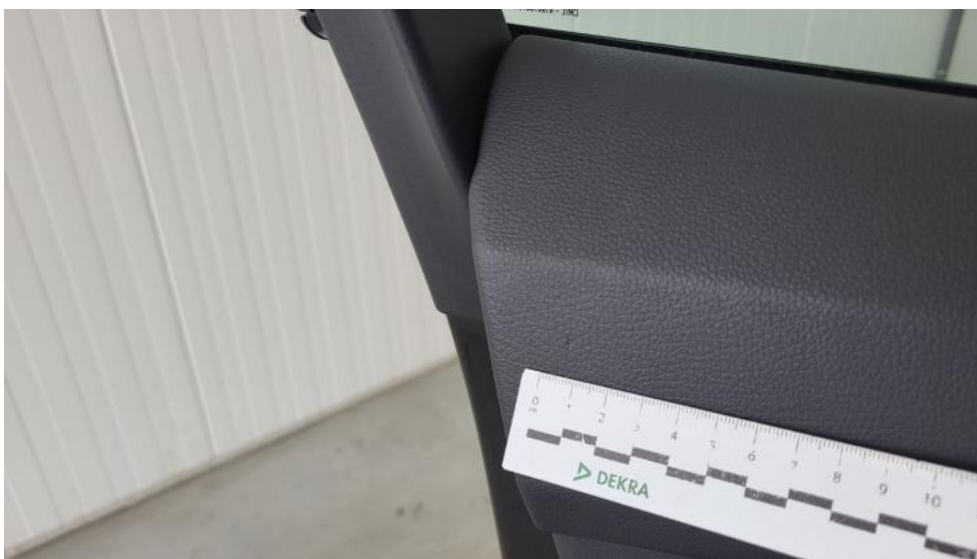
Photo 49.
Tapicerka drzwi przednich L - Wgniecenie/odkształcenie 1

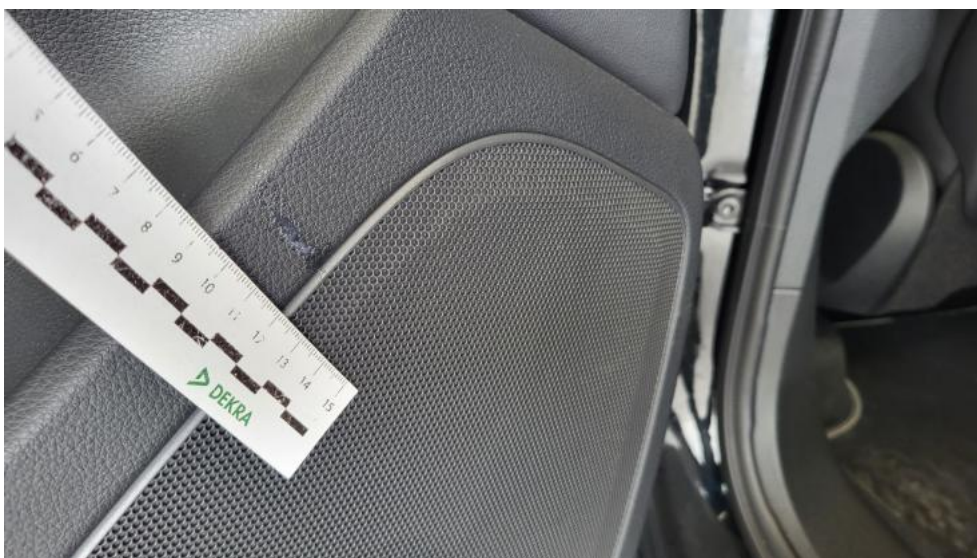
Photo 50.
Tapicerka drzwi tylnych L - Inne 1

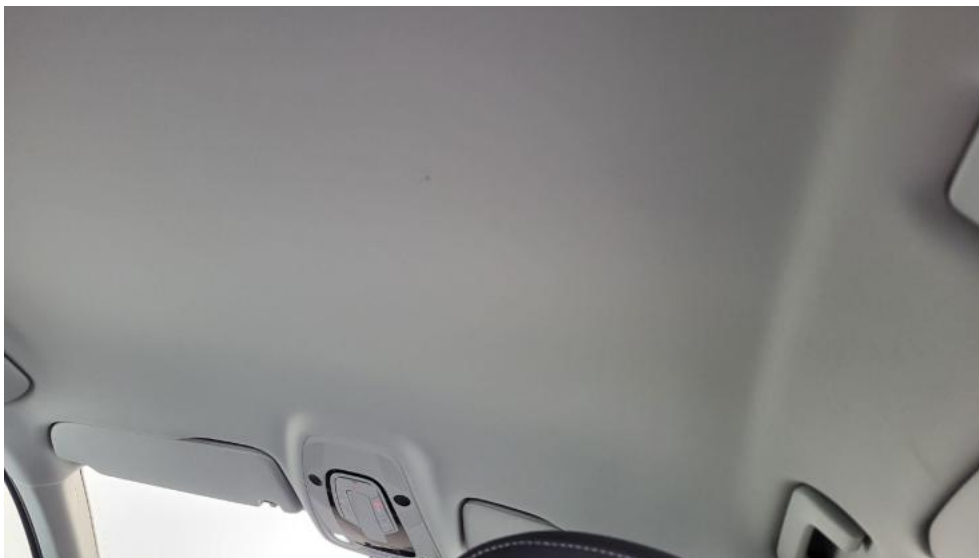
Photo 51.
Podsufitka - Inne 1
