DEKRA's commission No. : PKOL(W)/LODZ/07663/25/01/31
 commission/ damage No. : PS18/03279
 Date of commission: 31-01-2025

Group of objects (Eurotax)	jeeps
EC code (Eurotax)	0132888
Manufacturer	KIA
Model	Sportage 18-21
Type / version	Sportage 2.0 CRDI GT Line 4WD aut
Body type	KOM
Number of doors / seats	5/5
Curb weight [kg]	1672
Gross vehicle weight [kg]	2250
Wheelbase 1/2	2670
Engine type	Automatic ignition
Pollution reduction system	KSC
Engine capacity [ccm]	1995
Engine Power [hp/kW]	185/136
Gearbox	automatic
Registration /record No.	GD874TH
VIN / serial number	U5YPK813DKL717348
Date of first registration	16-04-2019
Date of next. tech. test	16-04-2024
Year of manufacture	2019
Readout [km]	106 155 (read)
Body color / type of coating	blue/double-layered, metallized

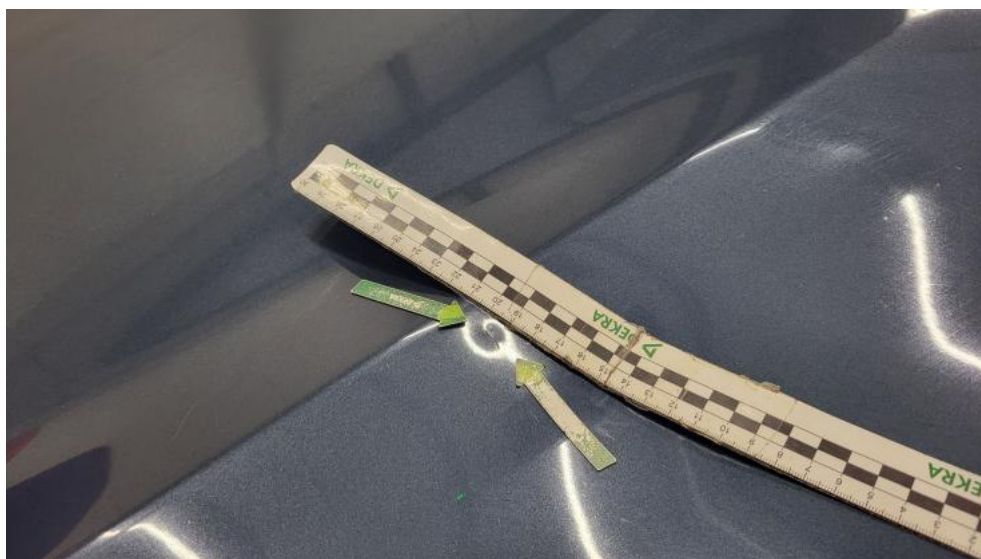
Photo 43.
Pokrywa komory silnika - Wgniecenie/odkształcenie 1

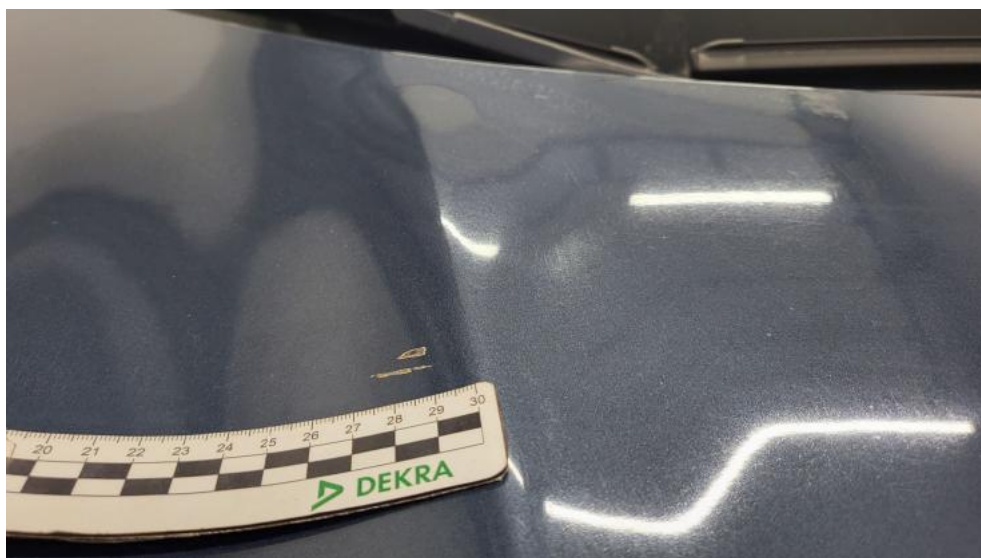
Photo 44.
Pokrywa komory silnika - Inne 1

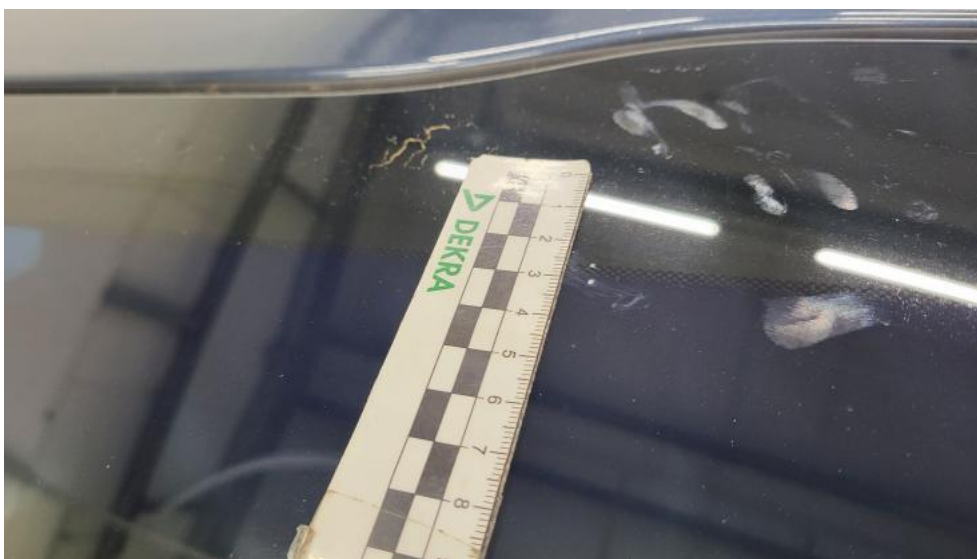
Photo 45.
Szyba czółowa - Rysa/odprysk 1

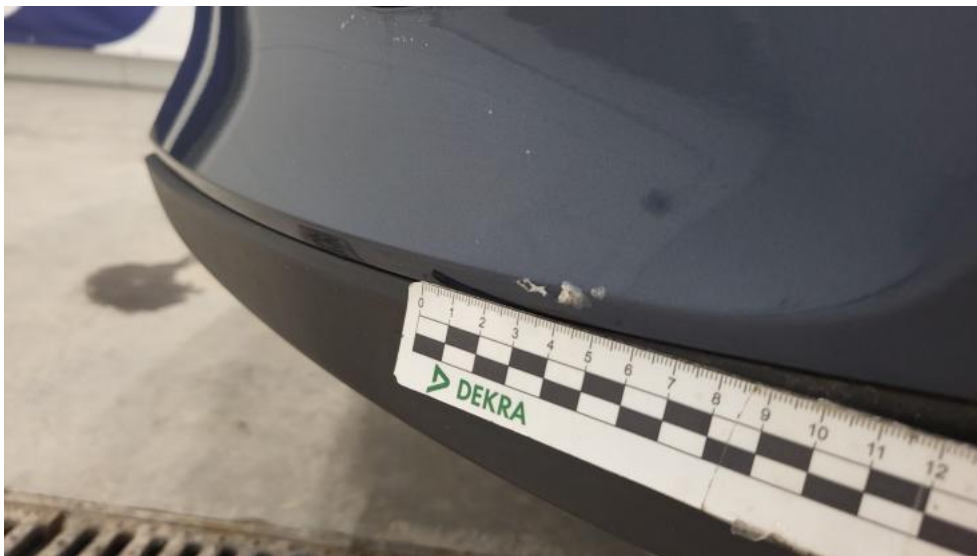
Photo 47.
Zderzak - Inne 2

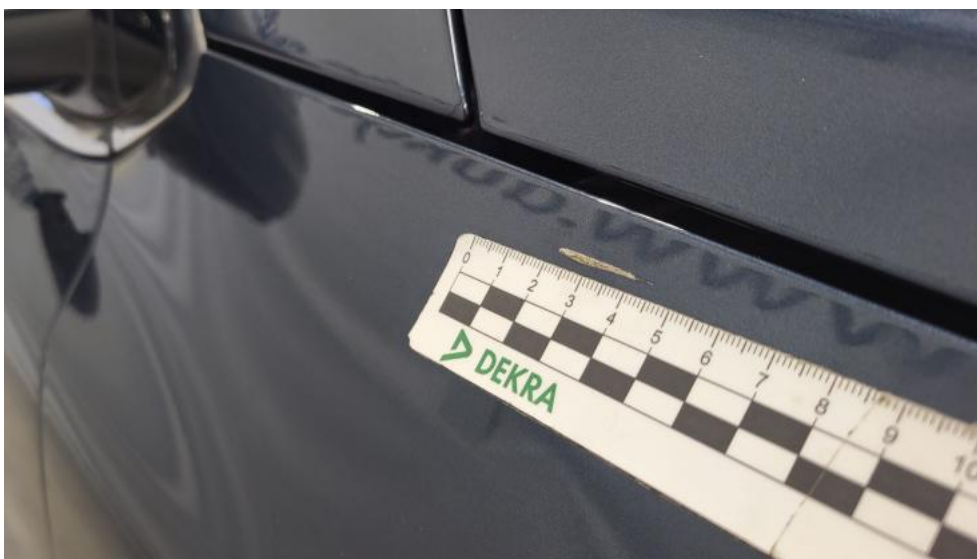
Photo 49.

Błotnik przedni P - Inne 1

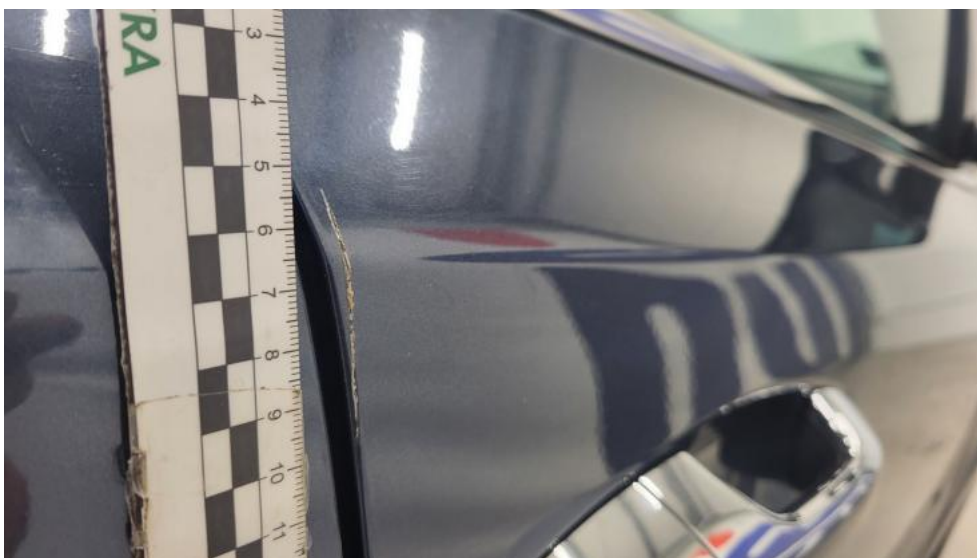
Photo 54.

Drzwi przednie P - Inne 2

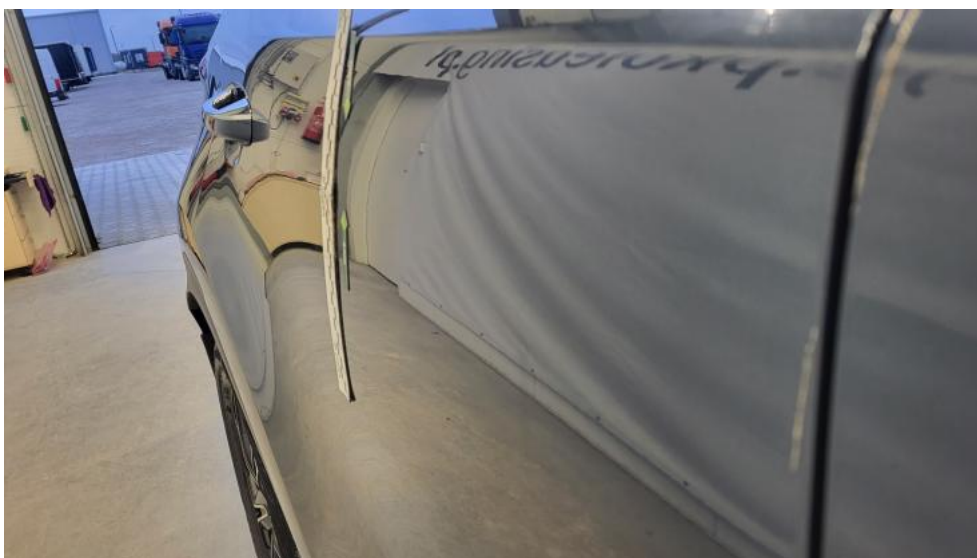
Photo 56.

Drzwi tylne P - Wgniecenie/odkształcenie 1

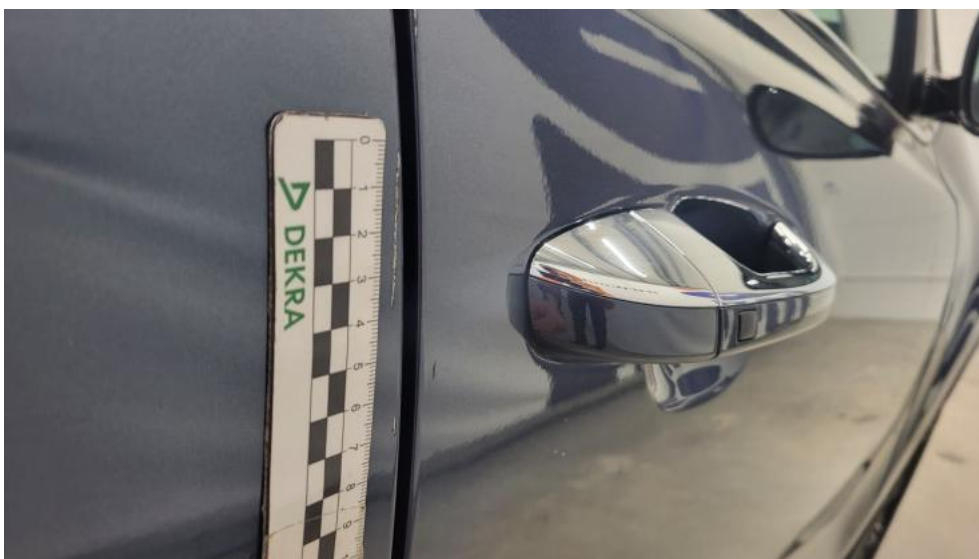
Photo 57.
Drzwi tylne P - Inne 1

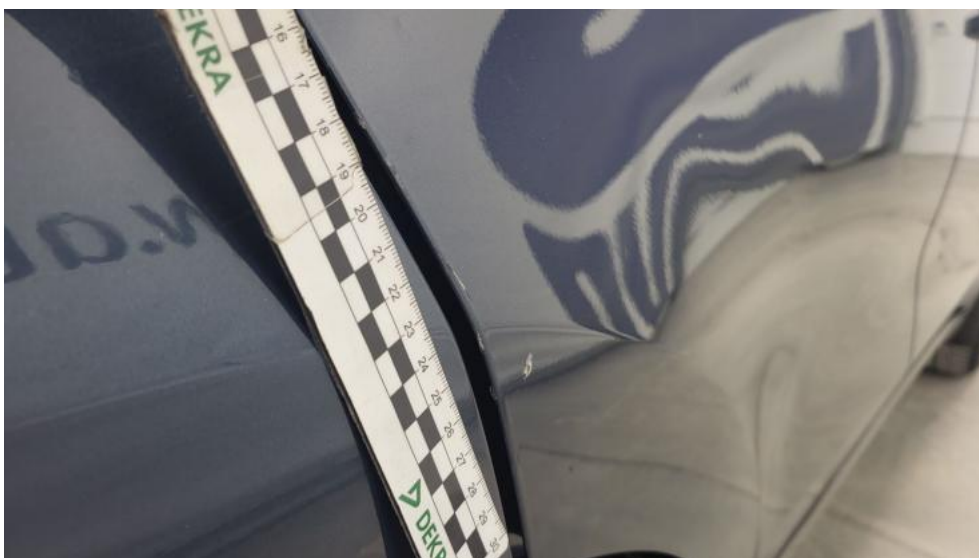
Photo 58.
Drzwi tylne P - Inne 2

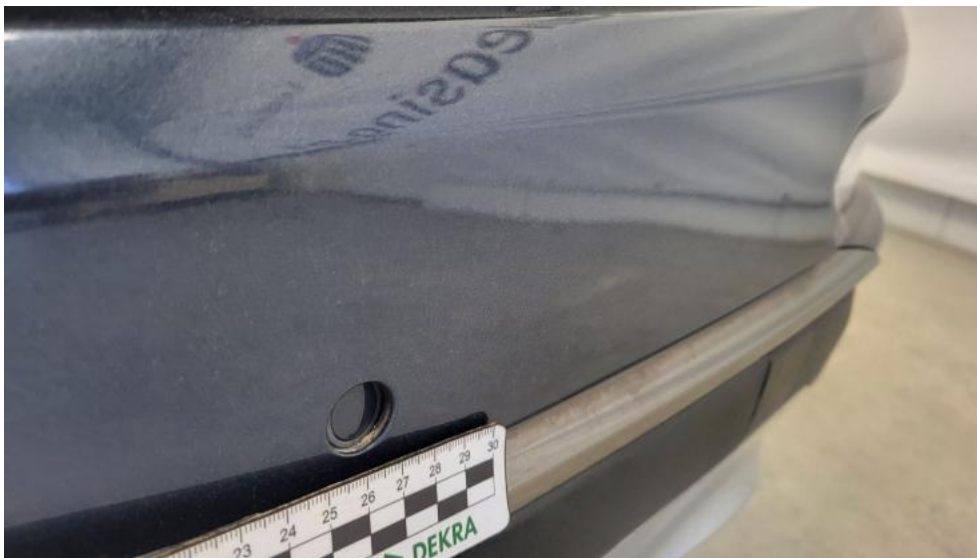
Photo 61.

Czujniki parkowania tył - Inne 1

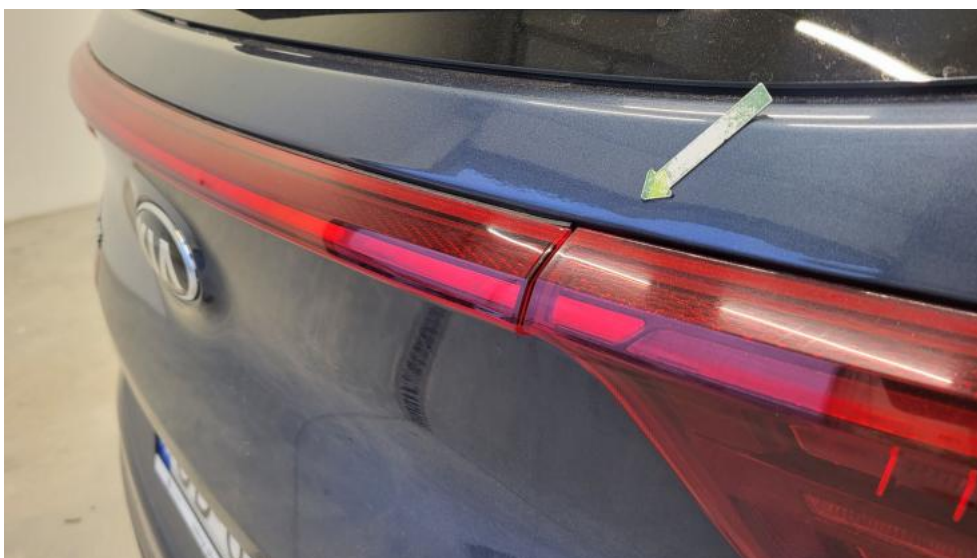
Photo 62.

Pokrywy bagażnika - Wgniecenie/odkształcenie 1

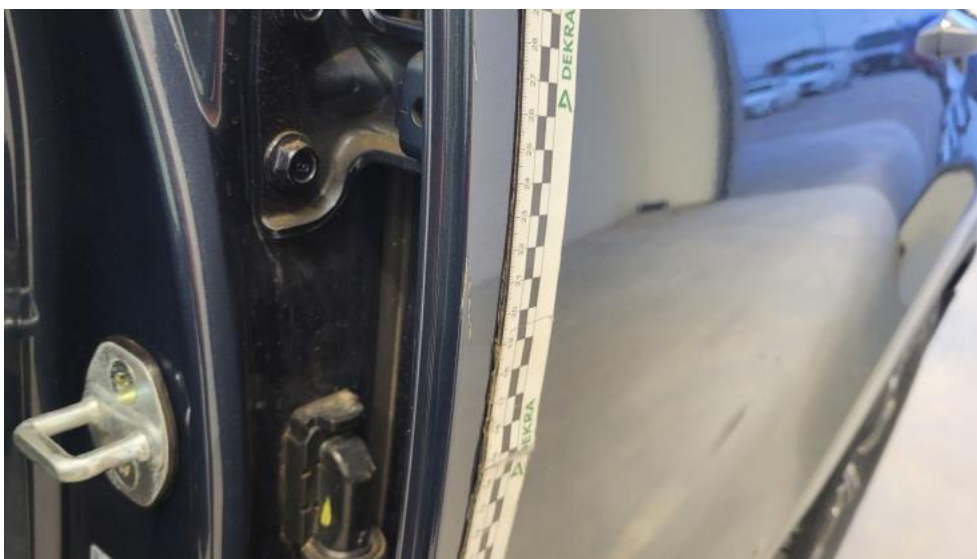
Photo 69.
Drzwi tylne L - Inne 2

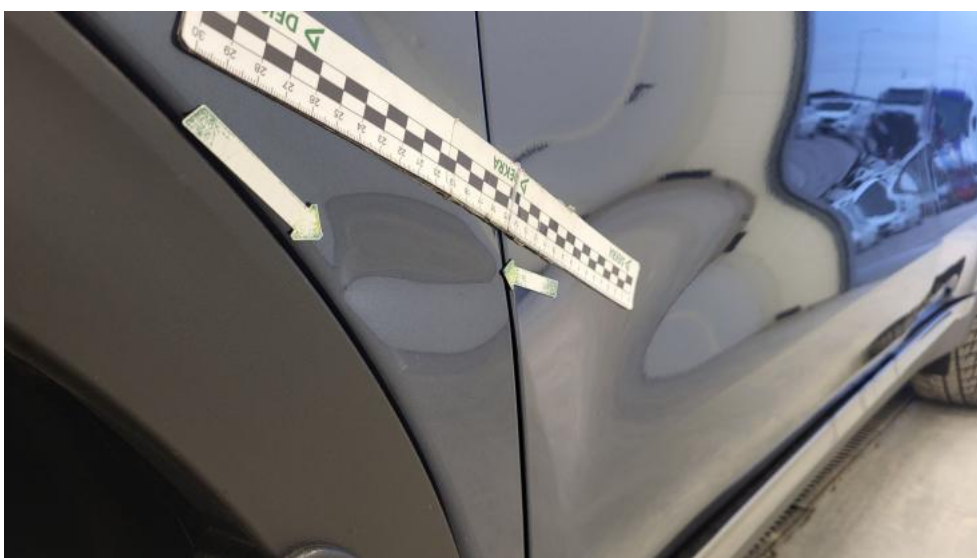
Photo 70.
Błotnik przedni L - Wgniecenie/odkształcenie 1

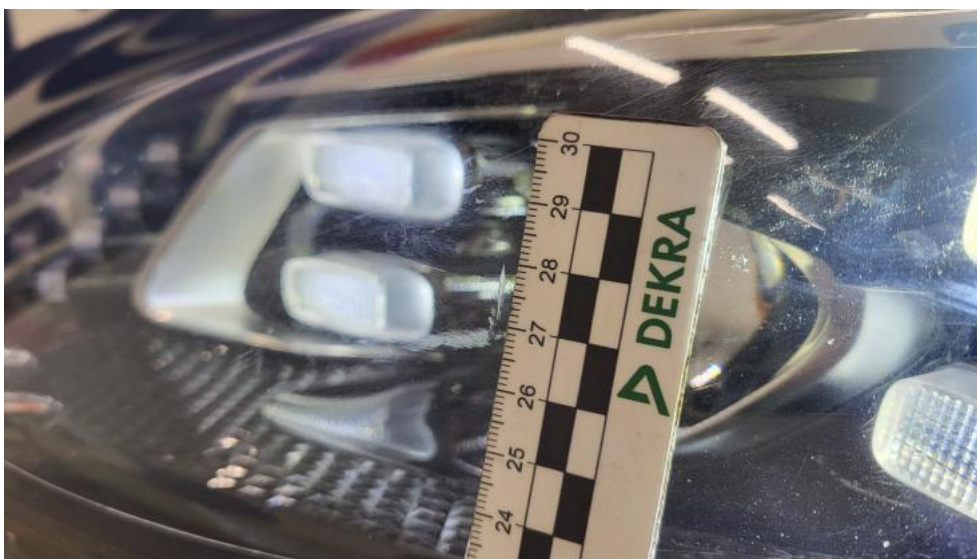
Photo 71.
Reflektor L - Rysa/odprysk 1

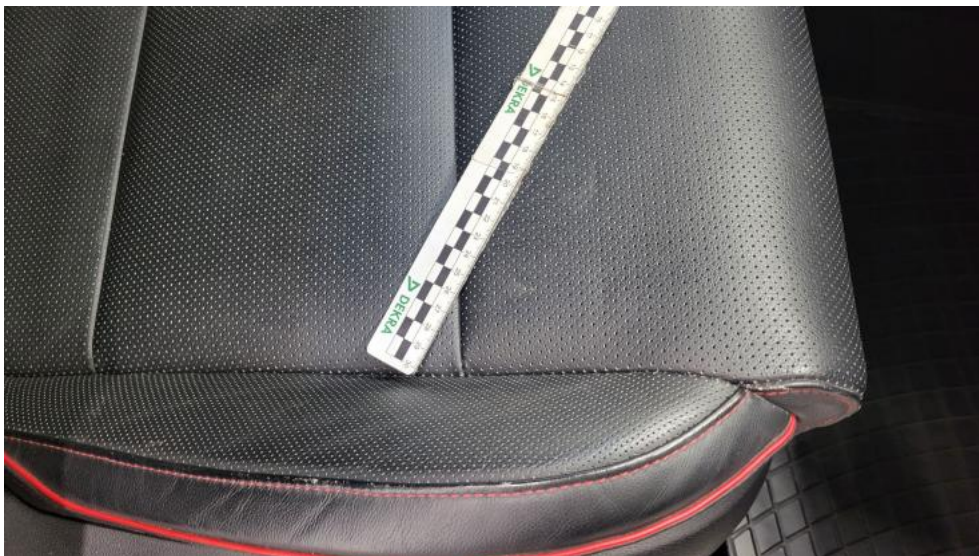
Photo 73.
Fotel prz. praw. - Inne 1

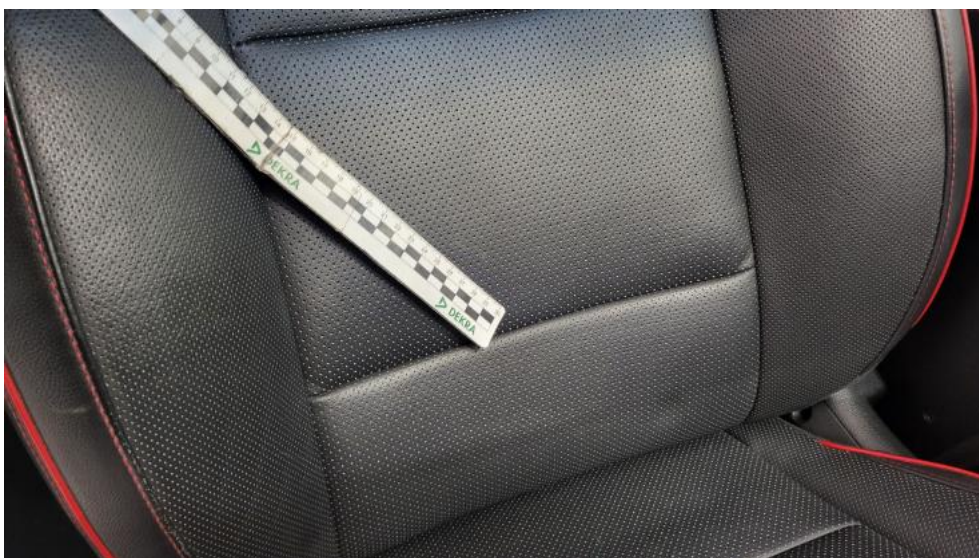
Photo 74.
Fotel prz. praw. - Inne 2
