DEKRA's commission No. : PKOL(W)/LODZ/08070/26/01/30  
commission/ damage No. : 21/012591  
Date of commission: 30-01-2026

| Manufacturer | LEXUS |
| Model | LC Convertible 20-24 |
| Registration /record No. | WZ855CL |

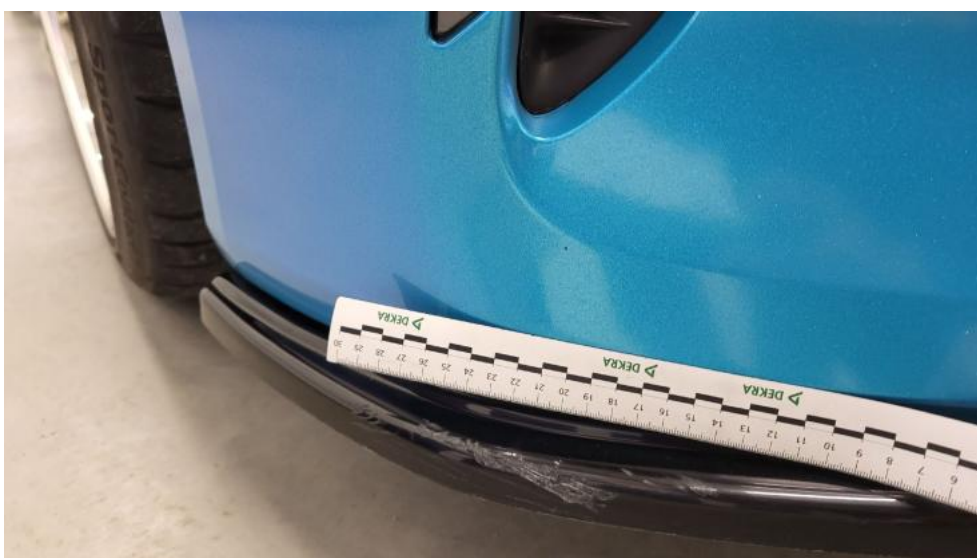
**Photo 43.**

Spoiler zderzaka przedniego - Rysa/odprysk 1

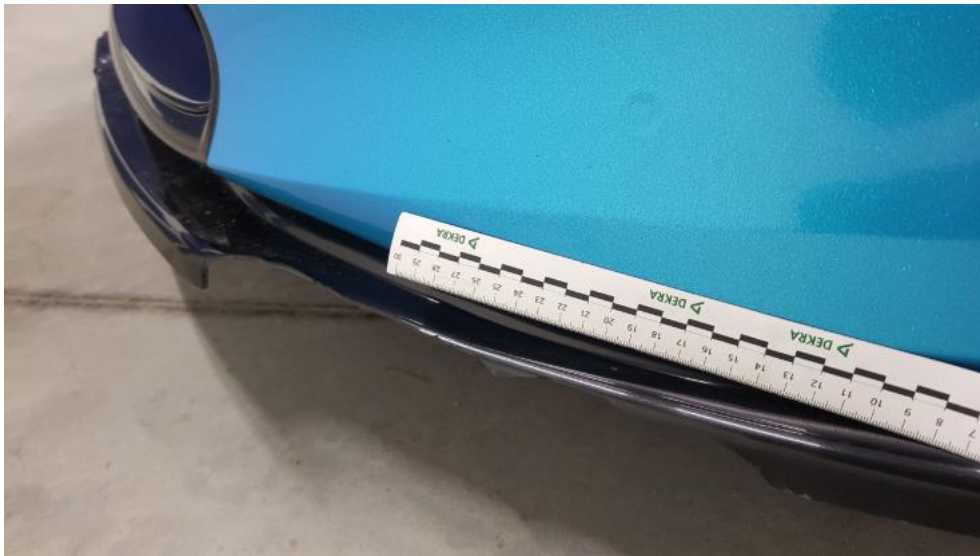
**Photo 45.**

Spoiler zderzaka przedniego - Pęknięcie/rozerwanie 1

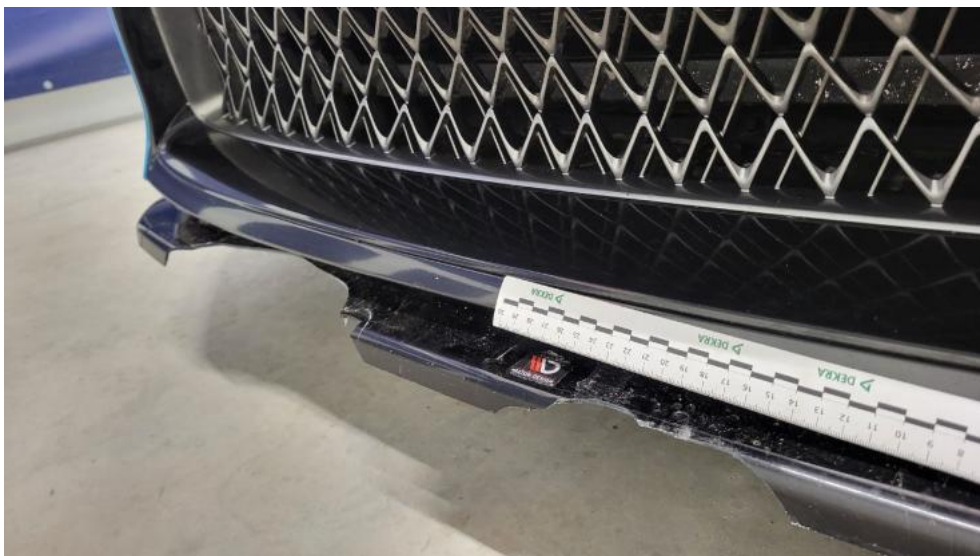
**Photo 46.**

Spoiler zderzaka przedniego - Pęknięcie/rozerwanie 2

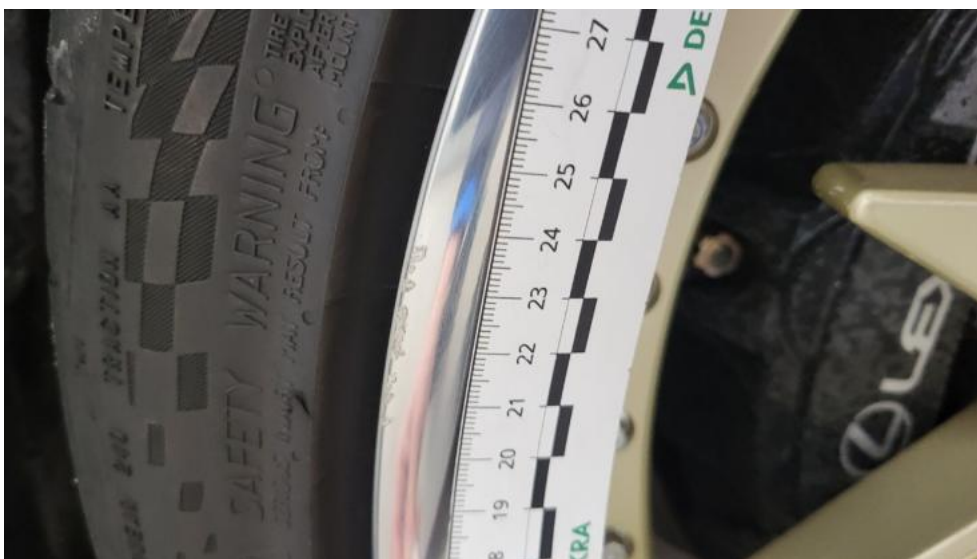
**Photo 47.**

Felga aluminiowa przednia P - Rysa/odprysk 1

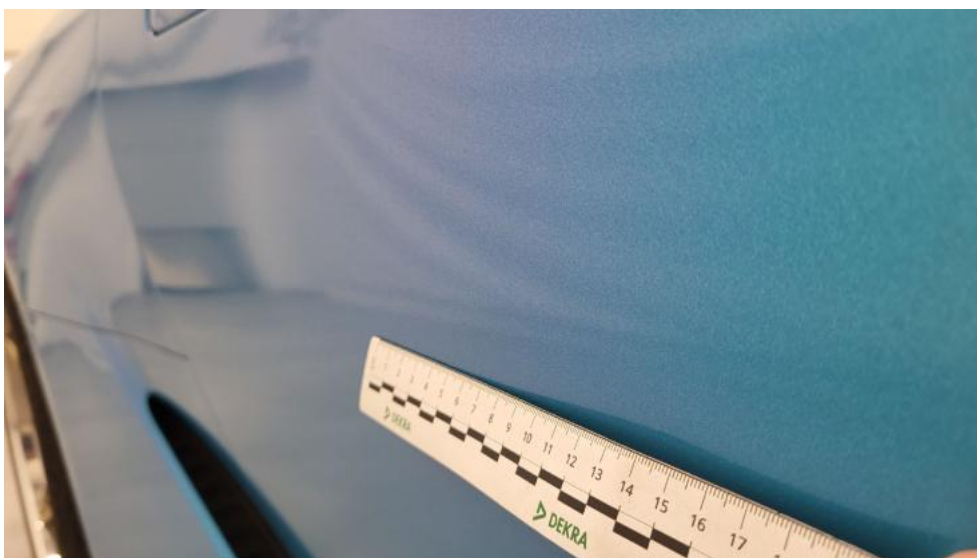
**Photo 48.**

Drzwi przednie P - Wgniecenie/odkształcenie 1

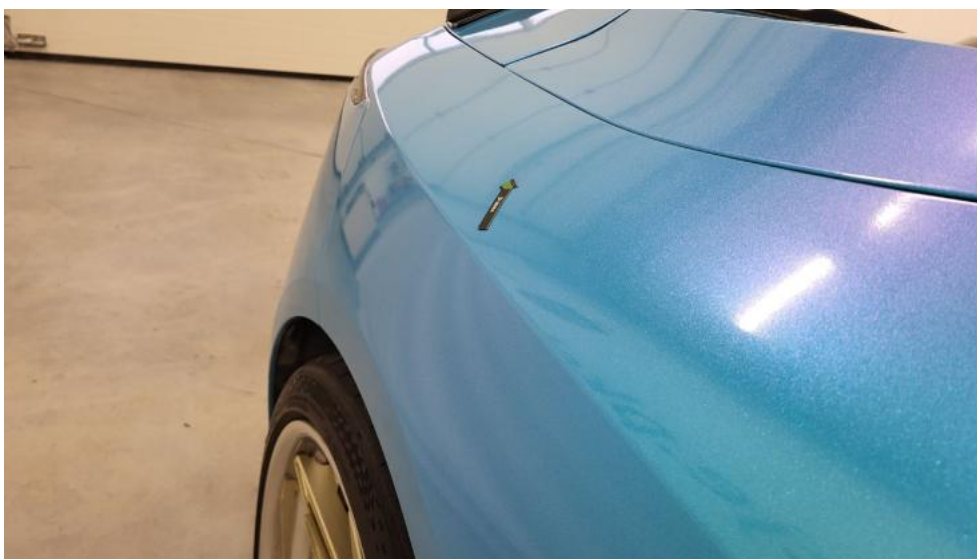
**Photo 49.**

Błotnik tylny P / Ściana boczna P - Wgniecenie/odkształcenie 1

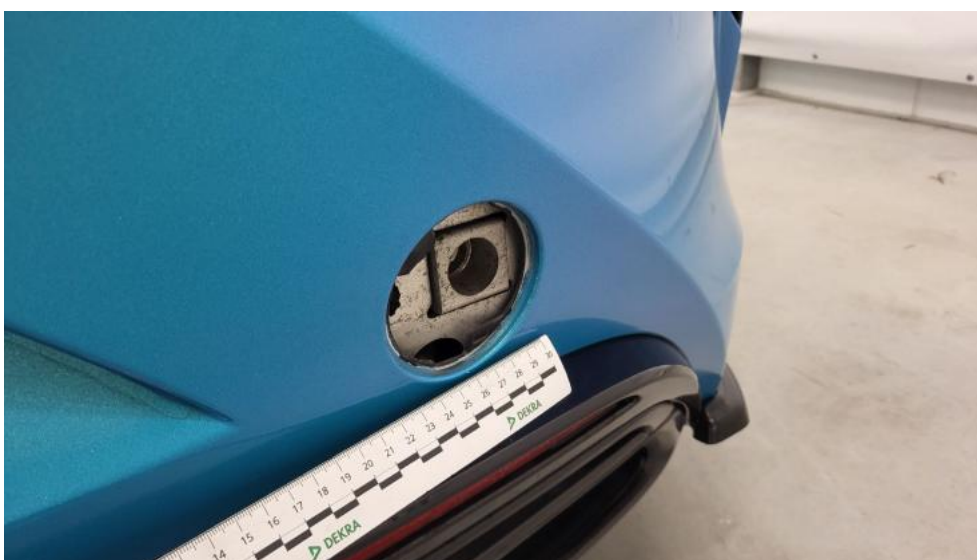
**Photo 50.**

Zaślepka tyl haka hol. - Inne 1

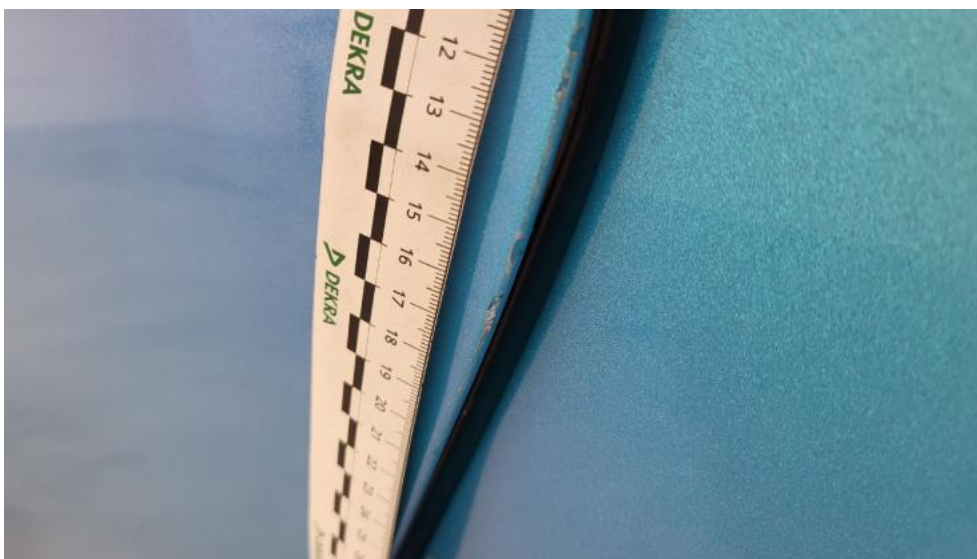
**Photo 51.**

Drzwi przed L - Rysa/odprysk 1

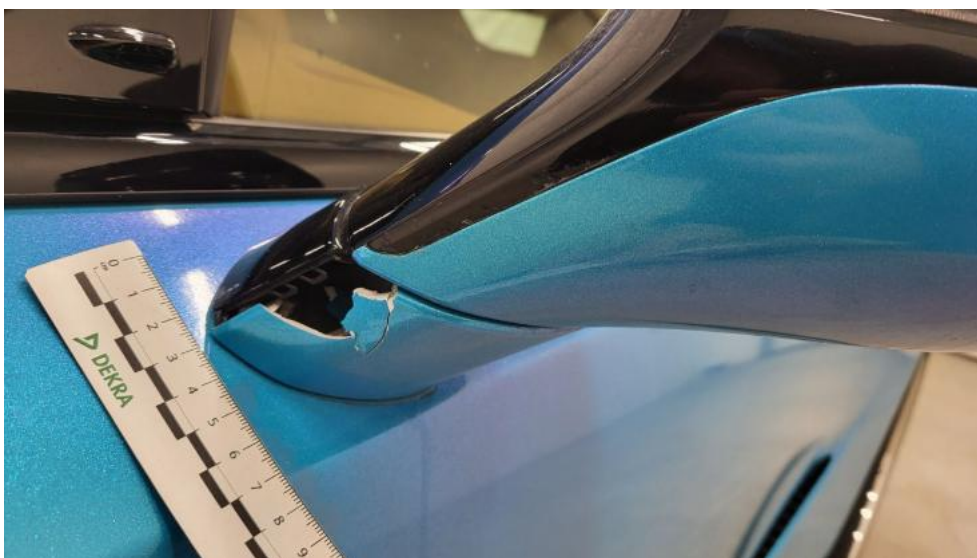
**Photo 52.**

Lusterko zew L - Pęknięcie/rozerwanie 1

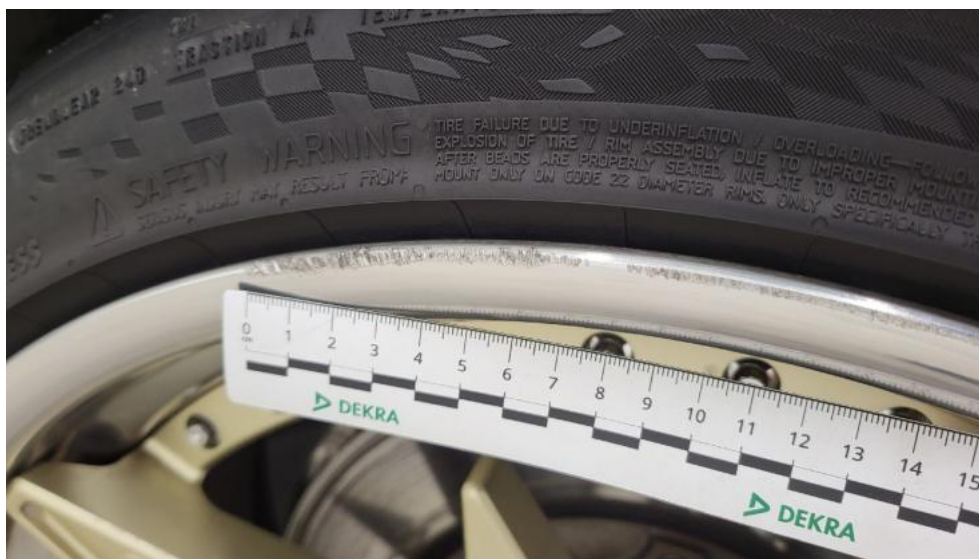
**Photo 53.**

Felga Aluminiowa przednia L - Rysa/odprysk 1

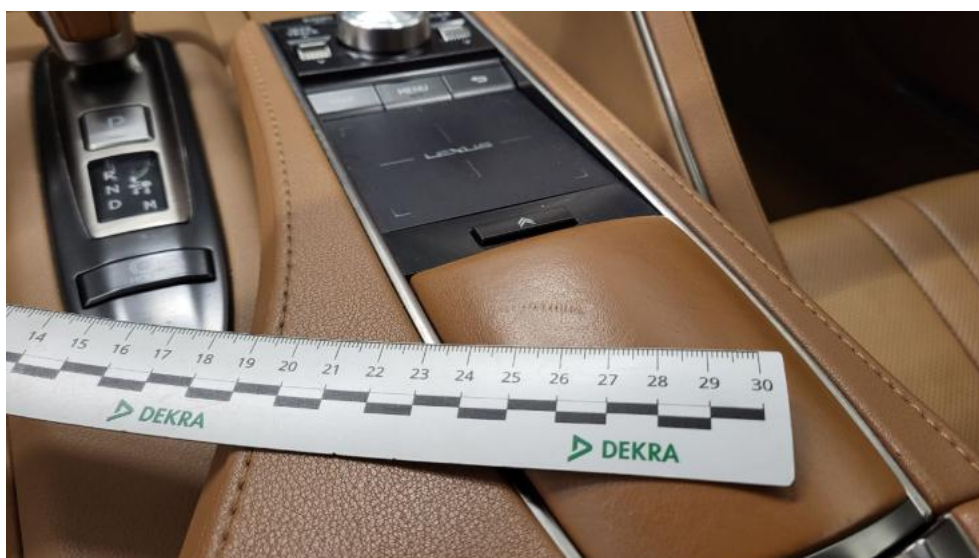
**Photo 54.**

Konsola tunelu śr. - Rysa/odprysk 1

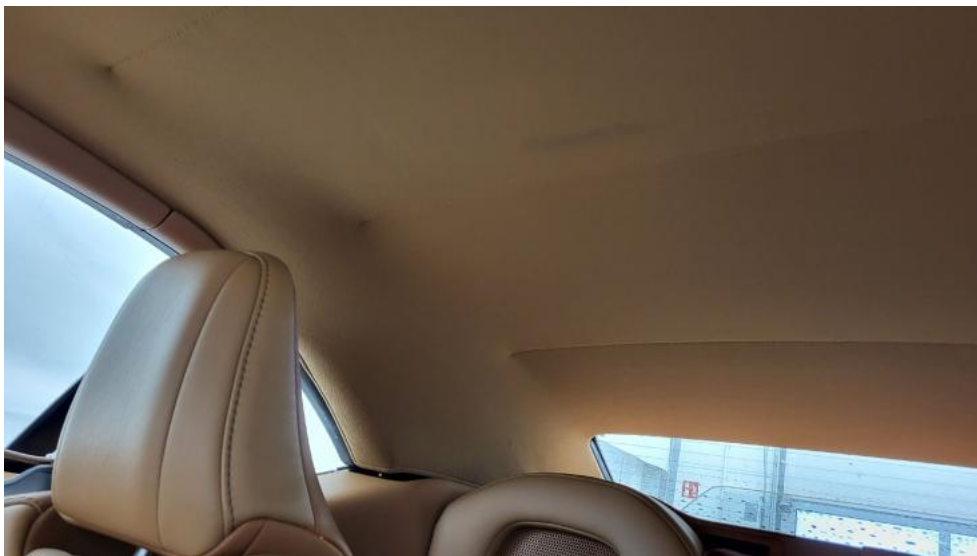
**Photo 55.**

Podsufitka - Inne 1

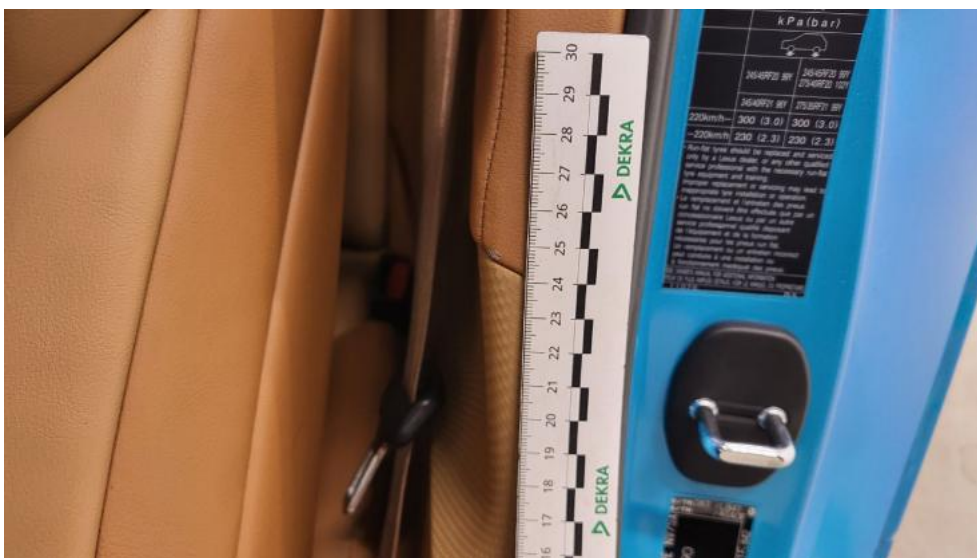
**Photo 56.**

Wykładzina(y) słupka środkowego L - Rysa/odprysk 1

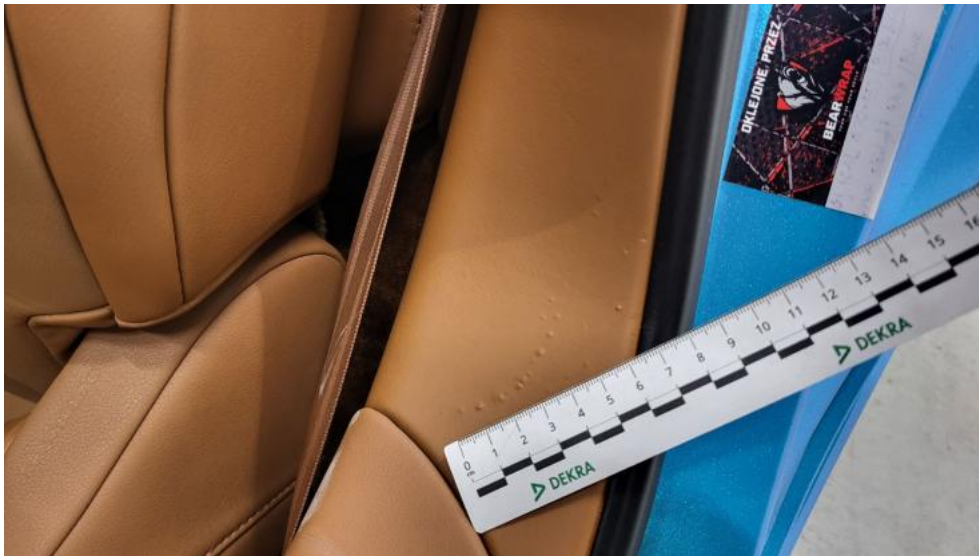
**Photo 57.**

Wykładzina(y) słupka środkowego L - Wgniecenie/odkształcenie 1

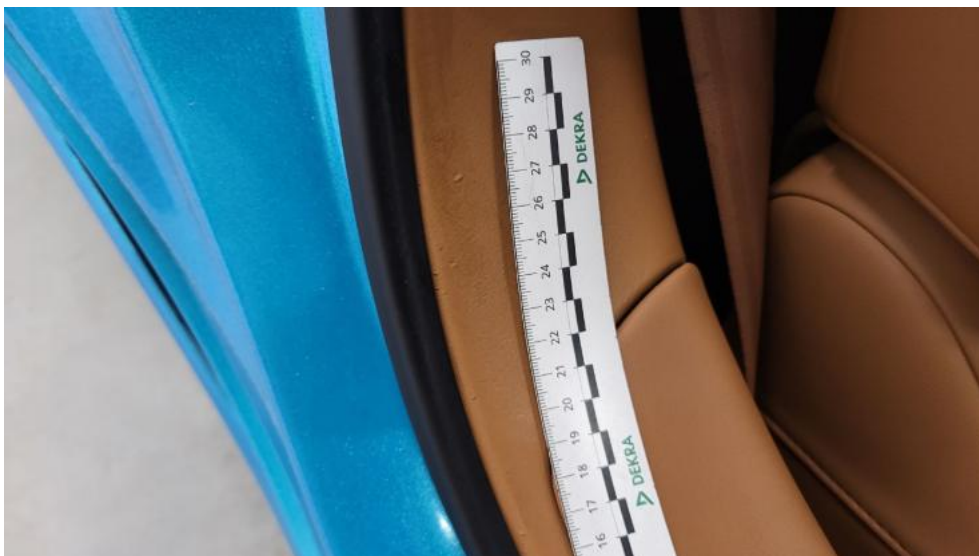
**Photo 58.**

Wykładzina(y) słupka środkowego P - Wgniecenie/odkształcenie 1
