DEKRA's commission No. : PKOL(W)/LODZ/15587/26/02/19
 commission/ damage No. : 24/019994
 Date of commission: 19-02-2026

Group of objects (Eurotax)	cars
EC code (Eurotax)	0134587
Manufacturer	VOLVO
Model	S90 16-20
Type / version	S90 D5 SCR AWD Inscription aut
Body type	sedan
Number of doors / seats	4/5
Curb weight [kg]	1847
Gross vehicle weight [kg]	2360
Wheelbase 1/2	2941
Engine type	Automatic ignition
Pollution reduction system	KSC
Emission standard	EURO 6
Engine capacity [ccm]	1969
Engine Power [hp/kW]	235/173
Gearbox	automatic 8- gear
Registration /record No.	WP7005S
VIN / serial number	LVYPS68UCKP058434
Date of first registration	26-09-2018
Date of next. tech. test	22-10-2025
Year of manufacture	2018 (year has been verified with the manufacturer's base)
Readout [km]	224 797 (read)
Body color / type of coating	blue/2-warstwowy metalik

Date: 13-03-2026

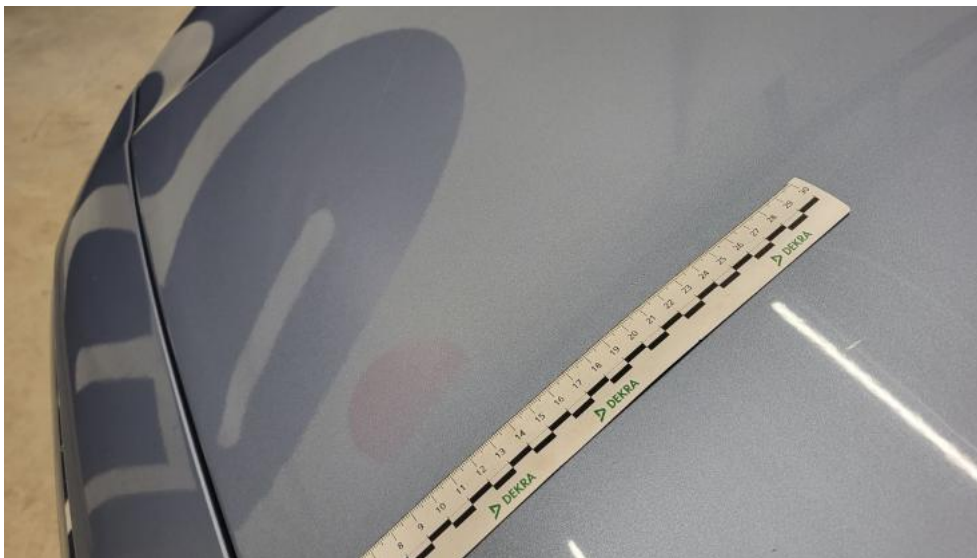
Photo 45.

Pokrywa komory silnika - Rysa/odprysk 1

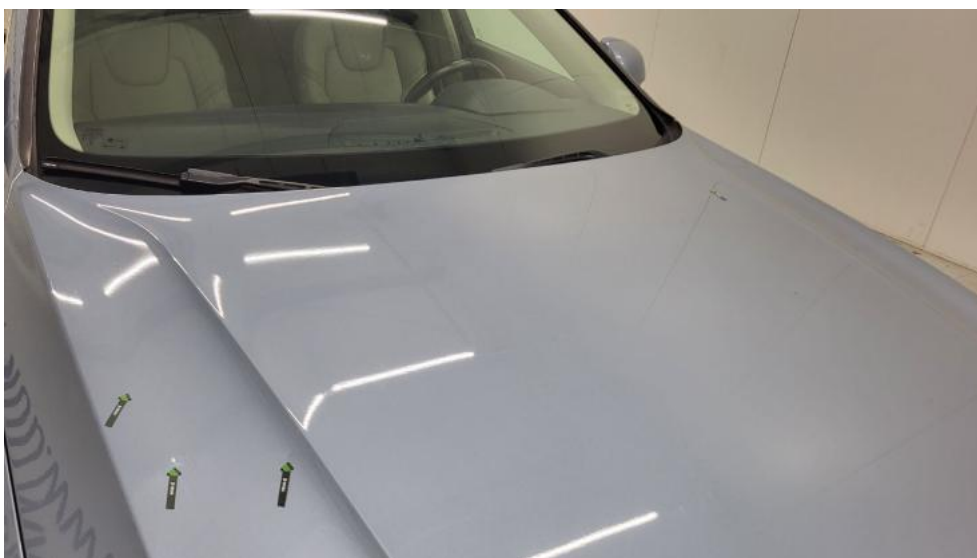
Photo 46.

Pokrywa komory silnika - Wgniecenie/odkształcenie 1

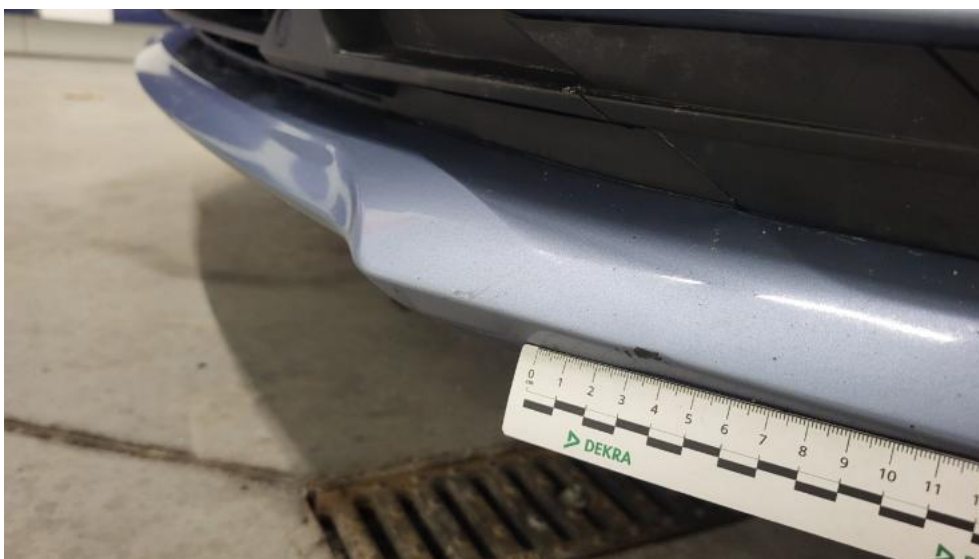
Photo 47.
Spoiler zderzaka przedniego - Rysa/odprysk 1

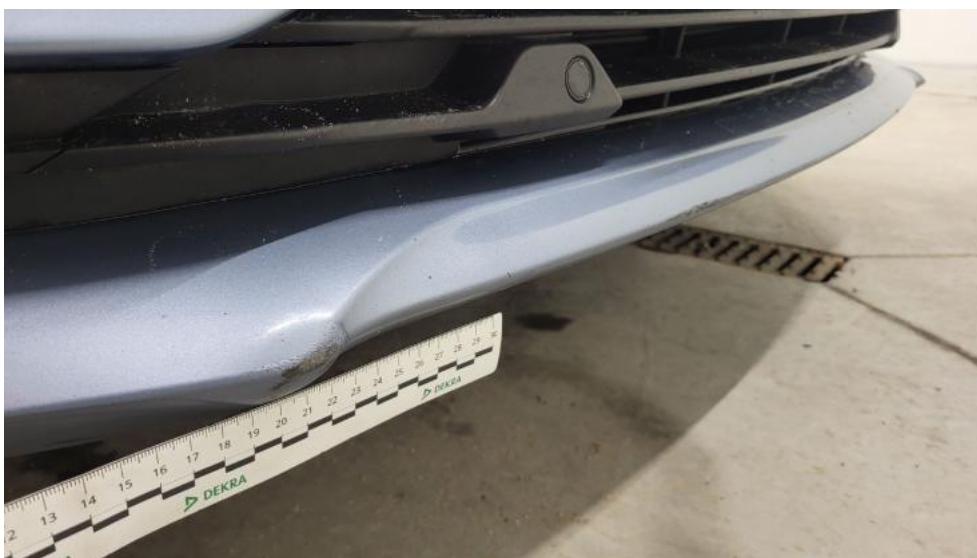
Photo 50.
Spoiler zderzaka przedniego - Wgniecenie/odkształcenie 1

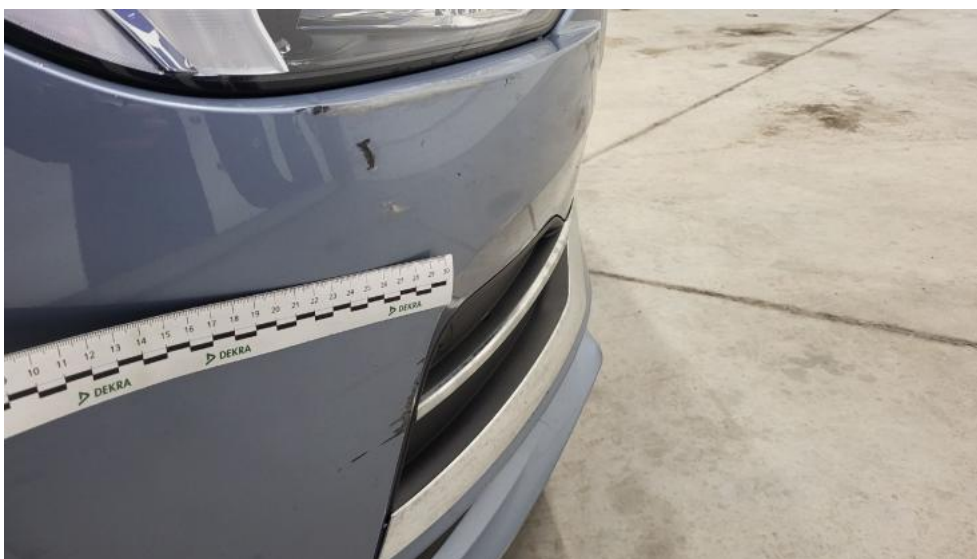
Photo 51.
Zderzak - Rysa/odprysk 1

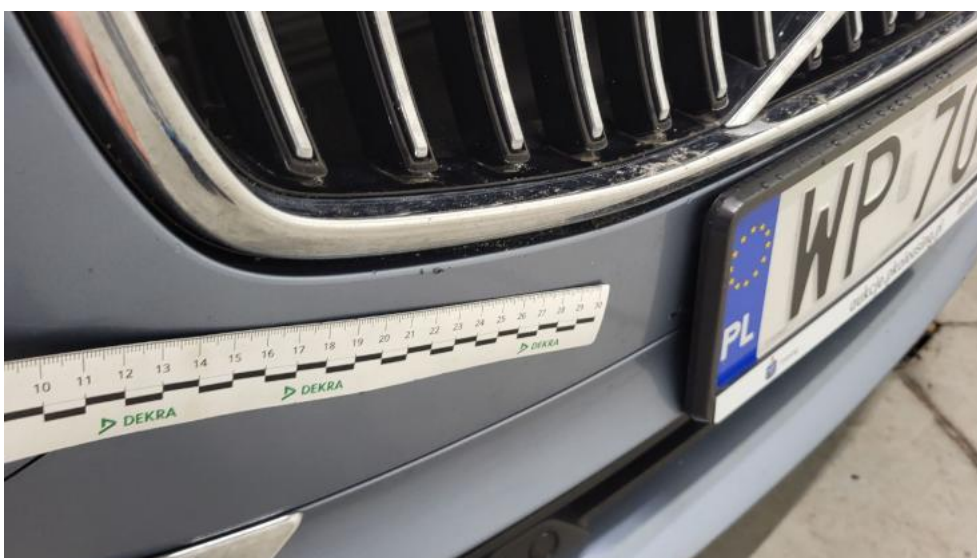
Photo 52.
Zderzak - Rysa/odprysk 2

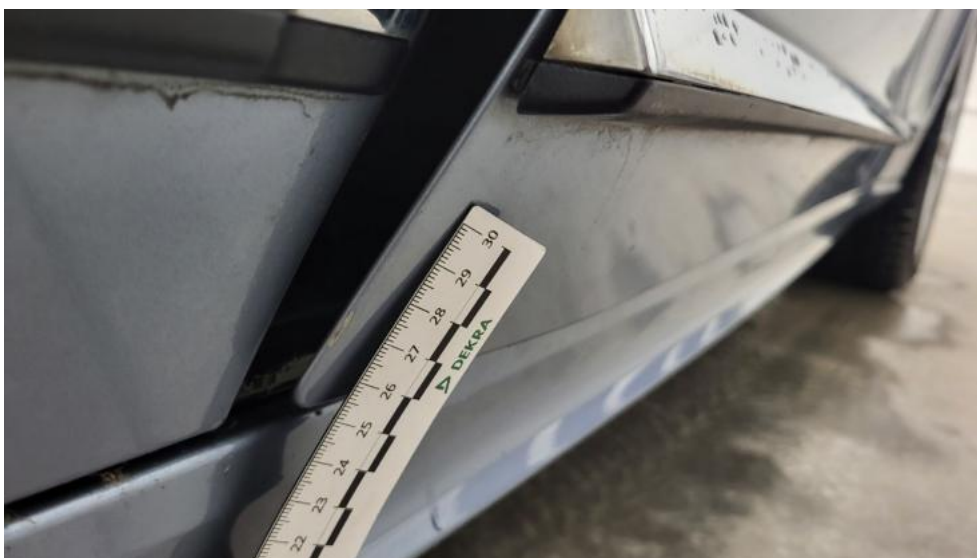
Photo 54.
Drzwi przednie P - Rysa/odprysk 1

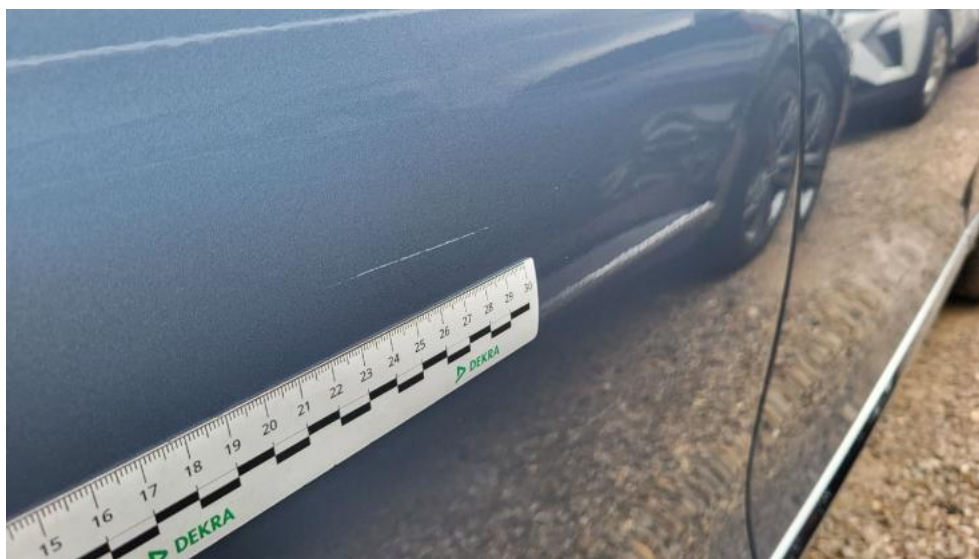
Photo 55.

Drzwi tylne P - Rysa/odprysk 1

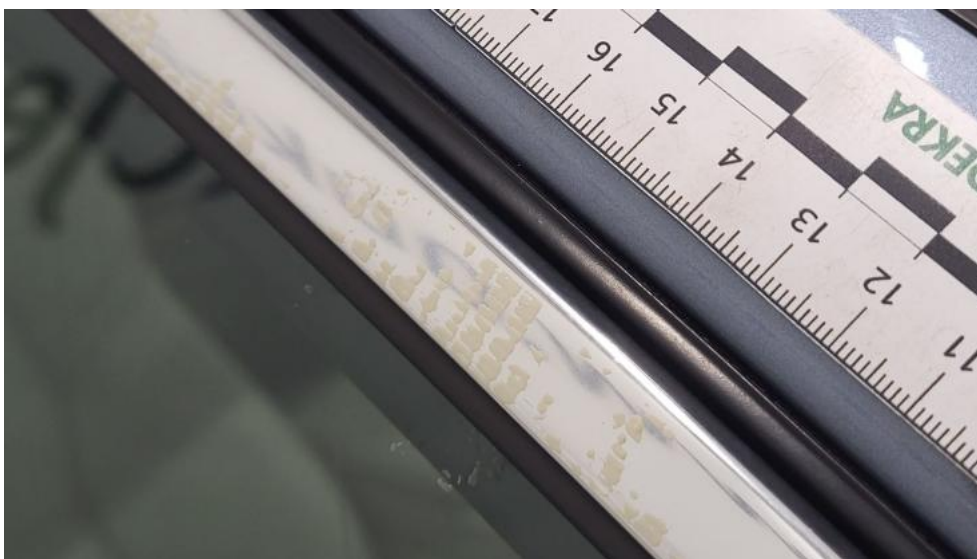
Photo 57.

Listwa drzwi przednich P - Inne 1

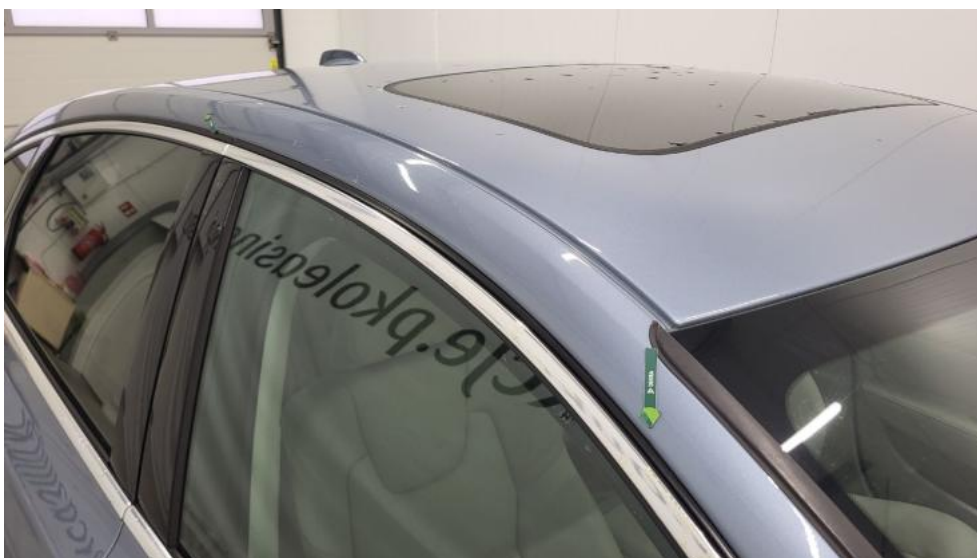
Photo 58.

Słupek przedni P - Wgniecenie/odkształcenie 1

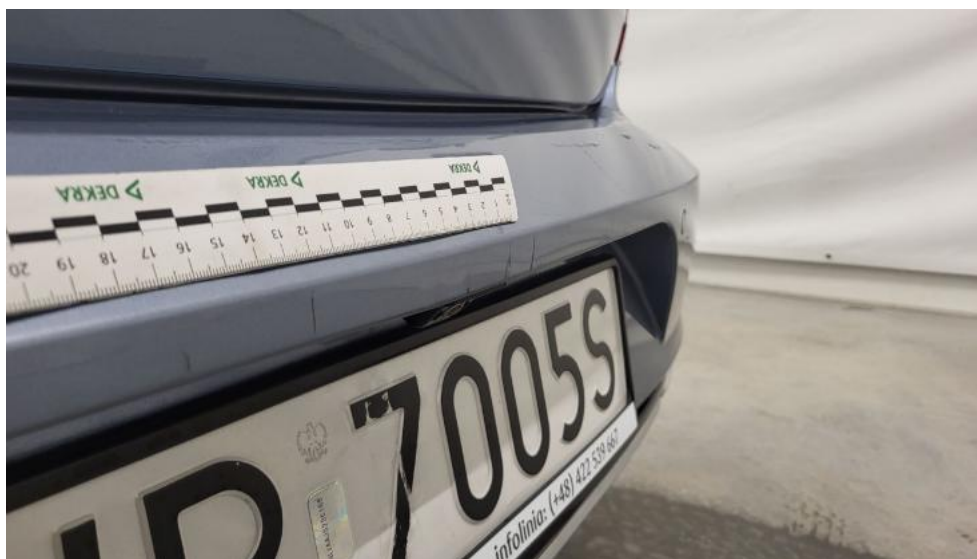
Photo 67.
Zderzak tylny - Wgniecenie/odkształcenie 2

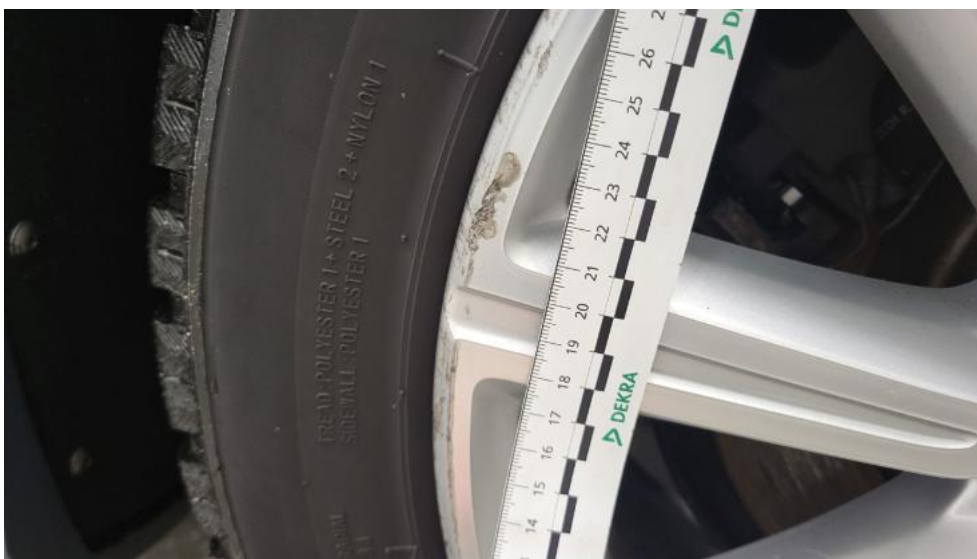
Photo 73.
Felga aluminiowa tylna L - Rysa/odprysk 1

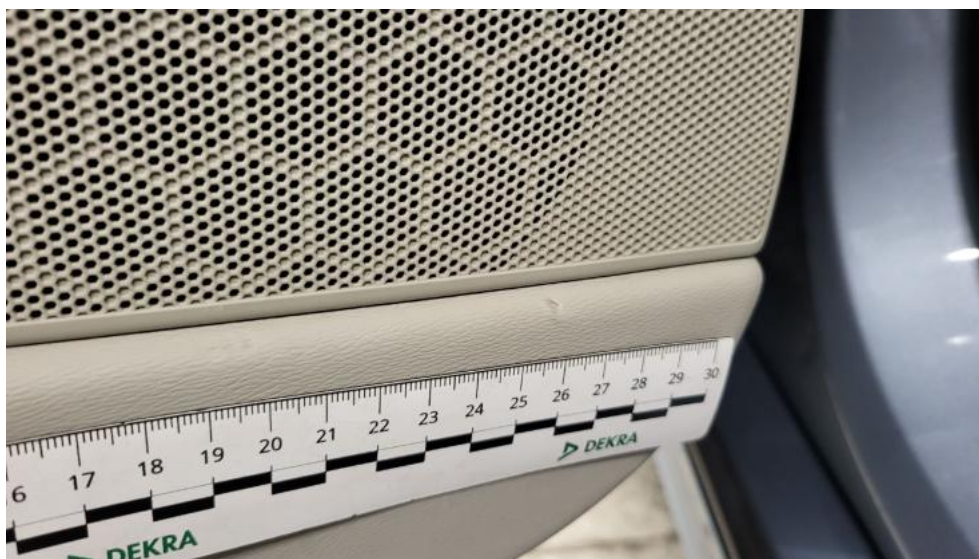
Photo 87.

Tapicerka drzwi tylnych L - Pęknięcie/rozerwanie 1

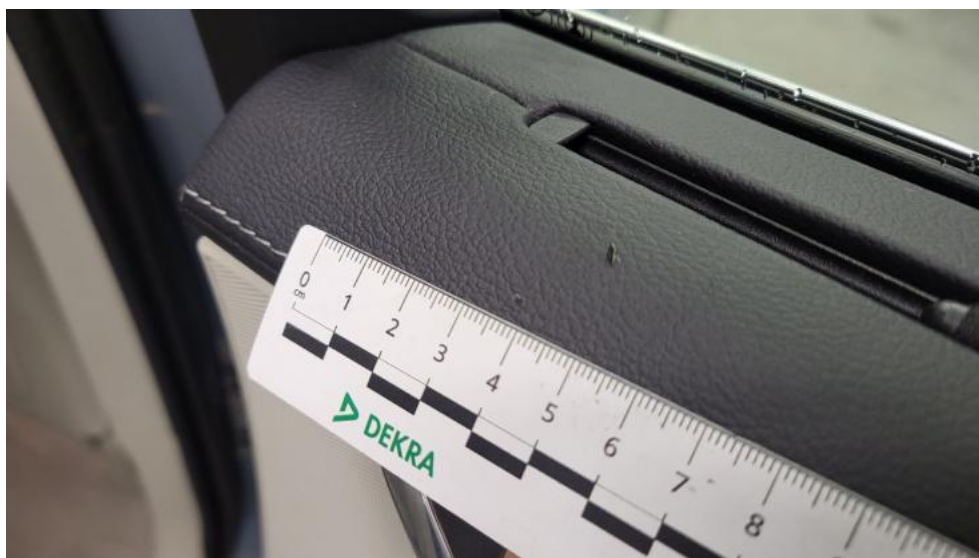
Photo 88.

Tapicerka drzwi tylnych P - Pęknięcie/rozerwanie 1
