DEKRA's commission No. : PKOL(W)/LODZ/07751/26/01/29
 commission/ damage No. : 20/049005
 Date of commission: 29-01-2026

PKO Leasing SA
 Świętokrzyska 36
 00-116 Warszawa

Group of objects (Eurotax)	jeeps
EC code (Eurotax)	0128373
Manufacturer	PORSCHE
Model	Cayenne III 17-23
Type / version	Cayenne Turbo
Body type	KOM
Number of doors / seats	5/5
Curb weight [kg]	2355
Gross vehicle weight [kg]	2935
Wheelbase 1/2	2895
Engine type	spark ignition
Pollution reduction system	three-way catalytic converter
Engine capacity [ccm]	3996
Engine Power [hp/kW]	550/404
Gearbox	automatic 8- gear
Registration /record No.	WU7629L
VIN / serial number	WP1ZZZ9YZMDA37059
Date of first registration	25-01-2021
Date of next. tech. test	19-01-2027
Year of manufacture	2020 (year has been verified with the manufacturer's base)
Readout [km]	65 449 (read)
Body color / type of coating	red/METALIK

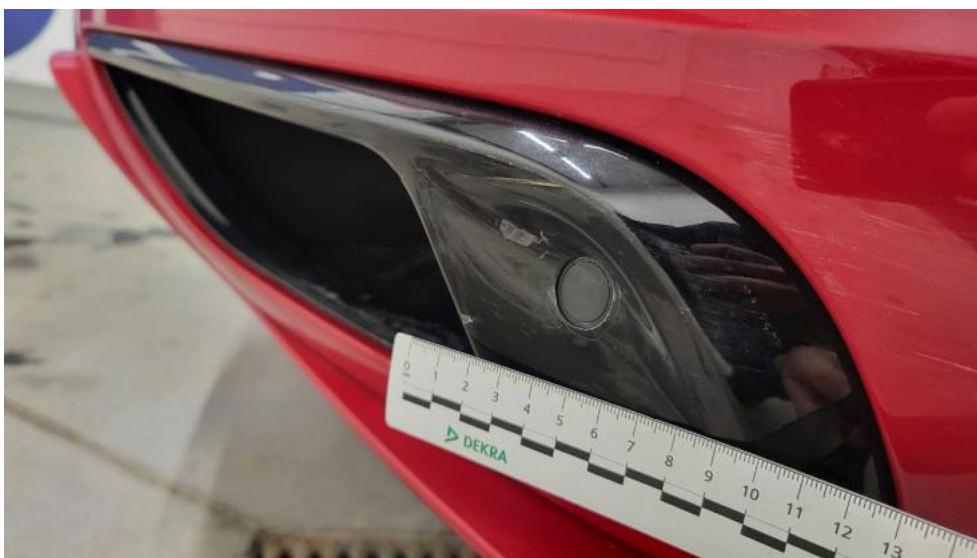
Photo 44.
Kratka/zaślepka halogenu L - Rysa/odprysk 1

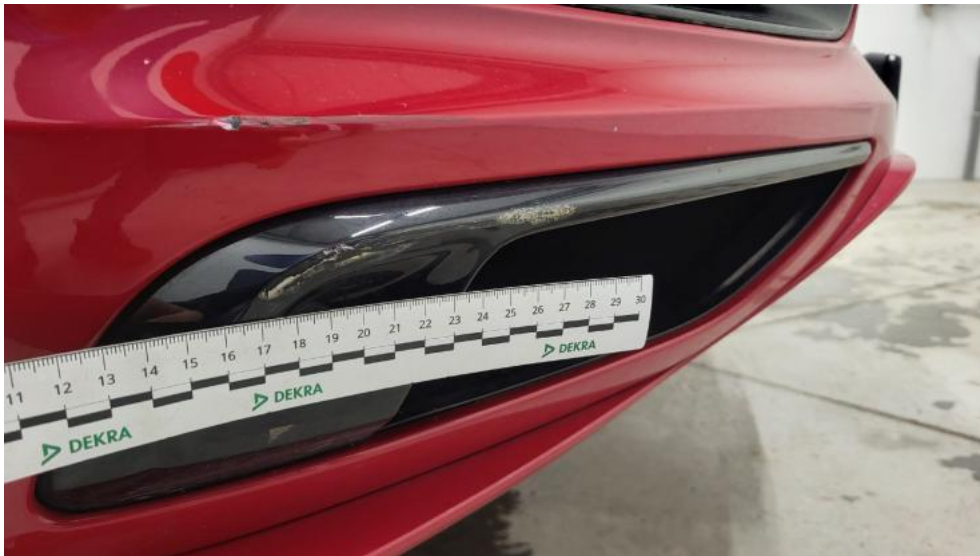
Photo 45.
Kratka/zaślepka halogenu P - Rysa/odprysk 1

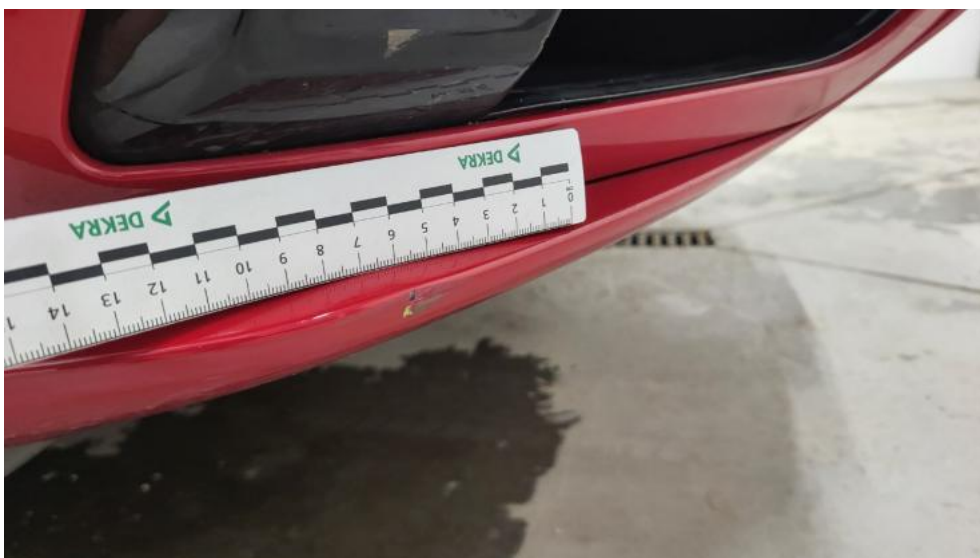
Photo 46.
Spoiler zderzaka przedniego - Rysa/odprysk 1

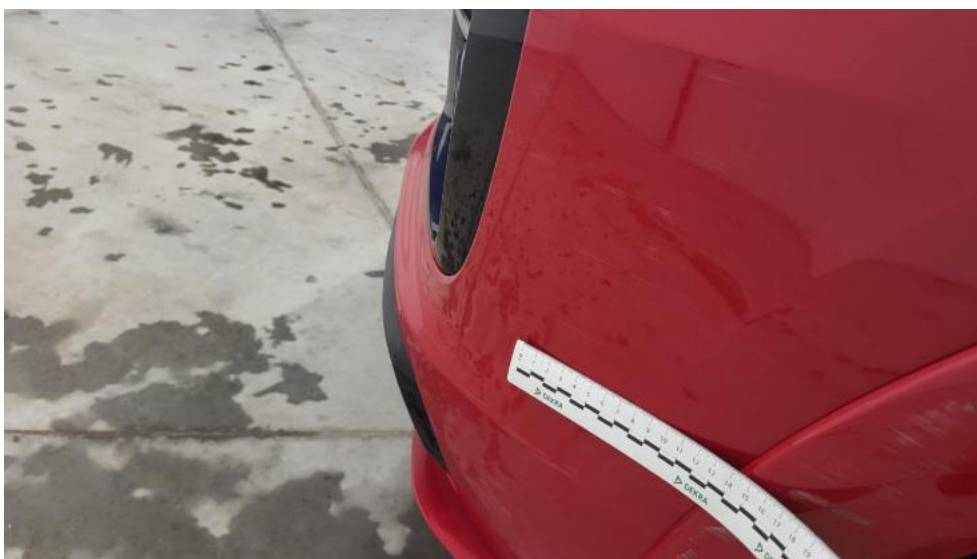
Photo 47.
Zderzak - Rysa/odprysk 1

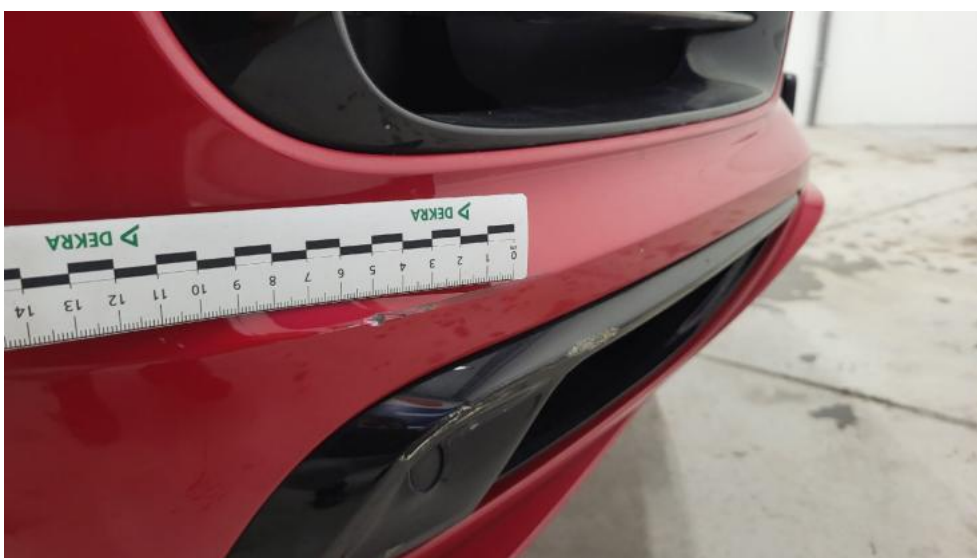
Photo 48.
Zderzak - Rysa/odprysk 2

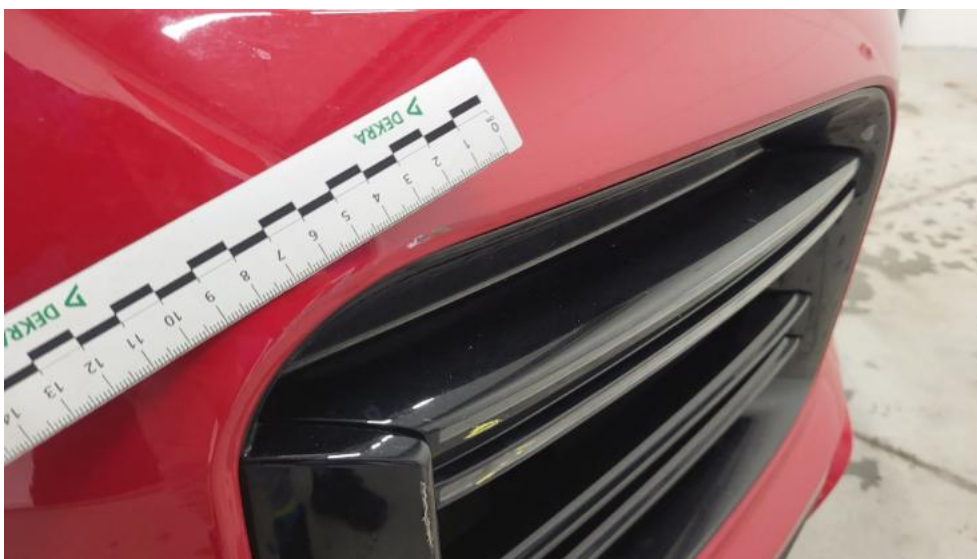
Photo 49.
Zderzak() - Rysa/odprysk 3

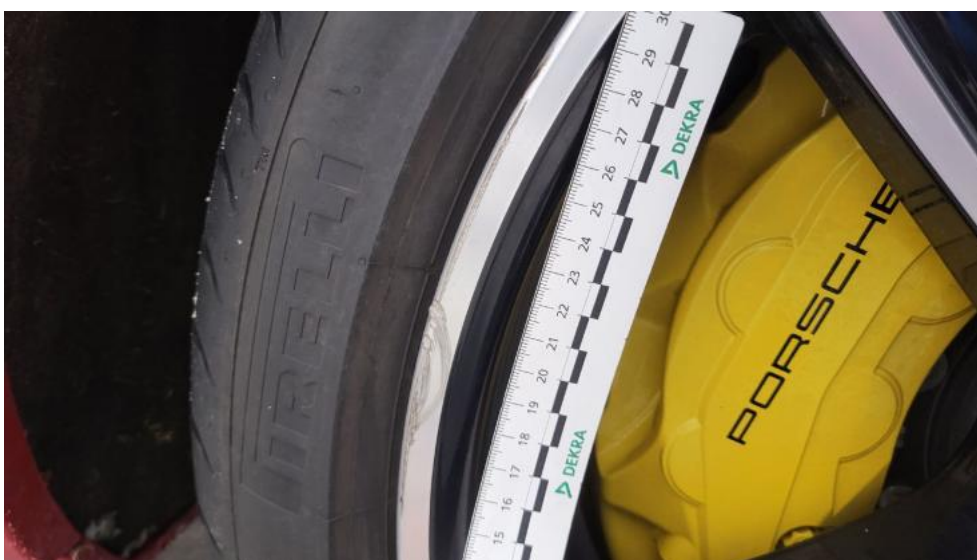
Photo 50.
Felga aluminiowa przednia P - Rysa/odprysk 1

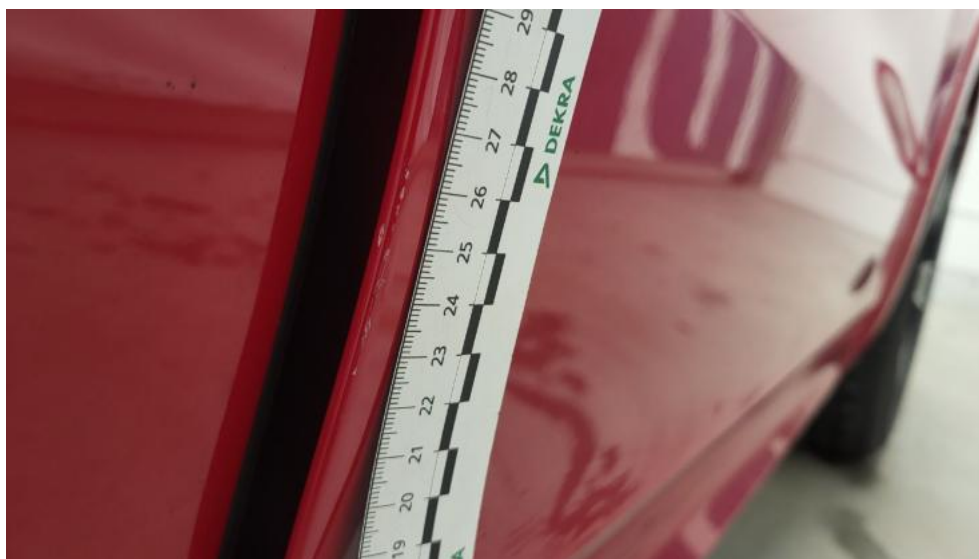
Photo 51.

Drzwi przednie P - Rysa/odprysk 1

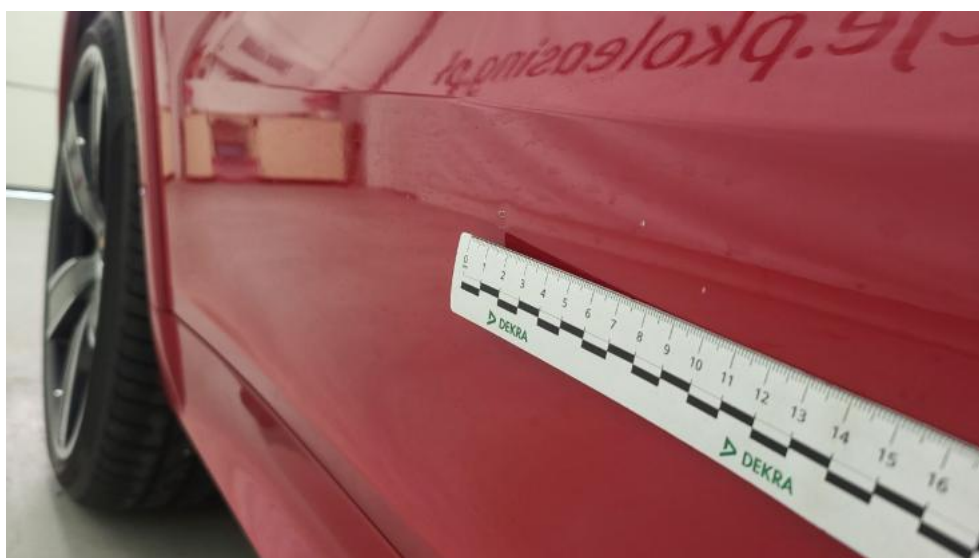
Photo 52.

Drzwi tylne P - Wgniecenie/odkształcenie 1

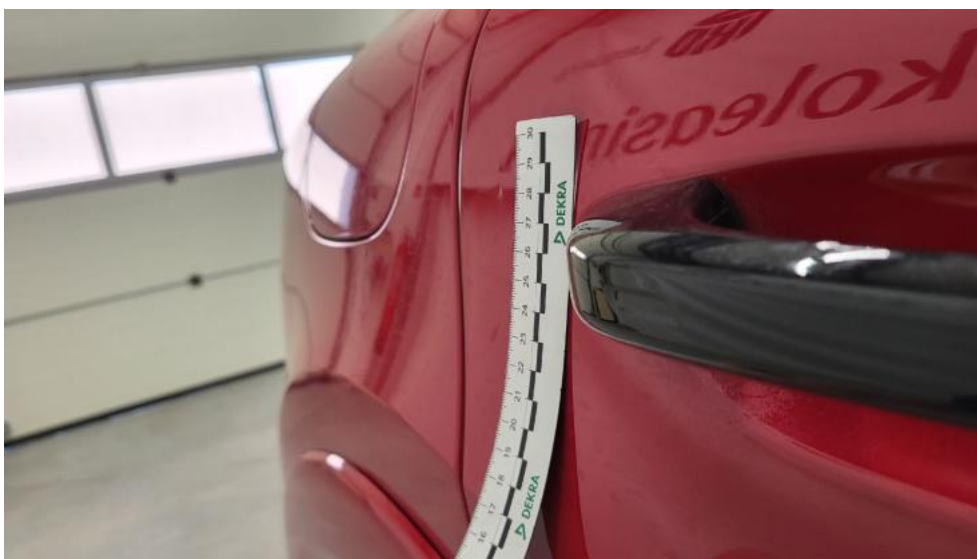
Photo 53.
Drzwi tylne P - Wgniecenie/odkształcenie 2

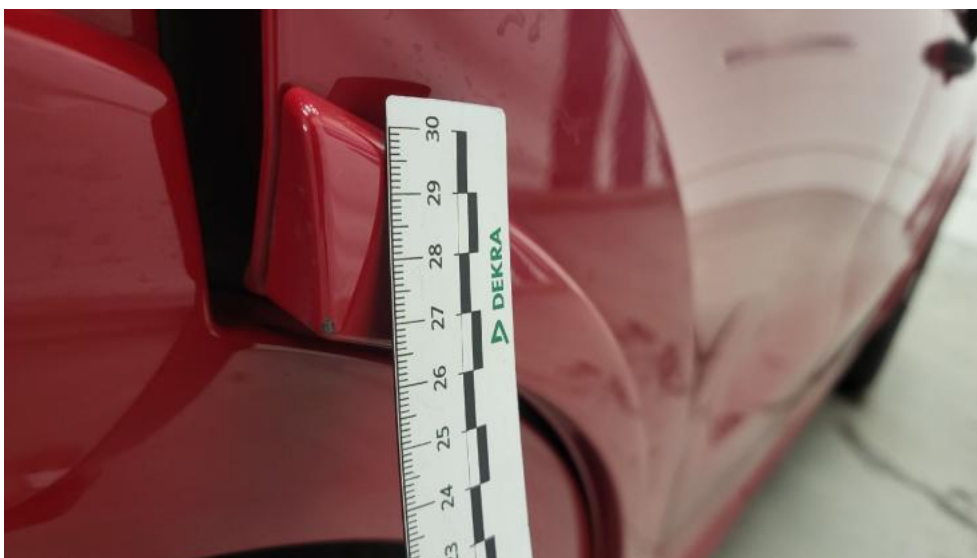
Photo 54.
Listwa drzwi tylnych P - Rysa/odprysk 1

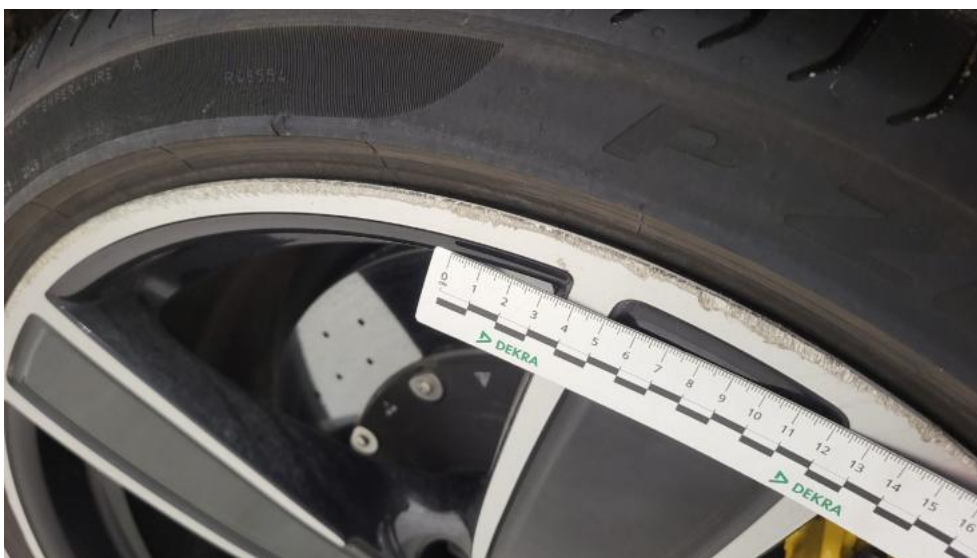
Photo 56.

Felga aluminiowa tylna P - Rysa/odprysk 1

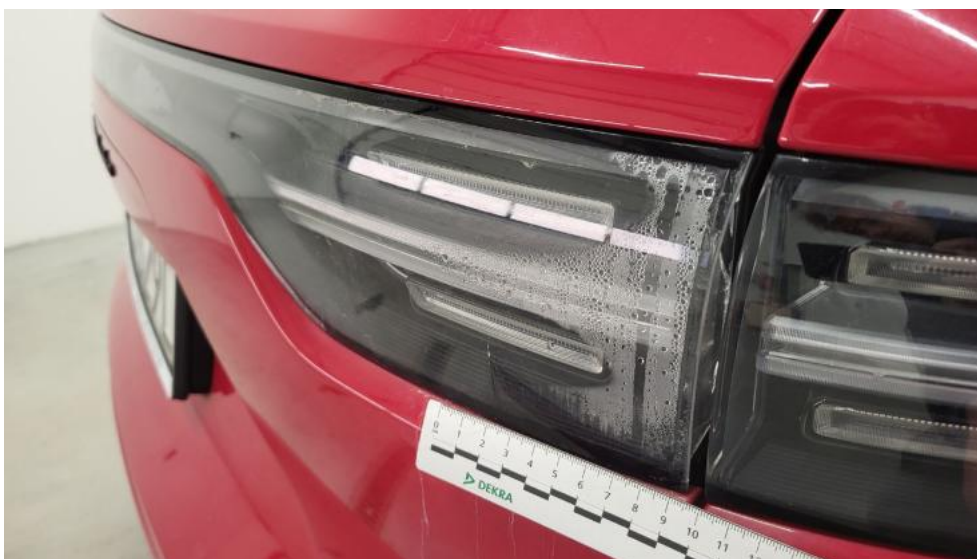
Photo 57.
Lampa tylna wew P - Inne 1

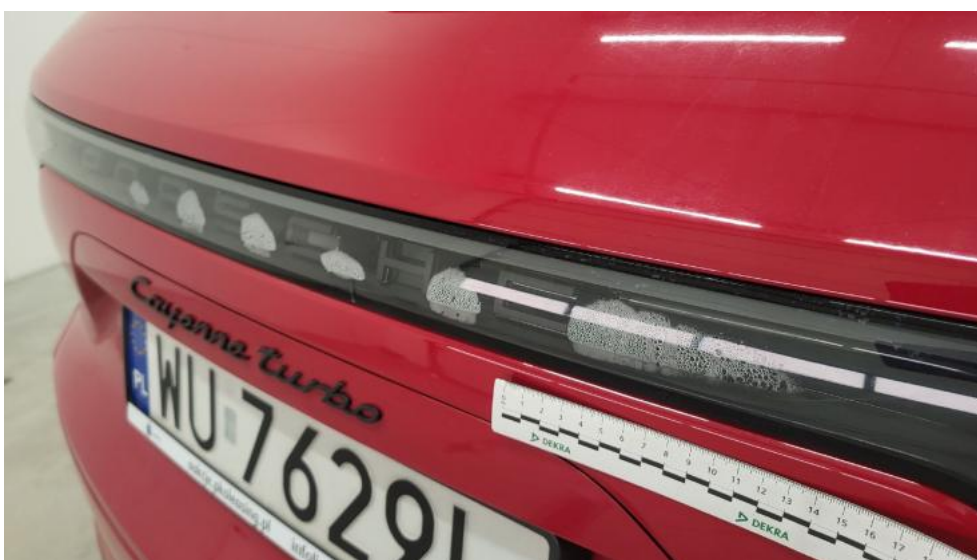
Photo 58.
Lampa tylna wew P - Inne 2

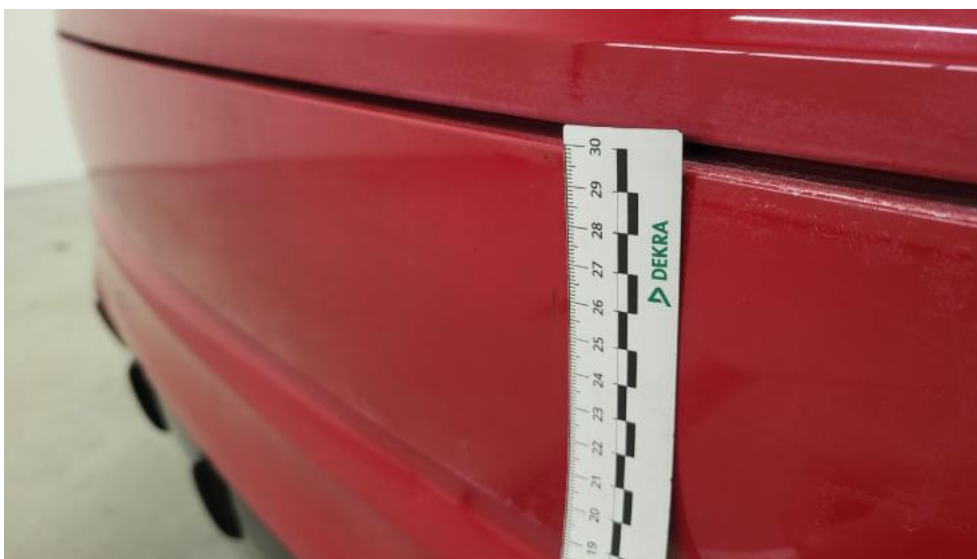
Photo 59.
Zderzak tylny - Rysa/odprysk 1

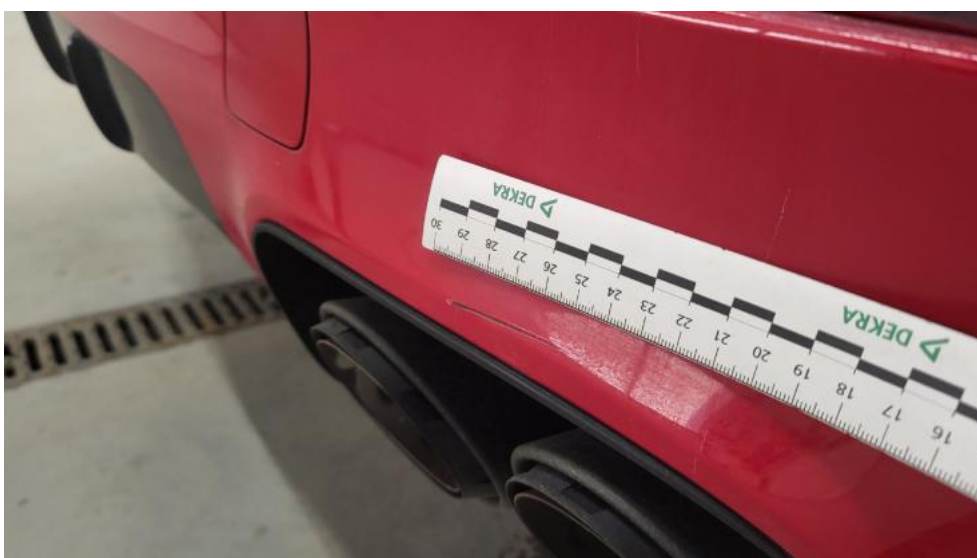
Photo 60.
Zderzak tylny cz dolna - Rysa/odprysk 1

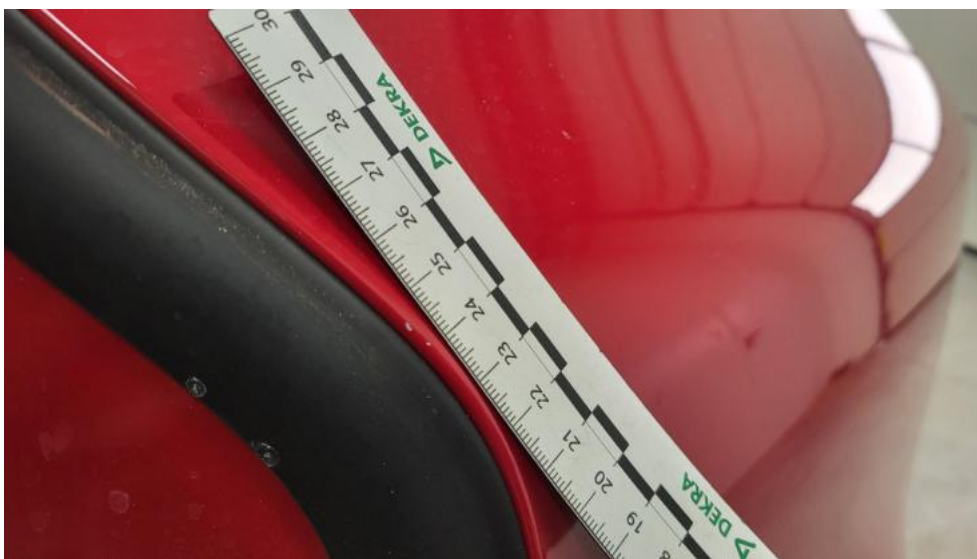
Photo 61.

Błotnik tylny L / Ściana boczna L - Rysa/odprysk 1

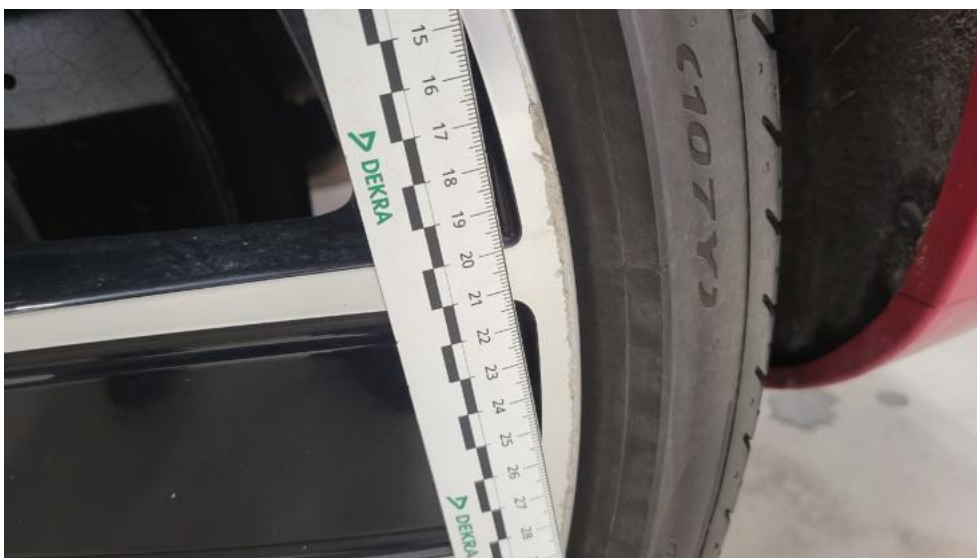
Photo 62.

Felga aluminiowa tylna L - Rysa/odprysk 1

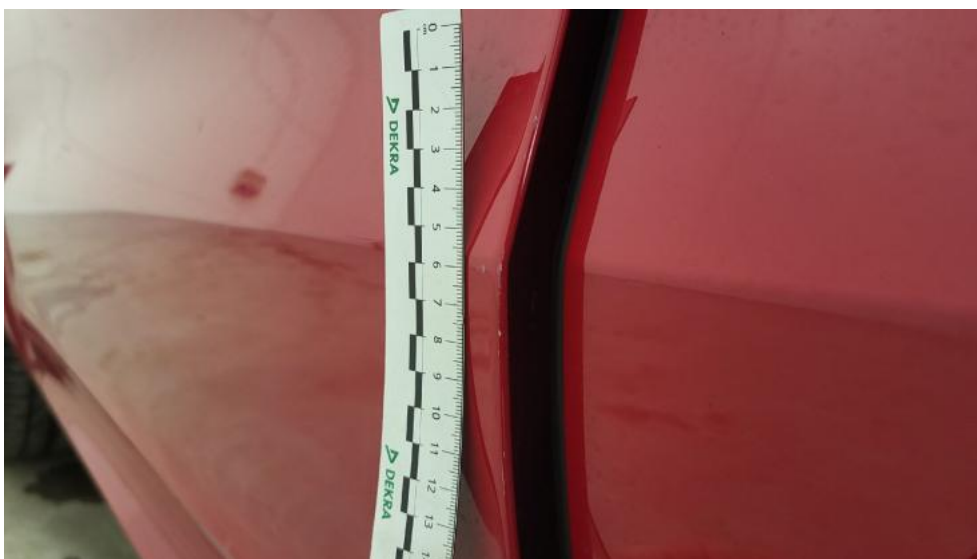
Photo 63.
Drzwi przed L - Rysa/odprysk 1

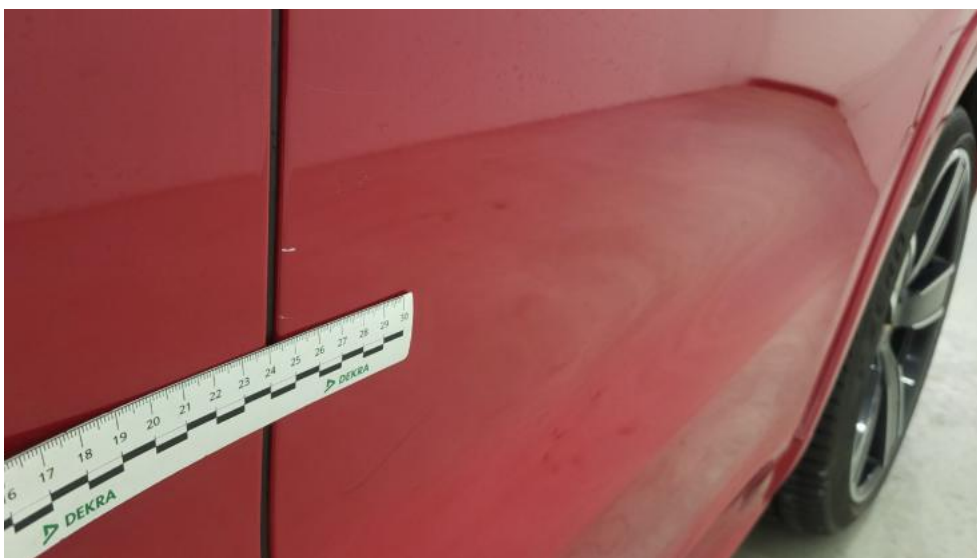
Photo 64.
Drzwi tylne L - Rysa/odprysk 1

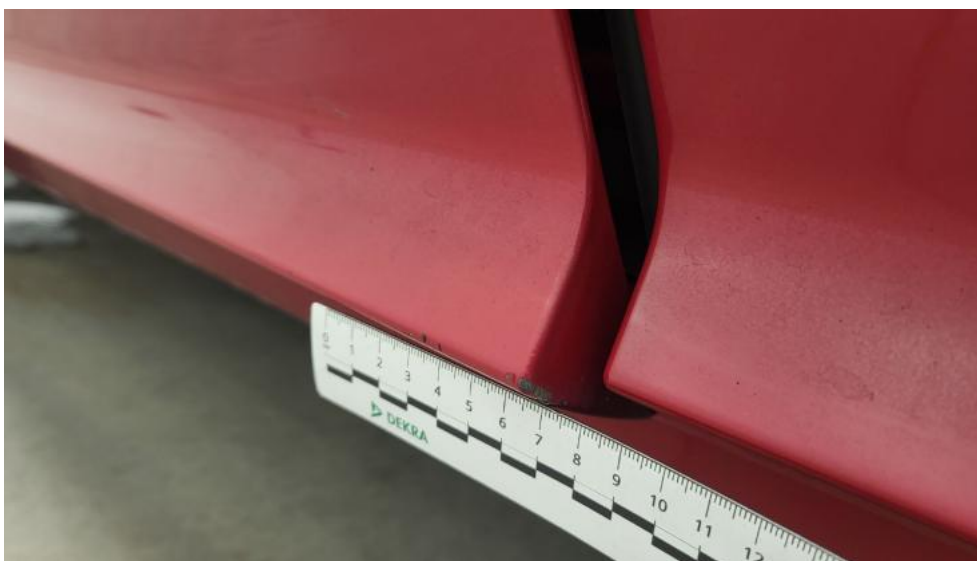
Photo 65.

Listwa drzwi przednich L - Rysa/odprysk 1

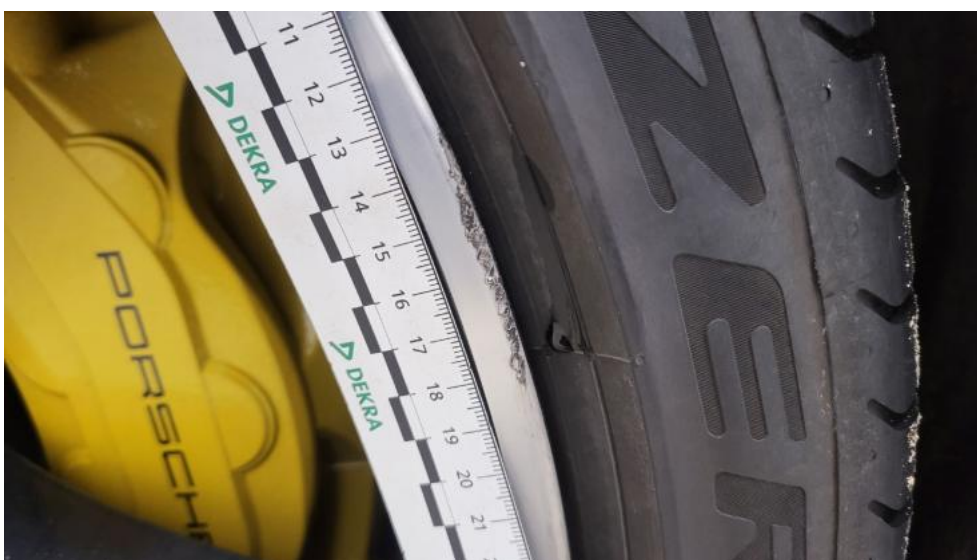
Photo 66.

Felga Aluminiowa przednia L - Rysa/odprysk 1

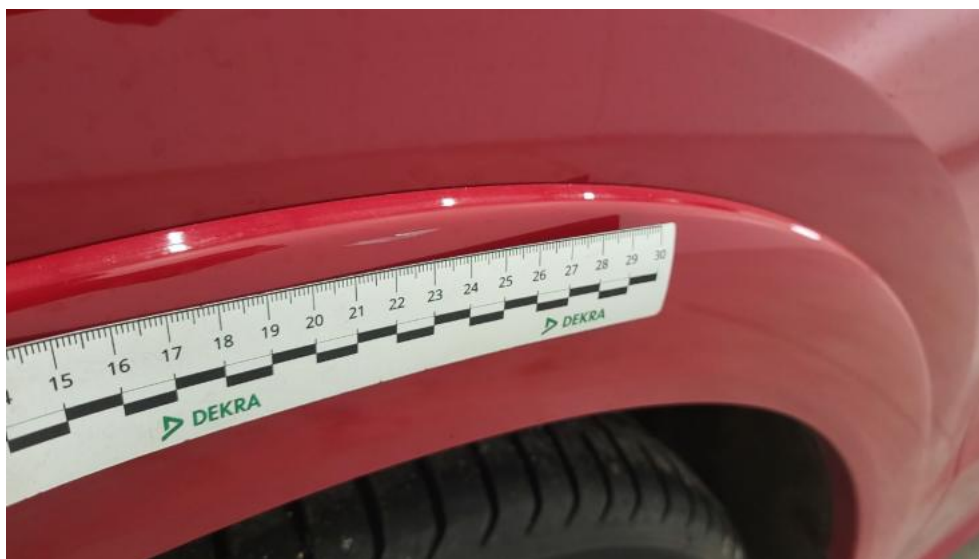
Photo 67.

Listwa błotnika przedniego L - Rysa/odprysk 1

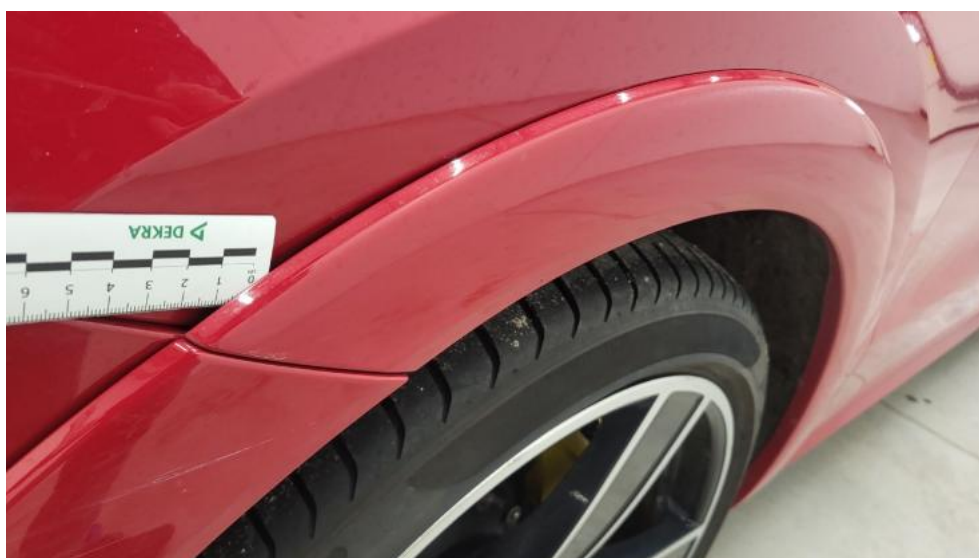
Photo 68.

Listwa błotnika przedniego L - Inne 1

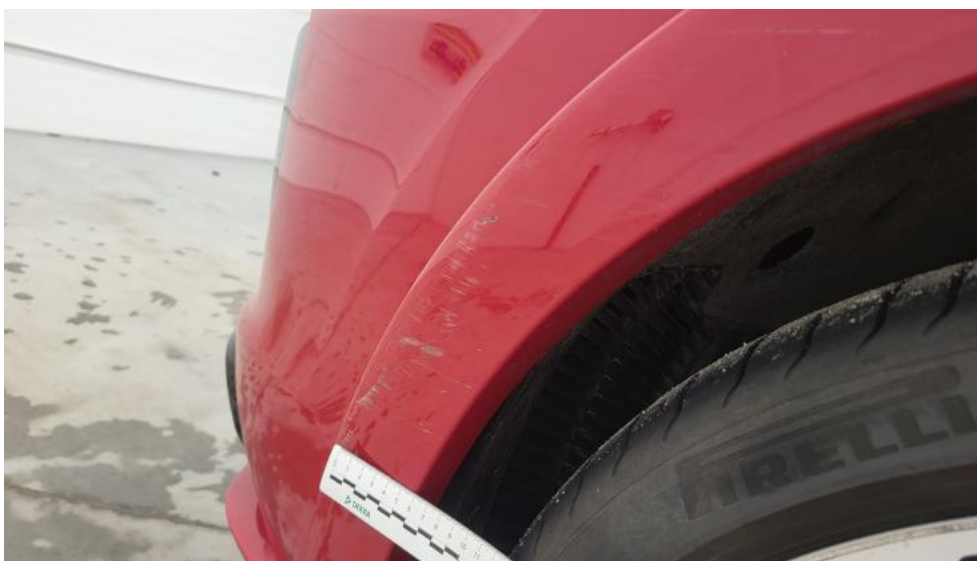
Photo 69.

Listwa zderzaka prz L - Rysa/odprysk 1

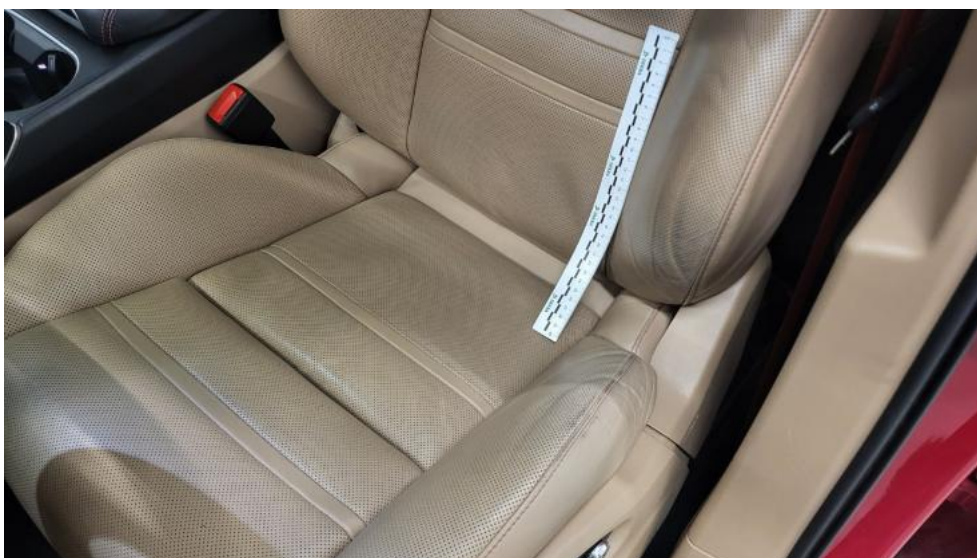
Photo 70.

Fotel prz. lew. - Inne 1

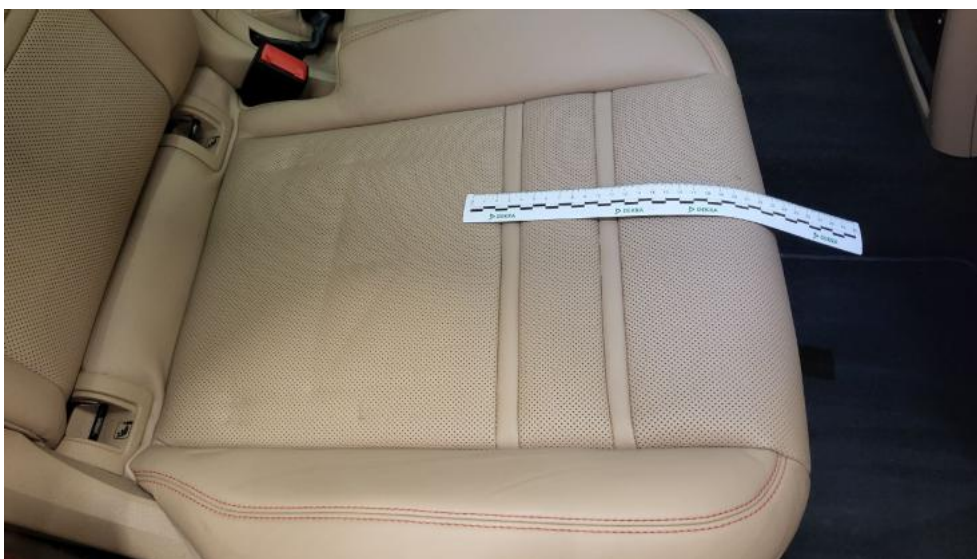
Pojazd oklejony folią, pomiar lakieru wykonany na folii elementy: pokrywa przednia, dach, błotnik przedni lewy/prawy. Lusterka oklejone folią. Odpryski na szybie czołowej. Rysy na samochodzie. Brak zaślepek w tylnej kanapie.

Photo 71.
Kanapa tyl. - Inne 1

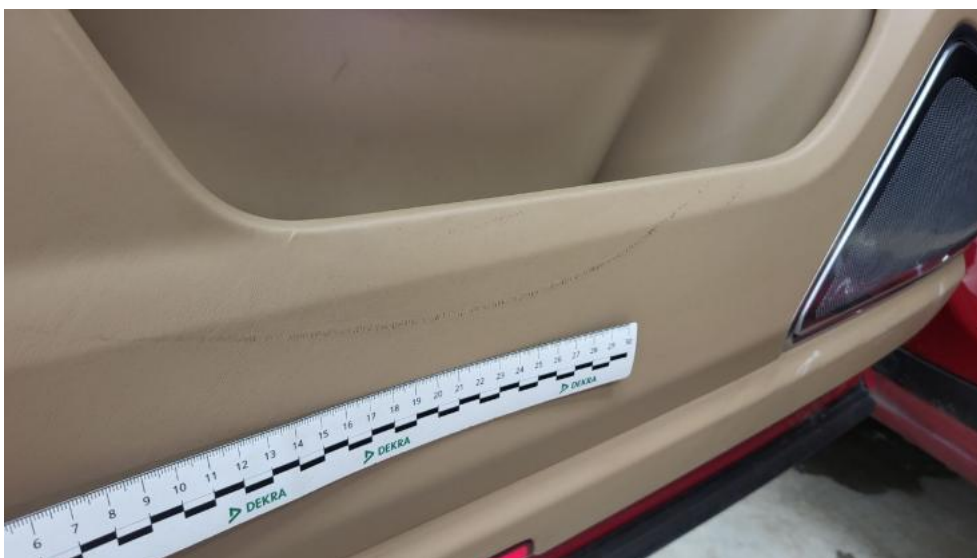
Photo 72.
Tapicerka drzwi przednich L - Rysa/odprysk 1

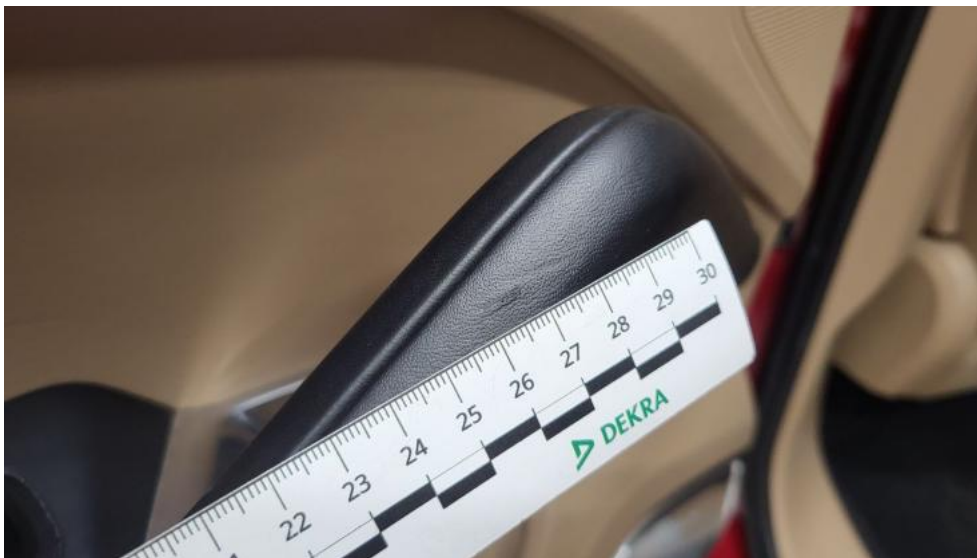
Photo 73.
Uchwyt drzwi tyl L - Rysa/odprysk 1

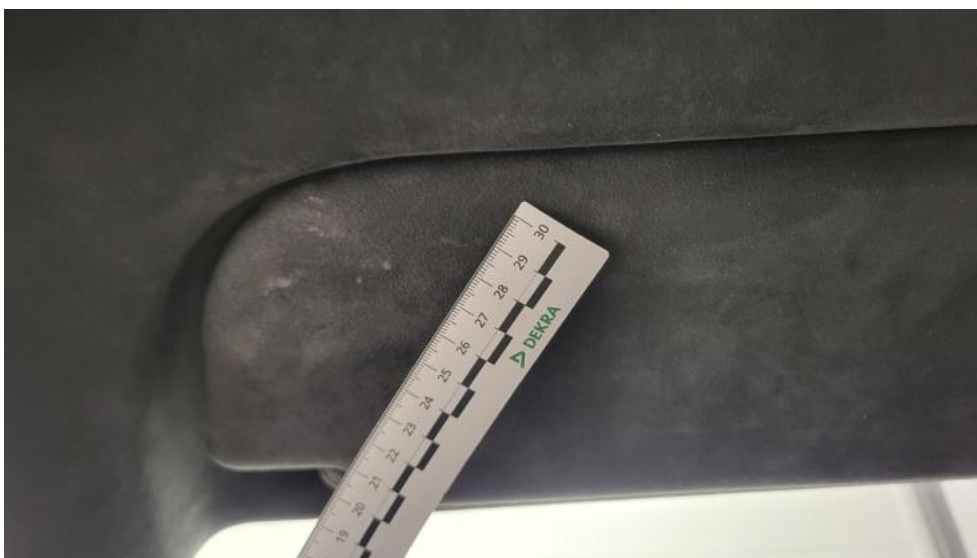
Photo 74.
Osłona p/słoneczna lewa - Inne 1

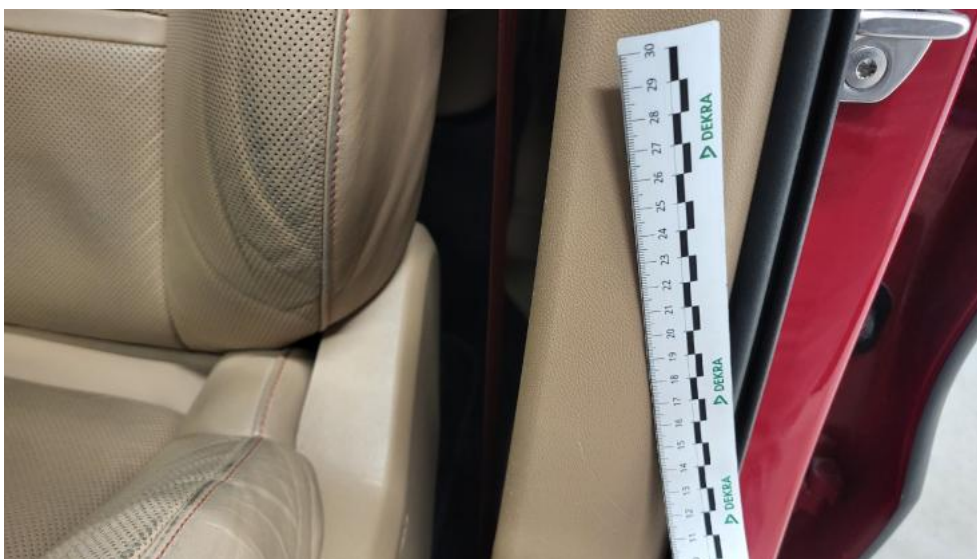
Photo 75.

Wykładzina(y) słupka środkowego L - Rysa/odprysk 1
