DEKRA's commission No. : PKOL(W)/LODZ/00657/26/01/05  
commission/ damage No. : 23/031151  
Date of commission: 05-01-2026

**DEKRA Poland - Headquarters**  
02-673 Warszawa, ul. Konstruktorska 12A

| Manufacturer | AUDI |
| Type / version | A8 50 TDI mHEV Quattro Tiptr. |

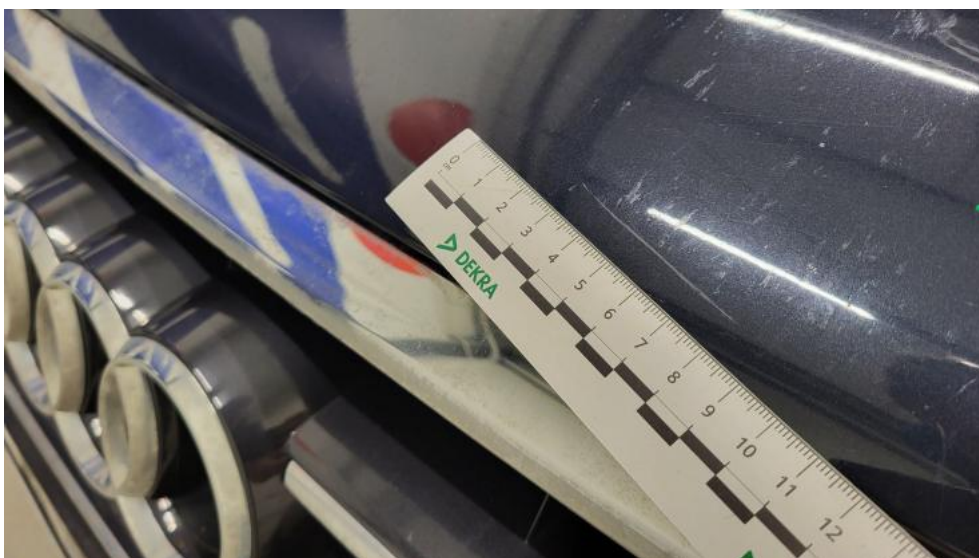
**Photo 48.**

Pokrywa komory silnika - Rysa/odprysk 1

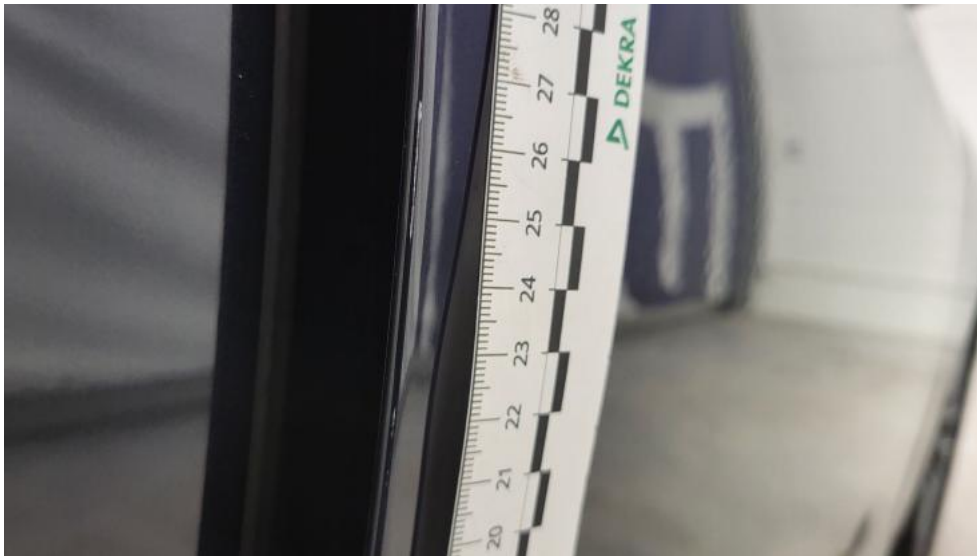
**Photo 49.**

Drzwi przednie P - Rysa/odprysk 1

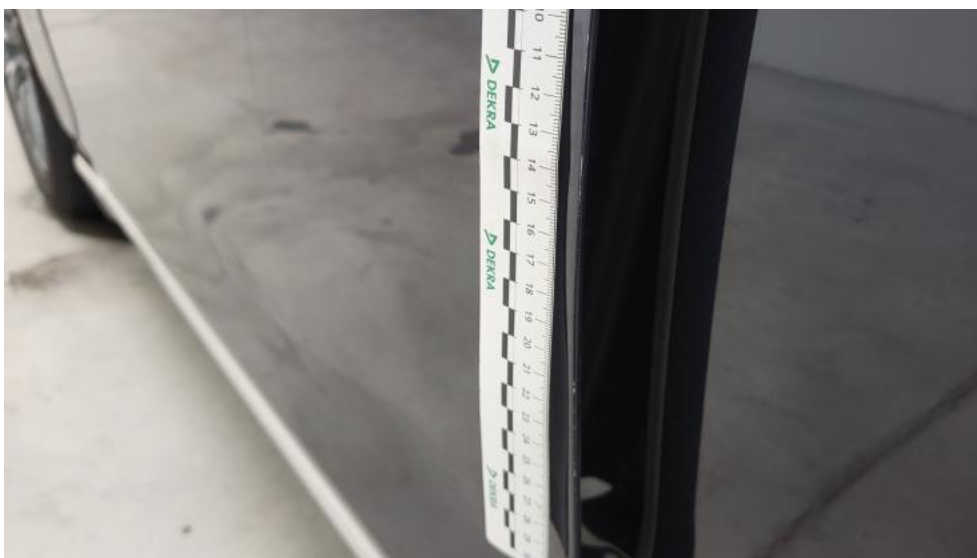
**Photo 56.**

Drzwi przed L - Rysa/odprysk 1

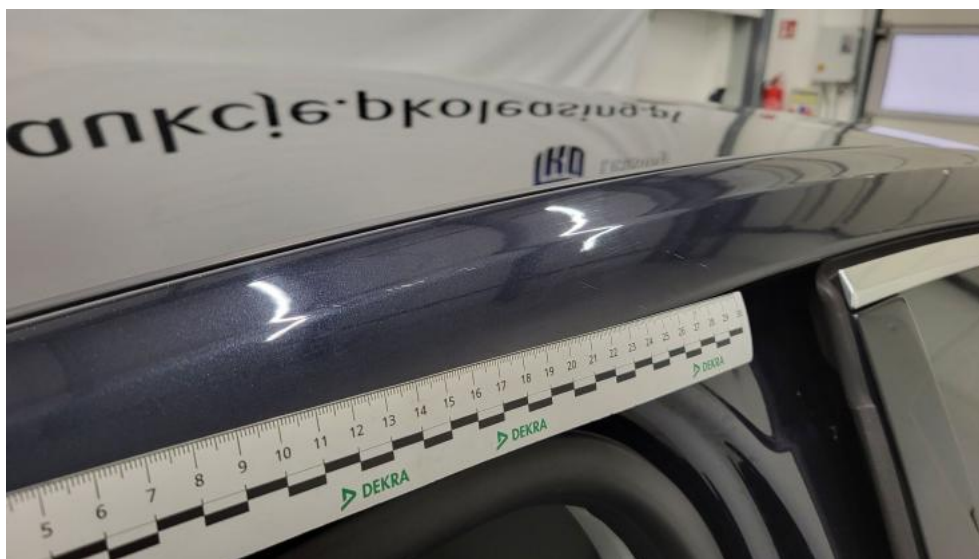
**Photo 61.**

Słupki przedni L - Rysa/odprysk 2

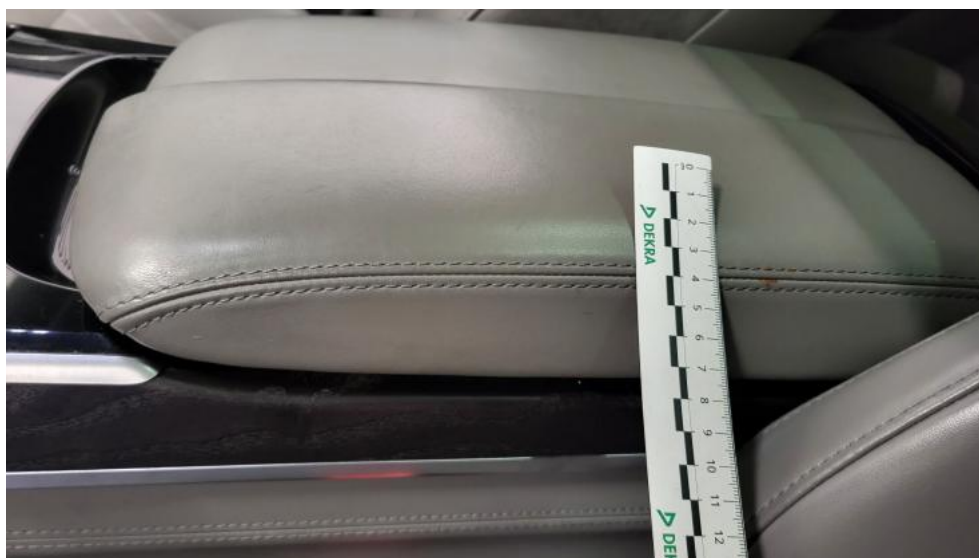
**Photo 62.**

Podłokietnik środkowy przedni - Inne 1

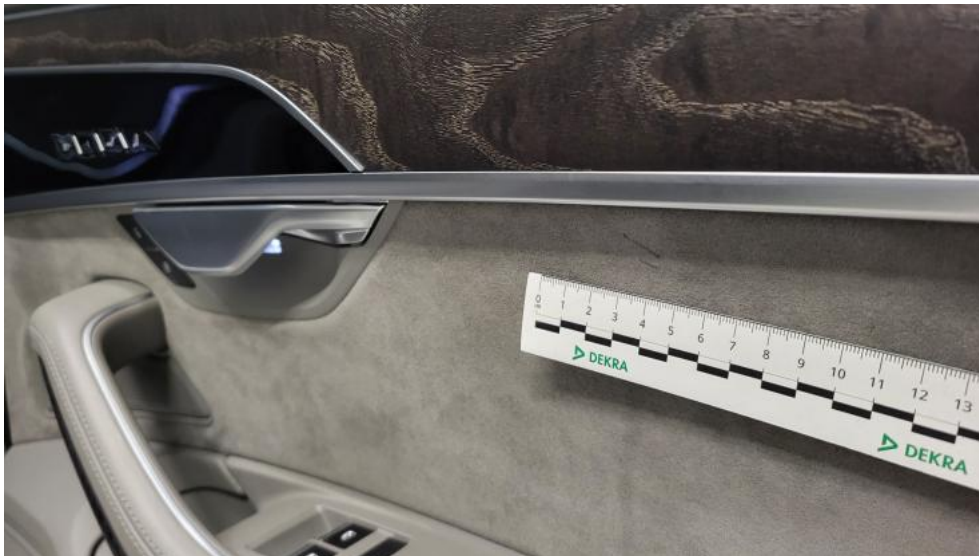
**Photo 63.**

Tapicerka drzwi tylnych P - Inne 1

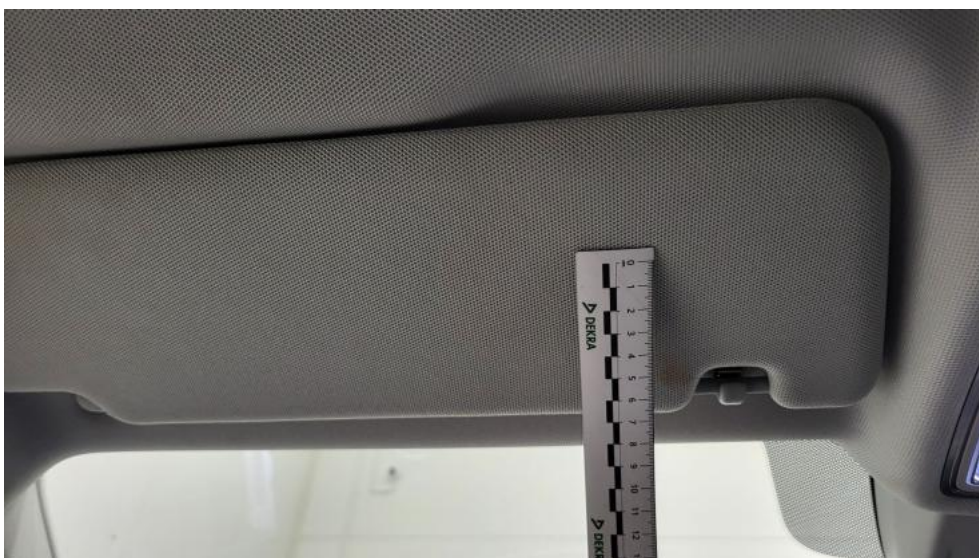
**Photo 64.**

Osłona p/słoneczna lewa - Inne 1

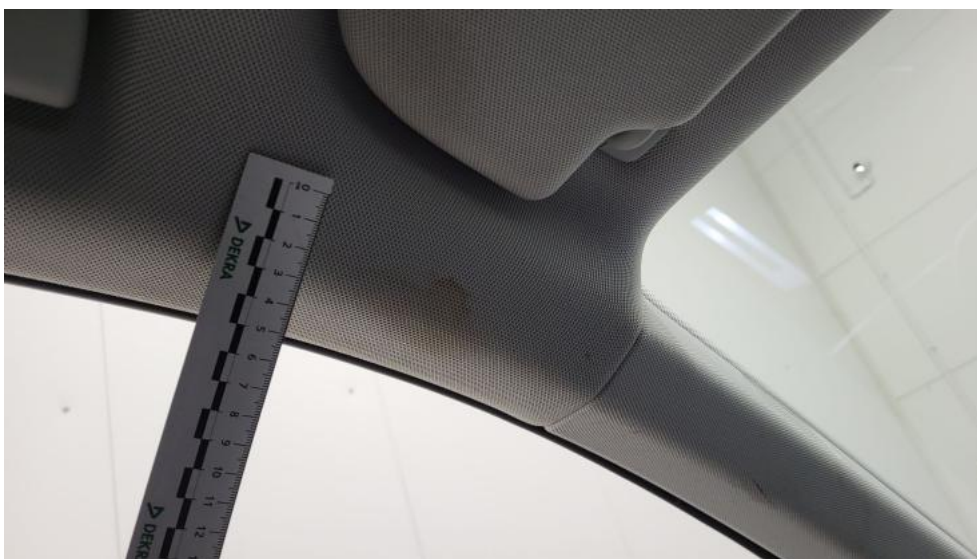
**Photo 65.**

Podsufitka - Inne 1

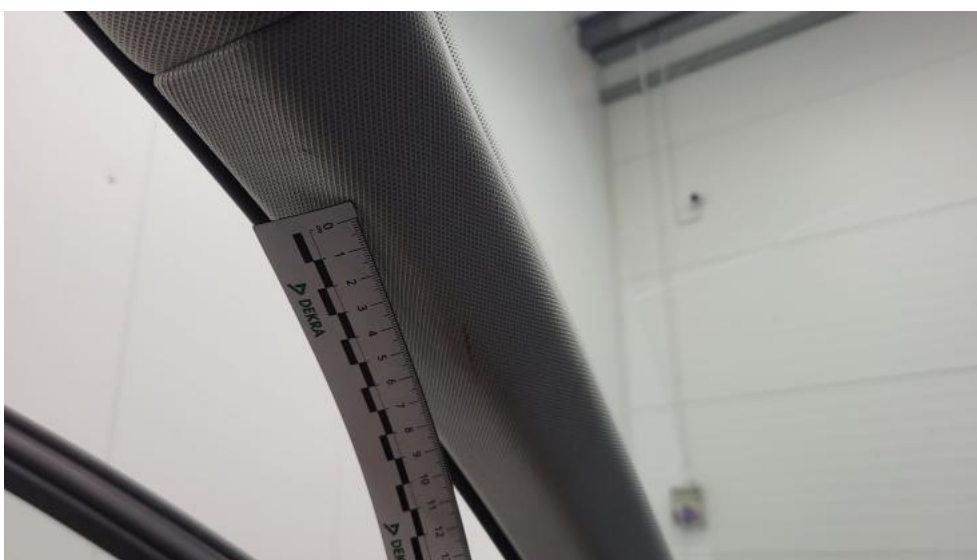
**Photo 66.**

Wykładzina(y) słupka przedniego L - Inne 1
