DEKRA's commission No. : PKOL(W)/LODZ/74697/24/09/27
 commission/ damage No. : 22/025253
 Date of commission: 27-09-2024

Vehicle data

Description of the technical condition

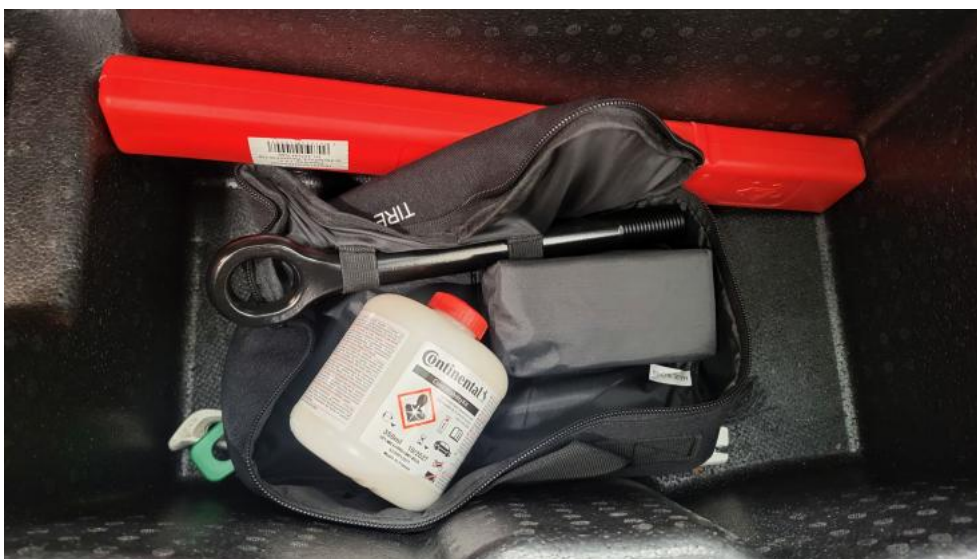
Dostarczono ksero pozwolenia czasowego. Brak kompresora zestawu naprawczego koła. Rysy na samochodzie.

Photo 35.
Zestaw naprawczy koła

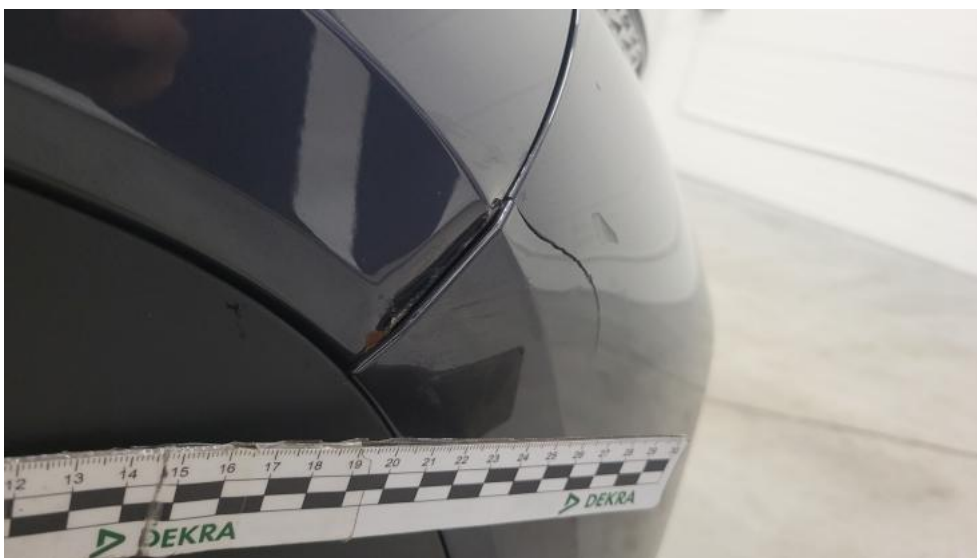
Photo 42.
Zderzak - Wgniecenie/odkształcenie 1

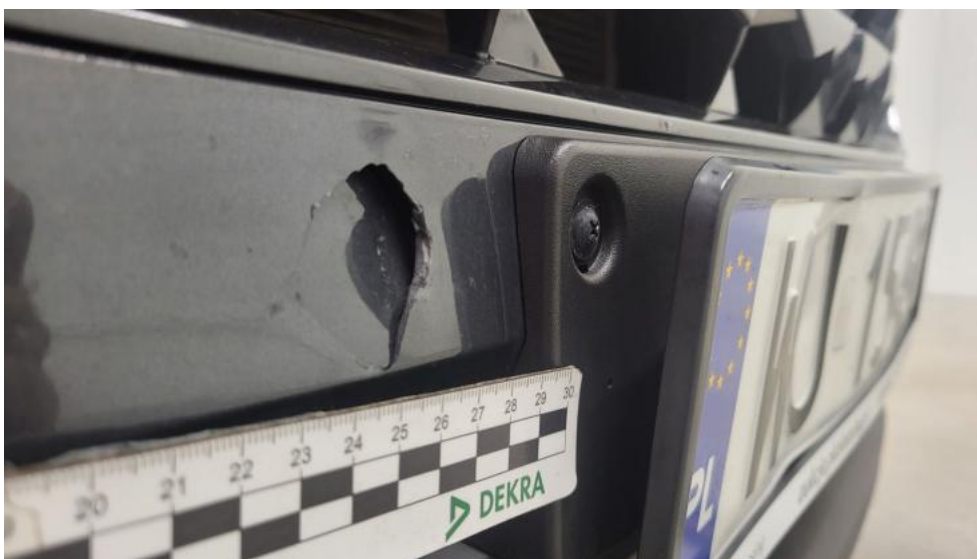
Photo 43.

Zderzak - Wgniecenie/odkształcenie 2

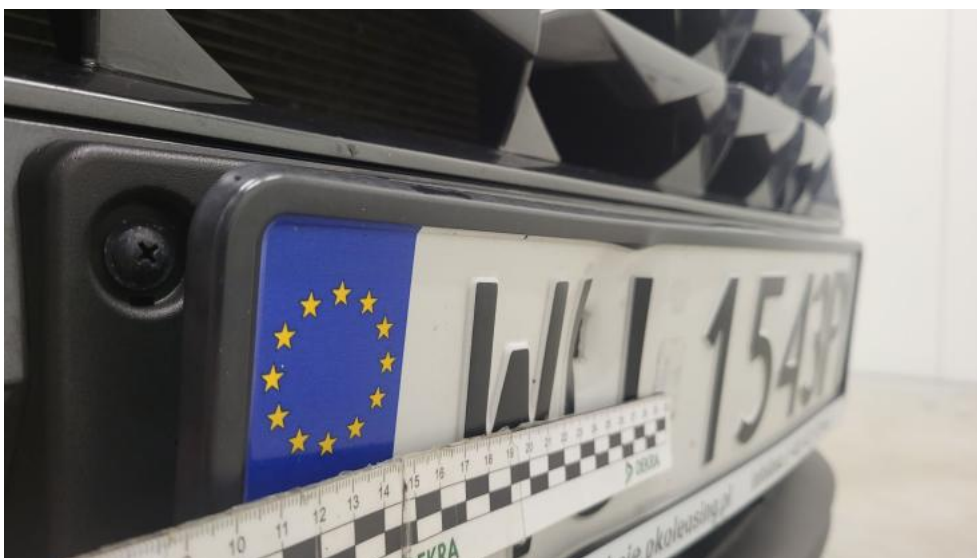
Photo 44.

Zderzak() - Wgniecenie/odkształcenie 3

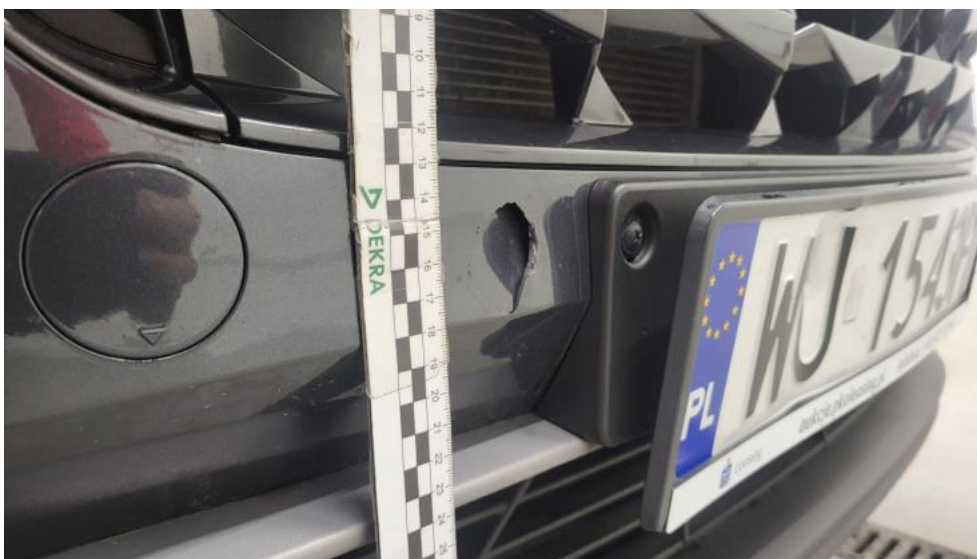
Photo 45.
Zderzak - Pęknięcie/rozerwanie 1

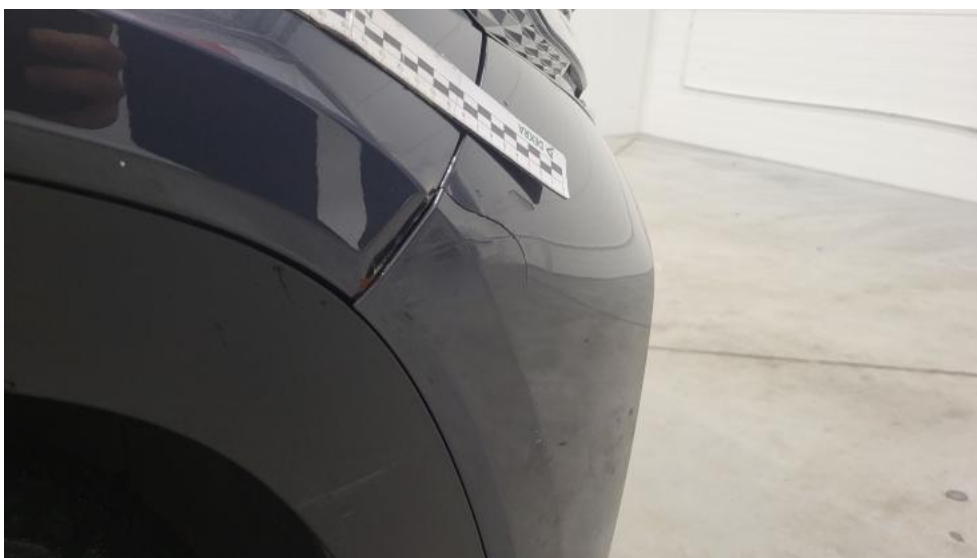
Photo 46.
Zderzak - Pęknięcie/rozerwanie 2

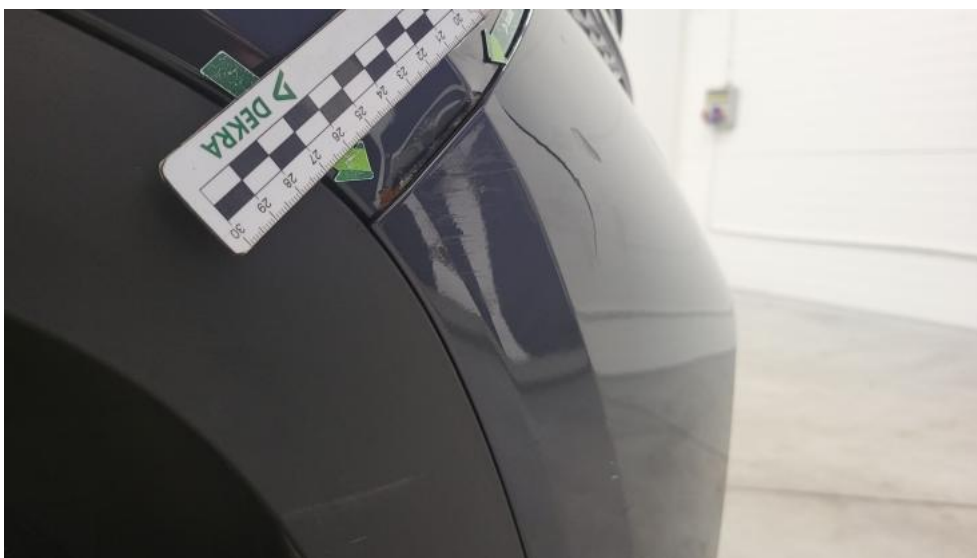
Photo 48.
Błotnik przedni P - Wgniecenie/odkształcenie 1

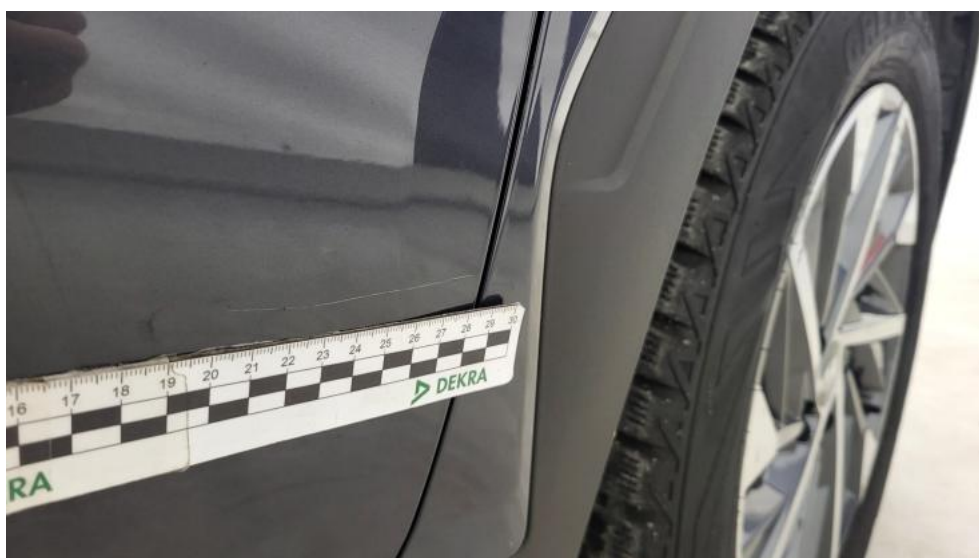
Photo 50.

Drzwi przednie P - Rysa/odprysk 1

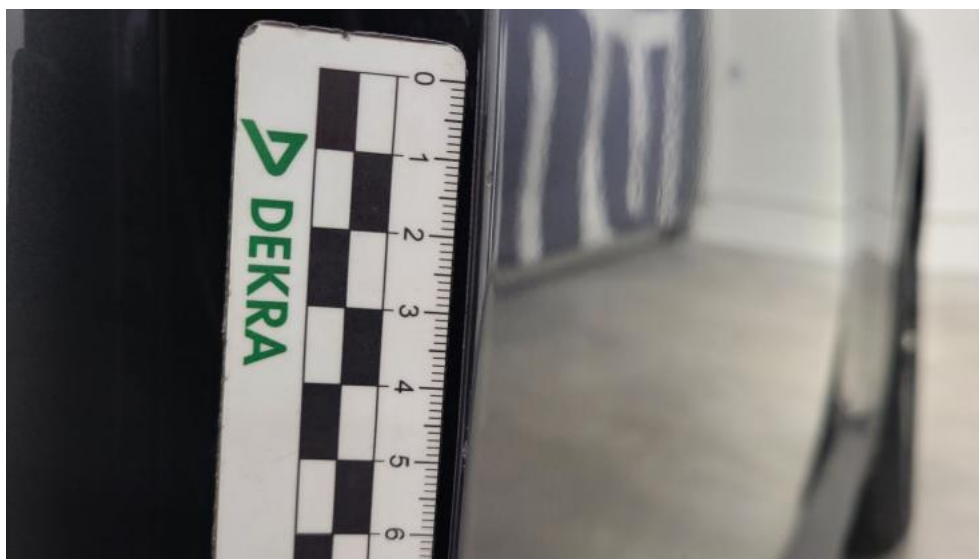
Photo 51.
Drzwi przednie P - Rysa/odprysk 2

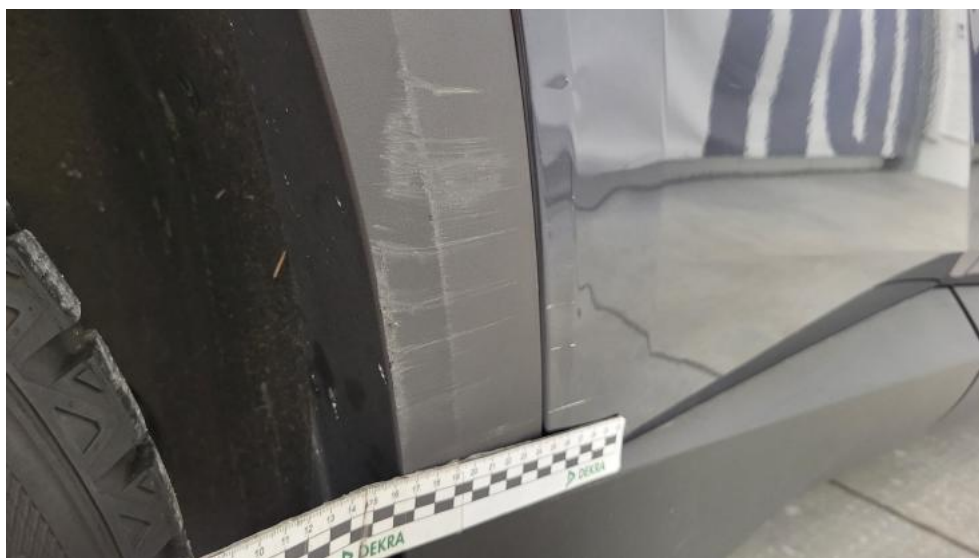
Photo 52.
Drzwi tylne P - Rysa/odprysk 1

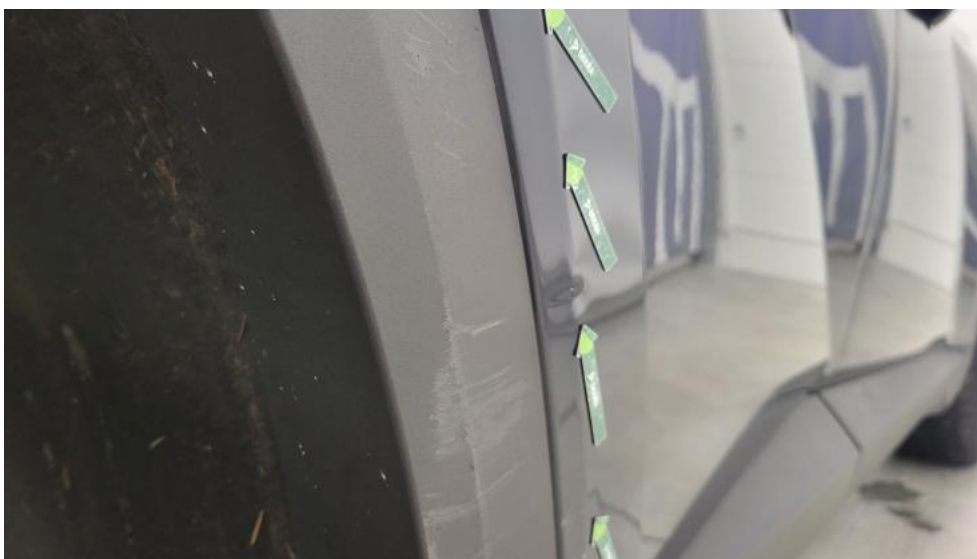
Photo 53.
Drzwi tylne P - Wgniecenie/odkształcenie 1

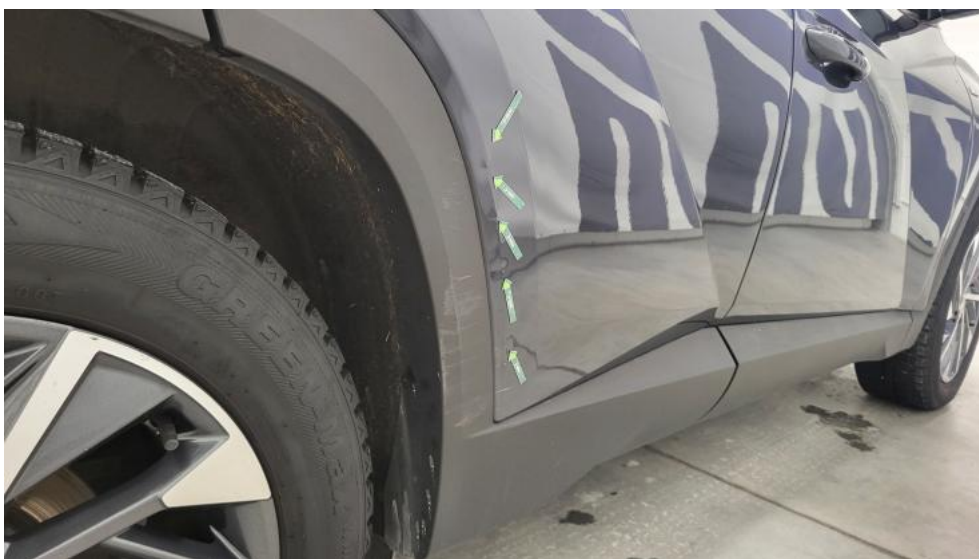
Photo 55.
Drzwi tylne P() - Wgniecenie/odkształcenie 3

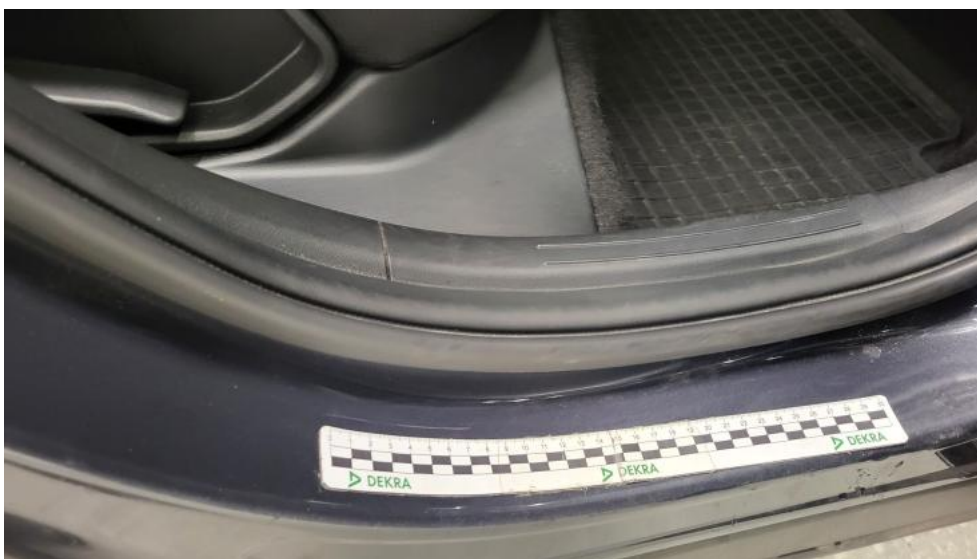
Photo 57.
Próg P - Rysa/odprysk 1

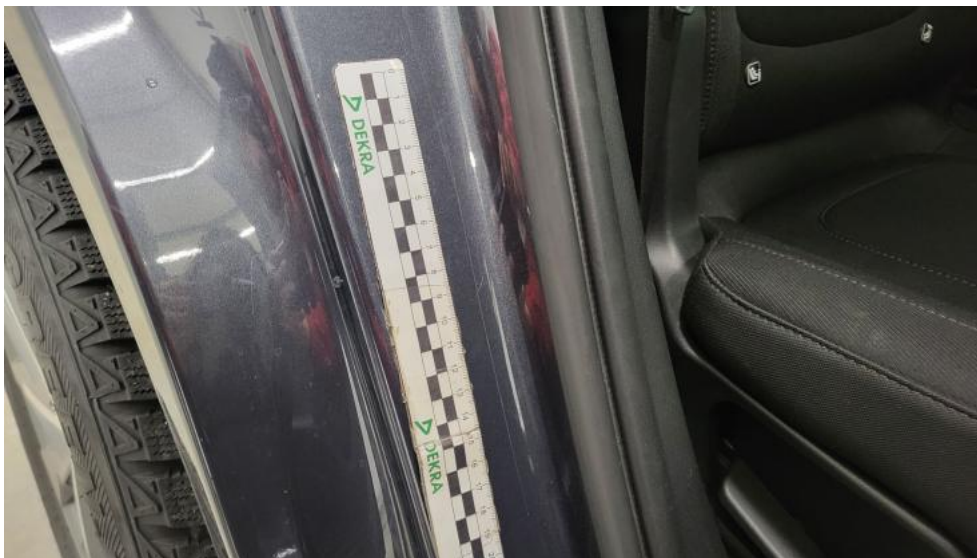
Photo 59.

Błotnik tylny P / Ściana boczna P - Rysa/odprysk 2

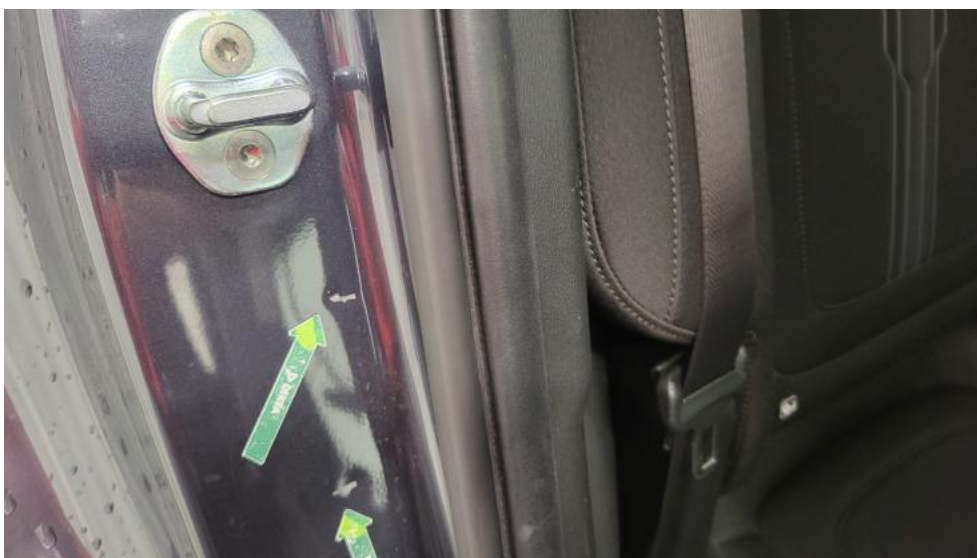
Photo 60.

Błotnik tylny P / Ściana boczna P - Wgniecenie/odkształcenie 1

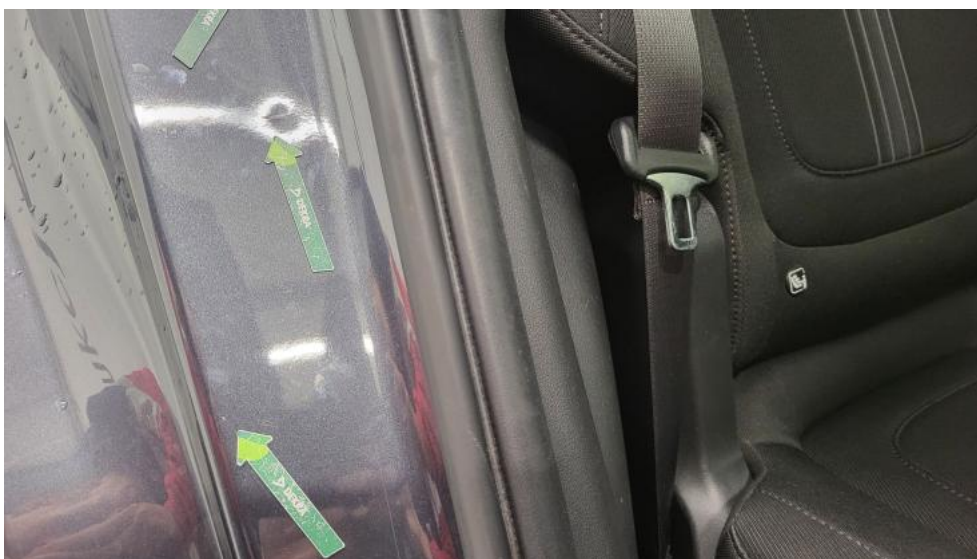
Photo 61.

Błotnik tylny P / Ściana boczna P - Wgniecenie/odkształcenie 2

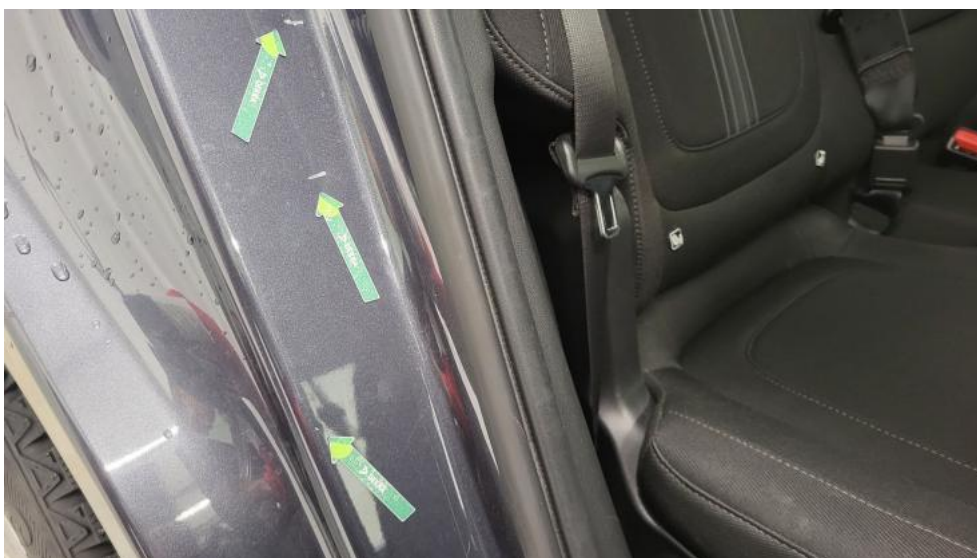
Photo 62.

Błotnik tylny P / Ściana boczna P() - Wgniecenie/odkształcenie 3

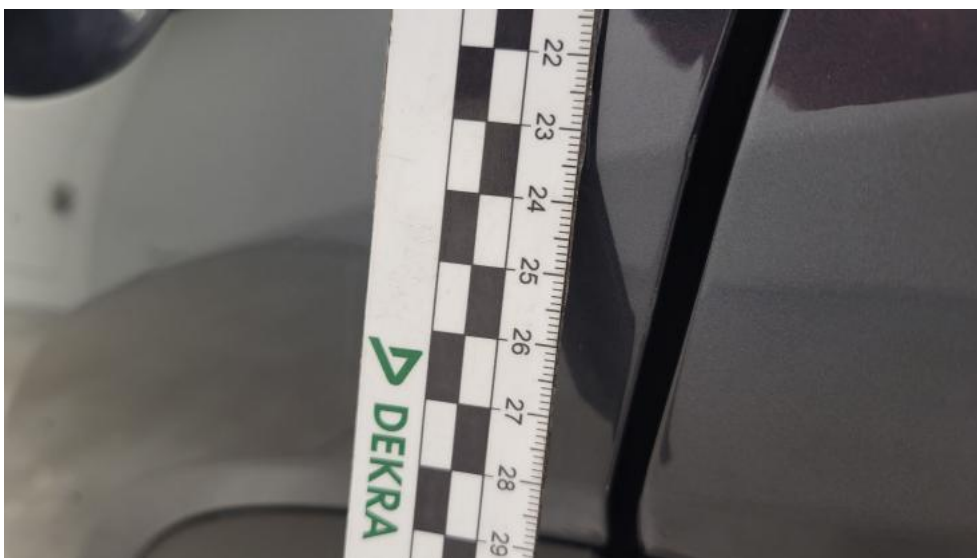
Photo 64.
Drzwi tylne L - Rysa/odprysk 1
