DEKRA's commission No. : PKOL(W)/LODZ/81909/26/09/01  
commission/ damage No. : 24/028962  
Date of commission: 01-09-2026

| Manufacturer | MERCEDES-BENZ |
| Model | V Klasa 14-19 |
| VIN / serial number | WDF44781313295887 |

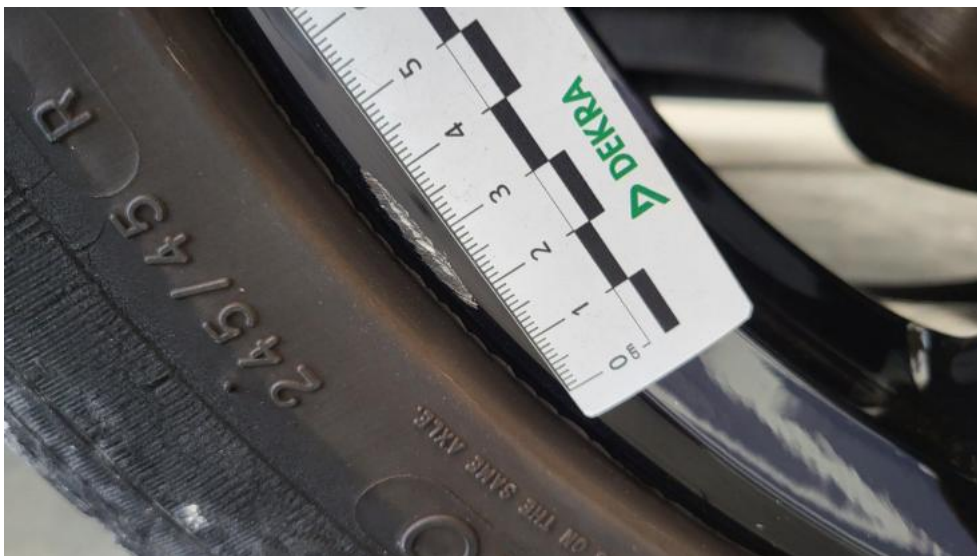
**Photo 50.**

Felga aluminiowa przednia P - Rysa/odprysk 1

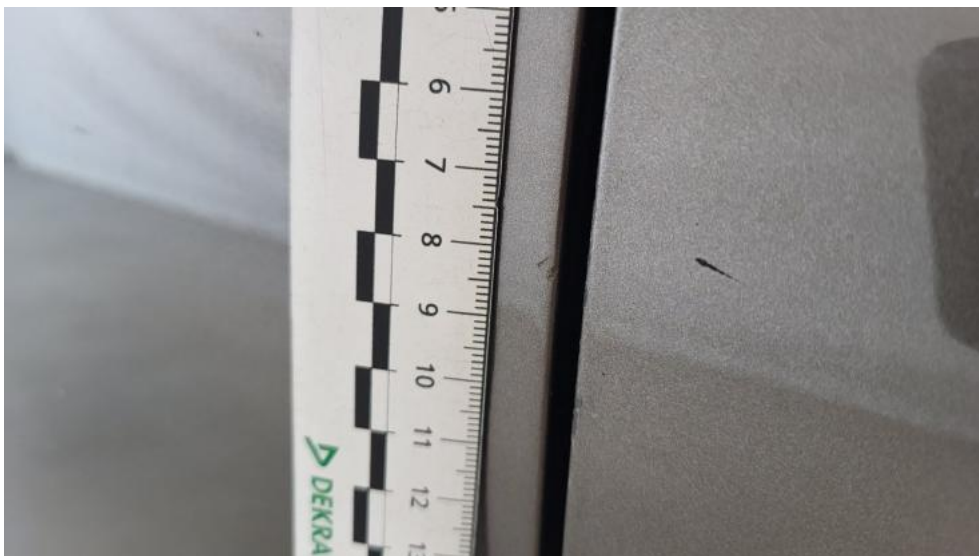
**Photo 56.**

Drzwi tylne P - Rysa/odprysk 1

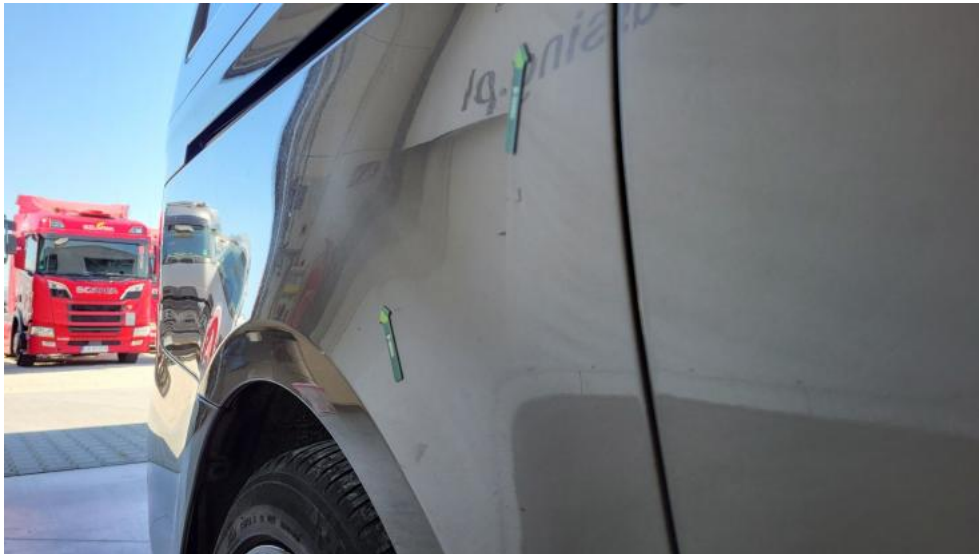
**Photo 61.**

Błotnik tylny P / Ściana boczna P - Wgniecenie/odkształcenie 1

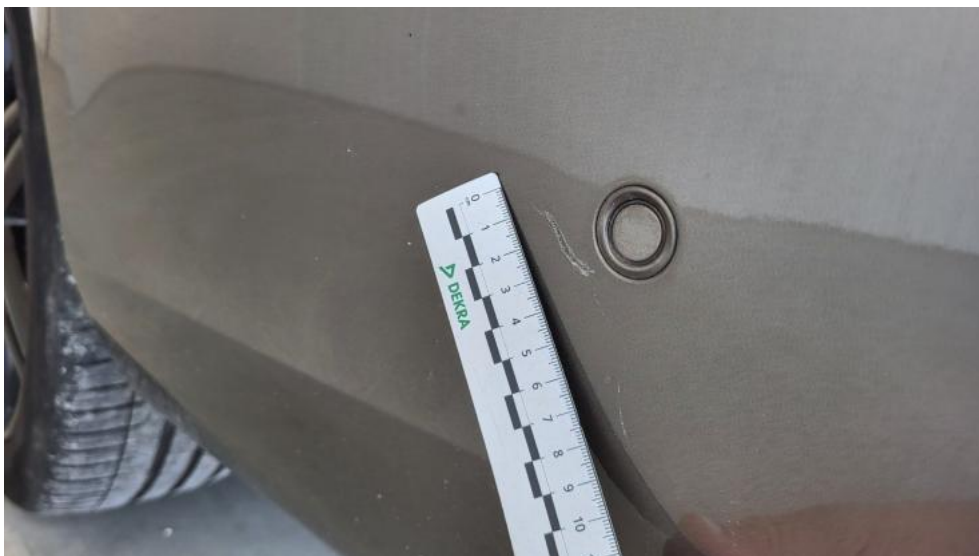
**Photo 62.**

Zderzak tylny - Rysa/odprysk 1

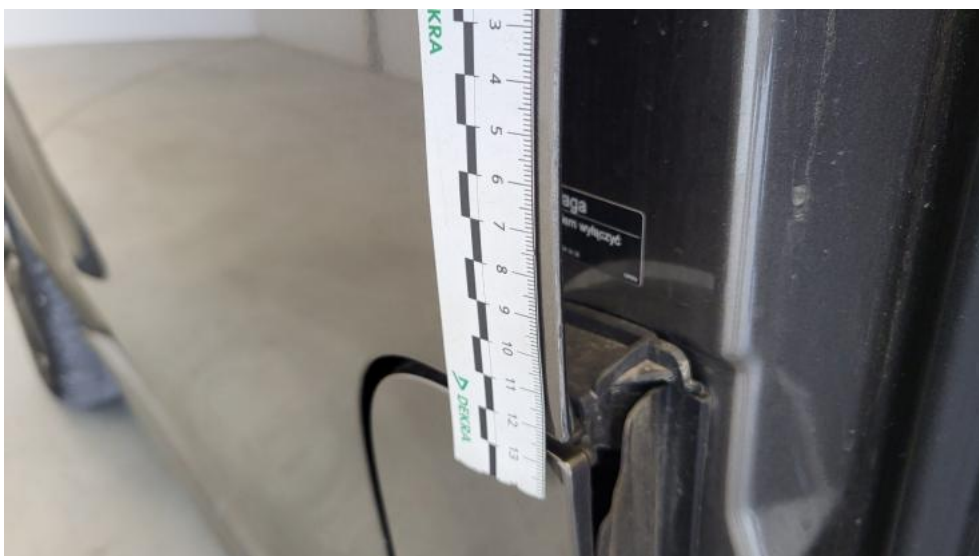
**Photo 64.**

Drzwi przed L - Rysa/odprysk 1

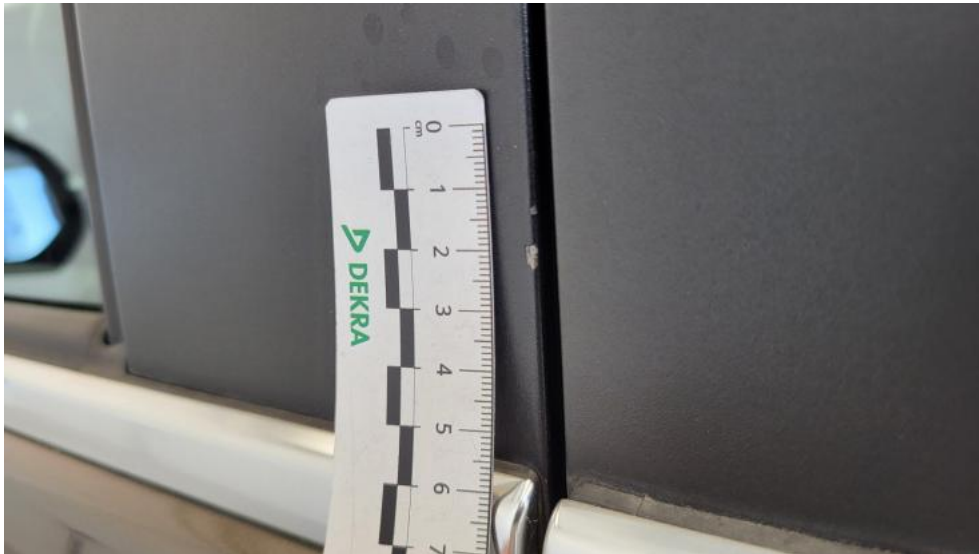
**Photo 65.**

Drzwi przed L - Rysa/odprysk 2

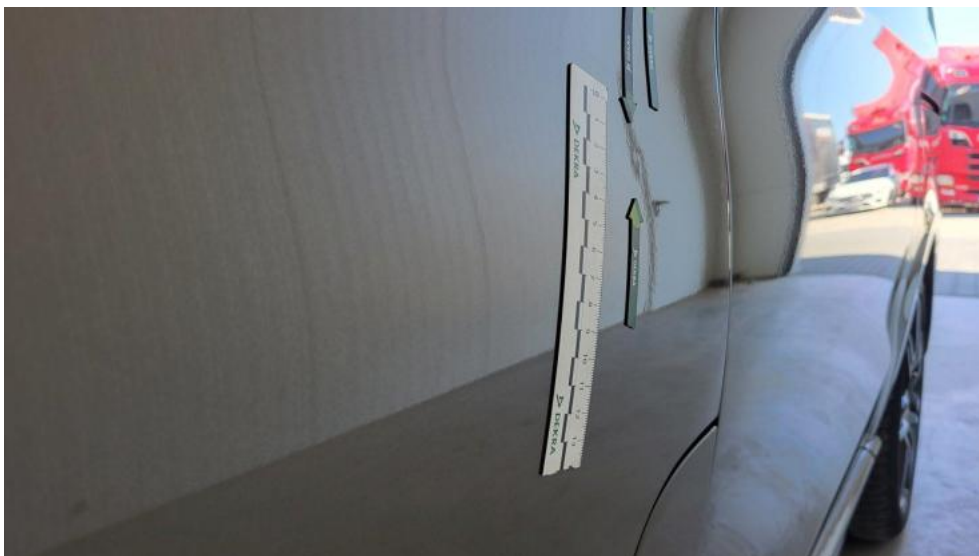
**Photo 66.**

Drzwi przed L - Wgniecenie/odkształcenie 1

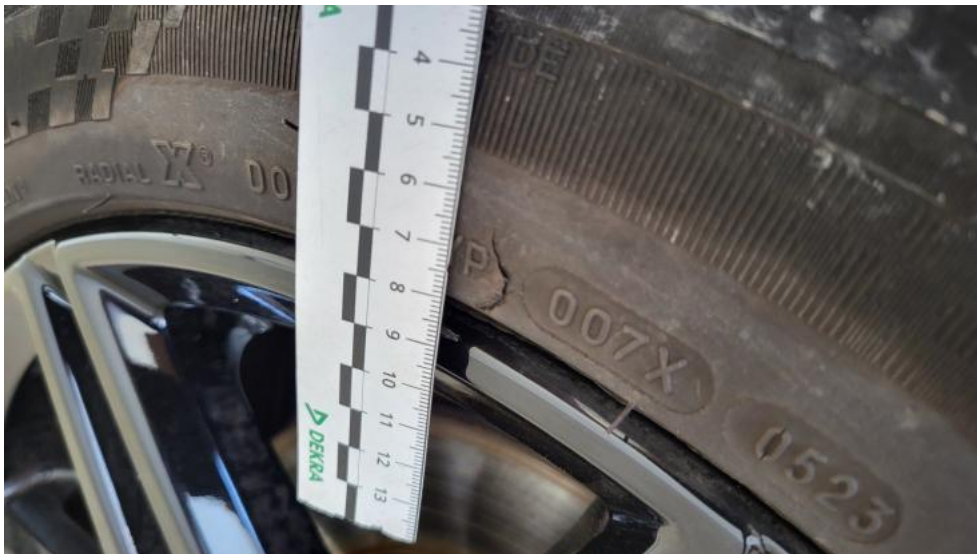
**Photo 71.**

Opona przednia L - Pęknięcie/rozerwanie 1

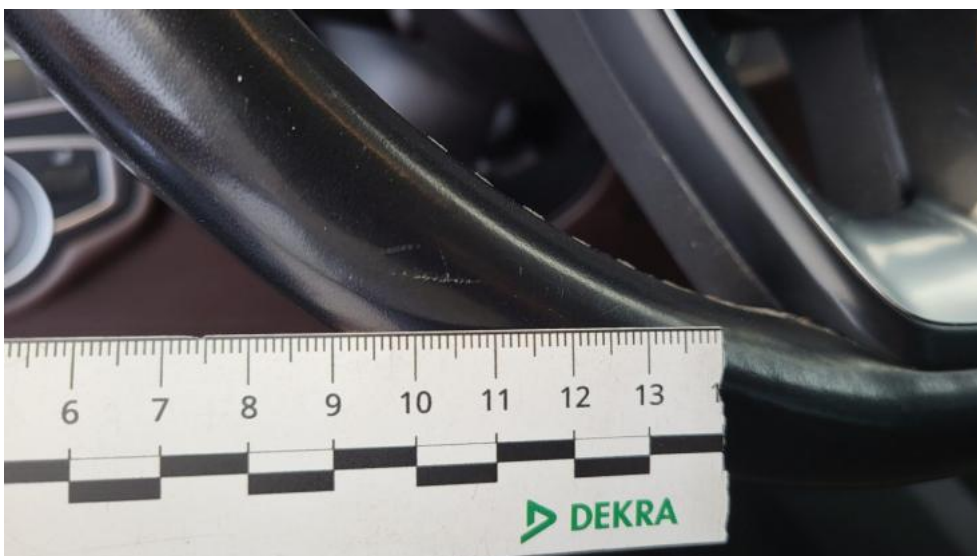
**Photo 72.**

Koło kierownicy - Rysa/odprysk 1

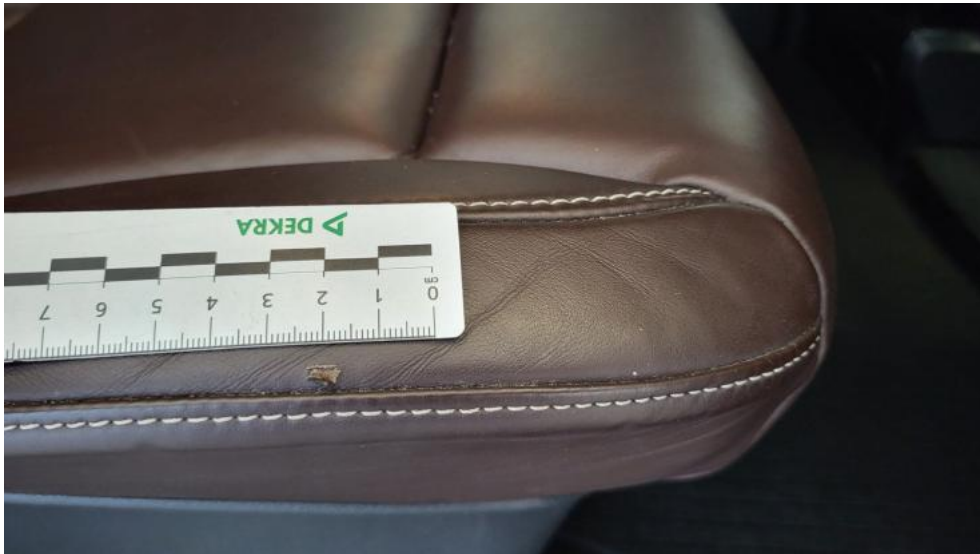
**Photo 75.**

Kanapa tyl. - Pęknięcie/rozerwanie 1

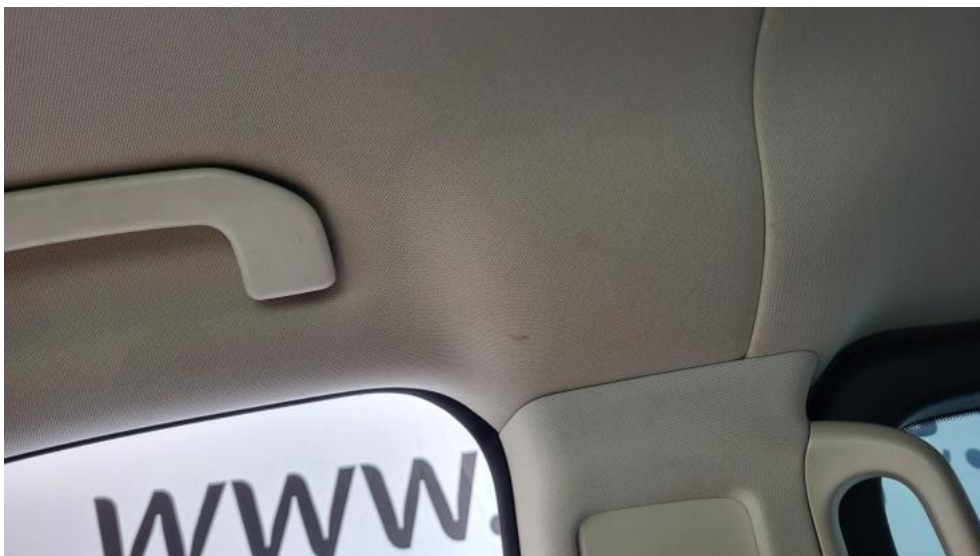
**Photo 76.**

Podsufitka - Inne 1
