DEKRA's commission No. : PKOL(W)/LODZ/70073/26/07/28  
commission/ damage No. : PS24/00708  
Date of commission: 28-07-2026

| Manufacturer | VOLKSWAGEN |
| Type / version | Multivan 6.1 2.0 TDI L1 Highline 4Motion DSG |
| Registration /record No. | CB081RG |

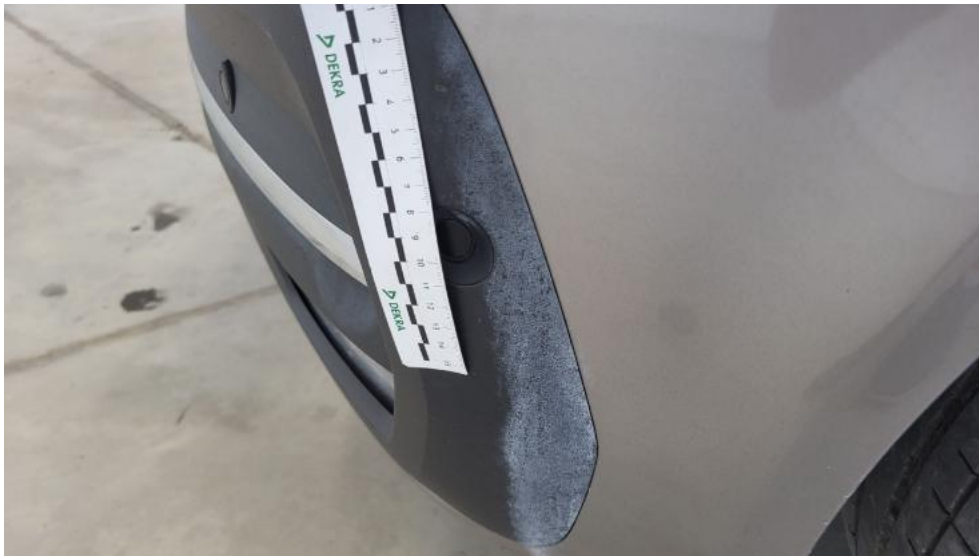
**Photo 45.**

Listwa śr zderzaka przedniego - Inne 1

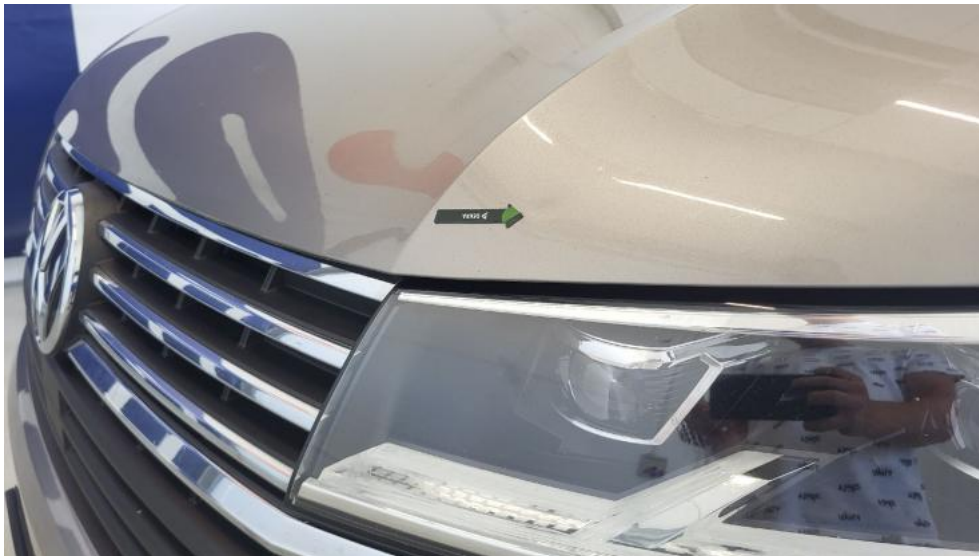
**Photo 47.**

Pokrywa komory silnika - Wgniecenie/odkształcenie 1

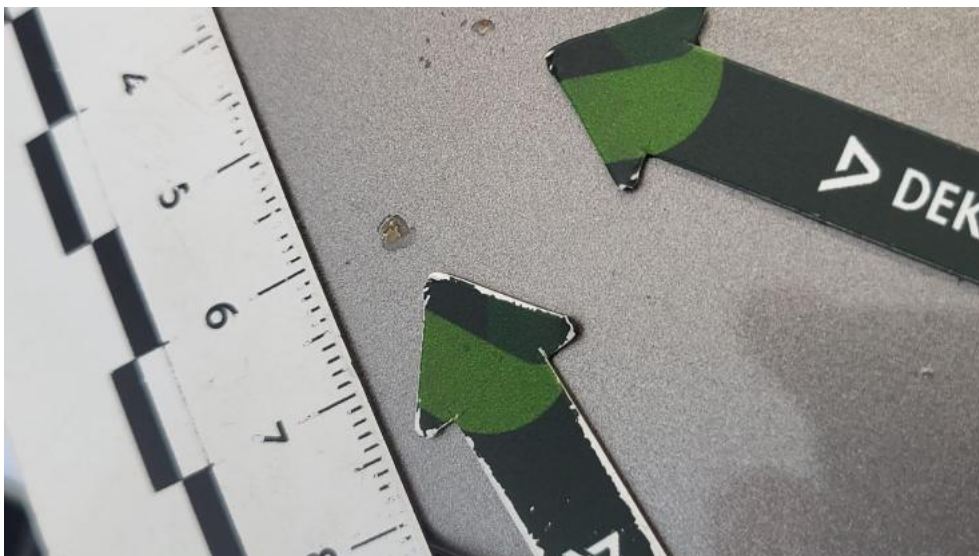
**Photo 48.**

Pokrywa komory silnika - Inne 1

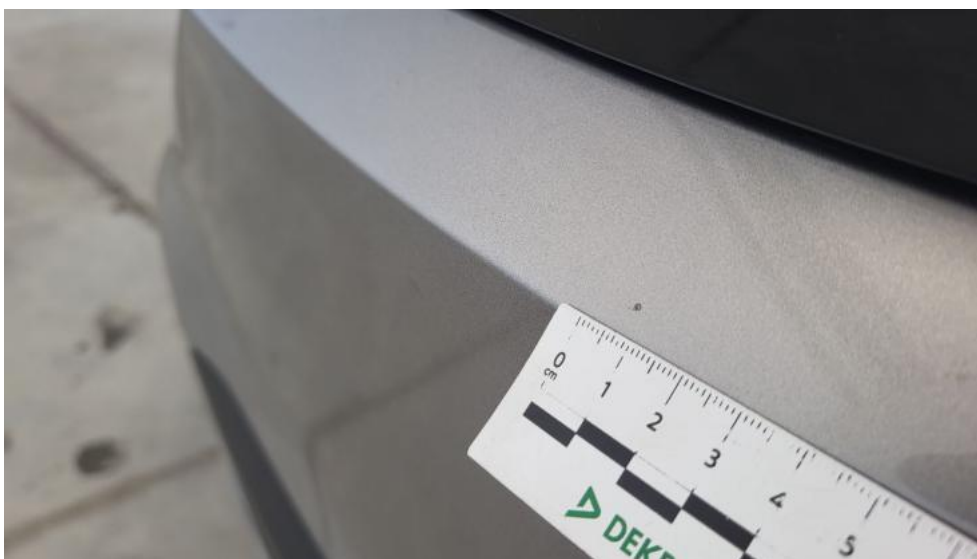
**Photo 49.**

Zderzak - Rysa/odprysk 1

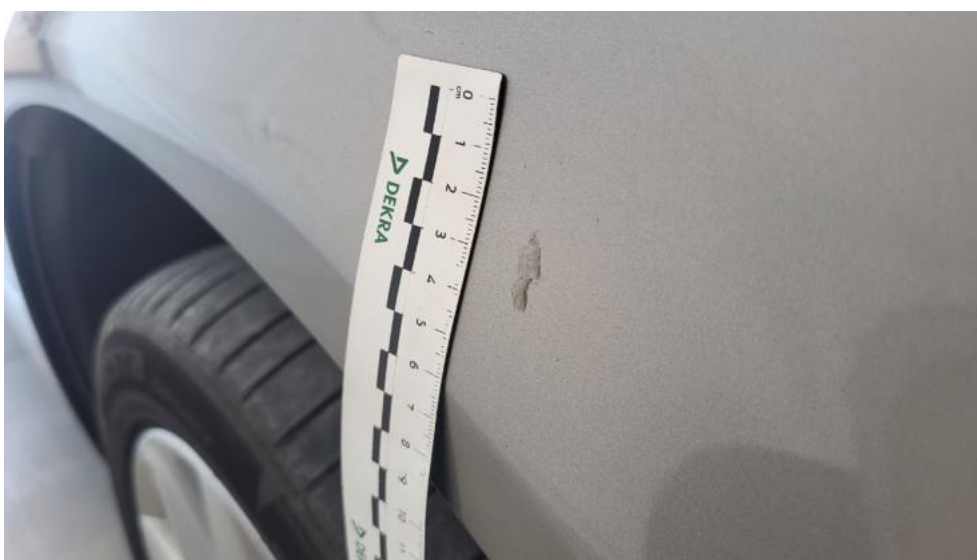
**Photo 50.**

Błotnik przedni P - Inne 1

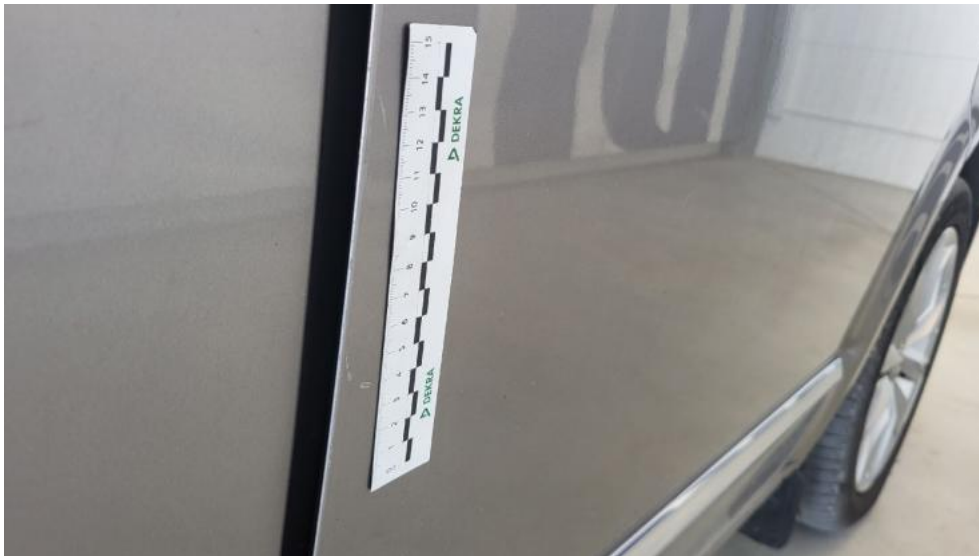
**Photo 53.**

Drzwi przednie P - Rysa/odprysk 1

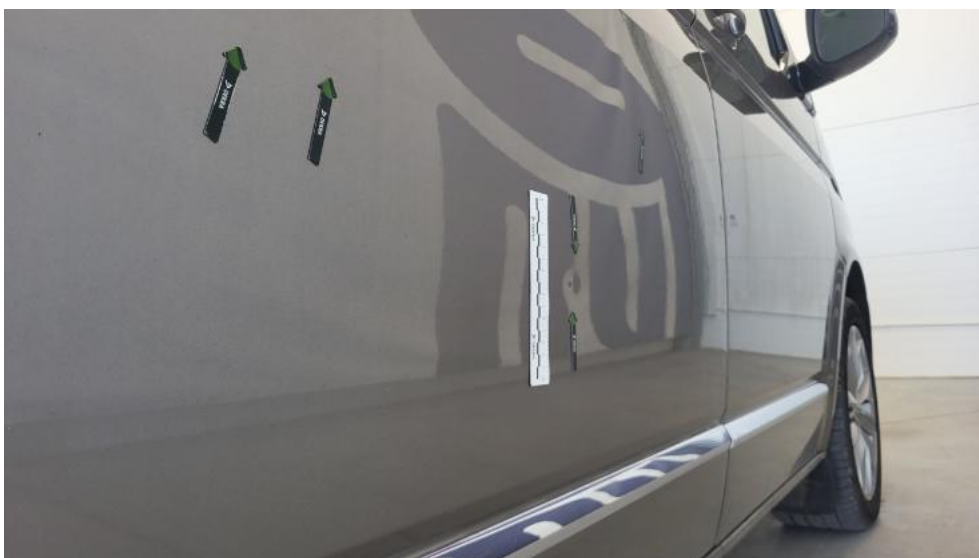
**Photo 54.**

Drzwi tylne P - Wgniecenie/odkształcenie 1

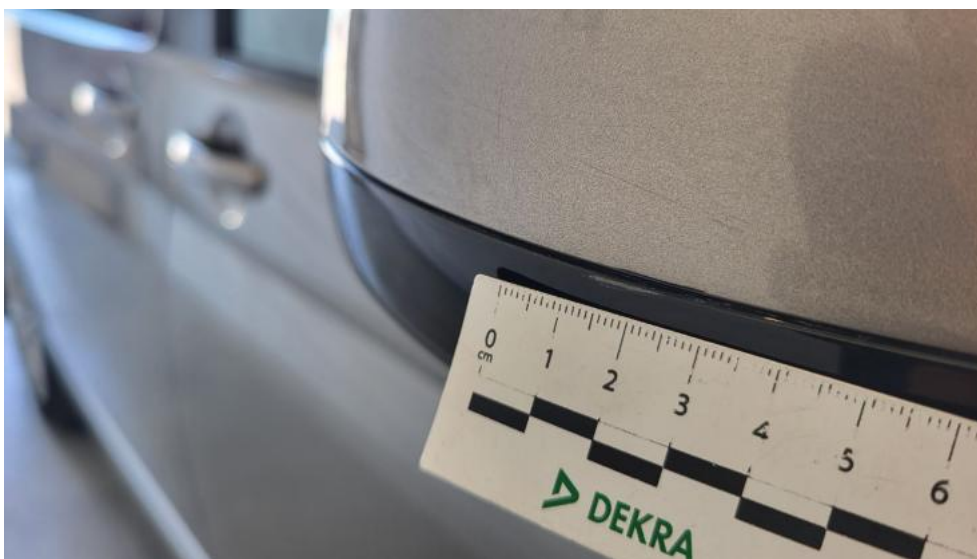
**Photo 55.**

Lusterko zew P - Rysa/odprysk 1

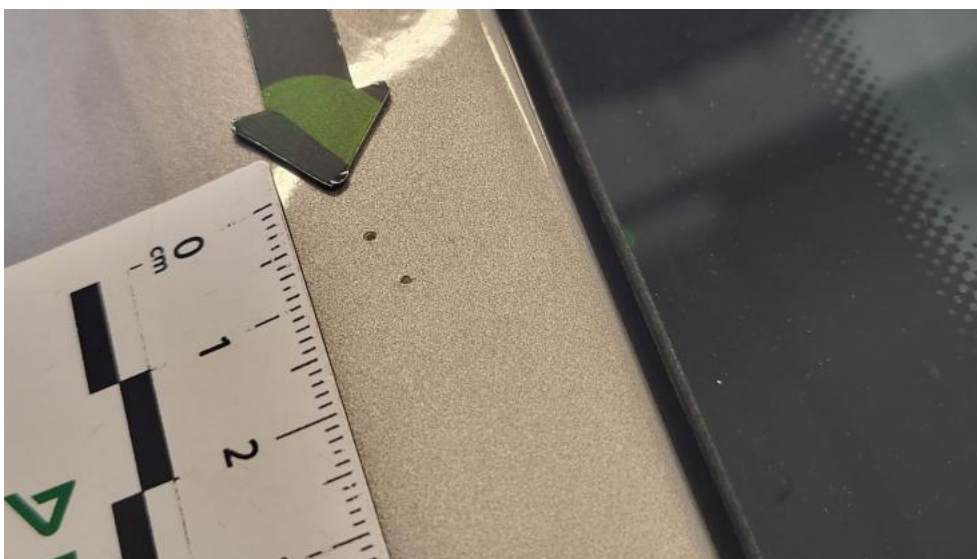
**Photo 57.**

Słupek przedni P - Inne 1

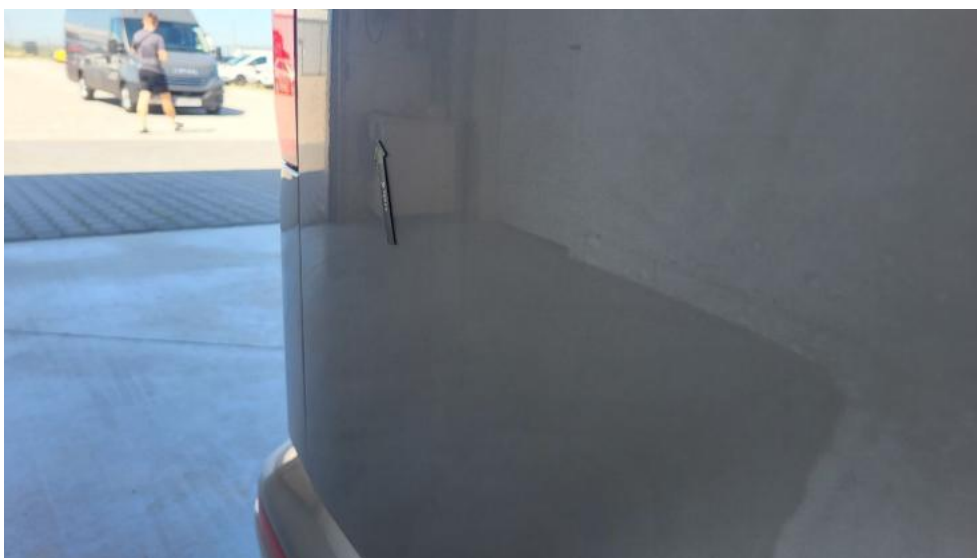
**Photo 58.**

Łotnik tylny P / Ściana boczna P - Wgniecenie/odkształcenie 1

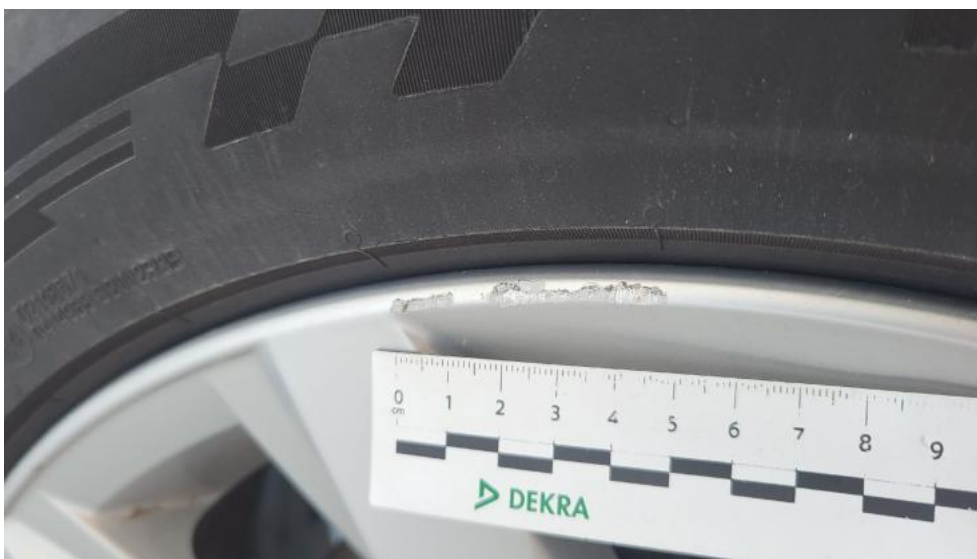
**Photo 59.**

Felga aluminiowa tylna P - Rysa/odprysk 1

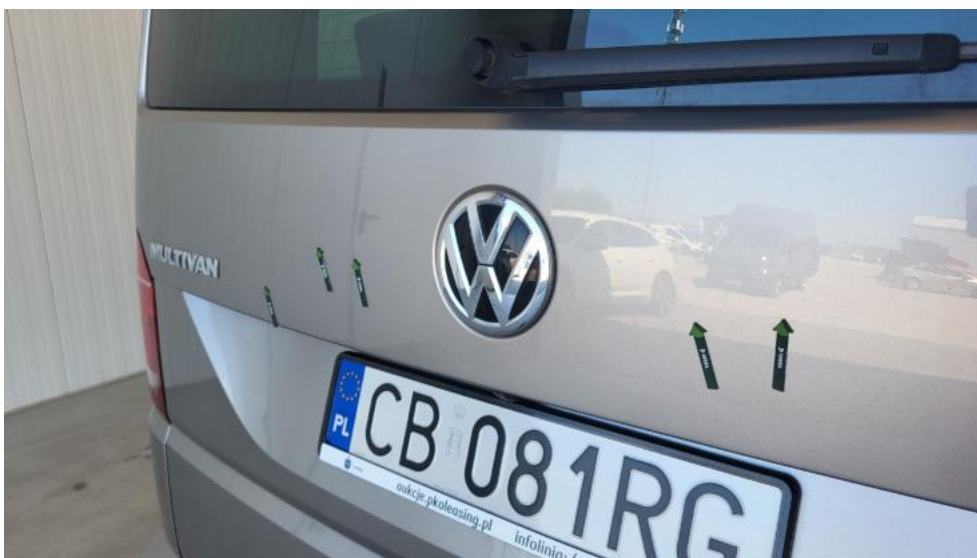
**Photo 60.**

Pokrywy bagażnika - Wgniecenie/odkształcenie 1

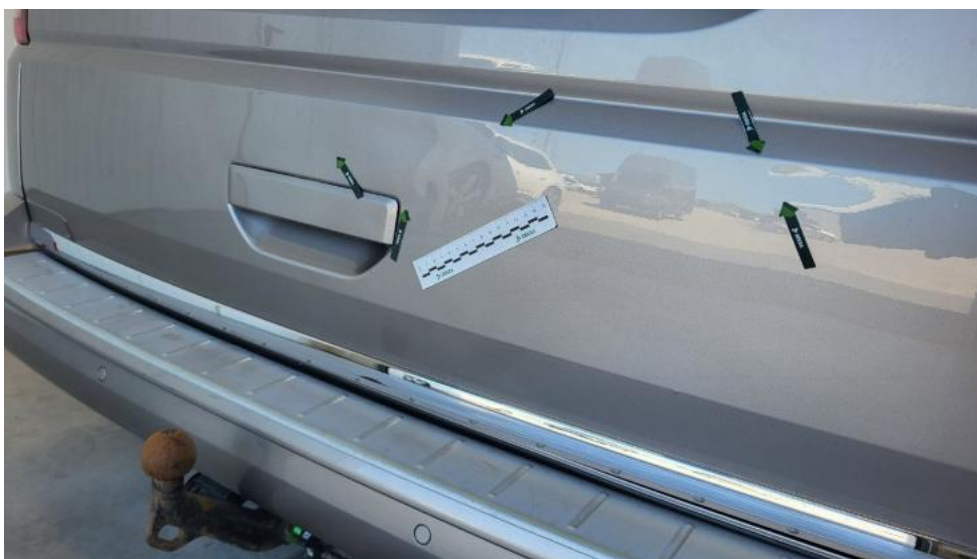
**Photo 61.**

Pokrywy bagażnika - Wgniecenie/odkształcenie 2

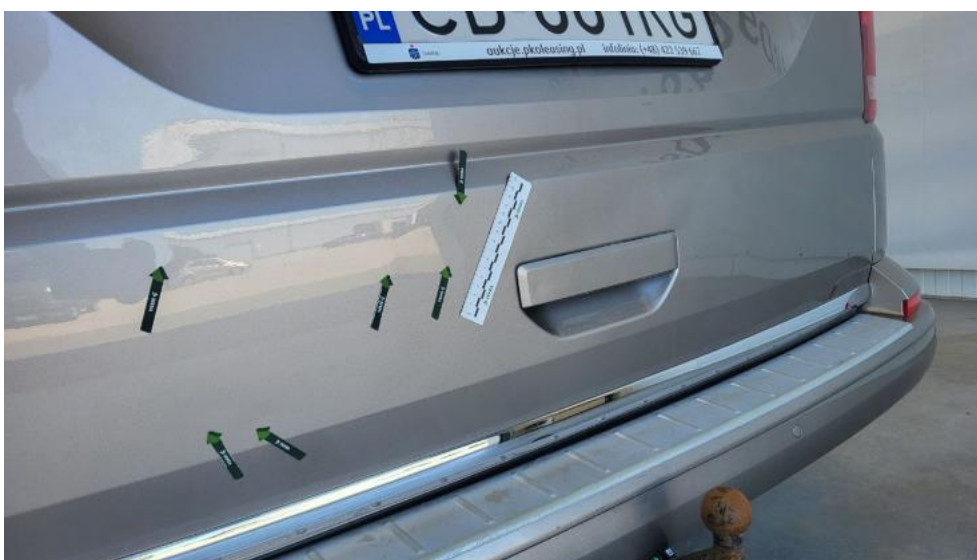
**Photo 62.**

Pokrywy bagażnika() - Wgniecenie/odkształcenie 3

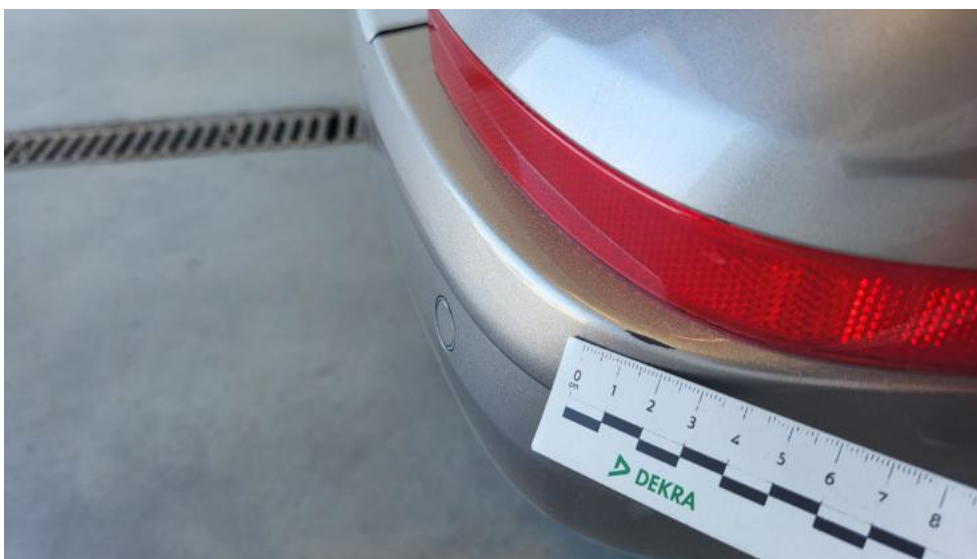
**Photo 63.**

Zderzak tylny - Rysa/odprysk 1

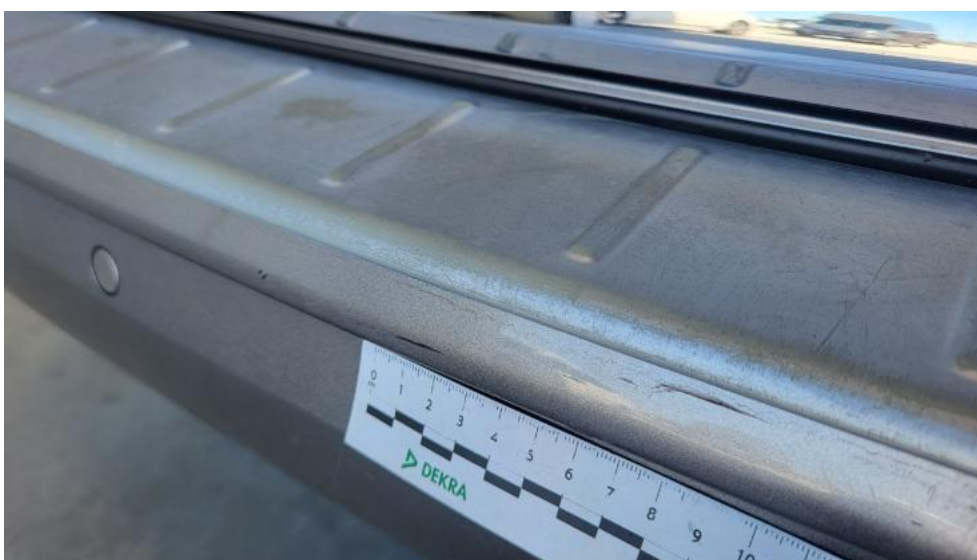
**Photo 64.**

Zderzak tylny - Rysa/odprysk 2

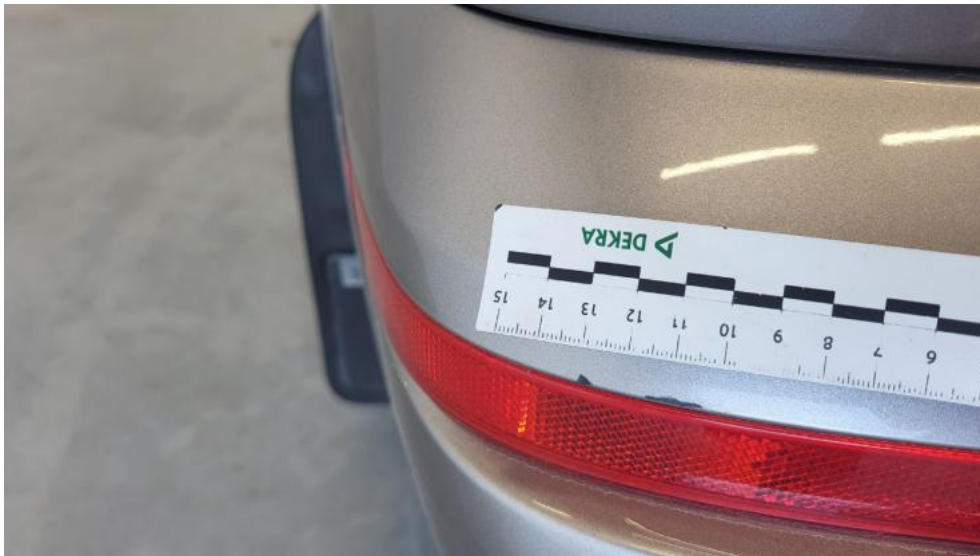
**Photo 65.**

Zderzak tylny() - Rysa/odprysk 3

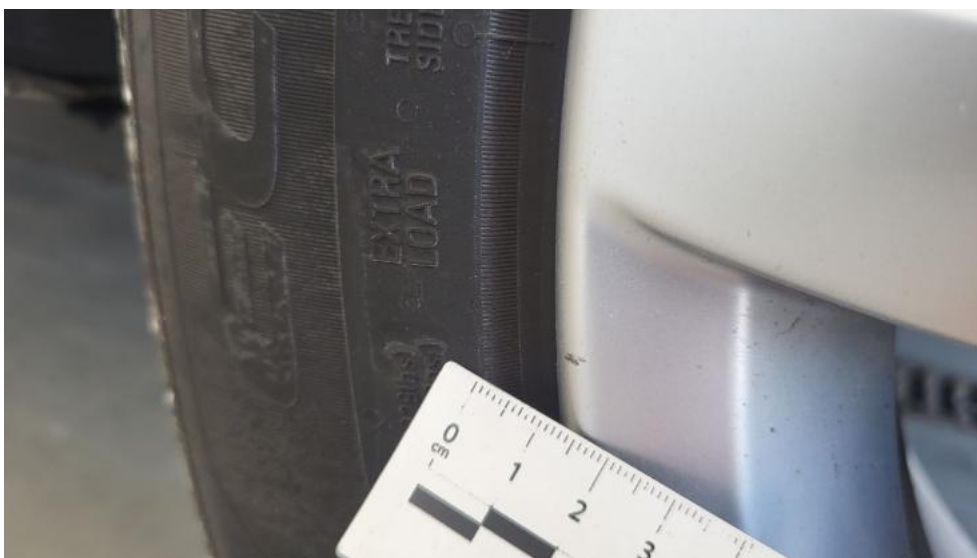
**Photo 68.**

Felga aluminiowa tylna L - Rysa/odprysk 1

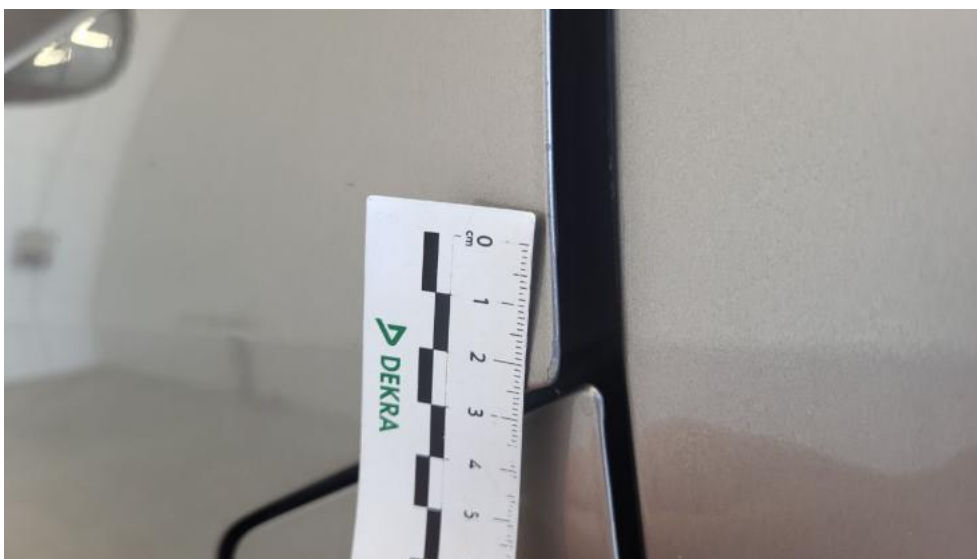
**Photo 69.**

Drzwi przed L - Rysa/odprysk 1

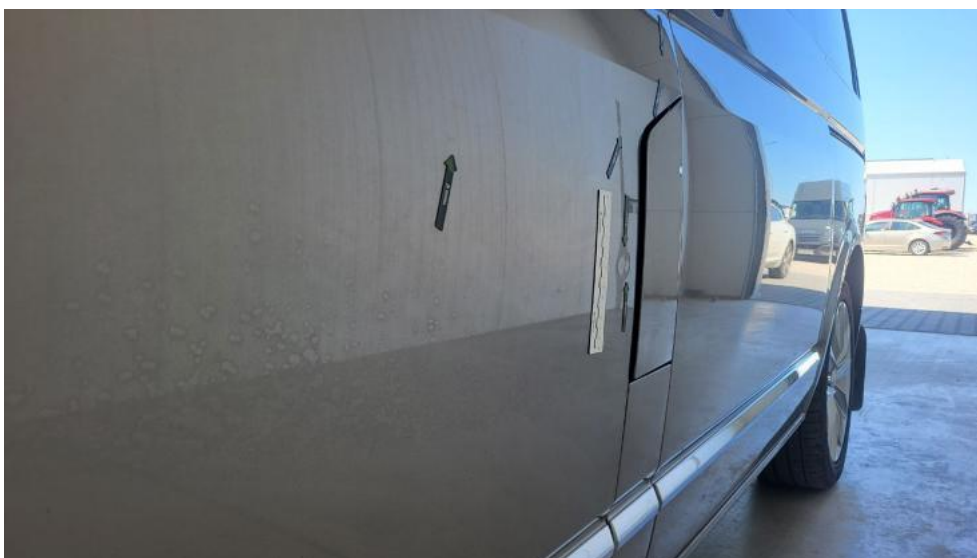
**Photo 70.**

Drzwi przed L - Wgniecenie/odkształcenie 1

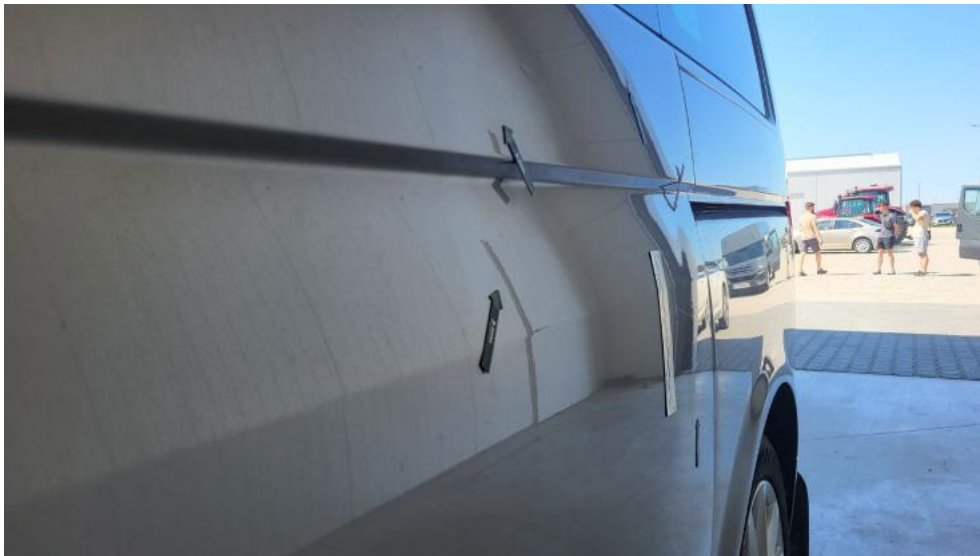
**Photo 71.**

Drzwi tylne L - Wgniecenie/odkształcenie 1

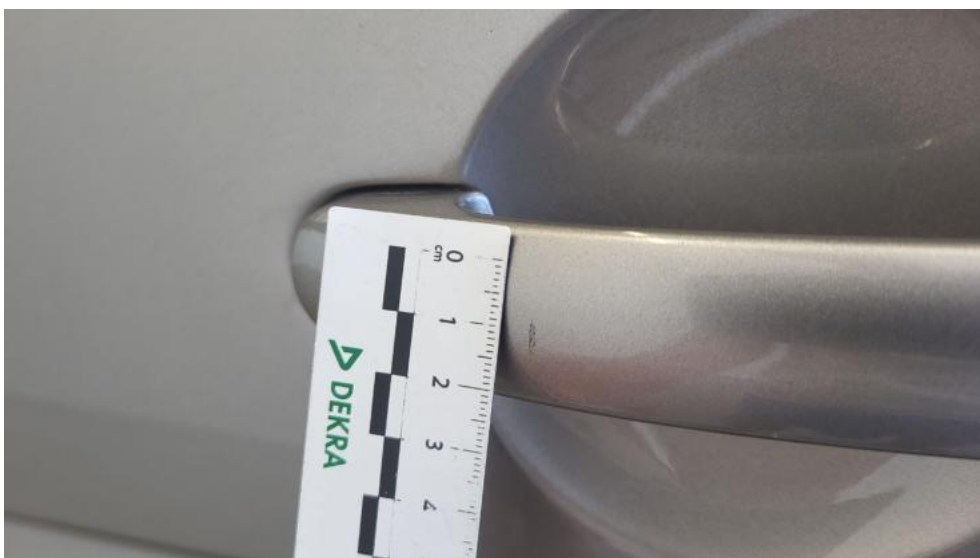
**Photo 72.**

Klamka drzwi prz L - Rysa/odprysk 1

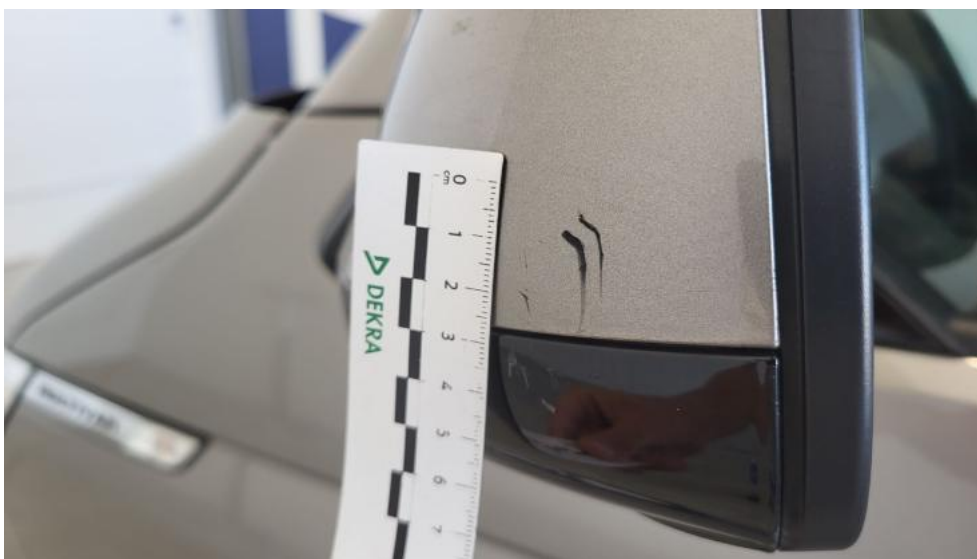
**Photo 73.**

Lusterko zew L - Rysa/odprysk 1

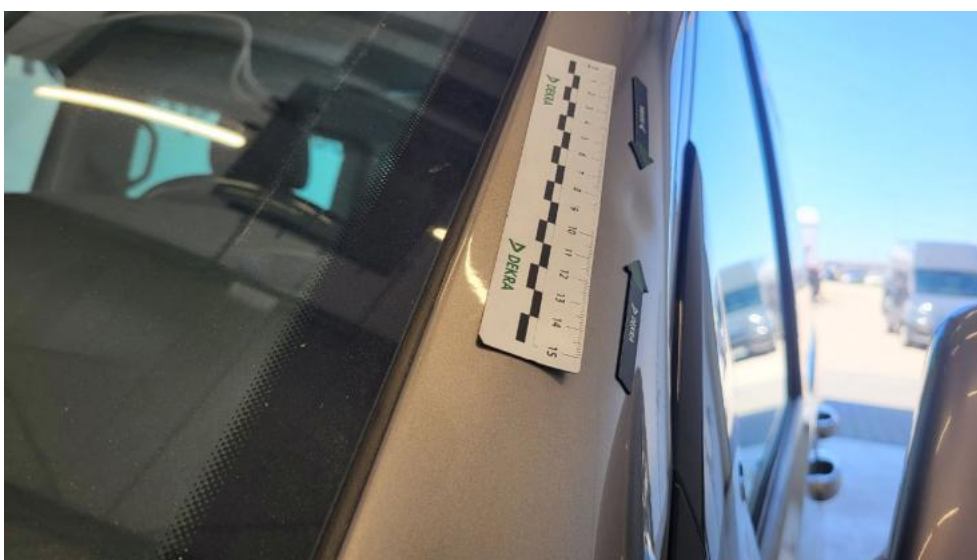
**Photo 74.**

Słupek przedni L - Wgniecenie/odkształcenie 1

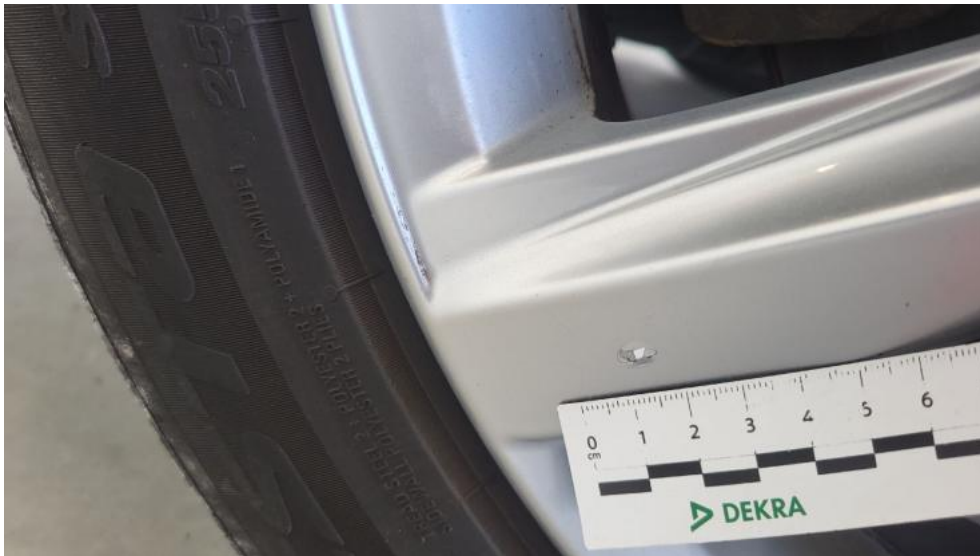
**Photo 75.**

Felga Aluminiowa przednia L - Rysa/odprysk 1

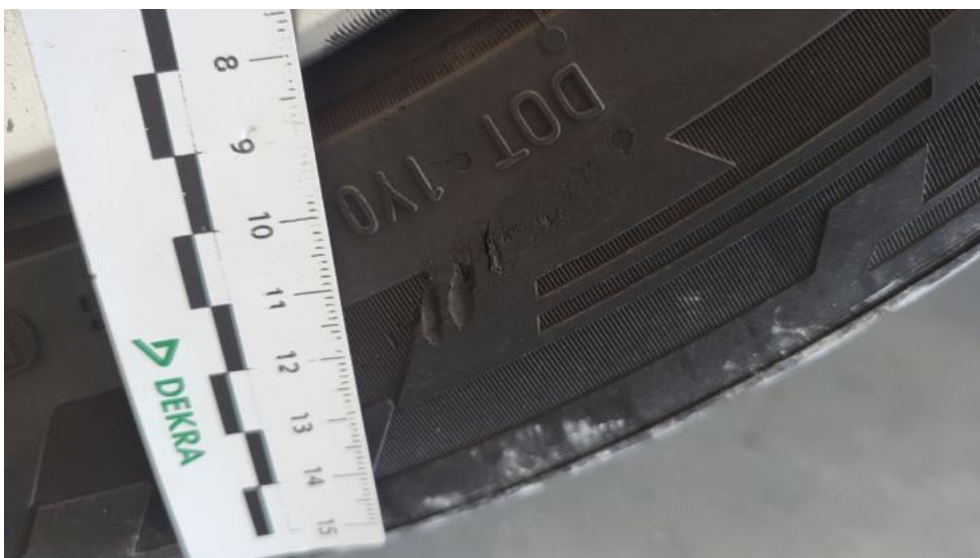
**Photo 76.**

Opona przednia L - Pęknięcie/rozerwanie 1

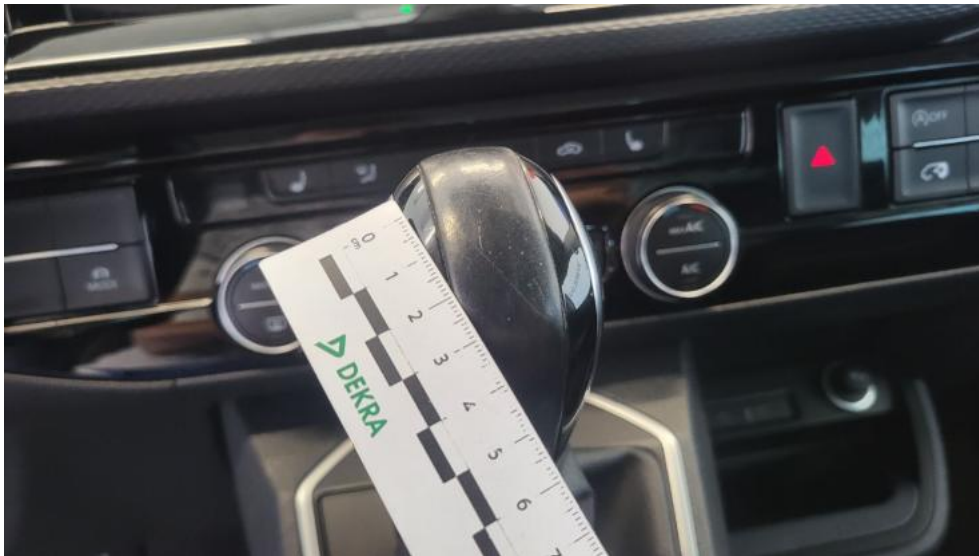
**Photo 77.**

Gałka dźwigni zmiany biegów - Rysa/odprysk 1

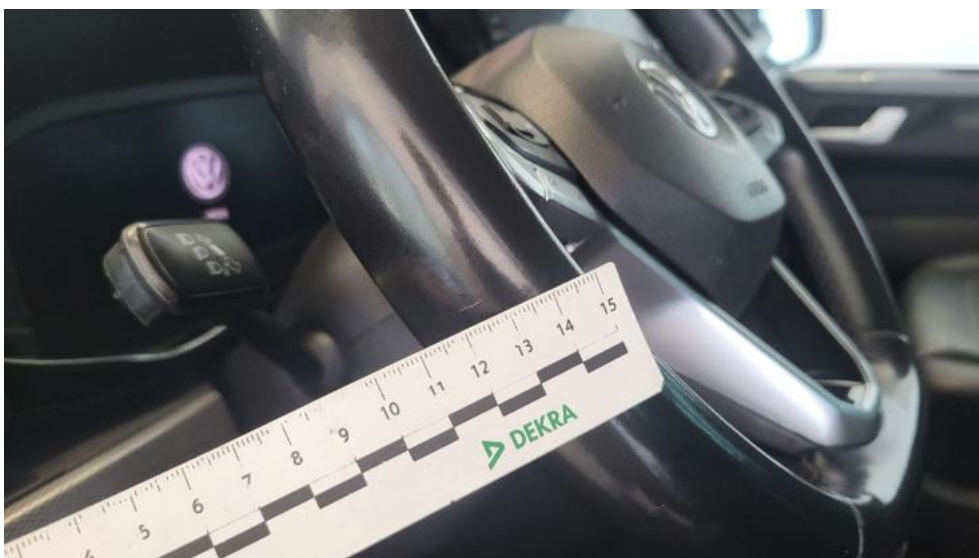
**Photo 78.**

Koło kierownicy - Rysa/odprysk 1

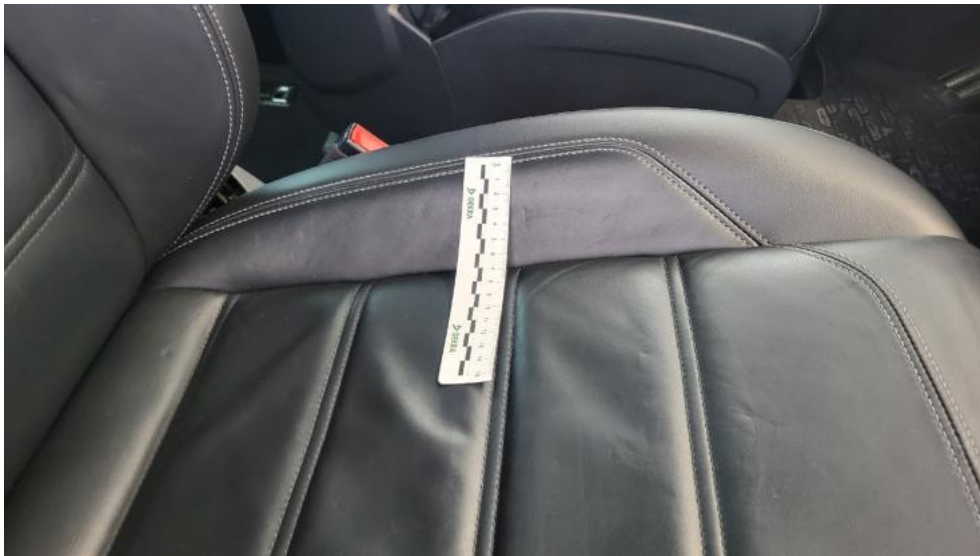
**Photo 79.**

Fotel prz. praw. - Wgniecenie/odkształcenie 1

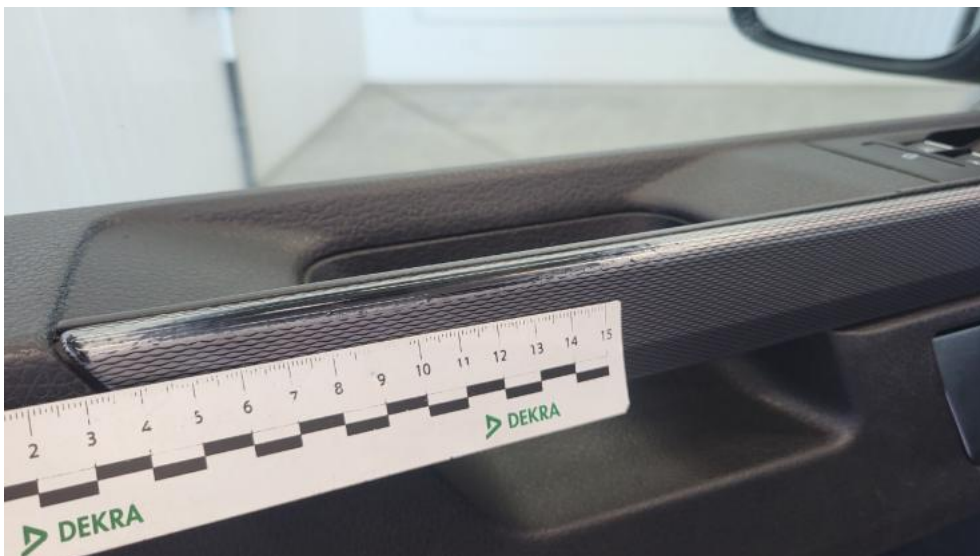
**Photo 80.**

Uchwyt drzwi prze L - Rysa/odprysk 1

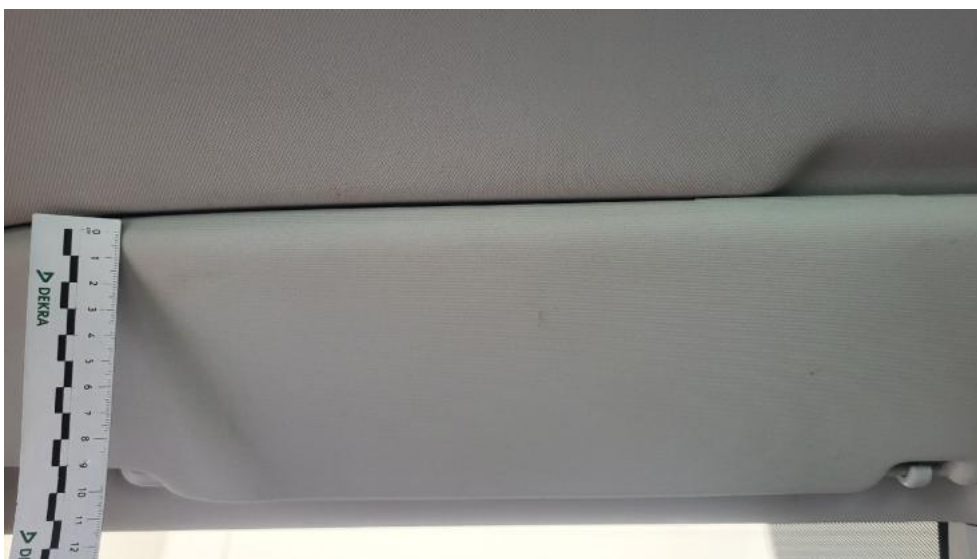
**Photo 81.**

Ośłona p/słoneczna lewa - Inne 1

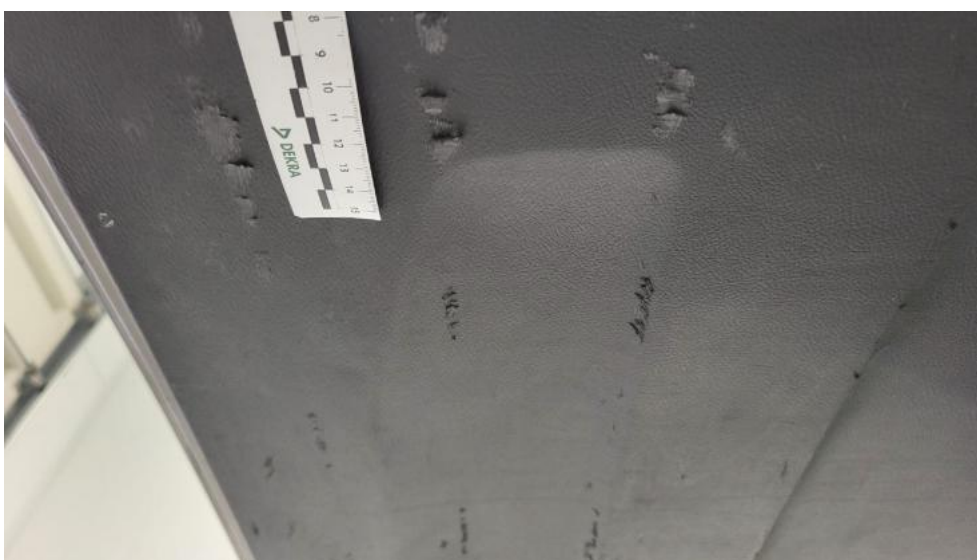
**Photo 82.**

Wykładzina pokrywy tylnej - Rysa/odprysk 1
