DEKRA's commission No. : PKOL(W)/LODZ/85578/26/09/11  
commission/ damage No. : 25/003741  
Date of commission: 11-09-2026

| Model | Mustang Fastback 18-24 |
| Type / version | Mustang 5.0 V8 Mach 1 aut |
| Registration /record No. | W2DZIK2 |

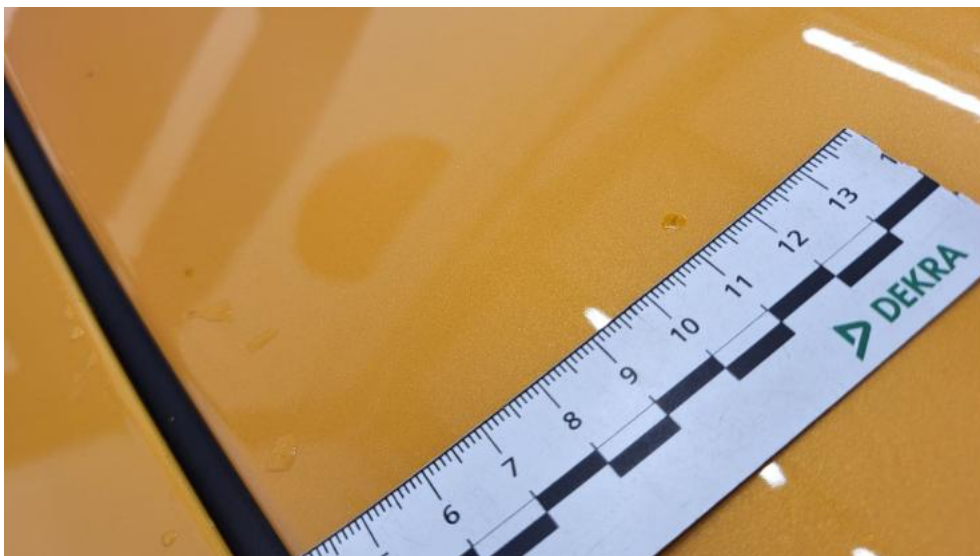
**Photo 38.**  
Pokrywa komory silnika - Rysa/odprysk 1

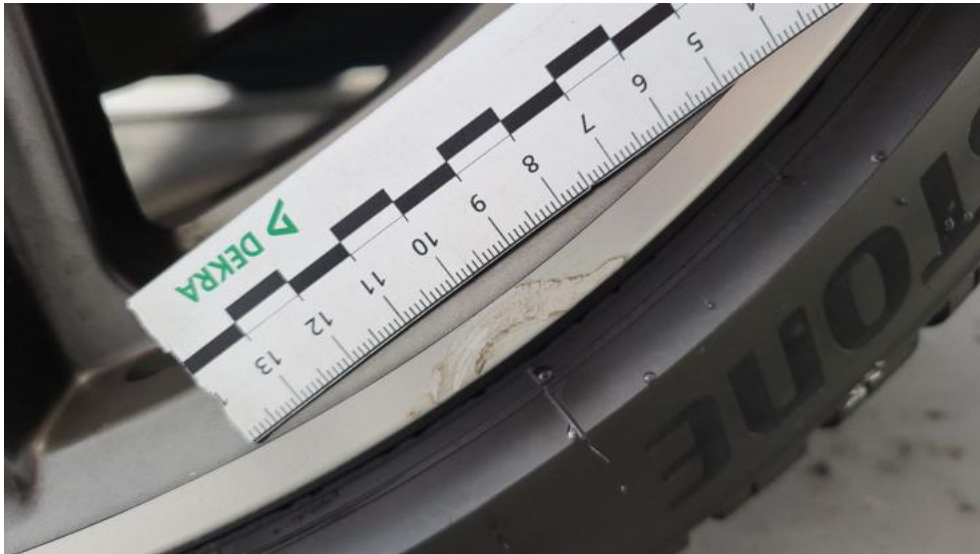
**Photo 39.**

Felga aluminiowa przednia P - Rysa/odprysk 1

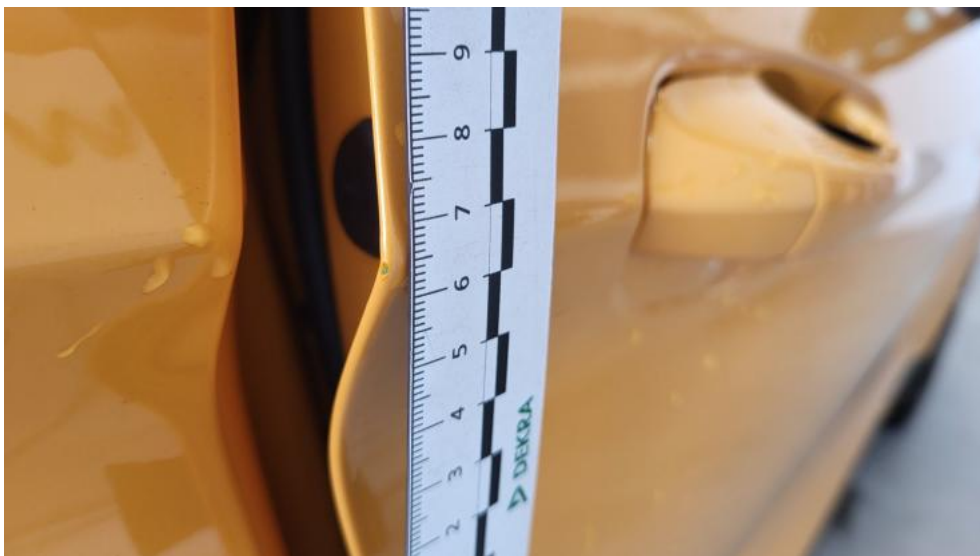
**Photo 40.**

Drzwi przednie P - Rysa/odprysk 1

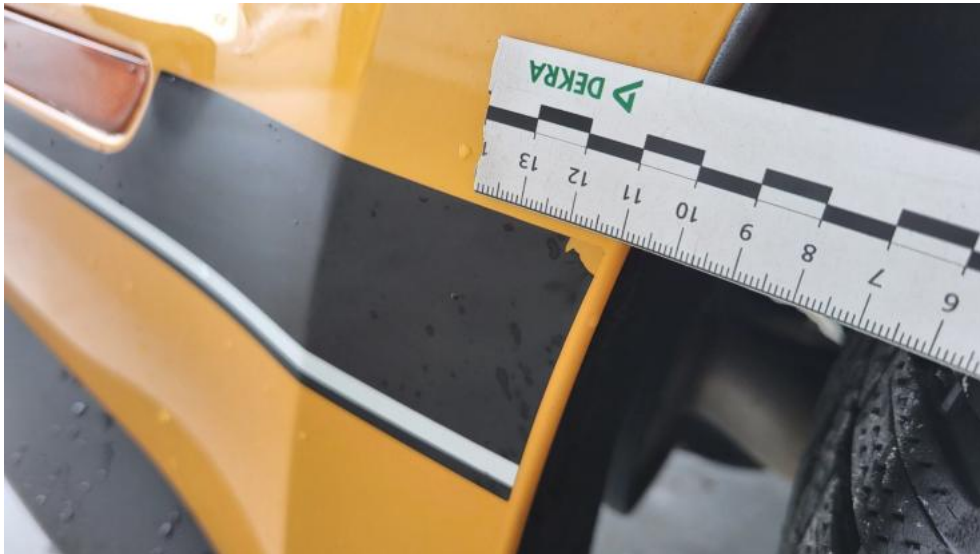
**Photo 41.**  
Zderzak tylny - Inne 1

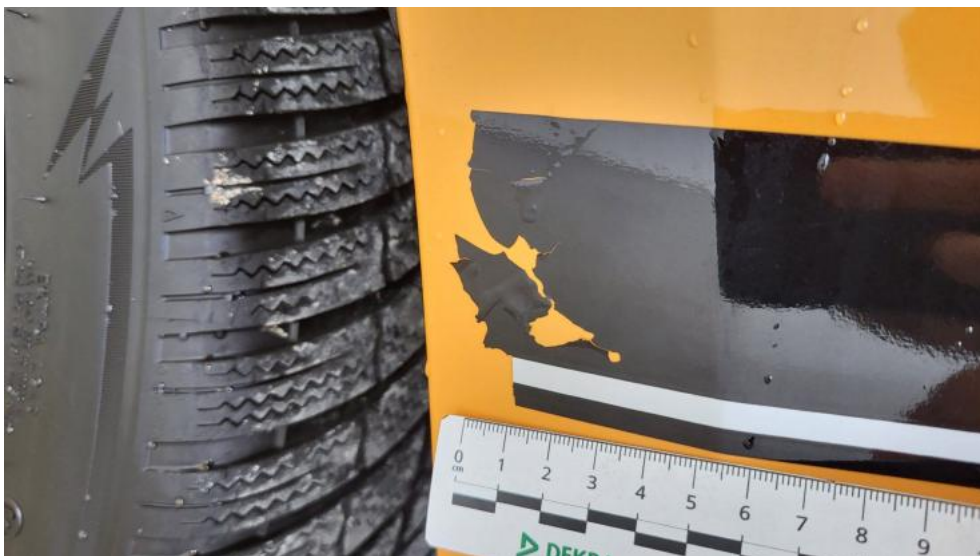
**Photo 42.**  
Zderzak tylny - Inne 2

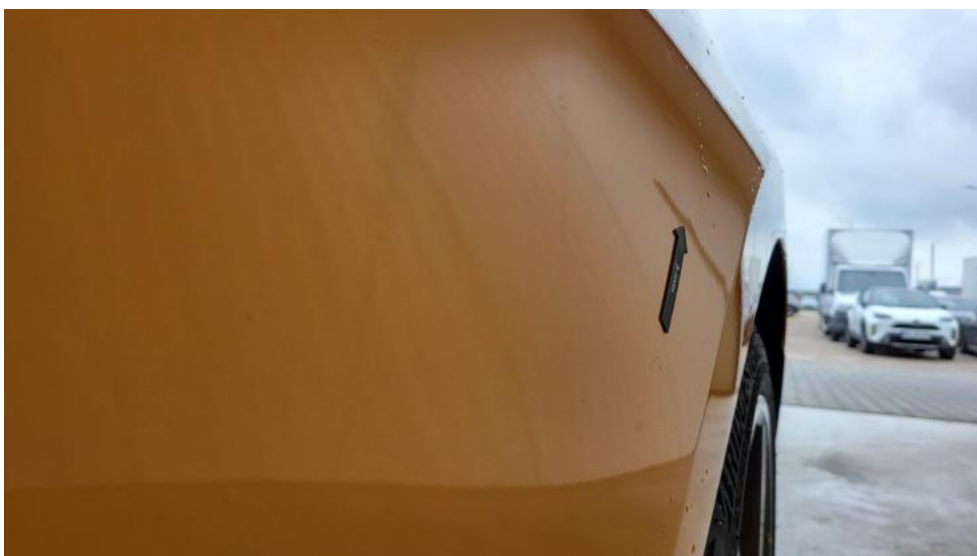
**Photo 44.**

Błotnik tylny L / Ściana boczna L - Wgniecenie/odkształcenie 2

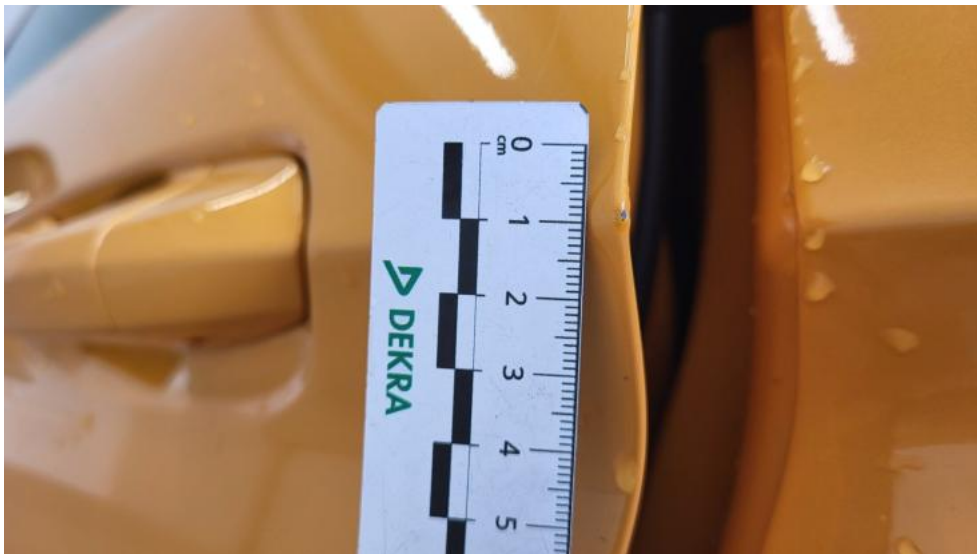
**Photo 45.**

Drzwi przed L - Rysa/odprysk 1

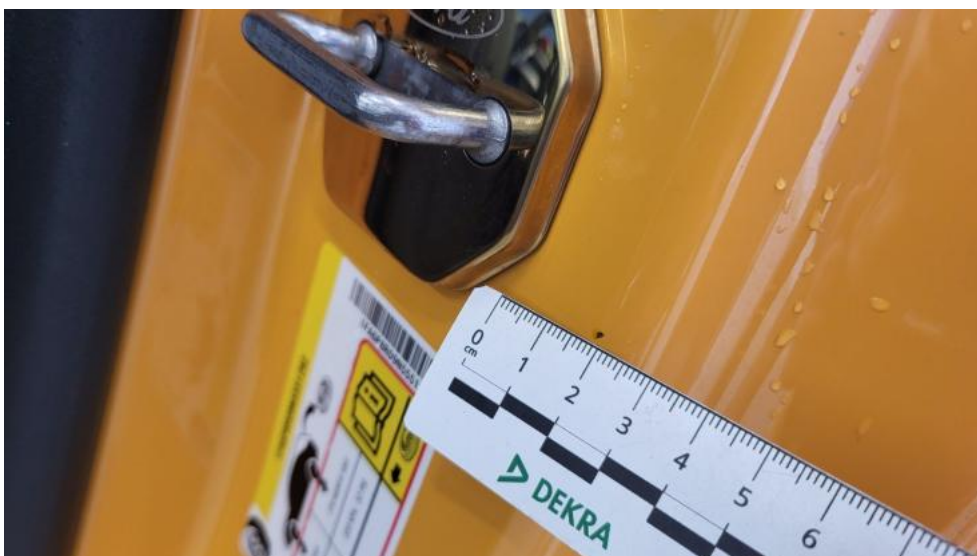
**Photo 46.**

Słupek środkowy L - Rysa/odprysk 1

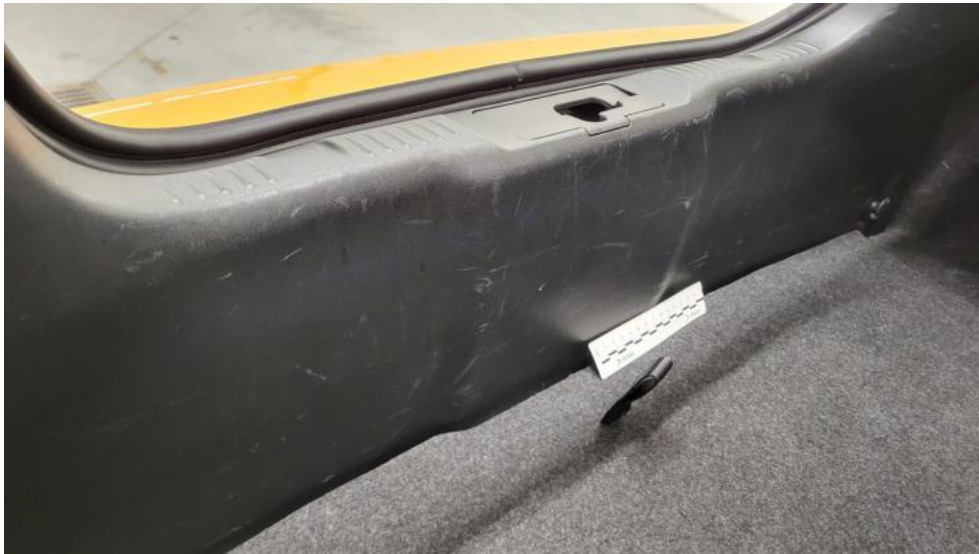
**Photo 47.**

Wykładzina przestrzeni bagażowej - Rysa/odprysk 1
