DEKRA's commission No. : PKOL(W)/LODZ/89088/26/09/22  
commission/ damage No. : 21/050722  
Date of commission: 22-09-2026

**DEKRA Poland - Headquarters**  
02-673 Warszawa, ul. Konstruktorska 12A

| Model | Insignia B Grand Sport 20-22 |
| Type / version | Insignia 2.0 CDTI GS Line S&S aut |

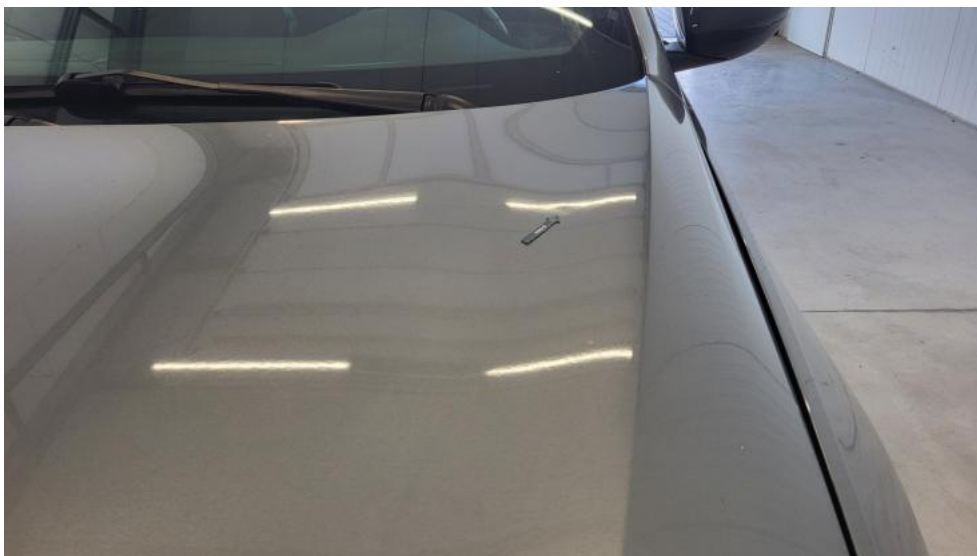
**Photo 40.**

Pokrywa komory silnika - Wgniecenie/odkształcenie 1

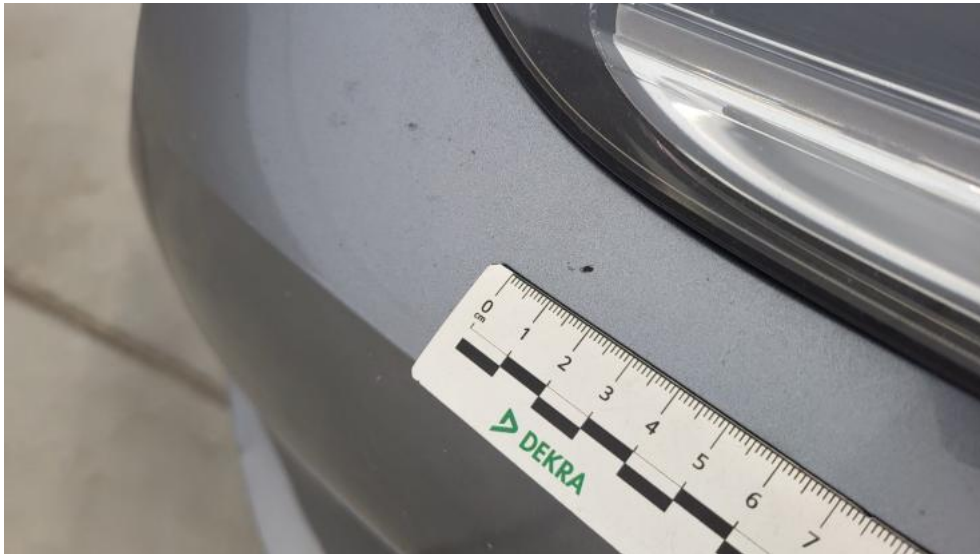
**Photo 41.**

Zderzak - Rysa/odprysk 1

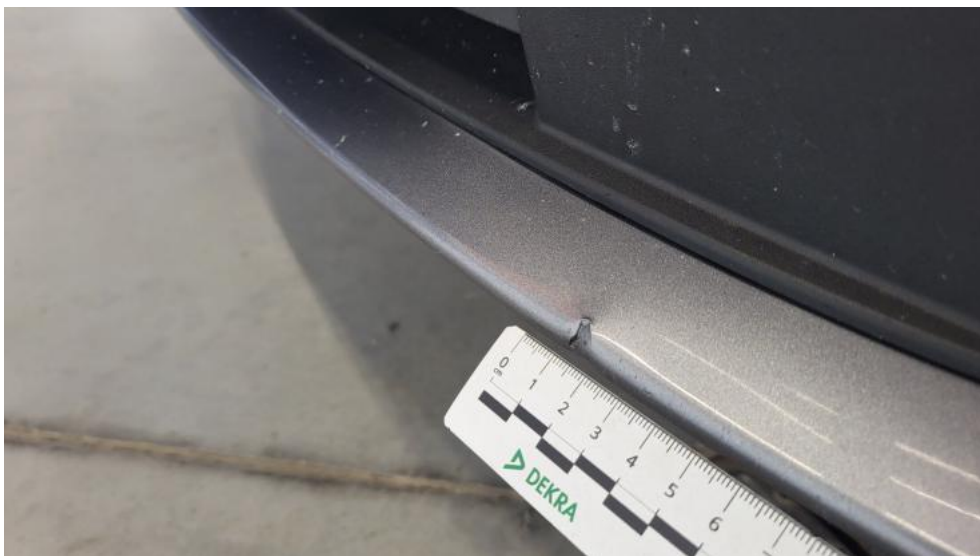
**Photo 42.**

Zderzak - Wgniecenie/odkształcenie 1

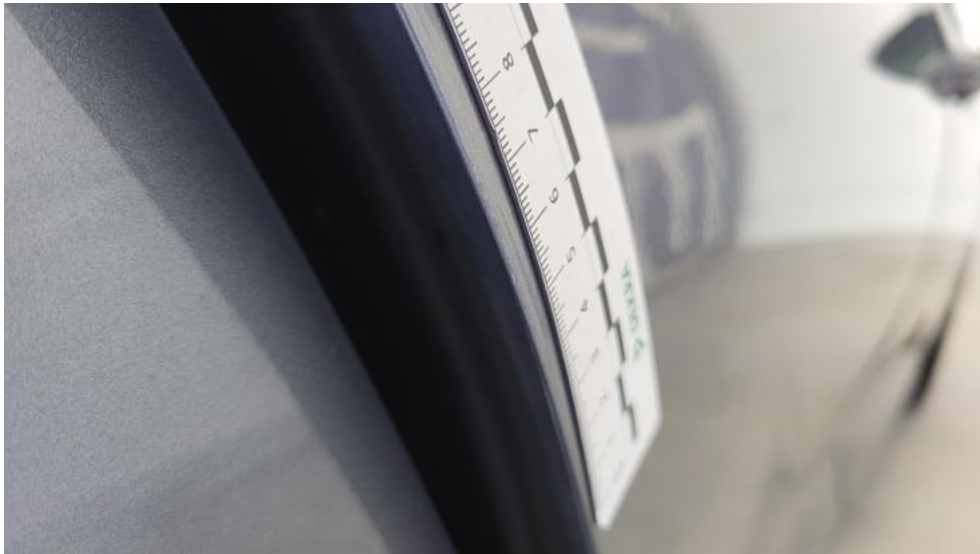
**Photo 47.**

Drzwi tylne P - Rysa/odprysk 1

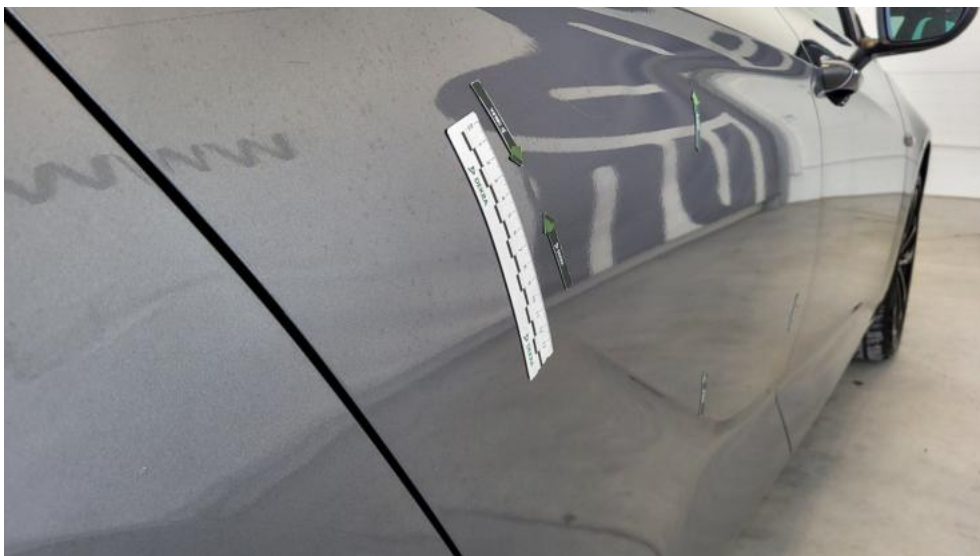
**Photo 48.**

Drzwi tylne P - Wgniecenie/odkształcenie 1

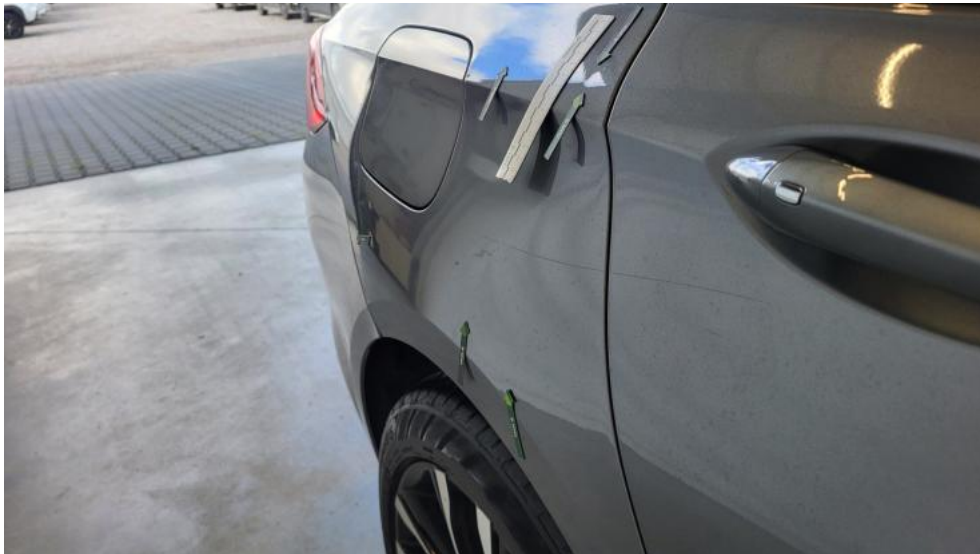
**Photo 49.**

Błotnik tylny P / Ściana boczna P - Wgniecenie/odkształcenie 1

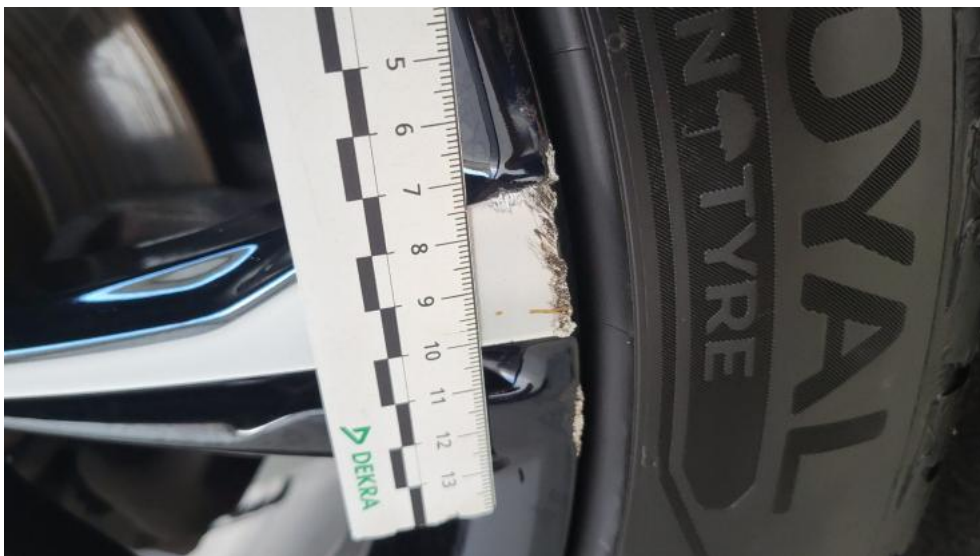
**Photo 50.**

Felga aluminiowa tylna P - Rysa/odprysk 1

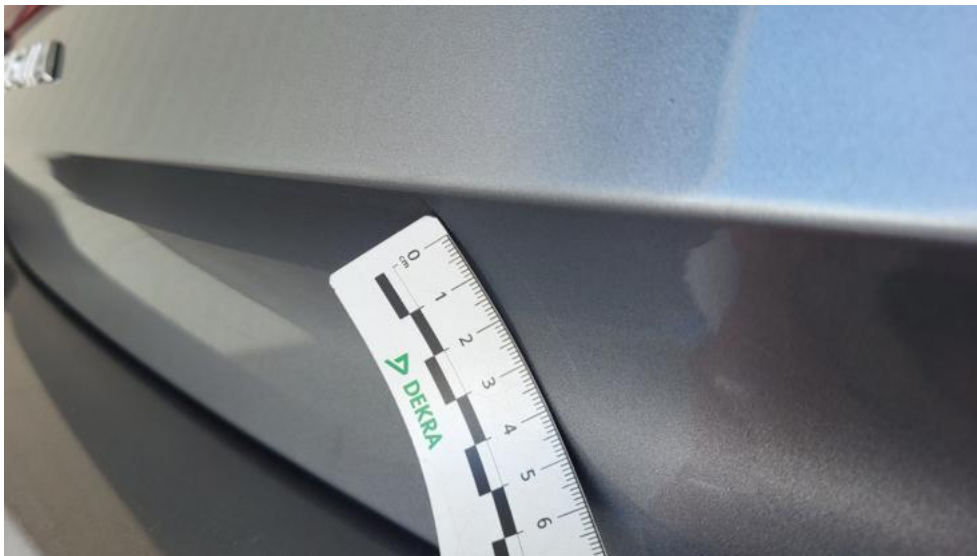
**Photo 51.**

Pokrywy bagażnika - Rysa/odprysk 1

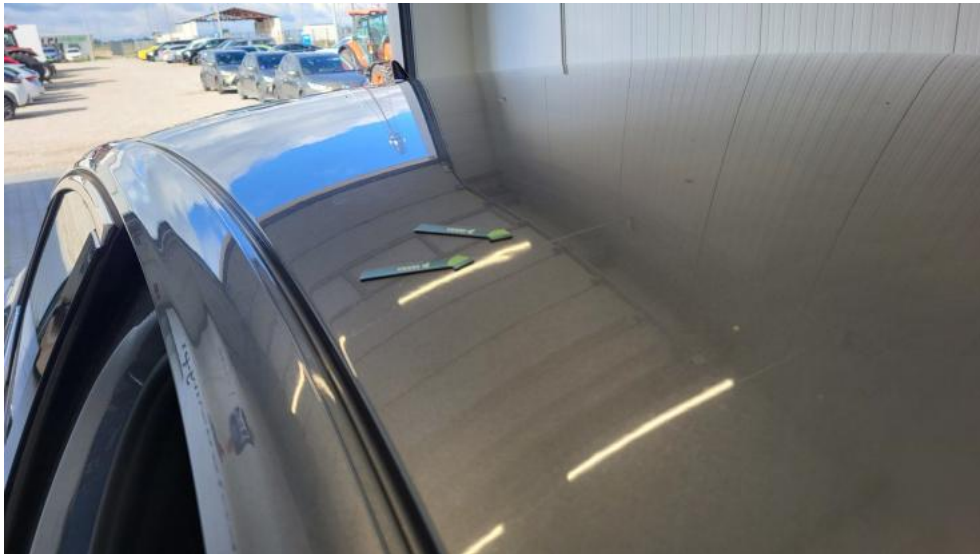
**Photo 57.**

Dach - Wgniecenie/odkształcenie 1

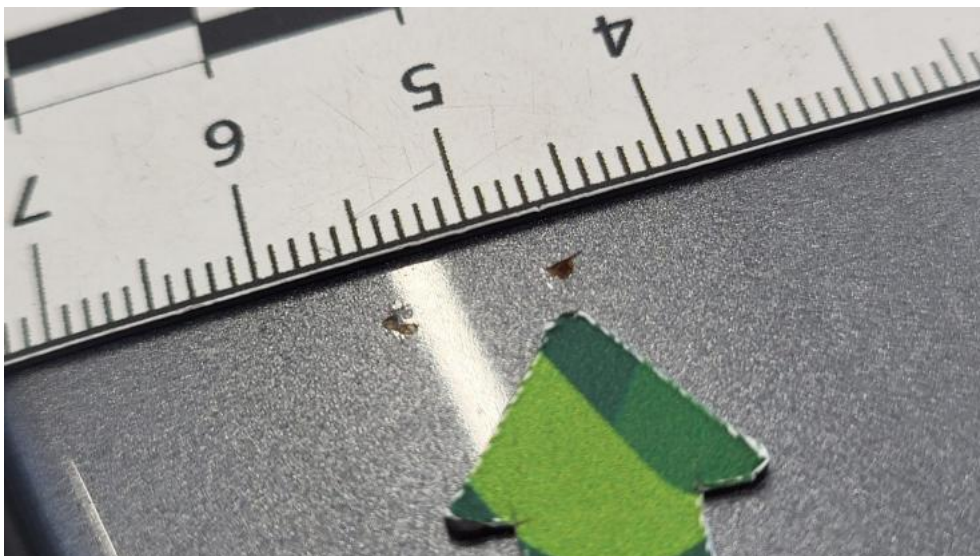
**Photo 58.**

Dach - Inne 1

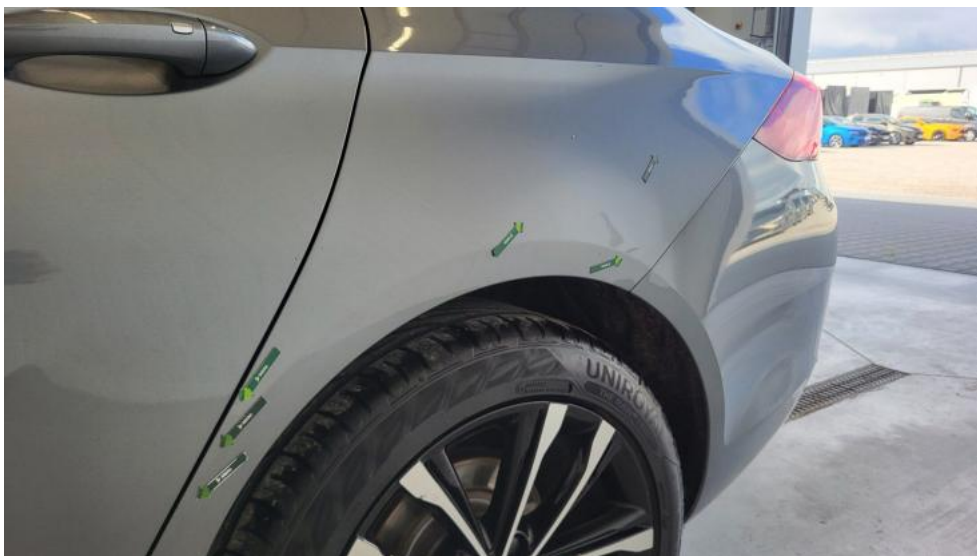
**Photo 59.**

Błotnik tylny L / Ściana boczna L - Wgniecenie/odkształcenie 1

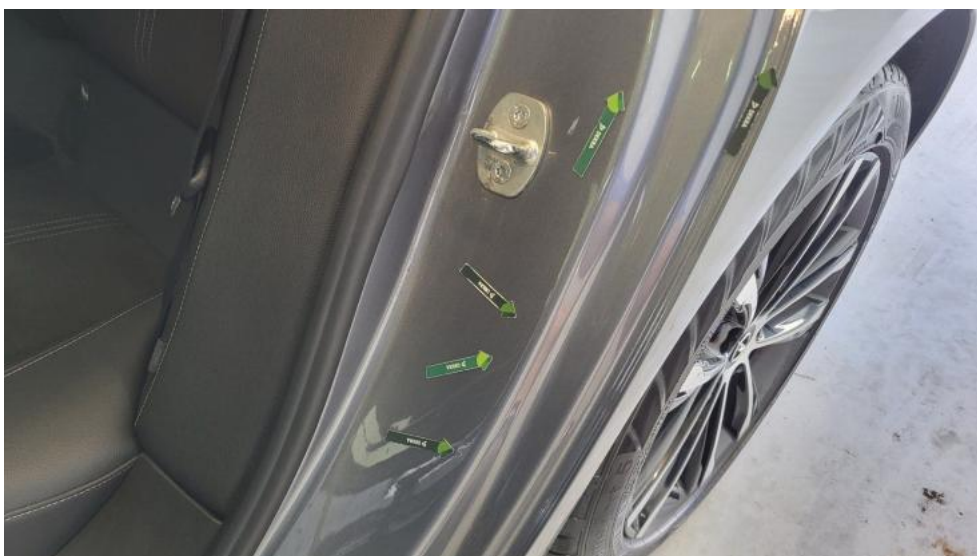
**Photo 60.**

Błotnik tylny L / Ściana boczna L - Wgniecenie/odkształcenie 2

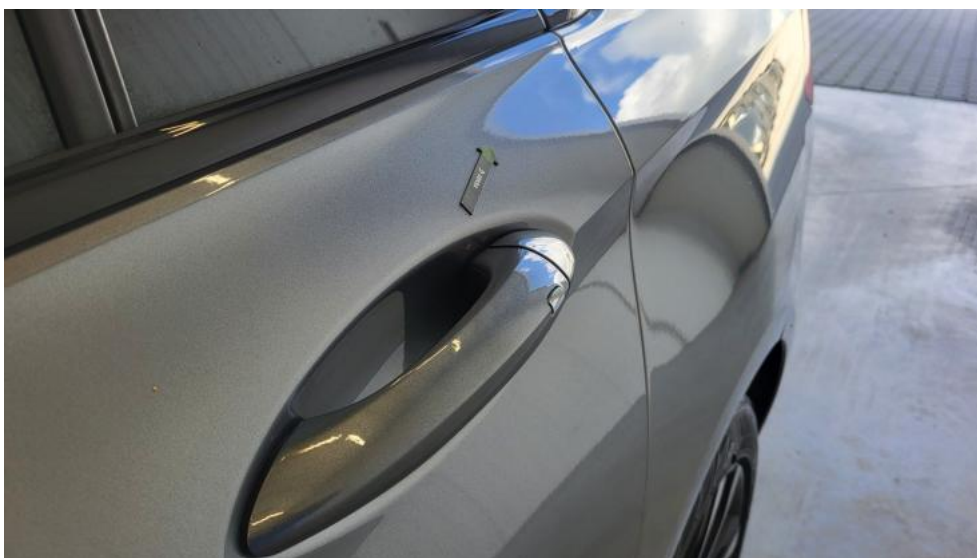
**Photo 66.**

Drzwi tylne L - Wgniecenie/odkształcenie 1

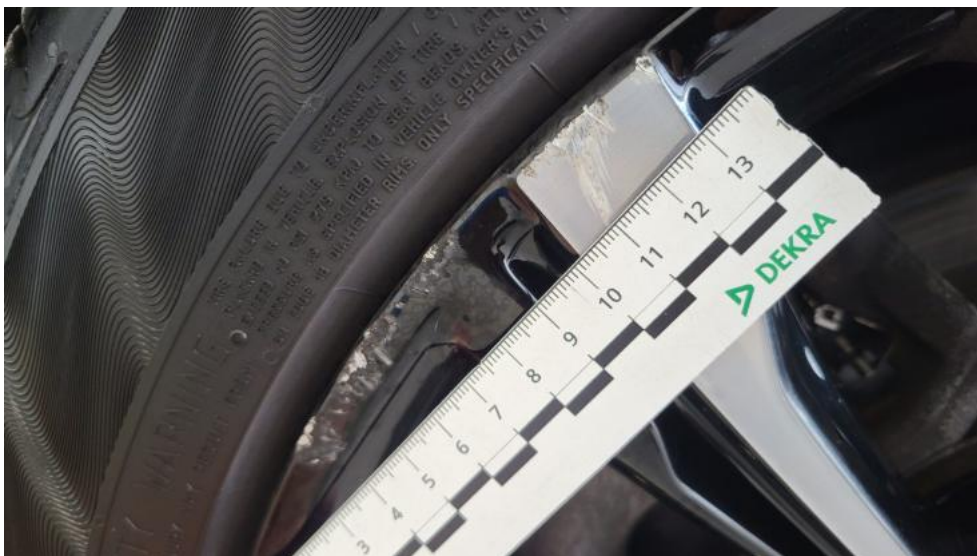
**Photo 67.**

Felga Aluminiowa przednia L - Rysa/odprysk 1

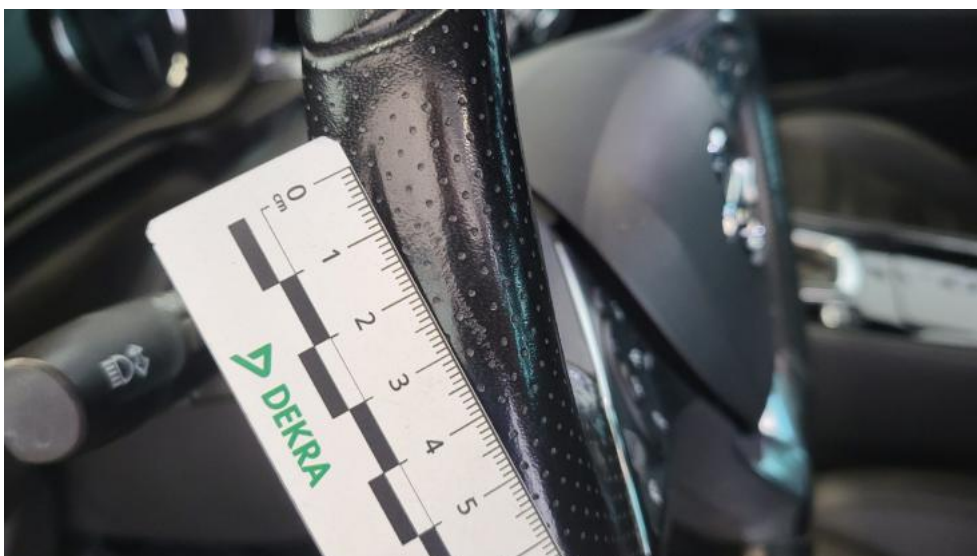
**Photo 68.**

Koło kierownicy - Rysa/odprysk 1

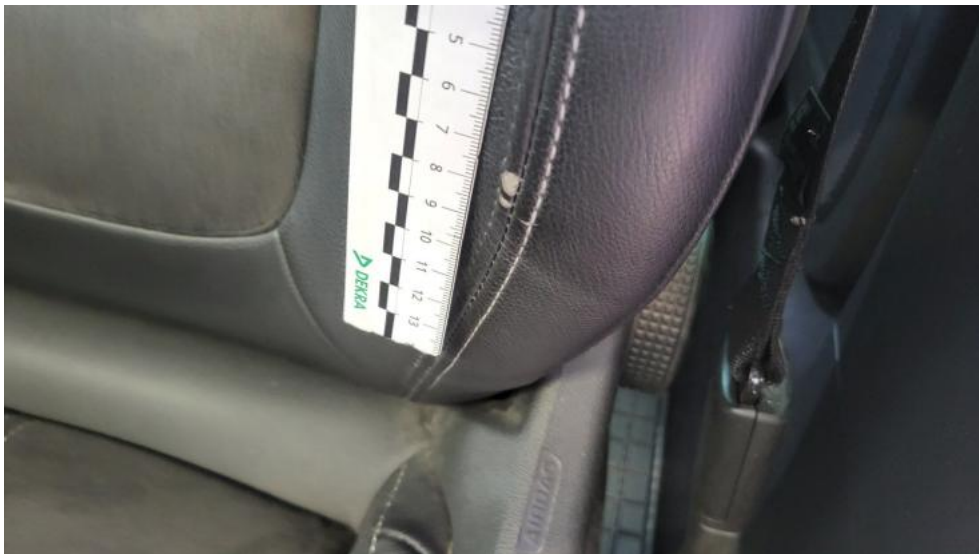
**Photo 69.**

Fotel prz. lew. - Pęknięcie/rozerwanie 1

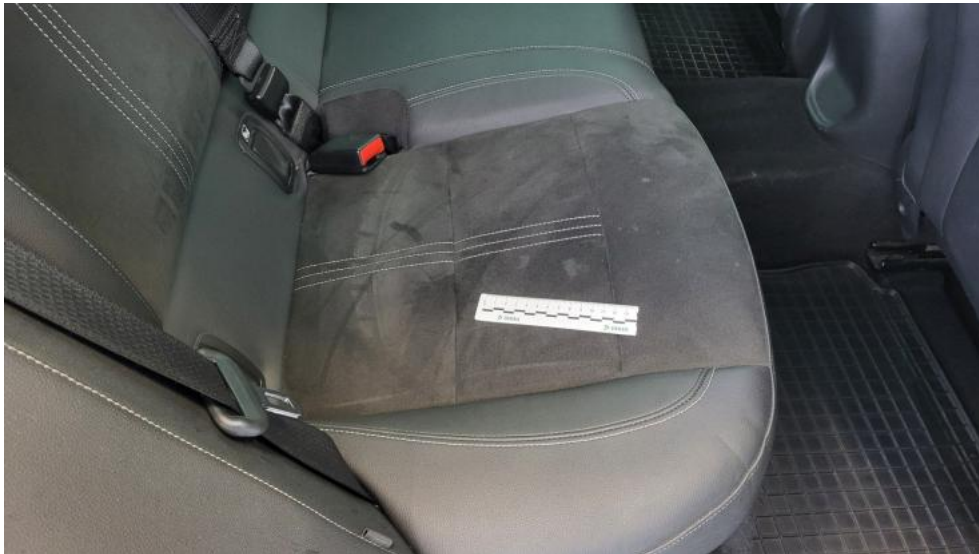
**Photo 71.**  
Kanapa tyl. - Inne 1

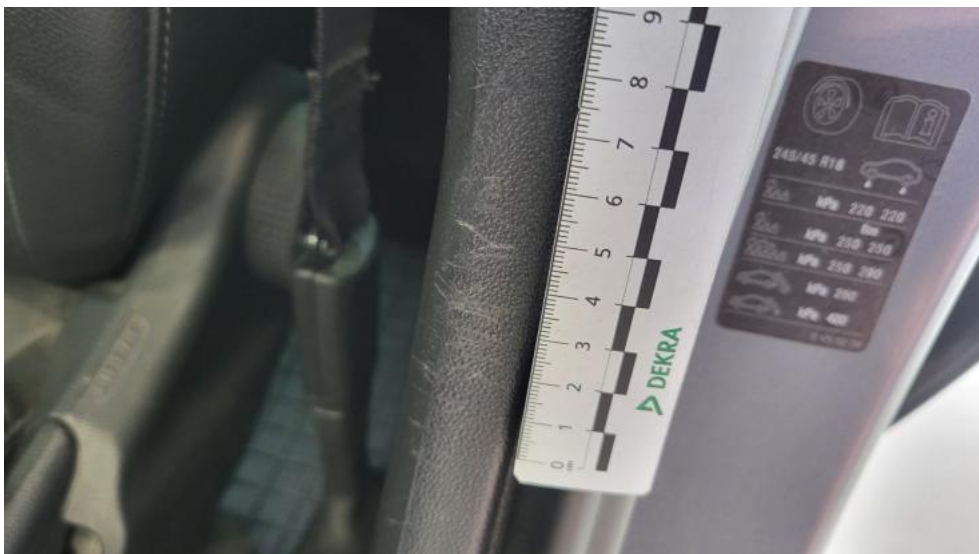
**Photo 72.**  
Wykładzina(y) słupka środkowego L - Rysa/odprysk 1
