DEKRA's commission No. : PKOL(W)/LODZ/71043/26/07/30  
commission/ damage No. : 22/036206  
Date of commission: 30-07-2026

| Manufacturer | MAZDA |
| Model | MX-30 EV 20- |
| Registration /record No. | KR7XY36 |

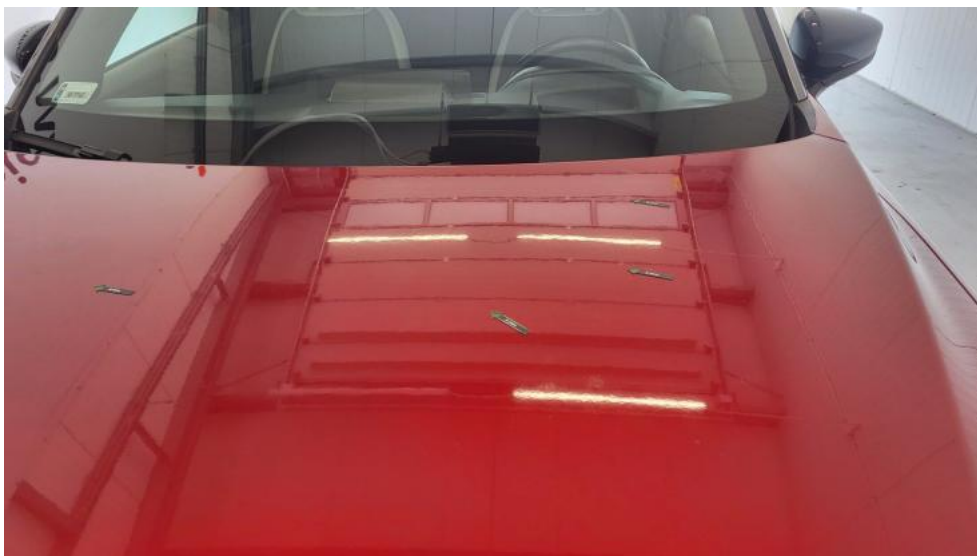
**Photo 43.**

Pokrywa komory silnika - Wgniecenie/odkształcenie 1

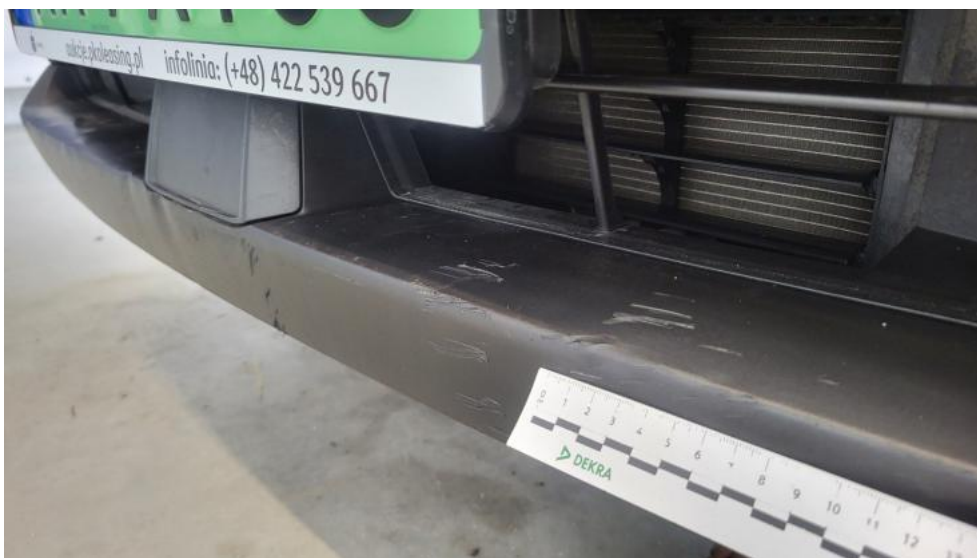
**Photo 44.**

Spoiler zderzaka przedniego - Rysa/odprysk 1

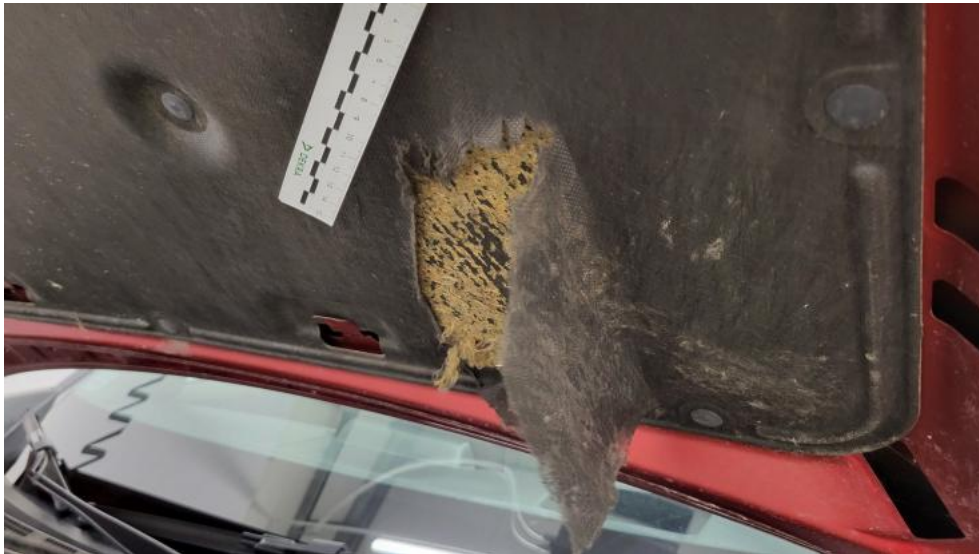
**Photo 47.**

Wykładzina pokrywy komory silnika - Pęknięcie/rozerwanie 1

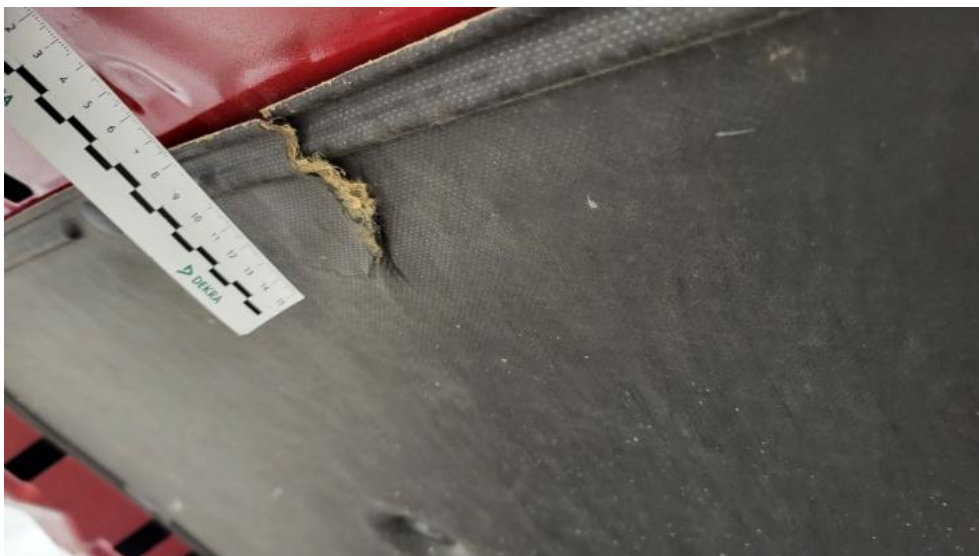
**Photo 48.**

Wykładzina pokrywy komory silnika - Pęknięcie/rozerwanie 2

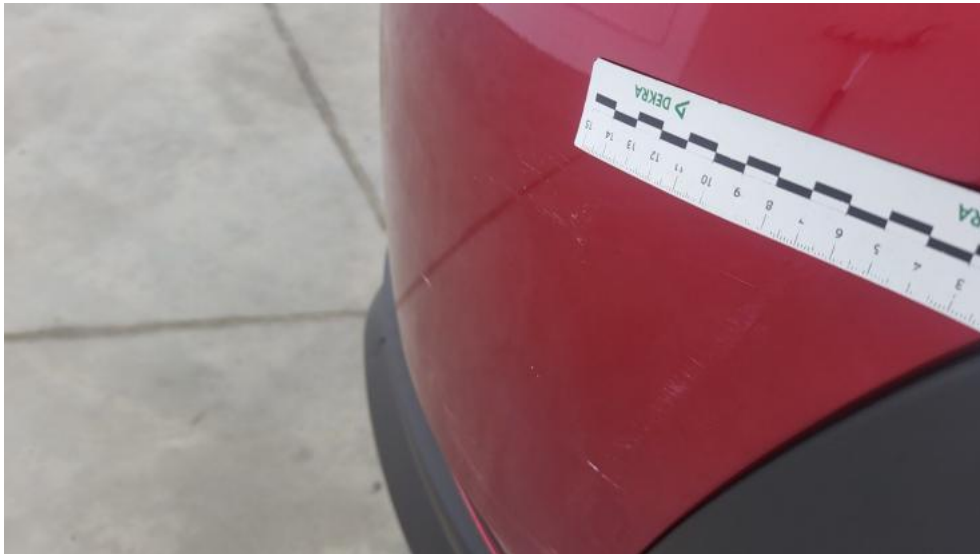
**Photo 49.**

Zderzak - Rysa/odprysk 1

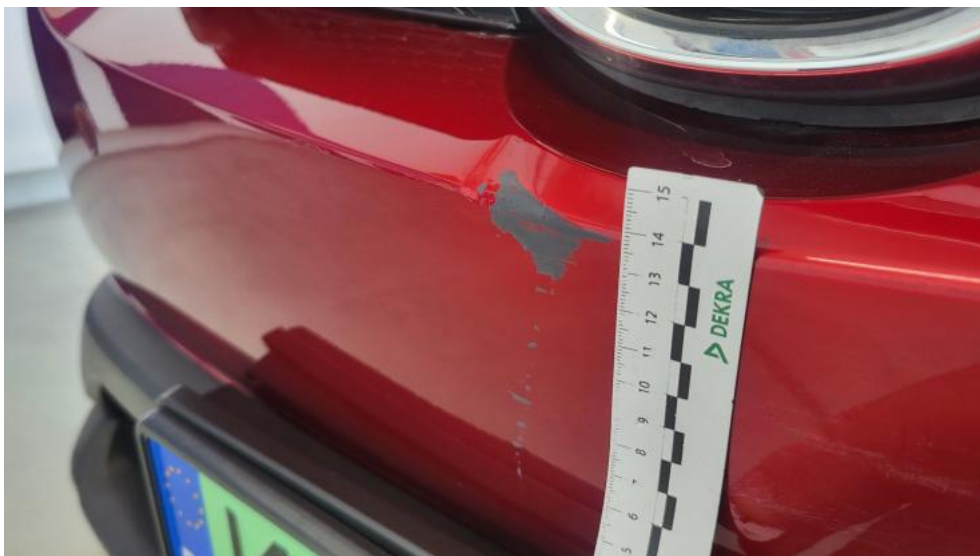
**Photo 50.**

Zderzak - Rysa/odprysk 2

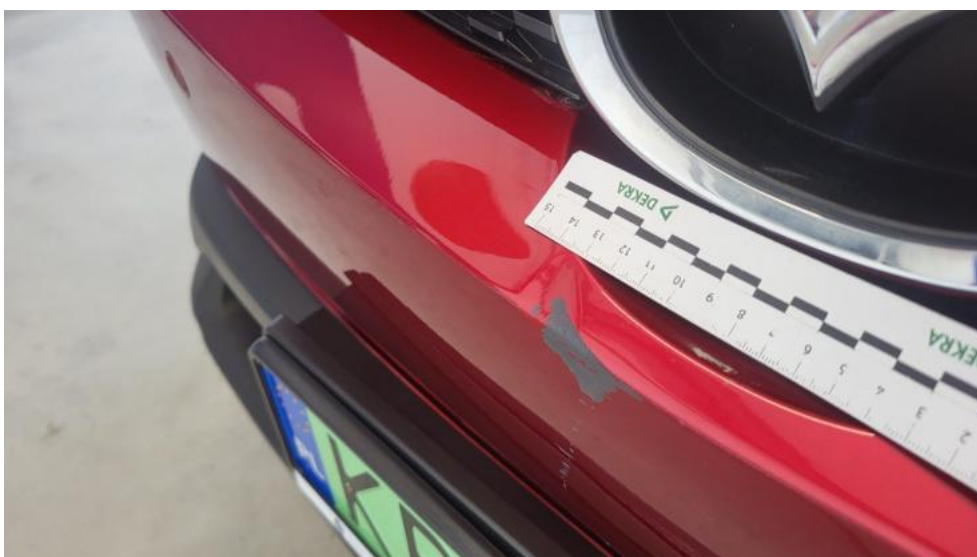
**Photo 51.**

Zderzak - Wgniecenie/odkształcenie 1

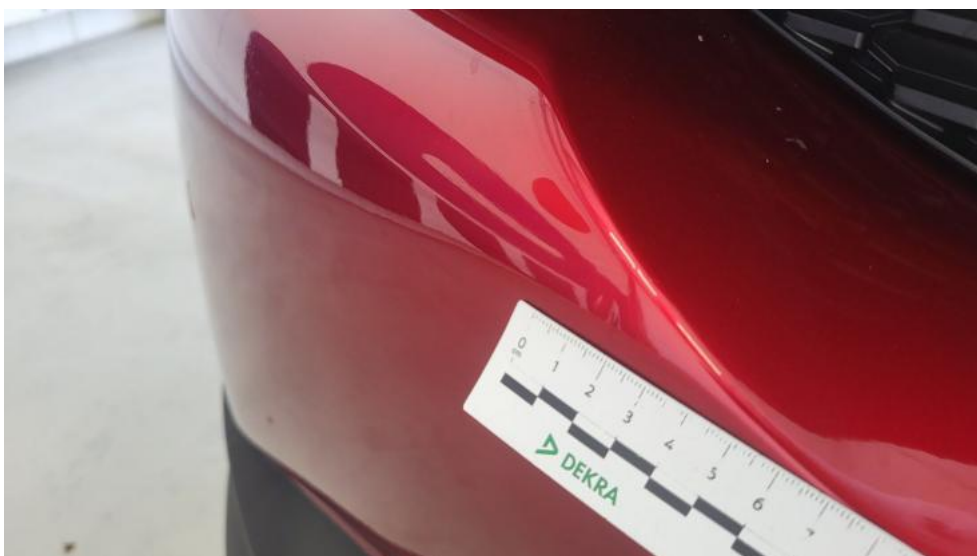
**Photo 52.**

Zderzak - Wgniecenie/odkształcenie 2

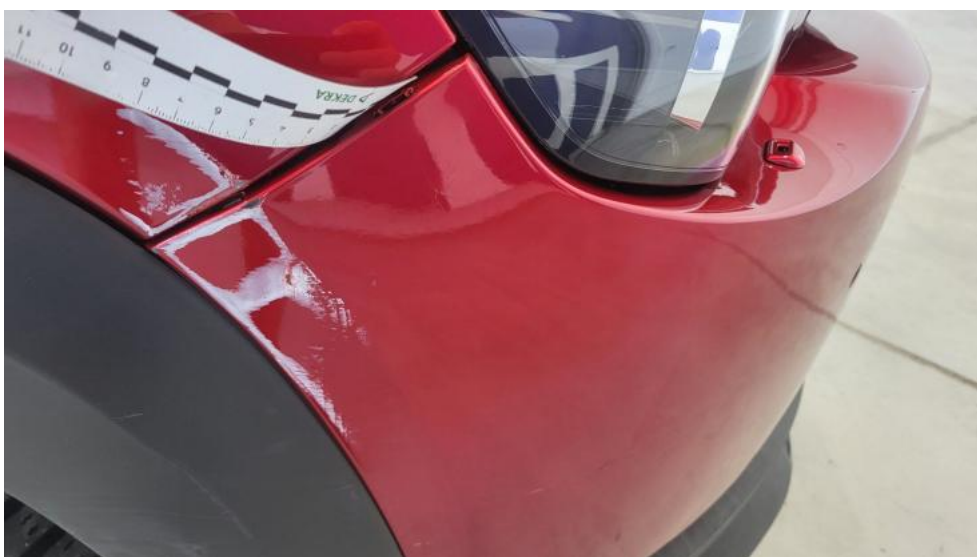
**Photo 53.**

Zderzak - Inne 1

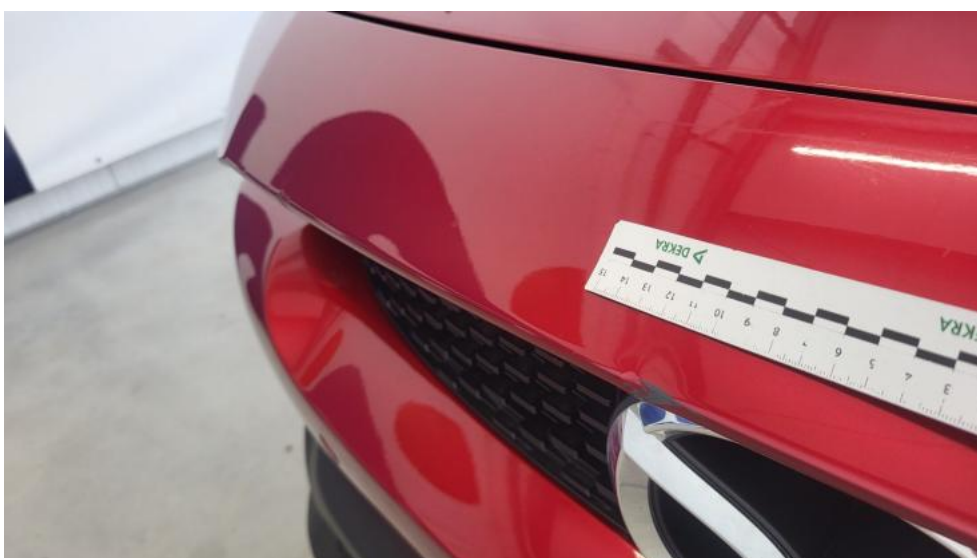
**Photo 54.**

Zderzak przedni cz górna - Wgniecenie/odkształcenie 1

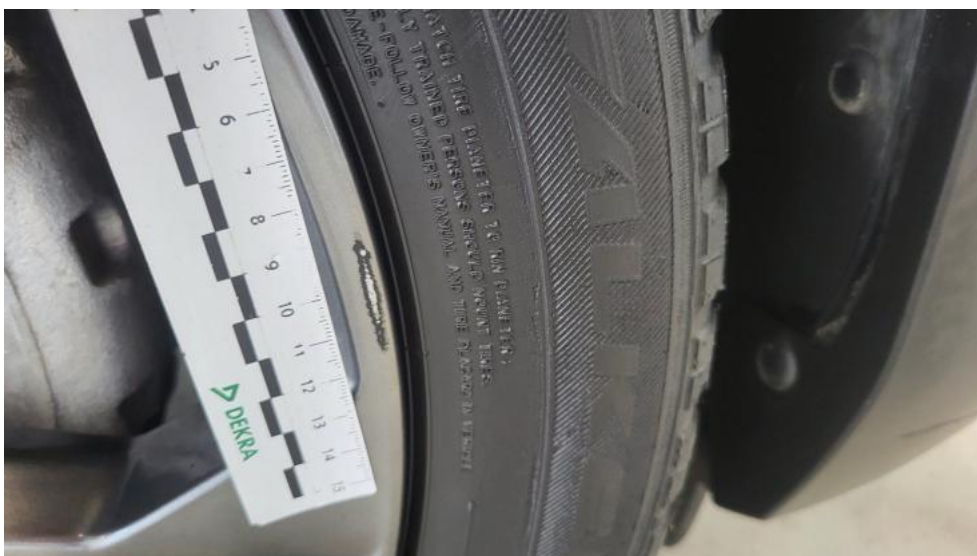
**Photo 56.**

Felga aluminiowa przednia P - Rysa/odprysk 1

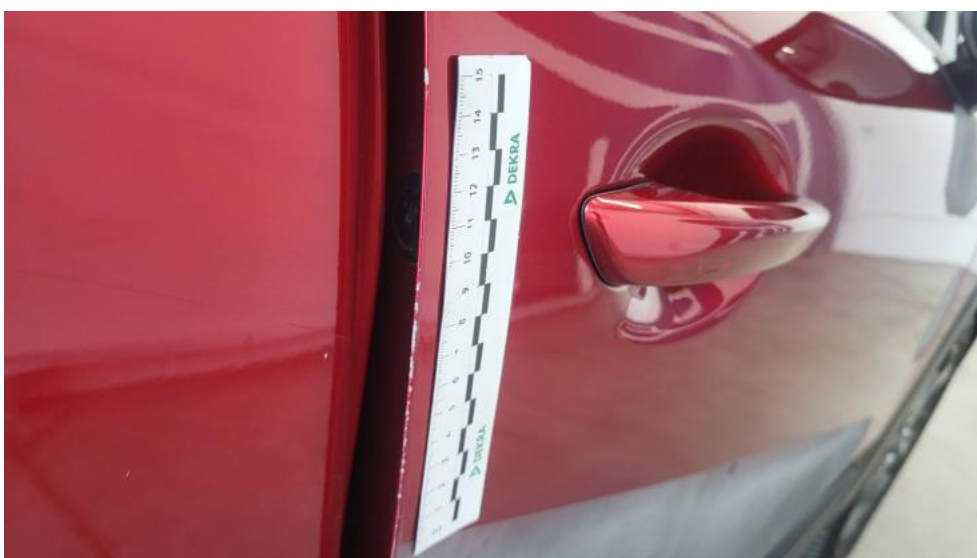
**Photo 58.**

Drzwi przednie P - Rysa/odprysk 1

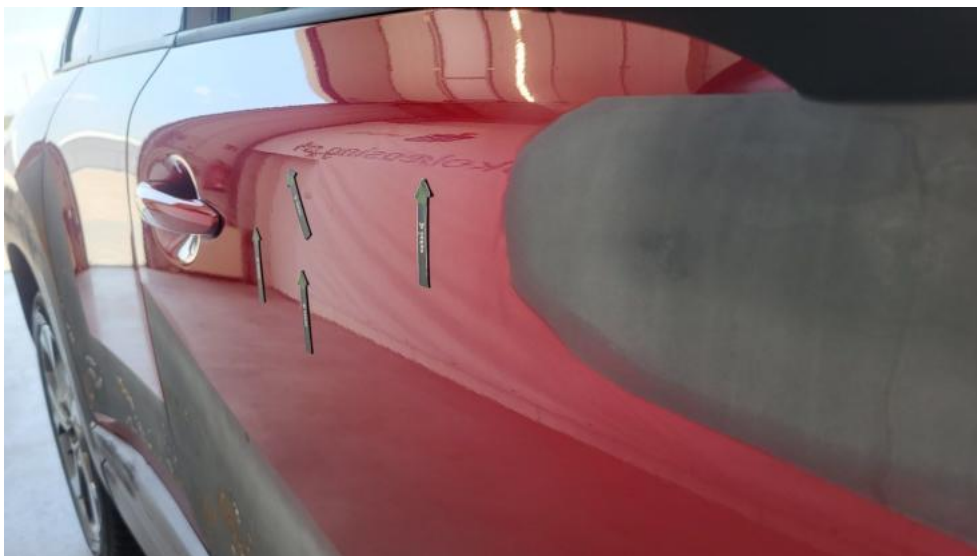
**Photo 59.**

Drzwi przednie P - Wgniecenie/odkształcenie 1

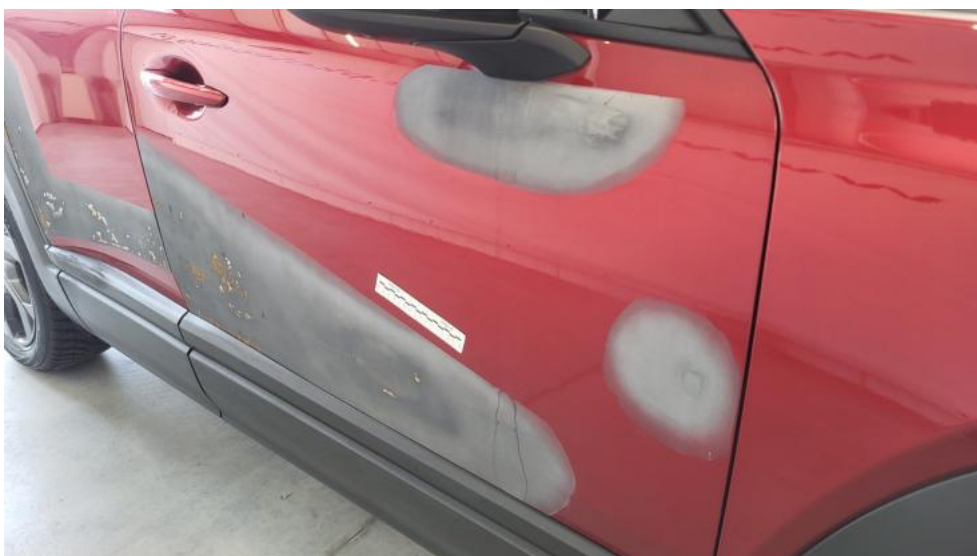
**Photo 60.**

Drzwi przednie P - Inne 1

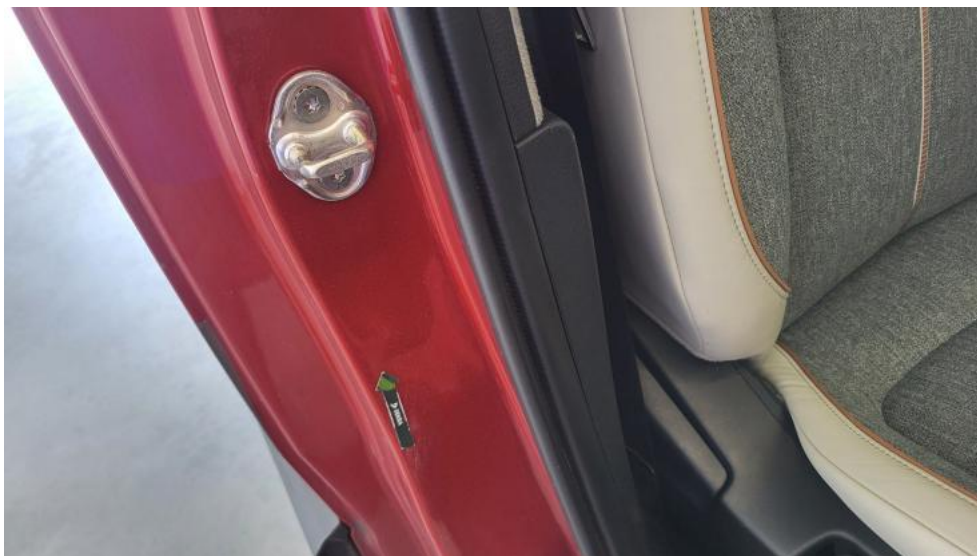
**Photo 62.**

Drzwi tylne P - Wgniecenie/odkształcenie 1

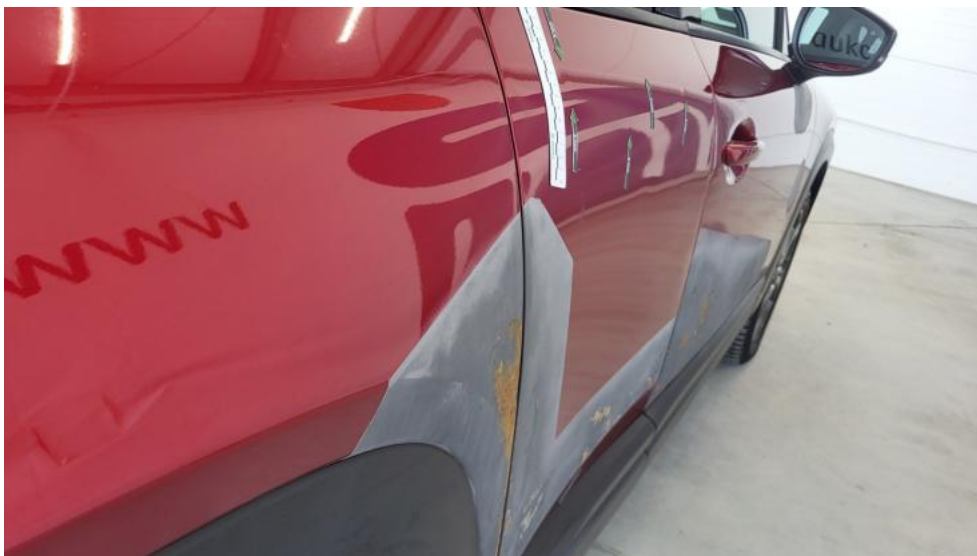
**Photo 63.**

Drzwi tylne P - Wgniecenie/odkształcenie 2

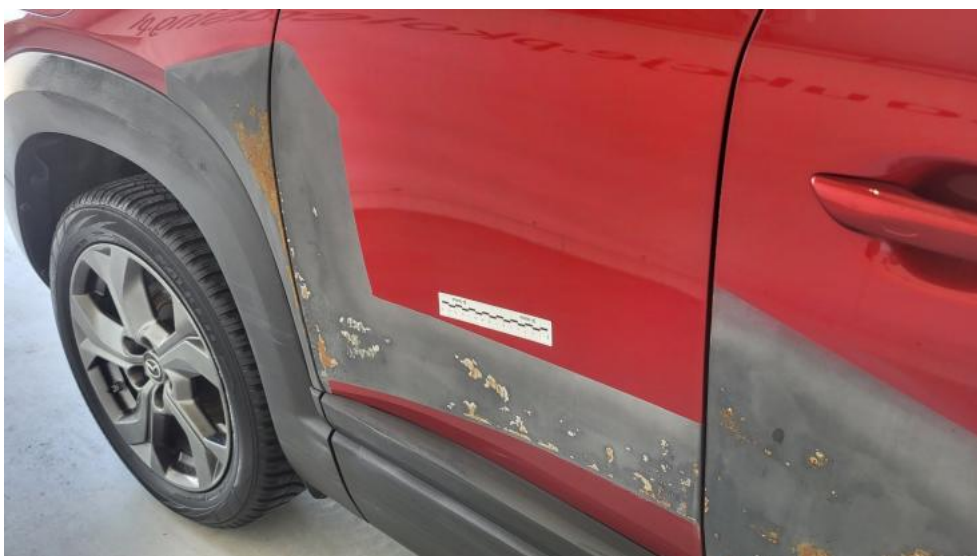
**Photo 64.**

Drzwi tylne P - Inne 1

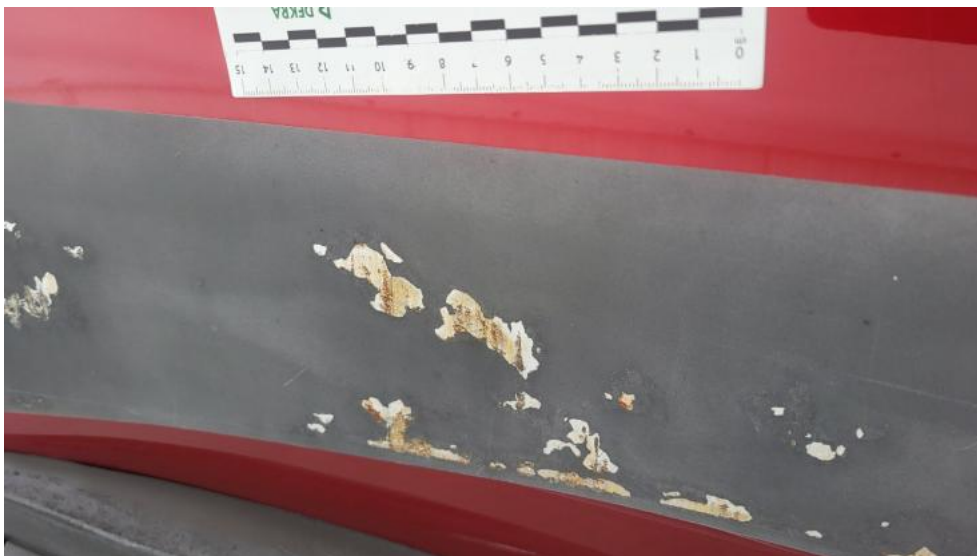
**Photo 65.**  
Drzwi tylne P - Inne 2

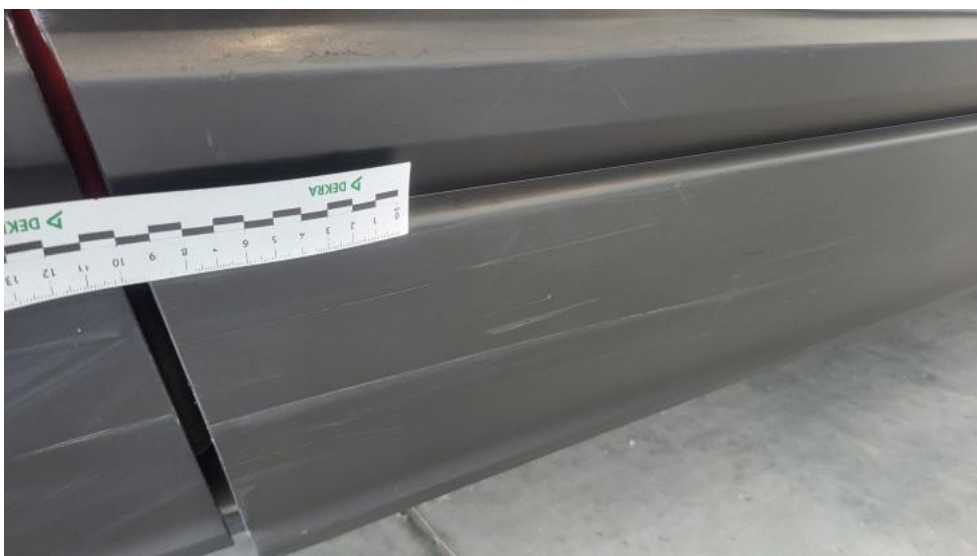
**Photo 66.**  
Listwa drzwi przednich P - Rysa/odprysk 1

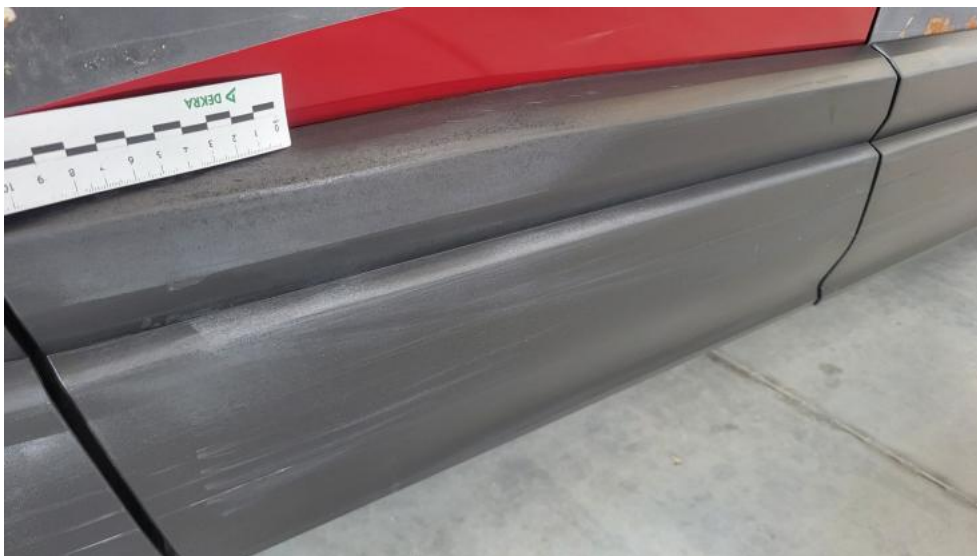
**Photo 67.**

Listwa drzwi tylnych P - Rysa/odprysk 1

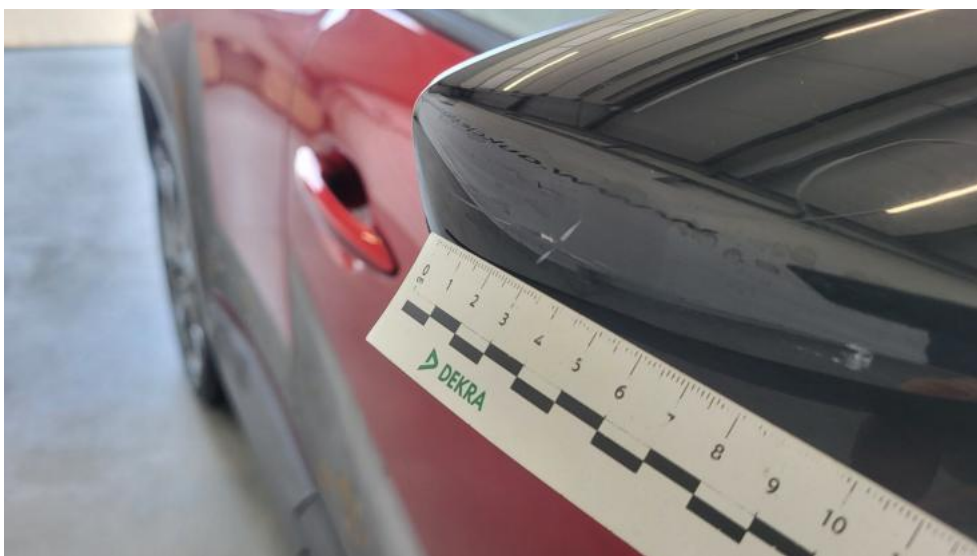
**Photo 68.**

Lusterko zew P - Rysa/odprysk 1

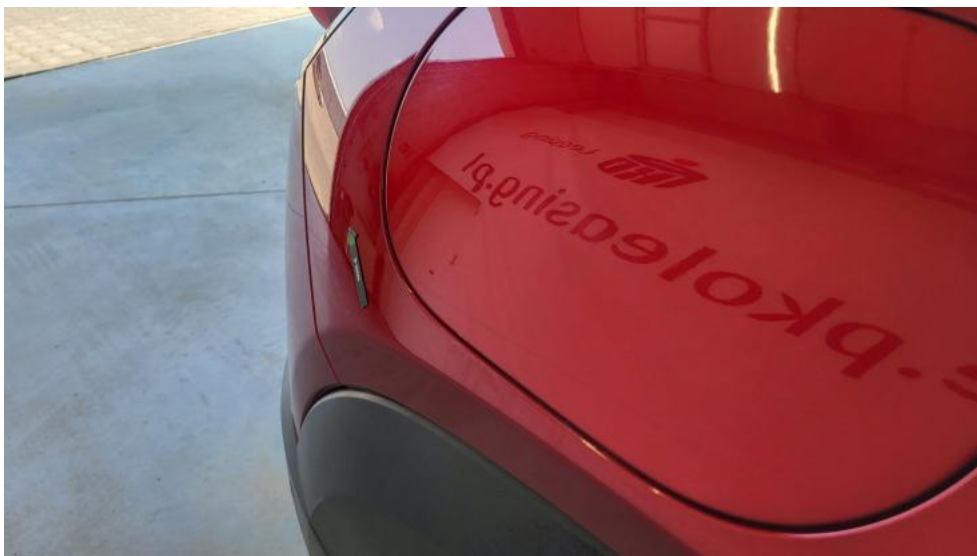
**Photo 70.**

Łotnik tylny P / Ściana boczna P - Wgniecenie/odkształcenie 1

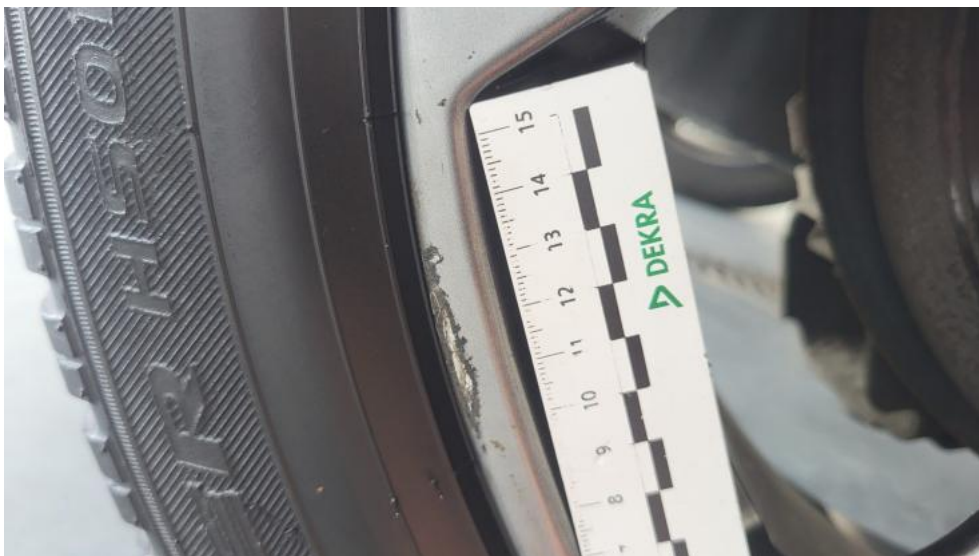
**Photo 72.**

Felga aluminiowa tylna P - Rysa/odprysk 1

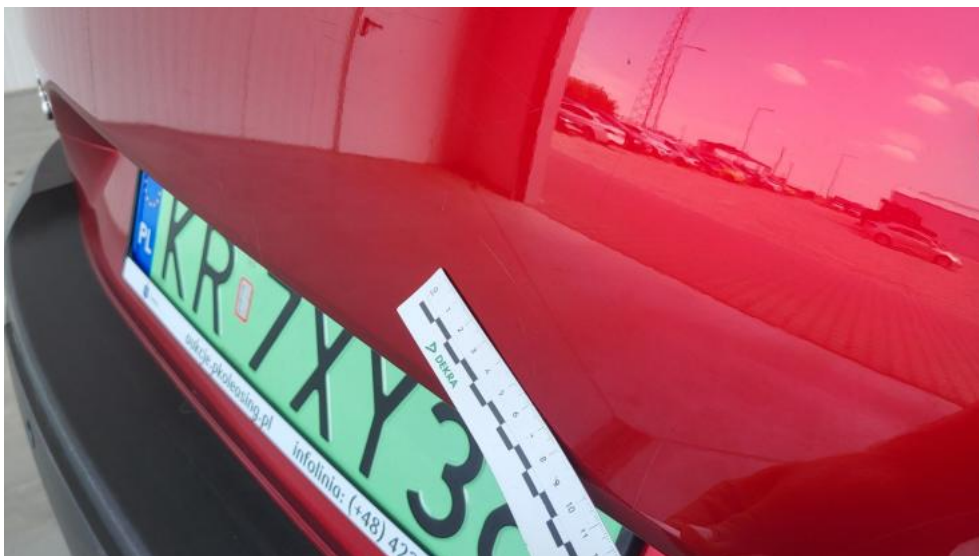
**Photo 74.**

Pokrywy bagażnika - Rysa/odprysk 1

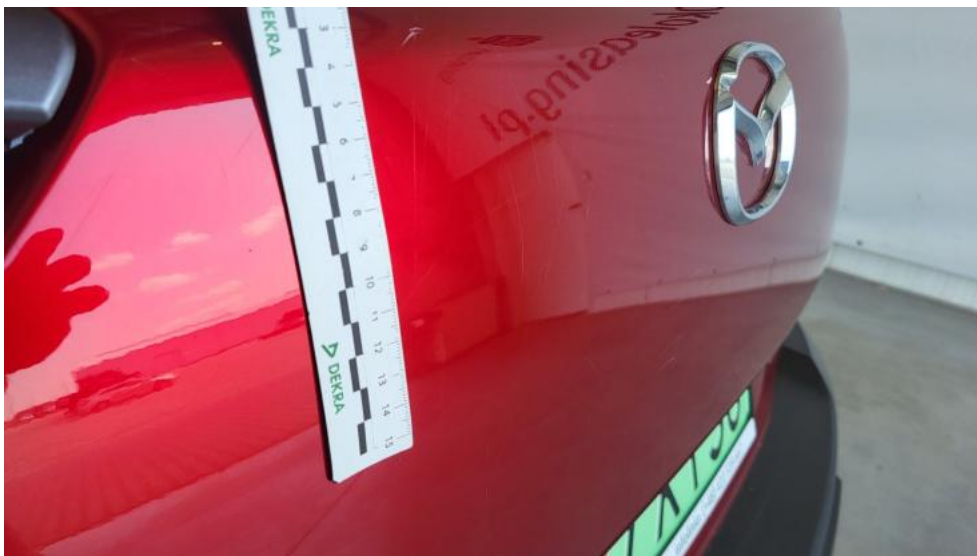
**Photo 75.**

Pokrywy bagażnika - Rysa/odprysk 2

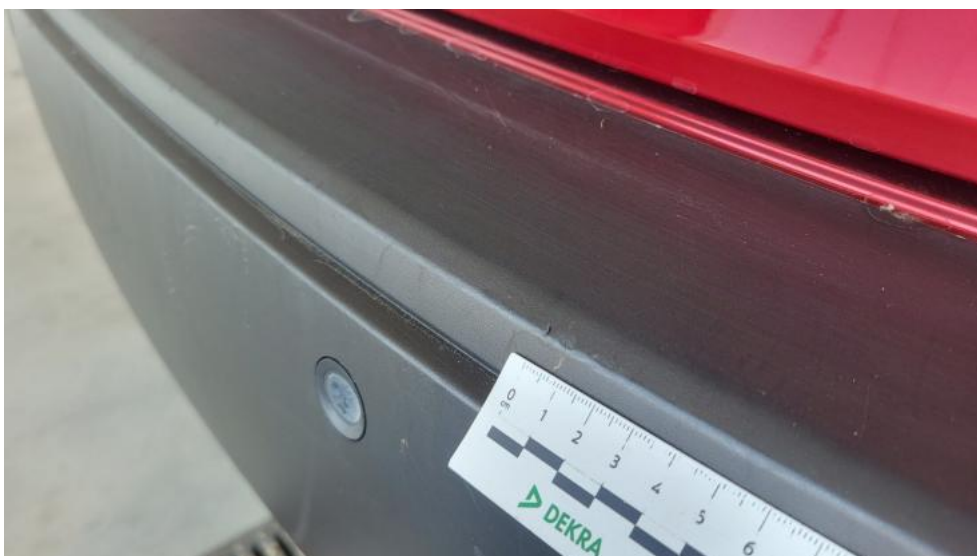
**Photo 76.**

Zderzak tylny - Rysa/odprysk 1

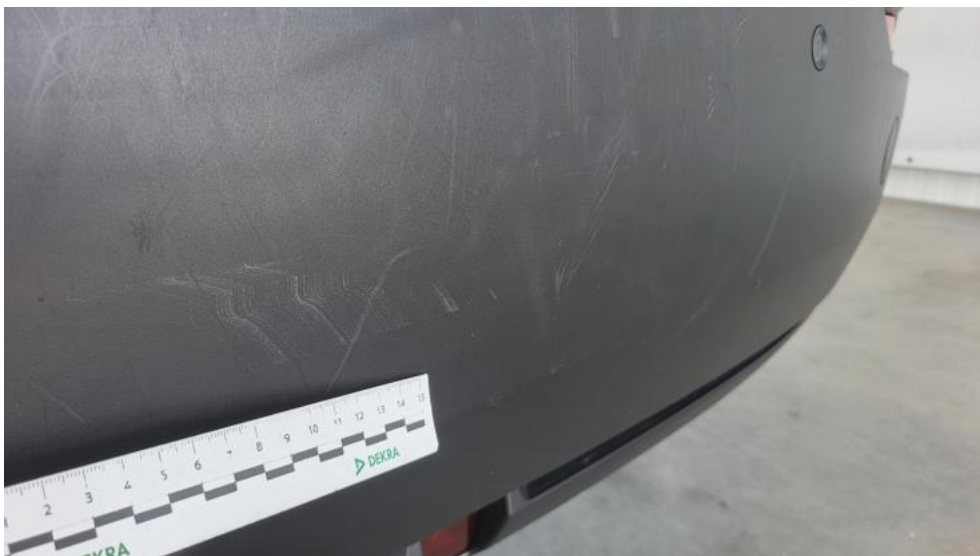
**Photo 78.**

Zderzak tylny() - Rysa/odprysk 3

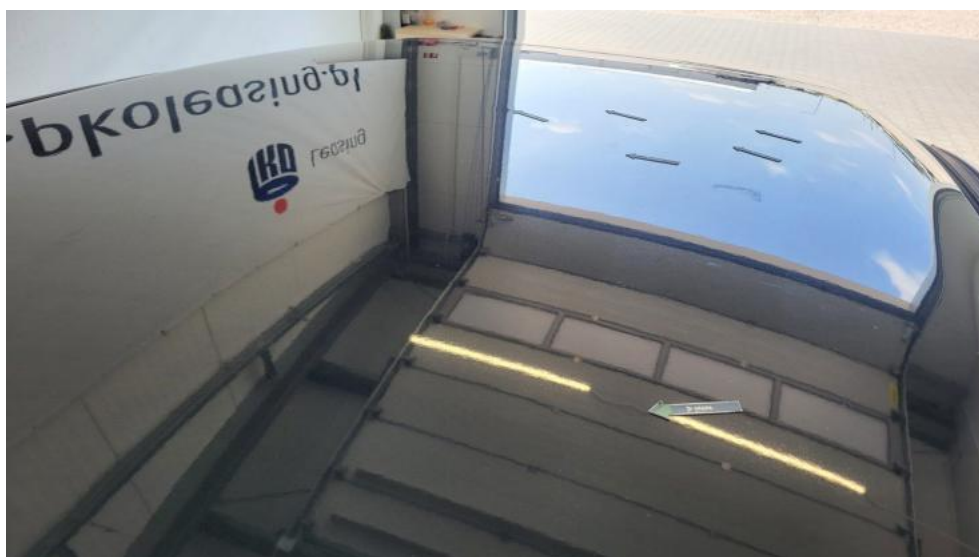
**Photo 79.**

Dach - Wgniecenie/odkształcenie 1

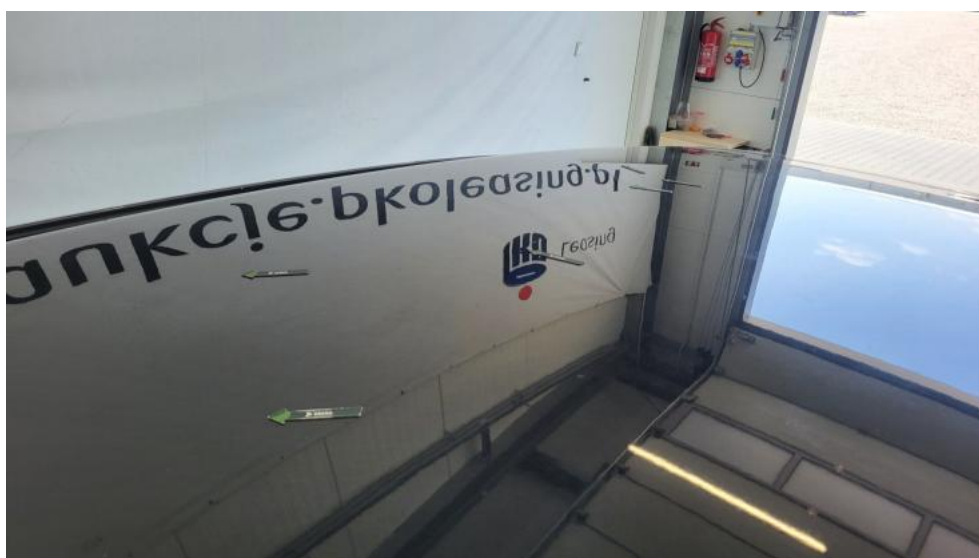
**Photo 80.**

Dach - Wgniecenie/odkształcenie 2

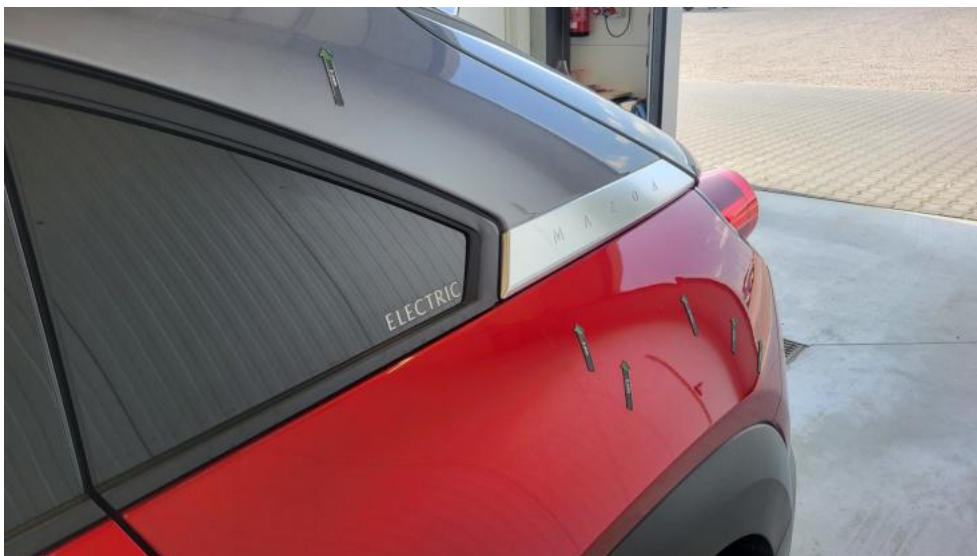
**Photo 81.**

Błotnik tylny L / Ściana boczna L - Wgniecenie/odkształcenie 1

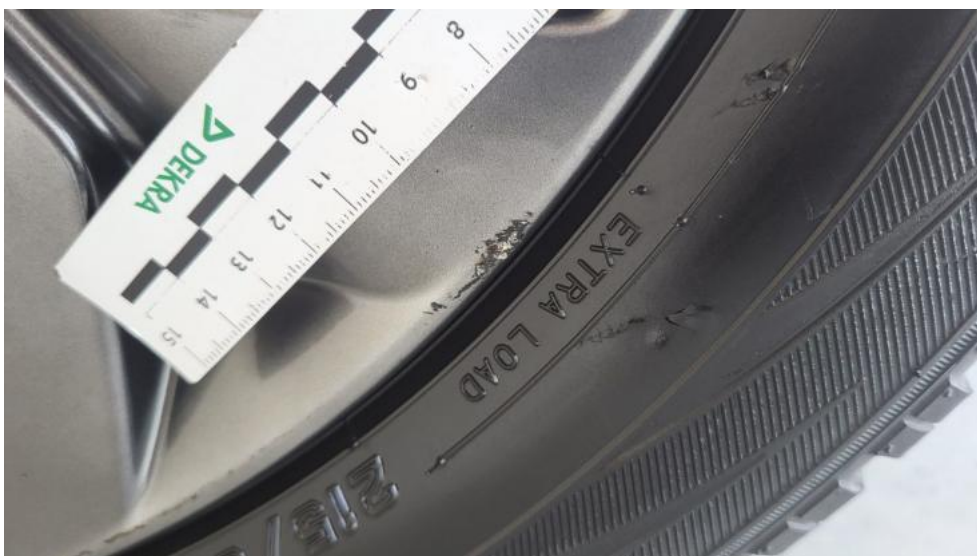
**Photo 82.**

Felga aluminiowa tylna L - Rysa/odprysk 1

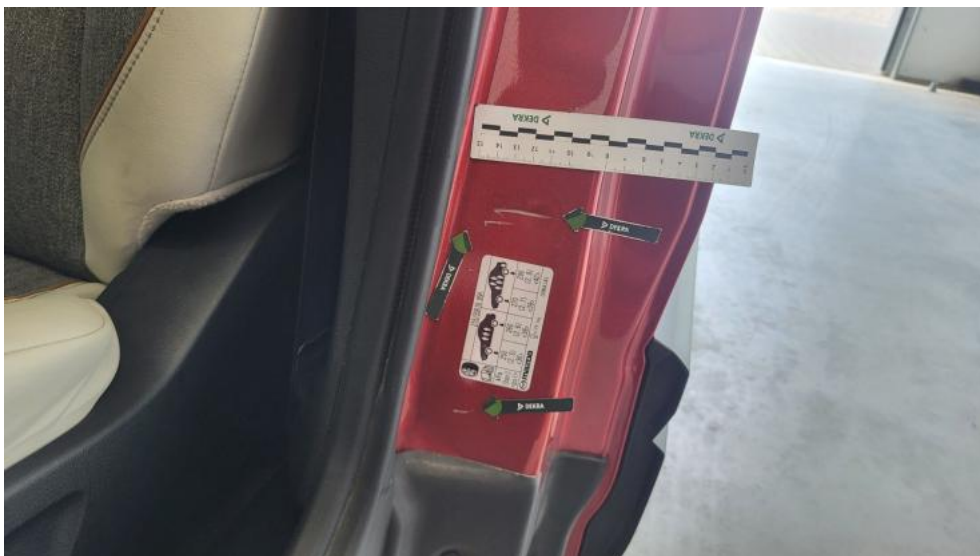
**Photo 86.**

Drzwi tylne L - Wgniecenie/odkształcenie 2

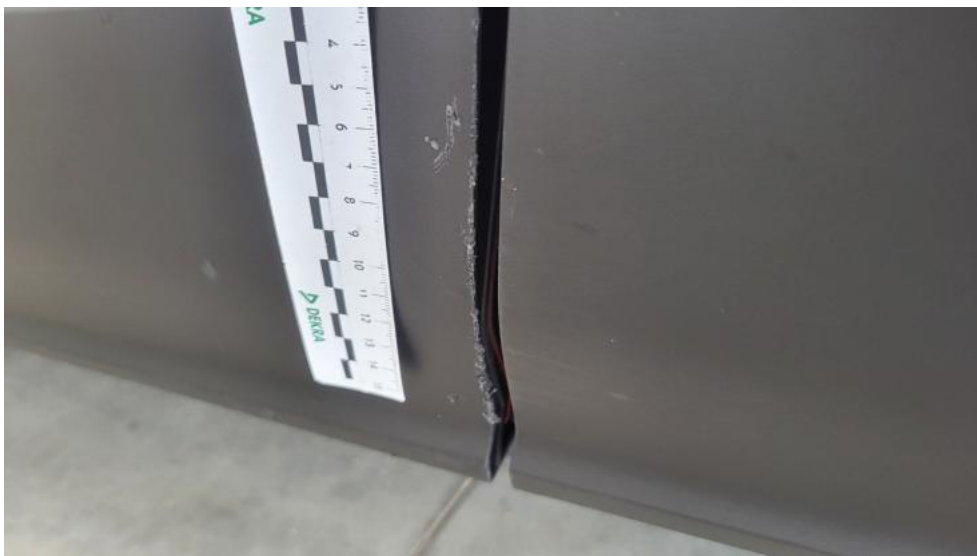
**Photo 87.**

Listwa drzwi przednich L - Rysa/odprysk 1

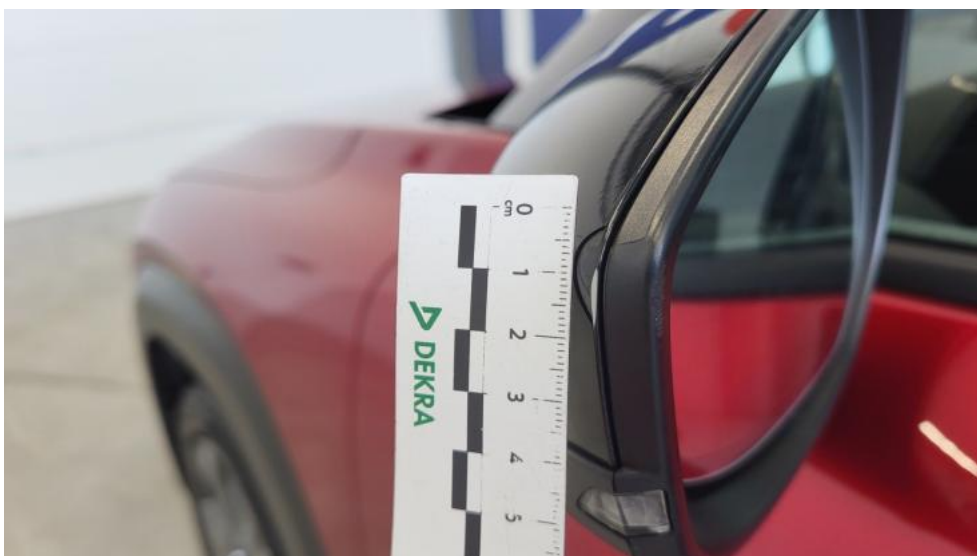
**Photo 88.**

Lusterko zew L - Rysa/odprysk 1

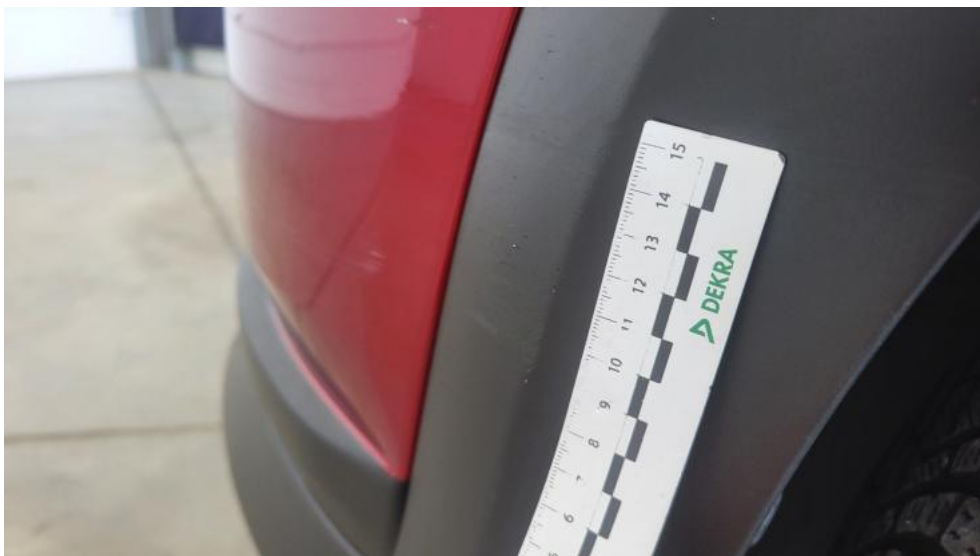
**Photo 90.**

Listwa krawędzi błotnika prz L - Rysa/odprysk 1

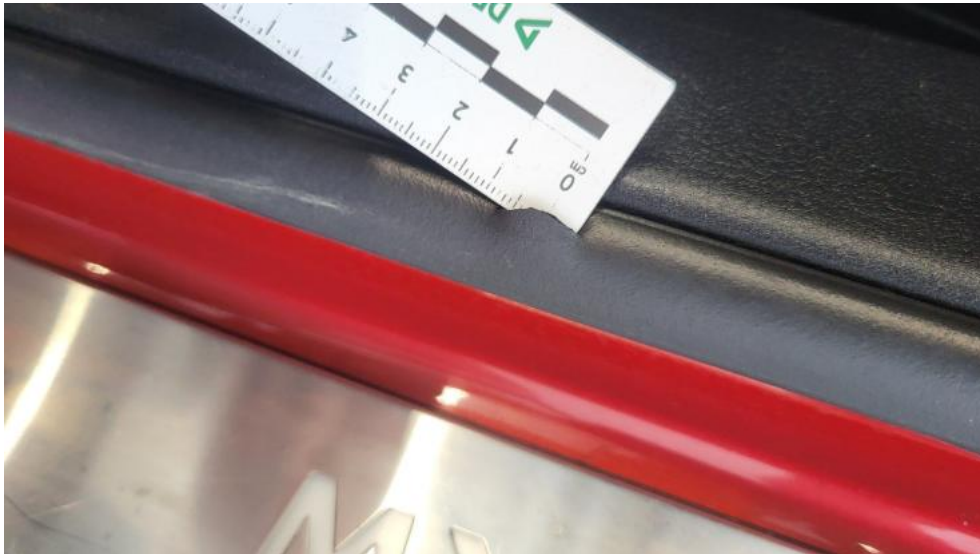
**Photo 91.**

Uszczelka drzwi przednich L - Pęknięcie/rozerwanie 1

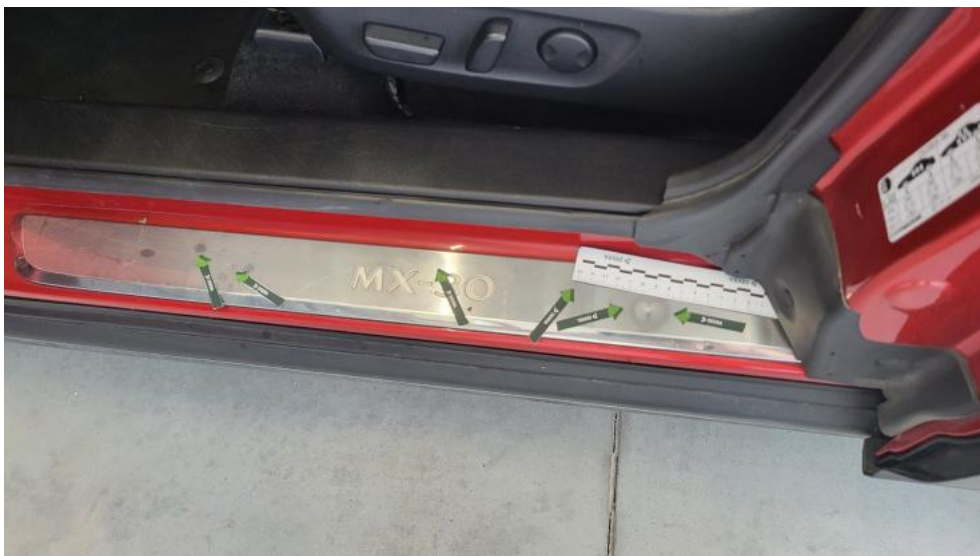
Listwy progowe lew. - Wgniecenie/odkształcenie 1

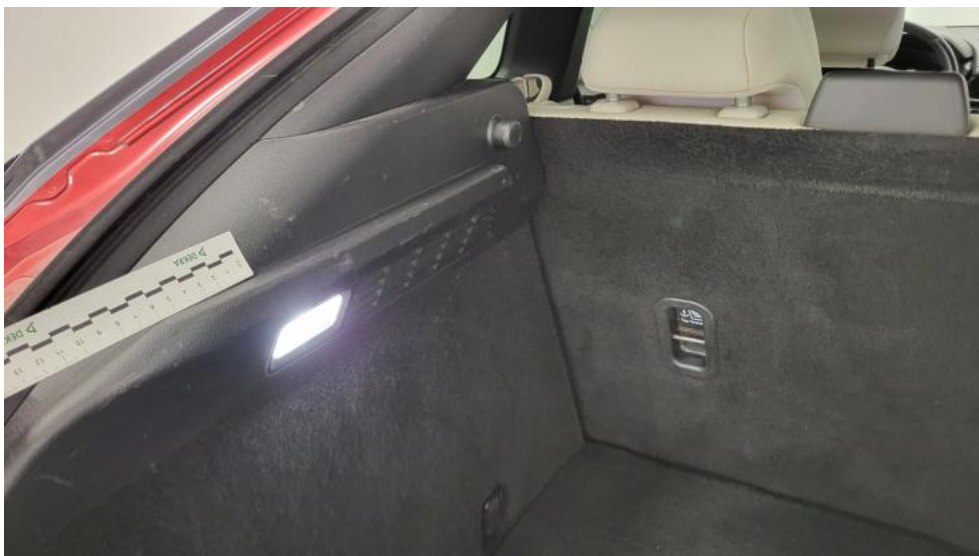
Półka/roleta tylna - Inne 1
