DEKRA's commission No. : PKOL(W)/LODZ/76732/26/08/17  
commission/ damage No. : 23/012899  
Date of commission: 17-08-2026

**Vehicle data**

| Manufacturer | BMW |
| Model | X7 [G07] 22- |

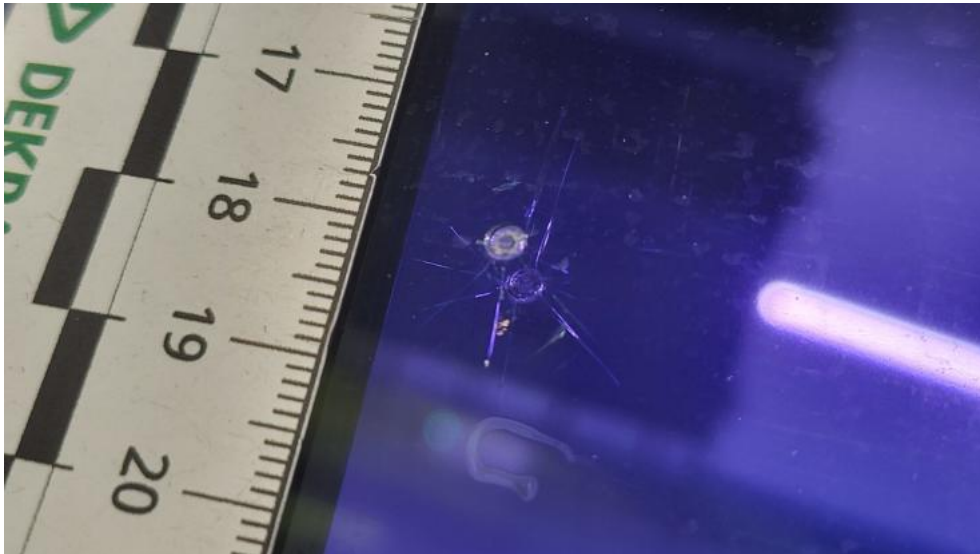
**Photo 53.**

Szyba czołowa - Pęknięcie/rozerwanie 1

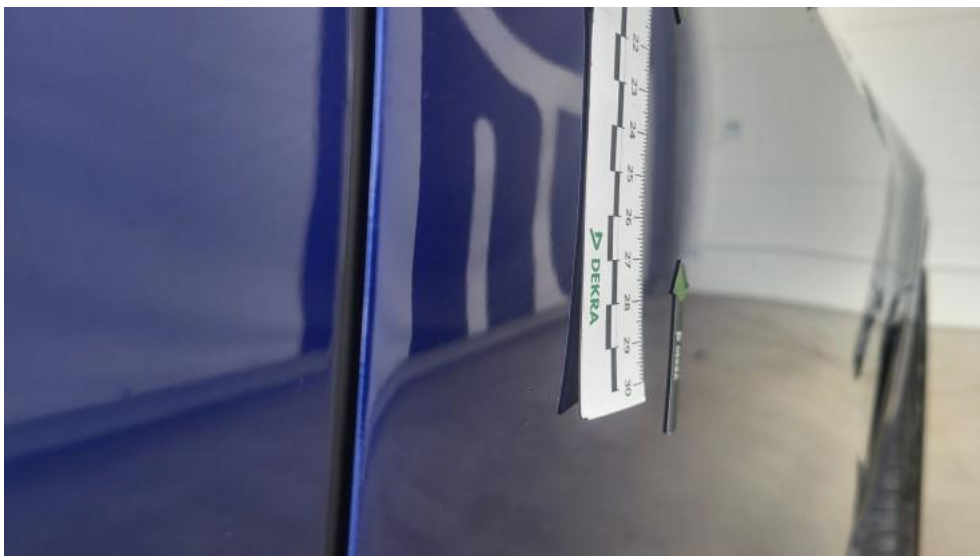
**Photo 58.**

Drzwi przednie P - Wgniecenie/odkształcenie 1

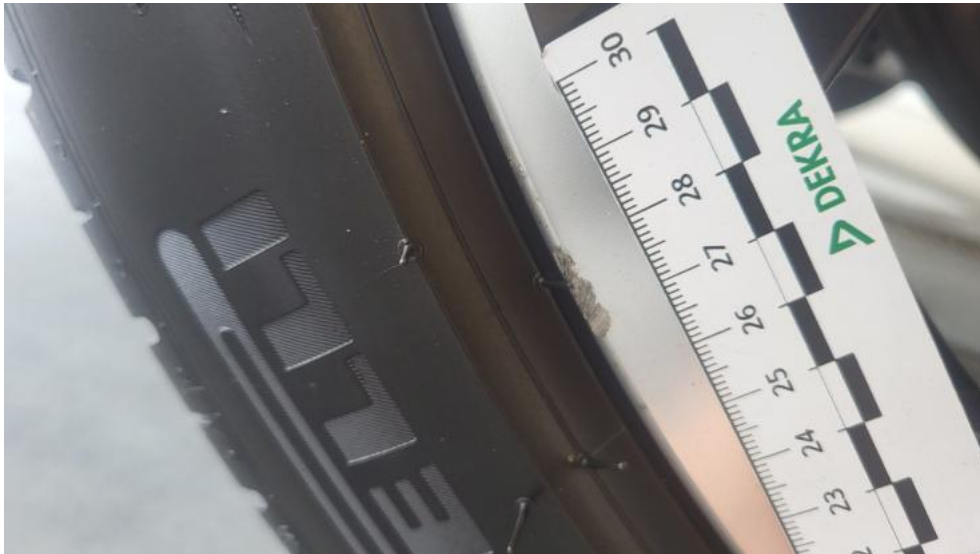
**Photo 59.**

Felga aluminiowa tylna P - Rysa/odprysk 1

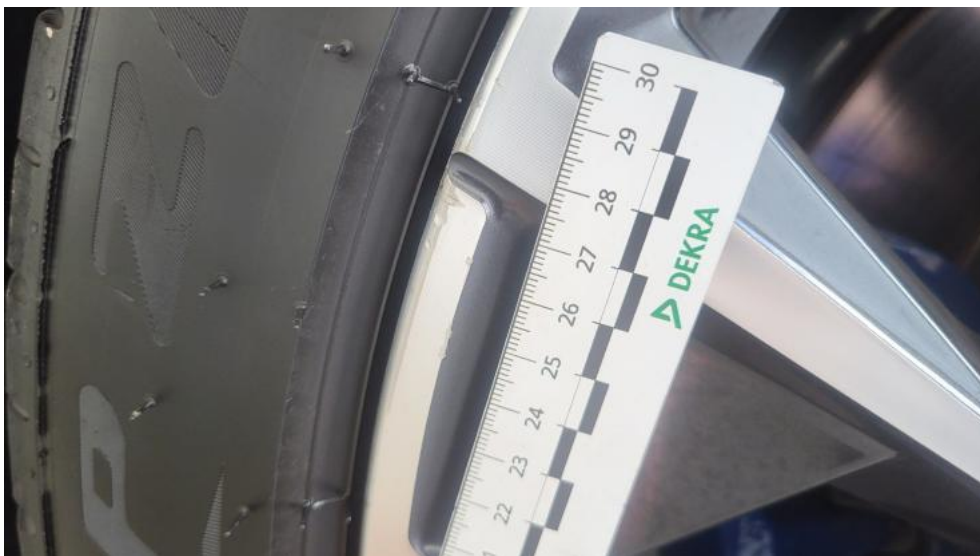
**Photo 60.**

Felga aluminiowa tylna L - Rysa/odprysk 1

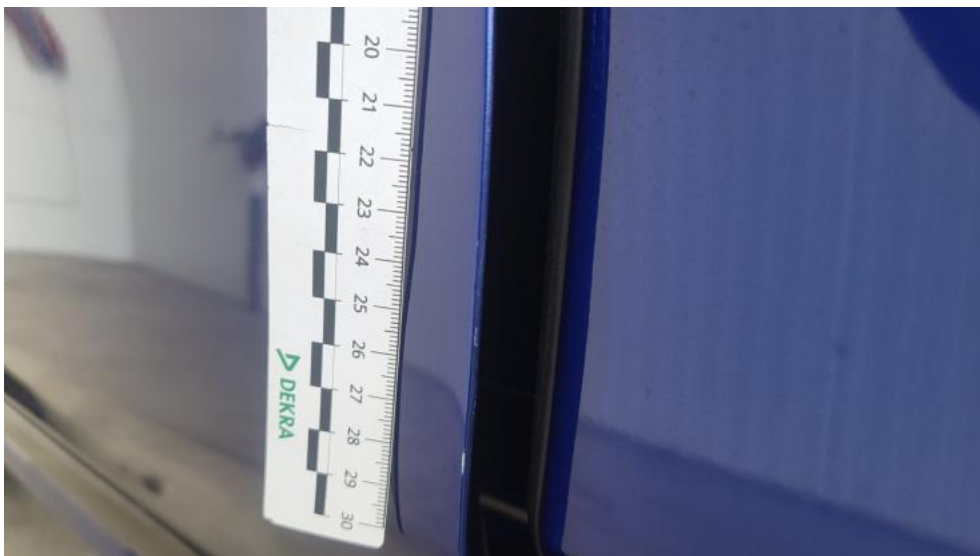
**Photo 62.**

Drzwi przed L - Rysa/odprysk 1

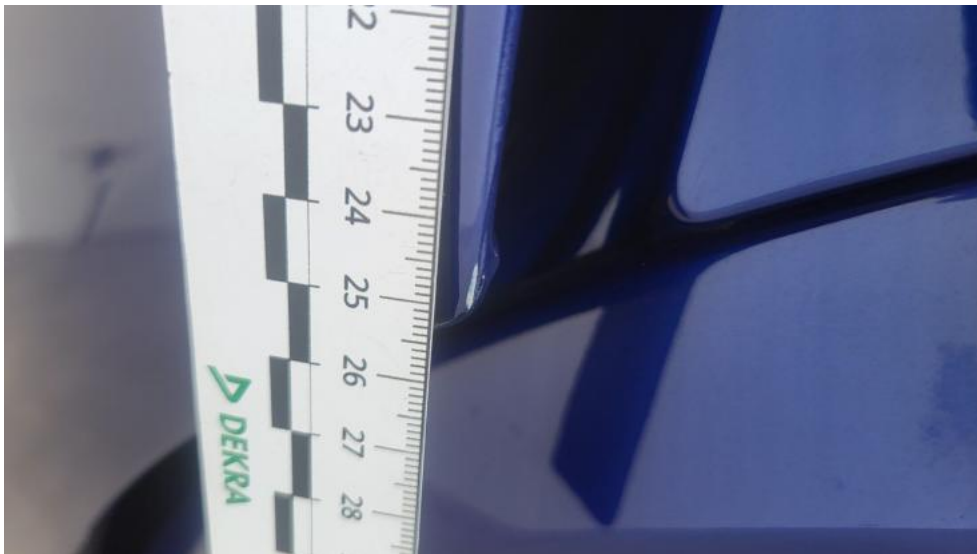
**Photo 65.**

Drzwi tylne L - Rysa/odprysk 1

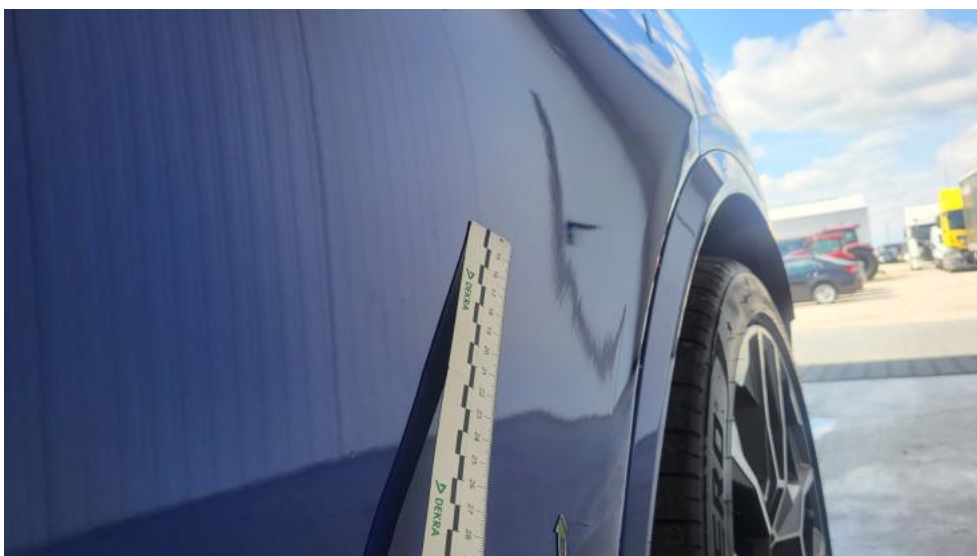
**Photo 66.**

Drzwi tylne L - Wgniecenie/odkształcenie 1
