DEKRA's commission No. : PKOL(W)/LODZ/91148/26/09/29  
commission/ damage No. : 21/047231  
Date of commission: 29-09-2026

| Manufacturer | ALFA ROMEO |
| Type / version | Stelvio 2.0 Turbo Business Q4 aut |
| VIN / serial number | ZARPAHLN7M7D15529 |

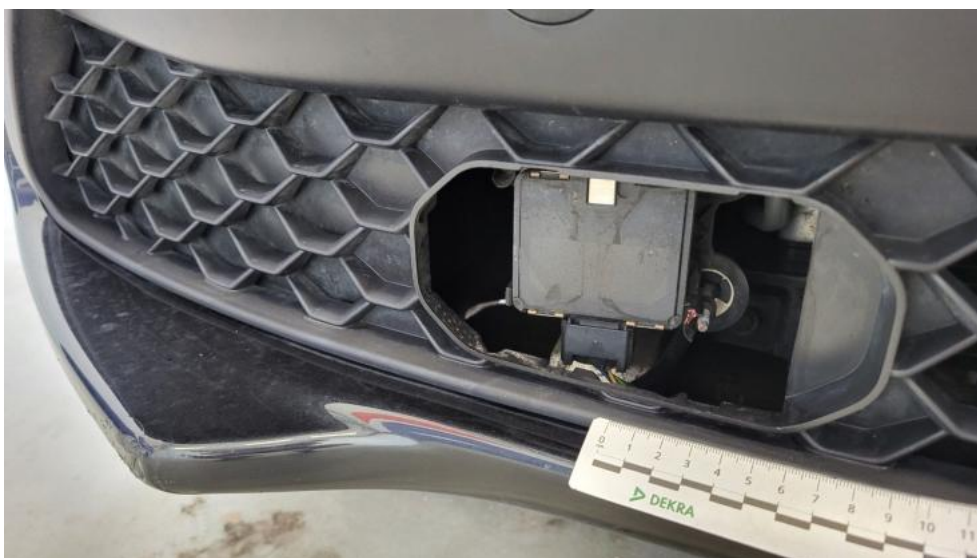
**Photo 42.**  
Kratka/zaślepka halogenu P - Inne 1

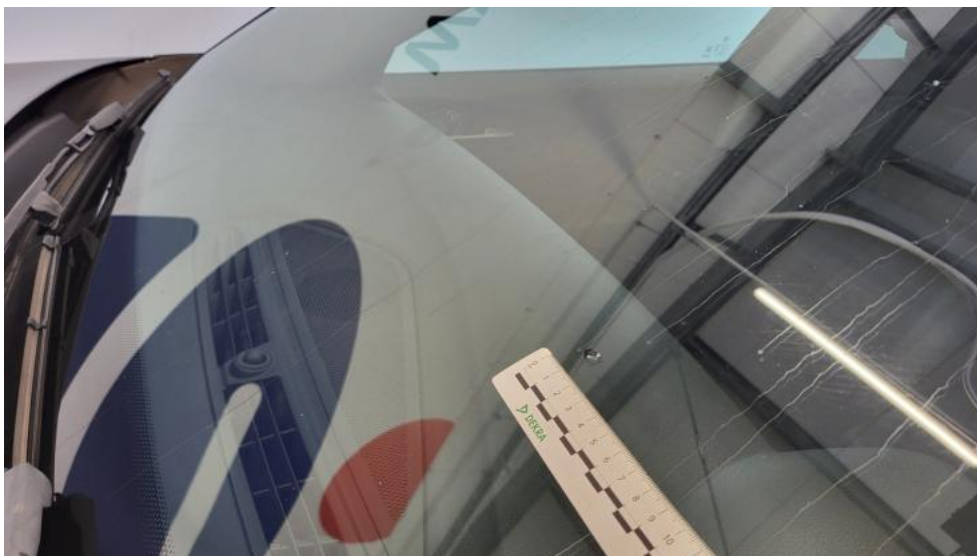
**Photo 43.**

Rysy na samochodzie. Niesprawne przyciski funkcyjne w jednym z kluczyków, grot prawidłowy. Odpryski na szybie czołowej.

Szyba czołowa - zdjęcie poglądowe 1

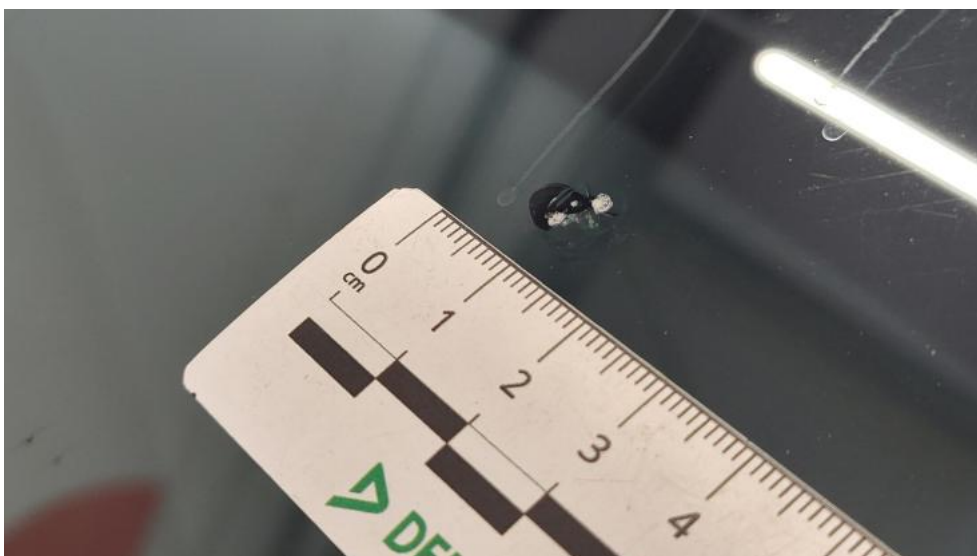
**Photo 44.**

Szyba czołowa - Pęknięcie/rozerwanie 1

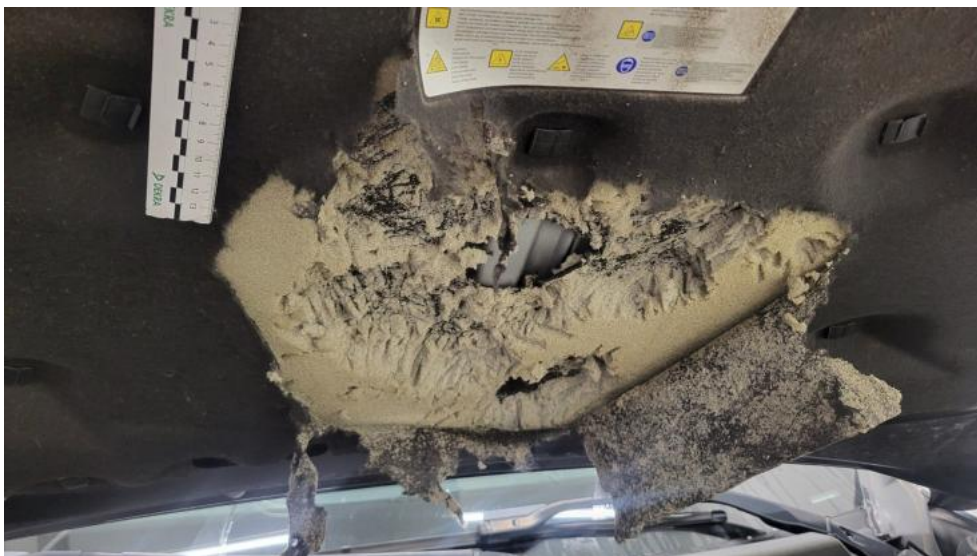
**Photo 45.**

Wykładzina pokrywy komory silnika - Pęknięcie/rozerwanie 1

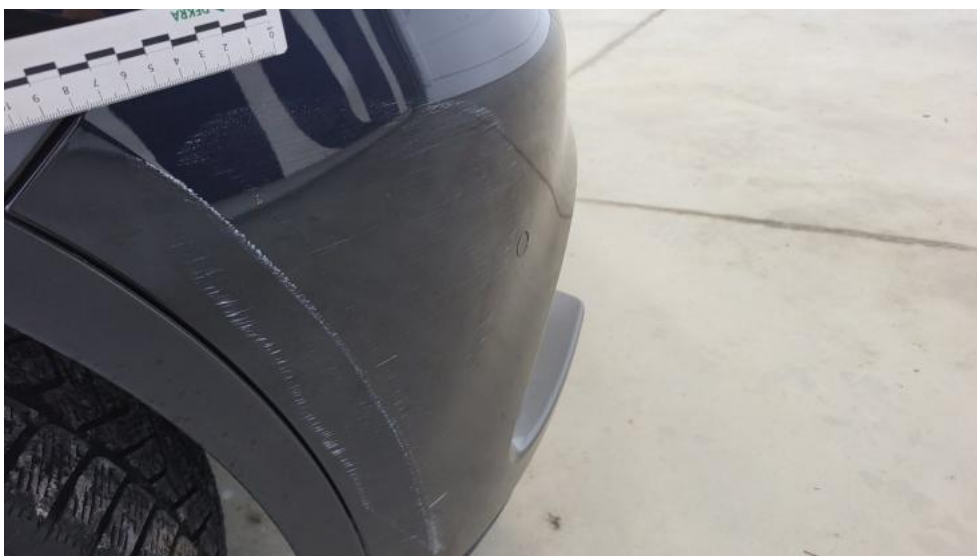
**Photo 46.**

Zderzak - Rysa/odprysk 1

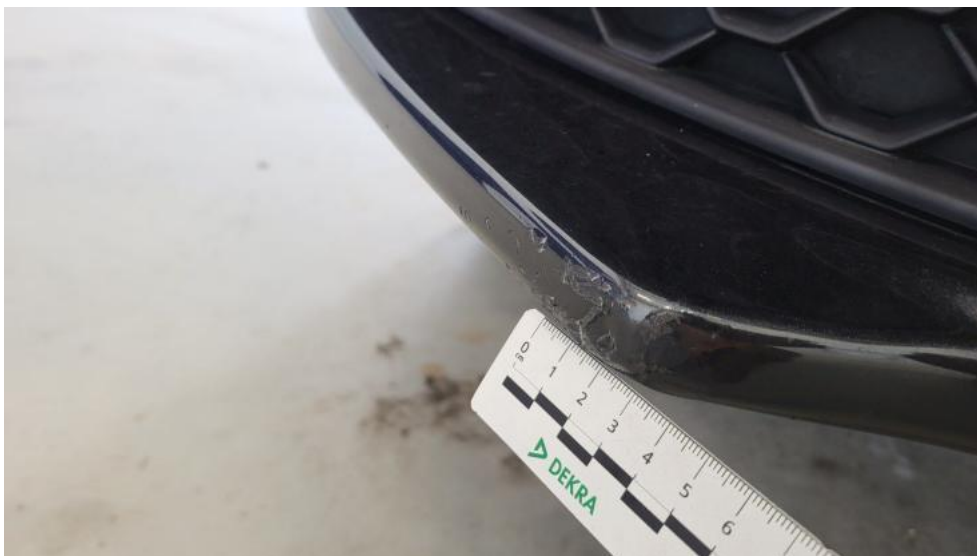
**Photo 47.**

Zderzak - Wgniecenie/odkształcenie 1

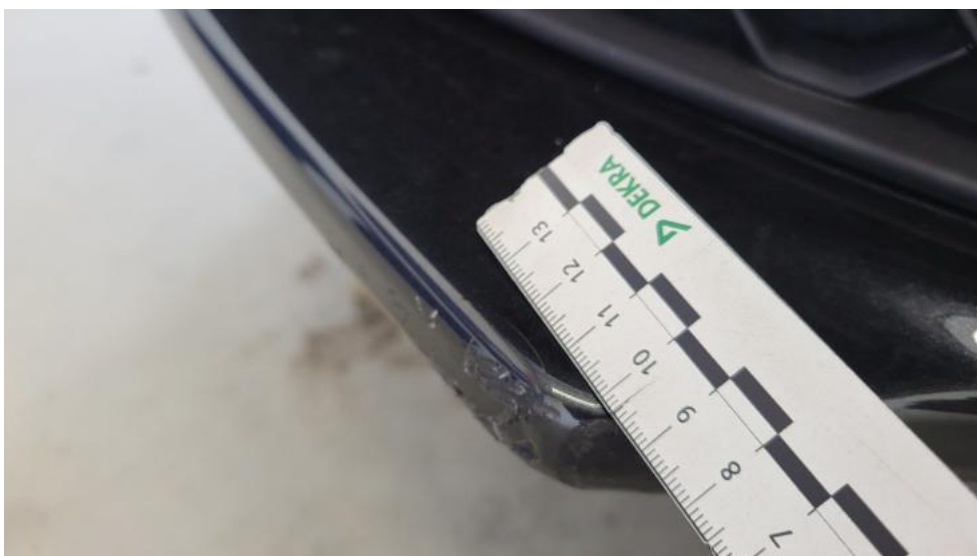
**Photo 48.**

Zderzak - Pęknięcie/rozerwanie 1

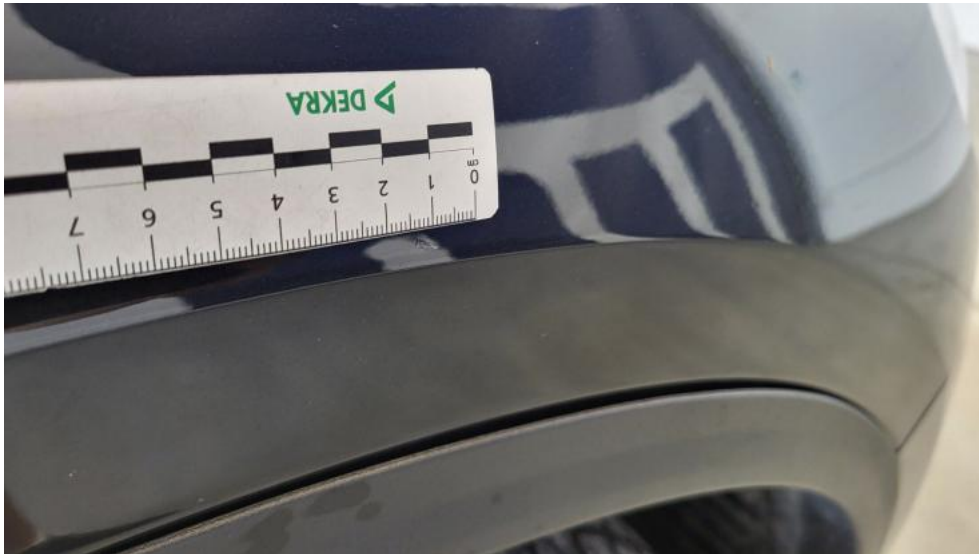
**Photo 49.**

Błotnik przedni P - Rysa/odprysk 1

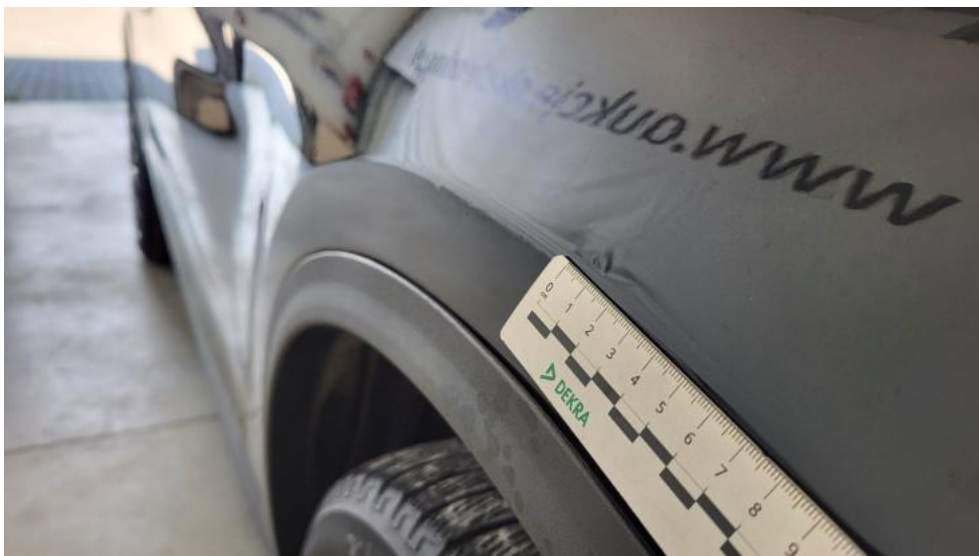
**Photo 50.**

Błotnik przedni P - Wgniecenie/odkształcenie 1

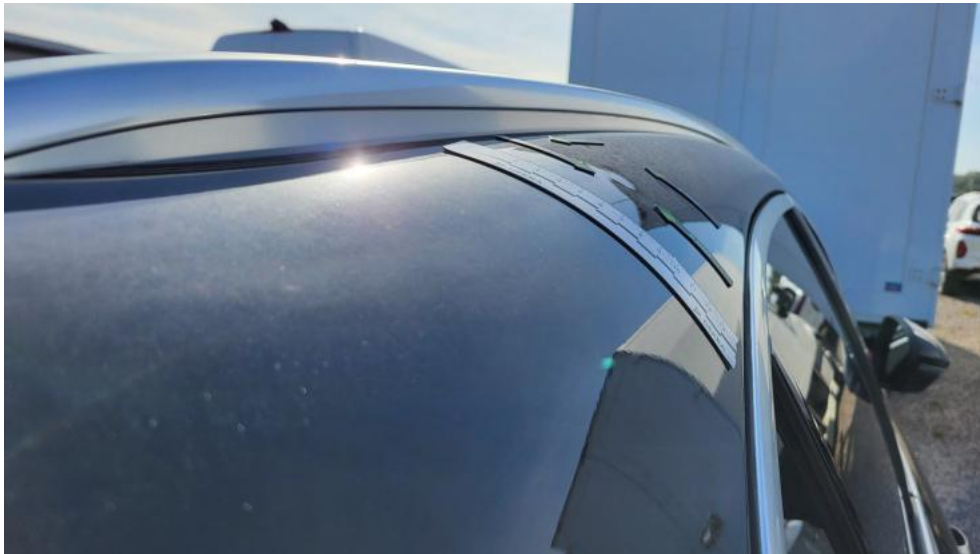
**Photo 53.**

Błotnik tylny P / Ściana boczna P() - Wgniecenie/odkształcenie 3

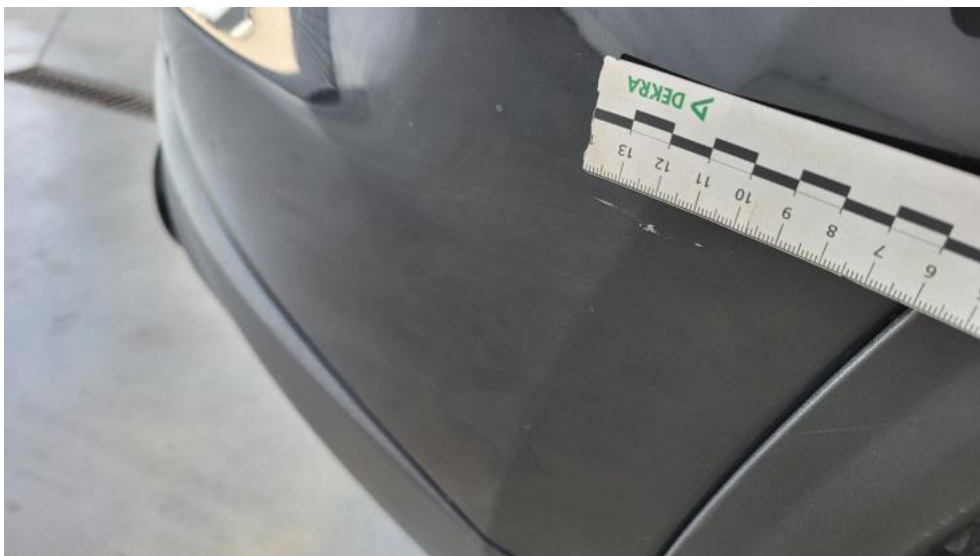
**Photo 54.**

Zderzak tylny - Rysa/odprysk 1

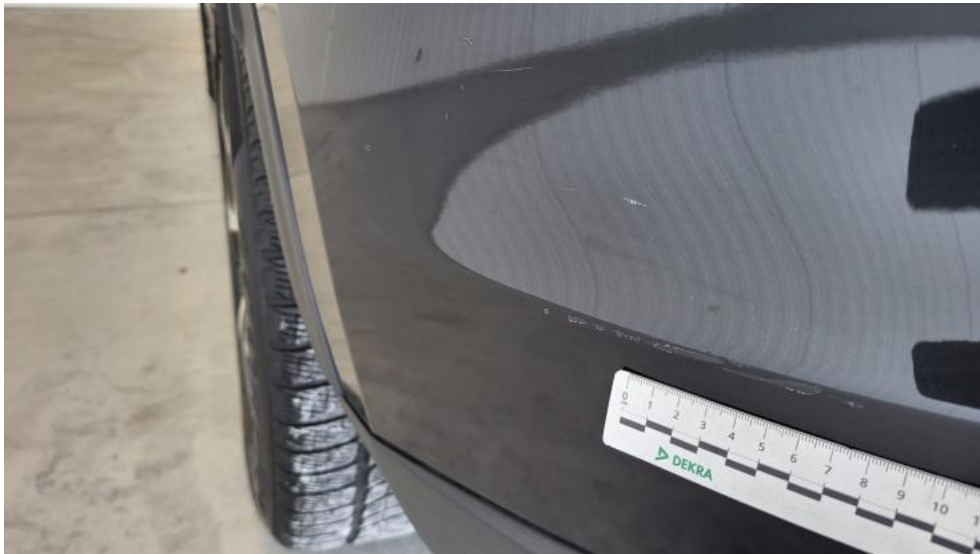
**Photo 55.**

Zderzak tylny - Rysa/odprysk 2

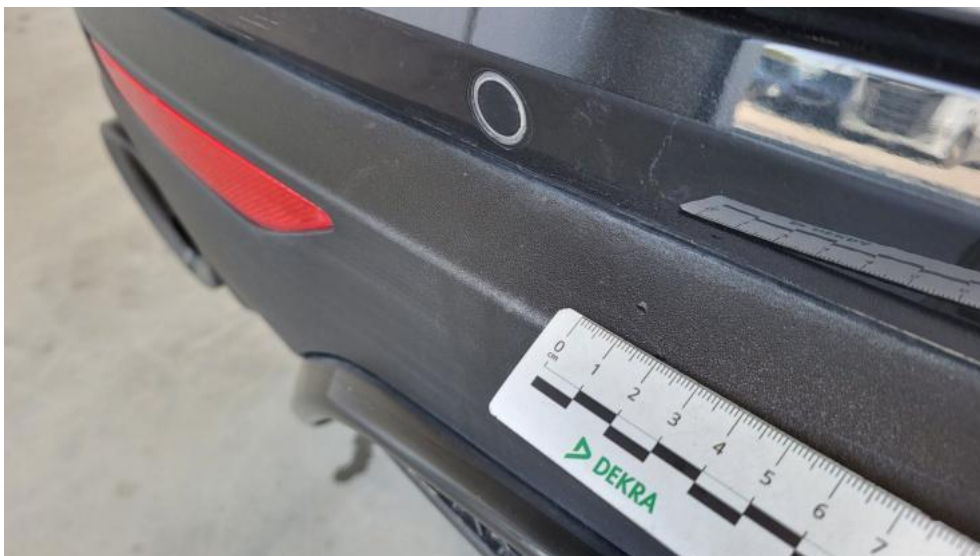
**Photo 56.**

Zderzak tylny cz dolna - Rysa/odprysk 1

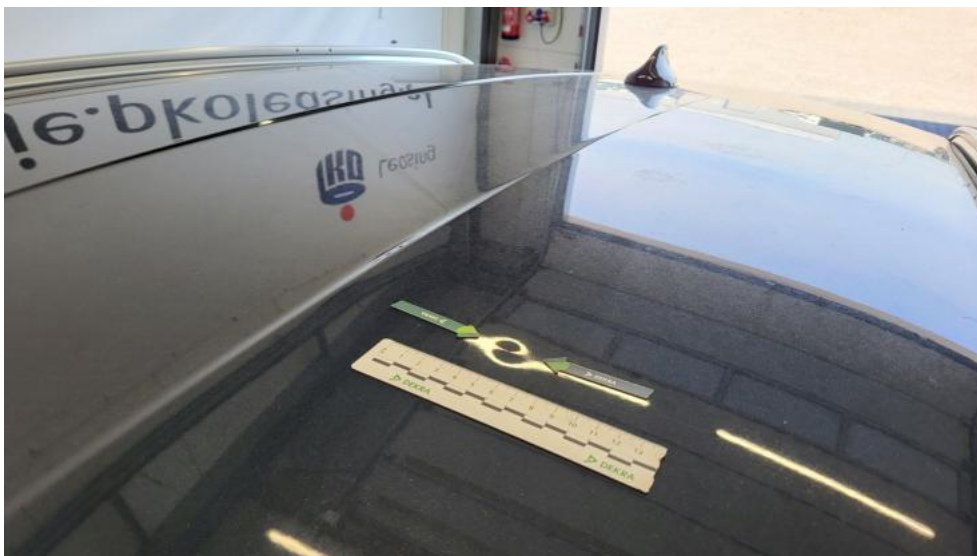
**Photo 57.**

Dach - Wgniecenie/odkształcenie 1

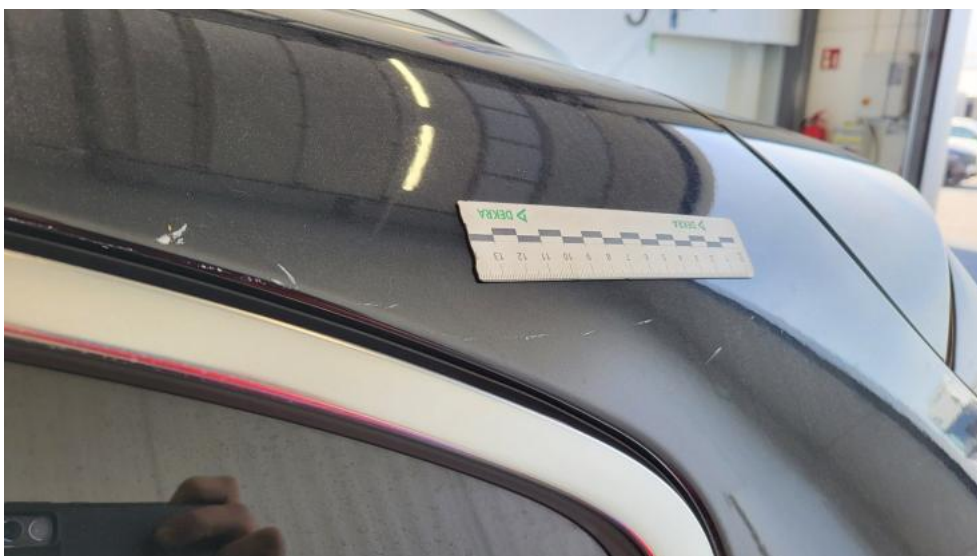
**Photo 58.**

Ścianka tylna L / Ścianka boczna L - Rysa/odprysk 1

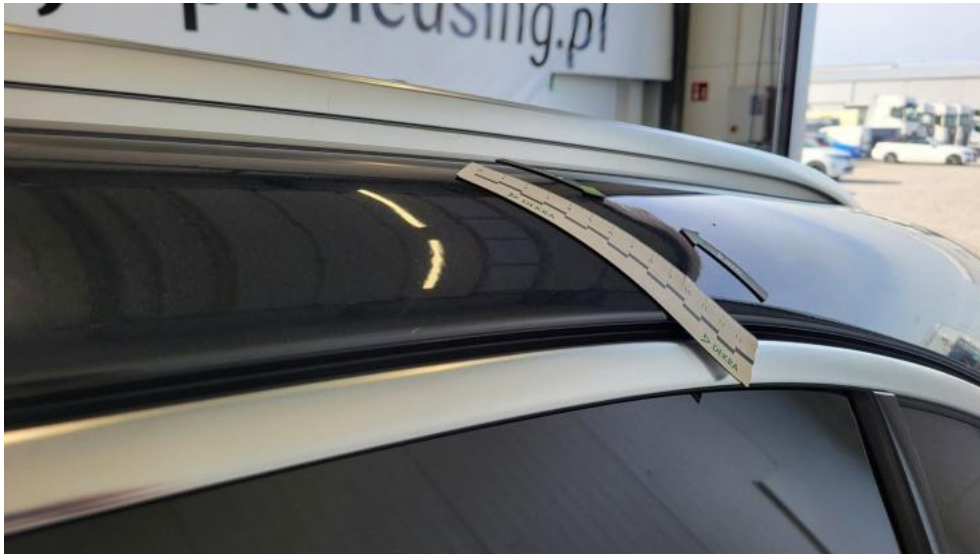
**Photo 59.**

Błotnik tylny L / Ściana boczna L - Wgniecenie/odkształcenie 1

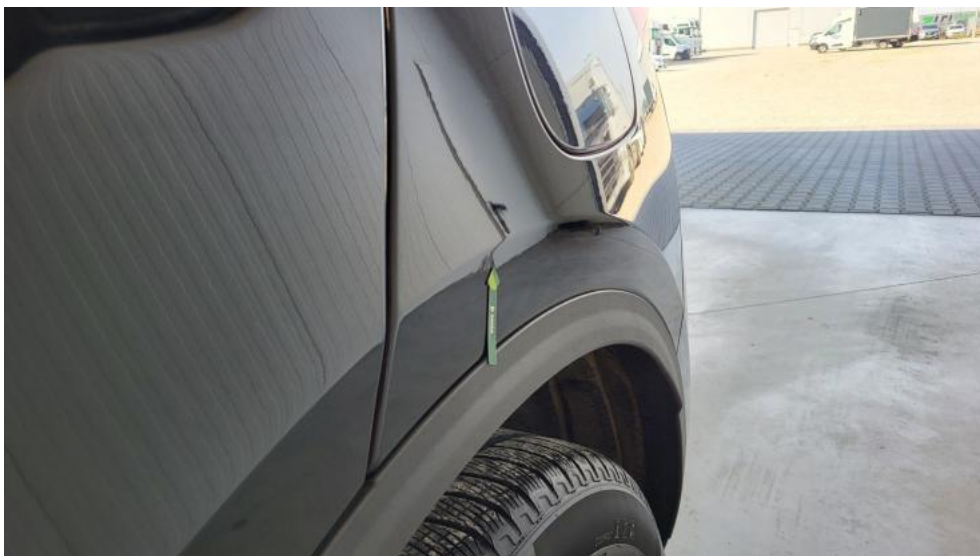
**Photo 60.**

Błotnik tylny L / Ściana boczna L - Wgniecenie/odkształcenie 2

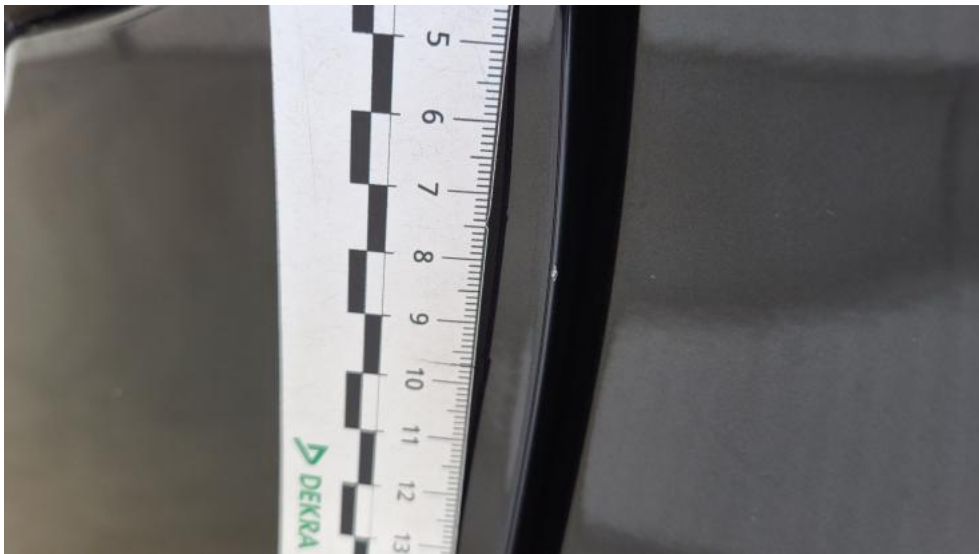
**Photo 61.**

Drzwi przed L - Rysa/odprysk 1

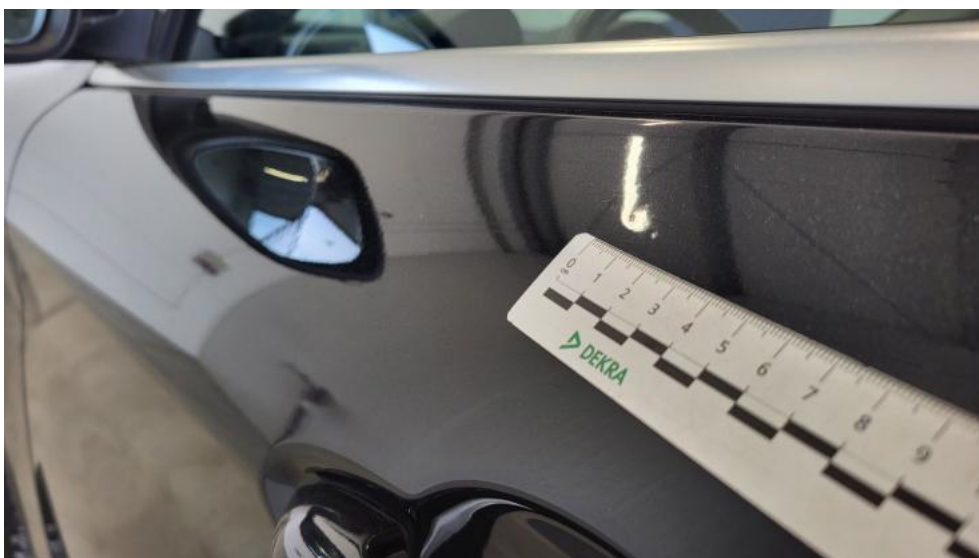
**Photo 62.**

Drzwi przed L - Wgniecenie/odkształcenie 1
