DEKRA's commission No. : PKOL(W)/LODZ/25486/26/03/23  
commission/ damage No. : 24/043938  
Date of commission: 23-03-2026

Group of objects (Eurotax)	cars
EC code (Eurotax)	0155574
Manufacturer	MITSUBISHI
Model	Space Star 20-25
Type / version	Space Star 1.2 Invite SDA CVT
Body type	hatchback
Number of doors / seats	5/5
Curb weight [kg]	900
Gross vehicle weight [kg]	1370
Wheelbase 1/2	2450
Engine type	spark ignition
Pollution reduction system	three-way catalytic converter
Engine capacity [ccm]	1193
Engine Power [hp/kW]	71/52
Gearbox	automatic
Registration /record No.	FZ1171V
VIN / serial number	MMCXTA03ARH016310
Date of first registration	06-11-2024
Date of next. tech. test	05-11-2027
Year of manufacture	2023
Readout [km]	28 738 (read)
Body color / type of coating	gray/double-layered, metallized

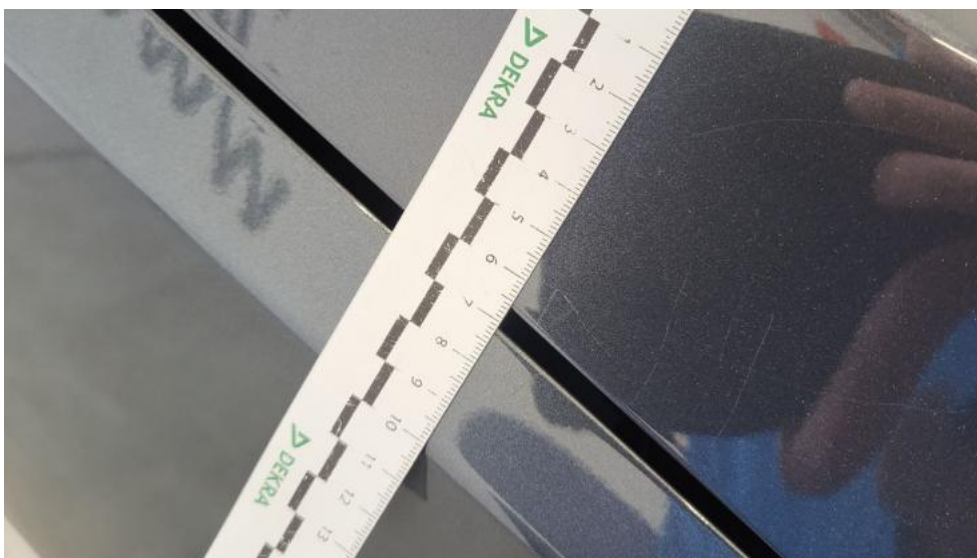
**Photo 36.**  
Pokrywa komory silnika - Rysa/odprysk 1

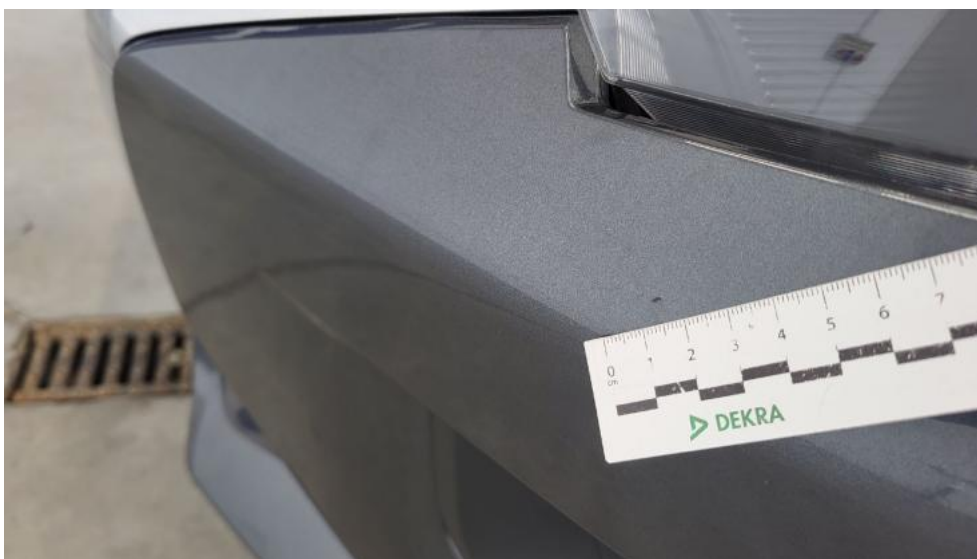
**Photo 37.**  
Zderzak - Rysa/odprysk 1

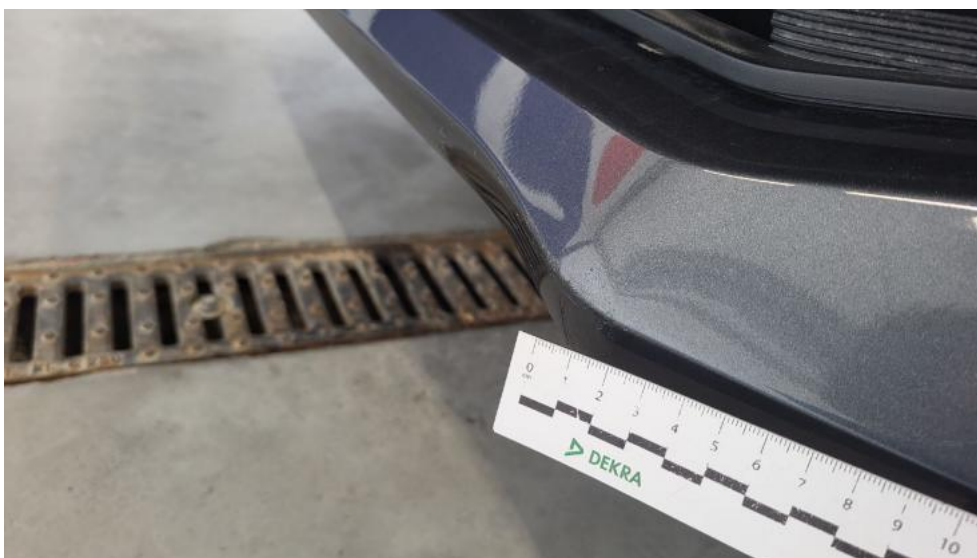
**Photo 38.**  
Zderzak - Wgniecenie/odkształcenie 1

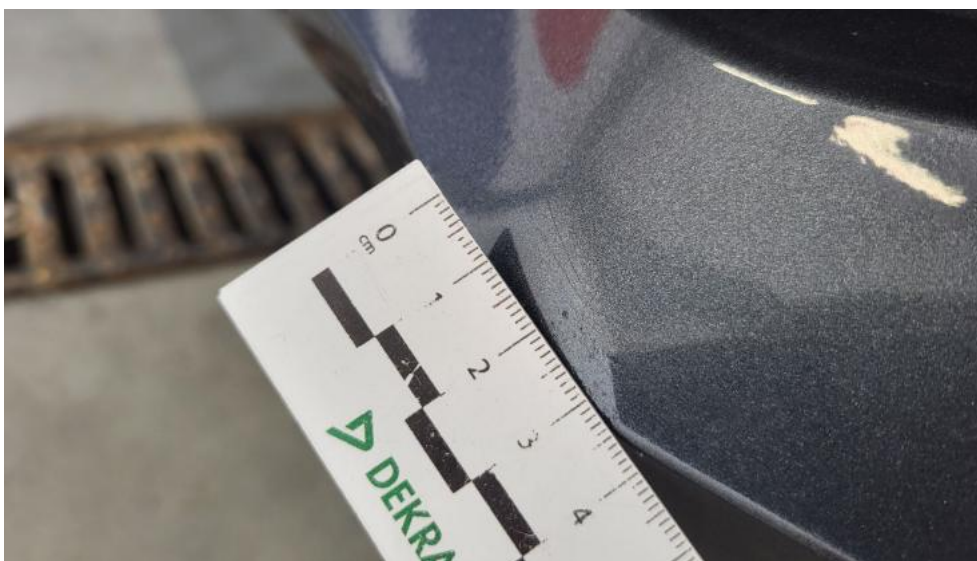
**Photo 39.**  
Zderzak - Pęknięcie/rozerwanie 1

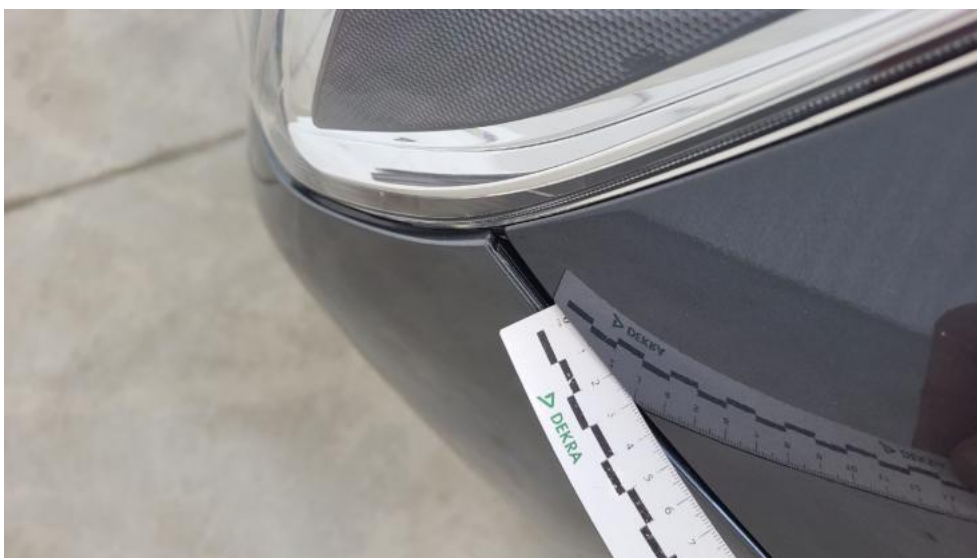
**Photo 40.**  
Zderzak - Inne 1

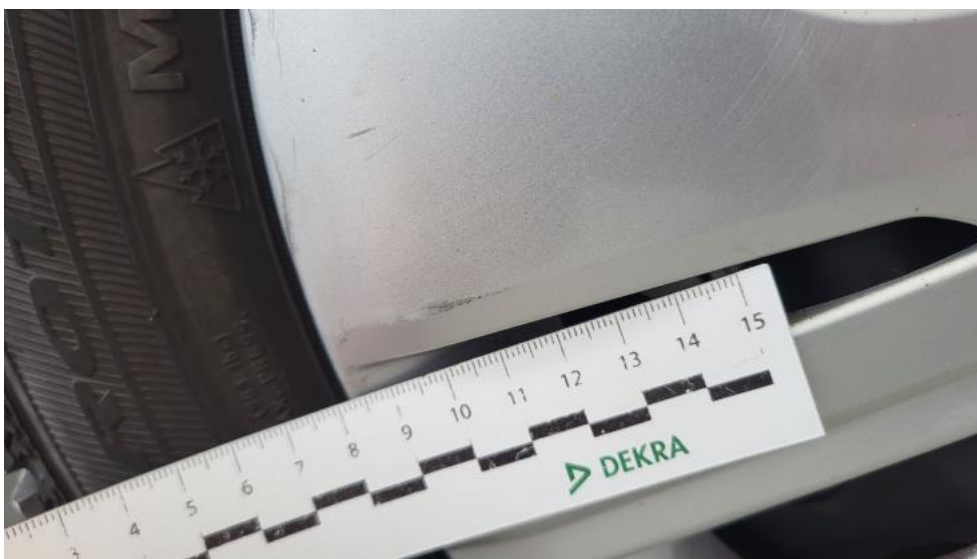
**Photo 41.**

Kołpak przedni P - Rysa/odprysk 1

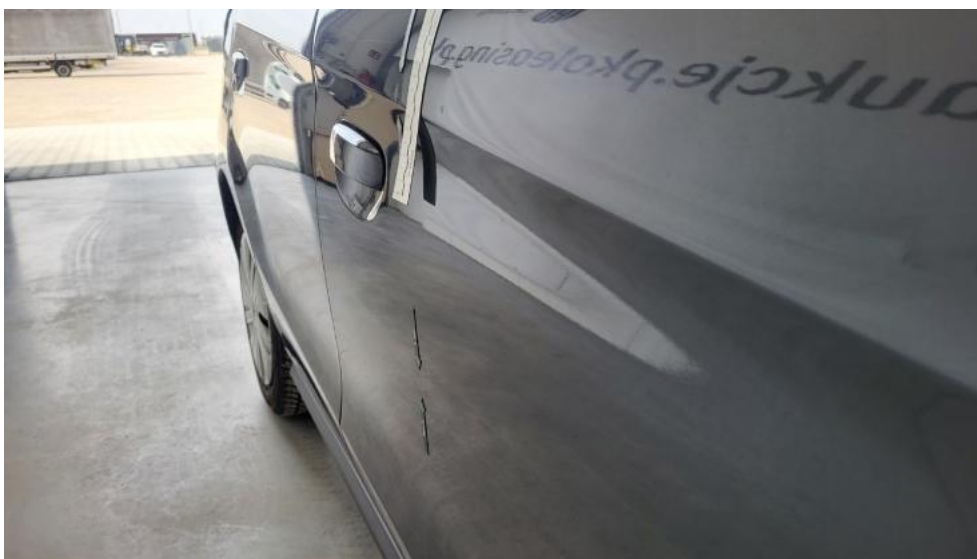
**Photo 43.**  
Drzwi przednie P - Wgniecenie/odkształcenie 1

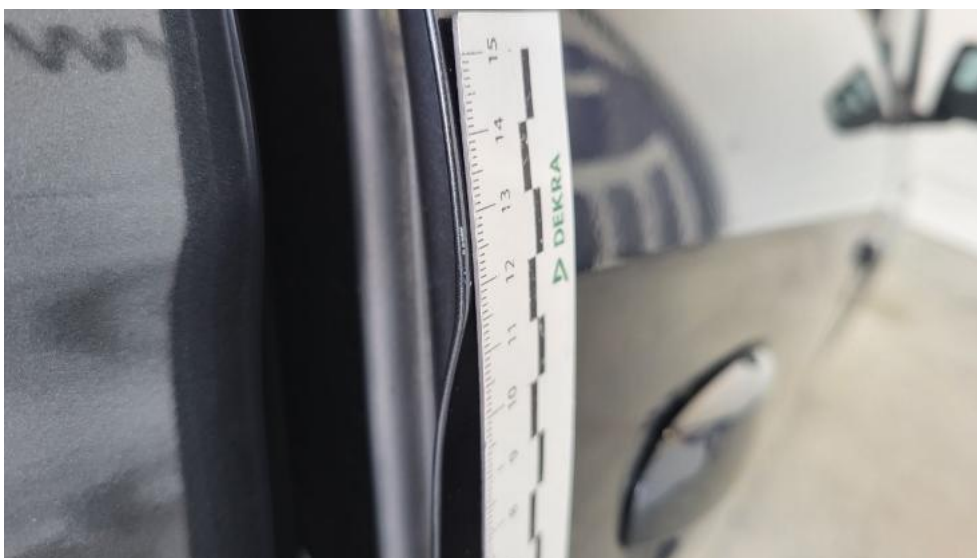
**Photo 44.**  
Drzwi tylne P - Rysa/odprysk 1

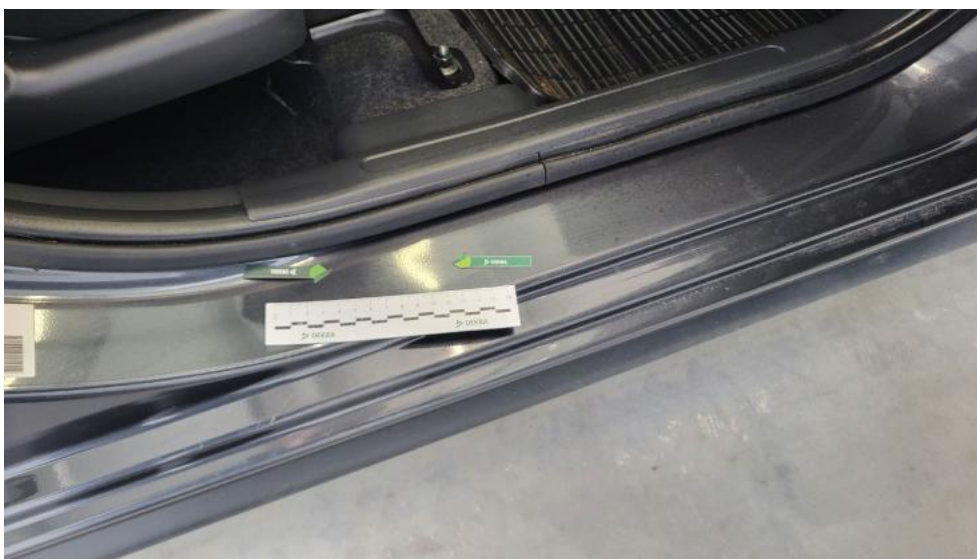
**Photo 45.**  
Próg P - Wgniecenie/odkształcenie 1

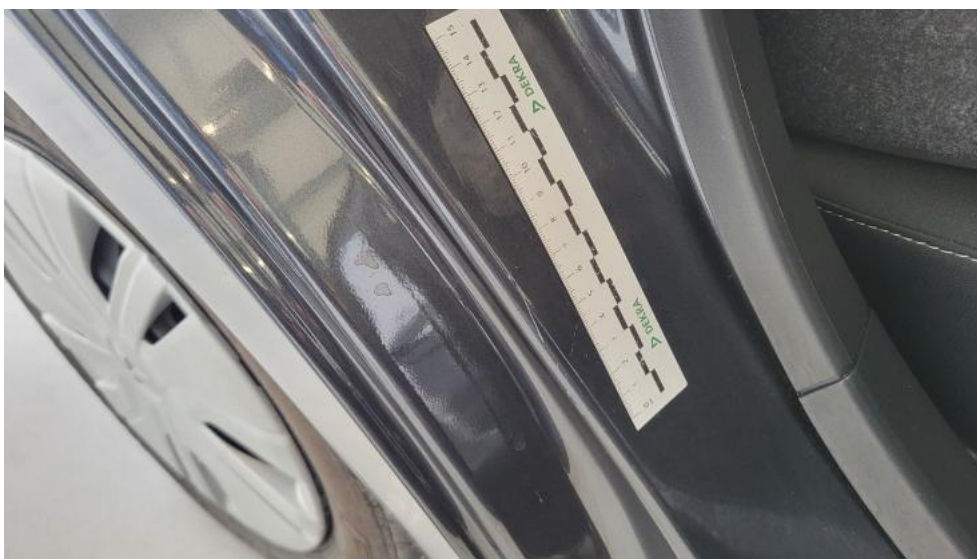
**Photo 47.**

Błotnik tylny P / Ściana boczna P - Rysa/odprysk 1

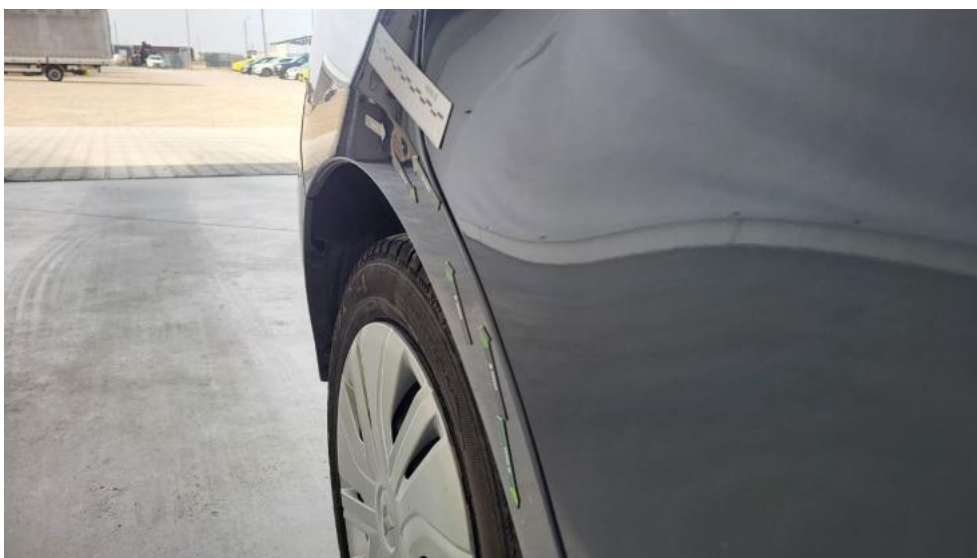
**Photo 48.**

Błotnik tylny P / Ściana boczna P - Wgniecenie/odkształcenie 1

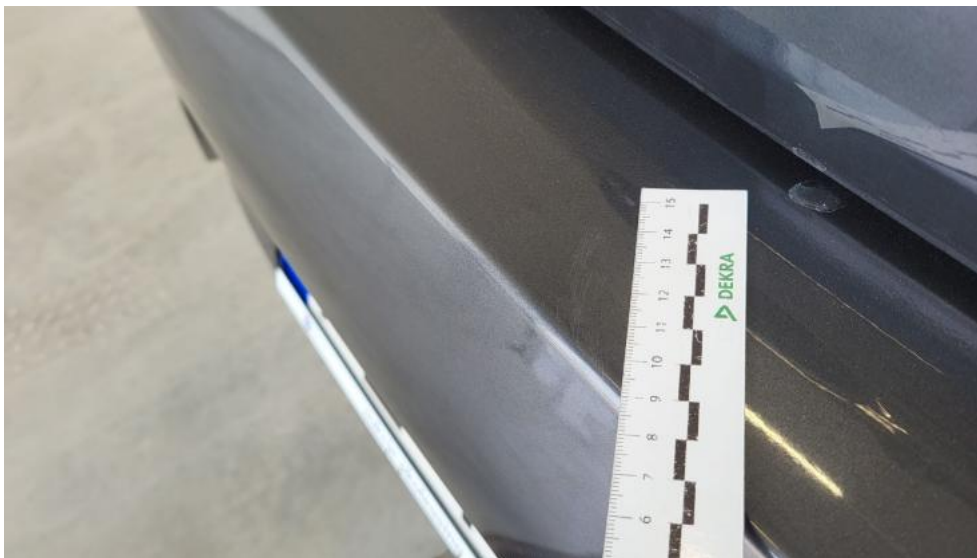
**Photo 49.**

Zderzak tylny - Rysa/odprysk 1

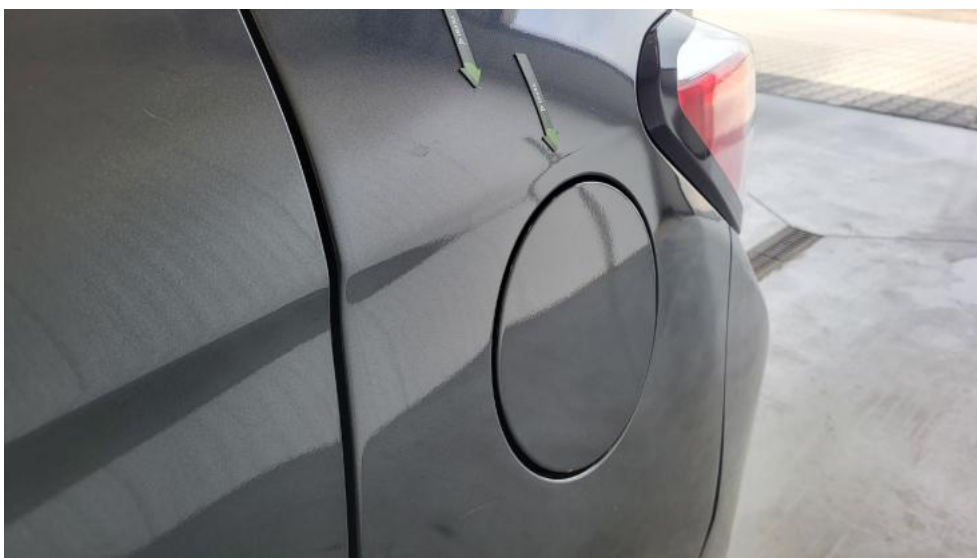
**Photo 50.**

Błotnik tylny L / Ściana boczna L - Wgniecenie/odkształcenie 1

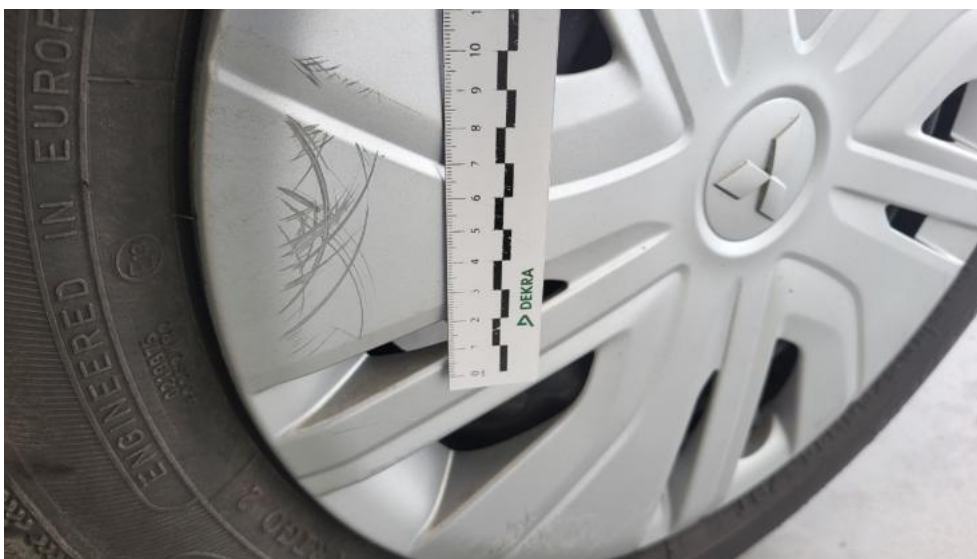
**Photo 51.**

Kółpak tylny L - Rysa/odprysk 1

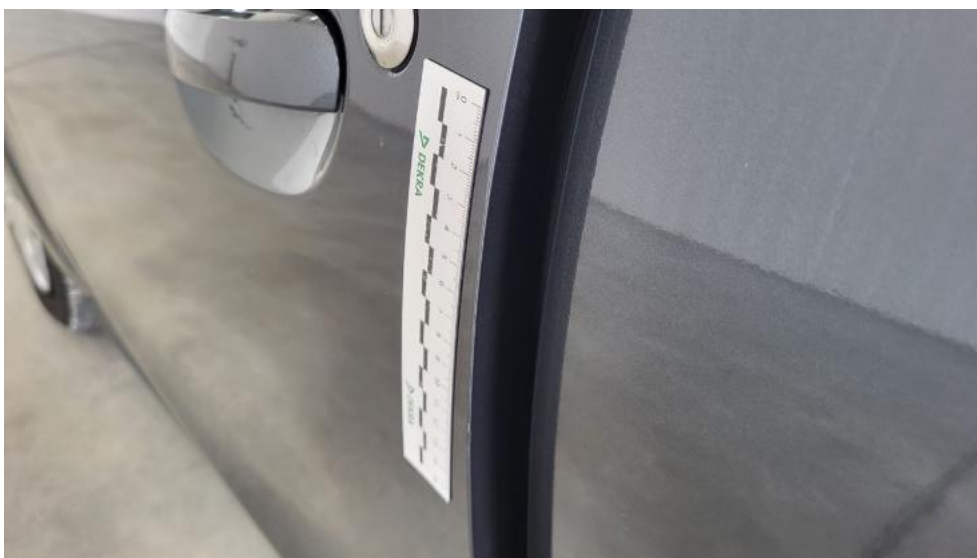
**Photo 52.**

Drzwi przed L - Rysa/odprysk 1

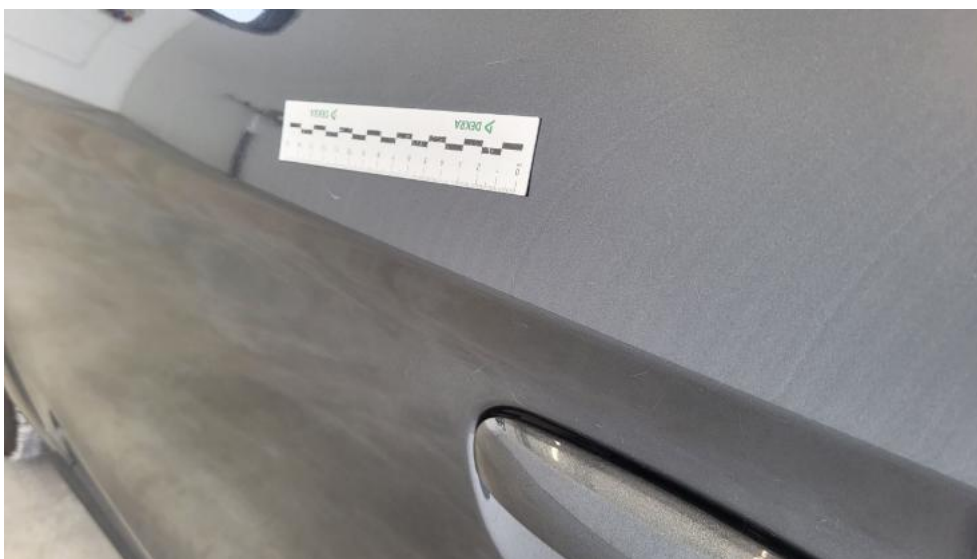
**Photo 53.**

Drzwi przed L - Rysa/odprysk 2

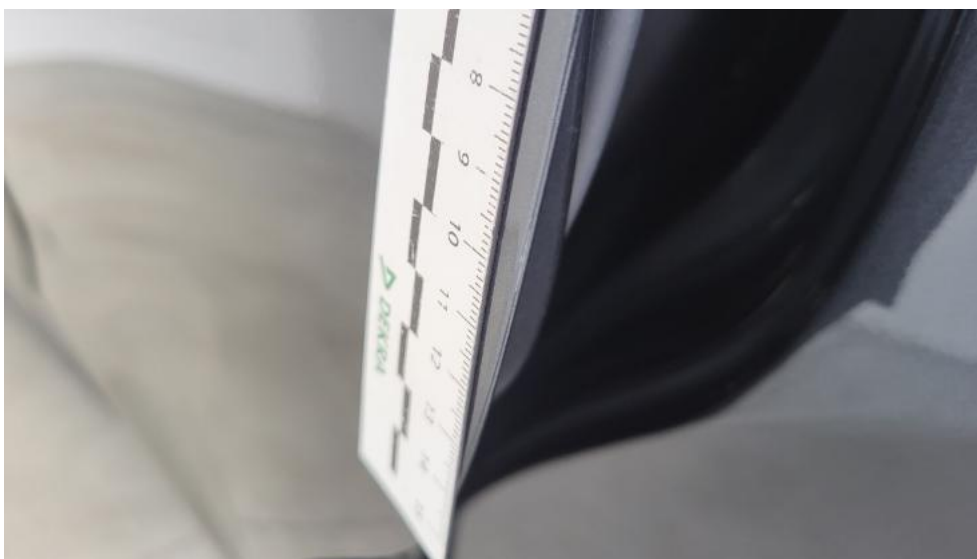
**Photo 55.**  
Drzwi tylne L - Rysa/odprysk 1

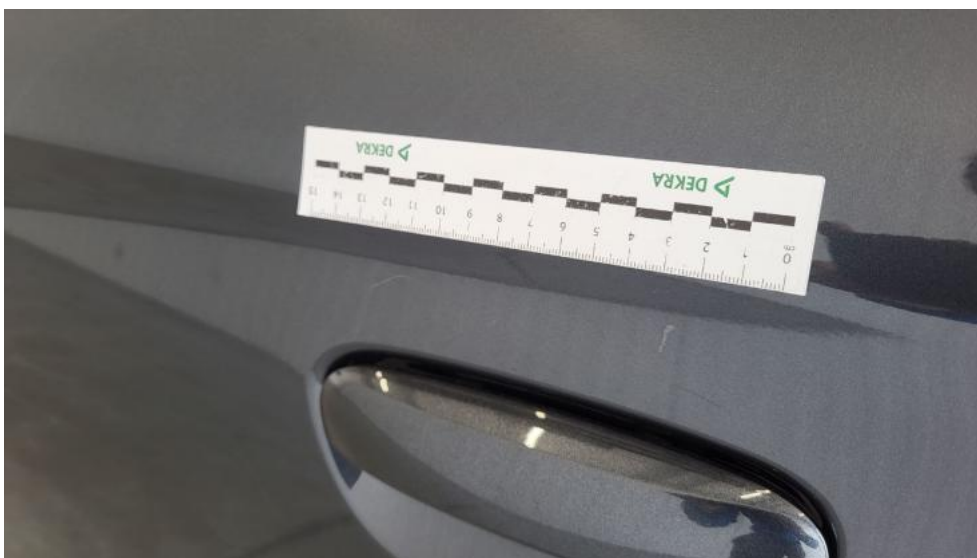
**Photo 56.**  
Drzwi tylne L - Rysa/odprysk 2

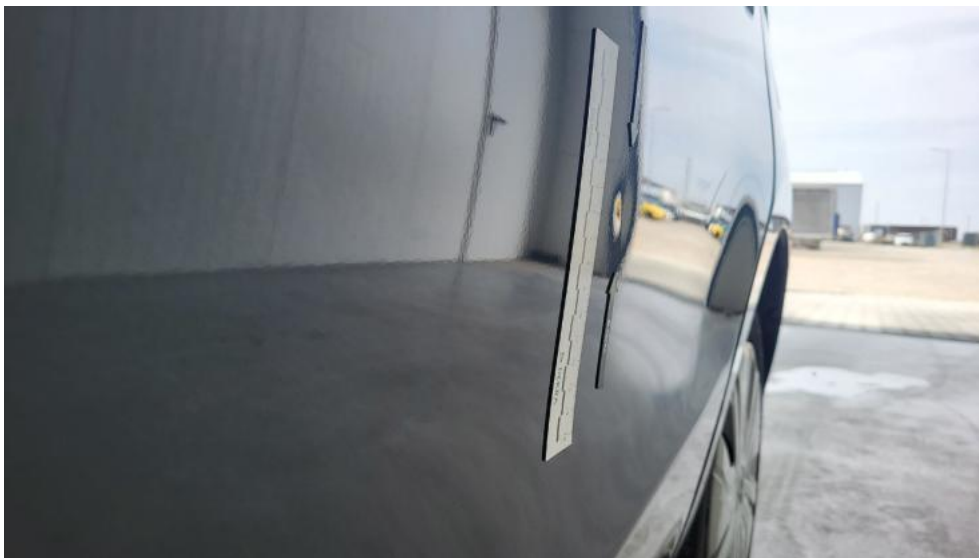
**Photo 57.**  
Drzwi tylne L - Wgniecenie/odkształcenie 1

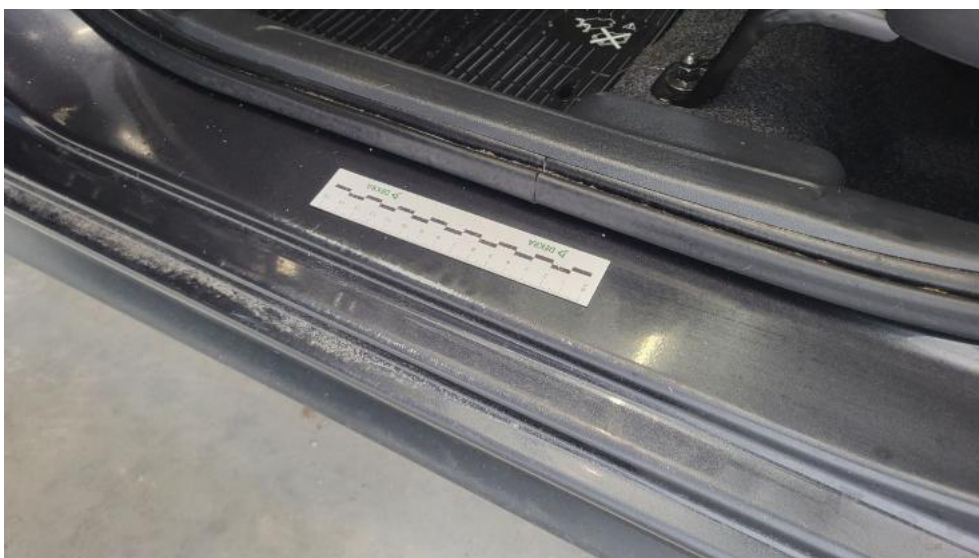
**Photo 58.**  
Próg L - Rysa/odprysk 1

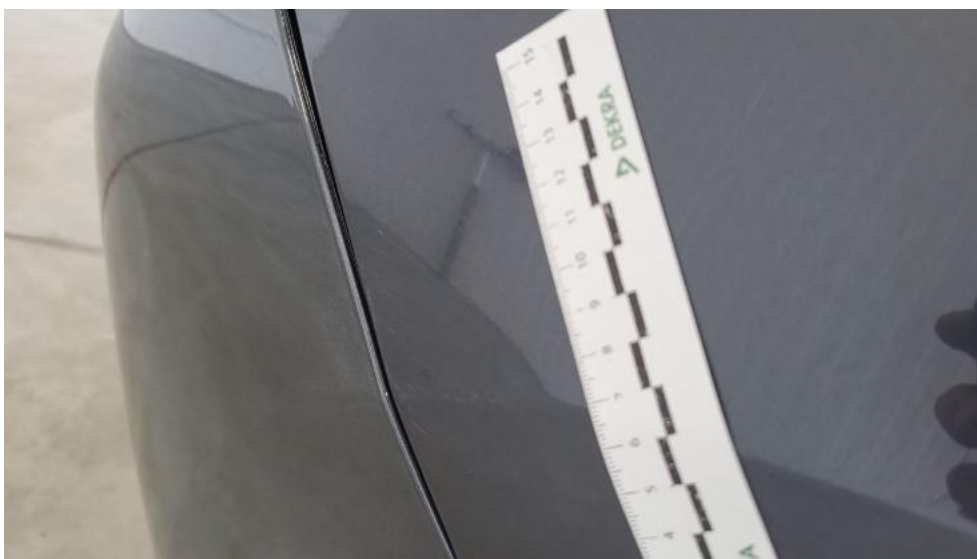
**Photo 59.**

Błotnik przedni L - Rysa/odprysk 1

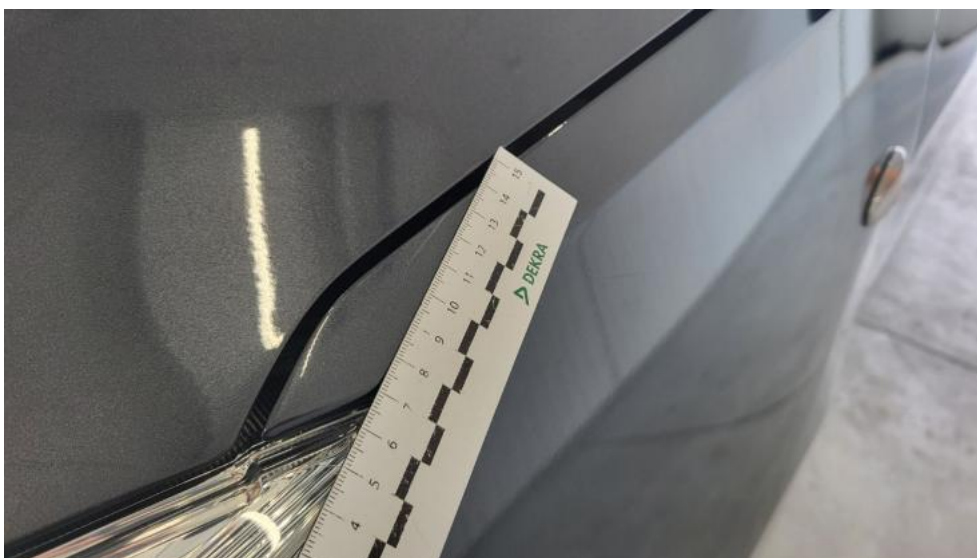
**Photo 60.**

Błotnik przedni L - Rysa/odprysk 2

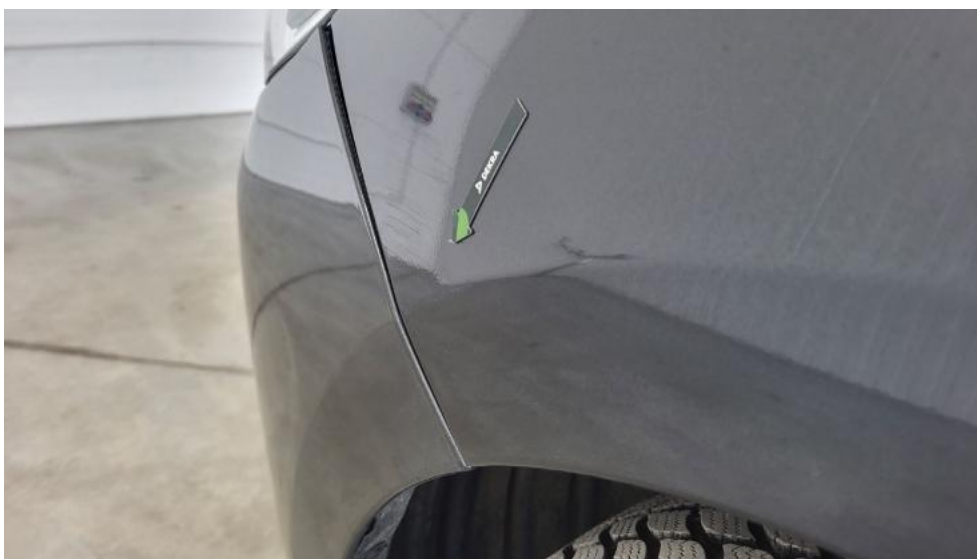
**Photo 61.**  
Błotnik przedni L - Wgniecenie/odkształcenie 1

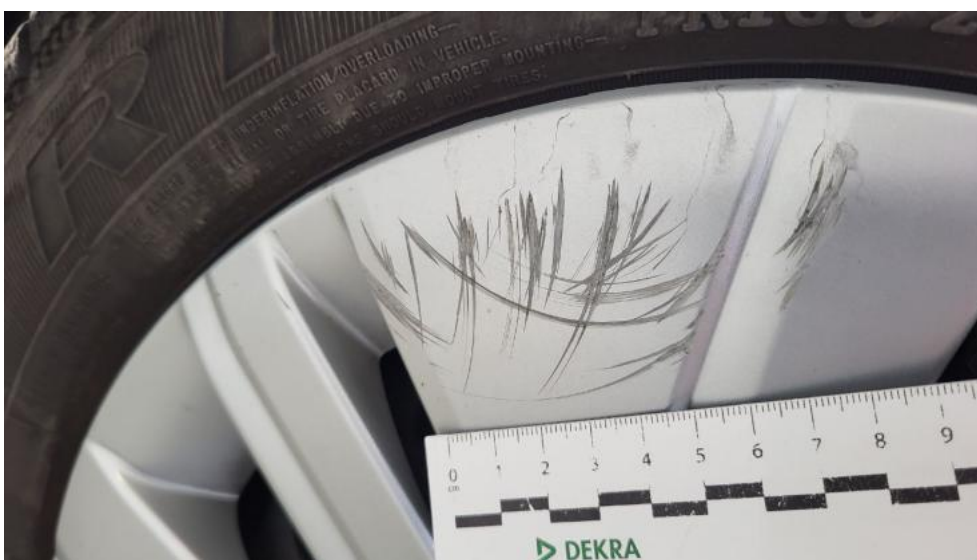
**Photo 62.**  
Kołpak przedni L - Rysa/odprysk 1

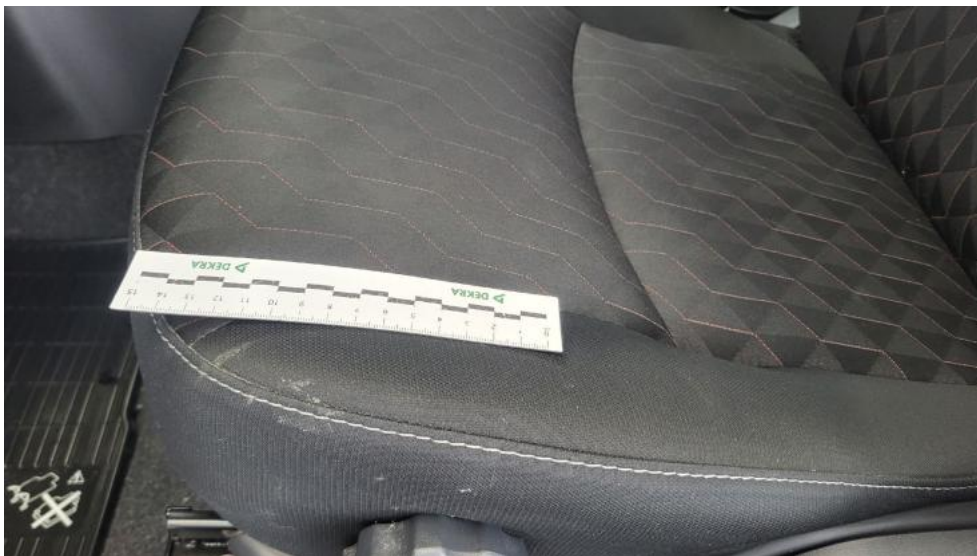
**Photo 63.**  
Fotel prz. lew. - Inne 1

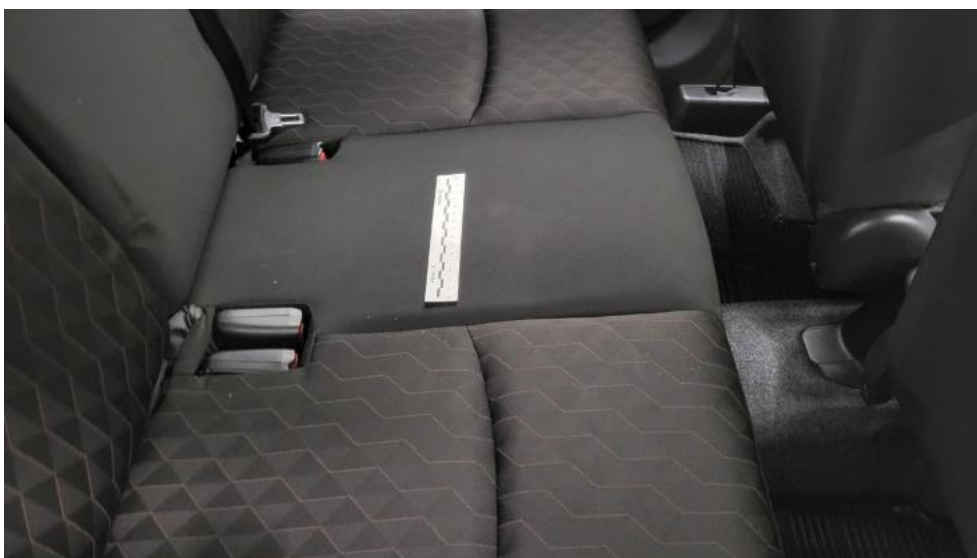
**Photo 64.**  
Kanapa tyl. - Inne 1

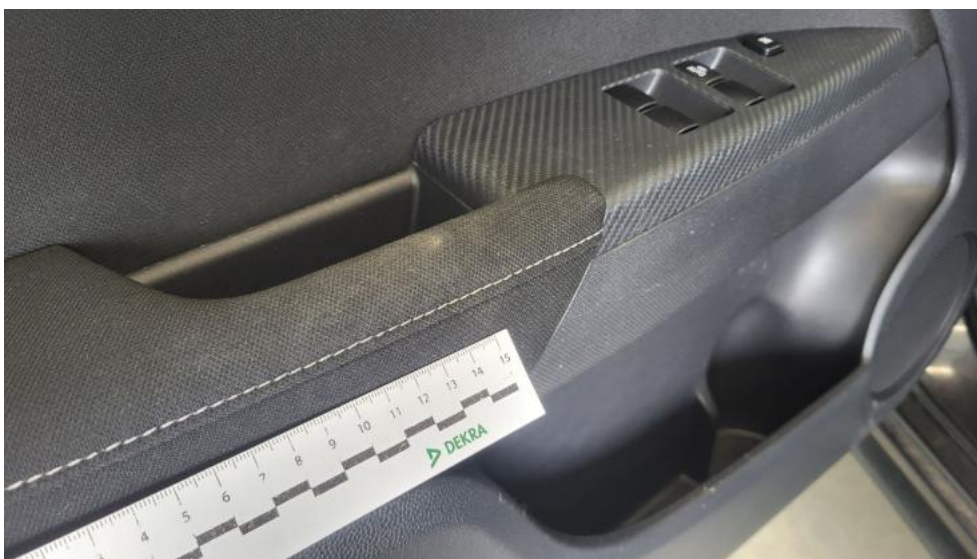
**Photo 65.**

Tapicerka drzwi przednich L - Inne 1

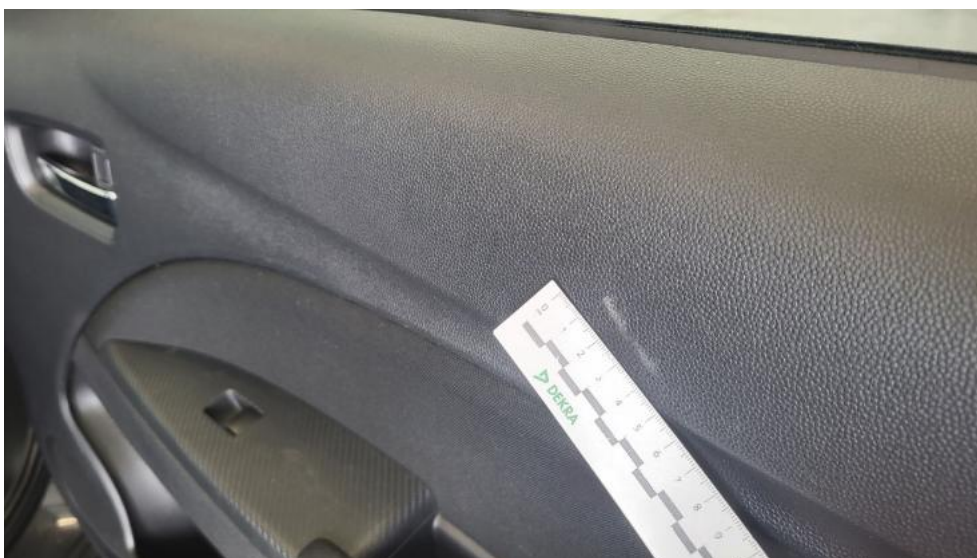
**Photo 66.**

Tapicerka drzwi przednich P - Inne 1

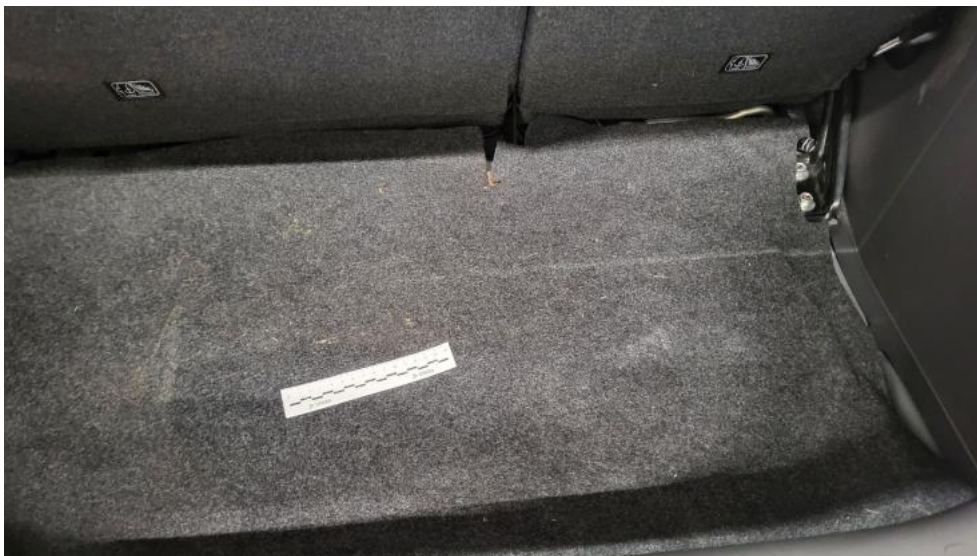
**Photo 67.**

Wykładzina podłogi bagażnika - Inne 1
