DEKRA's commission No. : PKOL(W)/LODZ/67876/26/07/21  
commission/ damage No. : PS22/02298  
Date of commission: 21-07-2026

**DEKRA Poland - Headquarters**  
02-673 Warszawa, ul. Konstruktorska 12A

| Manufacturer | FORD |
| Model | Focus Kombi 18-21 |

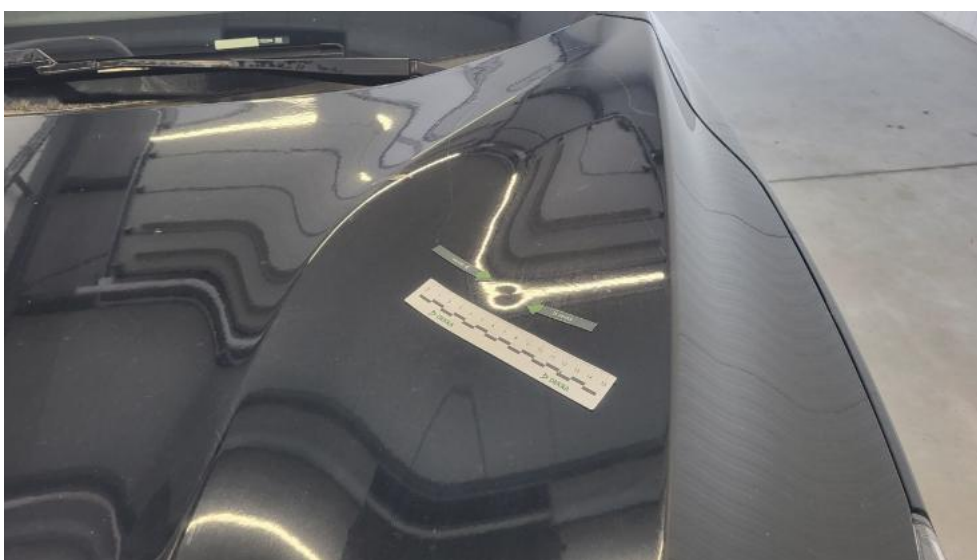
**Photo 42.**

Pokrywa komory silnika - Wgniecenie/odkształcenie 1

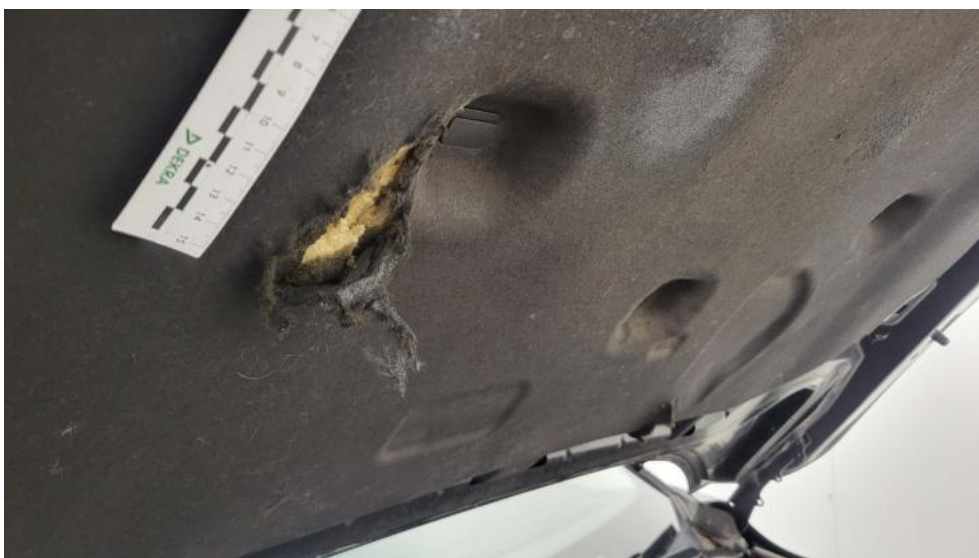
**Photo 44.**

Wykładzina pokrywy komory silnika - Pęknięcie/rozerwanie 1

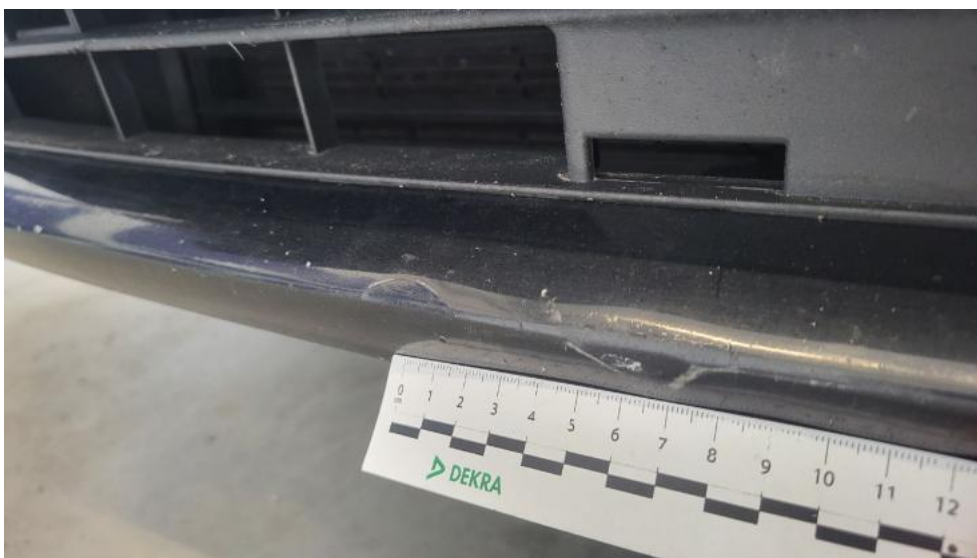
**Photo 48.**

Zderzak - Wgniecenie/odkształcenie 1

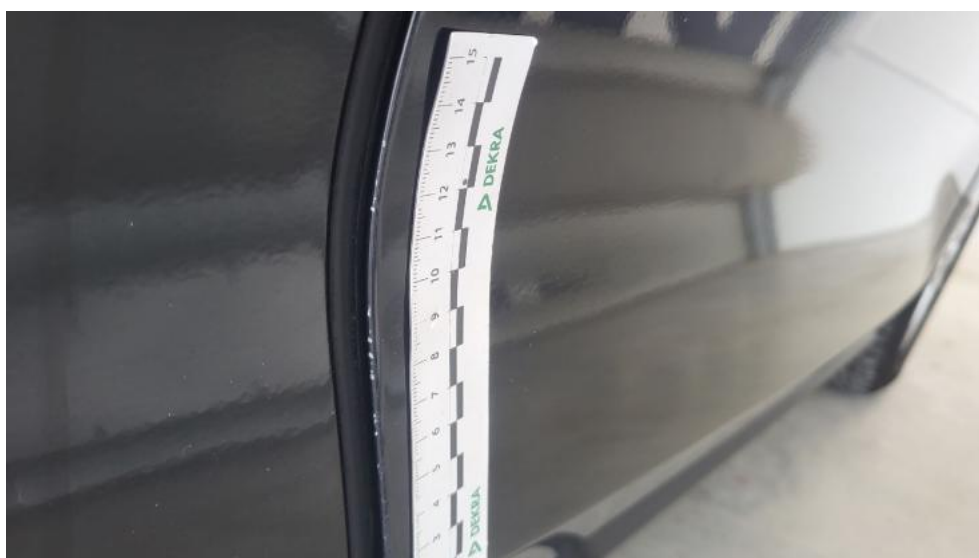
**Photo 52.**

Drzwi przednie P - Rysa/odprysk 1

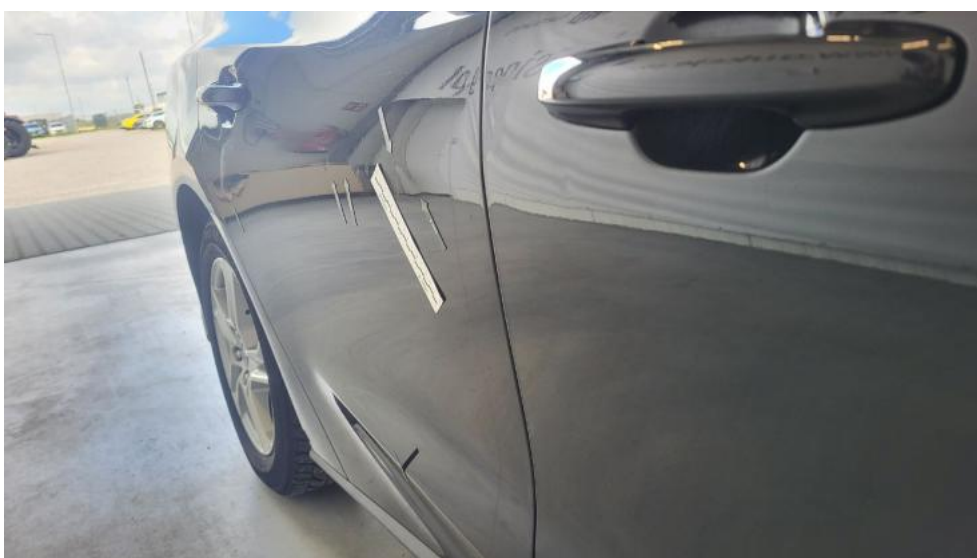
**Photo 56.**

Drzwi tylne P - Wgniecenie/odkształcenie 1

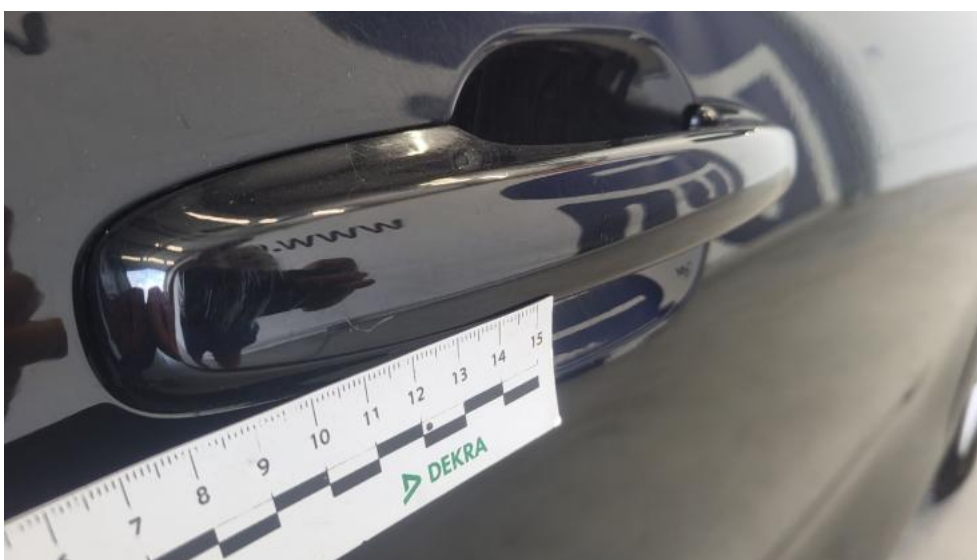
**Photo 58.**

Klamka drzwi prz P - Rysa/odprysk 1

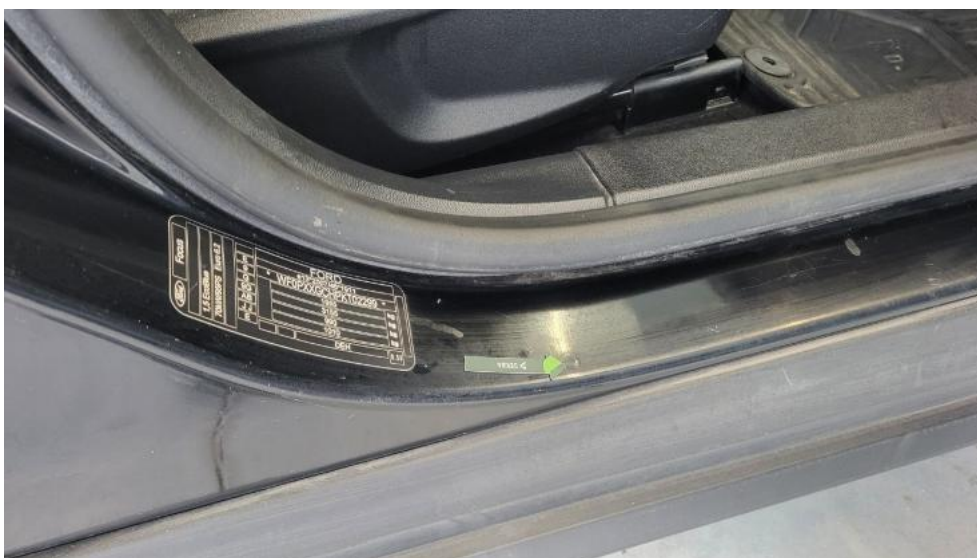
**Photo 60.**

Próg P - Wgniecenie/odkształcenie 1

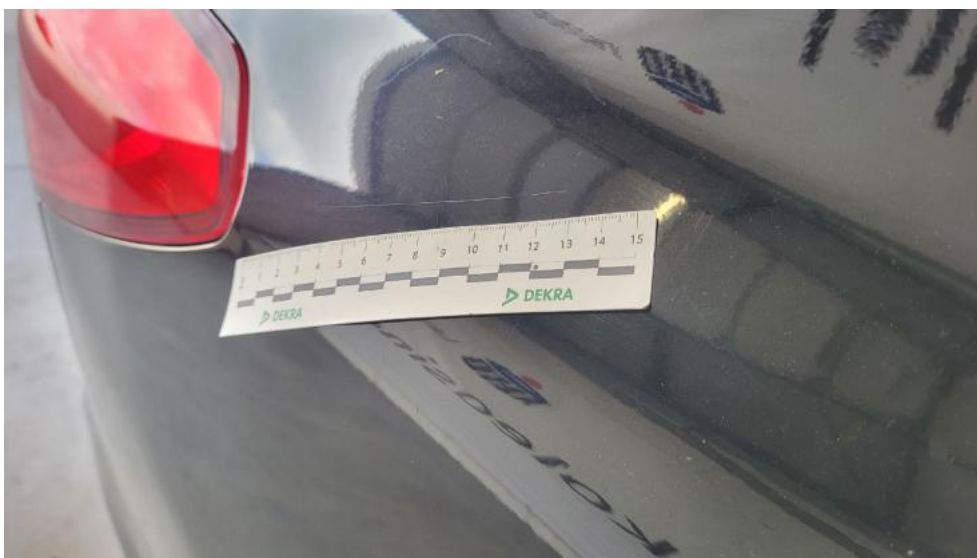
**Photo 62.**

Błotnik tylny P / Ściana boczna P - Rysa/odprysk 1

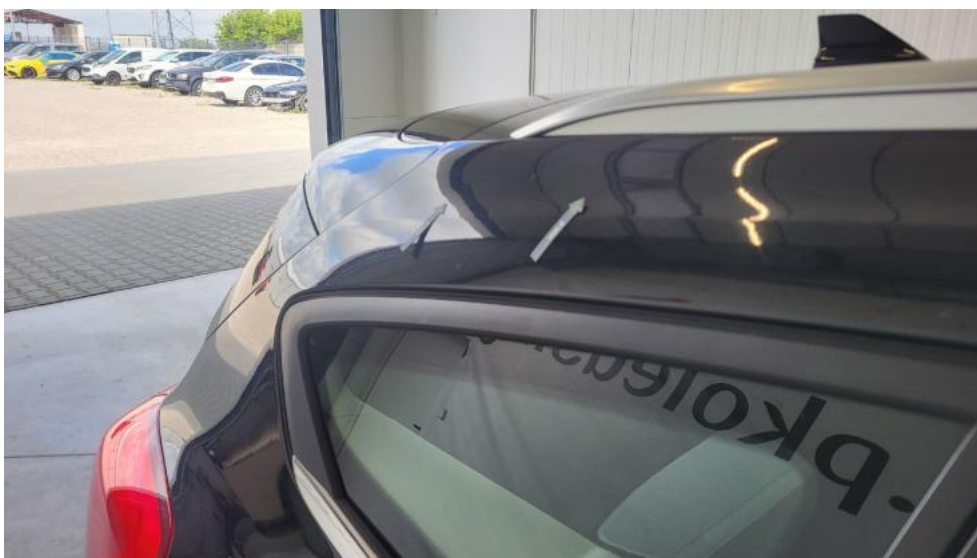
**Photo 64.**

Błotnik tylny P / Ściana boczna P - Wgniecenie/odkształcenie 2

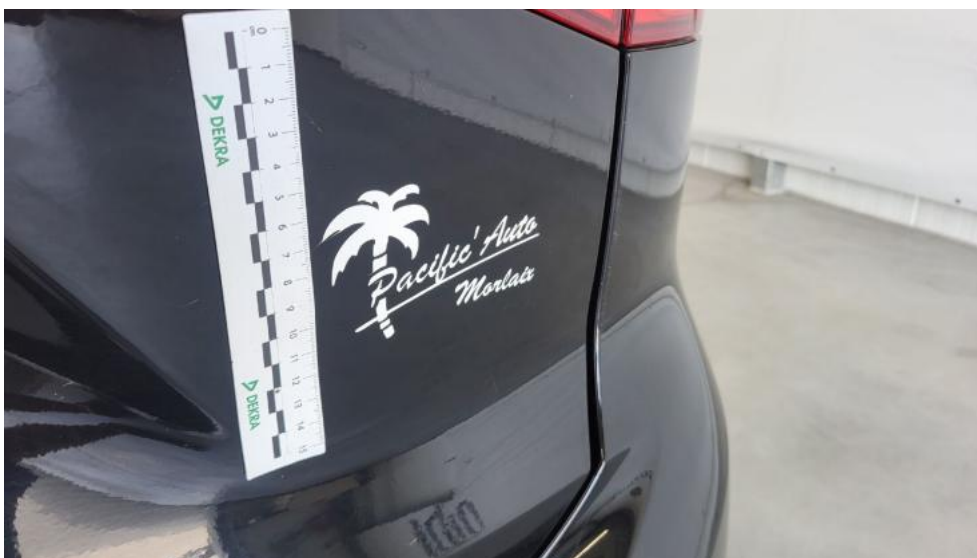
**Photo 68.**

Pokrywy bagażnika - Inne 1

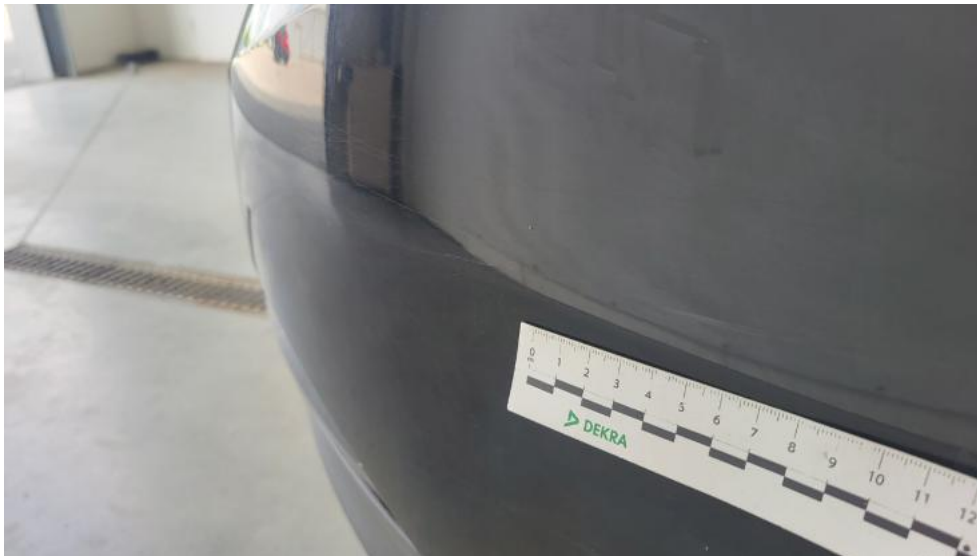
**Photo 71.**

Zderzak tylny - Rysa/odprysk 1

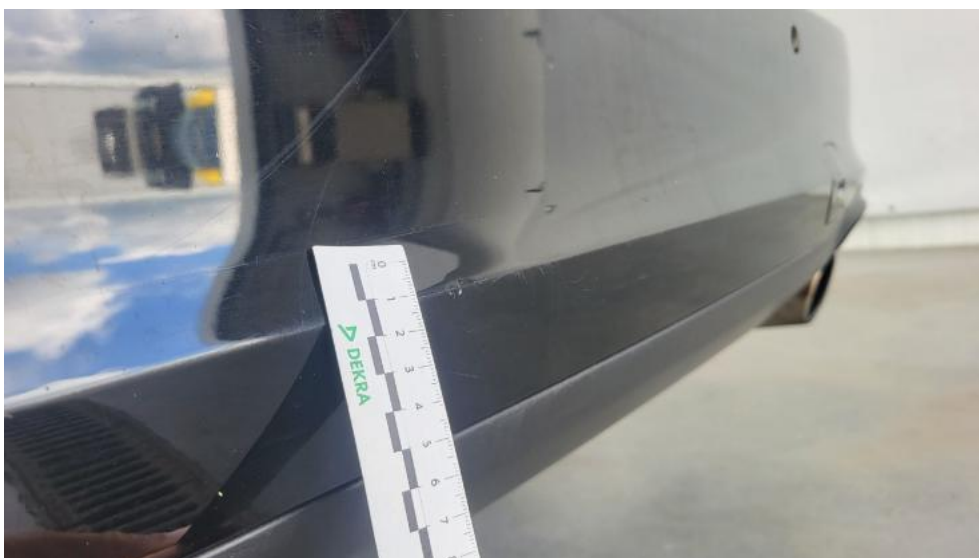
**Photo 74.**

Zderzak tylny - Wgniecenie/odkształcenie 1

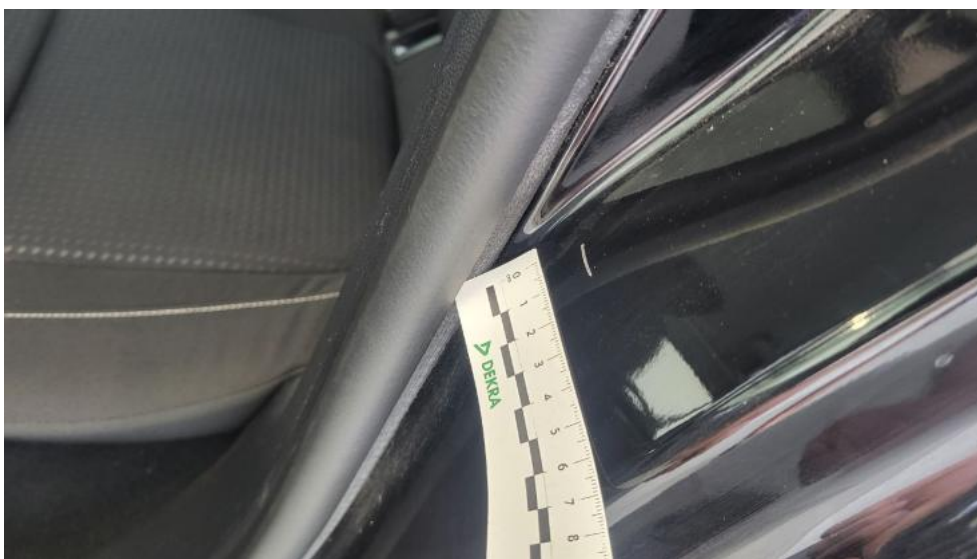
**Photo 77.**

Błotnik tylny L / Ściana boczna L - Rysa/odprysk 1

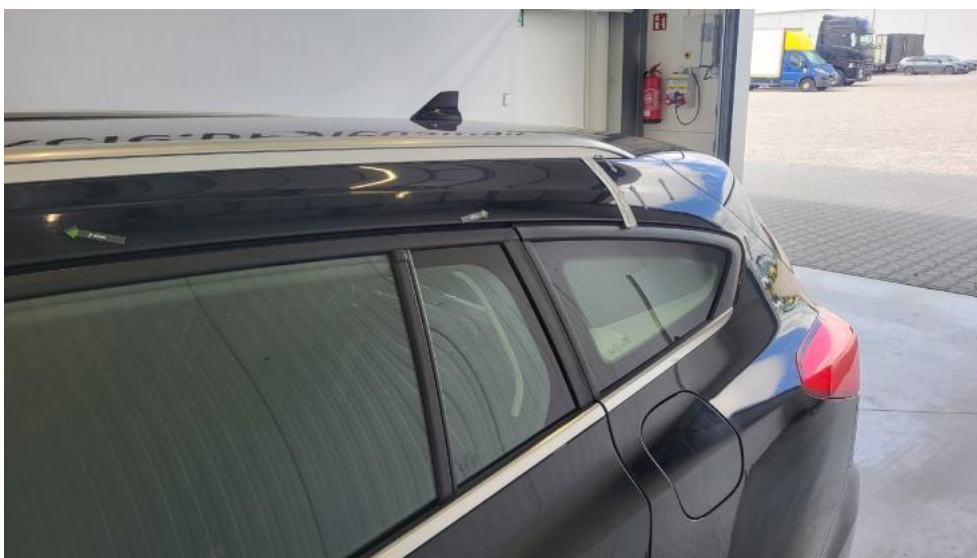
**Photo 78.**

Błotnik tylny L / Ściana boczna L - Wgniecenie/odkształcenie 1

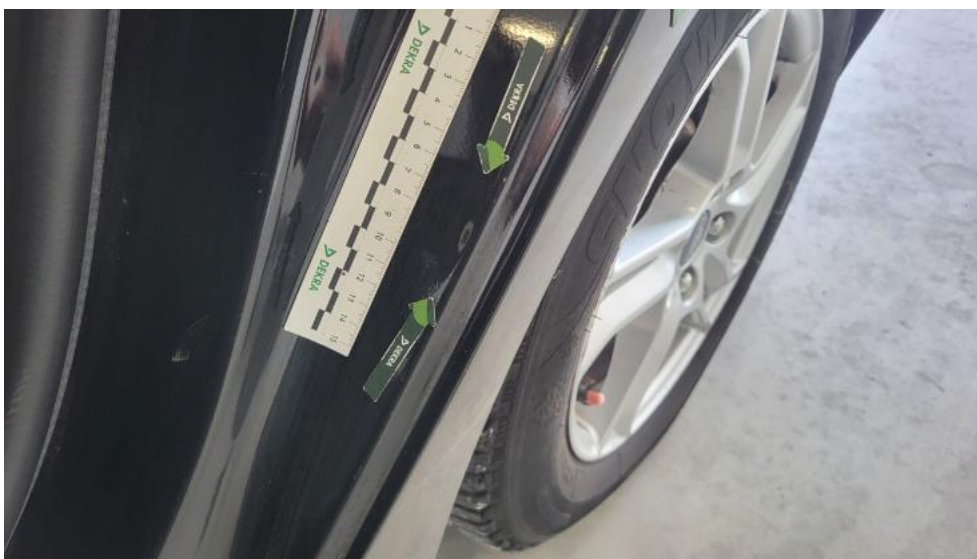
**Photo 79.**

Błotnik tylny L / Ściana boczna L - Wgniecenie/odkształcenie 2

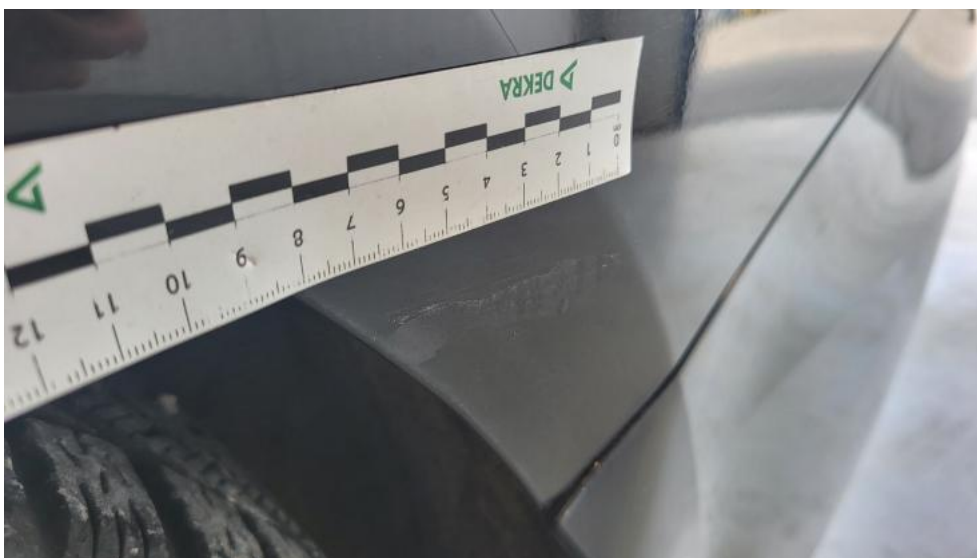
**Photo 80.**

Błotnik tylny L / Ściana boczna L - Inne 1

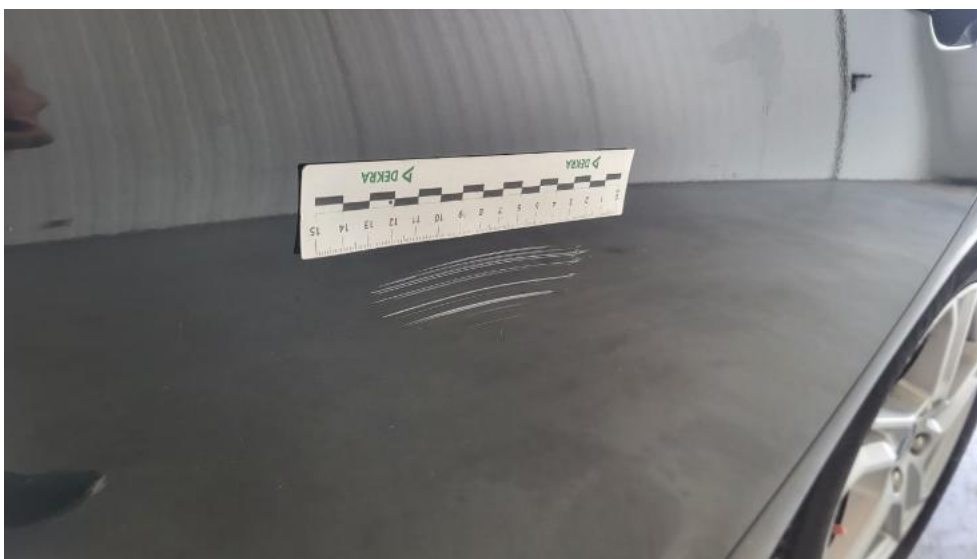
**Photo 85.**

Drzwi tylne L - Rysa/odprysk 2

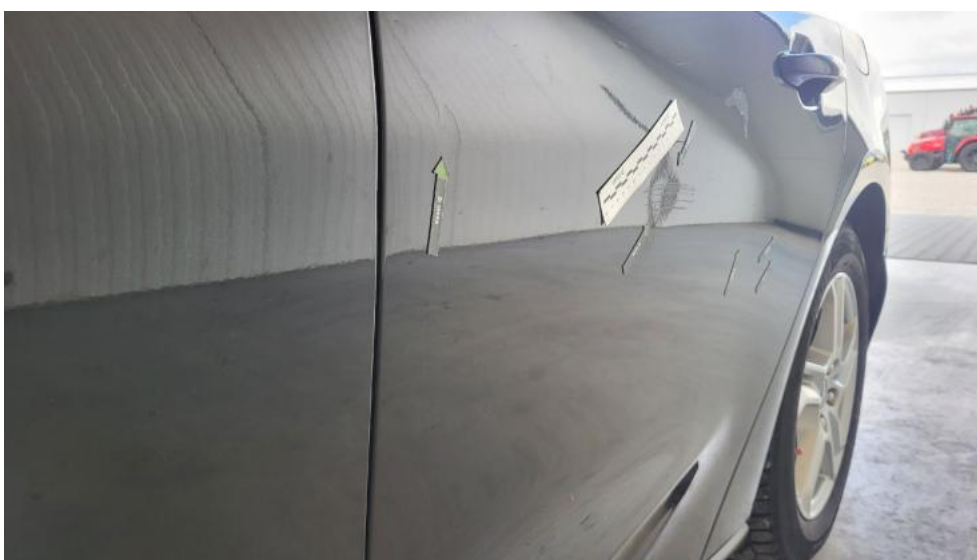
**Photo 86.**

Drzwi tylne L - Wgniecenie/odkształcenie 1

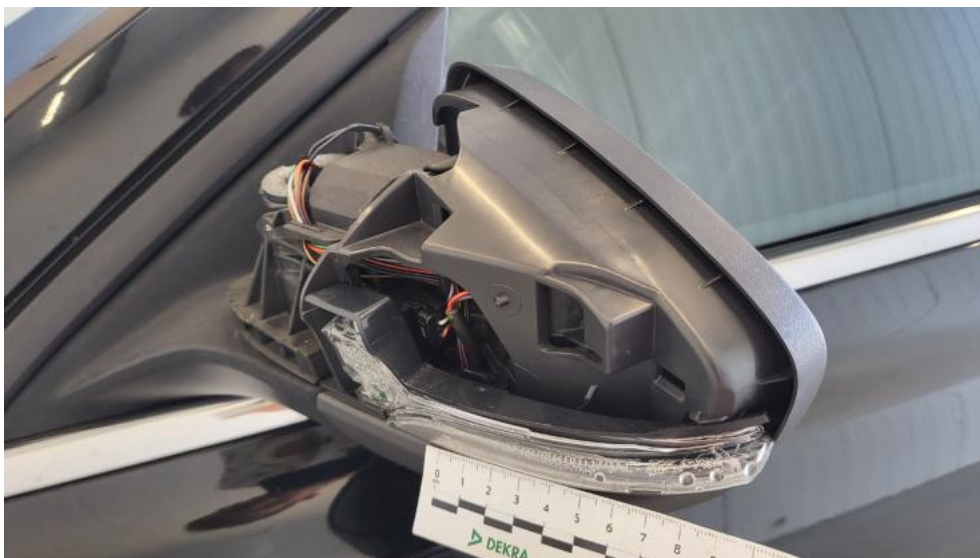
**Photo 88.**

Lusterko zew L - Inne 1

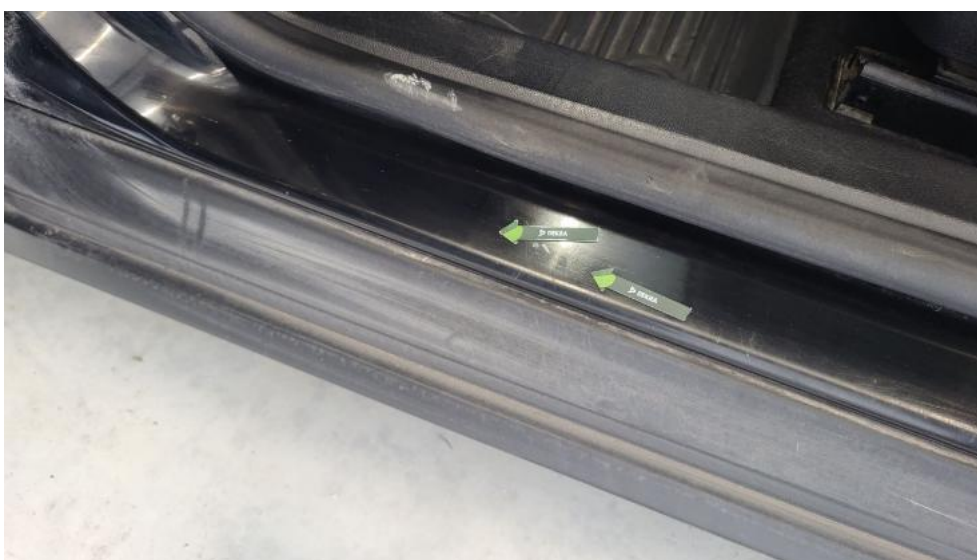
**Photo 90.**

Próg L - Wgniecenie/odkształcenie 1

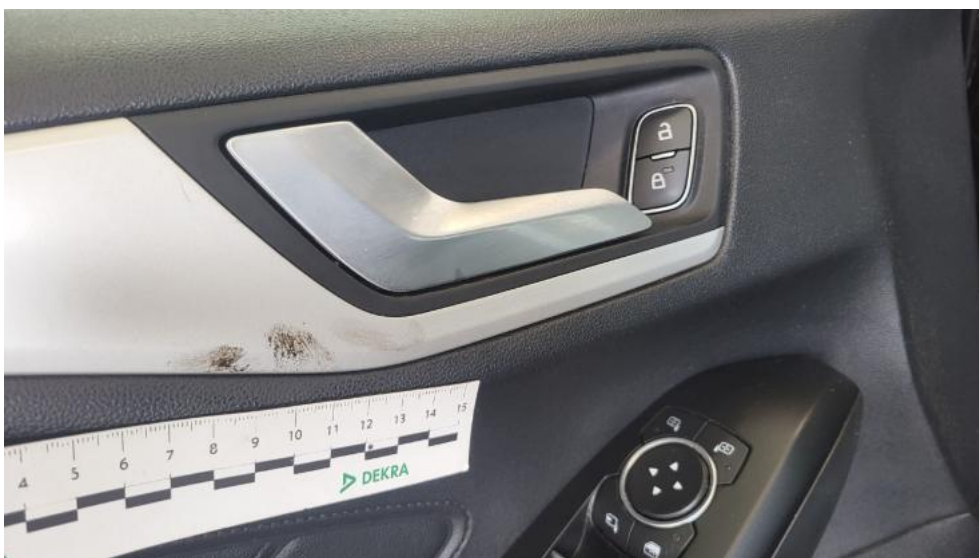
**Photo 100.**  
Tapicerka drzwi przednich L - Inne 1

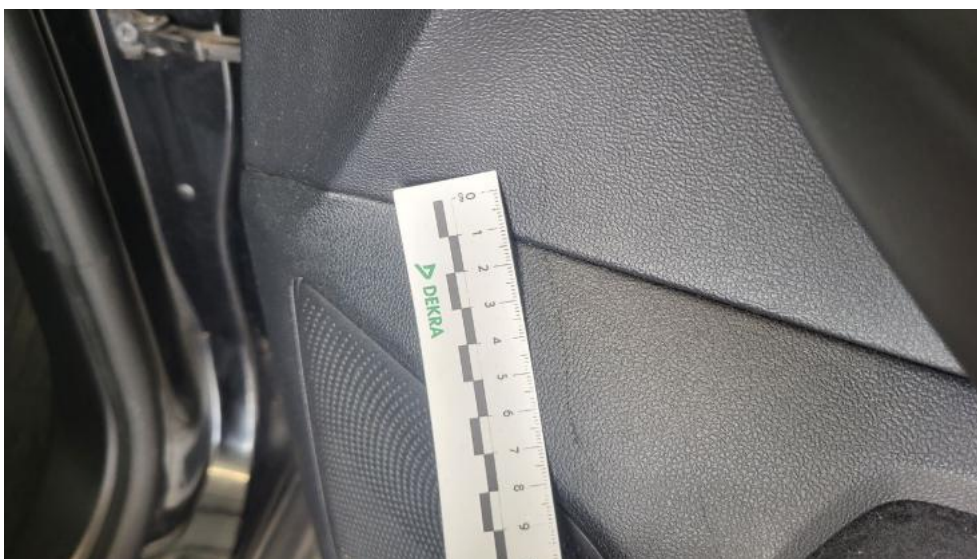
**Photo 101.**

Tapicerka drzwi przednich P - Rysa/odprysk 1

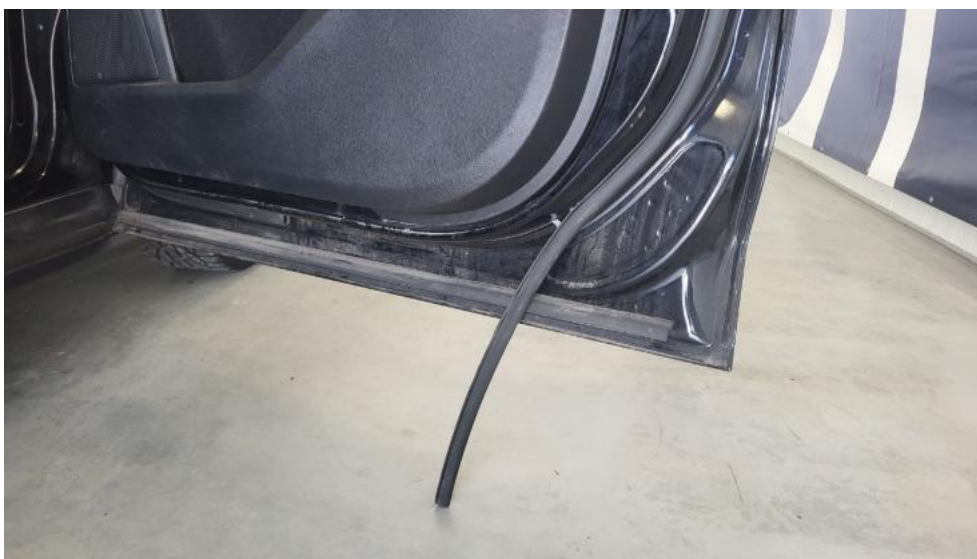
**Photo 103.**

Uszczelka drzwi przednich P - Inne 1
